Atmospheric corrosivity of the Bay of Plenty region

BRANZ Study Report SR458

Abstract

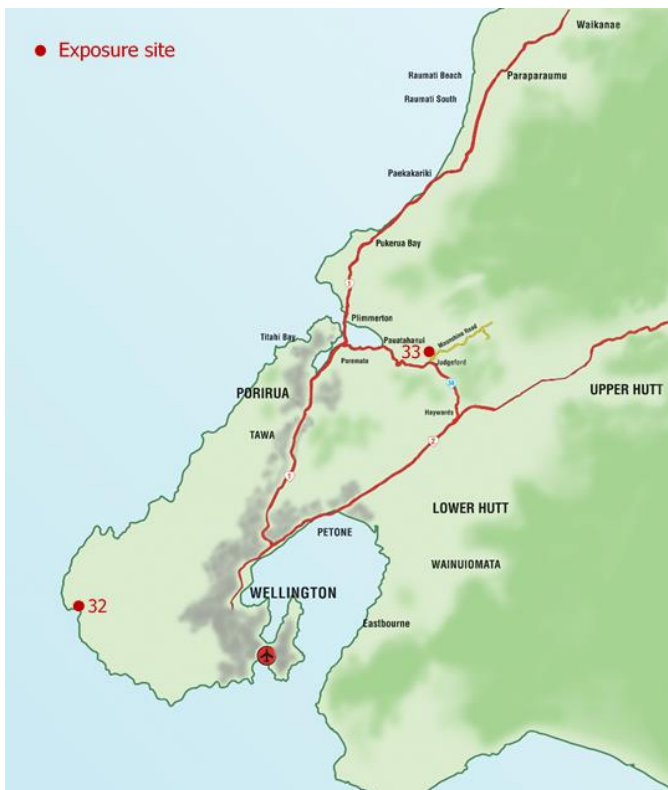
Figure 3. Reference exposure sites established in the greater Wellington region.

Two reference exposure sites have been established in the greater Wellington region (Figure 3). One is located within the BRANZ campus at Judgeford, Porirua, and the other at Oteranga Bay on the southwest coast of Wellington. The Judgeford site is in a sheltered semi-rural environment separated by approximately 3 km from the nearest saltwater, a tidal estuary, and further protected by gently rolling hills. It lies within zone C of the atmospheric corrosivity map in NZS 3604:2011. However, it is a fairly benign example of this classification as demonstrated by previous tests using mild steel and zinc (hot-dip galvanised steel and pure zinc). The Oteranga Bay site is approximately 60 m away from the sea, which passes through Cook Strait. It is a (very) severe marine environment with (very) strong westerly winds in some seasons. Its atmospheric corrosivity can be classified as ISO 9223:2012 C5 – Very high or C4 – High based on the first-year corrosion rates of mild steel and zinc.

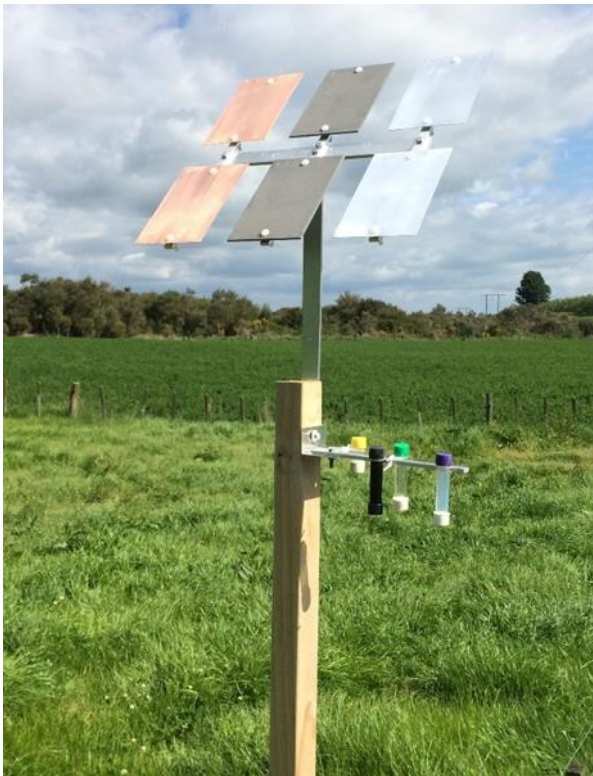
Figure 4. A typical exposure rack with a selection of passive tube sensors.

Exposure racks were fabricated with aluminium extrusions to support coupons and sensors (Figure 4).

Large separation distances were made between individual coupons to minimise potential cross-contamination and/or galvanic corrosion risk from corrosion products formed on mild steel, copper and zinc.

Nylon bolts, nuts and washers were used to fix the metallic coupons onto the racks to avoid potential galvanic corrosion risks between testing materials and aluminium extrusions. Washers of 12 mm thickness were also used to increase the gaps between the underside of the coupons and the aluminium supporting arms. This was to minimise water ponding and dirt accumulation in these sheltered areas and gaps.

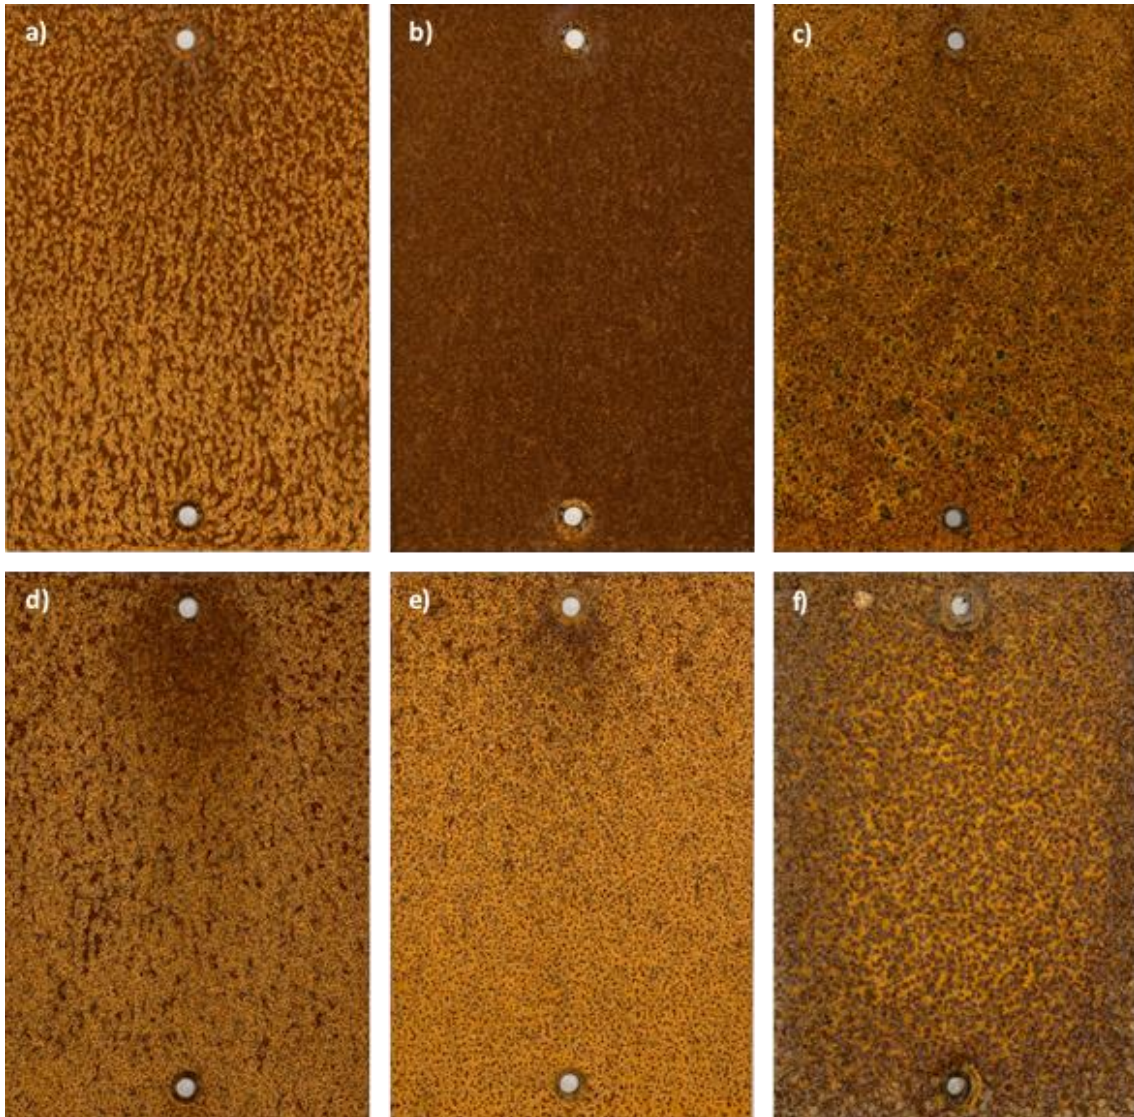
Figure 5. Mild steel coupons exposed for 1 year (July 2017 to July 2018) – a) Galatea – rural, b) Hewletts Road, Tauranga – industrial and marine, c) 3xx SH30, Tikitere – strong geothermal, d) Lakes Ranch, Rotorua – weak geothermal, e) Kawerau – geothermal and paper/pulp manufacturing, f) Waihou Bay – severe marine.

Corrosion products formed on the metallic coupons exposed at Galatea, a rural environment, are adherent, compact and uniform (Figures 5a, 6a and 7a). They also seem to be thin. This is understandable as this inland environment is relatively benign due to the absence of corrosive pollutants in the air. The concentration of ammonia, approximately 5.68 ppb, is also comparable to that in other areas.

When exposed to severe marine environments, such as Waihou Bay in eastern Bay of Plenty and Oteranga Bay in Wellington, mild steel suffered severe corrosion. At Waihou Bay, a thin corrosion product layer detached from the skyward surface completely, and a rough surface with corrosion products of a slightly different colour was revealed (Figure 5f). This spallation phenomenon was similar to that observed with the mild steel coupons exposed in areas with strong geothermal influences (Figure 5c). However, the composition and phase structure of these corrosion product layers was quite different, evidenced in part by the presence of black sublayers on the coupons exposed at Tikitere. Furthermore, this spallation behaviour was different from that observed within another marine environment. At Oteranga Bay, some corrosion products were lost from the mild steel coupon surface as flakes, while others remained on the surface after 1-year exposure, leading to a very rough surface (Figure 8a).

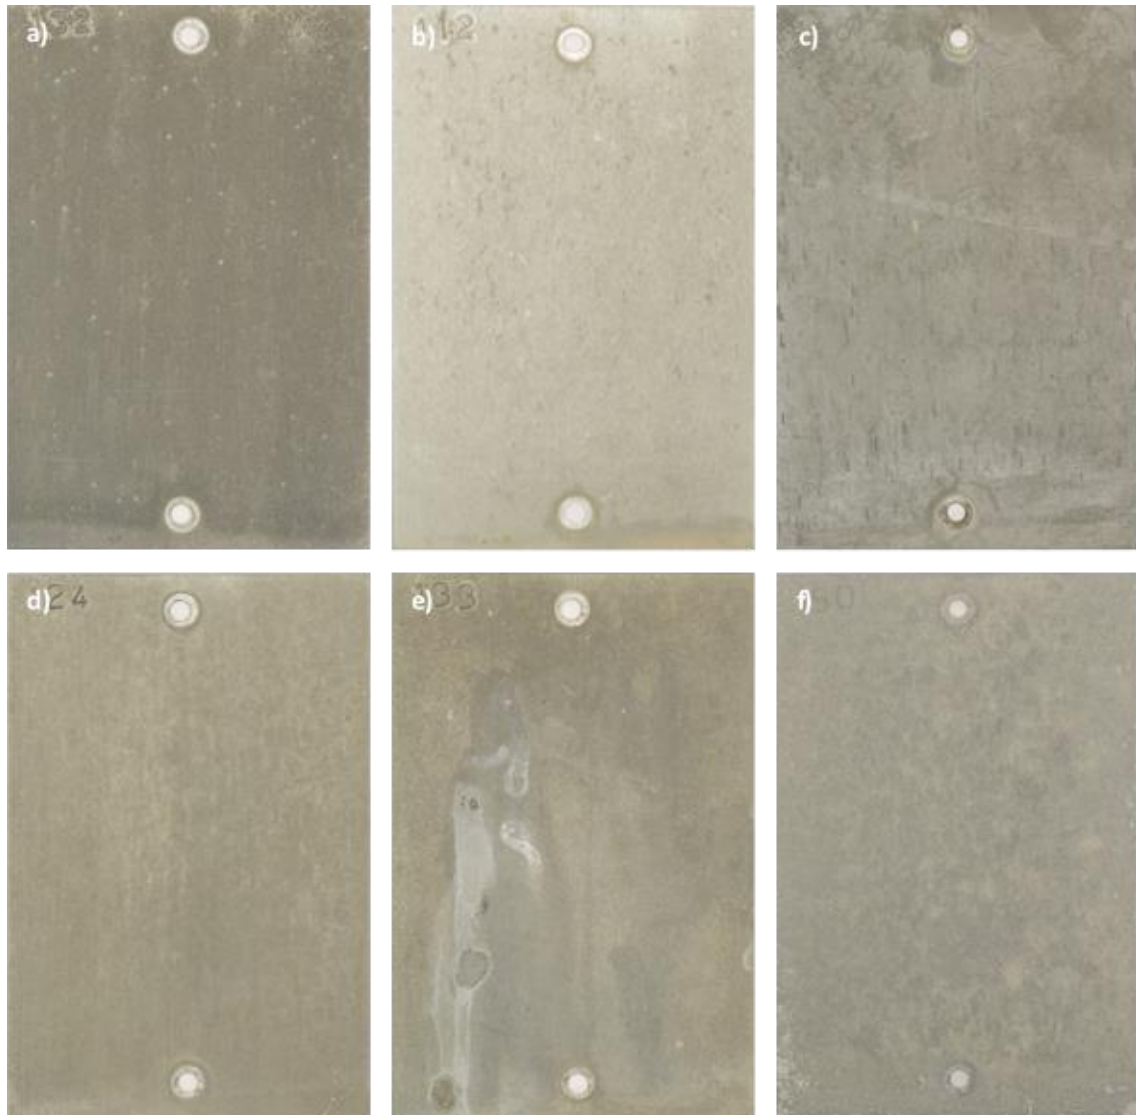
Figure 6. Zinc coupons exposed for 1 year (July 2017 to July 2018) – a) Galatea – rural, b) Hewletts Road, Tauranga – industrial and marine, c) 3xx, SH30, Tikitere – strong geothermal, d) Lakes Ranch, Rotorua – weak geothermal, e) Kawerau – geothermal and paper/pulp manufacturing, f) Waihou Bay – severe marine.

The surfaces of the metallic coupons exposed at Hewletts Road, Tauranga, an industrial area with marine influences, are relatively rough but still uniform (Figures 6b and 7b). They also collected and retained a reasonable amount of dust on their skyward surfaces. This was particularly evident on the zinc and copper coupons.

The surface morphologies of zinc coupons exposed at Waihou Bay and Oteranga Bay were similar, showing the formation of grey-white corrosion products (Figures 6f and 8b). However, it was evident that sand might interact with the growing corrosion products, leading to the formation of yellow patches on the skyward surfaces. Blue corrosion products covered the copper coupon exposed at Oteranga Bay (Figure 8c). Meanwhile, this blue layer was only observed in the edge areas of the copper coupon exposed at Waihou Bay (Figure 7f). Most of the surface was still brown – a colour typical in environments with no significant airborne chloride-containing or sulphur-containing pollutants.

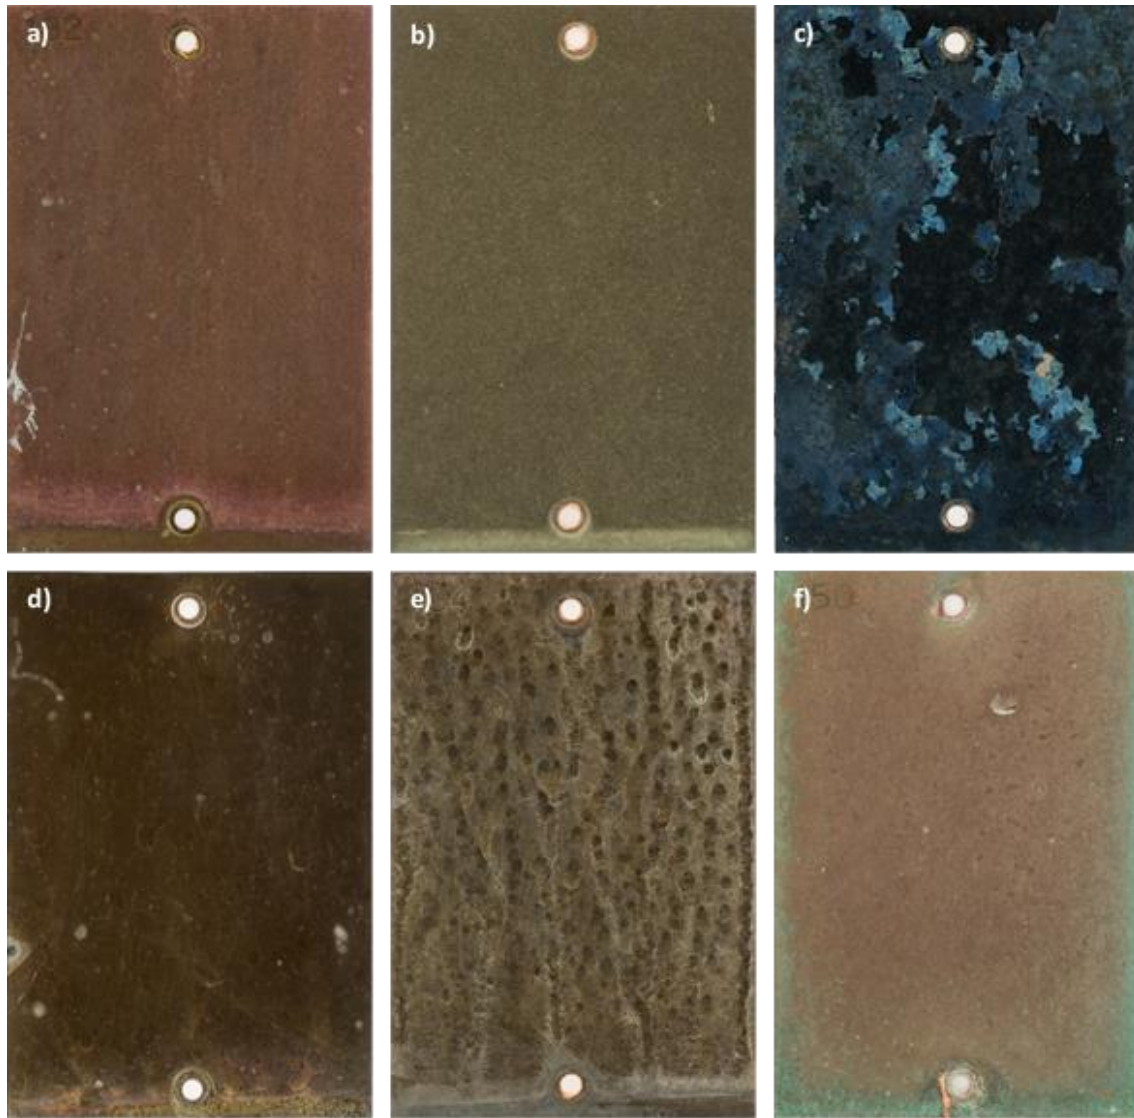
Figure 7. Copper coupons exposed for 1 year (July 2017 to July 2018) – a) Galatea – rural, b) Hewletts Road, Tauranga – industrial and marine, c) 3xx SH30, Tikitere – strong geothermal, d) Lakes Ranch, Rotorua – weak geothermal, e) Kawerau – geothermal and paper/pulp manufacturing, f) Waihou Bay – severe marine.

When exposed in an area with strong geothermal influence such as Tikitere (highest concentrations of H_2S and SO_2 among all exposure sites), severe corrosion took place on all metallic coupons. The mild steel coupons had very rough surfaces with very thick corrosion product layers formed on both skyward and groundward surfaces (Figure 5c). Frequently, a whole layer spalled off from their groundward surface and another layer with black corrosion products was revealed. A large number of physical defects, such as pores and cracks, were also observed. White powdery corrosion products were observed on zinc (Figure 6c). More powdery materials could be seen on the groundward surface. These could be easily removed to reveal another compact, dense and adherent layer. The dark blue corrosion products formed on copper were not adherent – some of them spalled off in small flakes (Figure 7c).

An example can be seen with the mild steel and zinc coupons exposed at Onepu Spring Road, Kawerau. The coupons exposed during the period November 2016 to November 2017 had a less-uniform corrosion product layer when compared with those exposed during the period July 2017 to July 2018. This morphological difference is quite obvious in Figures 5e and 6e and Figures 9a and 9b. Meanwhile, a large quantity of light-yellow powdery corrosion products was not observed on the copper coupon exposed during the November 2016 to November 2017 period (Figure 9c versus Figure 7e).

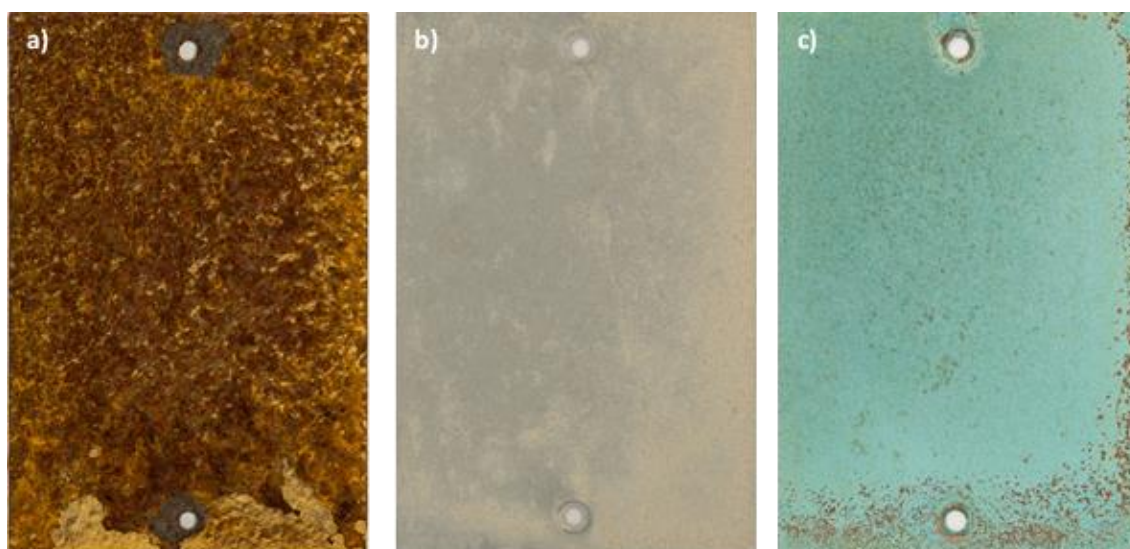
Figure 8. Coupons exposed for 1 year (July 2017 to July 2018) at Oteranga Bay, Wellington (severe marine) – a) mild steel, b) zinc, c) copper.

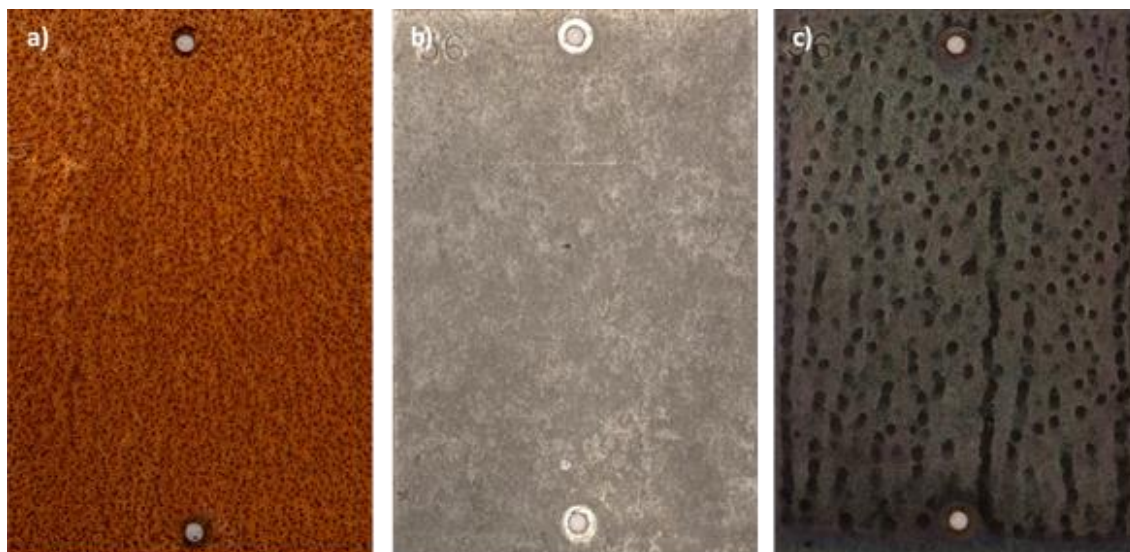
Figure 9. Coupons exposed for 1 year (November 2016 to November 2017) at Onepu Spring Road, Kawerau (geothermal and paper/pulp manufacturing) – a) mild steel, b) zinc, c) copper.
