SR452 [2021]

# Indoor climate and mould in New Zealand homes

## BRANZ Study Report SR452

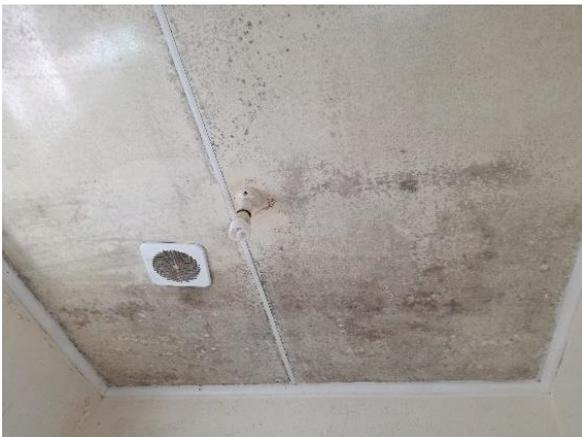
- “an indoor pool” in the attached garage due to a major leak
- obvious signs of damp and moisture accumulation around the exterior of the property (which backs on to a hill)
- a leak in the roof, which resulted in part of the ceiling falling in and insulation sagging
- draughts around windows and exterior doors
- difficulty maintaining a warm home, despite heating (often for many hours a day) with a wood burner and an electric heater
- being unable to sleep in one bedroom in winter due to extreme cold
- smell of damp in two bedrooms and visible mould on window frames
- a bathroom “covered in mould” despite attempts to clean it.

**Figure 20. Mould on bathroom ceiling in house WN3.1.**

This property had no mechanical extract in the kitchen (which was open plan with the living space). Occupants would not open windows around the house in winter (even when cooking) due to it being “too cold”. The only rooms with windows open over winter were the bathroom and laundry. The house did have a whole-house ventilation system, and the occupant reported using this and noticing some difference (improvement) in condensation levels when it was on (for example, when cooking). However, they seemed unsure of how to use it to best effect.
