Recast Floors project

SESOC Journal Vol 35 No1 April 2022

SPECIAL EDITION SESOC RECAST ISSUE

RECAST FLOORS PROJECT: OVERVIEW AND KEY RECOMMENDATIONS

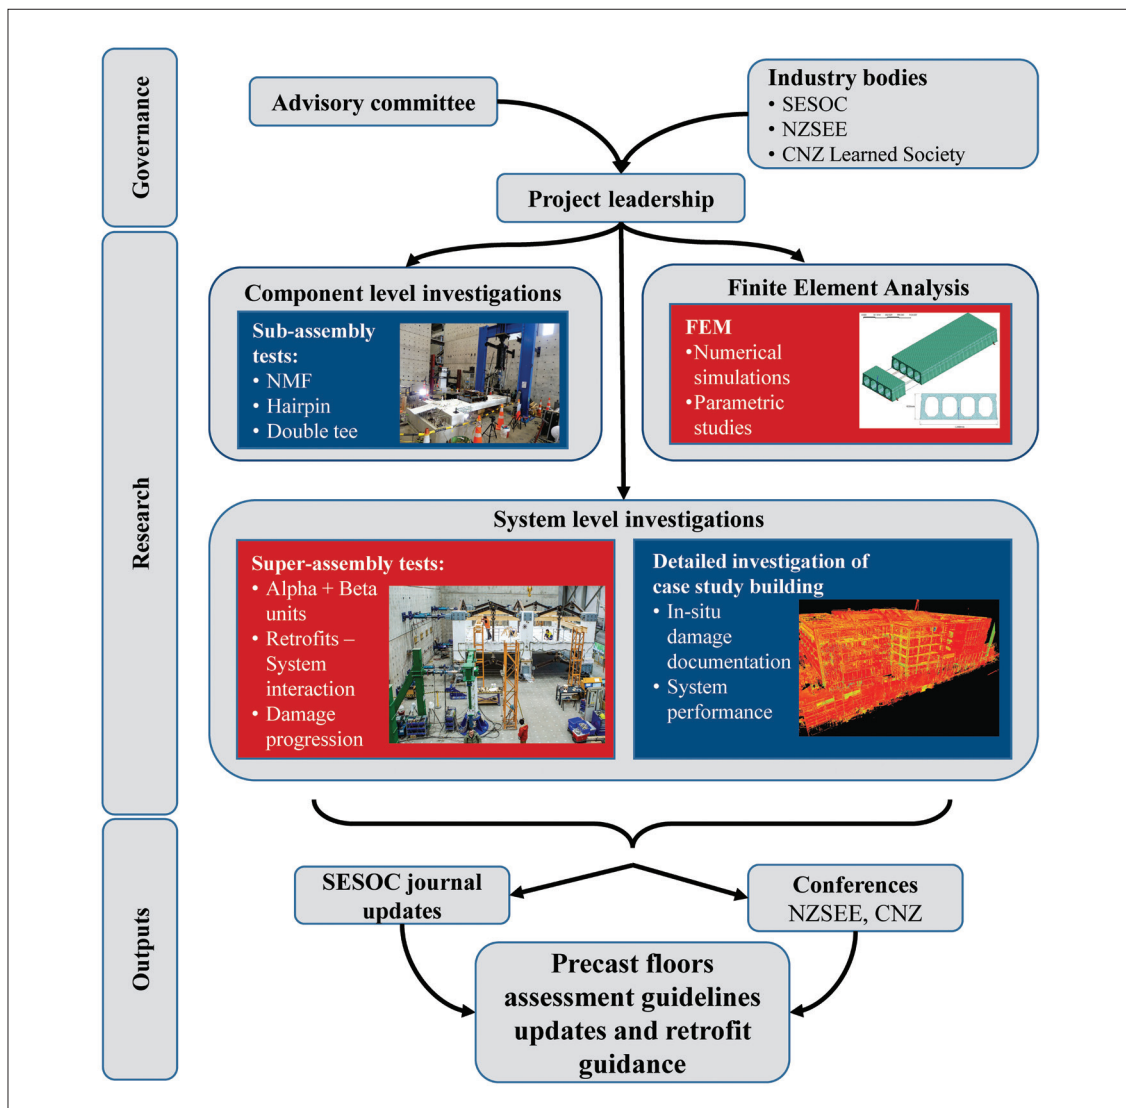
Figure 1: Overview of research projects, oversight arrangements, and outputs

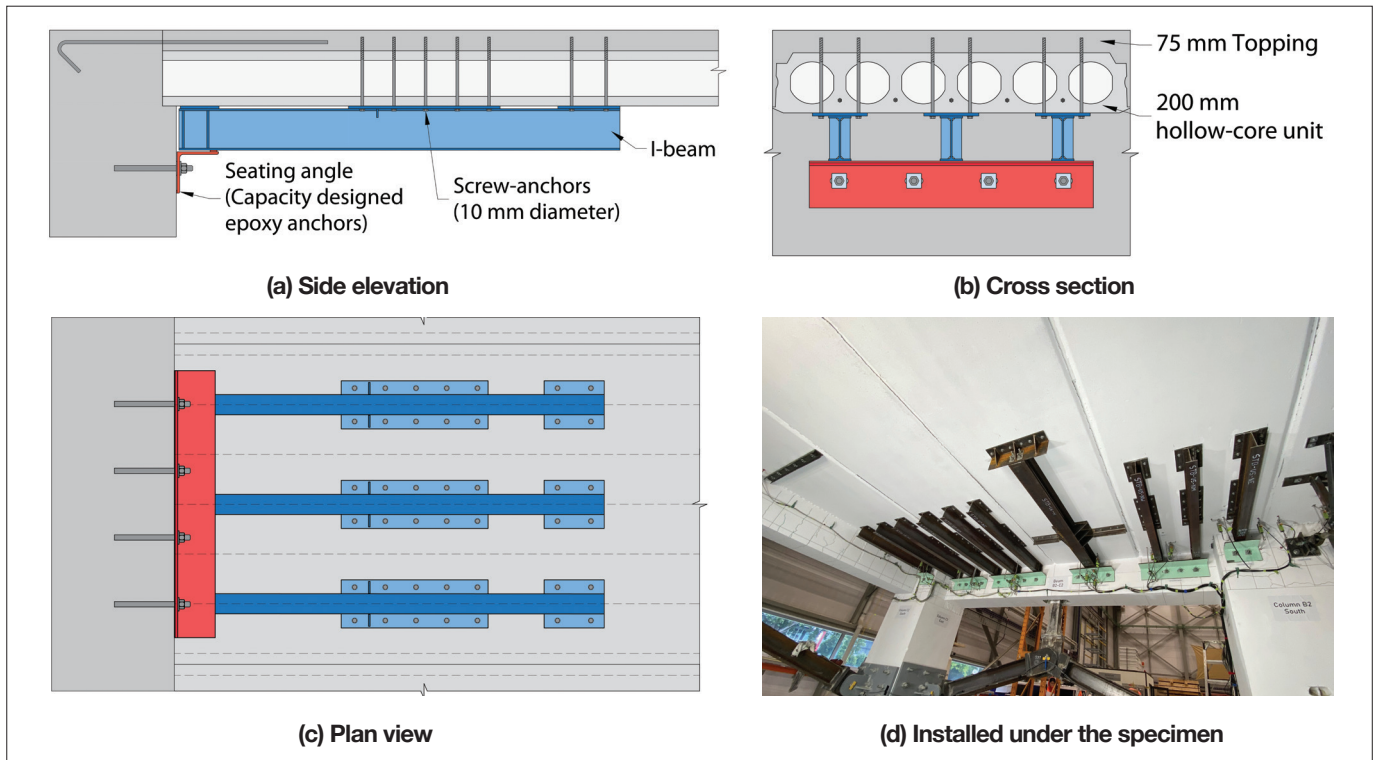
Figure 3: Strongback retrofit as used in the super-assembly test

The conceptual idea of the strongback retrofit is to provide an alternative load path if the floor loses its gravity load capacity. During the formation of an NMF in the floor unit, for instance, the shear capacity of the end of the hollow-core unit diminishes in a sudden, brittle fashion. The strongback retrofit prevents floor collapse by transferring the loads from the intact part of the floor beyond the failed section to the supporting beam via the seating angle.

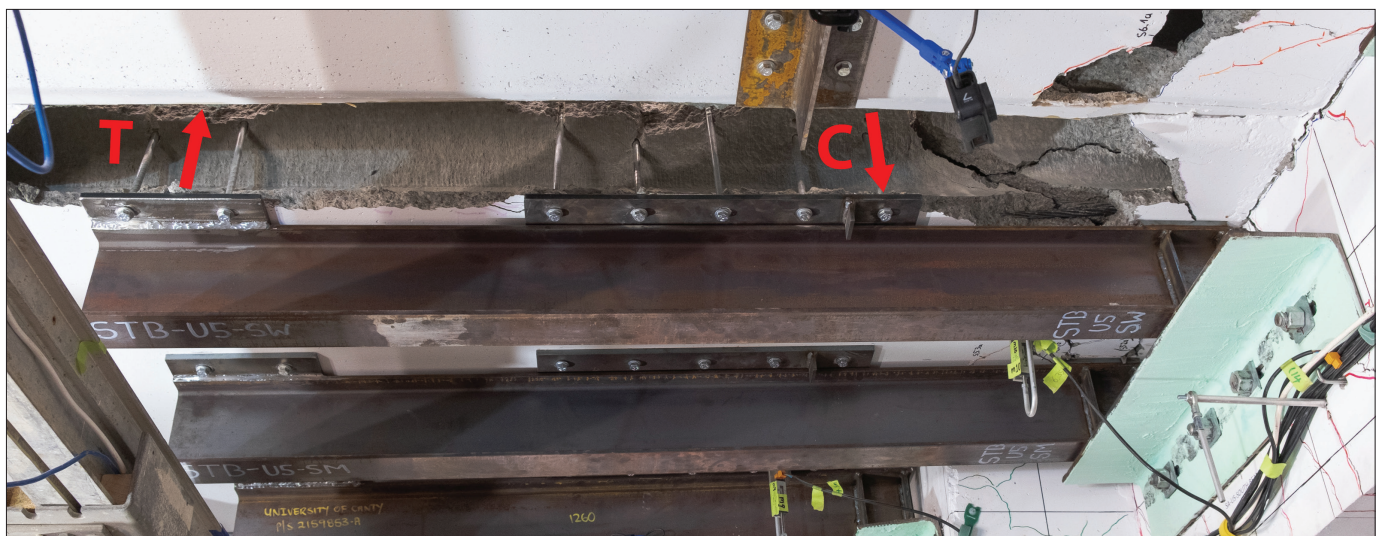
Figure 11: Strongback retrofit carrying the load of the floor after a negative moment failure has occurred. (Photo taken at 5% inter-storey drift)

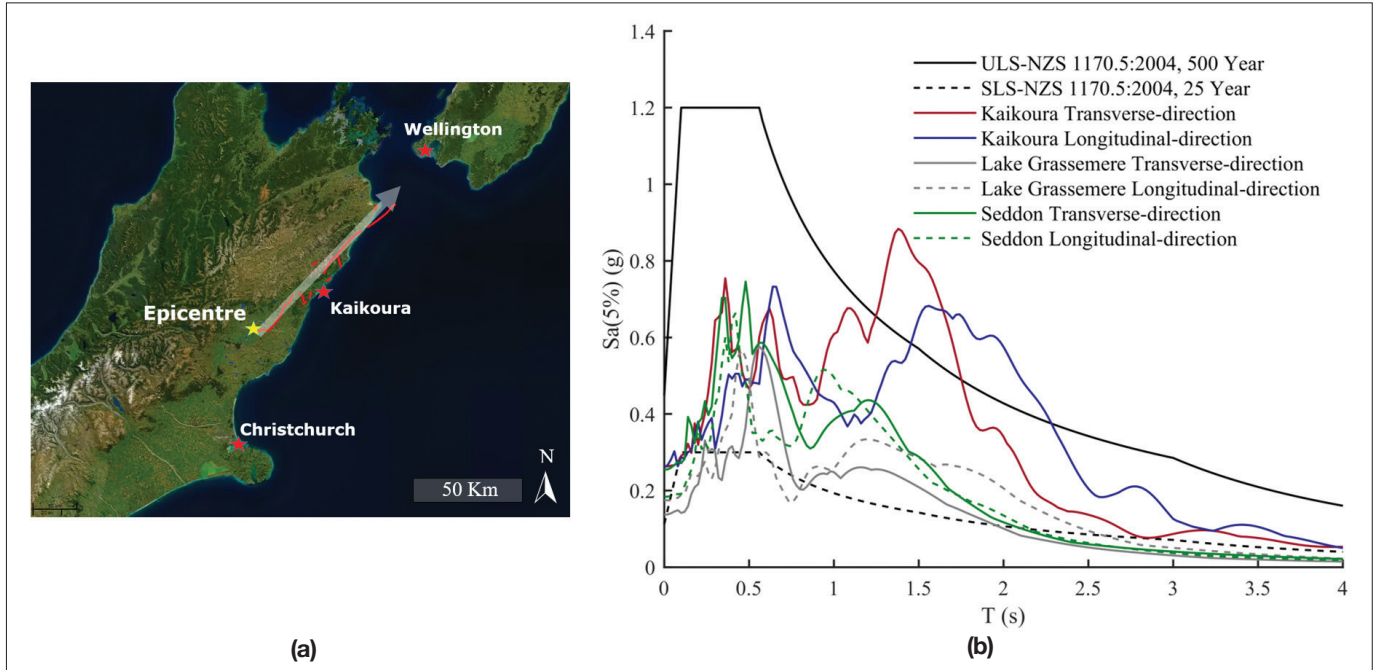
Figure 3: (a) approximate location of Kaikōura earthquake epicentre and faults ruptures according to Hamling et al., (2017) (b) 5% damped spectral accelerations of the free-field ground motions rotated to coincide with the longitudinal and transverse axes of the building and the ULS and SLS design response spectra according to NZS1170.5:2004.

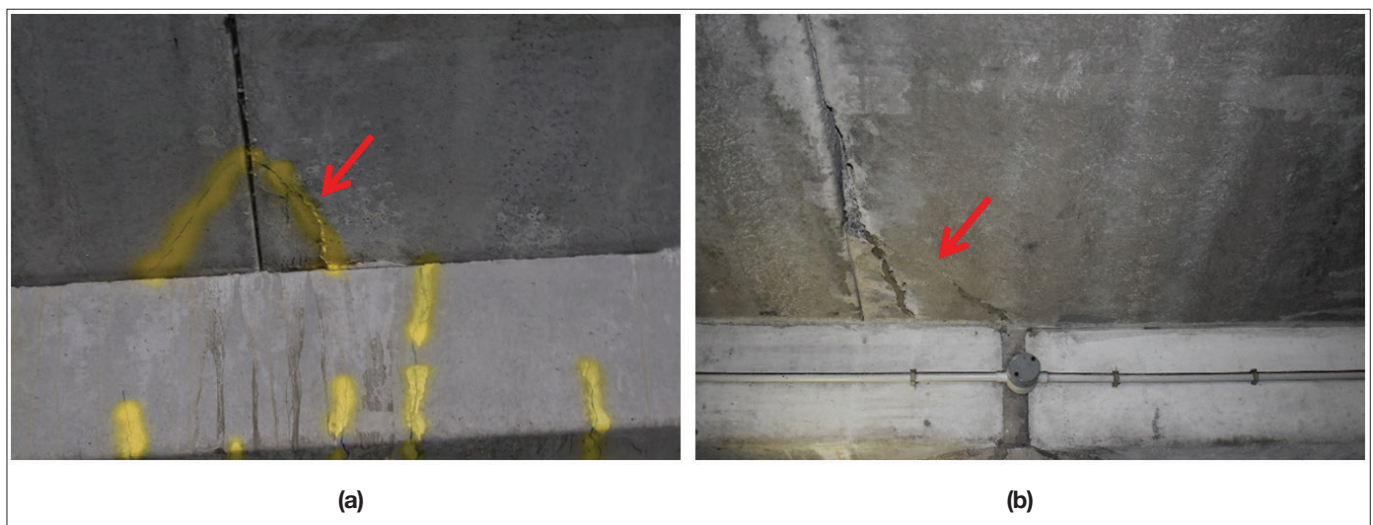
Figure 11: (a) corner crack with grout seeping out observed in the building investigated (b) corner crack observed in a carpark in Auckland

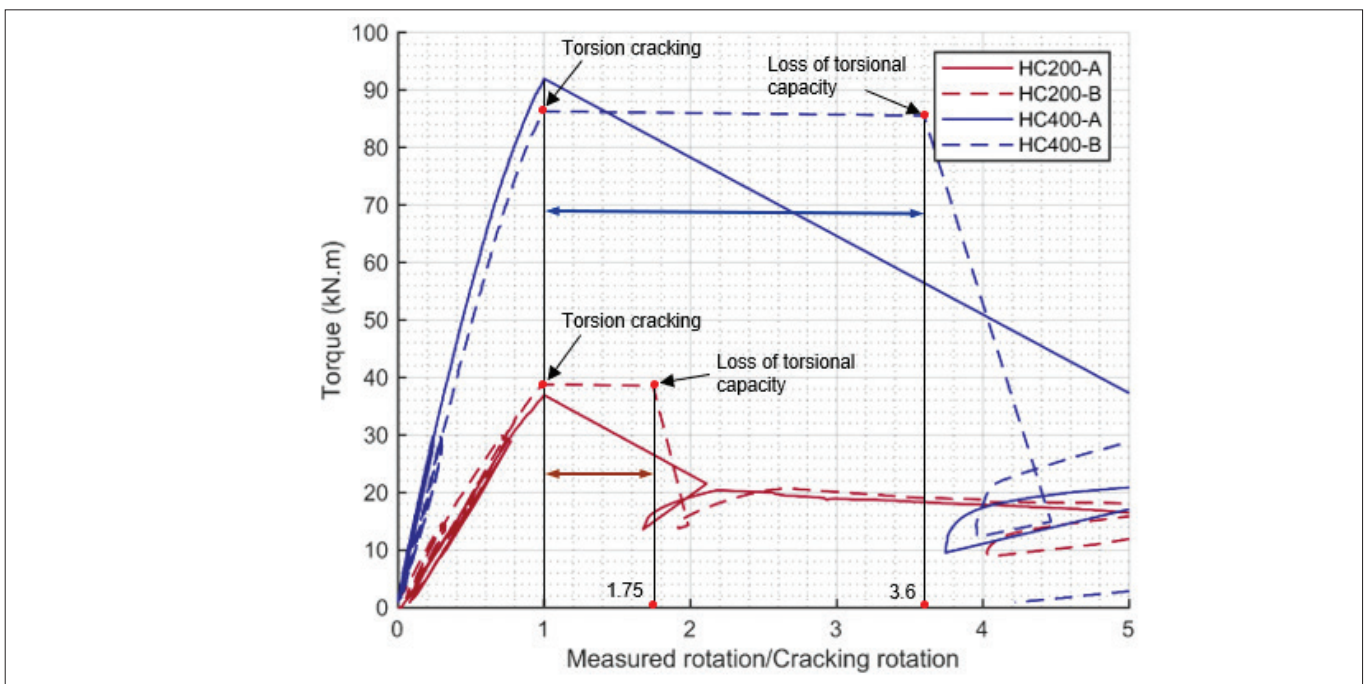
Figure 4: Pure torsion tests results modified from Pajari (2004a) showing two HC200 tests and two HC400 tests results

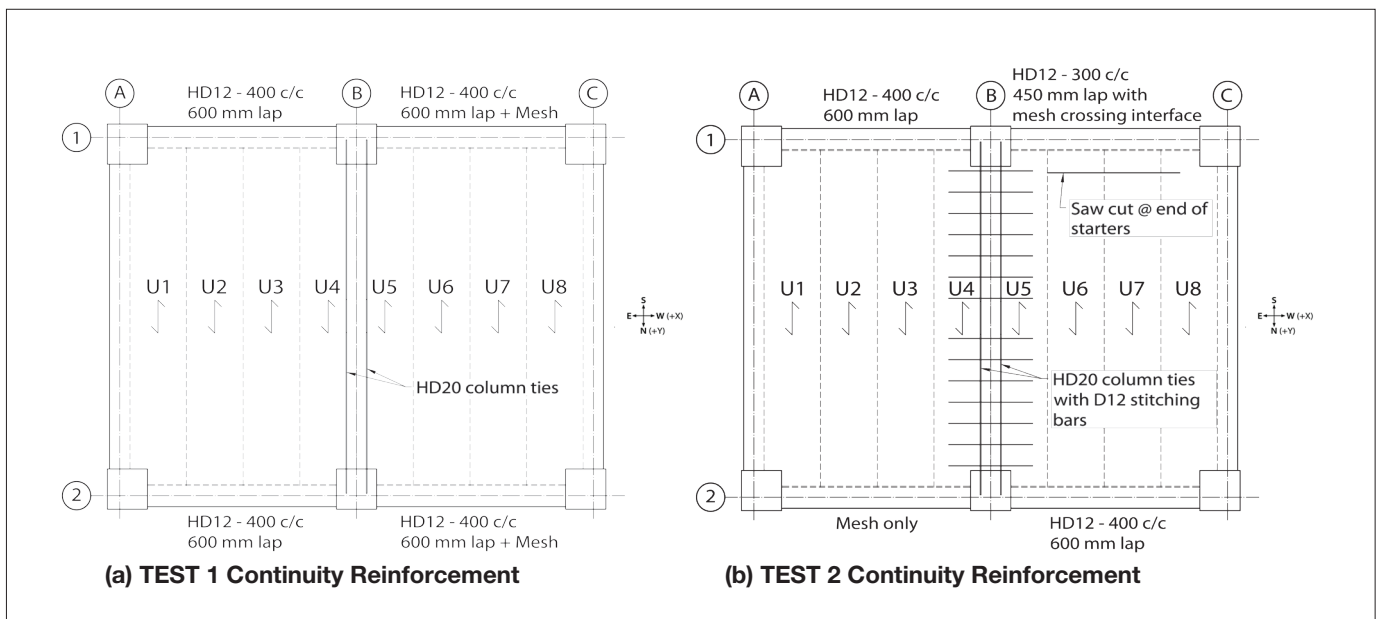
Figure 7: Floor continuity reinforcement arrangements for TEST 1 and TEST 2 (Büker et al. 2022)

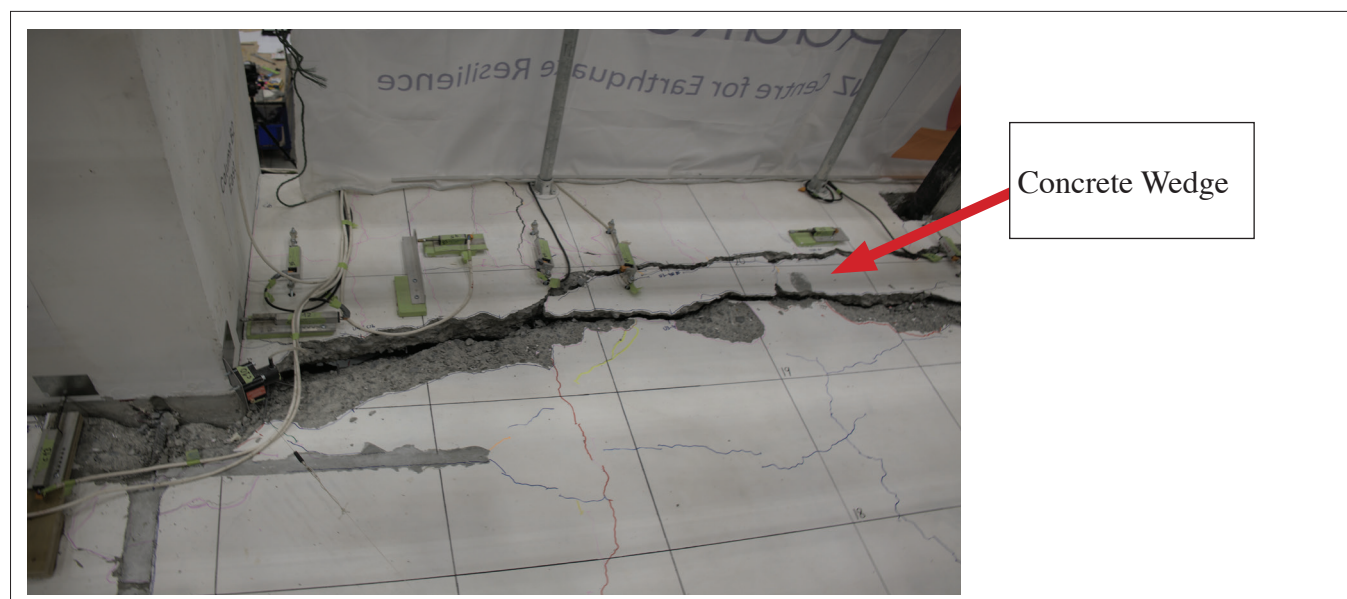
Figure 21: Beam-unit crack interface concrete wedge on east side of column B2 at 4.0% drift

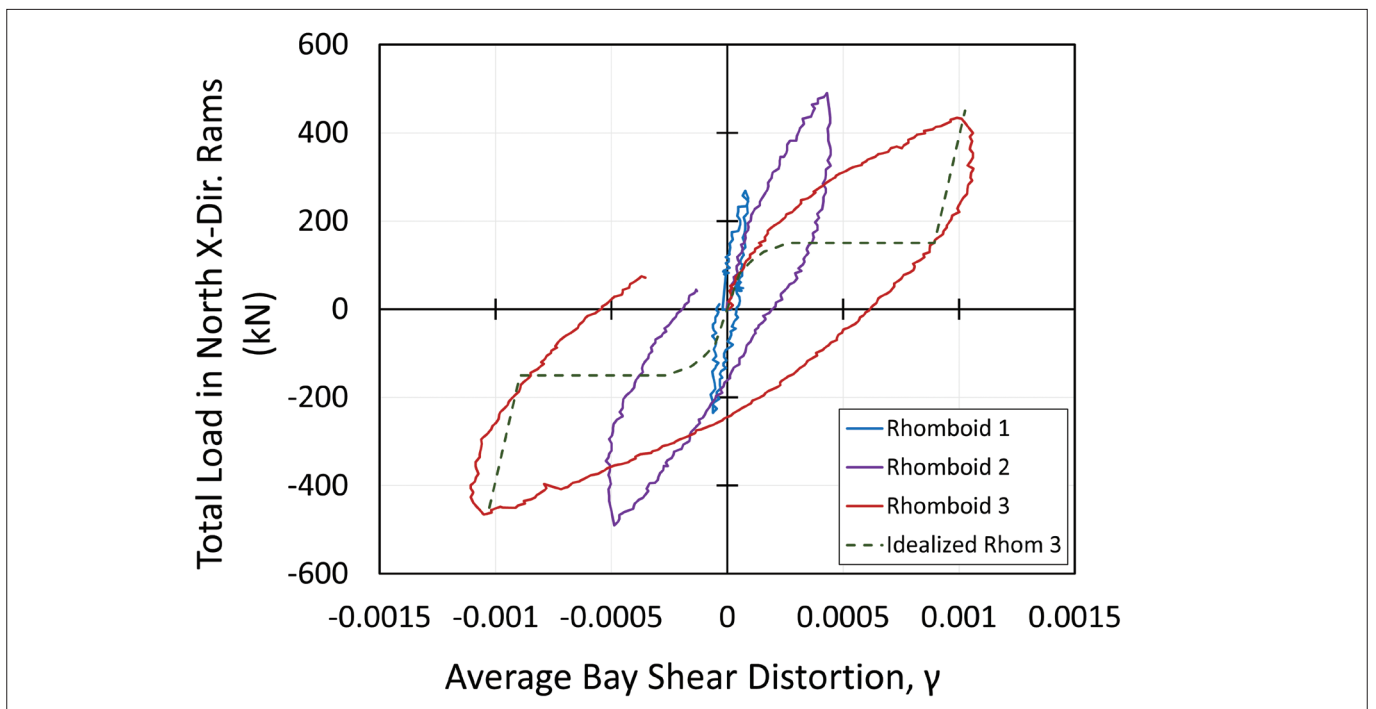
Figure 8: Observed plan shear stiffness behaviour for rhomboid loading protocols undertaken in TEST 1
