# Quantifying timber waste generated from construction and demolition sector in New Zealand

Project LR14435

Tonkin & Taylor Ltd, funded by the Building Research Levy

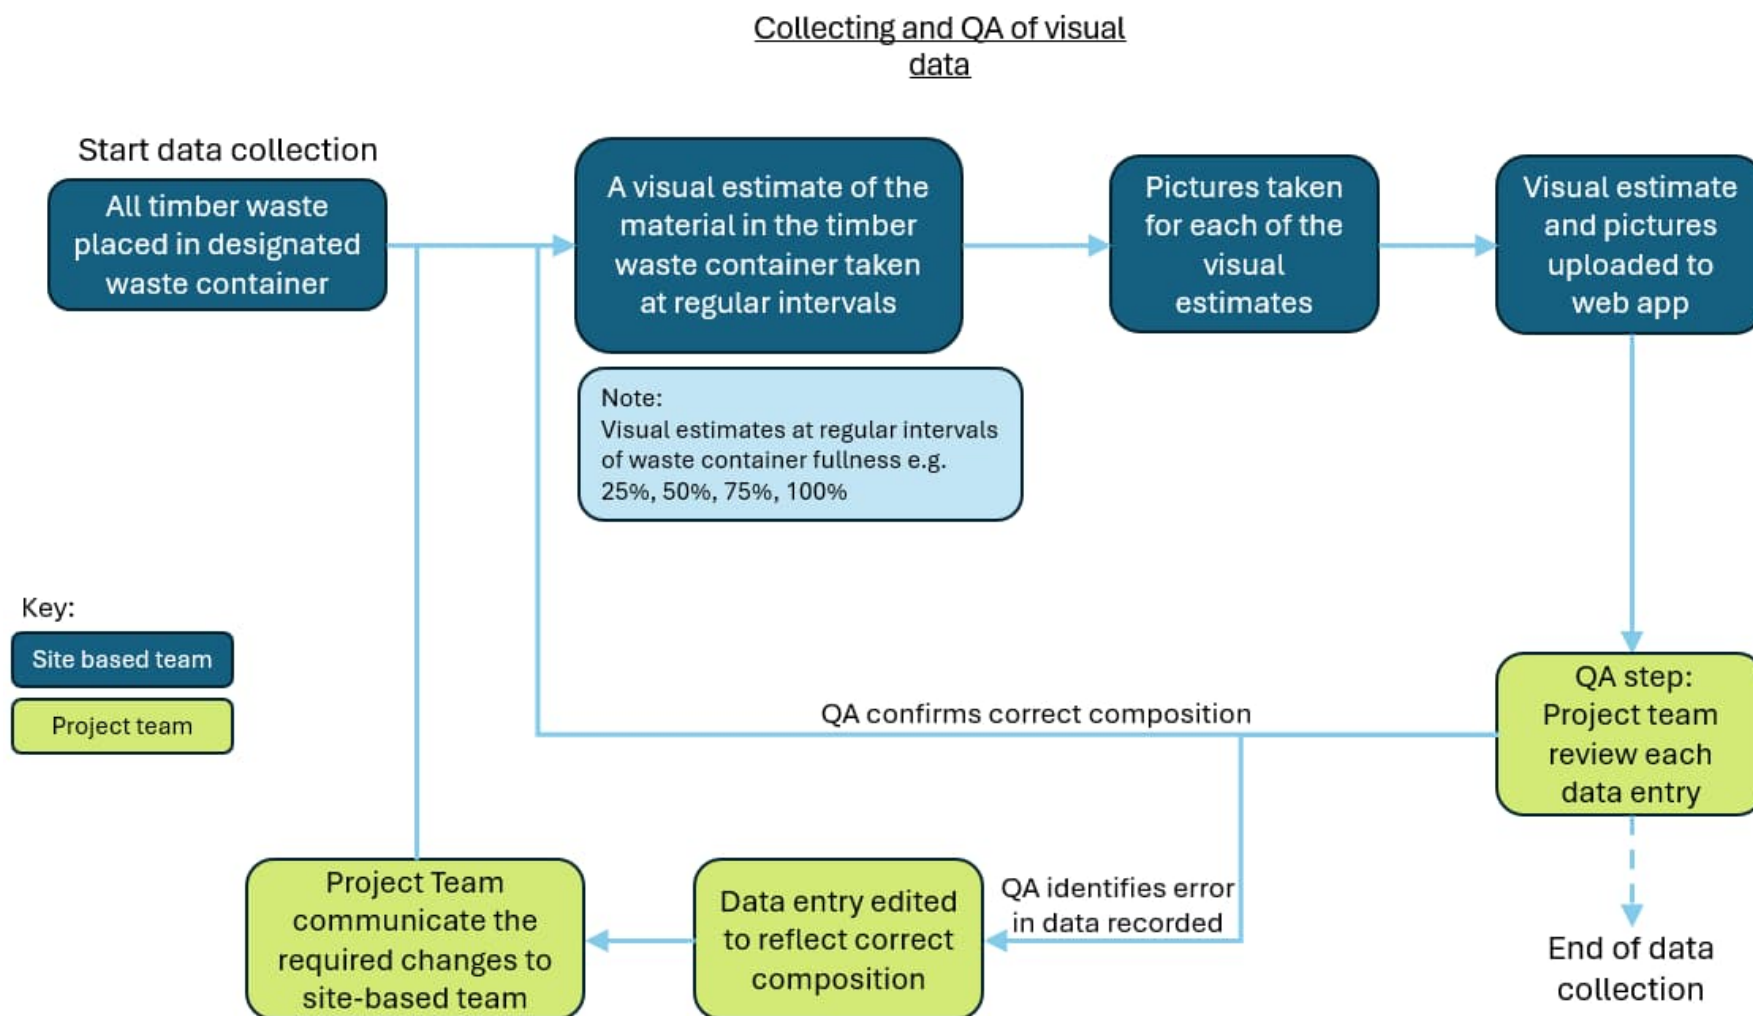
Figure 2.1: The collection and Q+A of visual data

The data collection method has been detailed in a flow diagram in Figure 2.1.

After all the data had been collected, we took the total skip weight and used this to calculate total weight for each timber type by the 25% splits based on the visual estimate of the volumes.

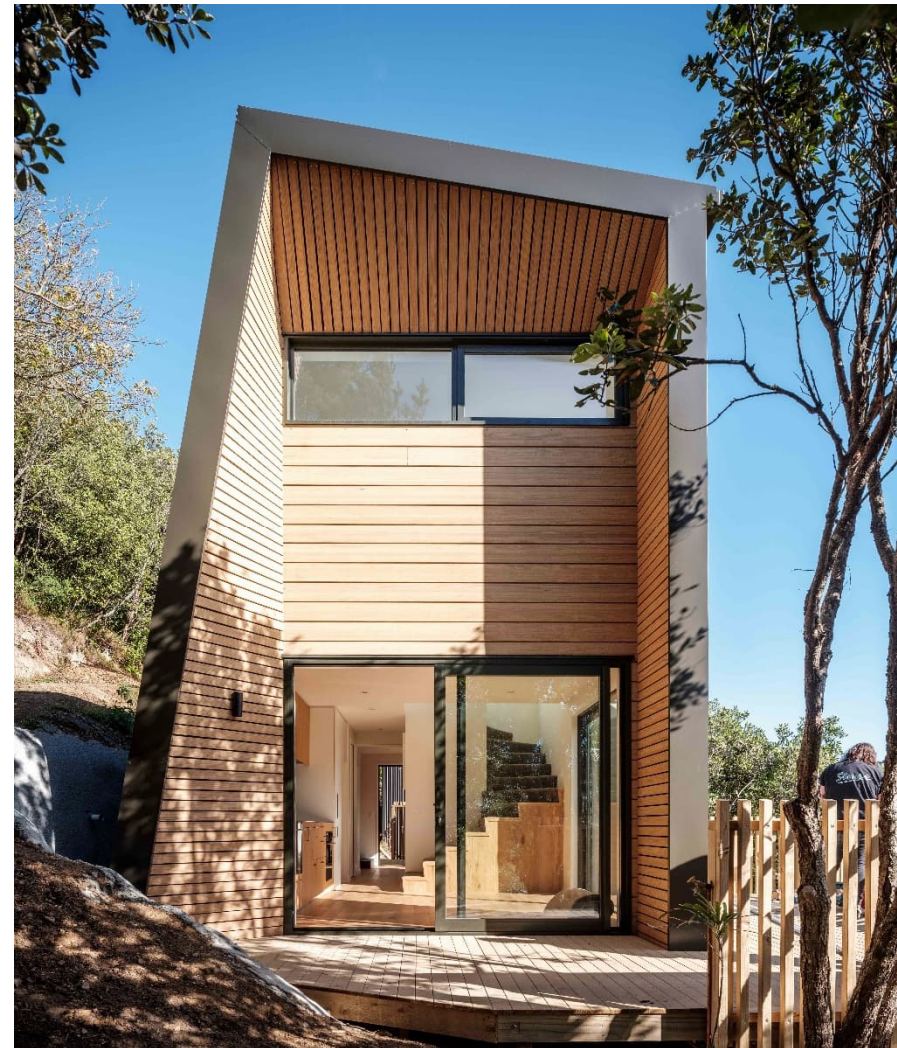
Figure 3.2: Site Two artists impression

The structure is a pre-nailed timber frame with some internal and external bracing. The roof for the property was constructed using timber rafters and weatherboard, with the cladding on the property a combination of timber battens and timber weatherboard. Internally the sub-flooring is a sheathing timber with plywood being used on the flooring and wall linings.

The decking which is present on two external walls of the property is a treated timber product.

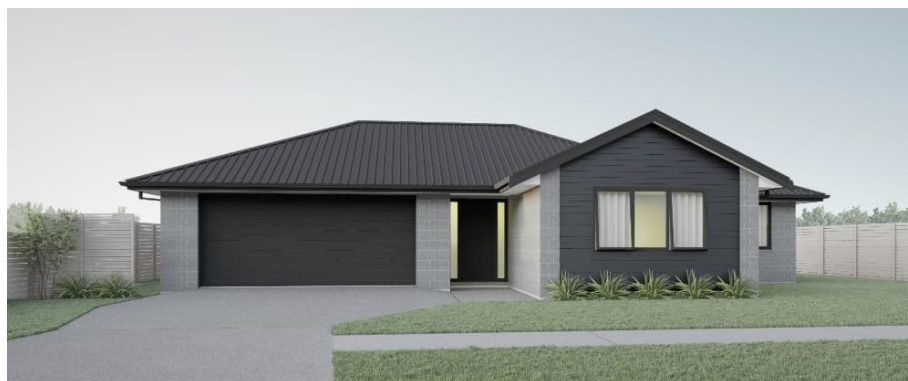
Figure 3.3: Site three artist's impression

Site Three is a 212m<sup>2</sup> ready-to-build residential building. It was classified as a 'typical' build, indicating a standard design used by them. The build is a single story four-bedroom home with; two bathrooms, an open plan kitchen and dining and an adjacent lounge as well as an attached two car garage.

The structure is a pre-nailed timber frame with some internal and external bracing. The roof is pre-nailed H1.2 timber trusses and purlins with metal ceiling battens. The roofing overlay is rib profiled metal roofing. The interior linings are plasterboard, stopped and painted. The exterior cladding is a mixture of brick veneer and a fibre cement weatherboard.

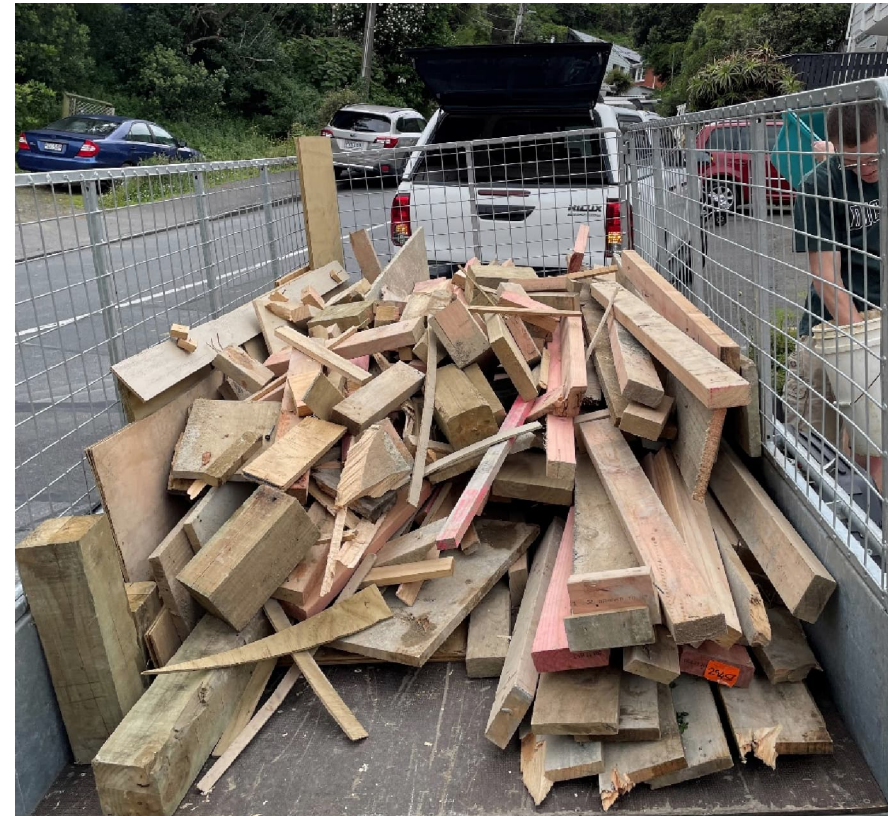
*Figure 3.4: Site Two waste collection and transportation method*

Sites One and Three were able to have a designated timber skip on site, therefore the visual data methodology detailed in Section 2.2 was followed for these two sites. However, due to the topography of Site Two and the limited space outside of the site boundary, the approach for data collection had to be amended. All timber waste from construction activities was stockpiled within the site boundary before a trailer would collect the material (Figure 3.4). As the waste accumulated the site arranged for all timber waste to be carried down to a trailer to be taken for disposal. During this phase the visual data was collected as the trailer was filled.

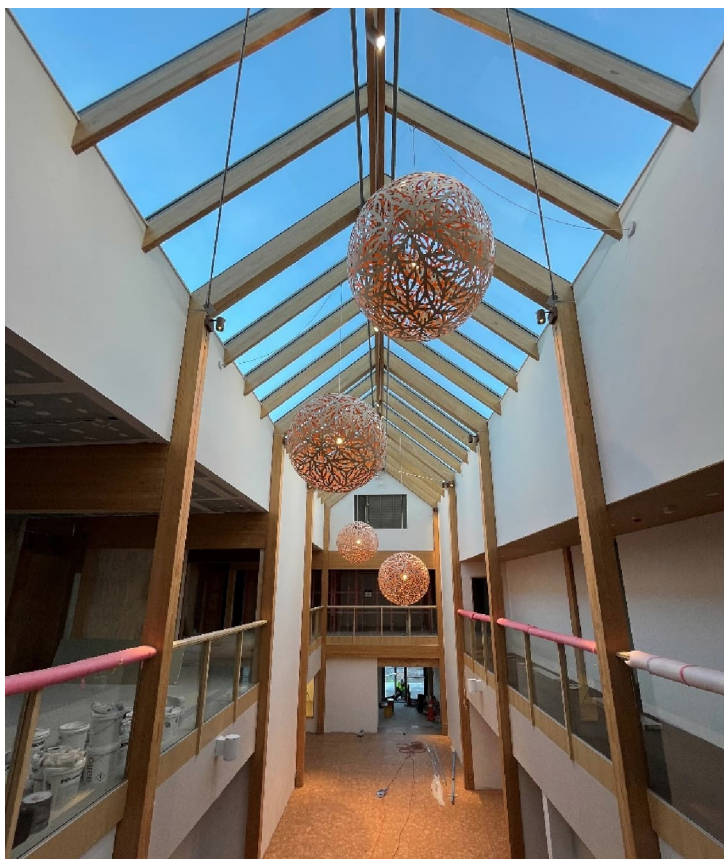
Figure 4.1: Site One Wrap Around Services building interior

Visual data that was collected from Site One showed treated sawn timber was the most common waste timber classification at 49% of the total timber waste (Figure 4.1). Pallets and prefabricated timber were the second most common timber wastes, both being 14% of overall timber collected. The majority of the timber placed in the skips for disposal was treated timber with 84% being a form of treated timber. The high quantity of treated timber waste was anticipated from this study as the building is a 100% timber framed construction as demonstrated in Figure 4.2 and Figure 4.3. As required by building regulations all framing and structure timber must be treated.

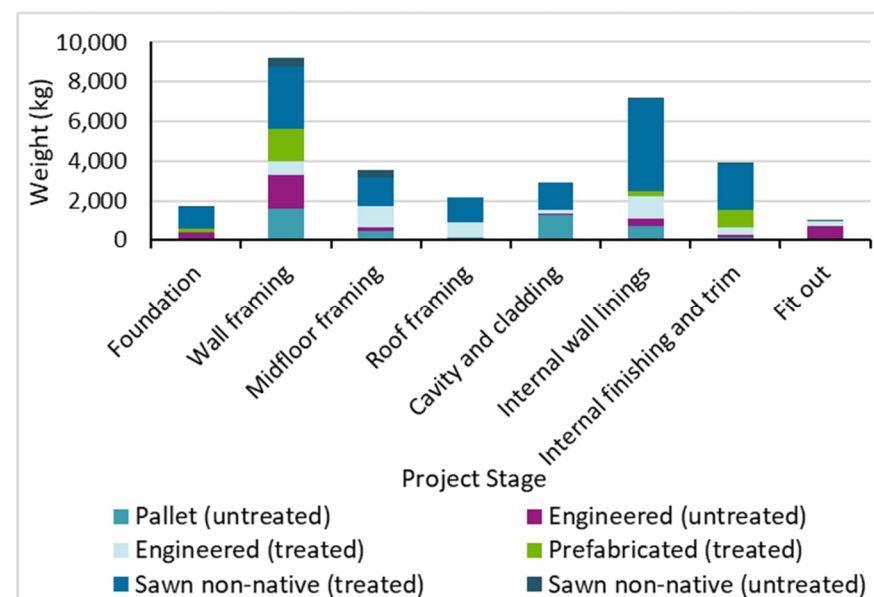
Figure 4.3: Site One weight of each timber type for the project stages

The timber profile across project stages is shown in Figure 4.3, composed of the weights of each timber type. Non-native sawn (treated) timber was

the biggest waste stream across all the project stages except for fit out. The most non-native sawn (treated) timber was present during wall framing and internal wall linings which were the two project stages with the most waste timber. The second most common waste timber was engineered product (untreated). Engineered product (untreated) was common through midfloor framing, roof framing and internal wall linings. Pallets were also a high timber waste stream common in wall framing, cavity and cladding and internal wall linings. The most untreated material was used in the wall framing project stage along with fit out, with untreated timber having the best potential for recovery.

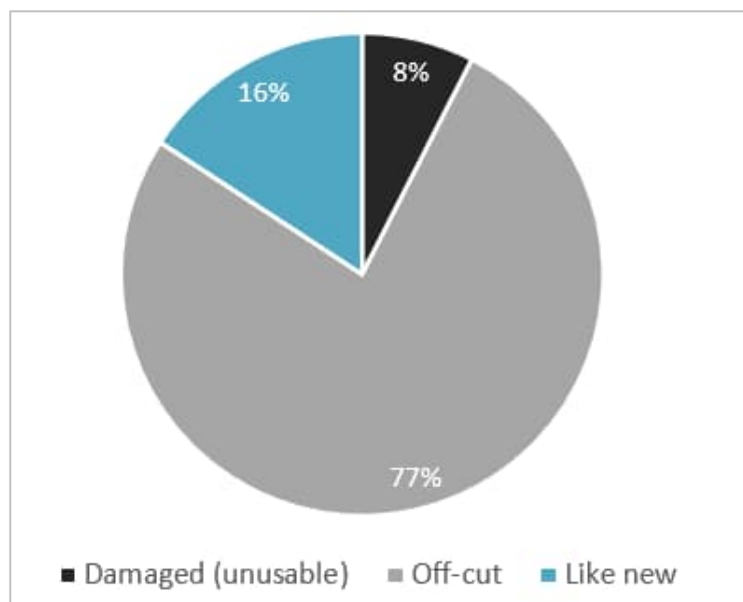
Figure 4.4: Site One quality of waste timber

A review of the quality of timber which was disposed of is detailed in Figure 4.4. The data demonstrates that 92% of the timber disposed was 'like new' or an off-cut. These timber pieces predominantly came from the wall framing, internal wall linings and internal finishing and trim project stages and were predominantly off cuts as demonstrated in Figure 4.5. The 5% of damaged and unusable timber also predominantly came from the same project stages.

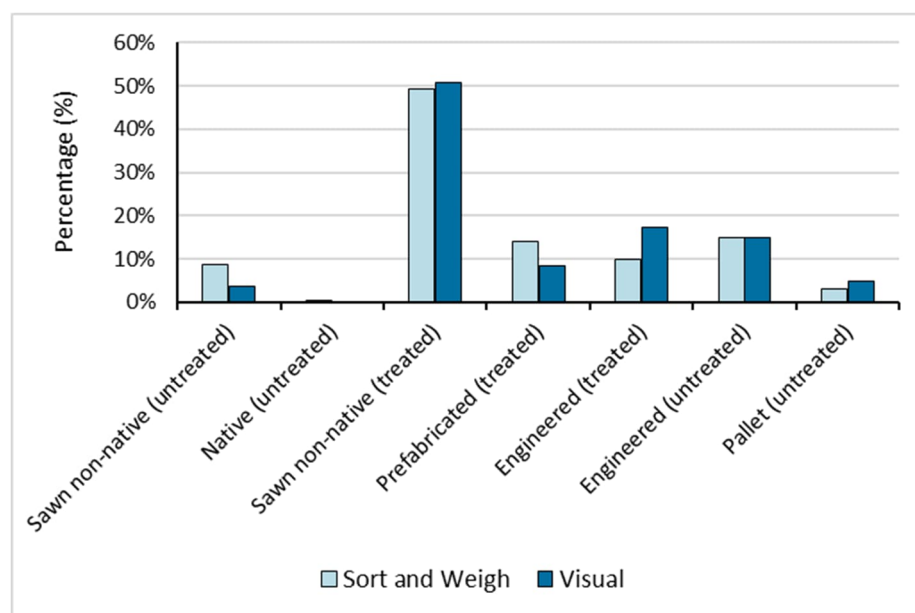
Figure 4.6: A comparison of visual and sort & weigh timber for the 8 skips that were audited visually and sort & weighed for Site One.

Sort and weigh audits were also undertaken at Site One to calibrate and verify the visual data. A comparison of the eight sort and weigh, and visual data skip collections are shown in Figure 4.6. Sawn non-native (treated) timber has the highest portion for both sort & weigh and visual audits with a difference of 1.59% in overall composition. Engineered product was also similar between the data collection methods with a difference in composition of 0.07%. The biggest differences in composition were for engineered (treated) (7.29%) and prefabricated (treated) (5.6%) timber.

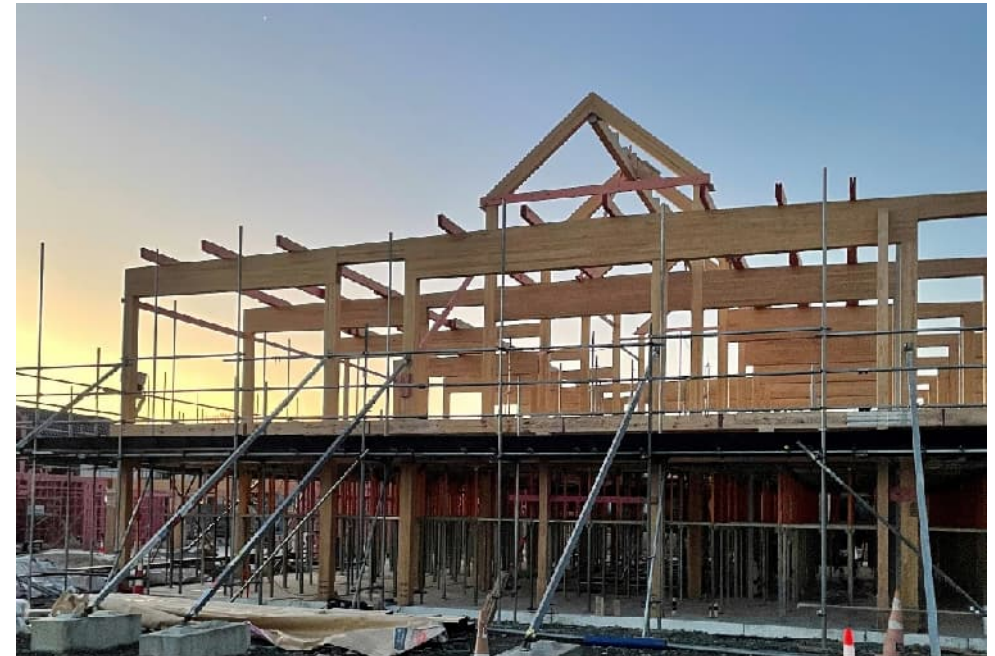
*Figure 4.7: Site One framing under construction.*

- Wall framing and internal wall linings were the most wasteful project stages for timber with 9.04 t and 7.05 t of timber waste materials recorded respectively. The reason being that due to the design of the Wrap Around Services building there was a lot more cutting required to fit specific dimensions as per the design. This results in a large quantity of off-cuts where the lengths of timber were unable to be reused for structural elements of the build.
- These findings were echoed in the carpenter's survey conducted on site. Refer to Section 4.3 of this report for further insights from the carpenters survey.

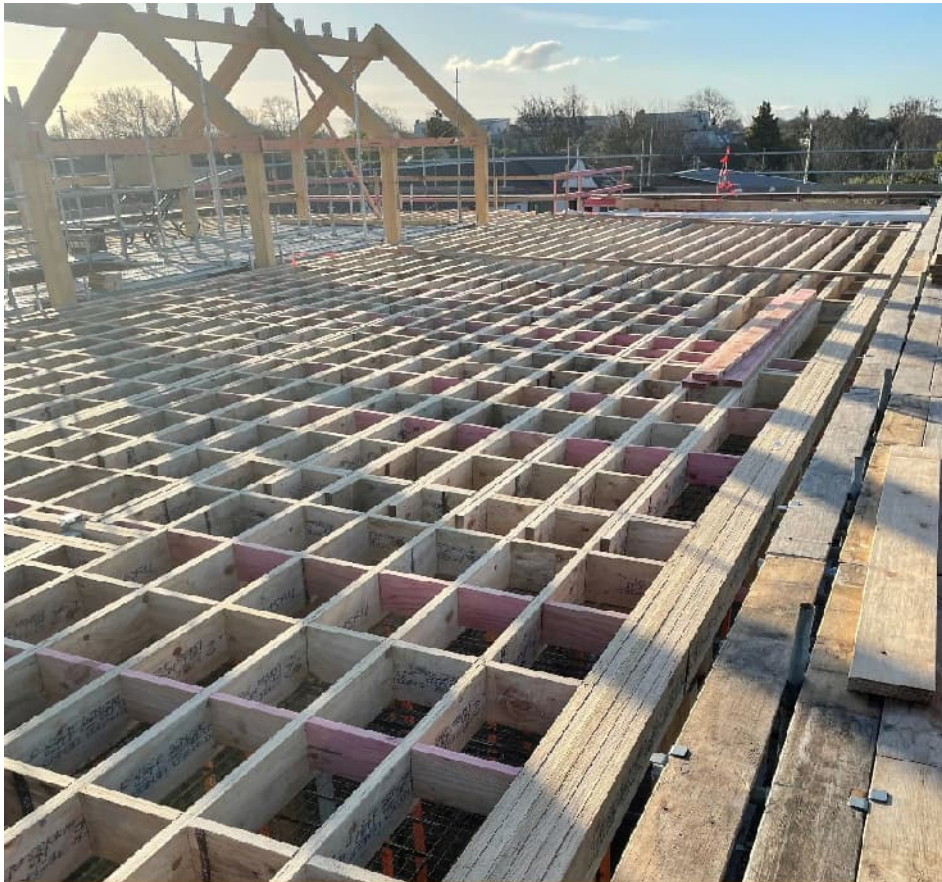
*Figure 4.8: Site One roof framing.*

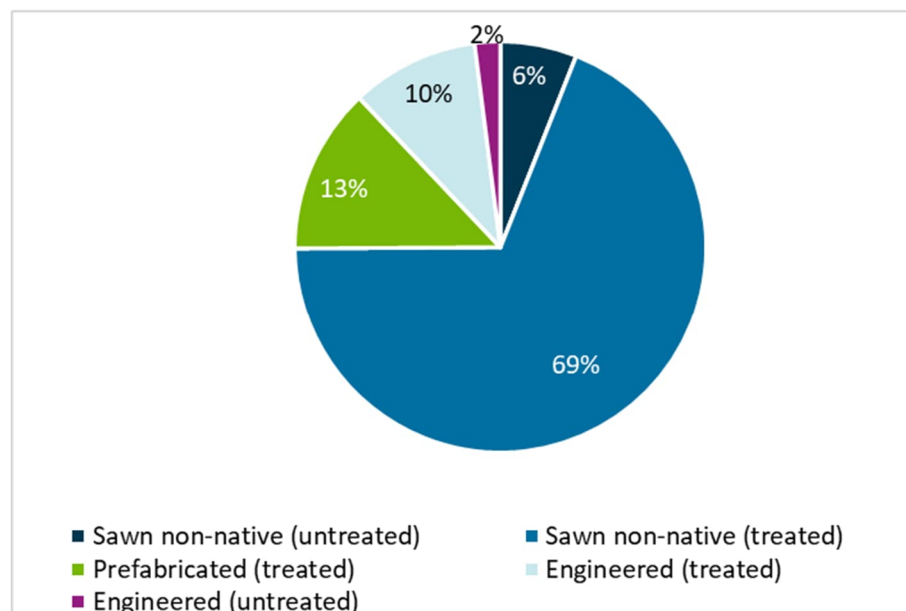
Figure 4.9: Site Two composition of wood from visual estimates.

Visual data collected for Site Two showed that Sawn non-native (untreated) timber (69%) was the highest portion of waste wood retrieved from the site (Figure 4.9). This was the same finding to that of Site One. Prefabricated (treated) timber (13%) was the second highest portion of waste timber, followed by engineered (treated) timber (10%)

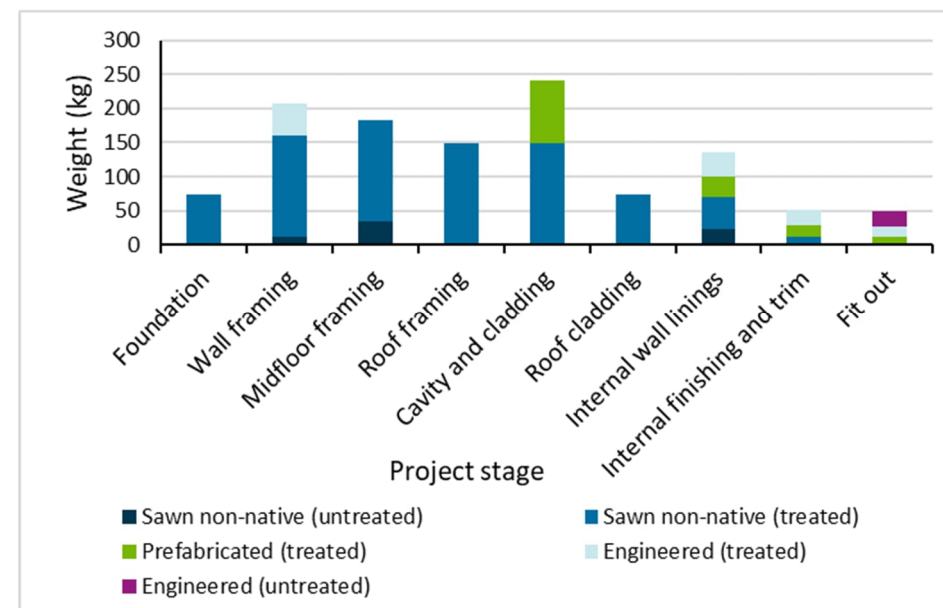
Figure 4.10: Site Two weight of each timber type for the project stages.

Sawn non-native (treated) timber was the most common waste timber throughout the project stages (Figure 4.10). The amounts varied but stayed consistent from the foundation project stage to roof cladding. Prefabricated (treated) timber was present in the cavity and cladding project stage and the internal wall linings to the fit-out stage. These were some similar patterns to what was found for Site One, with sawn non-native (treated) timber being the most dominant waste timber type.

Of all the waste timber removed from the project, 92% was treated, leaving 8% untreated and able to be recovered.

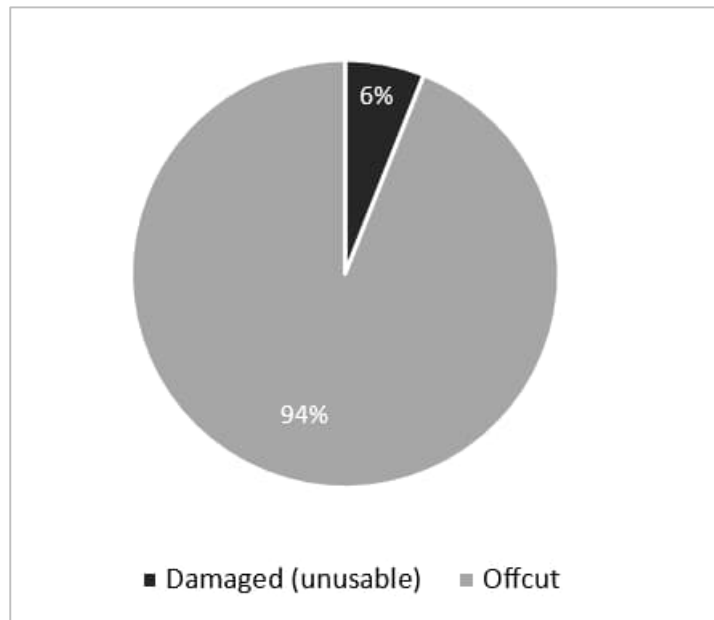
Figure 4.11: Site Two quality of waste timber.

A review of the quality of timber which was disposed of is detailed in Figure 4.11. The data demonstrates that 94% of the timber disposed was off-cuts. This covered project stages foundations through to roof cladding and four main timber categories (sawn non-native (treated), prefabricated (treated), engineered (treated and untreated). The remaining 6% of damaged and unusable timber came from sawn non-native (untreated) timber across the same project stages. This is attributed to damaged pallets.

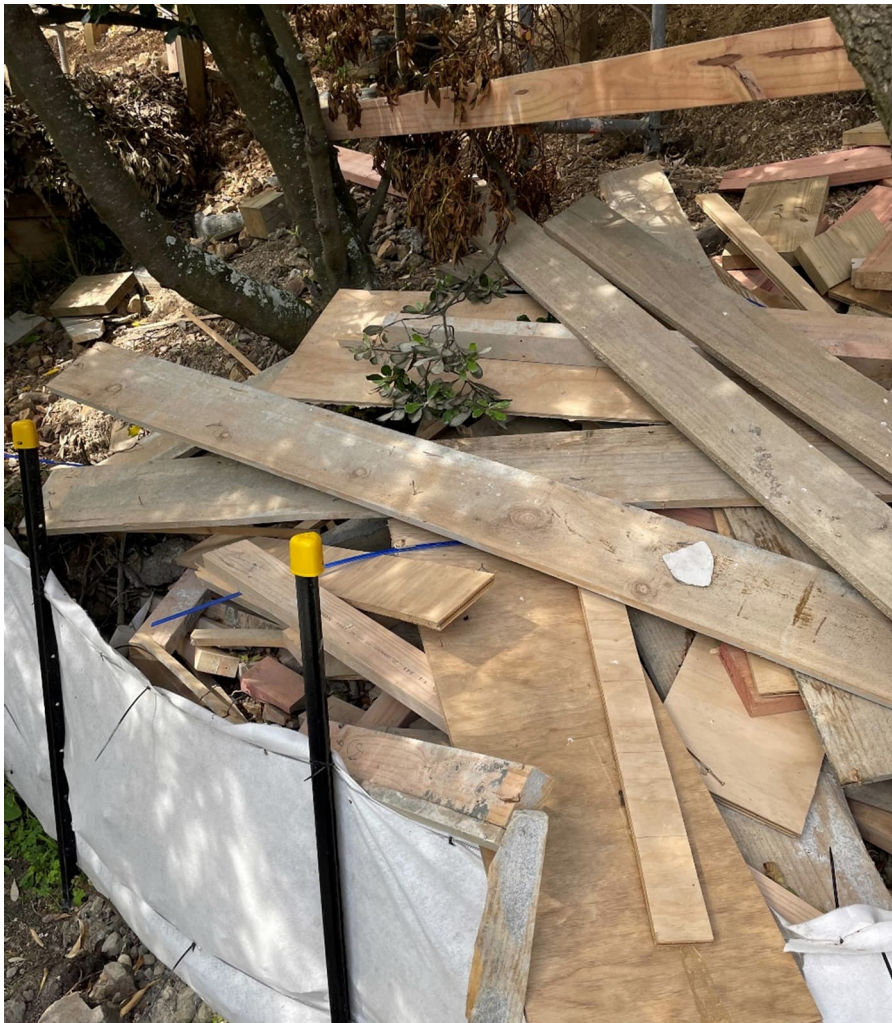
Figure 4.12: Site Two waste management storage method.

Due to the nature of the topography on the site, structural elements including wall framing were prefabricated offsite. This was driven by the unique structure and ensuring precision in the framing elements rather than waste reduction on site, noting that there was no waste container on the site and waste was stockpiled around the boundary (Figure 4.12). Where untreated timber waste was generated on site this was retained for the client and some of the site team to be used as firewood. The Site Manager also made a conscious effort to retain the larger elements of timber, those greater than 1 meter in length, predominantly from the foundation bracing, to be reused on other projects.

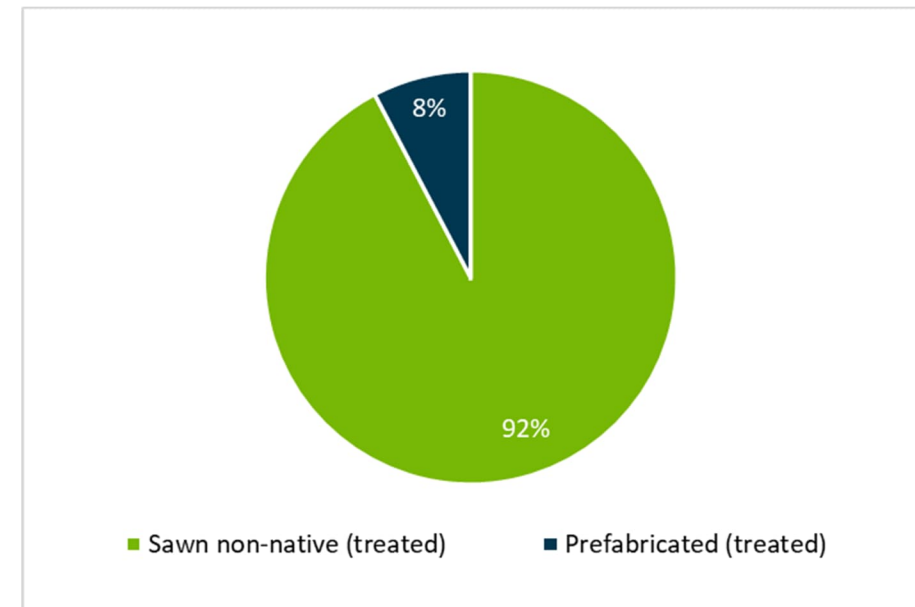
Figure 4.13: Site Three composition of wood from visual estimates.

At Site Three the waste timber generated on the project was only visually assessed and consisted of sawn non-native (treated) and prefabricated (treated) timber. The composition of the timber waste is shown in Figure 4.13 with sawn non-native (treated) timber 92% of the timber waste.

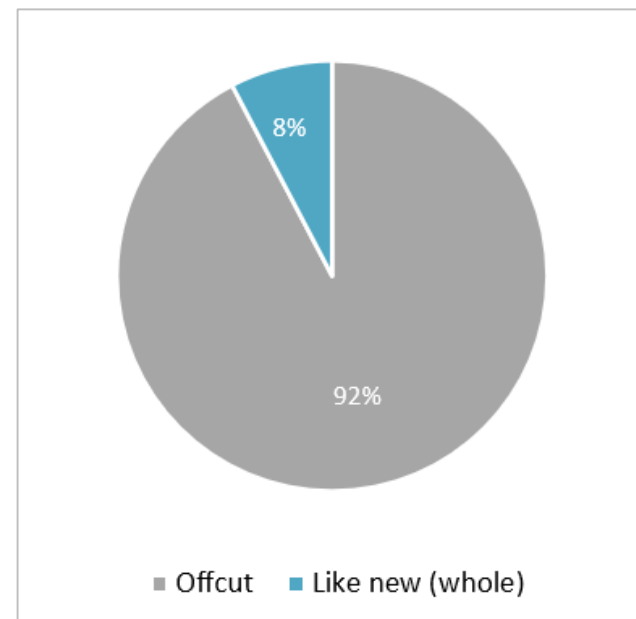
Figure 4.15: Site Three quality of timber waste.

A review of the quality of timber which was disposed of is detailed in Figure 4.11. The data demonstrates that 92% of the timber disposed was off-cuts. This covered the sawn non-native (treated) timber from the following project stages: wall framing, roof framing and cavity and cladding. The remaining 8% of like new timber came from prefabricated (treated) timber across the internal finishings and trim stage.

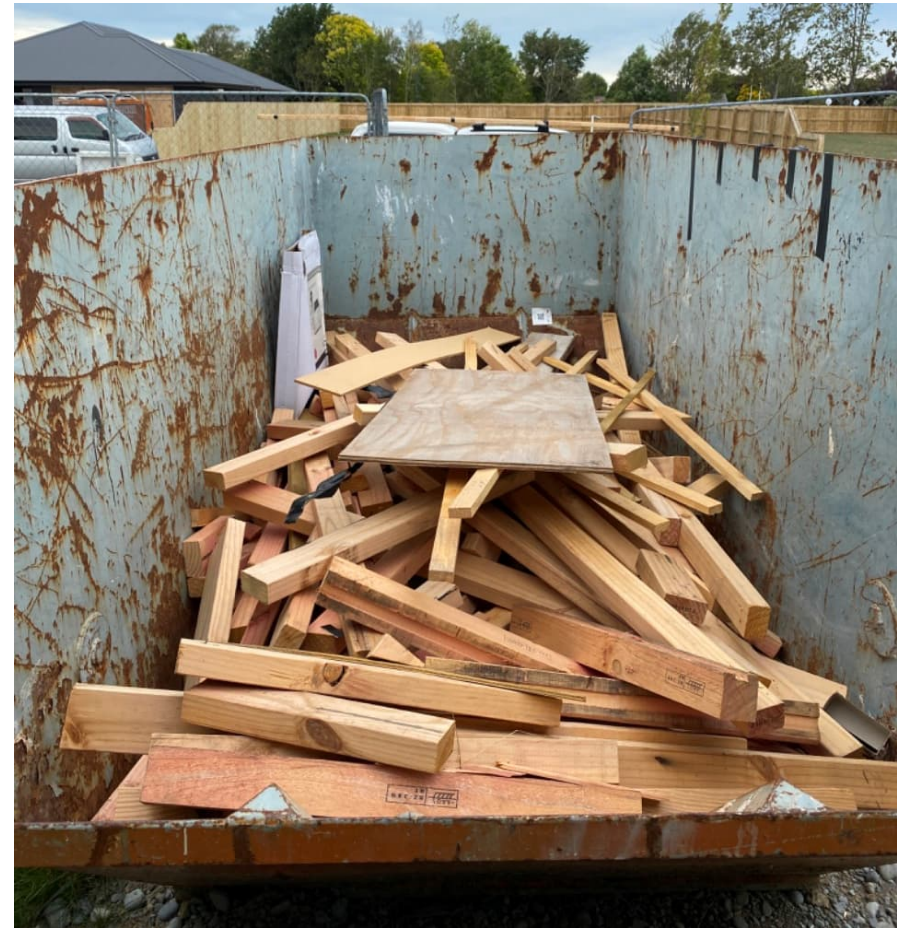
Figure 4.16: Site Three timber waste generation.

The site team indicated that this build would likely not produce large quantities of timber waste and across limited project stages due to the nature of it being a “ready-to-build” project, particularly in comparison to a bespoke or architectural build (Figure 4.16). This was mainly due to measures put in place to increase efficiencies and cost savings for standardised ready-to-build projects on the market. Some of these measures which are relevant to this build include:

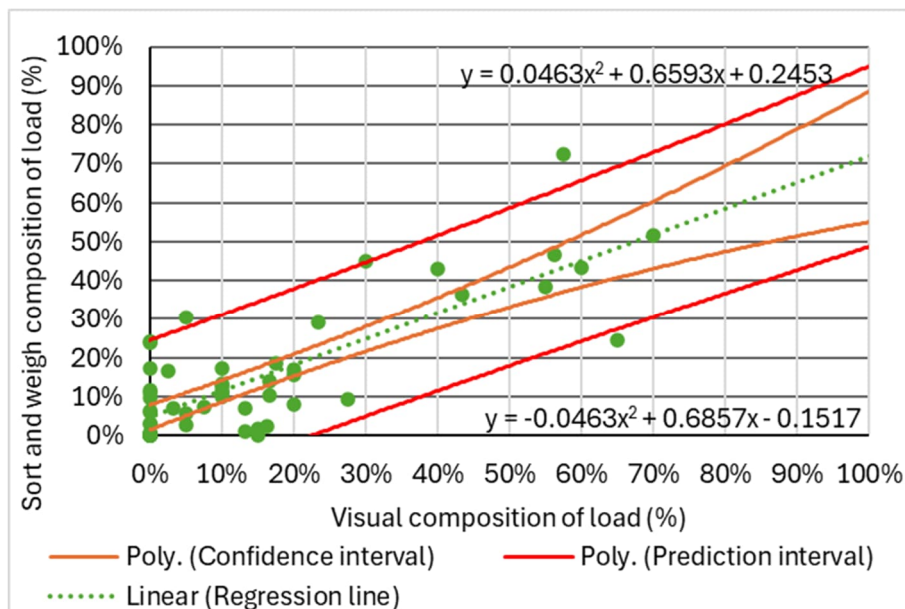
Figure Appendix D.1: A scatter plot comparing visual and sort & weigh data for Site One.

The least square linear regression statistical test established that there is a statistically significant relationship between the sort and weigh, and visual data. To further understand this relationship, confidence intervals and predication intervals have been calculated. Figure Appendix D.1 shows the relationship between the visual and sort and weigh data. There is a positive linear relationship between the sort and weigh and visual data. The confidence and prediction intervals are shown in Figure Appendix D.1. The confidence interval shows 95% of the timber data mean will fall between in the two orange lines. The prediction interval which is demonstrated by the red lines on the figure show 95% chance of the next observation falling within these lines.

The predictive interval has a polynomial fit with a 95% chance of new values varying between 19.76% and 21.19% from the mean. The confidence interval also has a polynomial fit with a 95% chance of the mean varying between 2.62% and 8.08%. This shows that where materials have a greater percentage of the composition, the confidence in the accuracy of the material composition decreases.

More information regarding the regression analysis completed to identify the relationship between the sort and weigh and visual data can be found in Appendix D.
