OPEN FIREPLACES AND INSERT SOLID FUEL STOVES - AN EXPERIMENTAL AND ANALYTICAL STUDY

A. Woodside and
M. J. Cunningham

BRANZ Study Report SR 26

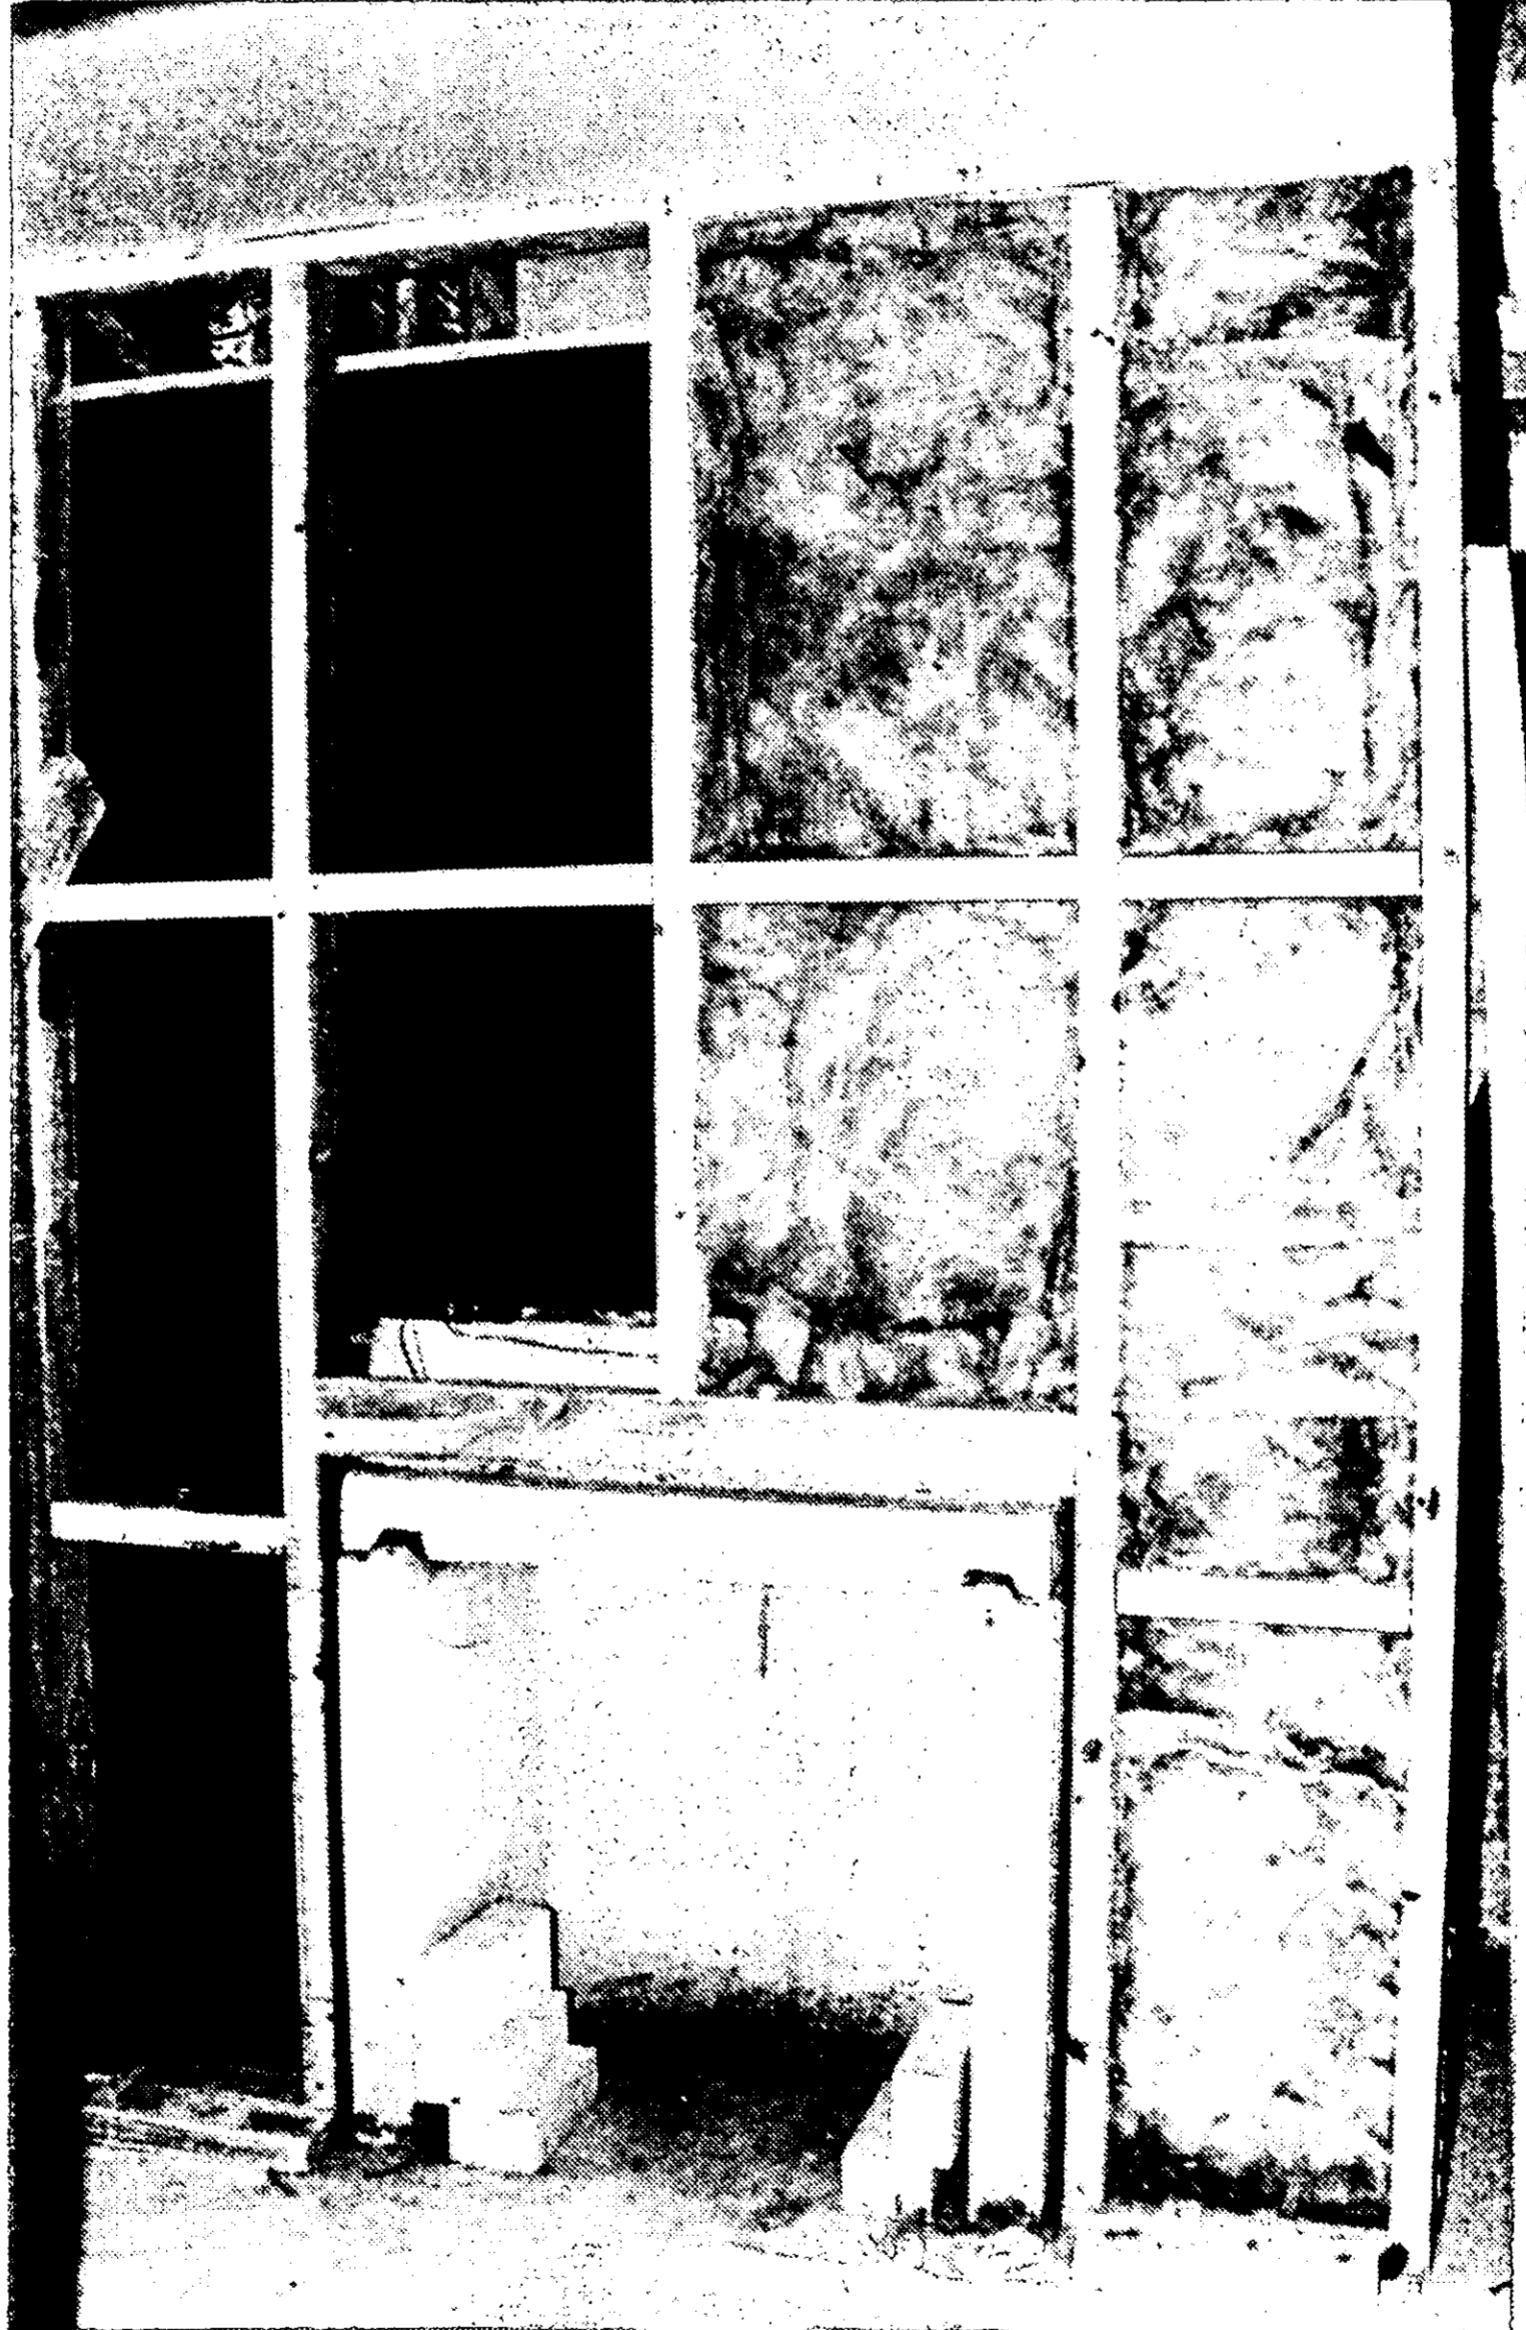
Figure 4: Test rig during construction, with framing at 25 mm clearances.

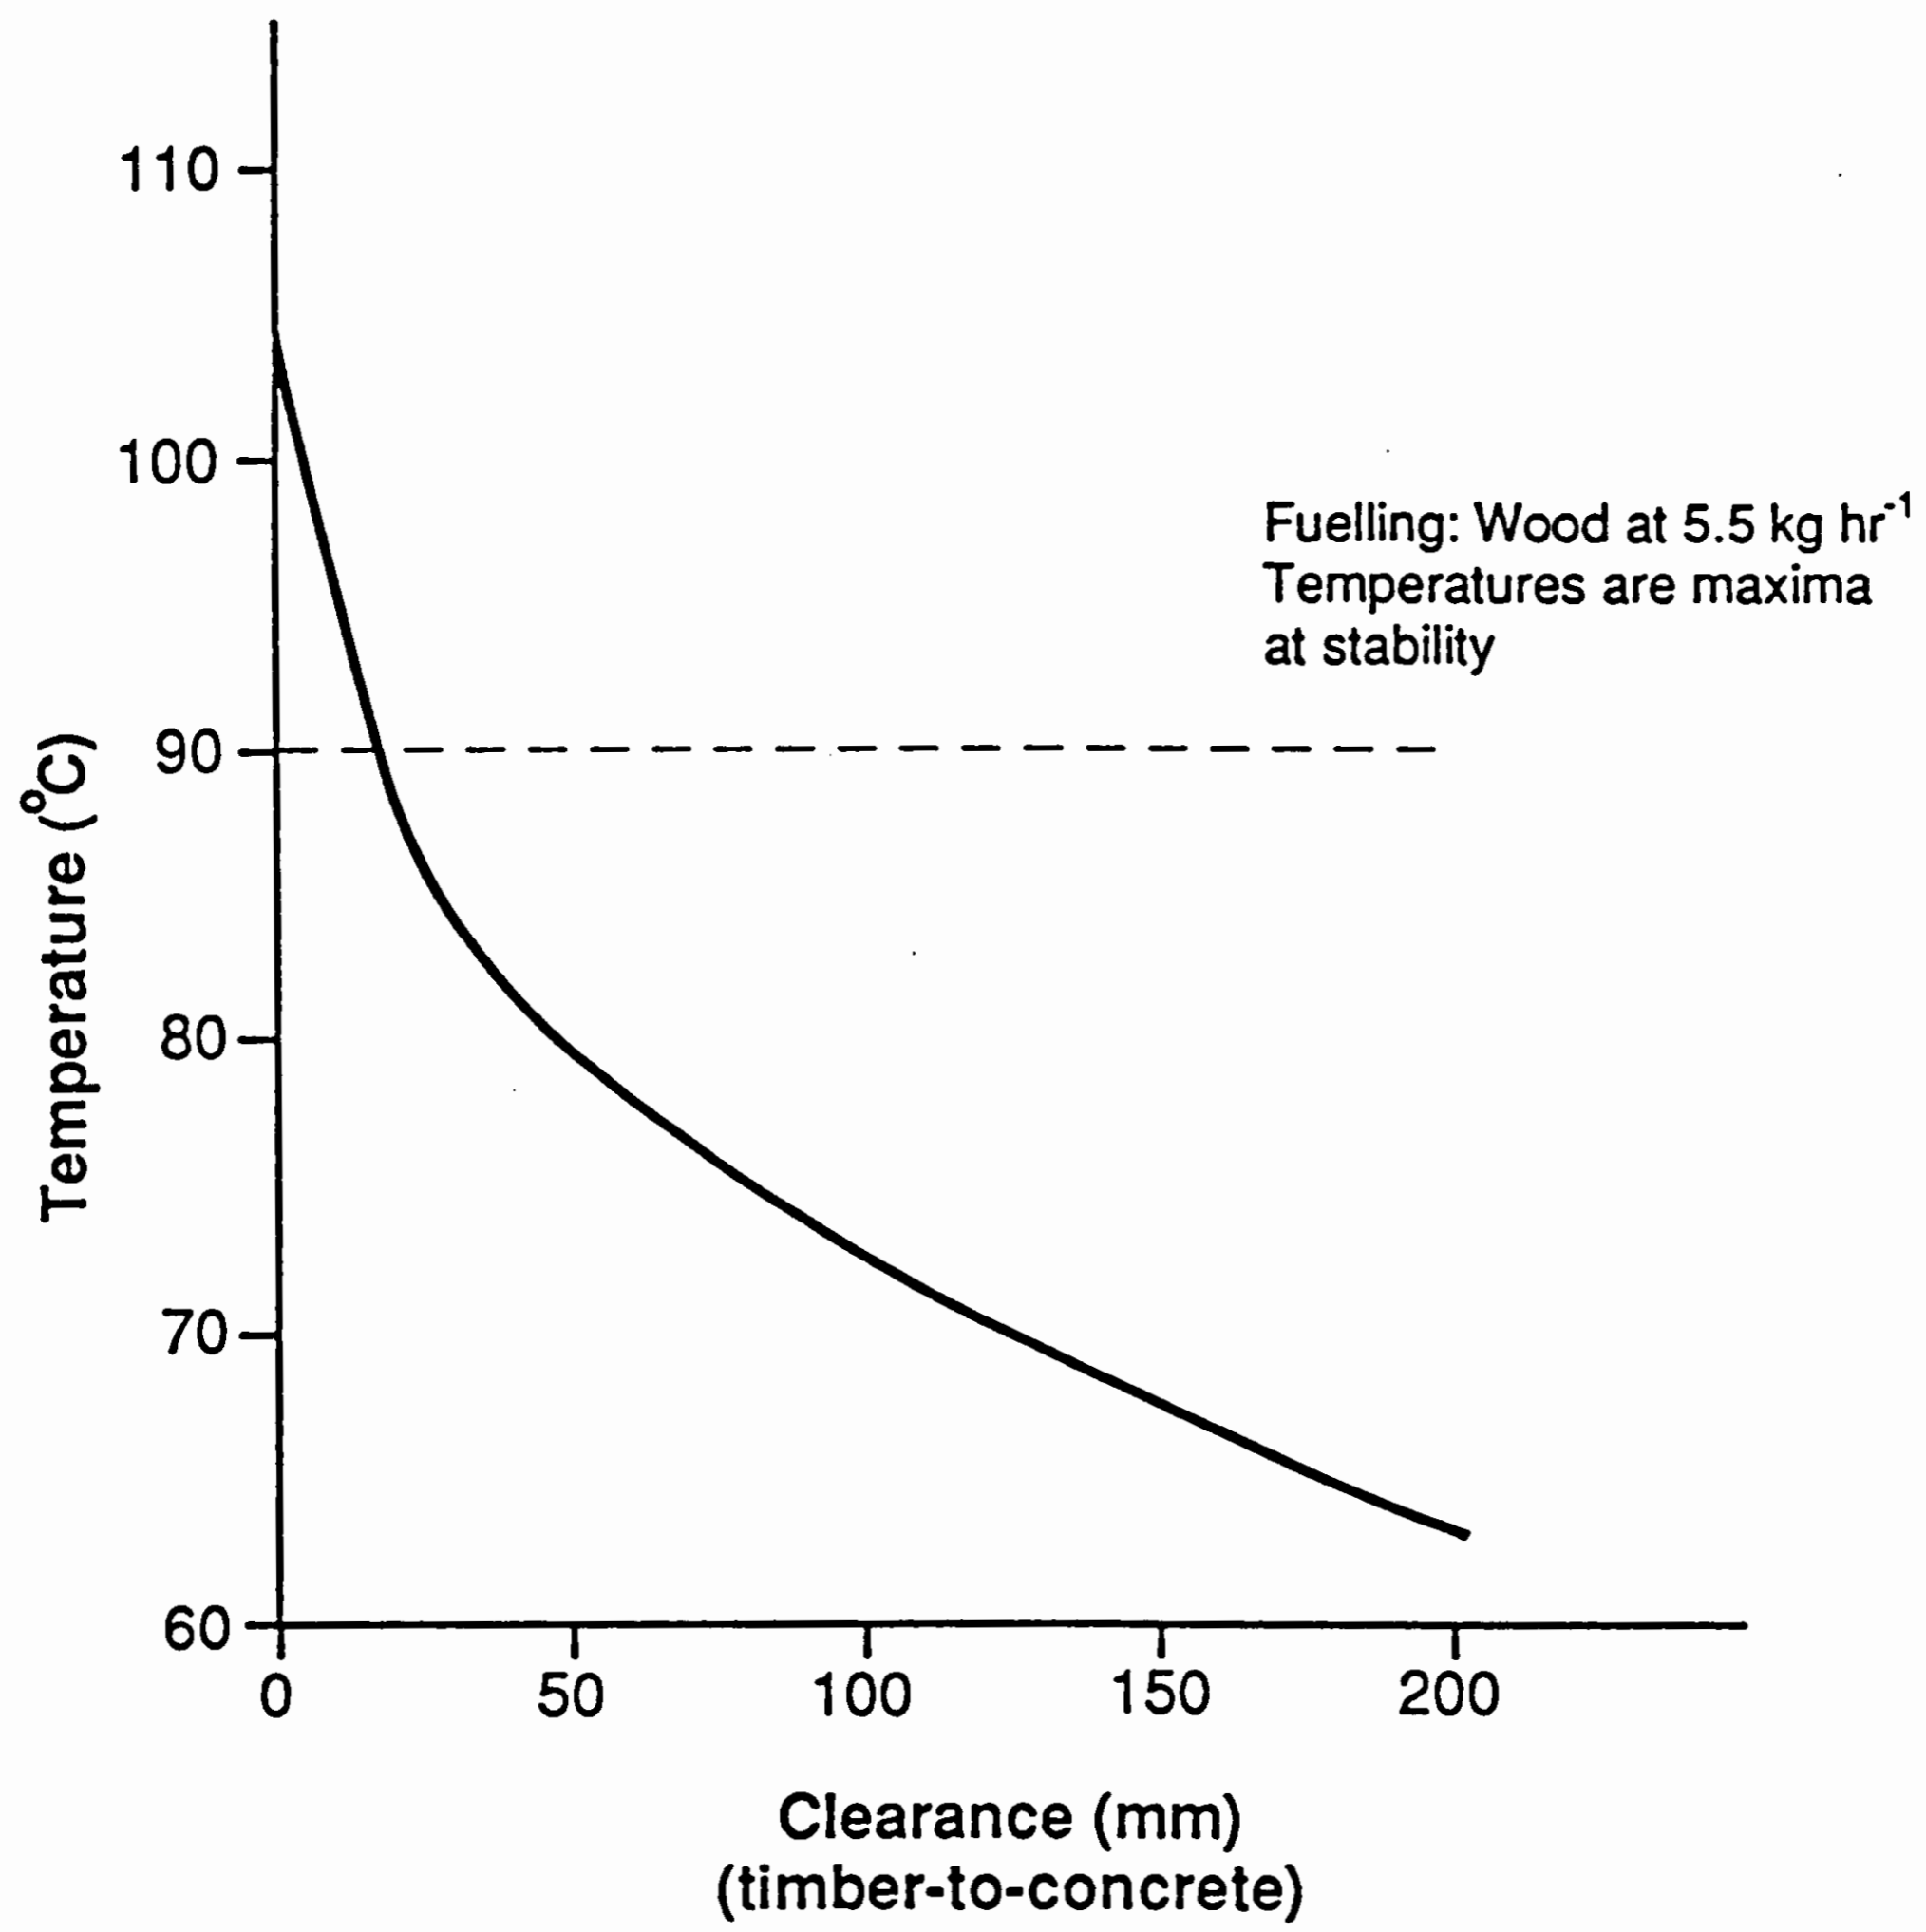
Figure 16: Predicted temperature of trimmer surface in pumice concrete open fireplaces

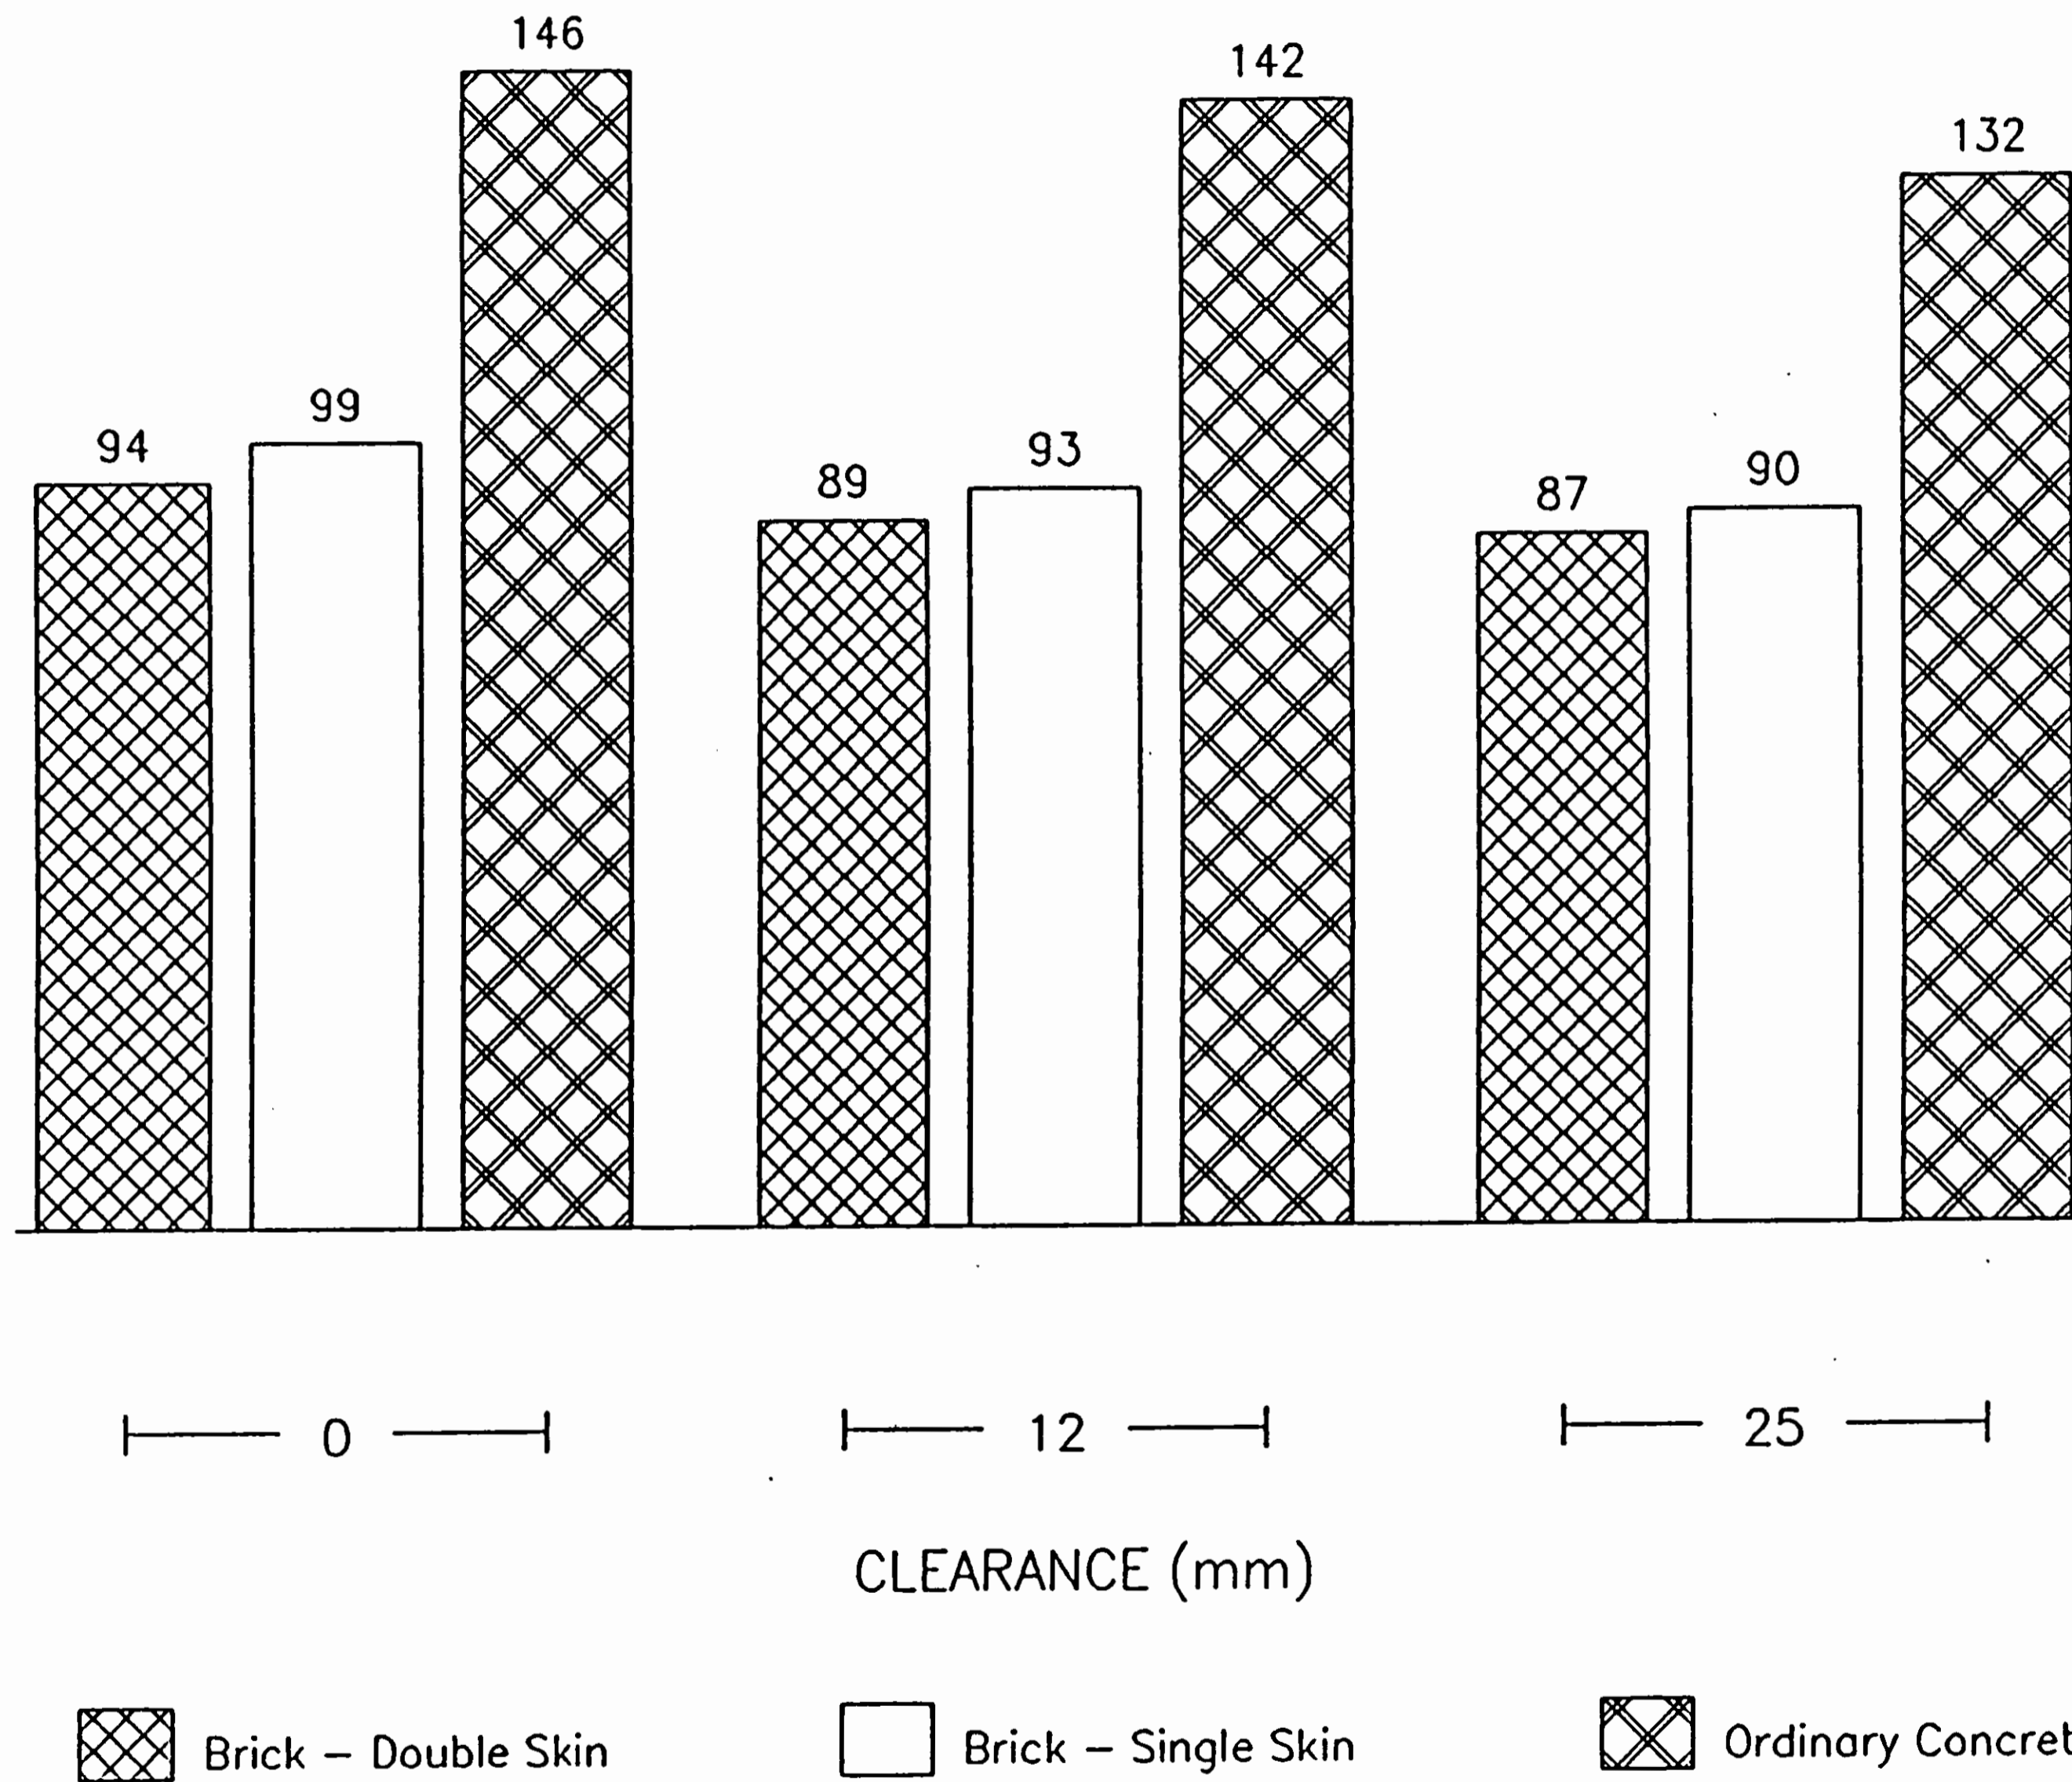
FIGURE 17 : PREDICTED TEMPERATURE (°C) OF TRIMMER SURFACE IN BRICK AND ORDINARY CONCRETE OPEN FIREPLACES

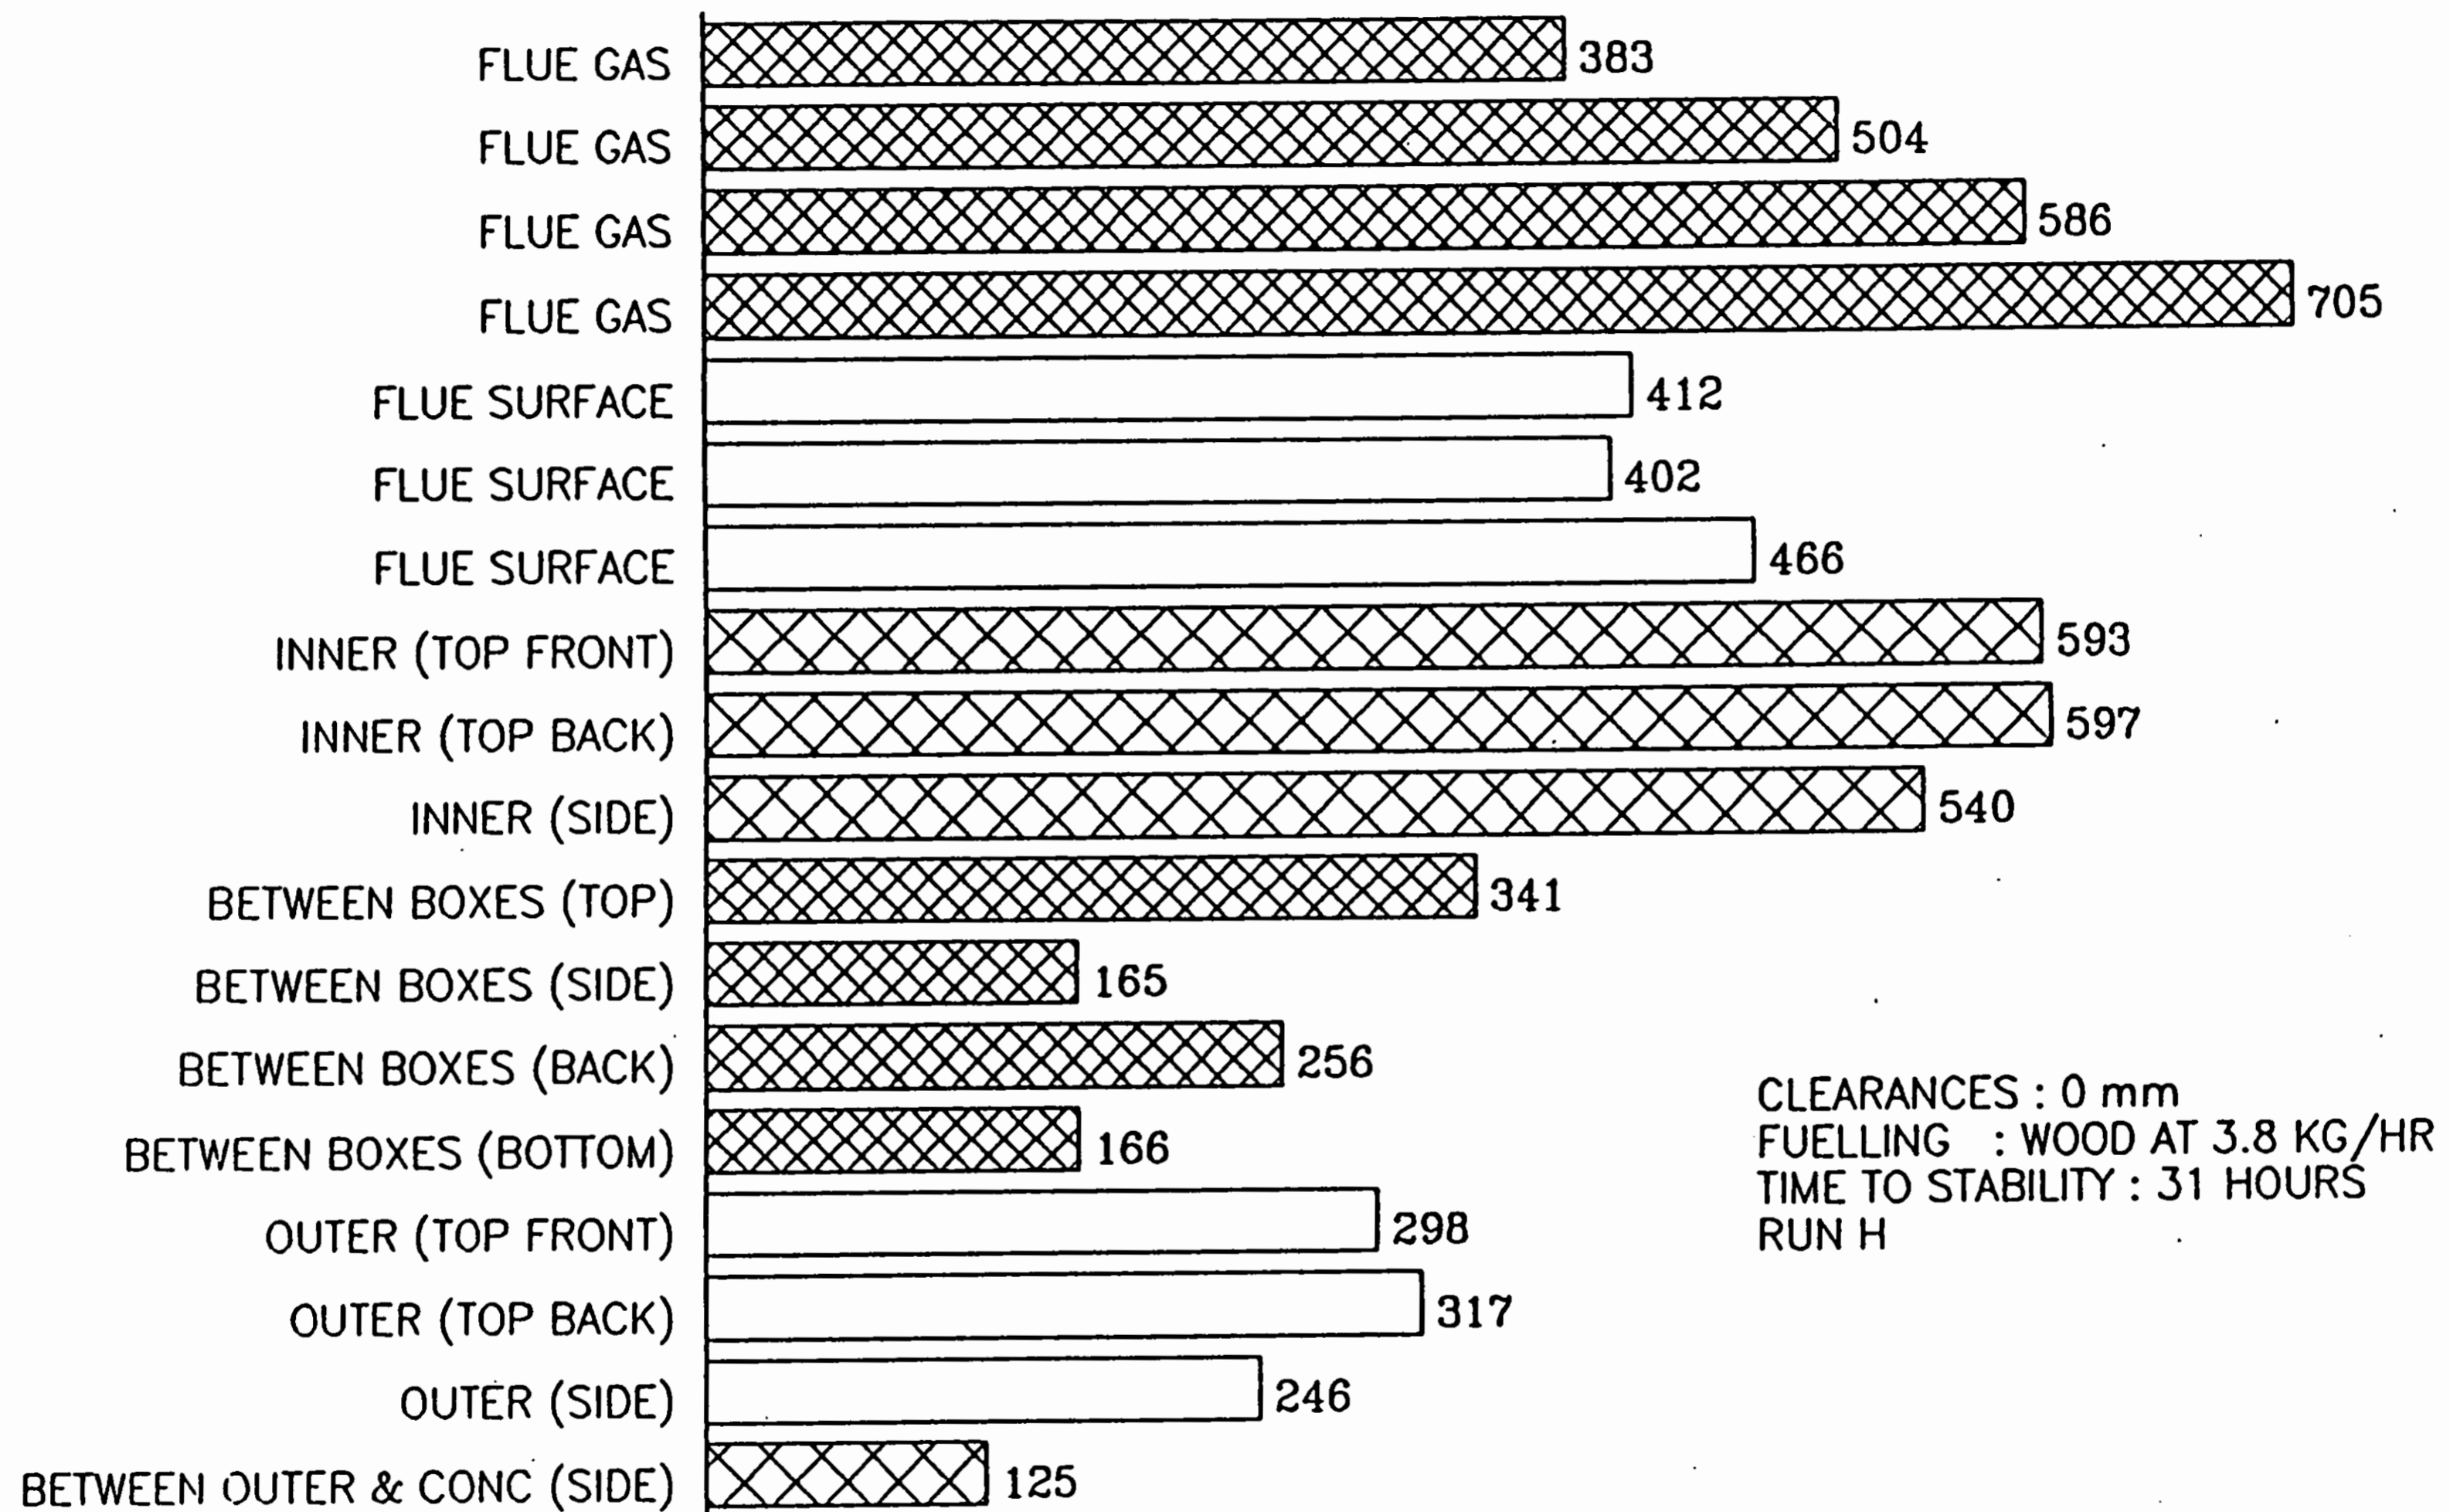
FIGURE 22 : TEMPERATURES (°C) OF INSERT HEATER, FLUE AND FLUE GASES (RECOMMENDED INSTALLATION)

Figure 22 shows typical maximum temperatures of the heater, flue and flue gases where a recommended method of installation has been used. The descriptors 'inner' and 'outer' refer to the heat exchanger and its outer cabinet respectively. The temperatures of both flue surface and flue gas
