# STUDY REPORT

No 53 (1995)

## Seismic Performance of Masonry Veneers and Ties

BRANZ Study Report 53

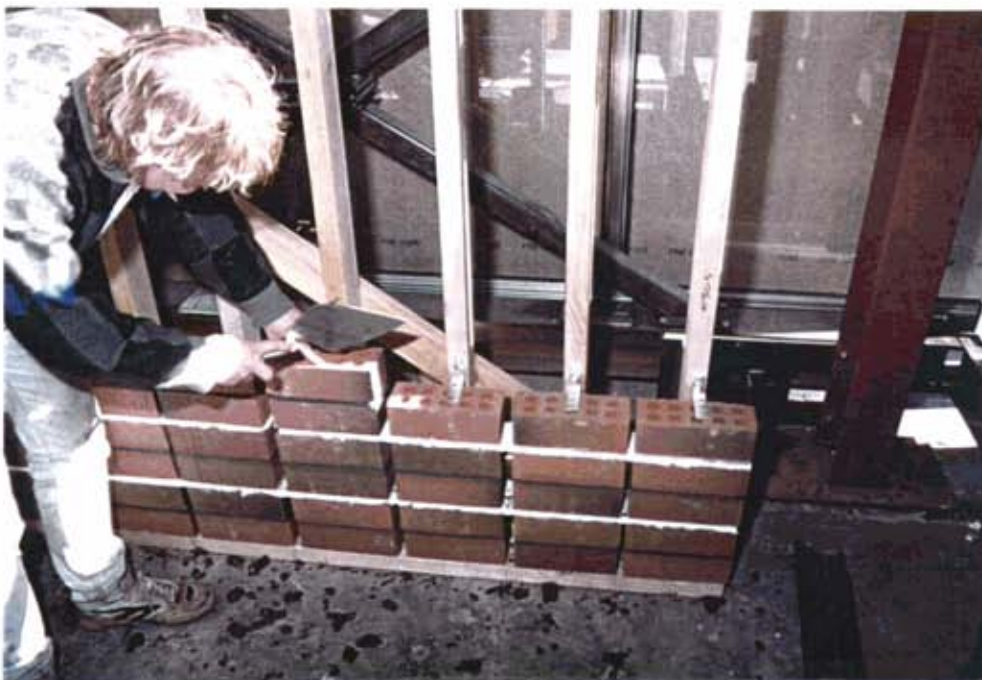
Photograph 2: Construction of series 1 specimens

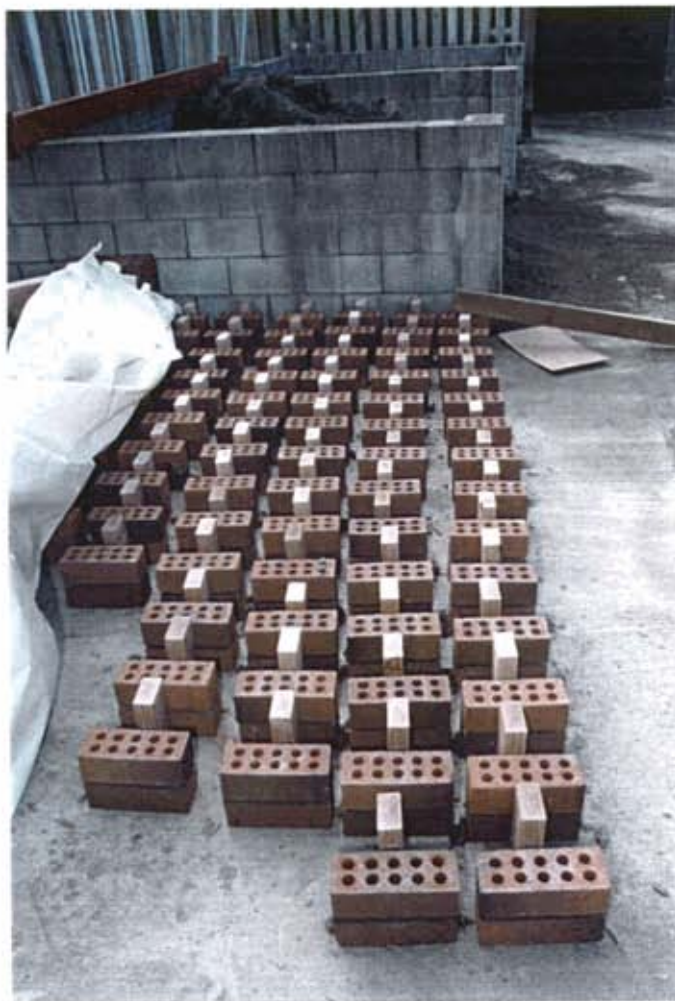
Photograph 3: Series 2 specimens

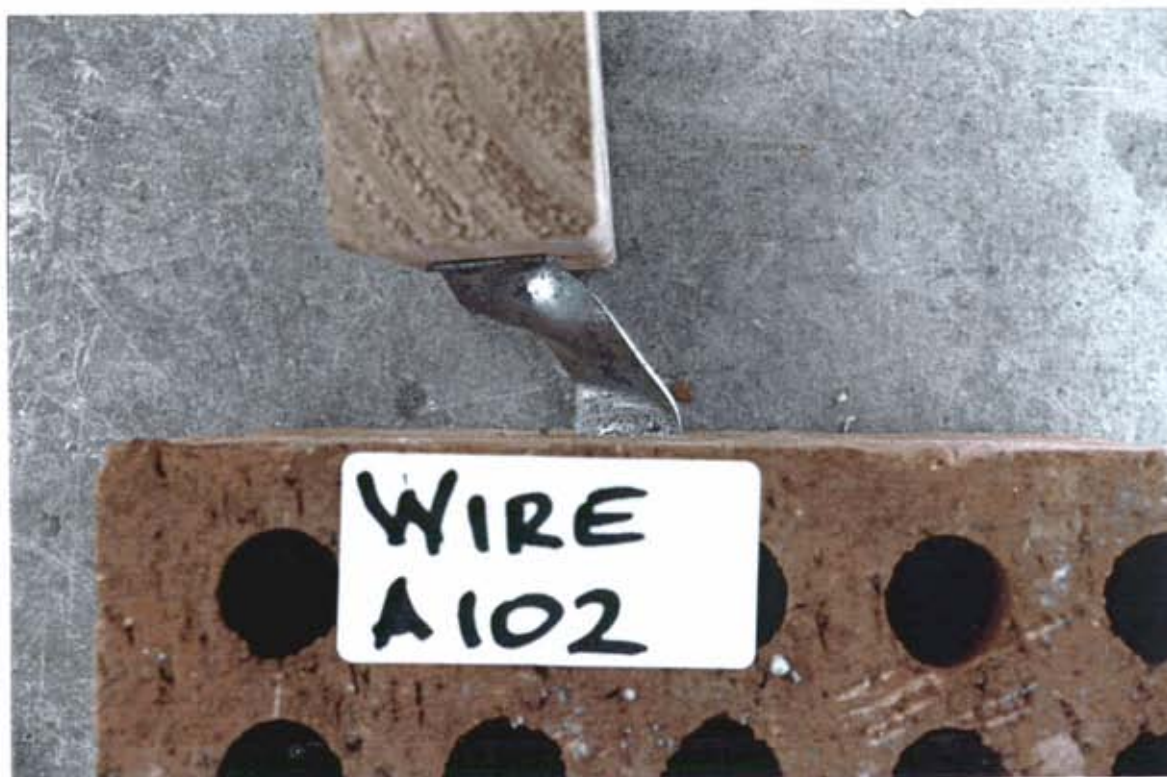
Photograph 4: Type 1 tie after in-plane cycling

The same twisting action of the ties under the cycles of in-plane displacement observed in series 1 tests was also apparent in this series. The distortion of the ties resulting from this part of the test is evident in Photographs 4, 5 and 6, showing typical examples of each of tie types 1, 2 and 3, respectively.

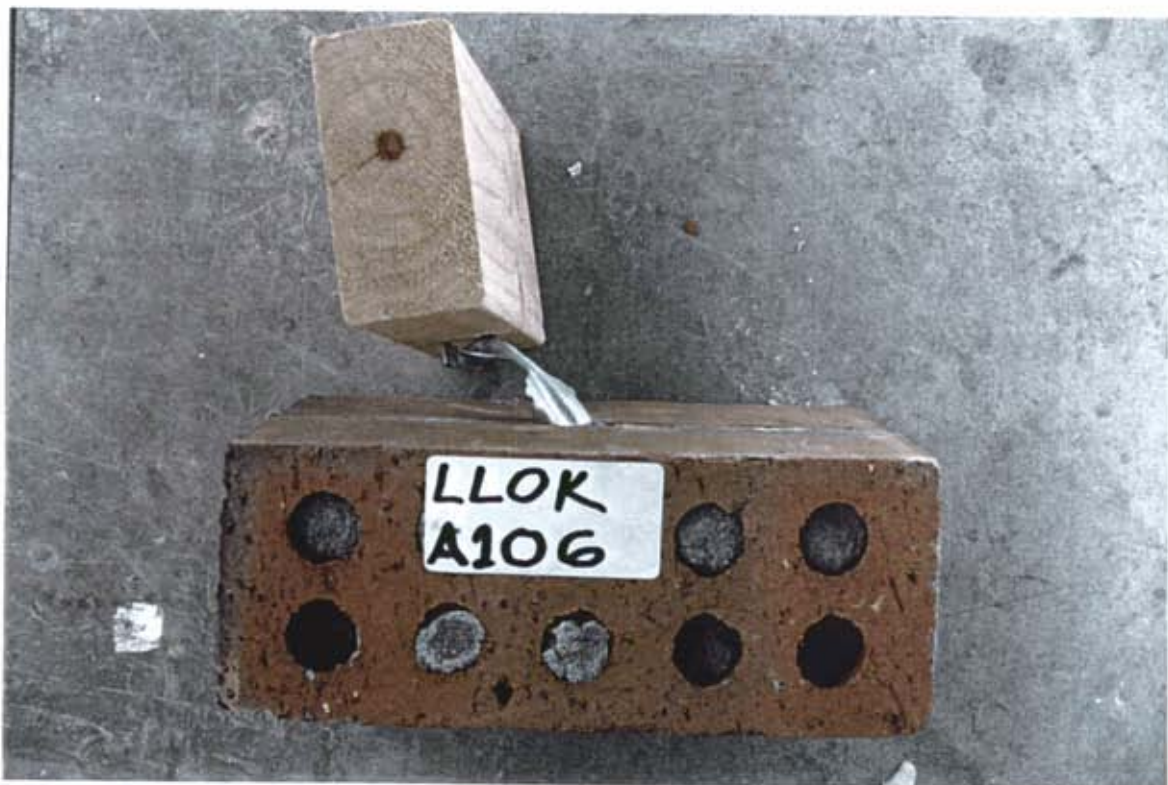
Photograph 6: Type 3 tie after in-plane cycling

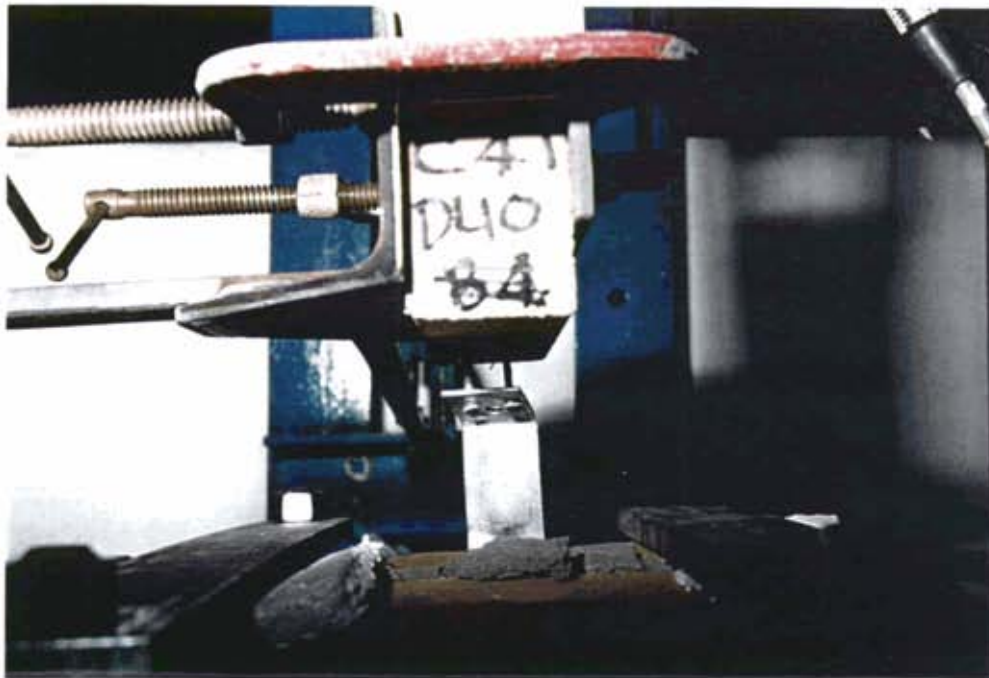
Photograph 8: Type 2 tie after axial cycling, showing nail withdrawal due to 'levering' action during compression

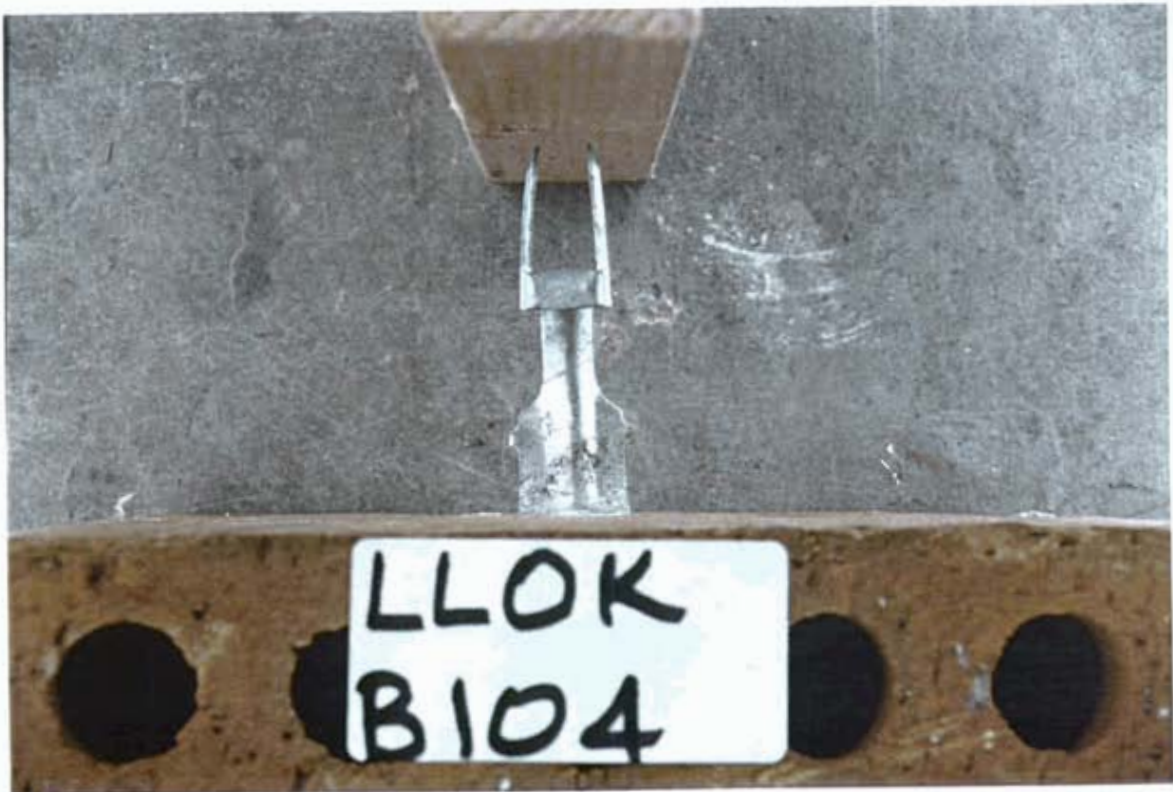
Photograph 9: Type 3 tie after axial cycling showing nail withdrawal

The result of this is that, during subsequent axial cyclic loading, some ties failed by nail withdrawal (Photograph 9), some failed by nails breaking off (Photograph 10), and some survived the test (Photograph 11). The unpredictability of failures rules out any possibility of ductile behaviour, which is desirable for good seismic performance.

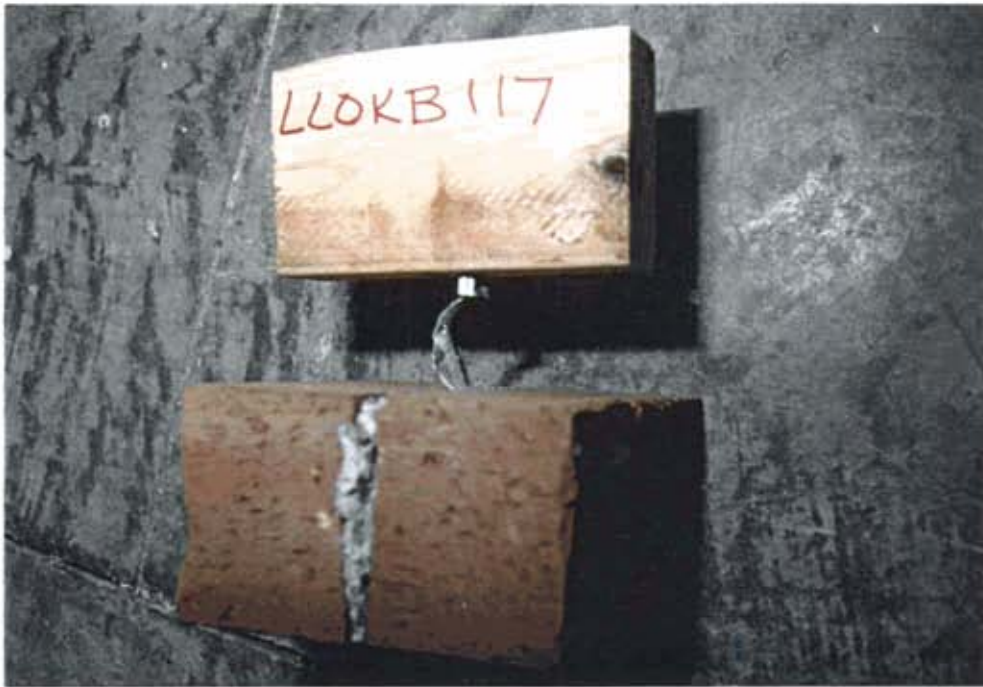
Photograph 11: Type 3 tie after axial cycling

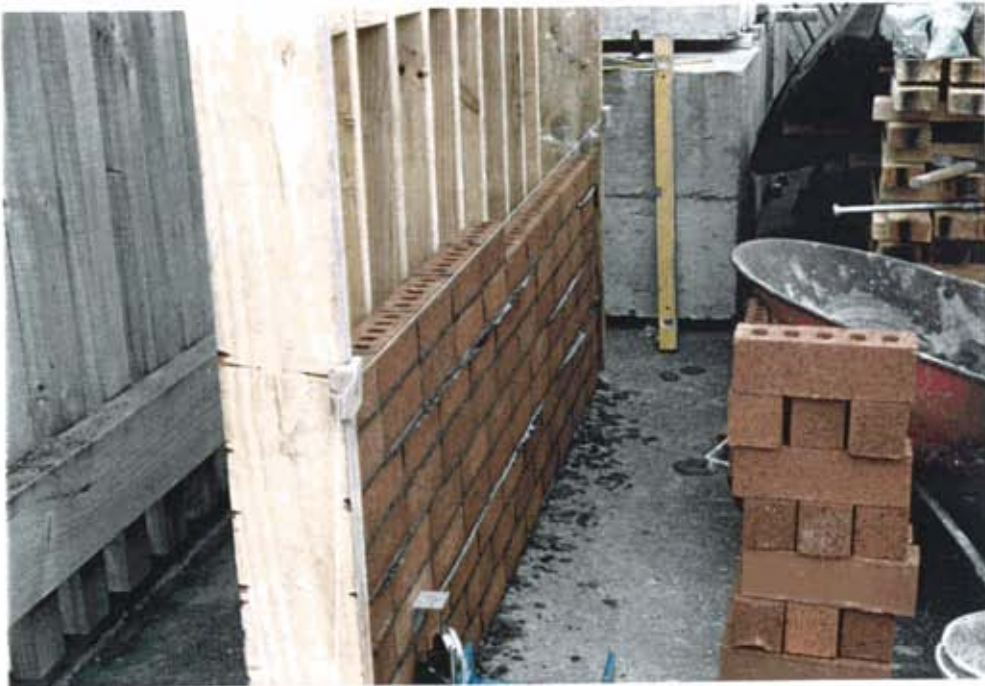
Photograph 12: Construction of series 4 specimens

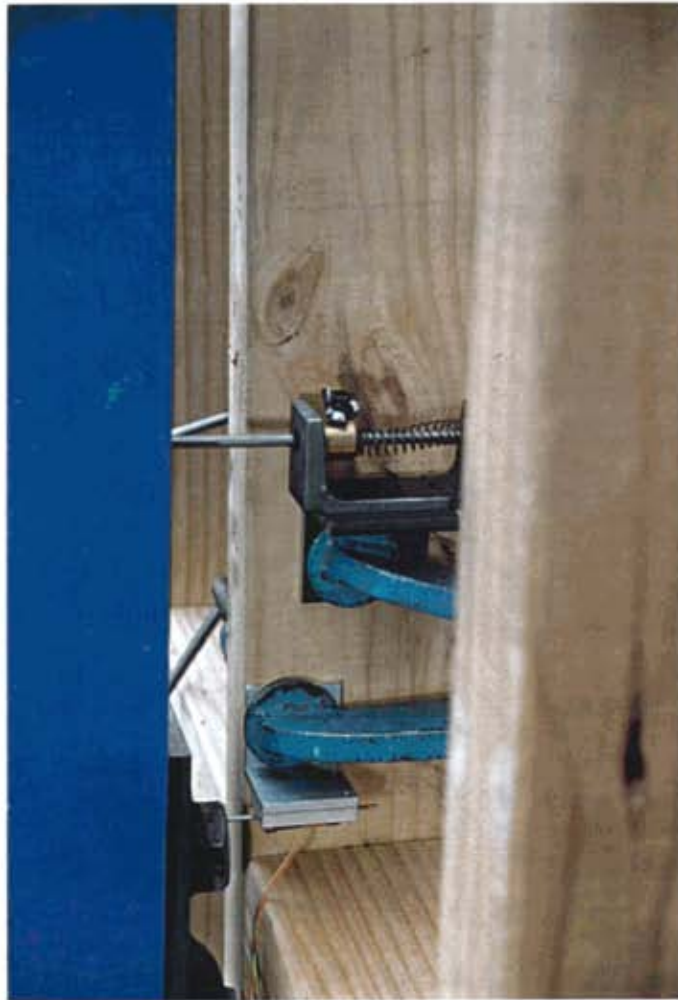
Photograph 13: Monitoring stud movement under tie installation

During bricklaying, the relative movement between studs and bricks under the hammering action of tie installation was monitored with a potentiometer (see Photograph 13). Studs moved up to 3mm under this action, measured at the tie below the one being installed. The lower tie was clearly observed moving in the partially hardened mortar.

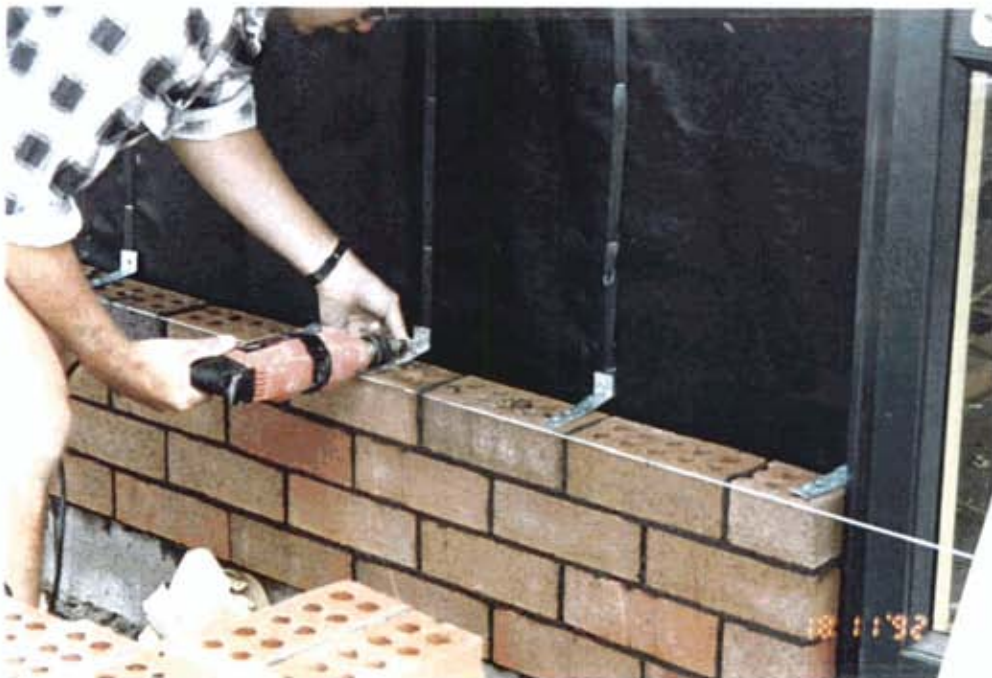
Photograph 14: Installing ties using screwdriver

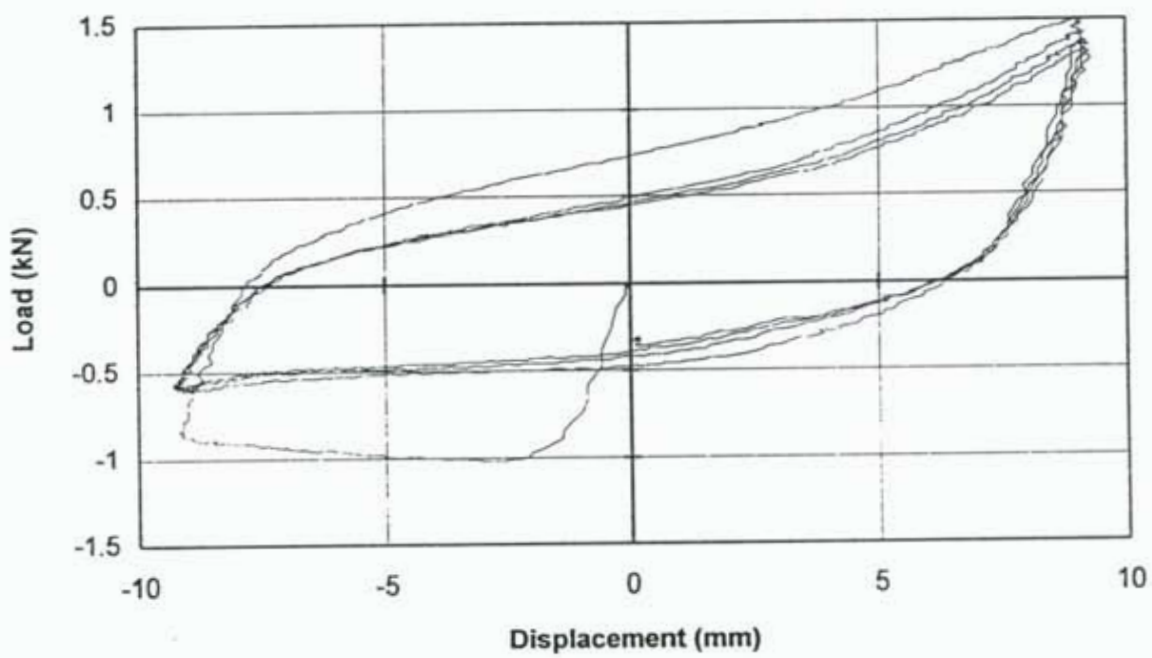
Figure 11: Tie type 1. Axial cycling in 70 series brick
