# STUDY REPORT

No. 162 (2007)

## **Maximum Wall Bracing Rating that is compatible with NZ 3604 Construction**

**Phase I: Theory, Summary and Bracing Testing of Single Walls on a  
Timber Piled Foundation**

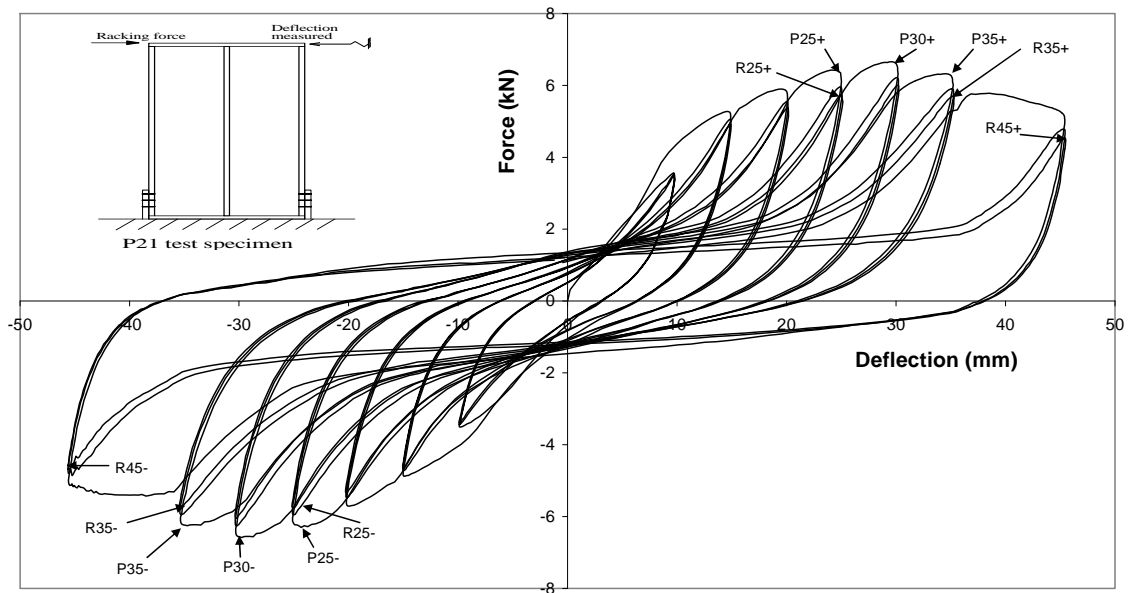
Figure 1 shows typical *hysteresis* loops generated in a P21 test. Such loops are used to determine the wall bracing rating.

**Figure 1. Hysteresis loops from a typical P21 test**

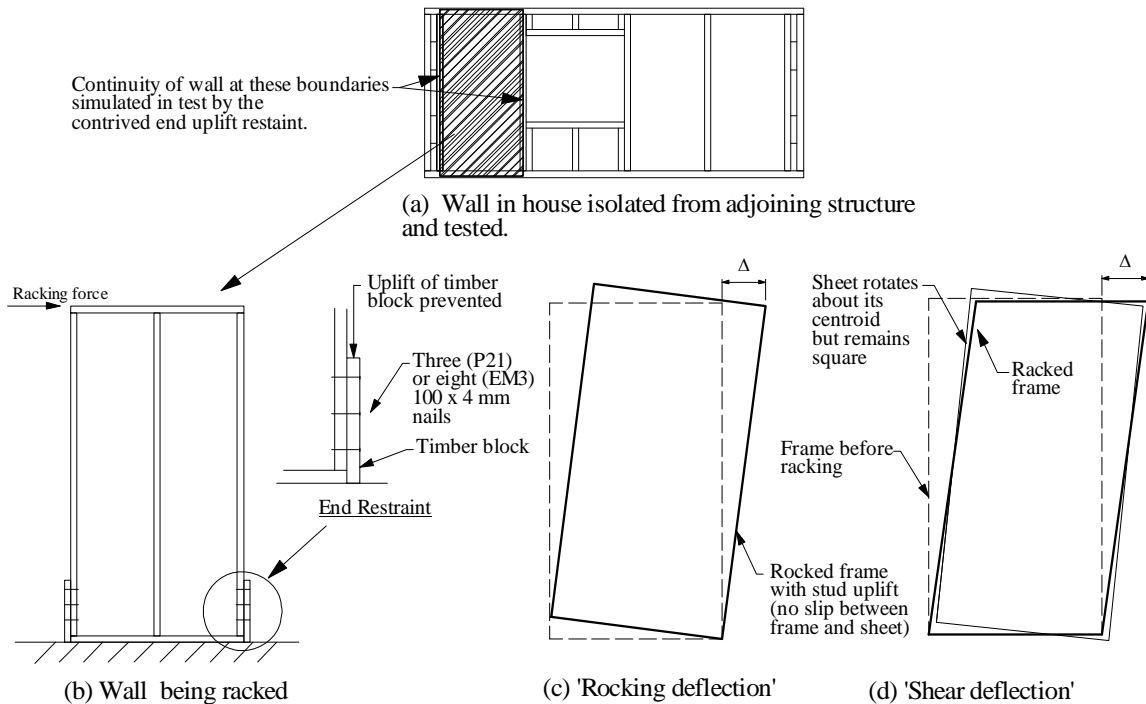
The P21 method uses a 'three-nail' end restraint to simulate the resistance to uplift which exists in real buildings due to the continuity of construction. This is illustrated in Figure 2(b).

**Figure 2. Components of racking wall deflection and sketch of the BRANZ P21 uplift restraints**

If bracing walls are isolated from the surrounding structure and laboratory tested under horizontal racking loads, without any 'supplementary' end restraints to simulate continuity of actual construction, they would fail at a low racking load unless they included 'special uplift restraints'. This is because the test wall 'rocks' about the bottom compression corner as shown in Figure 2(c).

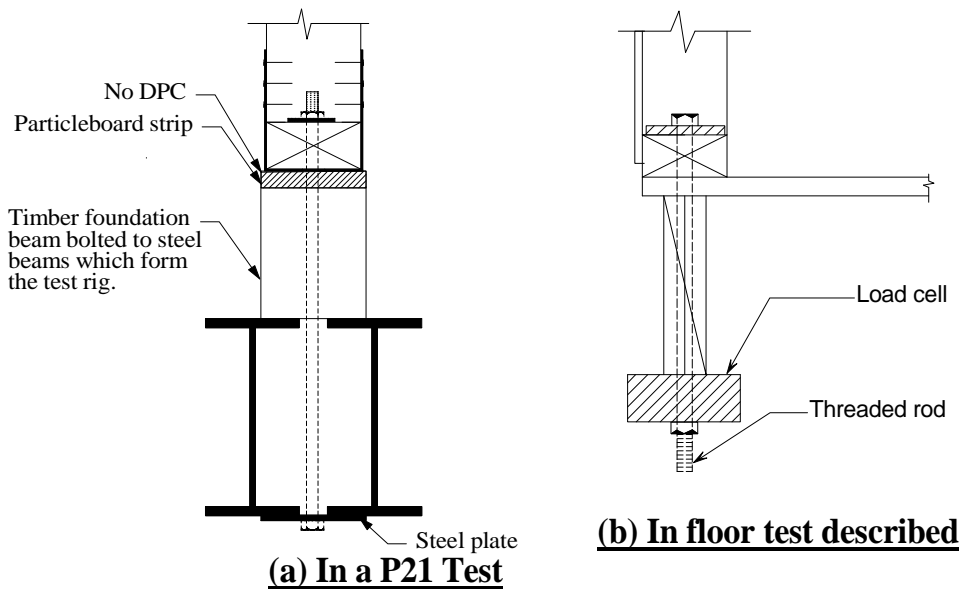
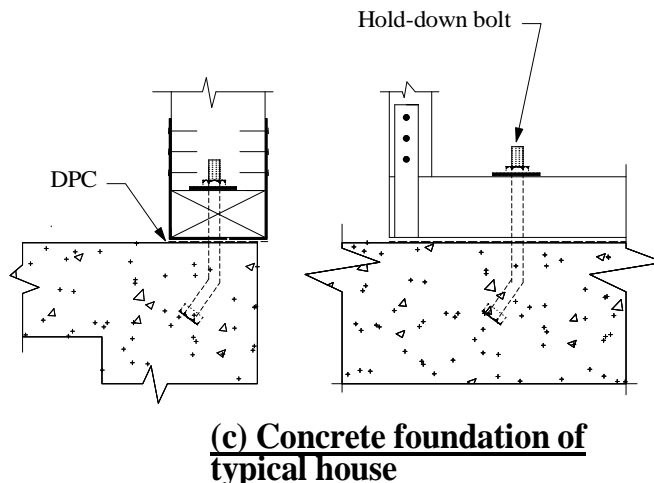
In a P21 test the foundation member is a composite beam consisting of a 19 mm thick particleboard strip fixed to the top of a 100 mm wide timber beam. The beam is fully restrained from movement by bolting it to steel test rig base as shown in Figure 4(a).

Figure 4. Using bolts to fix a wall to foundation

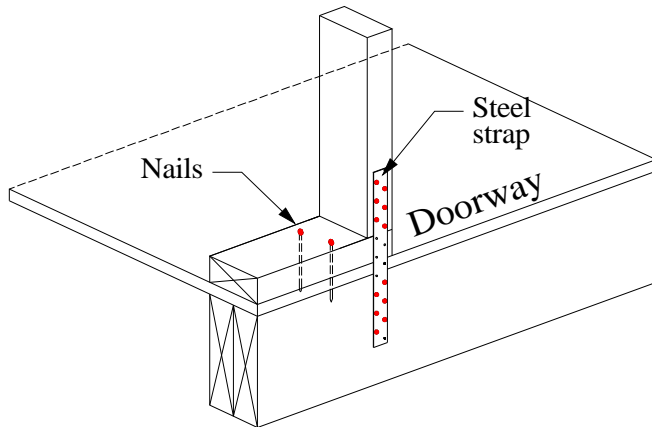
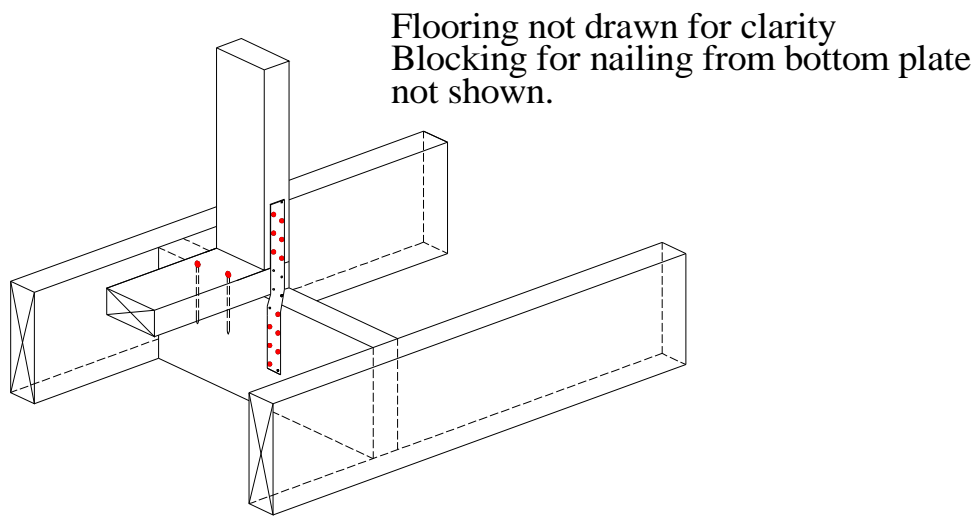
(a) Wall above joists

(b) Wall above blocking

Figure 5. Using straps to fix a wall-to-timber foundations

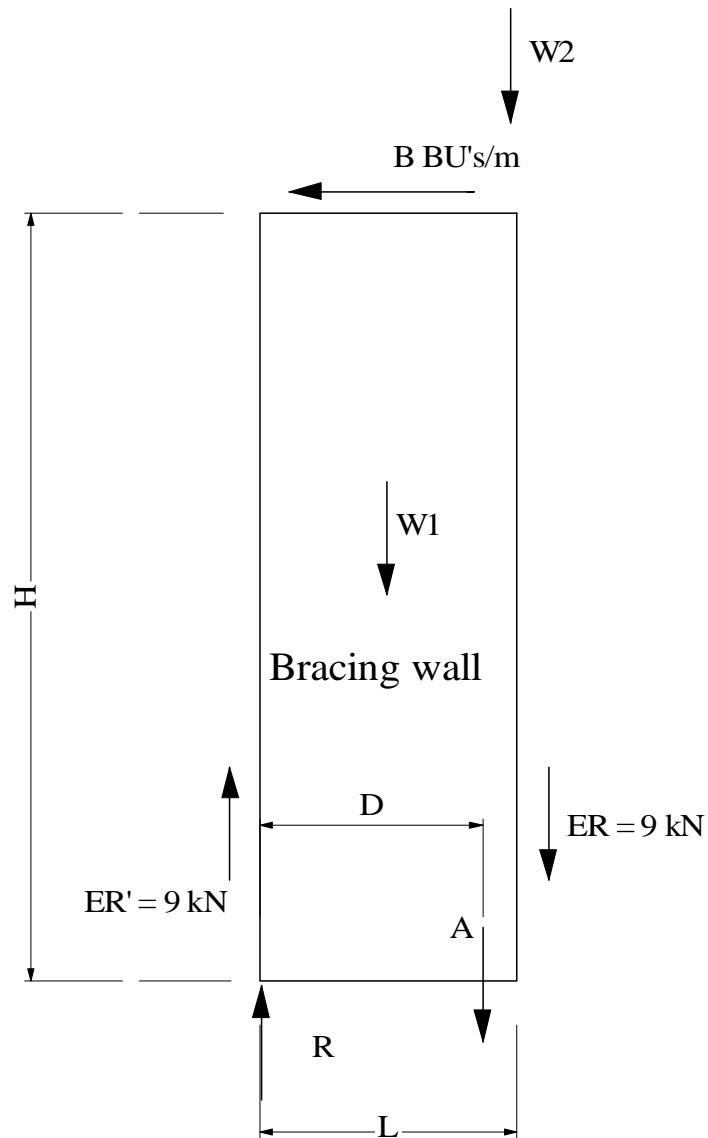
Figure 6 includes vertical gravity loads on the wall. W1 is the panel self-weight based on a weight per unit area of 0.4 kPa. The weight on the panel from the structure above, W2, has been assumed to act at the 'lifting' end of the panel, and is taken as 5.5 kN where there is a floor above and 0.6 kN where there is not. These were calculated using the same weights which are the basis of NZS 3604:1999 seismic design and assumed tributary areas.

Figure 6. Rocking forces on bracing panel

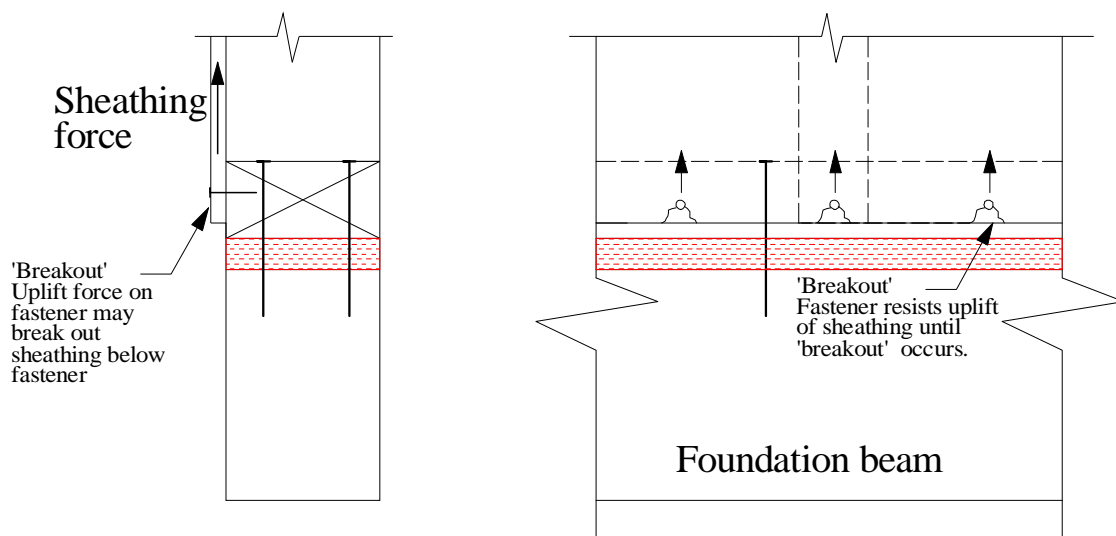
Figure 7. Transfer of sheathing uplift force to bottom plate via bottom plate nails

By taking moments about the wall corners, it can be shown that the presence of nail fixings tend to reduce the anchorage tension force, 'A', but increases the end downwards reaction, 'R'. However, the foundation below the wall is still subjected to the combined tension force from all connections from the wall to the foundation. The effect of these the additional fixings has not been included in Table 1 and Table 2.

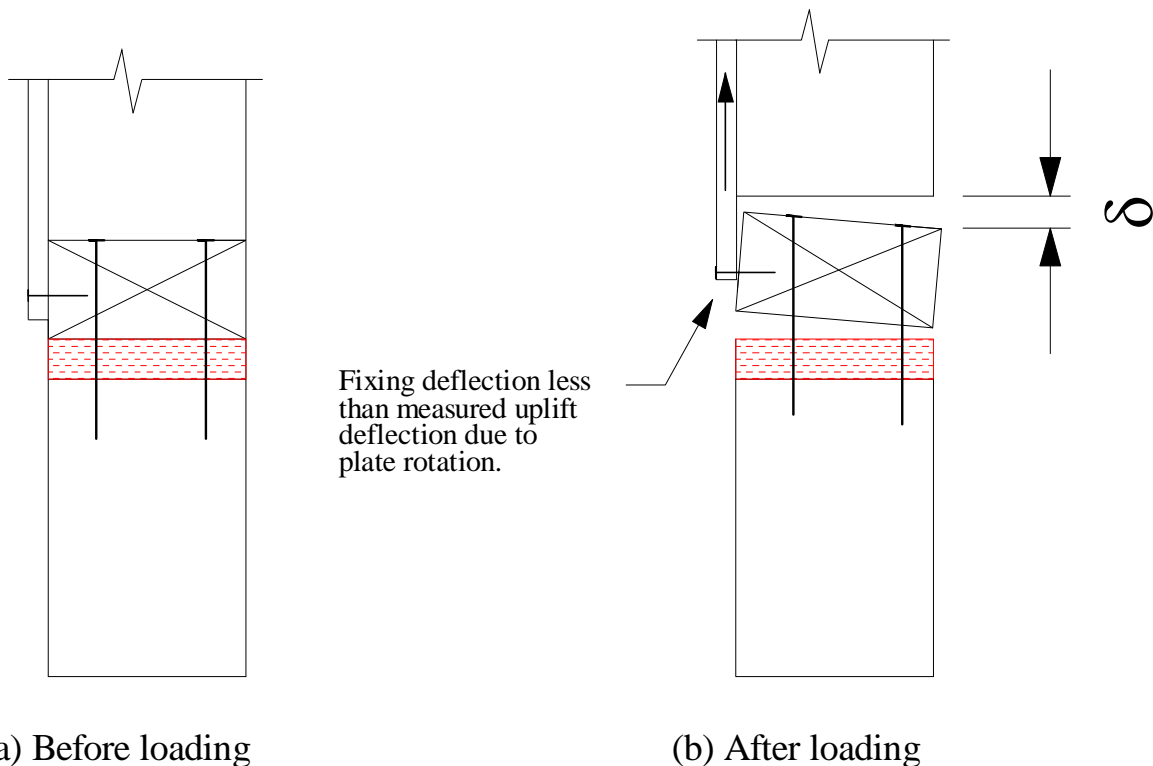
**Figure 8. Rotation of bottom plate in a wall sheathed on one side only**

If a bracing wall is governed by the anchor strength, then the additional bottom plate nails will increase the wall 'rocking' strength. Assume that the wall sheathing is sufficiently strong that a nail pull-out strength of  $F_n = 3.1$  kN for a pair of nails can be relied upon. This means that for a given anchorage force, 'A', a 1.2 m long wall with bottom plate nails at 600 mm centres can provide an increase in bracing per unit length of  $= \sum(F_n \cdot X_i) \cdot 20/H/L = 3.1 \times (1.1 + 0.5) \times 20/2.4/1.2 = 34$  BU's/m where  $X_i$  is the distance from nail pair 'i' to the compression toe of the wall. This is significant.

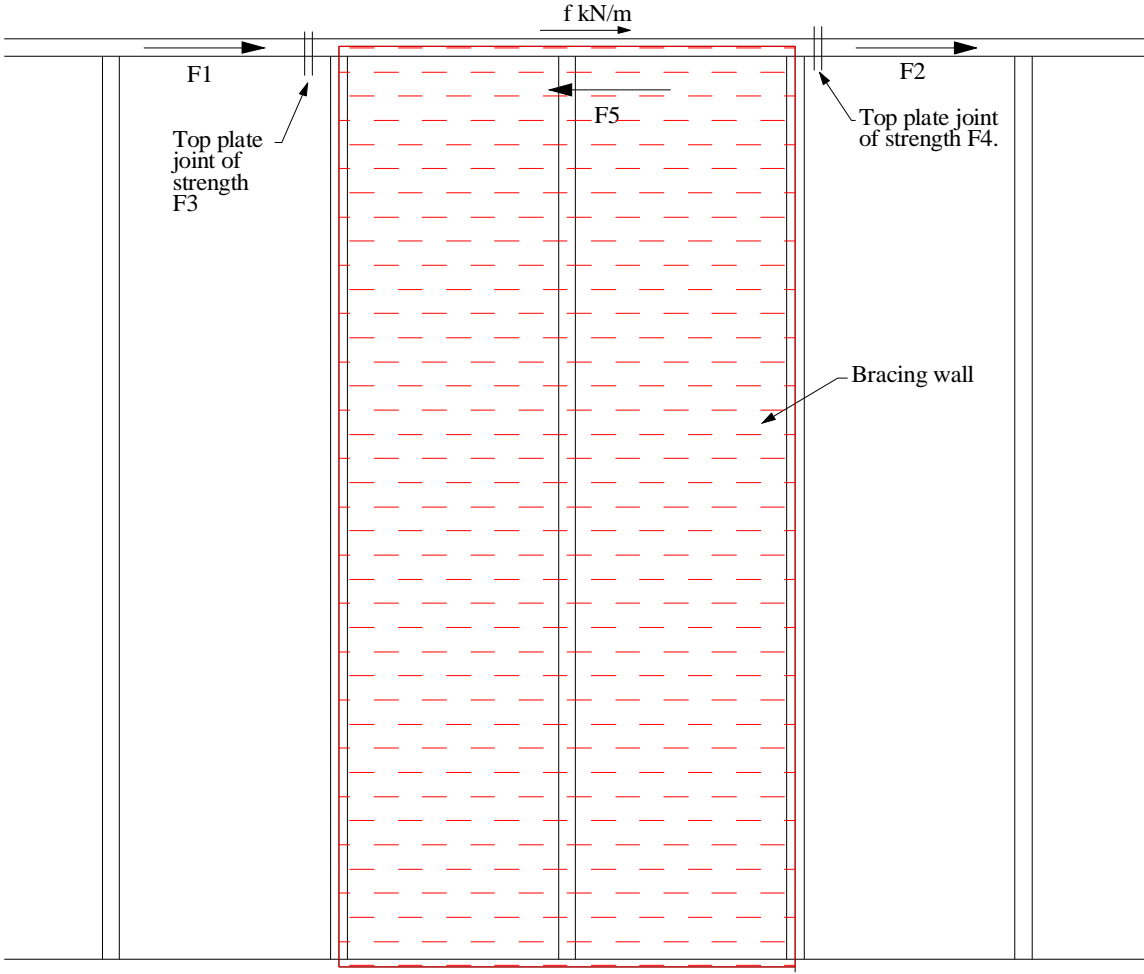
The provisions in NZS 3604 for joints in top plates are contained in Section 8.7.3.3. A 3 kN connection is required where the wall contains a bracing element of up to 100 BU's (5 kN), and 6 kN where the element is greater than 100 BU's. With regard to this project it can be considered that a 6 kN top plate connection exists at the two parallel vertical lines shown in the top plate in Figure 9. Bracing walls in the middle of long walls can be loaded from the plate on both sides which gives a total load of 12 kN which can be transmitted to the bracing wall. For bracing walls at wall corners NZS 3604 Section 8.7.3.4 requires a 6 kN connection at the corner, which again provides a total of 12 kN load which can be transmitted to the bracing wall.

Figure 9. Transmission of force from top plate into bracing wall

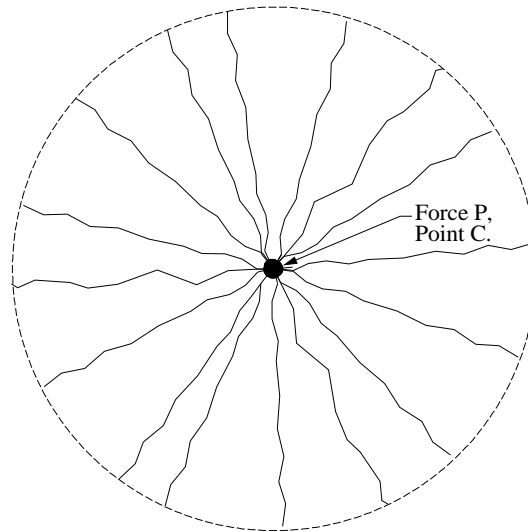
Figure 10. Yield line crack pattern in concrete slab

Although the slab may not be ductile enough to develop a full yield pattern, concrete slab failure is still unlikely to be critical. This conclusion also applies to uplift forces applied by exterior walls as the flexural strength of the local footing is even greater.

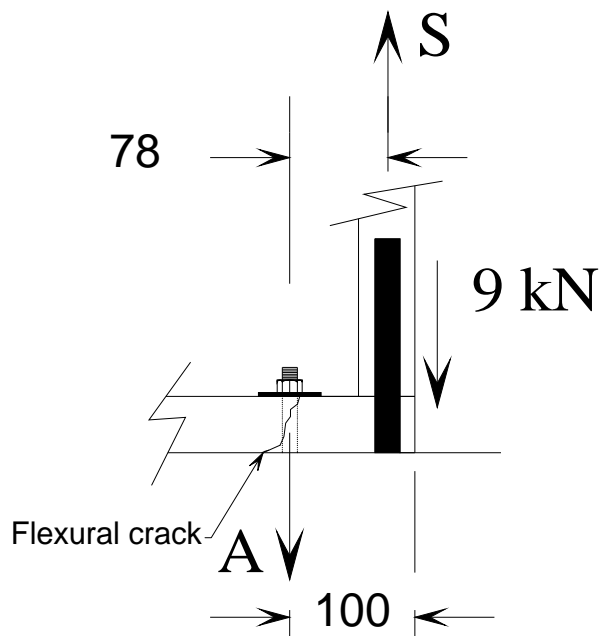
Figure 11. Flexural loading of bottom plate

Note that some bracing systems transfer the tension force in the end stud directly to the foundations by use of steel angle or straps, and thus do not load the bottom plate in flexure.

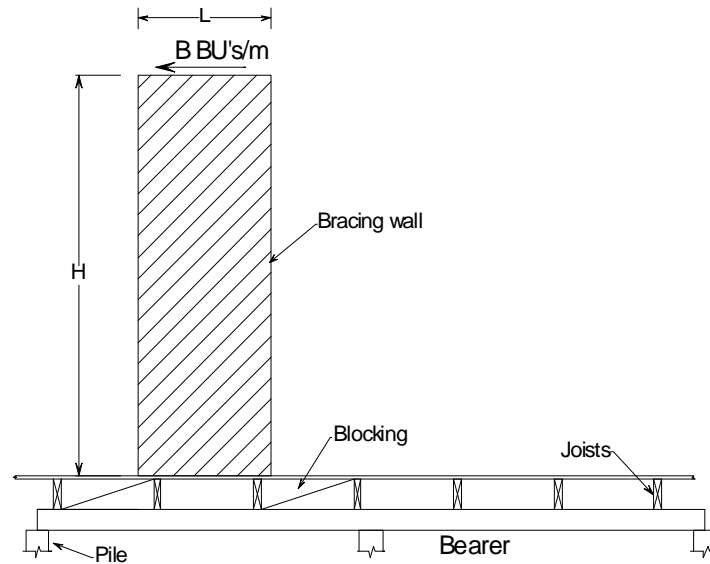
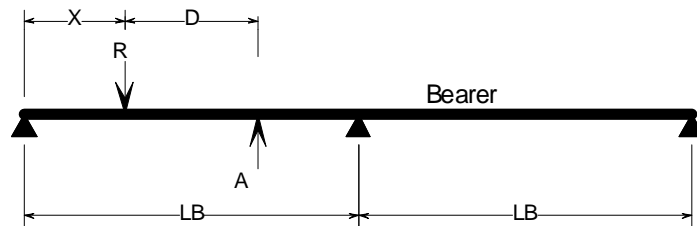
**(a) Construction**

**(b) Model to determine maximum joist bending moment**

**(c) Model to determine maximum bearer bending moment**

**Figure 12. Loading on joists and bearers**

Figure 12(a) shows the loading and Figure 12(b) shows the model used to determine the maximum joist bending moment. The bracing force B (BU's/m) can be in either horizontal direction, and so the absolute value of joist bending moments should be added to those produced by gravity loading. The most critical situation is the wall orientated perpendicular to the joists with the compression end located at joist mid-span (with no blocking being present), although loading from a wall directly above and parallel to a joist can produce similar bending moments.

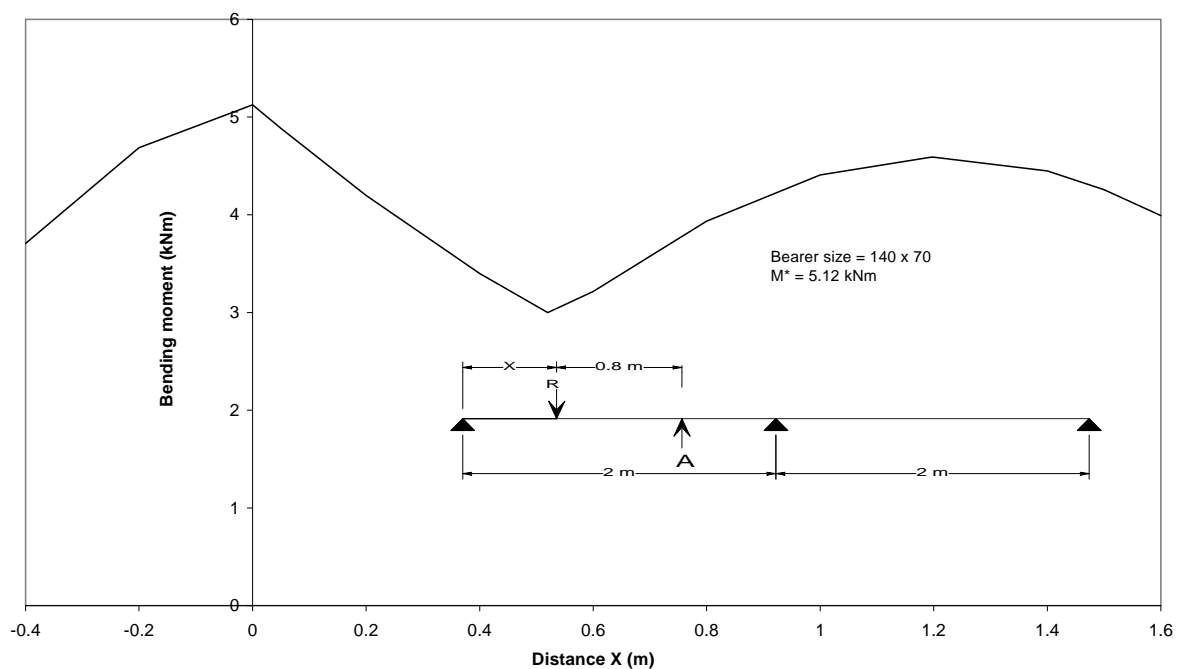
The maximum bending moment on the bearer is a function of the location of the wall on the bearer. For each wall length and bearer length an influence line was used to determine the most critical location. A typical example is shown in Figure 13.

**Figure 13. Typical influence line of maximum bearer bending moment**

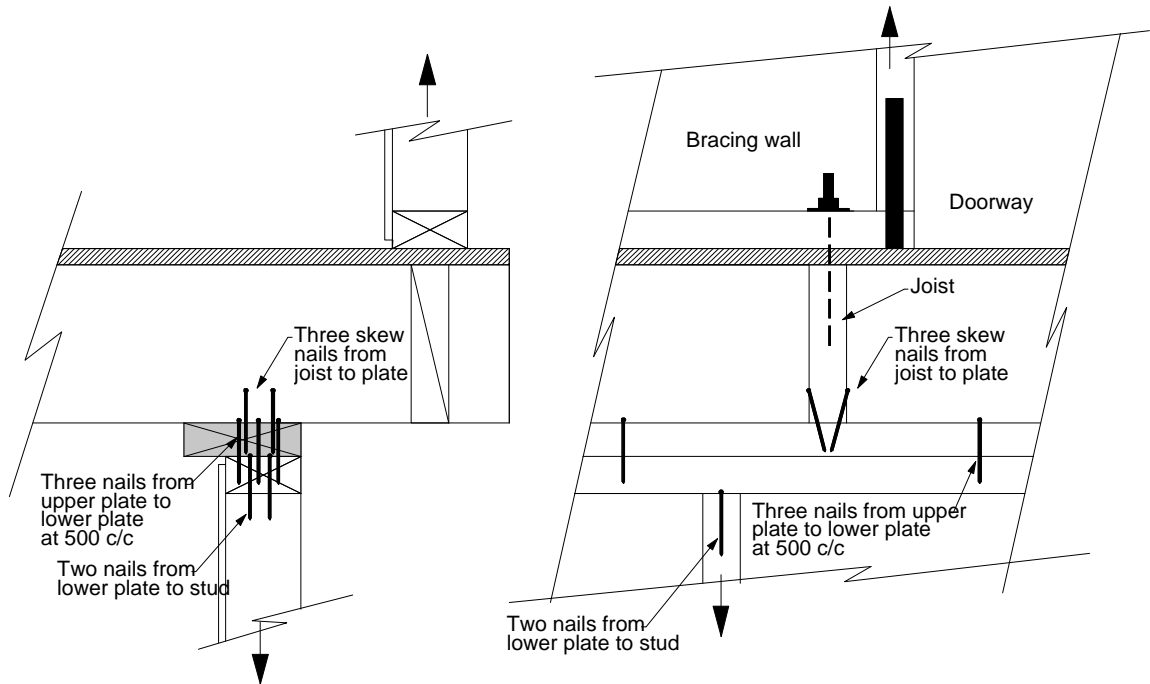
**Figure 14. Cross-section of typical upper floor to lower connection using power-driven nails**

Total gravity load =  $0.9 + 0.48 + 0.48 = 1.86 \text{ kN}$ . Factor this by 0.9 and add on the joint strength of 4.0 kN. Also add on ER, being the end continuity restraint which Thurston (2007(b)) recommends to be ER = 9 kN. Total now = 14.67 kN. From Figure 6 and eqn. (1) the bracing rating corresponding to this uplift resistance =  $20 \times 14.67 / H = 122 \text{ BU's/m}$ .

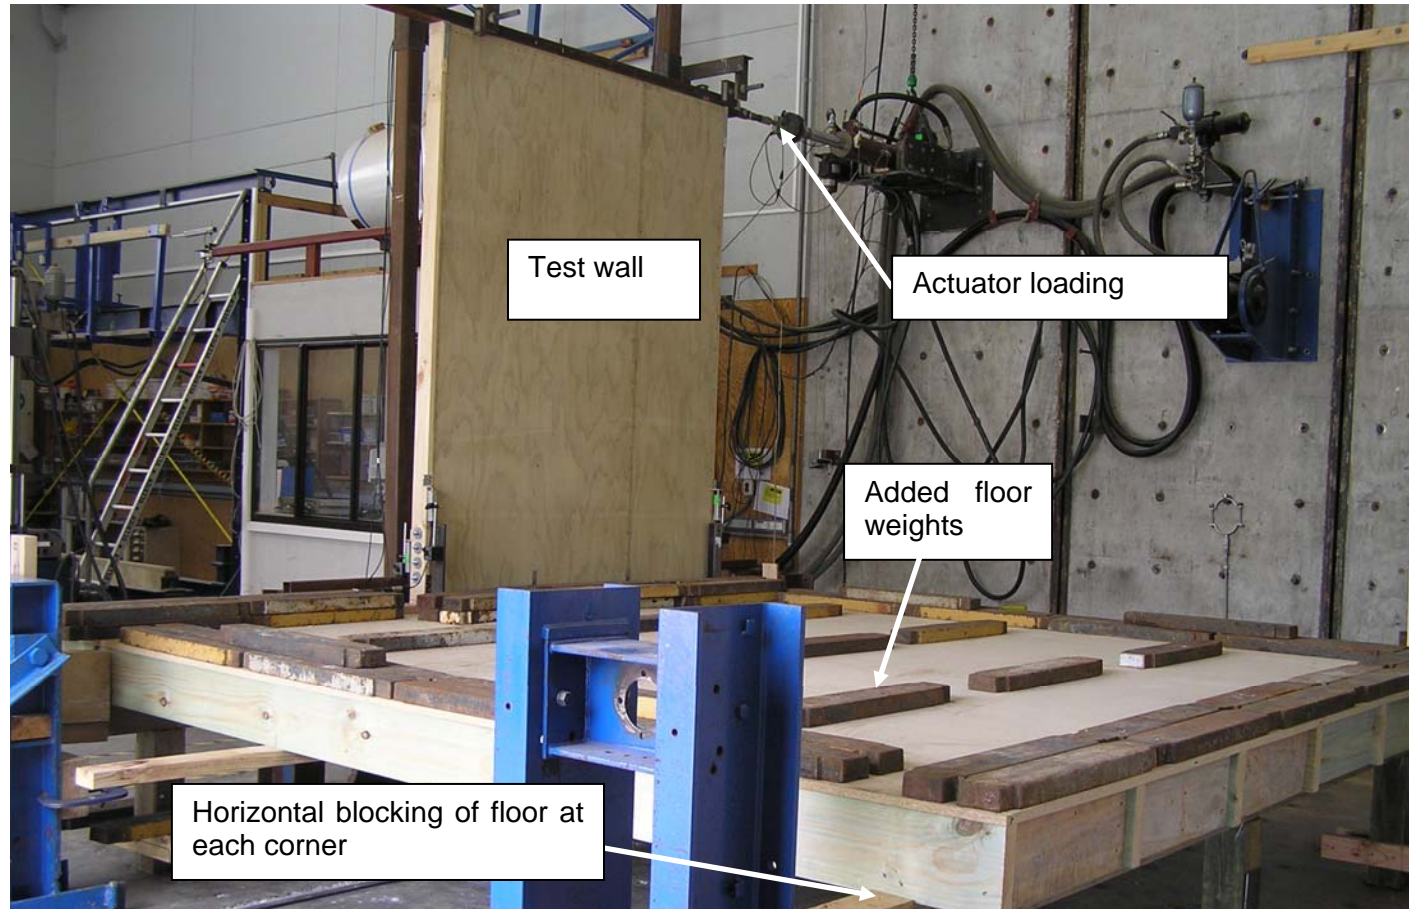
Figure 15. Typical flooring test

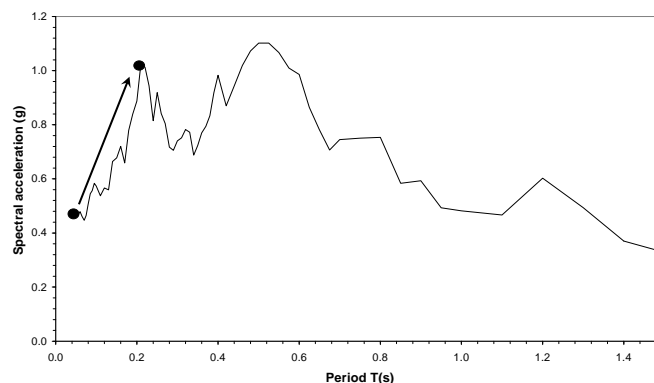
- The earthquake design loads specified in NZS 3604 assume houses have a period of 0.4 seconds, 5% damping and use estimated house weights. Due to the stepwise nature of selecting house weights, actual weights are mostly expected to be less than assumed weights, actual damping is expected to be higher, and periods at low deflections expected to be lower (Thurston 2002, Fischer et al 2000). Thus, houses will attract less than the design seismic load in a design level event. However, the racking flexibility of walls tested in this investigation at high loads was far greater than measured in P21 tests due to the vertical flexibility of the timber foundations. This means that the house period may migrate to more critical periods at high loads, thereby attracting more seismic load as illustrated in Figure 16.

**Figure 16. Typical acceleration response spectrum showing increase in response of a house when flexibility increases**

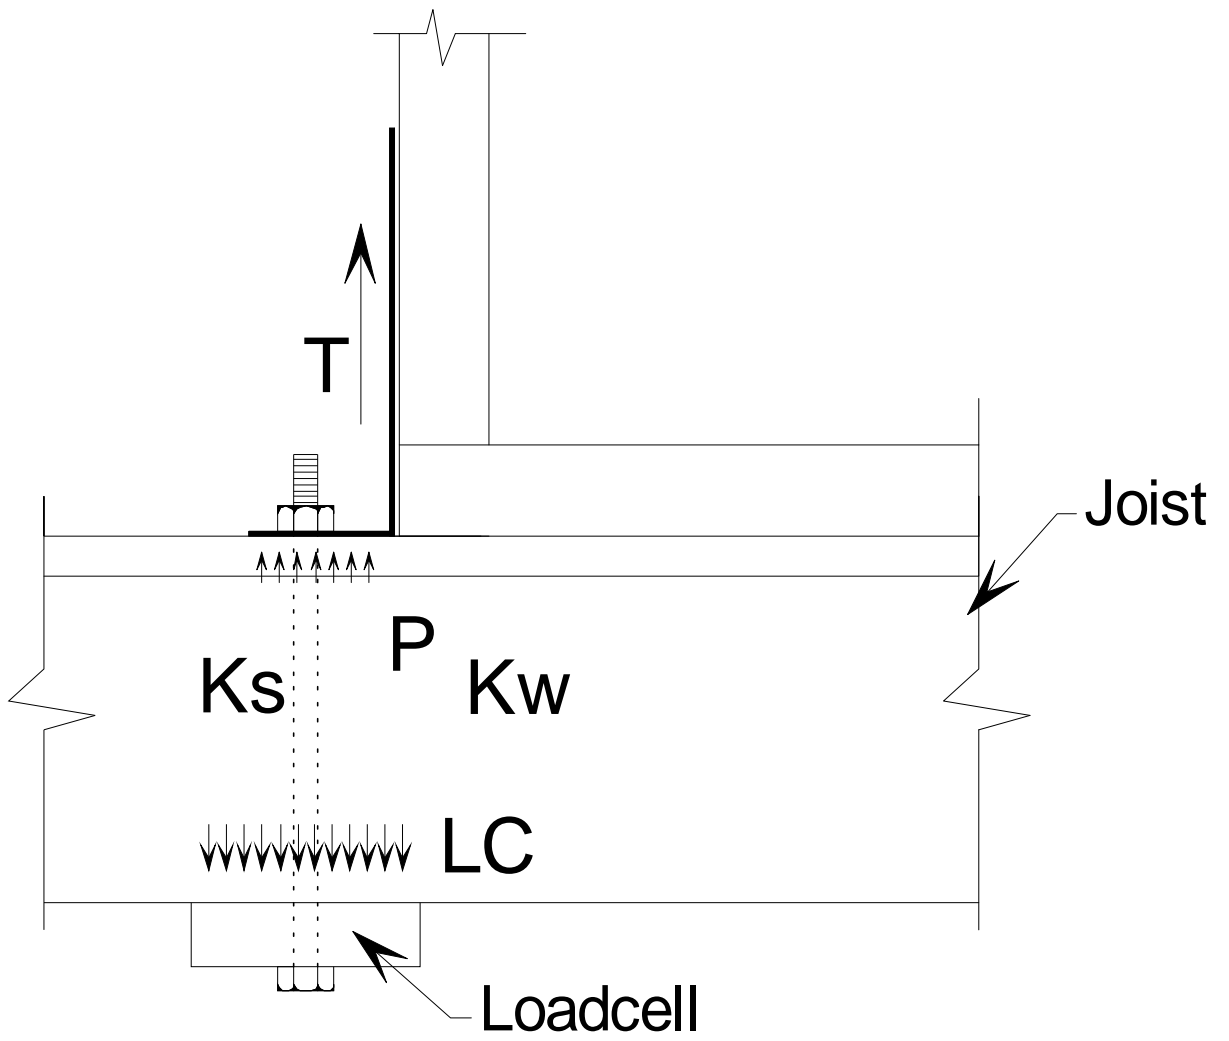
Figure 17. Pre-load of anchor bar and subsequent forces when angle pulled in tension

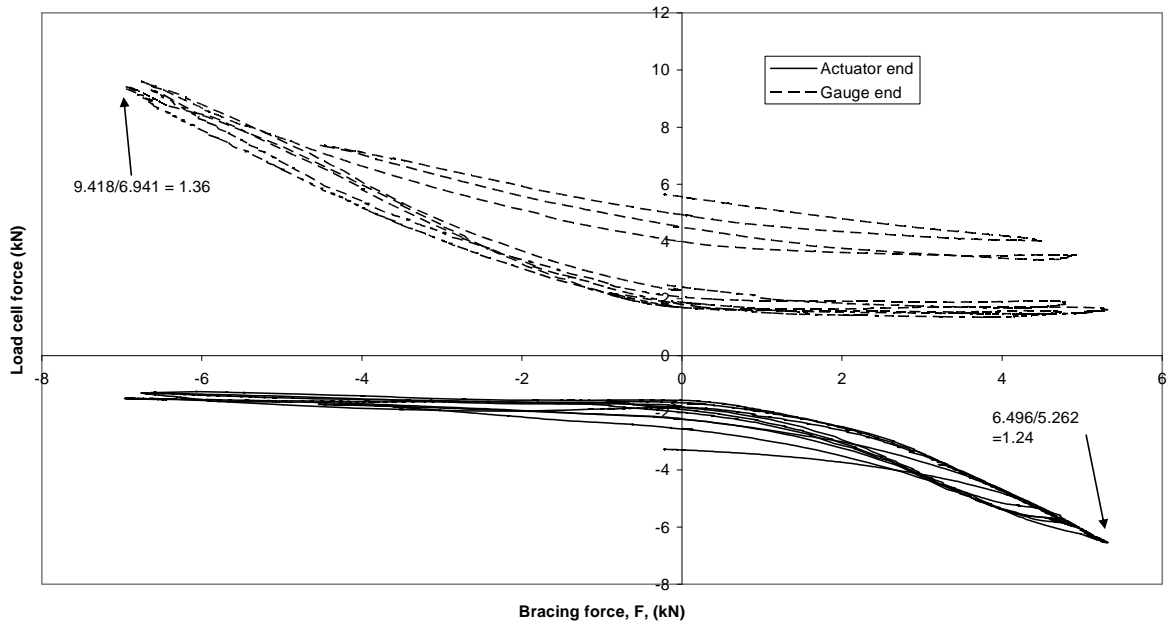
Figure 19. Forces in load cell in Test L1

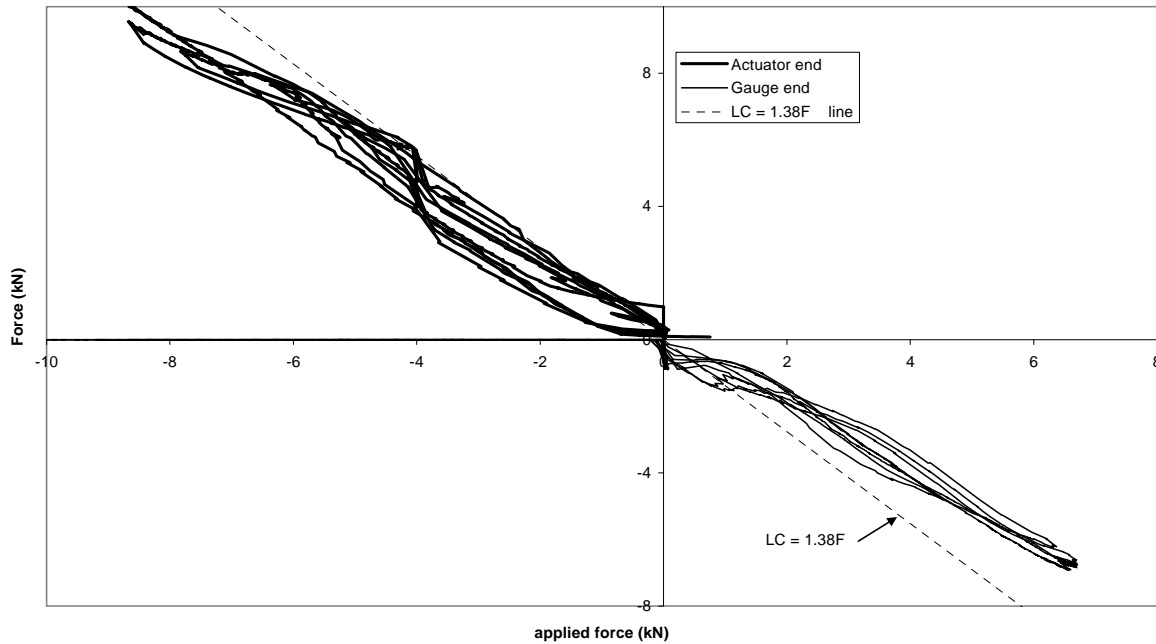
Figure 20 shows a similar plot to Figure 18 but for Test L3. There were two differences for Test L3. The first was that the bolts were only done up finger tight and hence the pre-compression was negligible. The other was that the bottom plate was also nailed with two 100 x 4 flat-head nails near both middle studs. As expected this decreased the measured anchor force from the  $LC = 1.38F$  line as some of the uplift force was taken by these nails.

Figure 20. Forces in load cell in Test L3

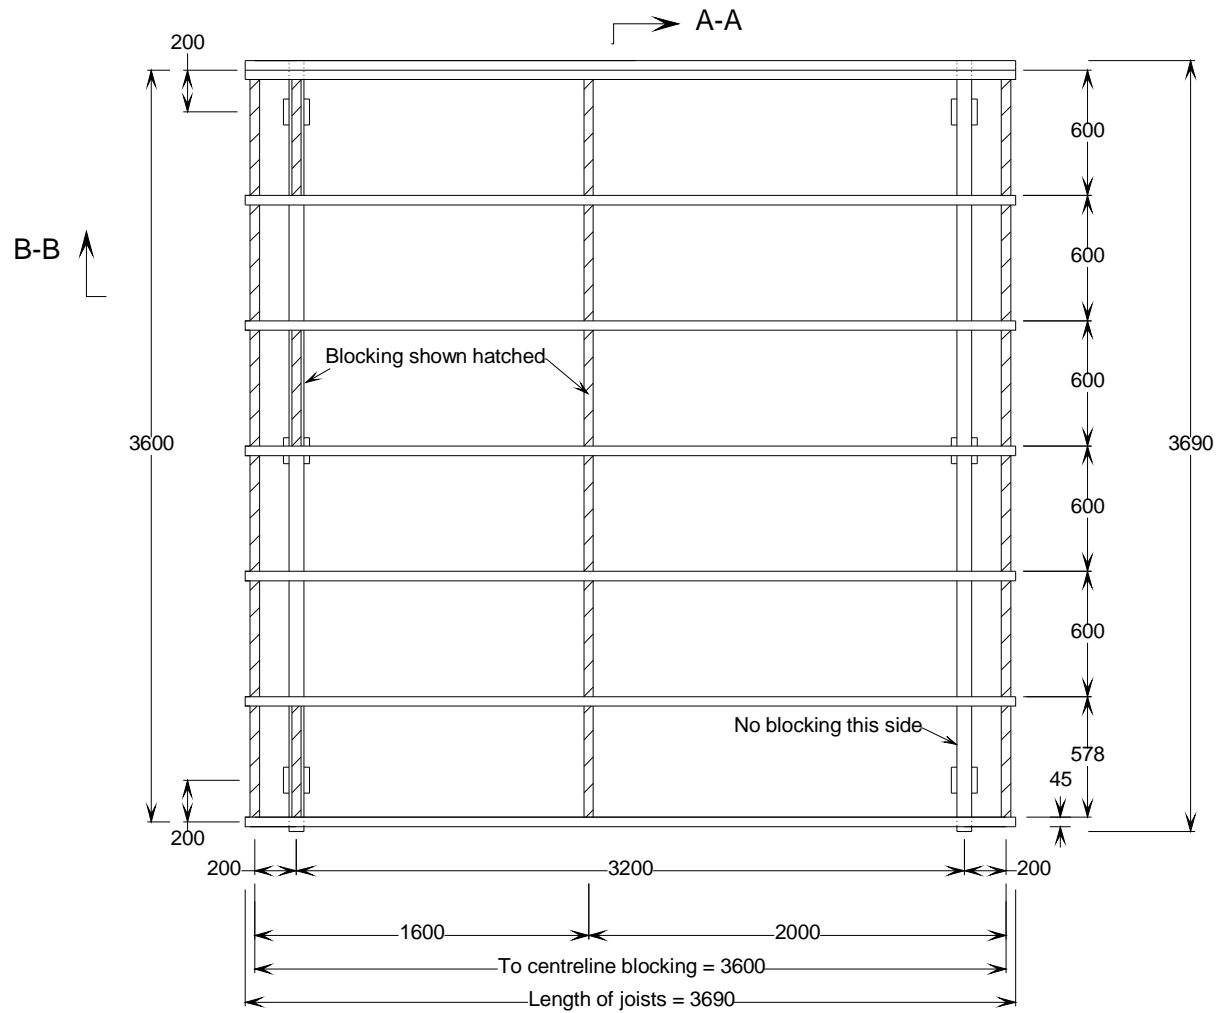
**Figure 21. Plan of floor test specimen**

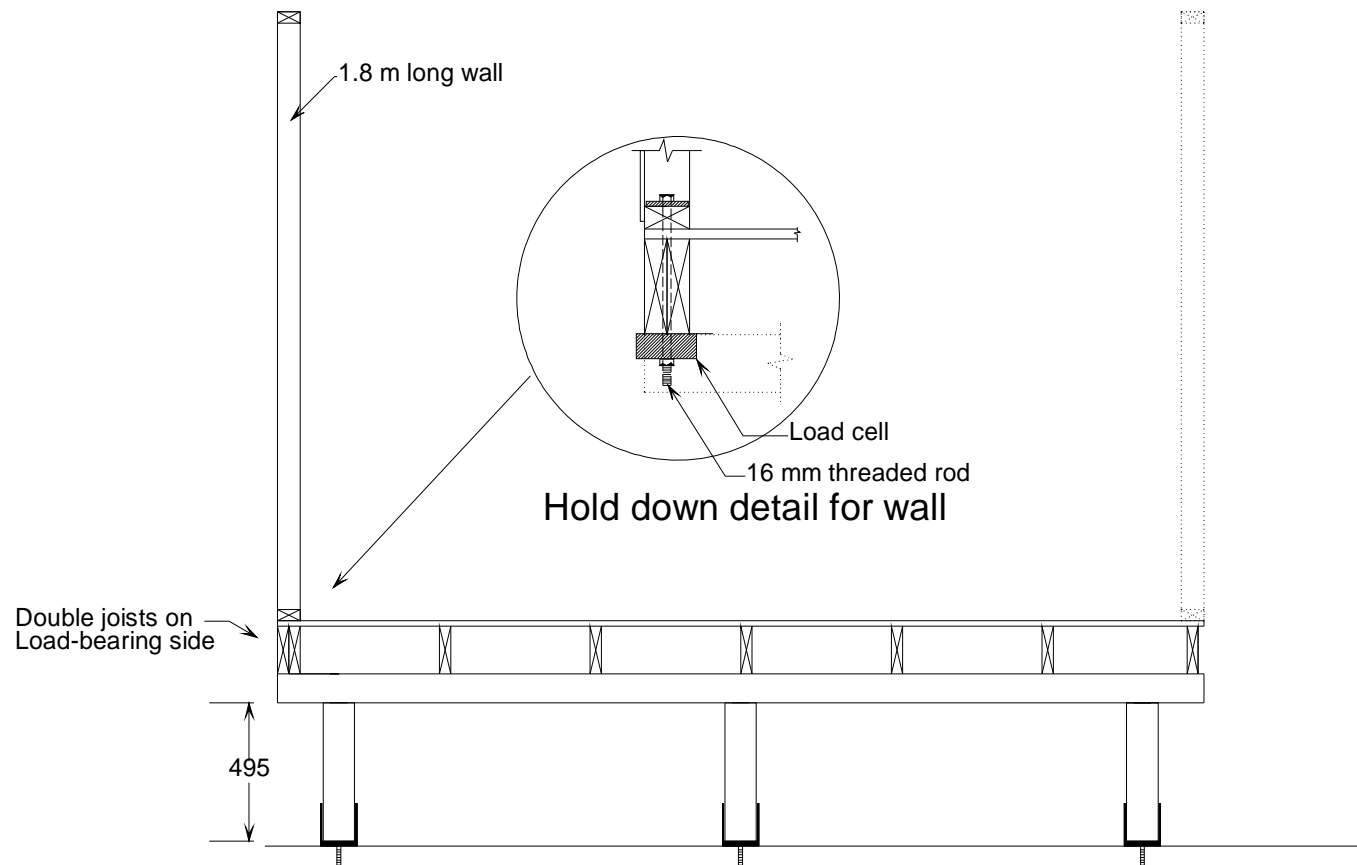
**Figure 22. Section A-A of floor test specimen**  
 (See Figure 21 for location of A-A)

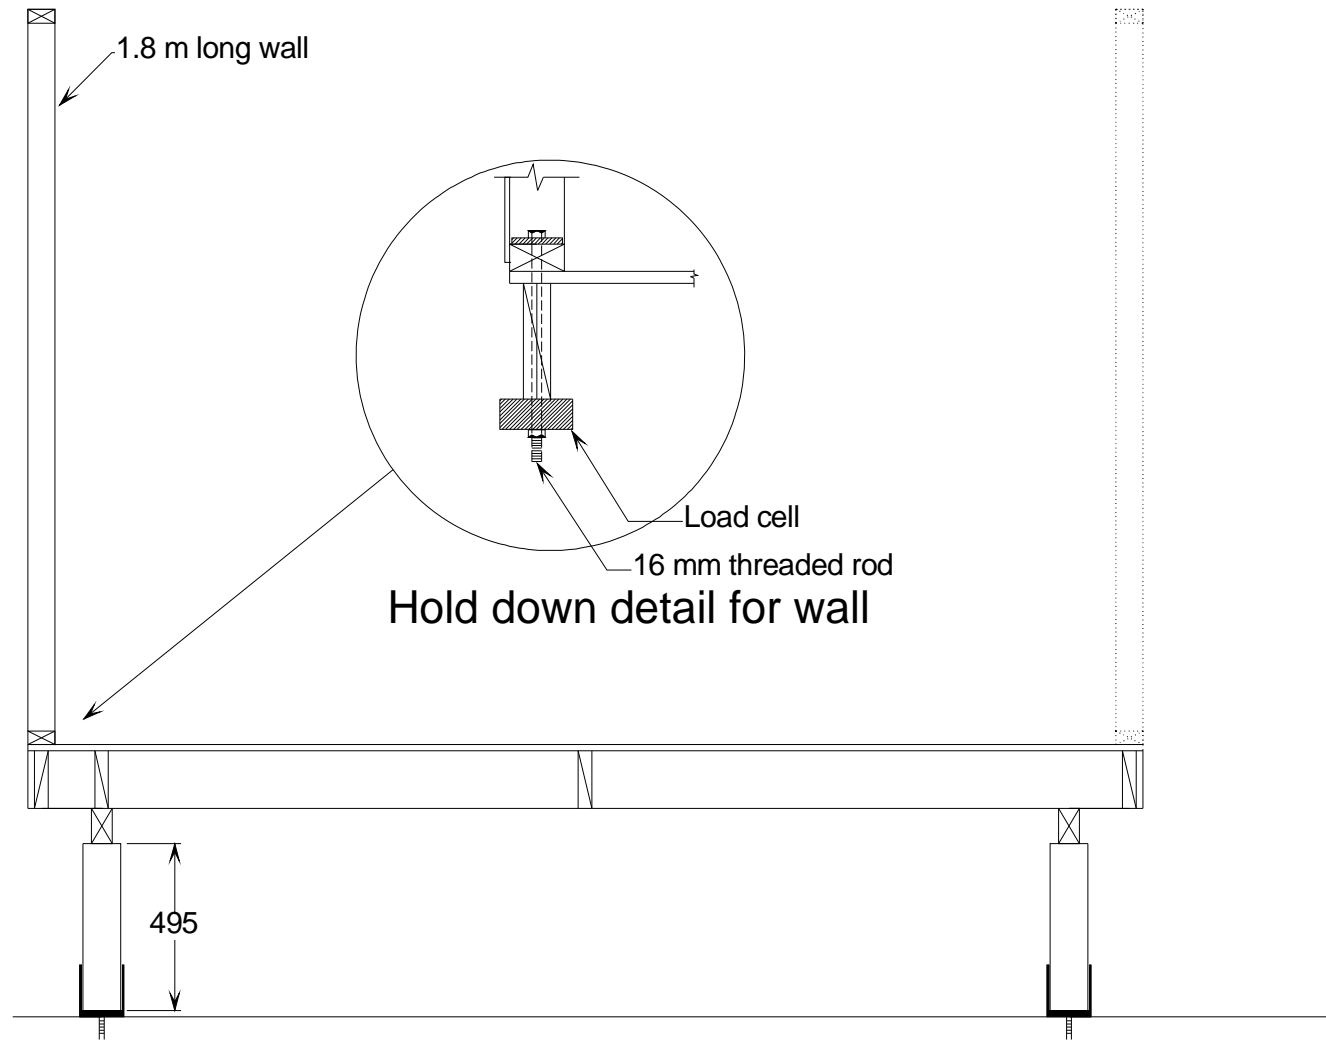
**Figure 23. Section B-B of floor test specimen**  
 (See Figure 21 for location of B-B)

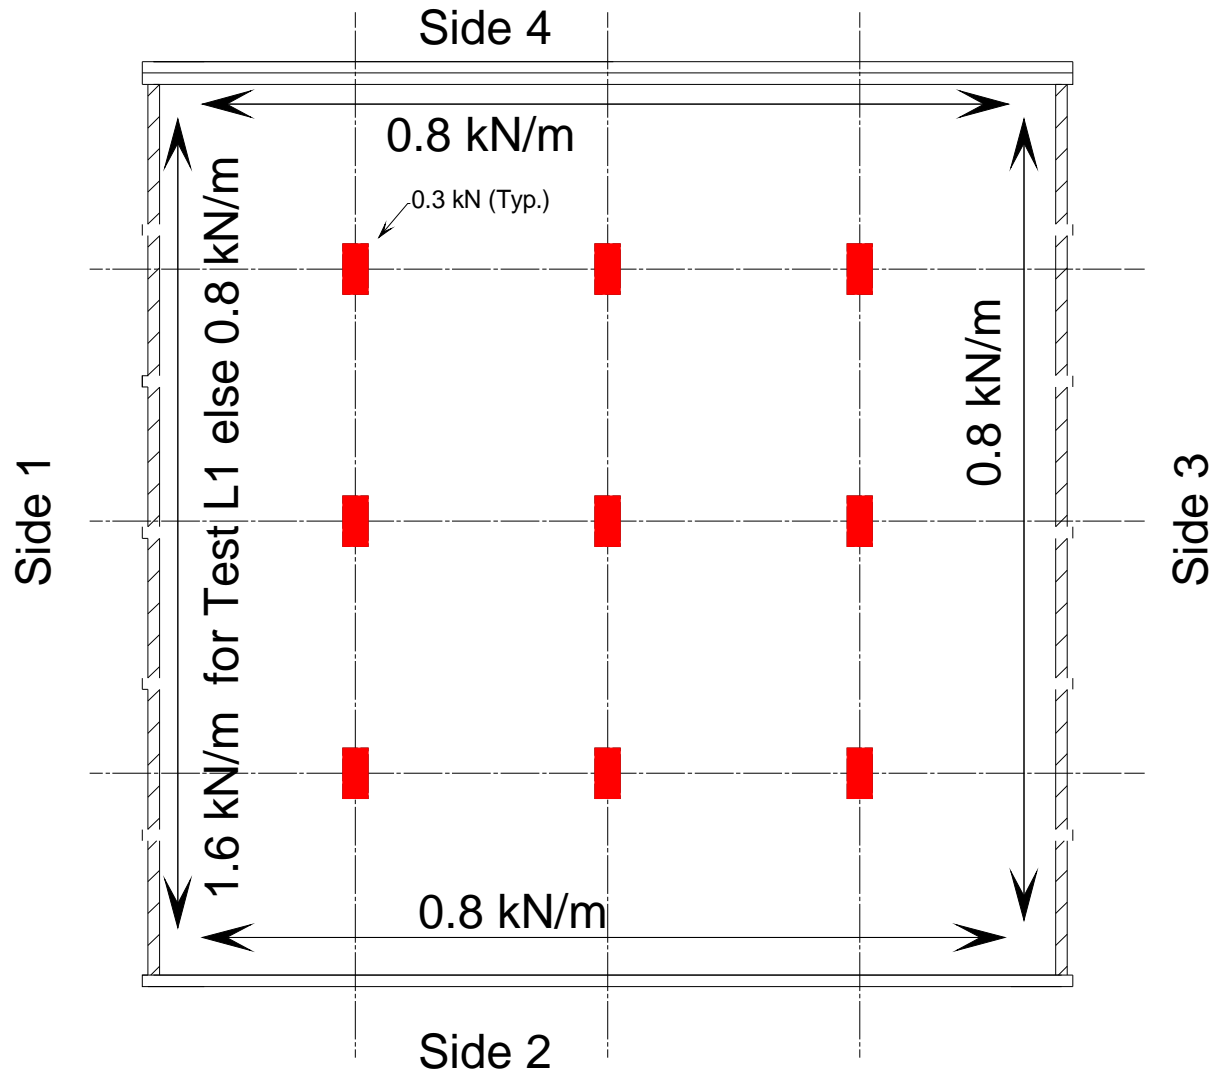
Figure 24. Added floor weights

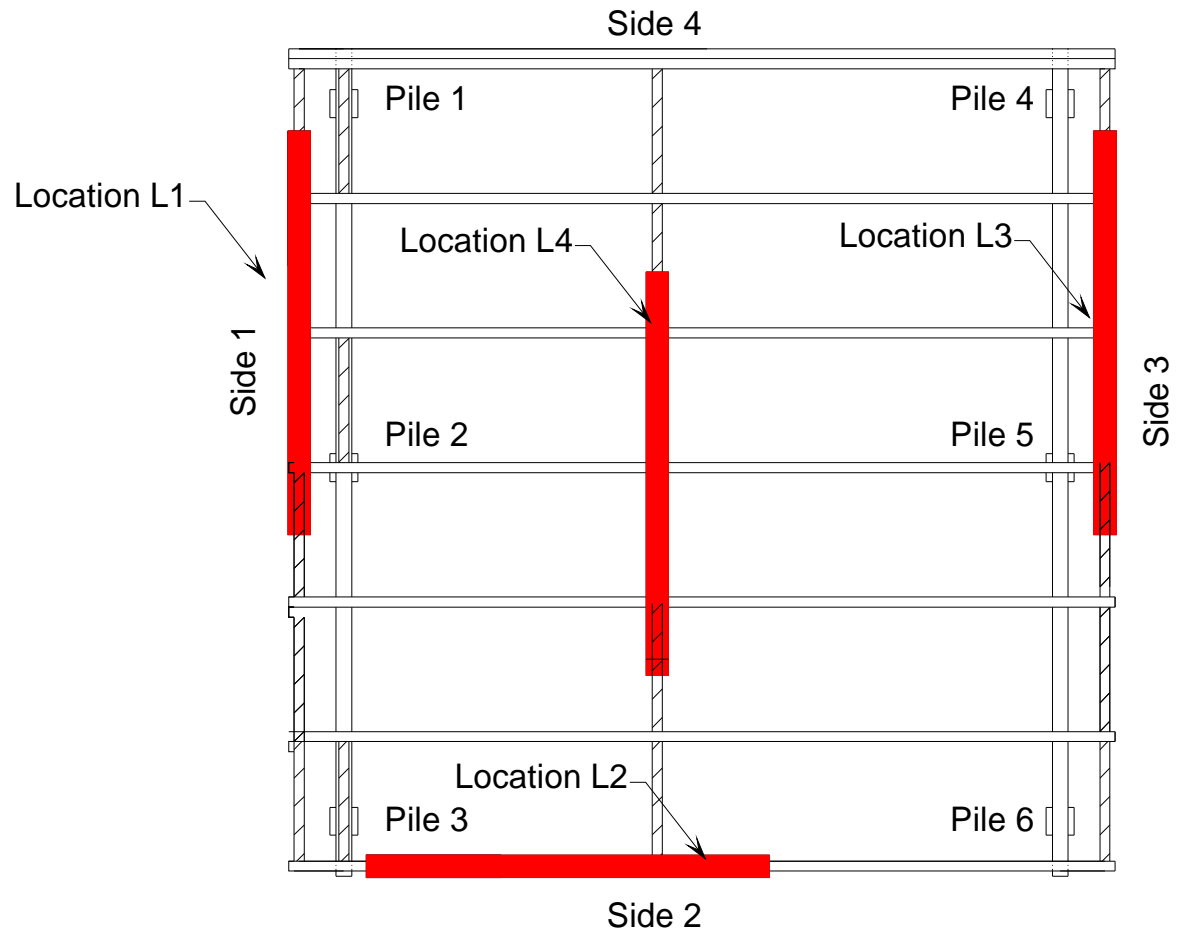
A single test wall was used at each of the above locations

**Figure 25. Location of test wall**

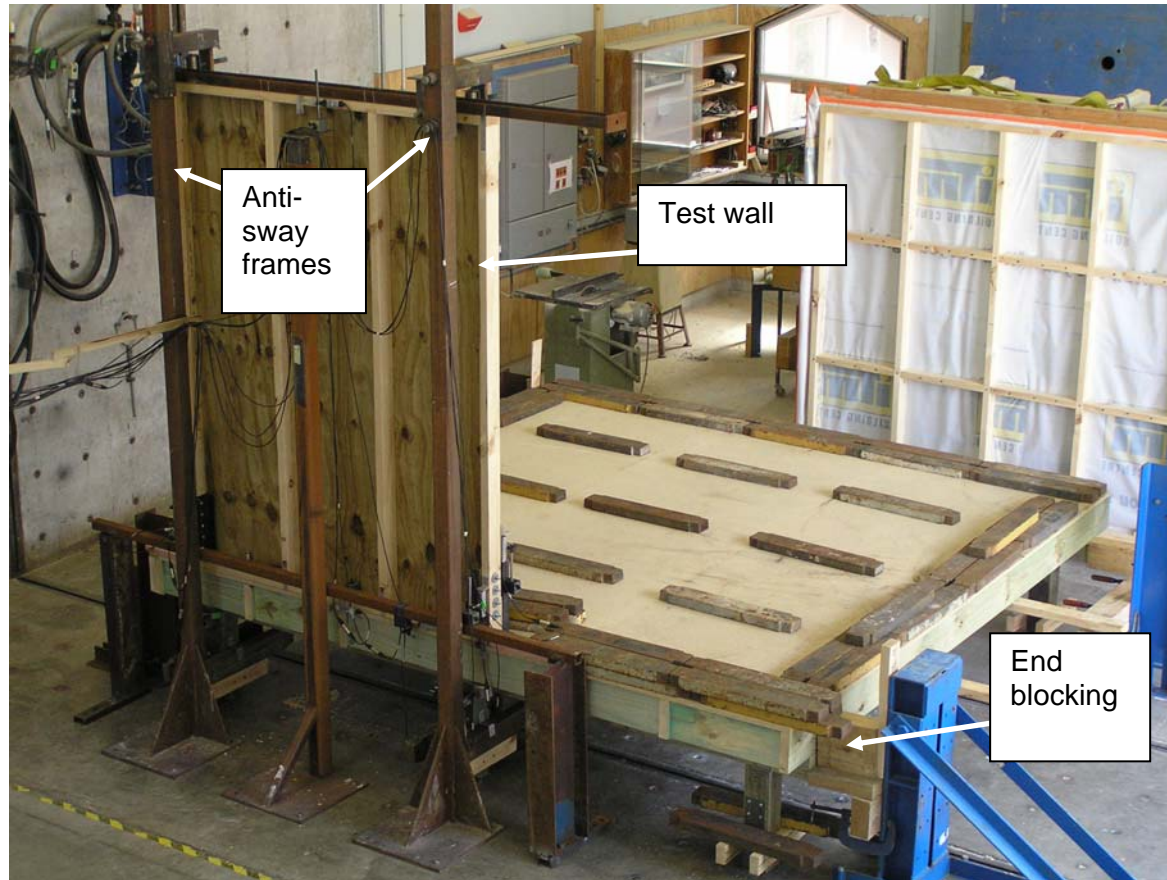
Figure 26. Test L1 – general view
