# STUDY REPORT

No. 162 (2007)

## **Maximum Wall Bracing Rating that is compatible with NZ 3604 Construction**

**Phase I: Theory, Summary and Bracing Testing of Single Walls on a  
Timber Piled Foundation**

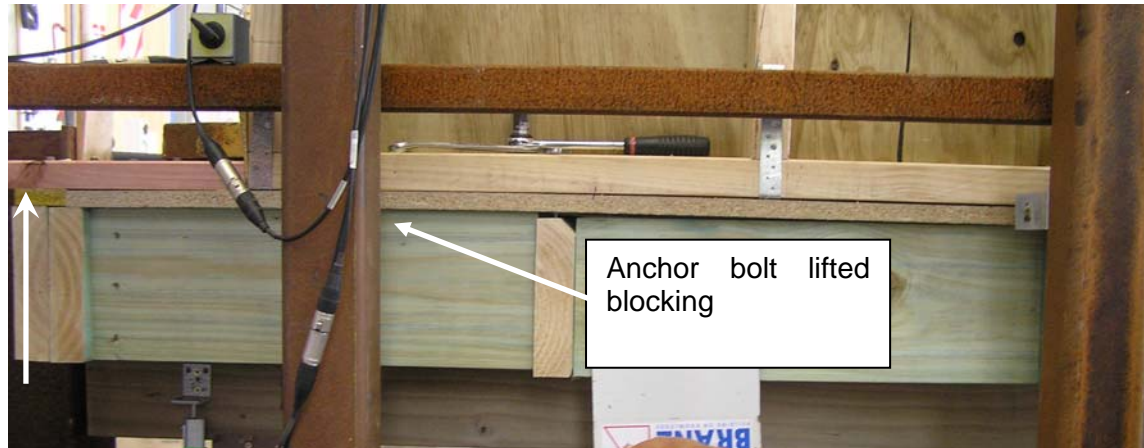
**Figure 27. Test L1 – uplift at racking force = 7.42 kN push at tension end of wall**

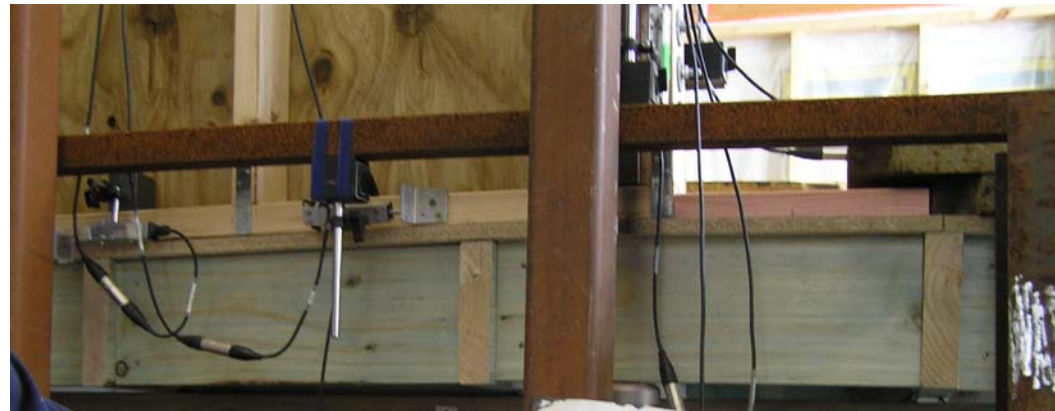
**Figure 28. Test L1 – uplift at racking force = 8.42 kN pull at tension end of wall**

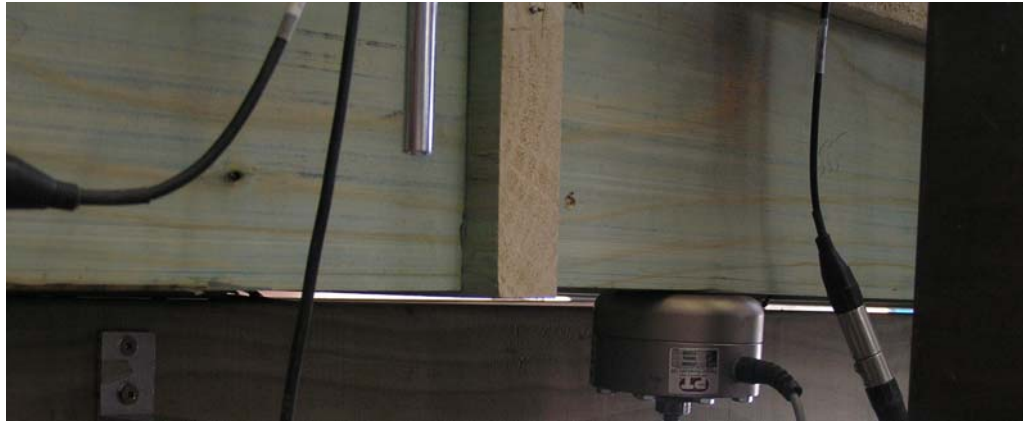
Figure 29. Test L1 – close-up of Figure 28

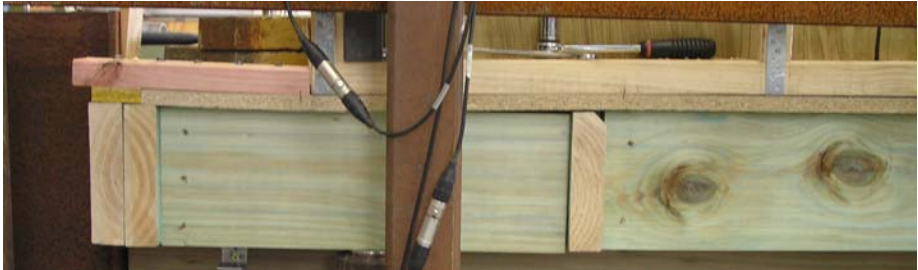
Figure 30. Test L1 – uplift at racking force of 8.42 kN pull at compression end of wall

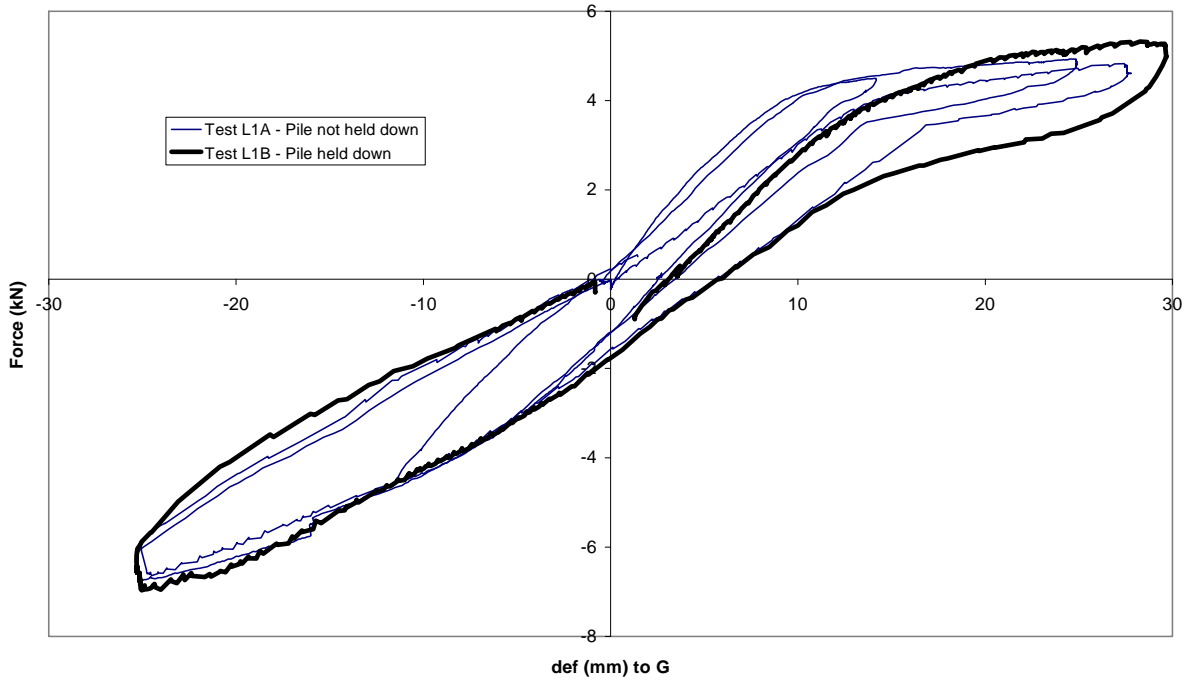
Figure 32. Hysteresis loops – Test L1A and L1B

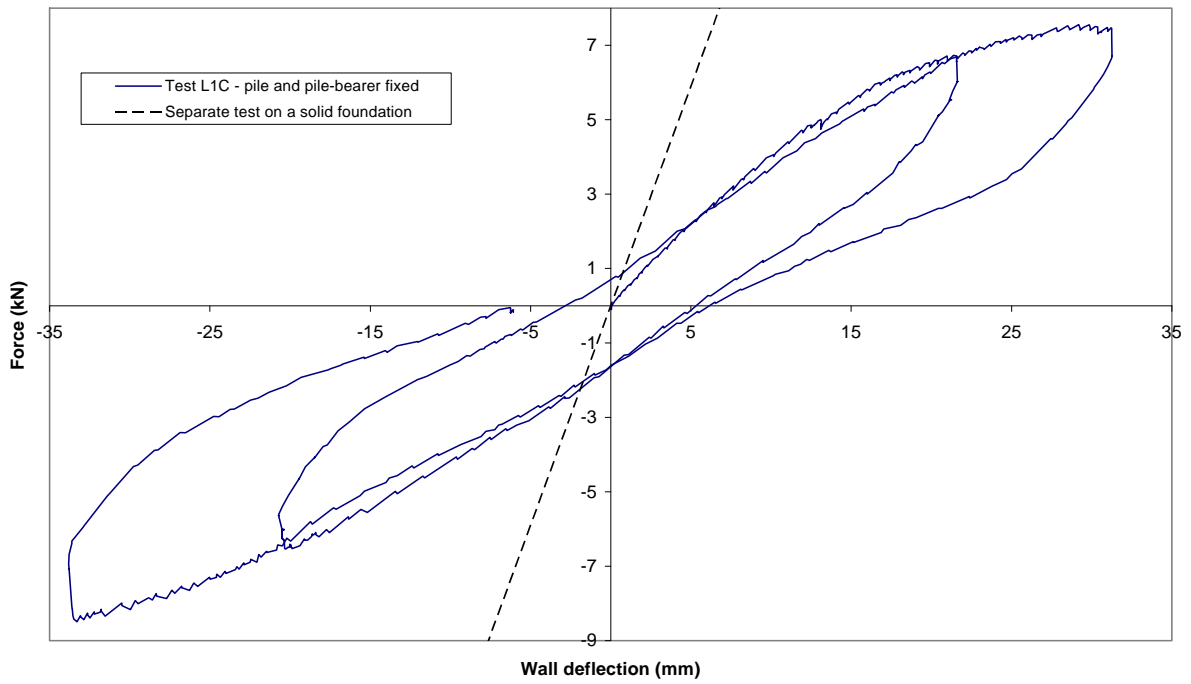
Figure 33. Hysteresis loops – Test L1C

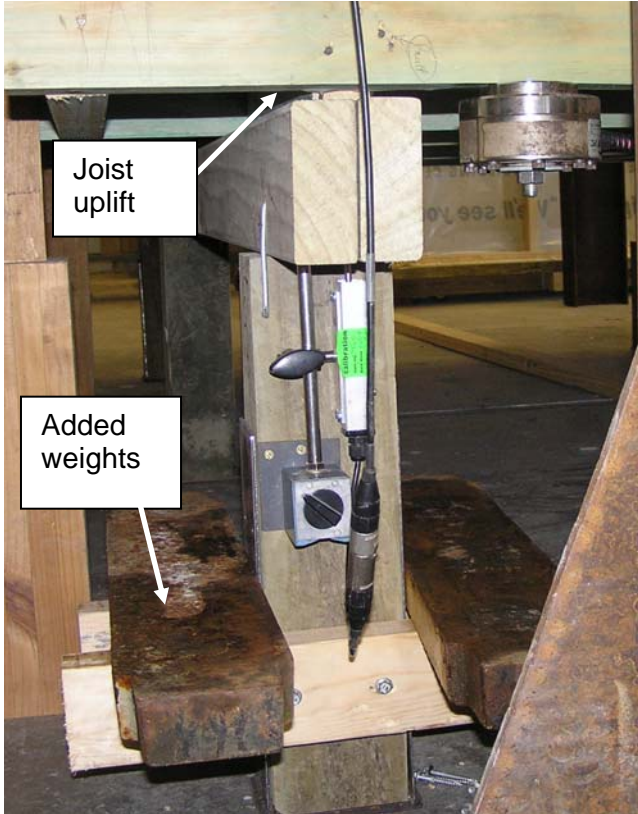
**Figure 34. Test L2 – uplift of joist from bearer**

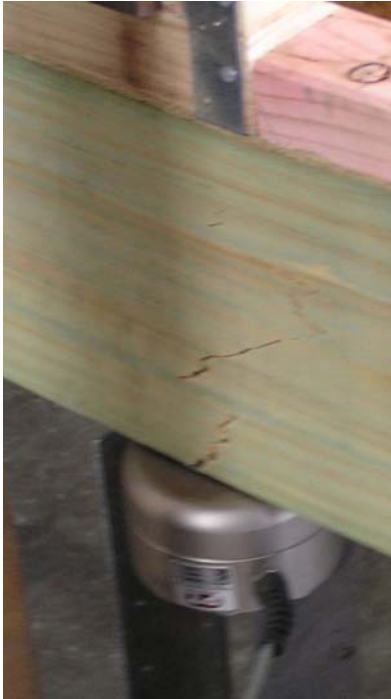
**Figure 35. Test L2 – crack in joist**

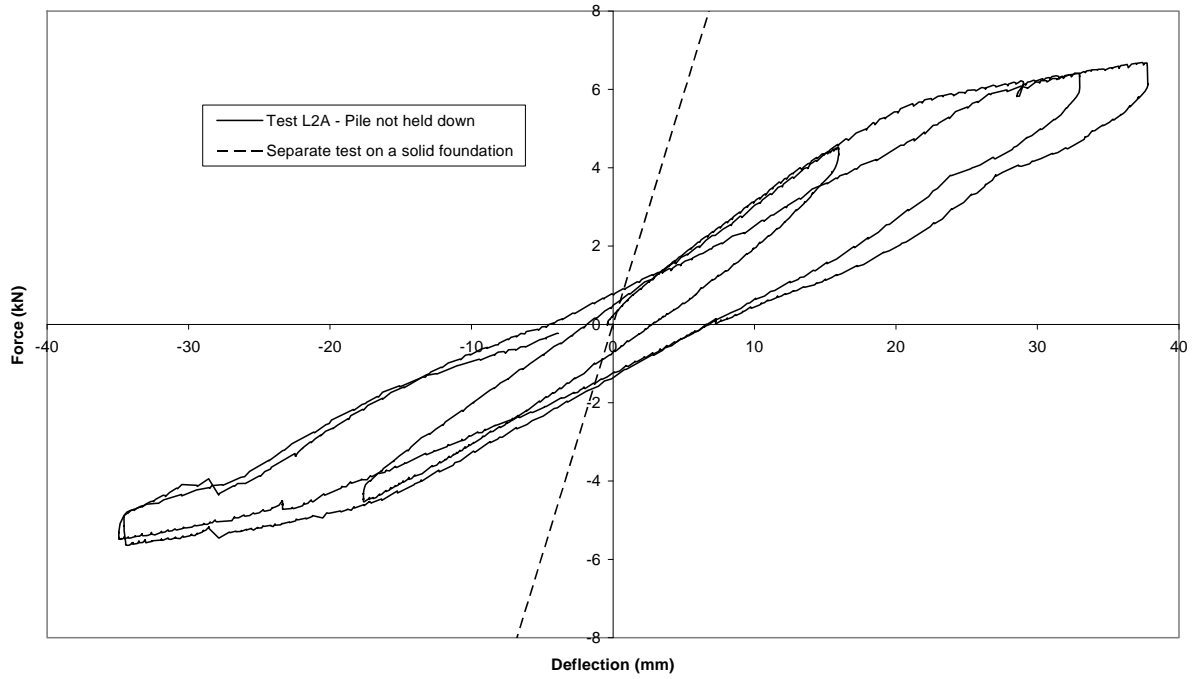
**Figure 36. Hysteresis loops – Test L2A**

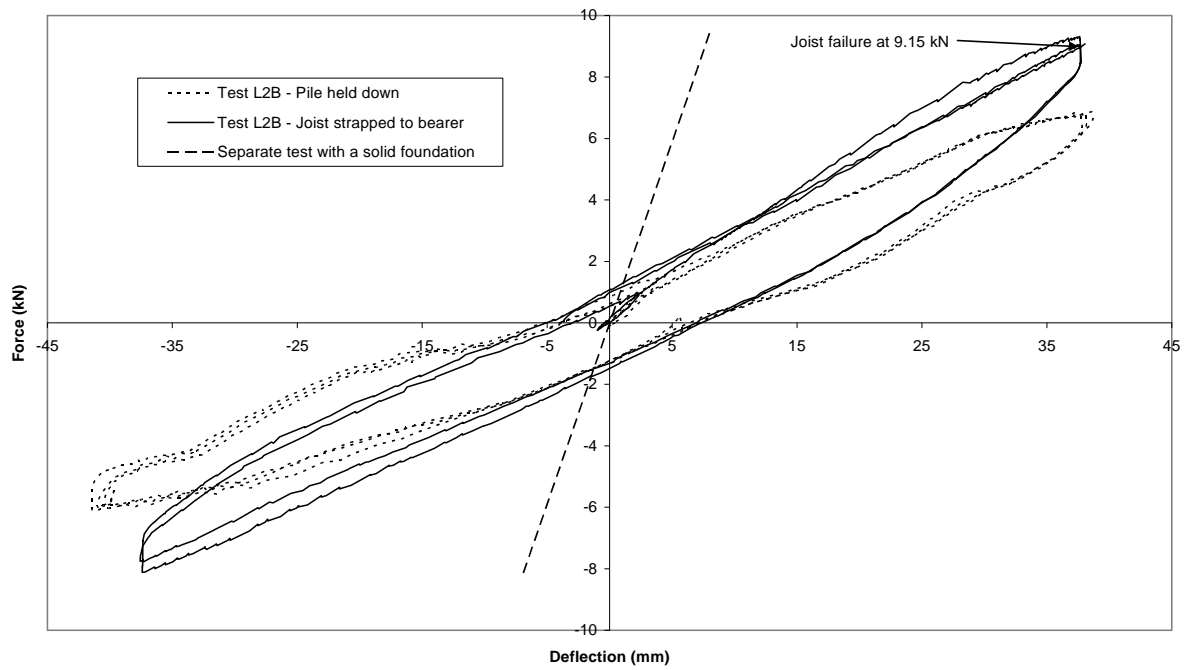
**Figure 37. Hysteresis loops – Test L2B**

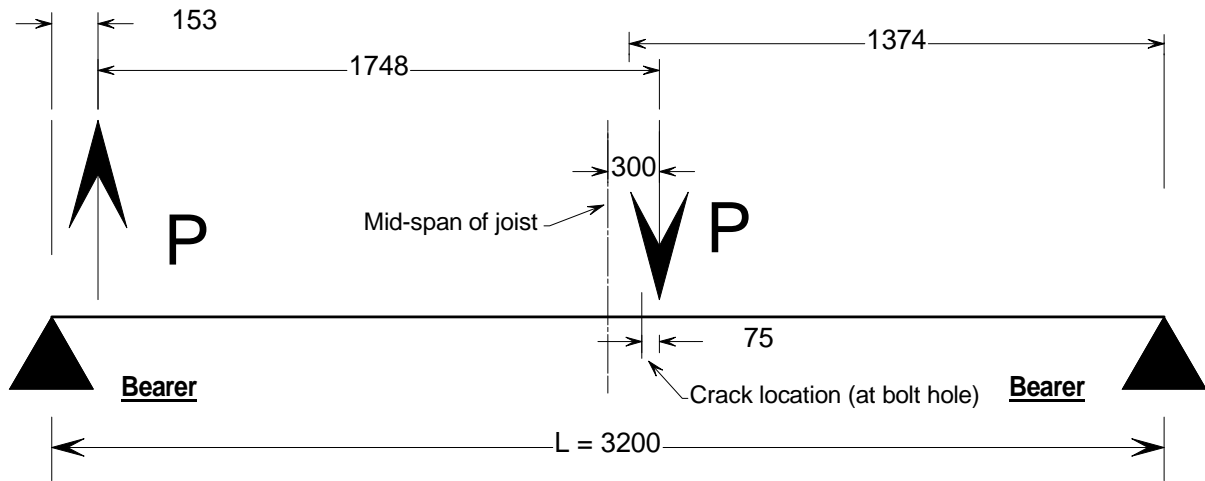
For a bracing wall of height 2.4 m and lever arm 1748 mm, with bracing force 9.15 kN:  
 End downwards reaction =  $P = 9.15 \times 2.4 / 1.748 = 12.56$  kN  
 RHS end reaction =  $1748/3200P = 0.546P$ .  
 Moment at crack location =  $1.374 \times 0.546 - 0.075P = 0.675P = 8.48$  kNm

**Figure 38. Calculation of bending moment at joist flexural failure location**

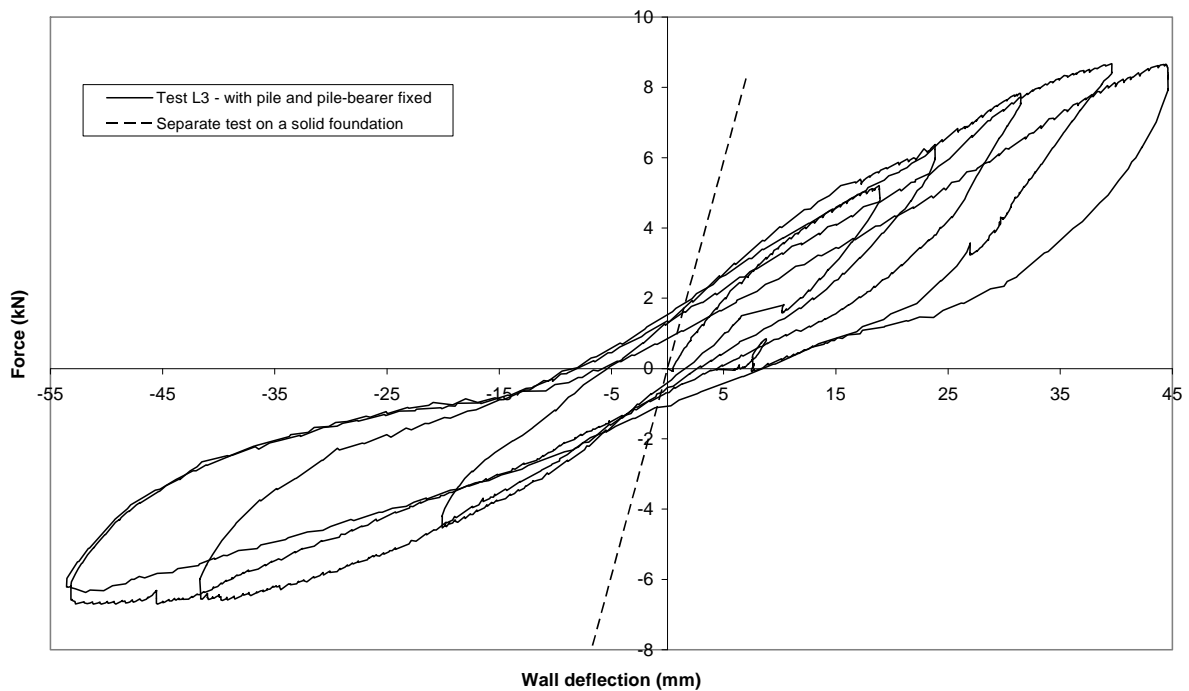
**Figure 39. Hysteresis loops – Test L3**

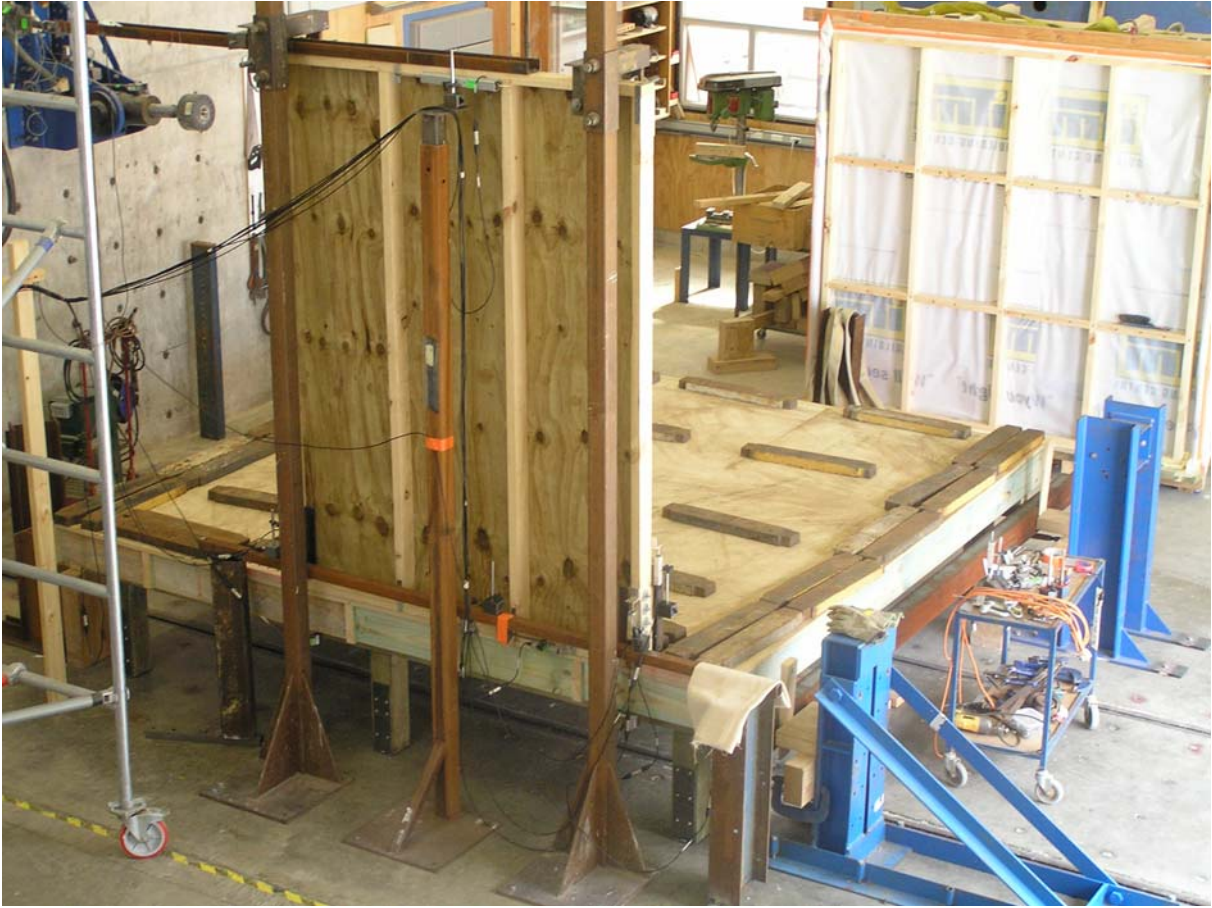
**Figure 40. Test arrangement – Test L3**

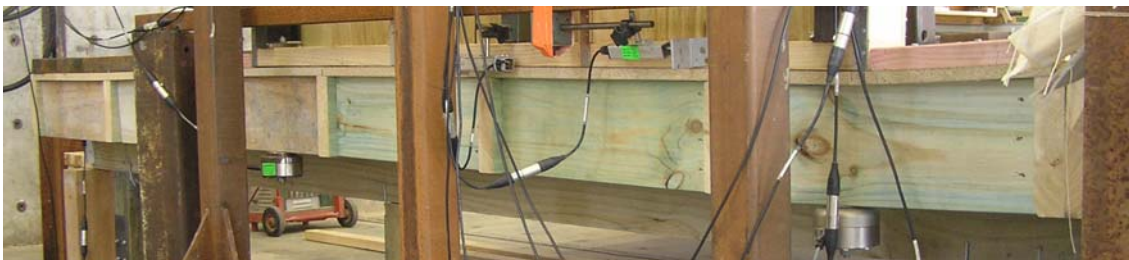
**Figure 42. Deflections along the loaded side of Test L3**

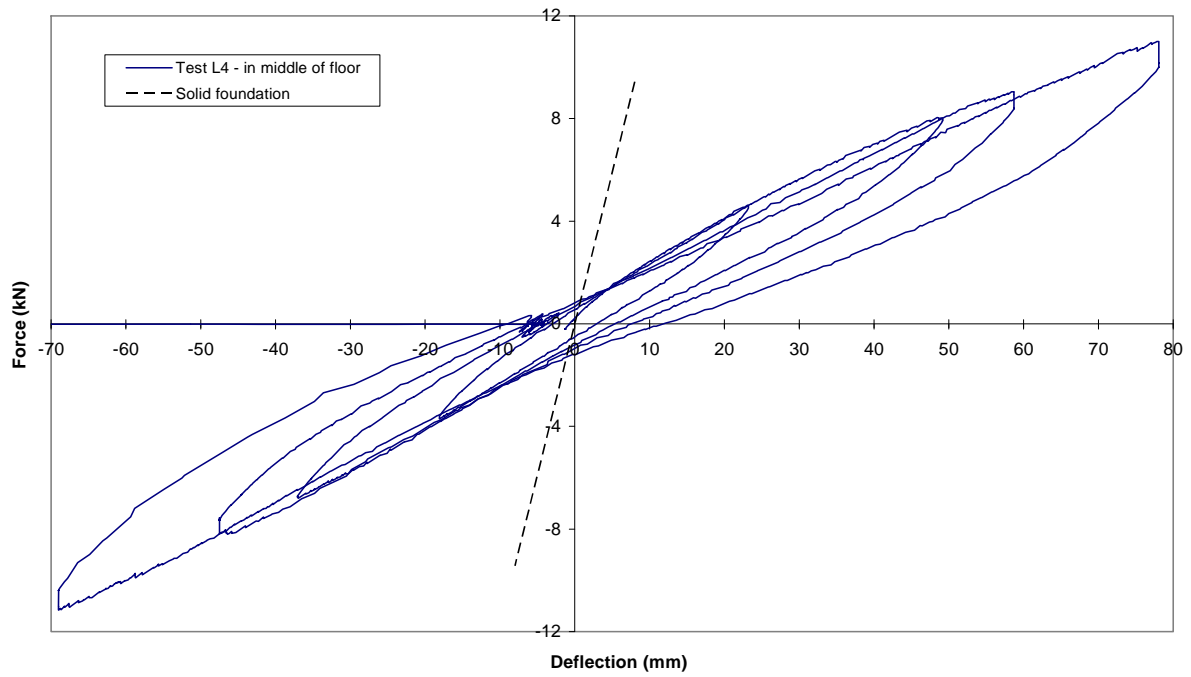
**Figure 43. Hysteresis loops – Test L4**

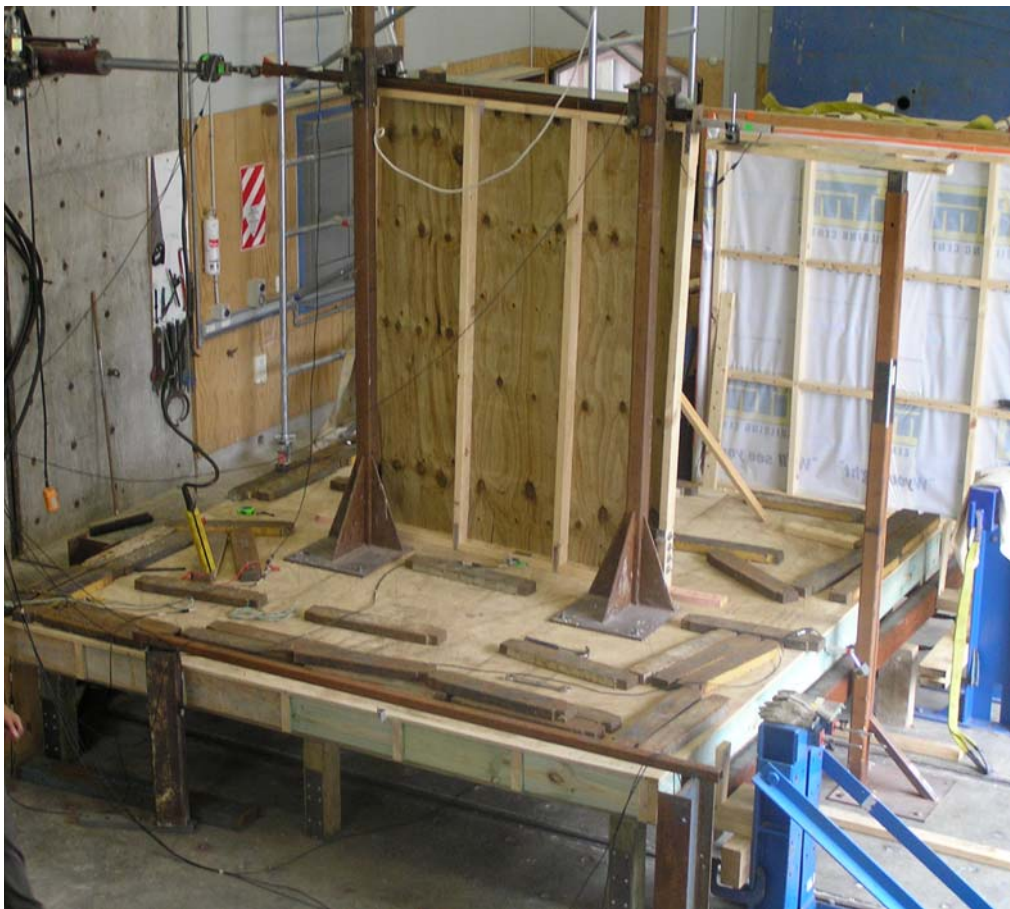
**Figure 44. Test L4 – specimen at peak push load**

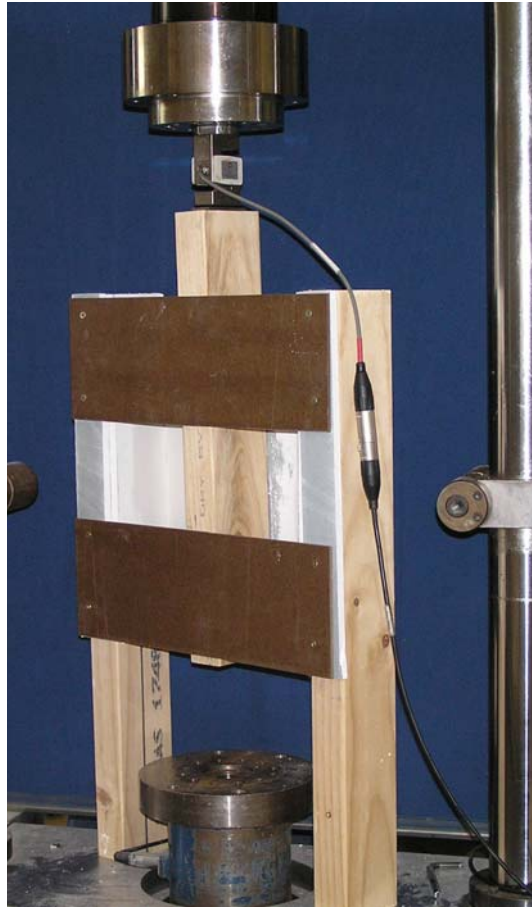
**Figure 46. Photograph of plaster joint test specimen in Dartec test machine**

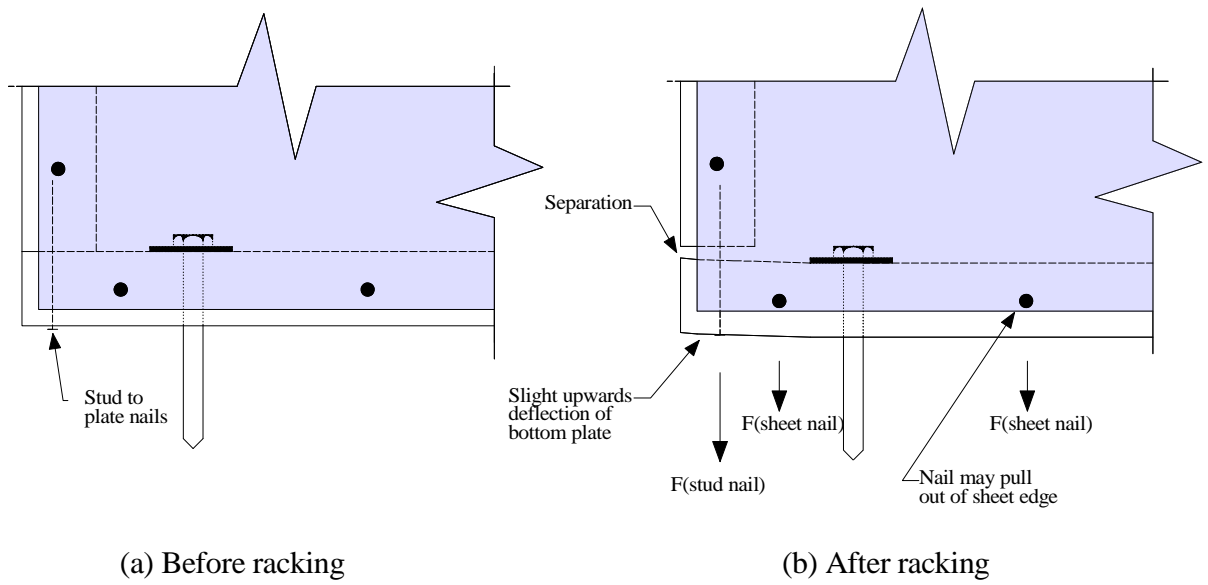
**Figure 47. Lifting of stud from bottom plate**

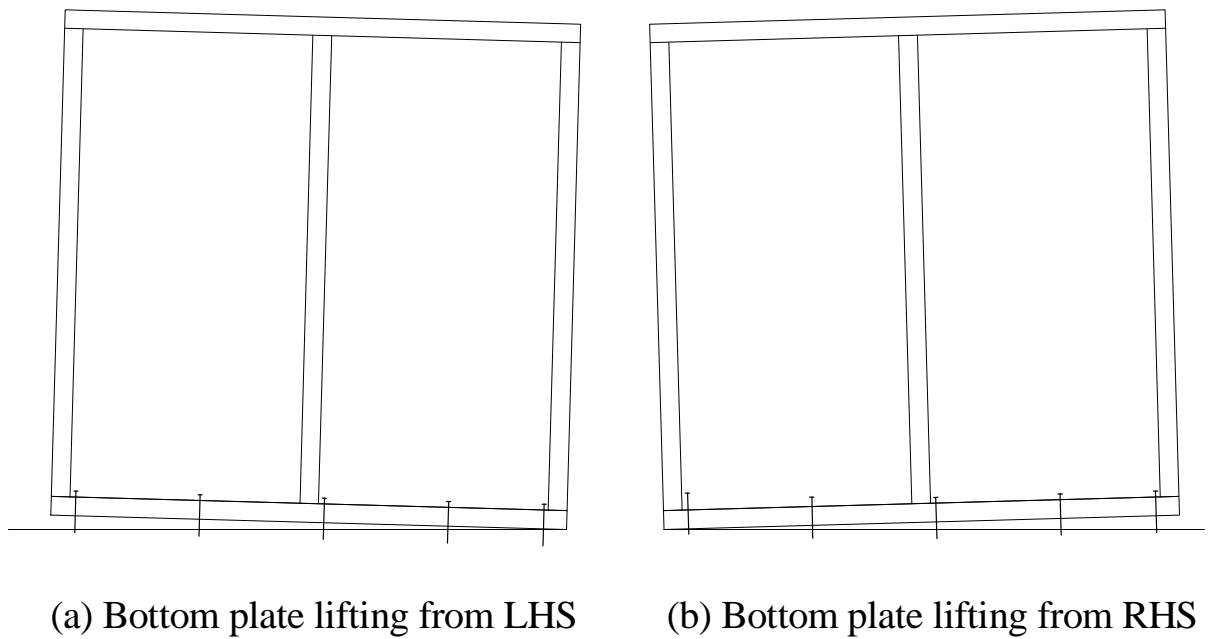
**Figure 48. Lifting of bottom plate from timber floor**

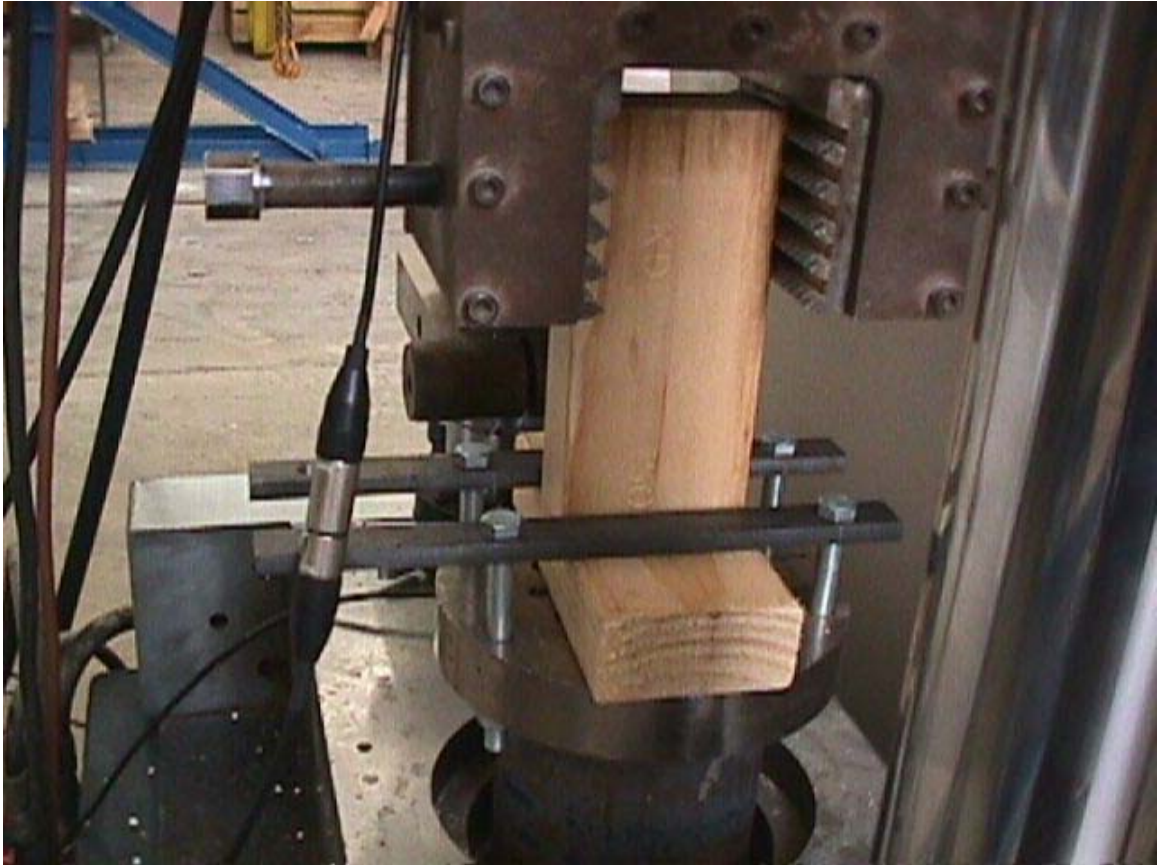
Figure 49. Test set-up used to measure stud/plate tension strength

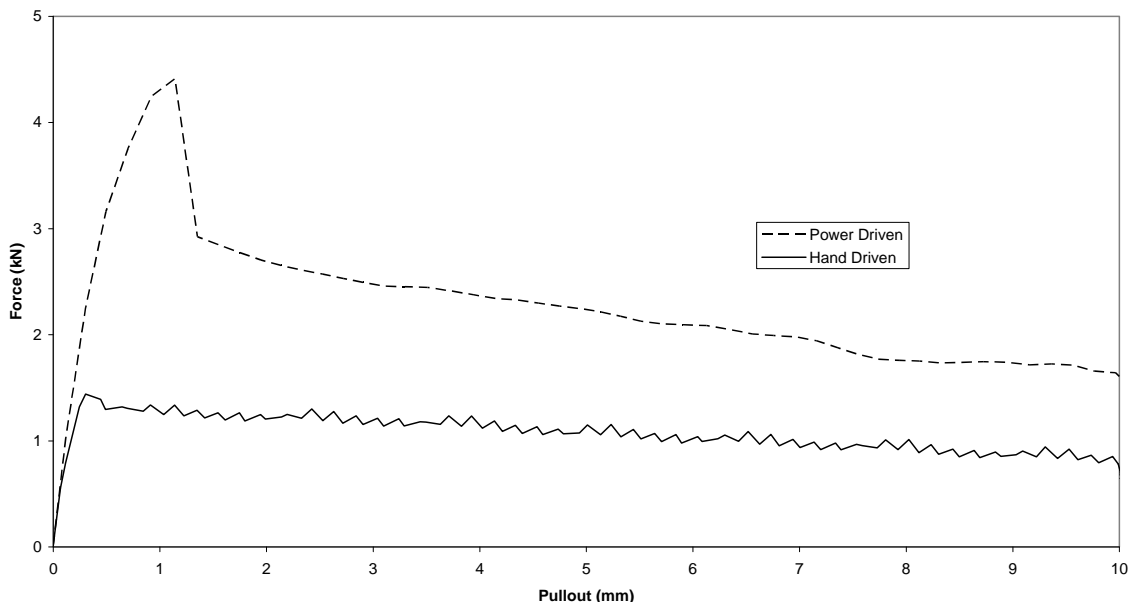
Sample plots for load versus pull-out deflection of the galvanised power-driven nails are shown in Figure 50. Note that after the peak load has been reached the load resisted by power-driven nails drops rapidly until reaching a slightly sloping plateau. The drop is attributed to the failure of the nail/timber glue bond. The 'residual load' is expected to be due to the nail/timber friction.

Figure 50. Typical relationship between tension load and two-nail stud/plate joint deflection

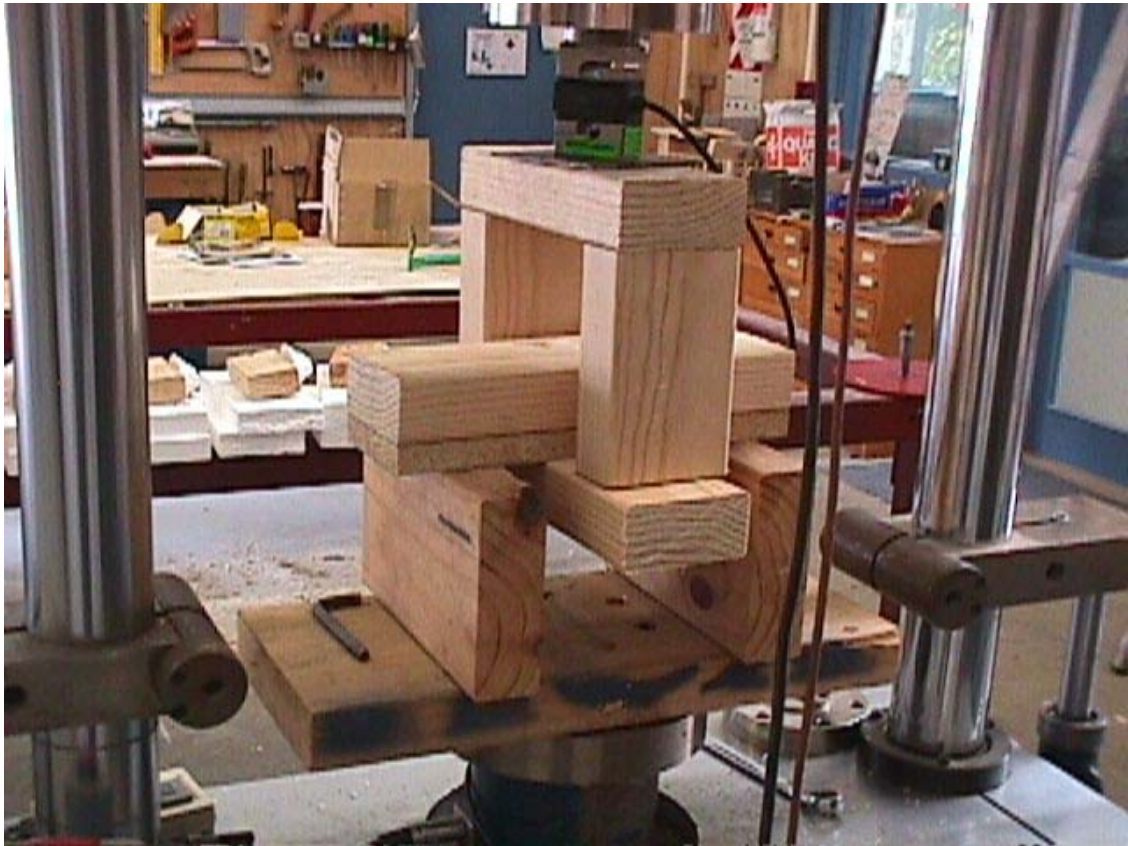
Figure 51. Test set-up used to measure bottom plate to timber joist tension strength

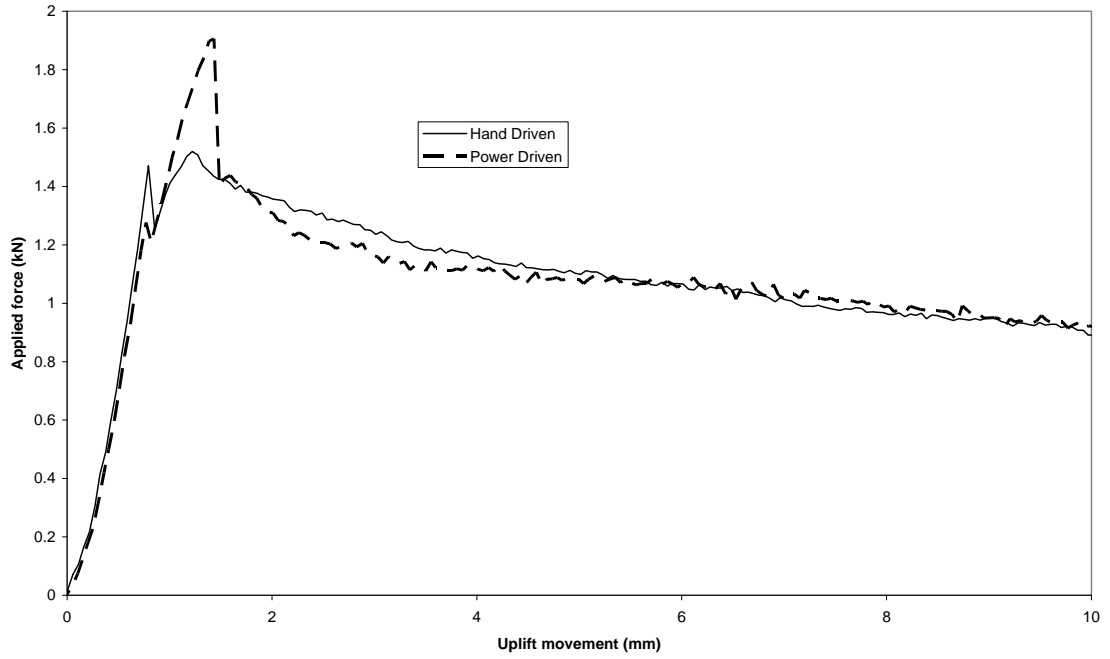
Sample plots are shown in Figure 52. Note that with power-driven nails after peak load has been reached, the load drops rapidly until reaching a sloping plateau. The sudden drop is attributed to the failure of the nail/timber glue bond. The residual load is expected to be due to the nail/timber friction.

Figure 52. Typical relationship between tension load and single nail plate to foundation beam joint deflection

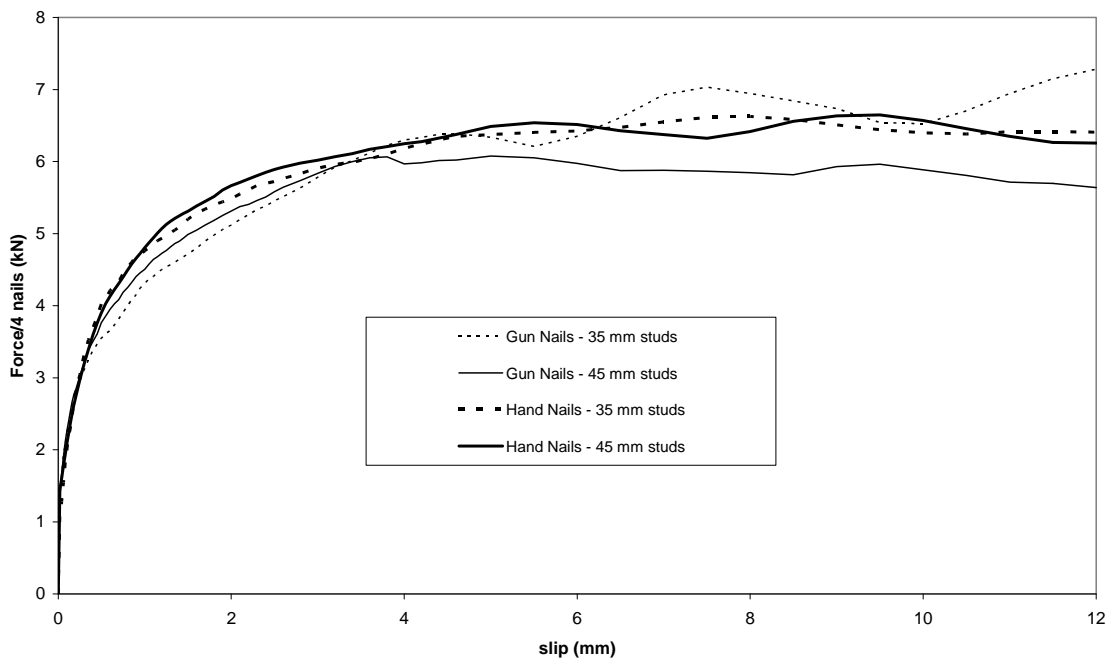
In Appendix B.2 of Thurston (2003), he measured the strength of the 'P21 end restraint' through 35 mm and 45 mm thick timber studs (kiln-dried machine stress graded F5 radiata pine) using an average from six replicas. The joints were cyclically tested at 0.2 mm/second. The averaged backbone curves to the hysteresis loops are given in Figure 53 for a 'four-nail' joint and indicate similar strengths for both power-driven nails and hand-driven nails with little variation due to thickness of stud. The value used for simulation of 'three-nail' P21 restraint (4.85 kN) is taken from Figure 53 at a 'fastener slip' of 6 mm, and is proportioned for three hand-driven nails using the mean test results for 35 and 45 mm studs. At 4 mm slip the value is 4.5 kN.

Figure 53. Backbone curves to hysteresis loops for a four-nail end restraint joint
