STUDY REPORT

No. 190 (2008)

Seismic performance of brick veneer houses

**Phase 2. Shake table tests on
a clay brick veneer specimen**

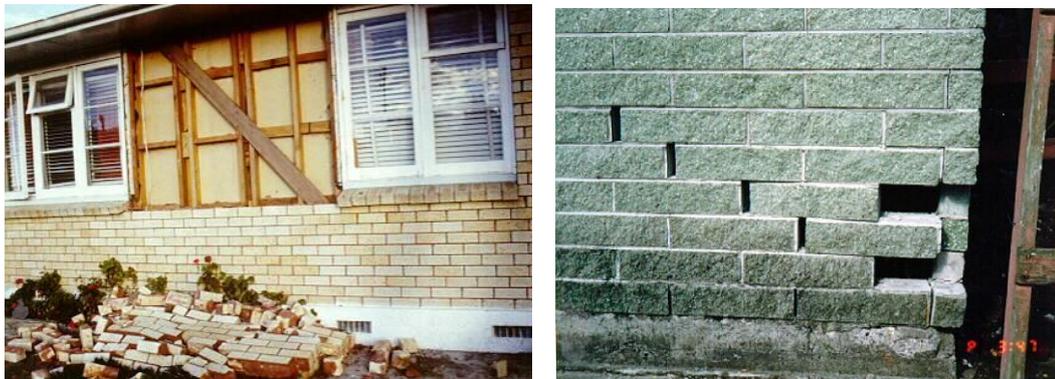
Figure 1. Examples of veneer damaged in the 1987 Edgecumbe earthquake

Historically brick veneer has performed poorly in earthquakes. Cracking, particularly at building corners, window/door corners and partial collapse of the veneer have been common (Figure 1). However, recent improvements in the way brick veneer cladding is constructed is expected to result in improved performance and this study is intended to quantify this.

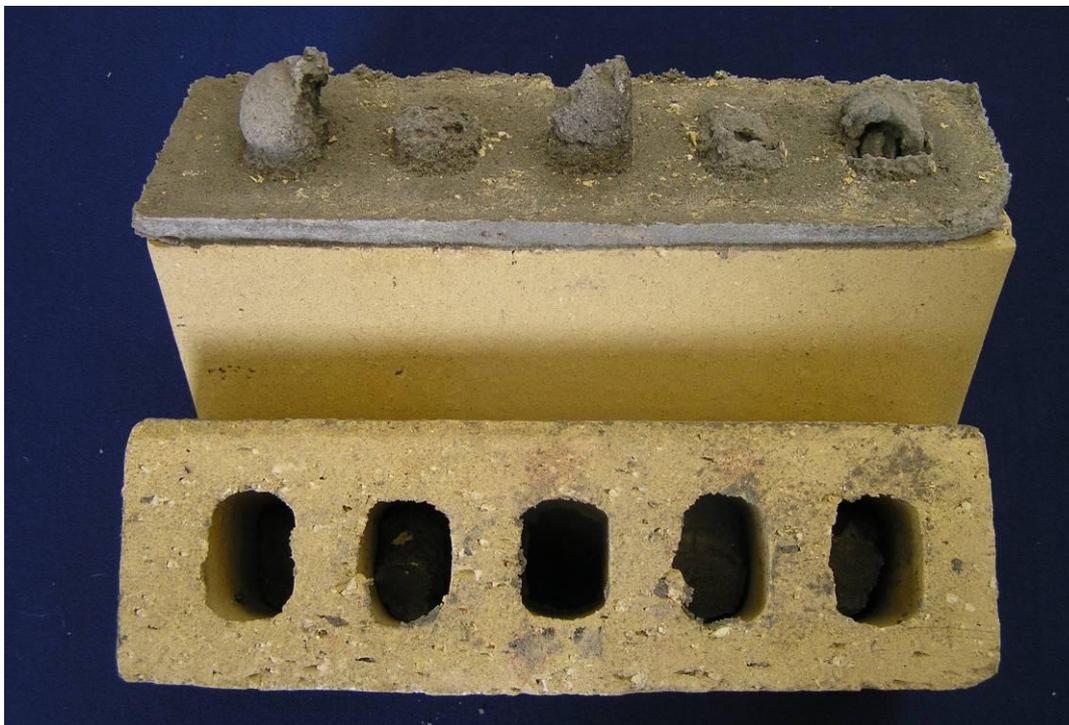
Figure 2. Typical 70 series clay brick – note how the holes in the bricks allow mortar dowels to form

The bricks used had five vertical holes, of cross-section 32 x 23 mm, for the full brick depth which partially filled with mortar as shown in Figure 2. This effectively formed mortar dowels which greatly enhances the horizontal shear strength between bricks. Thus, in the tests described in this report, brickwork did not slide along horizontal mortar cracks between bricks but isolated veneer panels did slide on the smooth face of the foundation concrete.

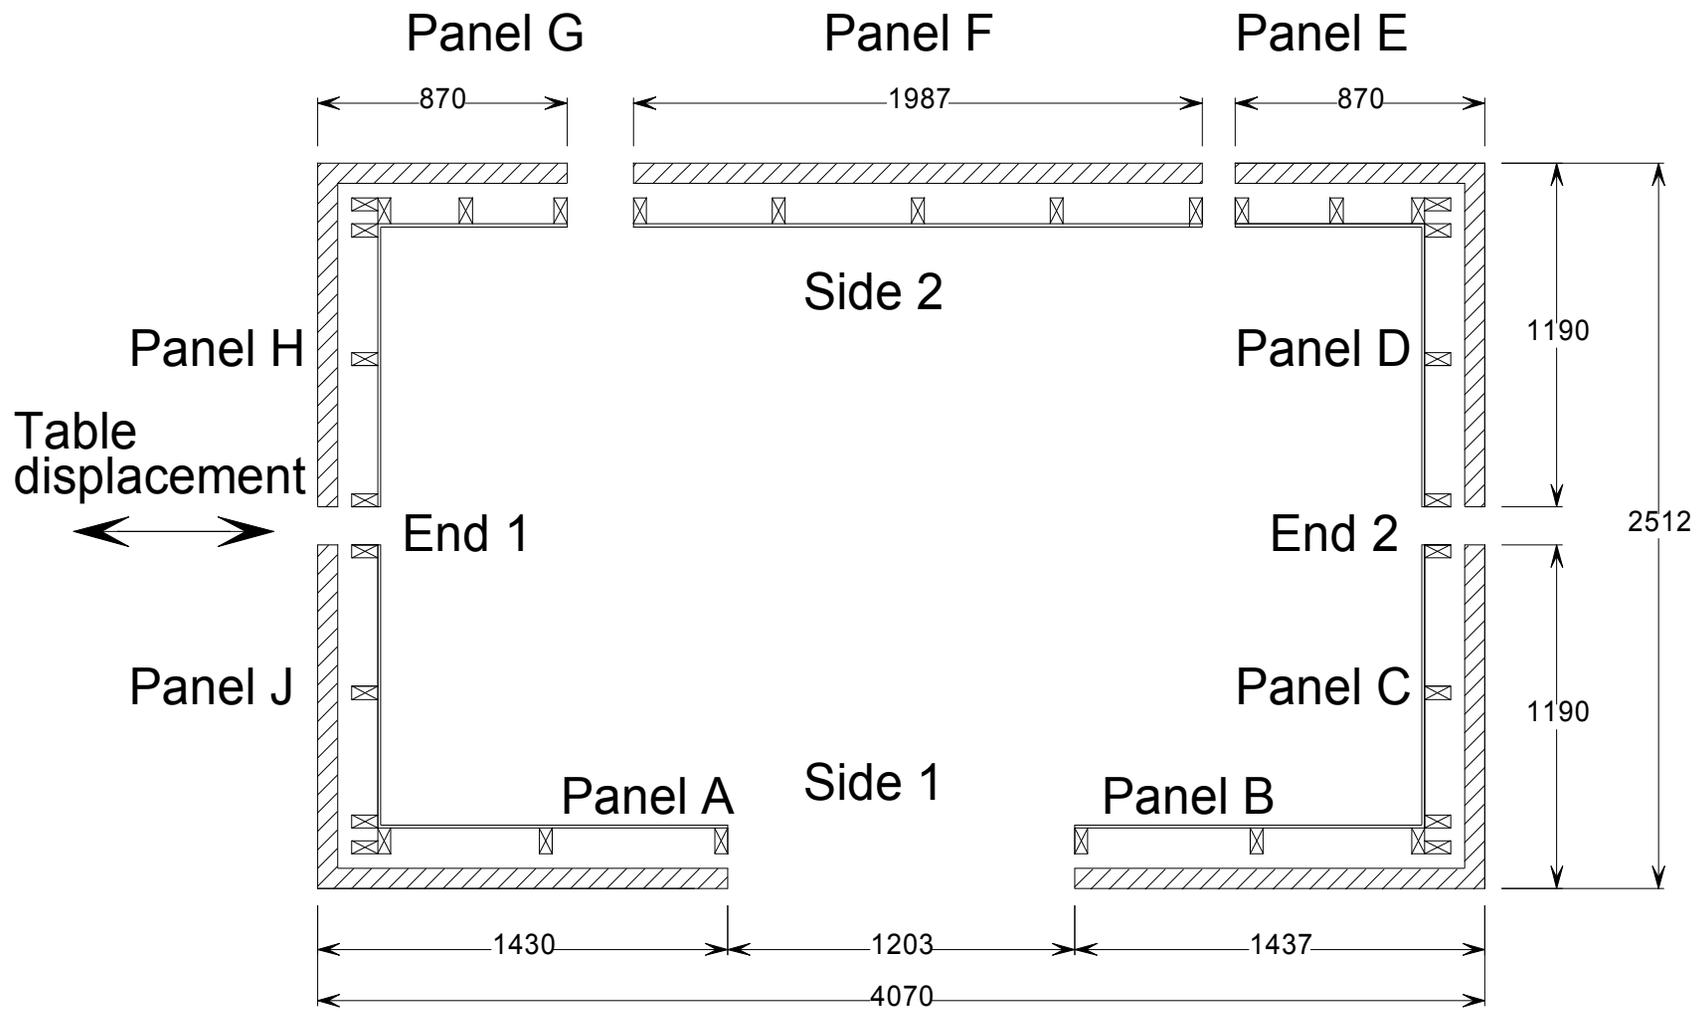
Figure 3. Plan section showing dimensions and labelling system

- The uplift deflection of each veneer panel relative to the shake table at each end of each side panel (i.e. Panels A, B, E, F and G), as shown in Figure 3 and Figure 12. Note that care was taken to ensure these measurements included all crack openings at these plan locations.

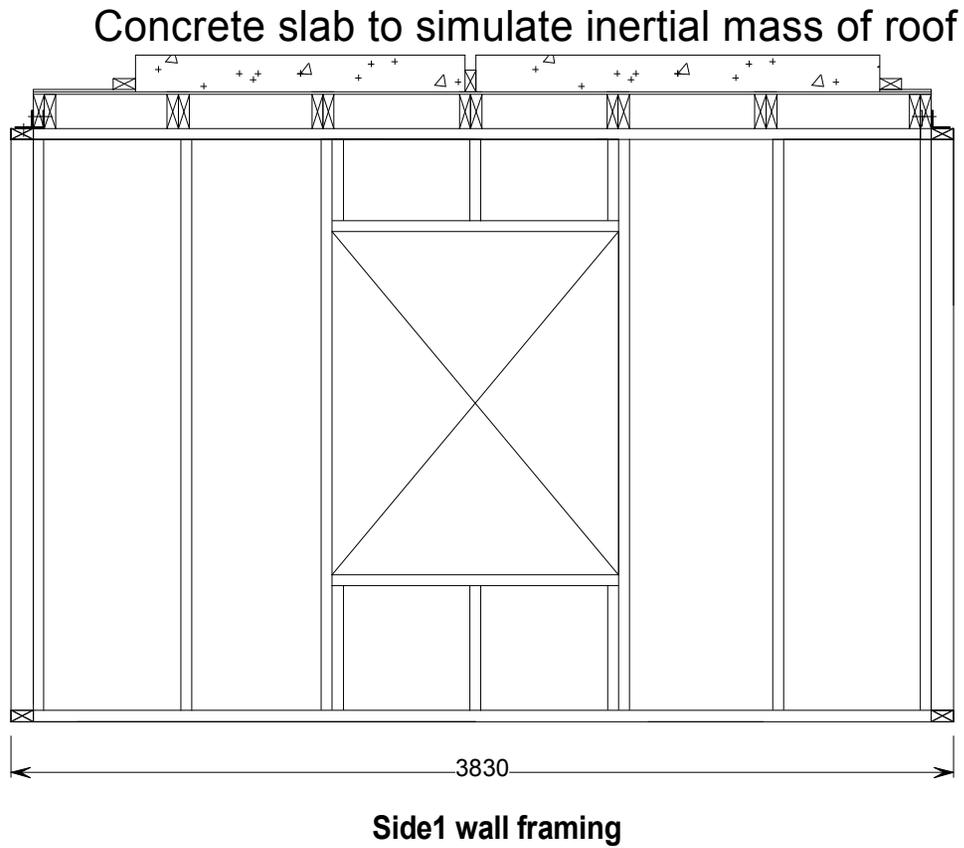
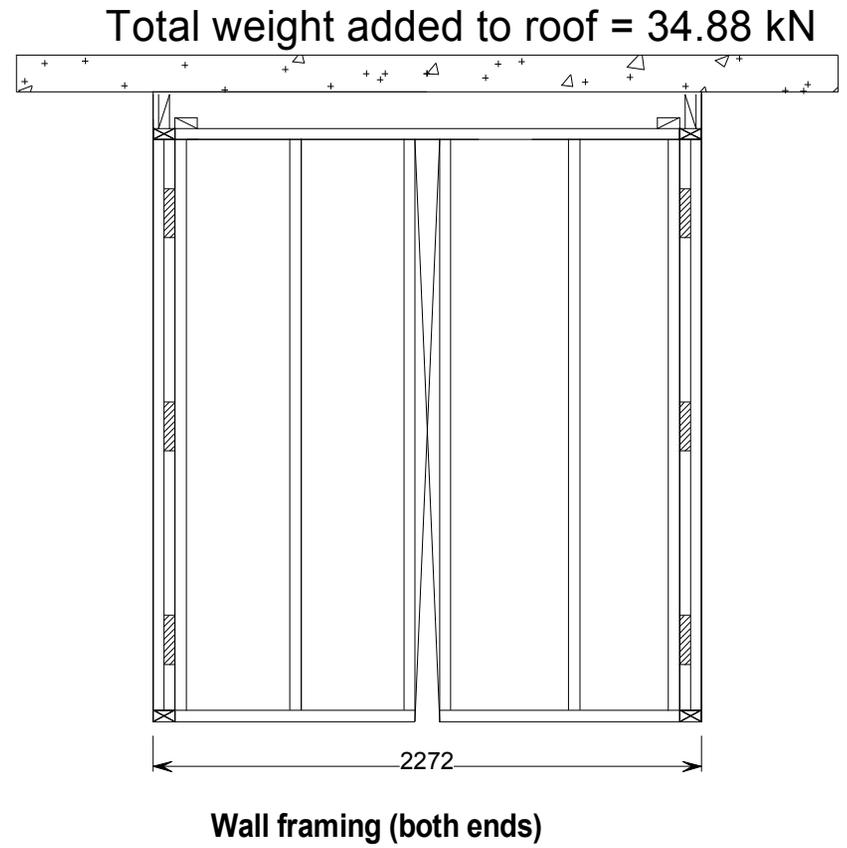
Figure 4. LTF framing on Side 1 and the end walls and added roof weights

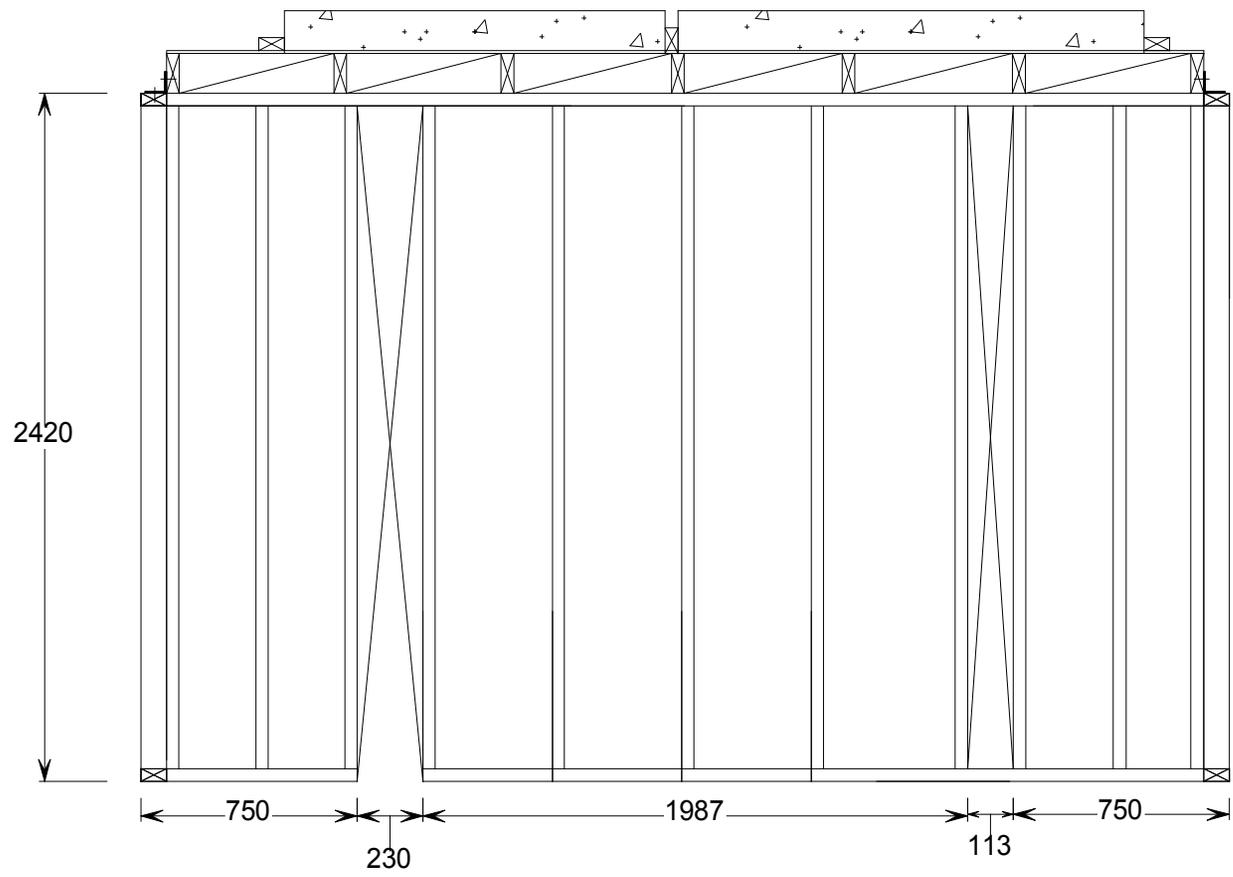
Figure 5. LTF framing on Side 2

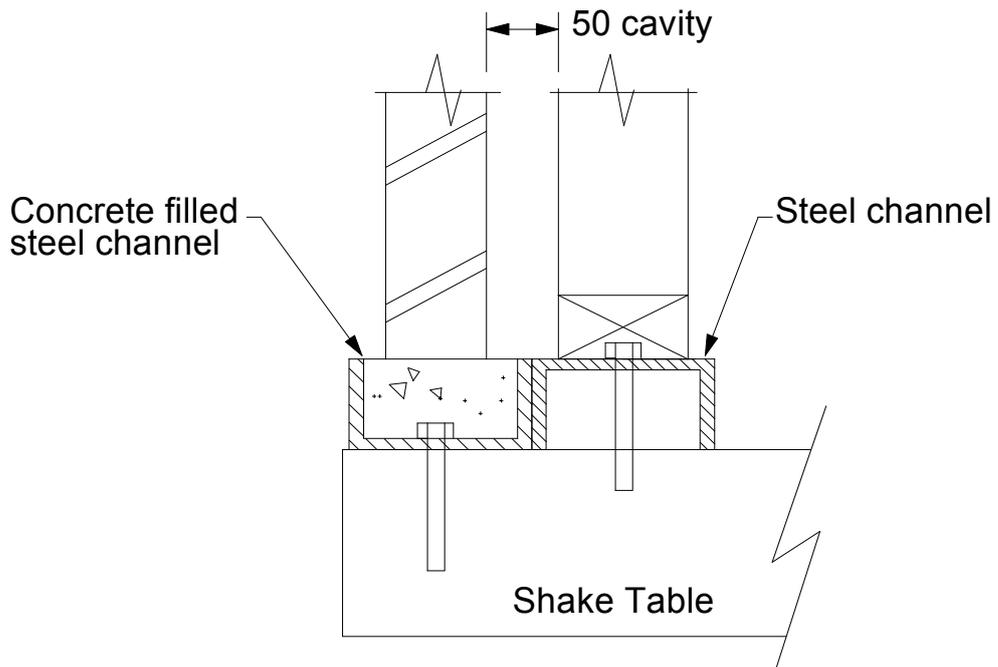
Figure 8. Cross-section through bottom of veneer and LTF walls

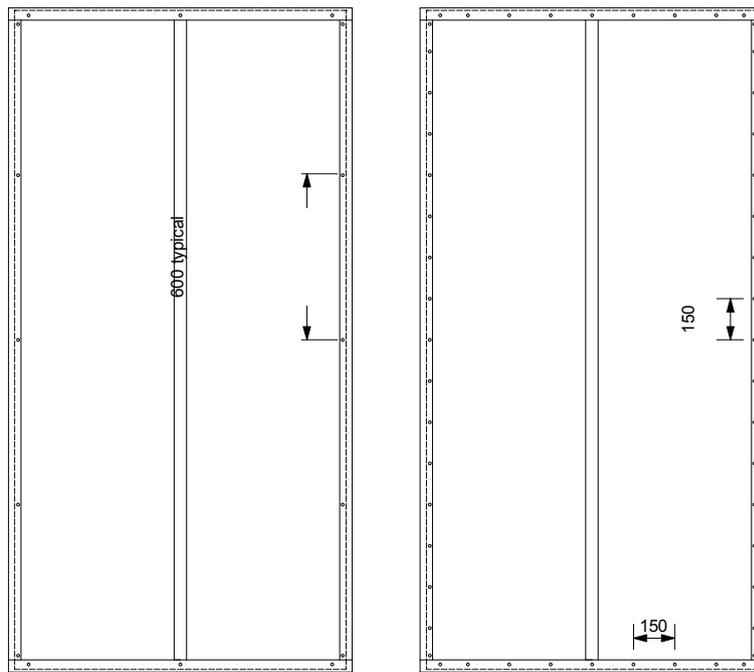
(a) Fixing for Stage I.
Screws at 600 mm centres

(b) Fixing for Stage II.
Screws at 150 mm centres

Note: All screws were 32 mm x 6g drywall plasterboard screws.
There were no fixings in the body of the sheets.

Figure 9. Typical fixing of plasterboard lining

The wall lining was 10 mm Elephant Multiboard plasterboard. As there was doubt about the ability of the shake table system to induce failure of the test room, in Stage I of the testing the lining was only lightly attached to the framing as shown in Figure 9(a). The lining was replaced in Stage II and the more dense screw-fixing pattern of Figure 9(b) was used. The reasons for the chosen lining strength are discussed in Section 4. The lining was placed vertically, and the joints between sheets (including at room corners) were not reinforced with tape or stopped to ensure there was no additional strength due to “systems effects”. However, all ceiling joints (including the junction between walls and ceiling) were reinforced with paper tape and stopped to ensure representative load transfer from the ceiling to the walls.

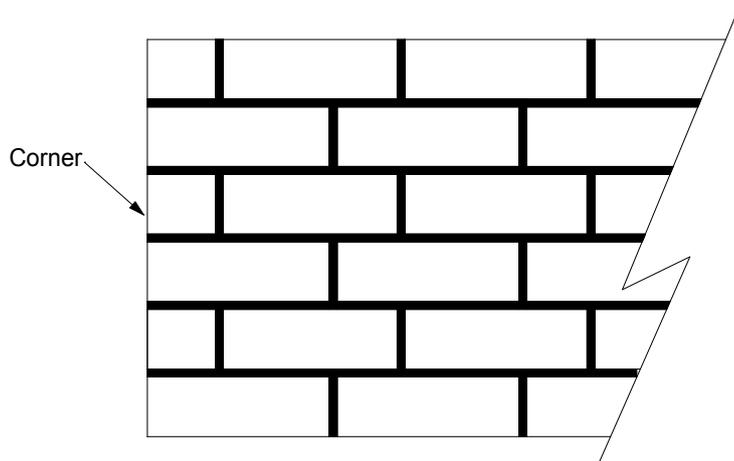
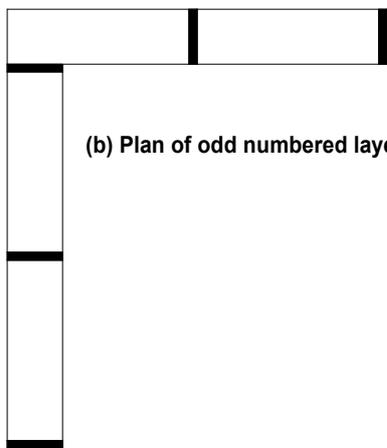
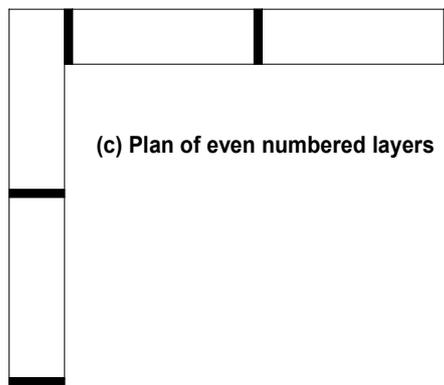
(a) Elevation of veneer layout at a corner

(b) Plan of odd numbered layers

(c) Plan of even numbered layers

Figure 10. Interlocking of brick veneer at corners

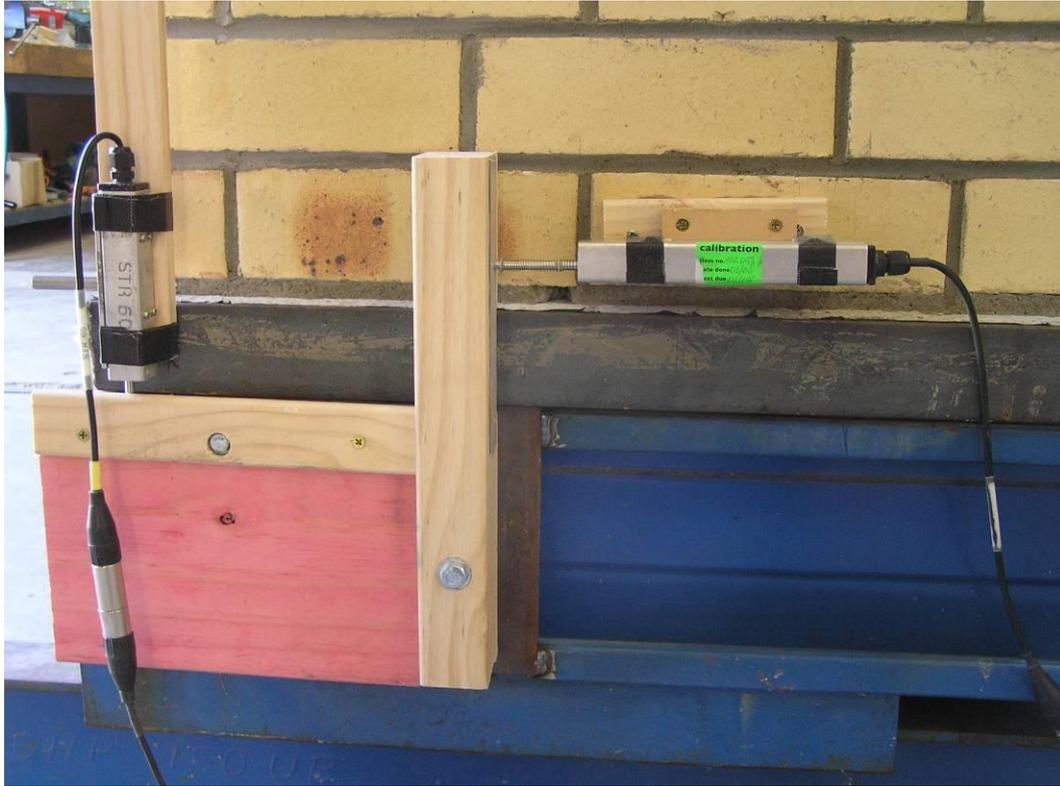
Figure 11. Gauges measuring veneer vertical and horizontal movement

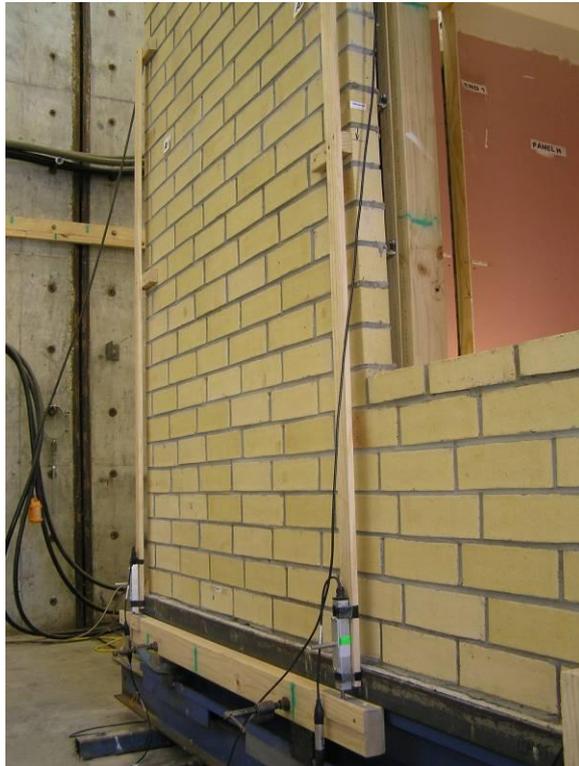
Figure 12. Gauges measuring veneer vertical movement

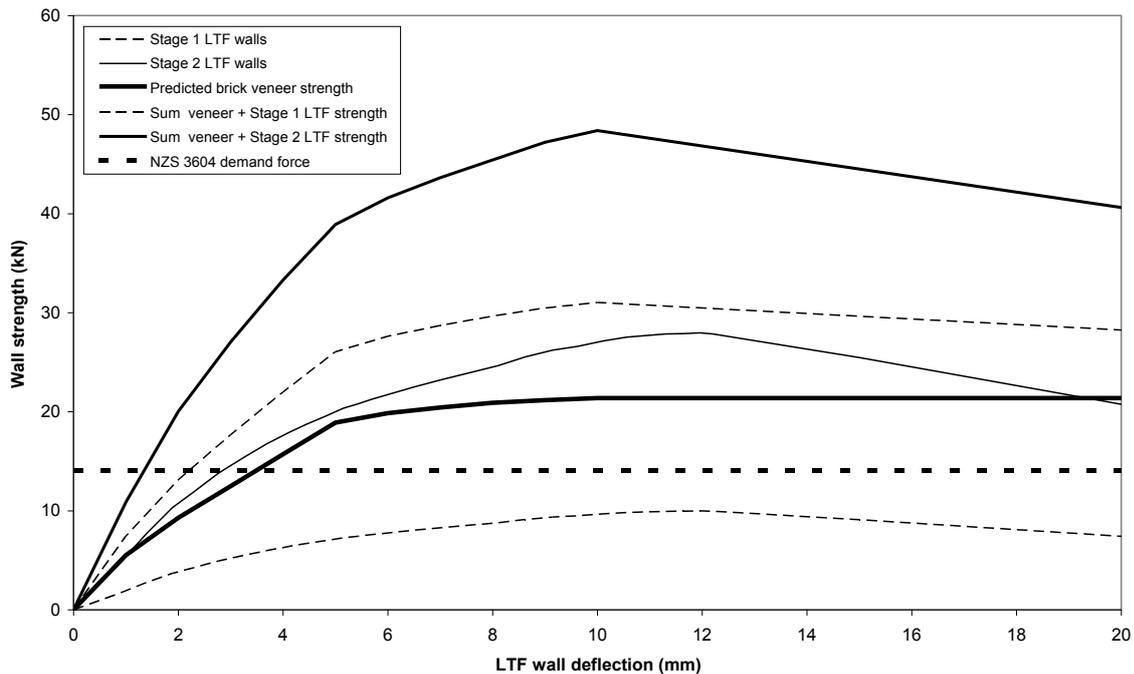
Figure 13. NZS 3604 demand load for Wellington and predicted strengths against deflection

Thurston and Beattie (2008a) recommended that the design strength of the veneer be taken as 0.7 times the calculated resistance, as given in Section 4.3 ($= 0.7 \times 21.4 = 14.98$ kN). As noted above, the total resistance of the lining based on wall bracing tests was 10 kN for Stage I and 28 kN for Stage II. This data is plotted in Figure 13. The ratio of the NZS 3604 demand load to the design strength is therefore:

(c) Linings ineffective: Ratio = $14.05 / (14.98 + 0) = 0.94$.

It was concluded that the test room would need to be shaken with a significantly greater intensity than that corresponding to the NZS 4203 spectra to induce failure.

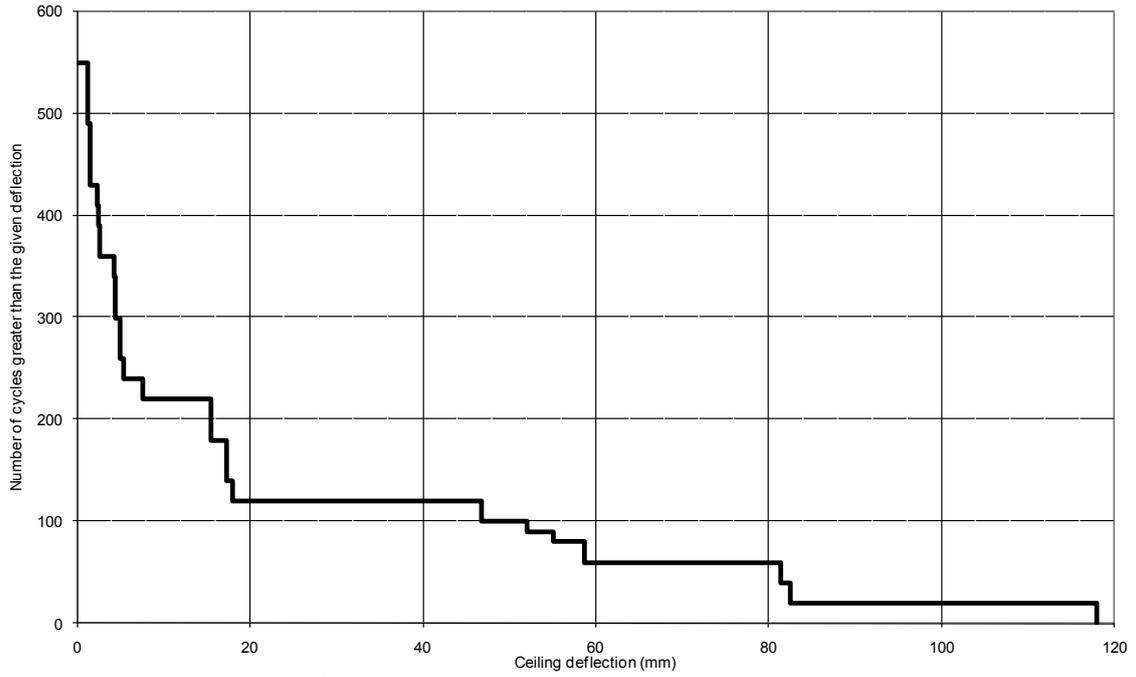
Figure 14. Number of excursions beyond discrete deflections

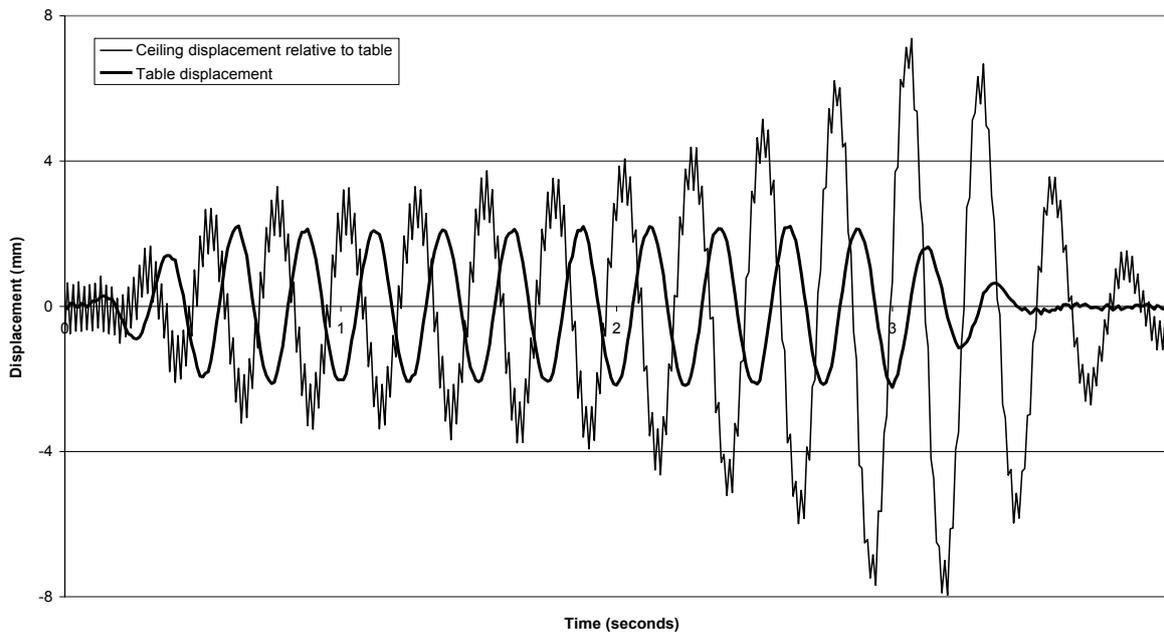
Figure 15. Table and ceiling displacements in Test T14 (cycling frequency 4 Hz)

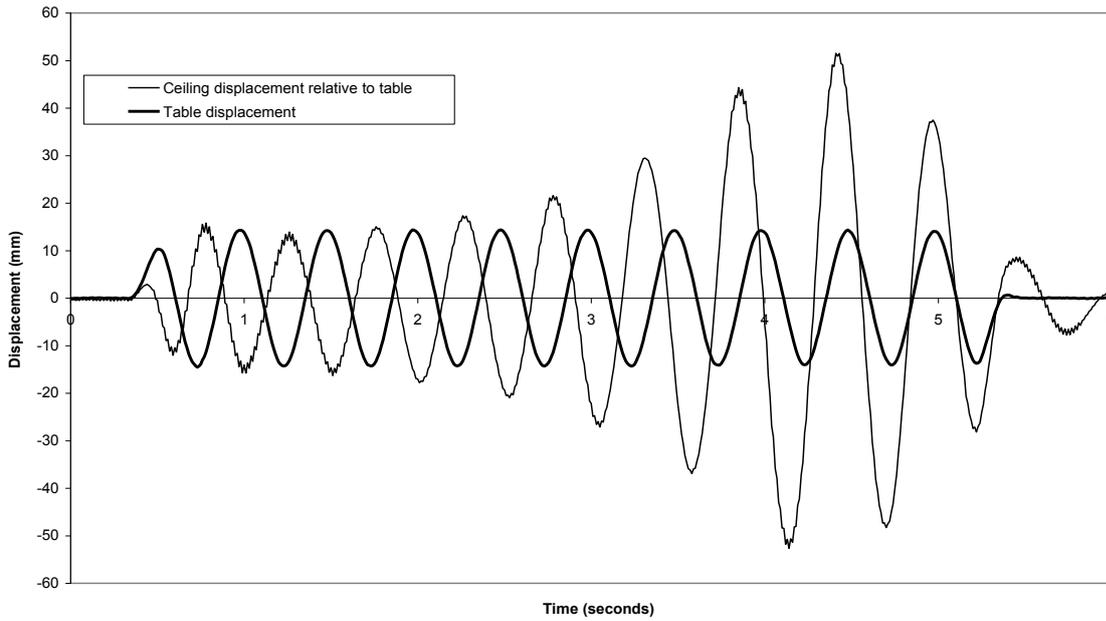
Figure 16. Table and ceiling displacements in Test T17 (cycling frequency 2 Hz)

In both Stage I and Stage II, the failure of the lining occurred at the same excitation frequency of 2 Hz in Test T17 and Test T25. Although this same frequency was used in Test T13, the shaking amplitude was only half and no lining failure occurred.

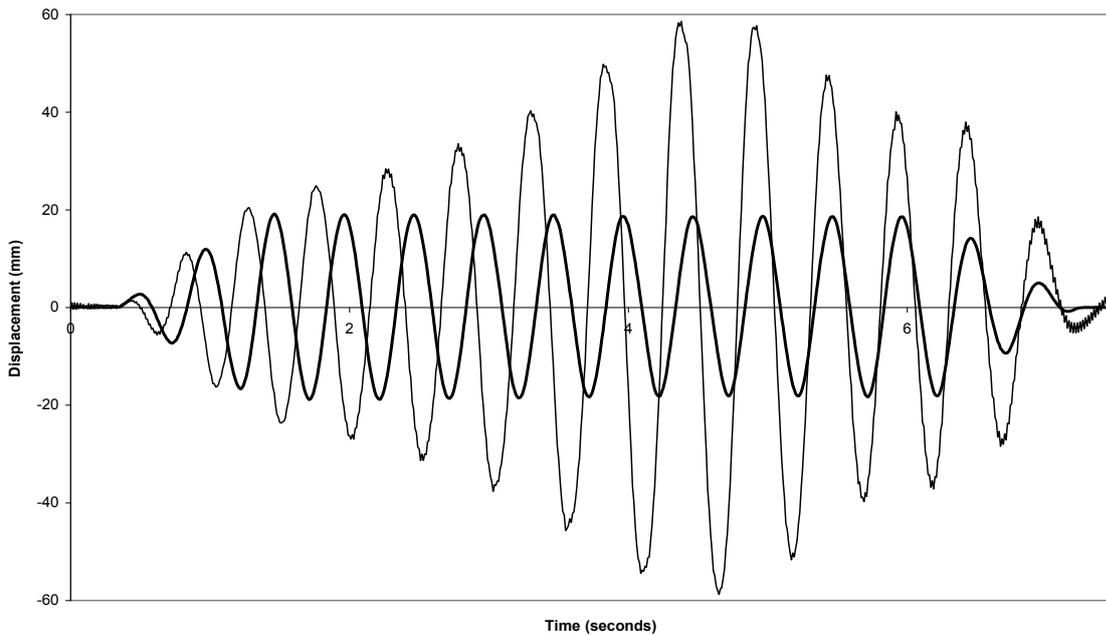
Figure 17. Table and ceiling displacements in Test T25 (cycling frequency 2 Hz)

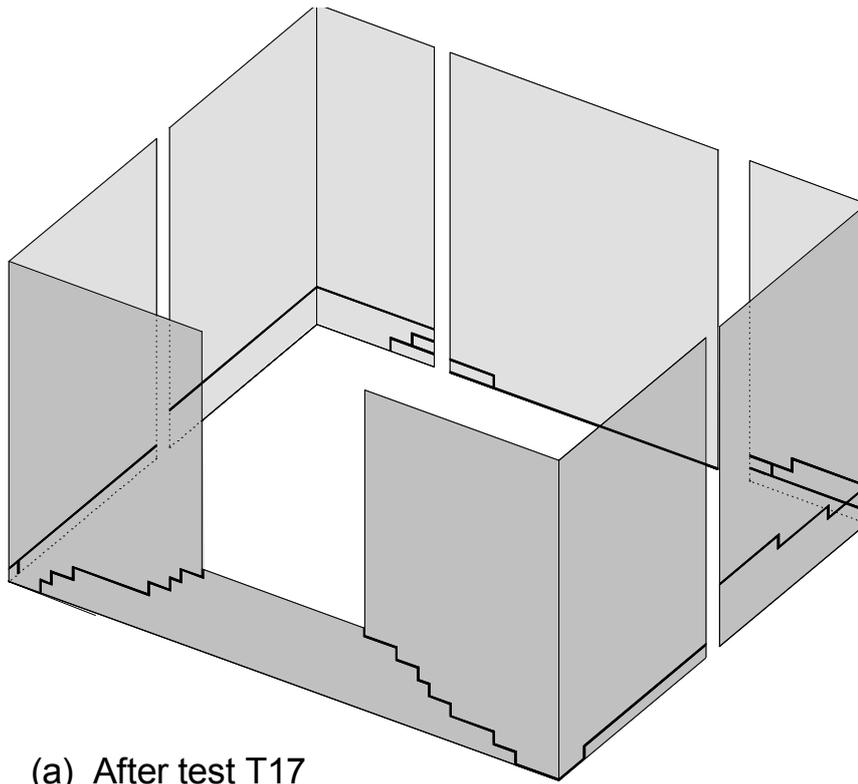
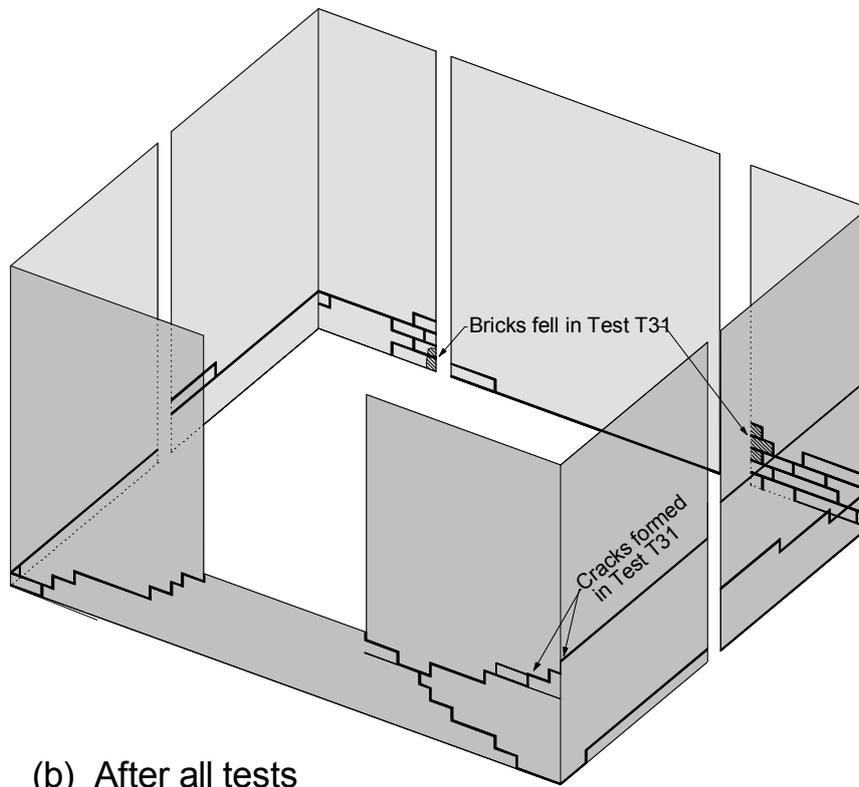
(a) After test T17

(b) After all tests

Figure 18. Three dimensional view of veneer crack patterns

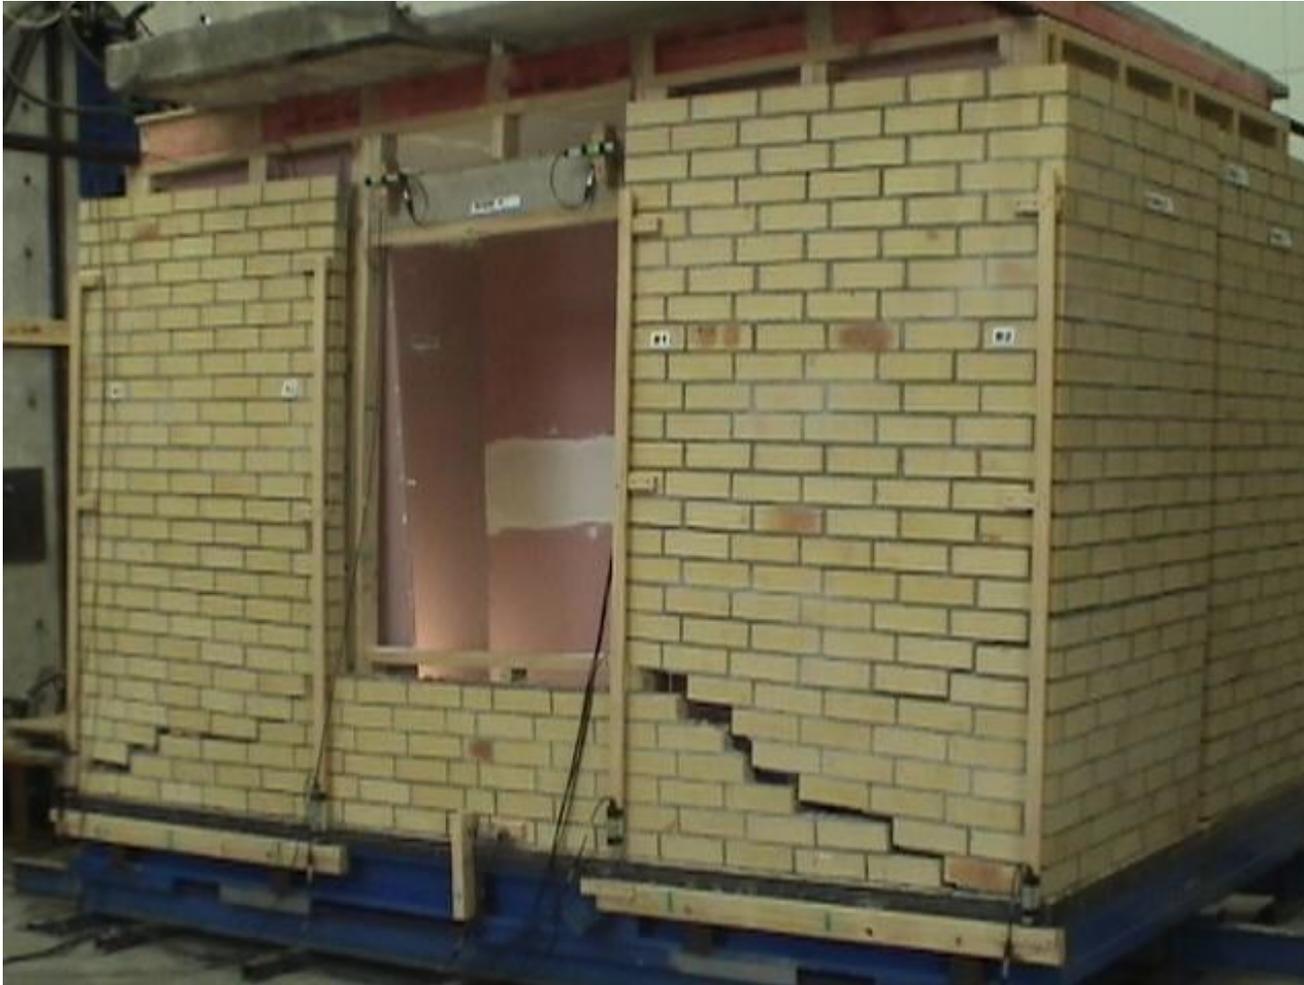
Figure 19. Cracks on Side 1 at peak forward deflection in Test 31

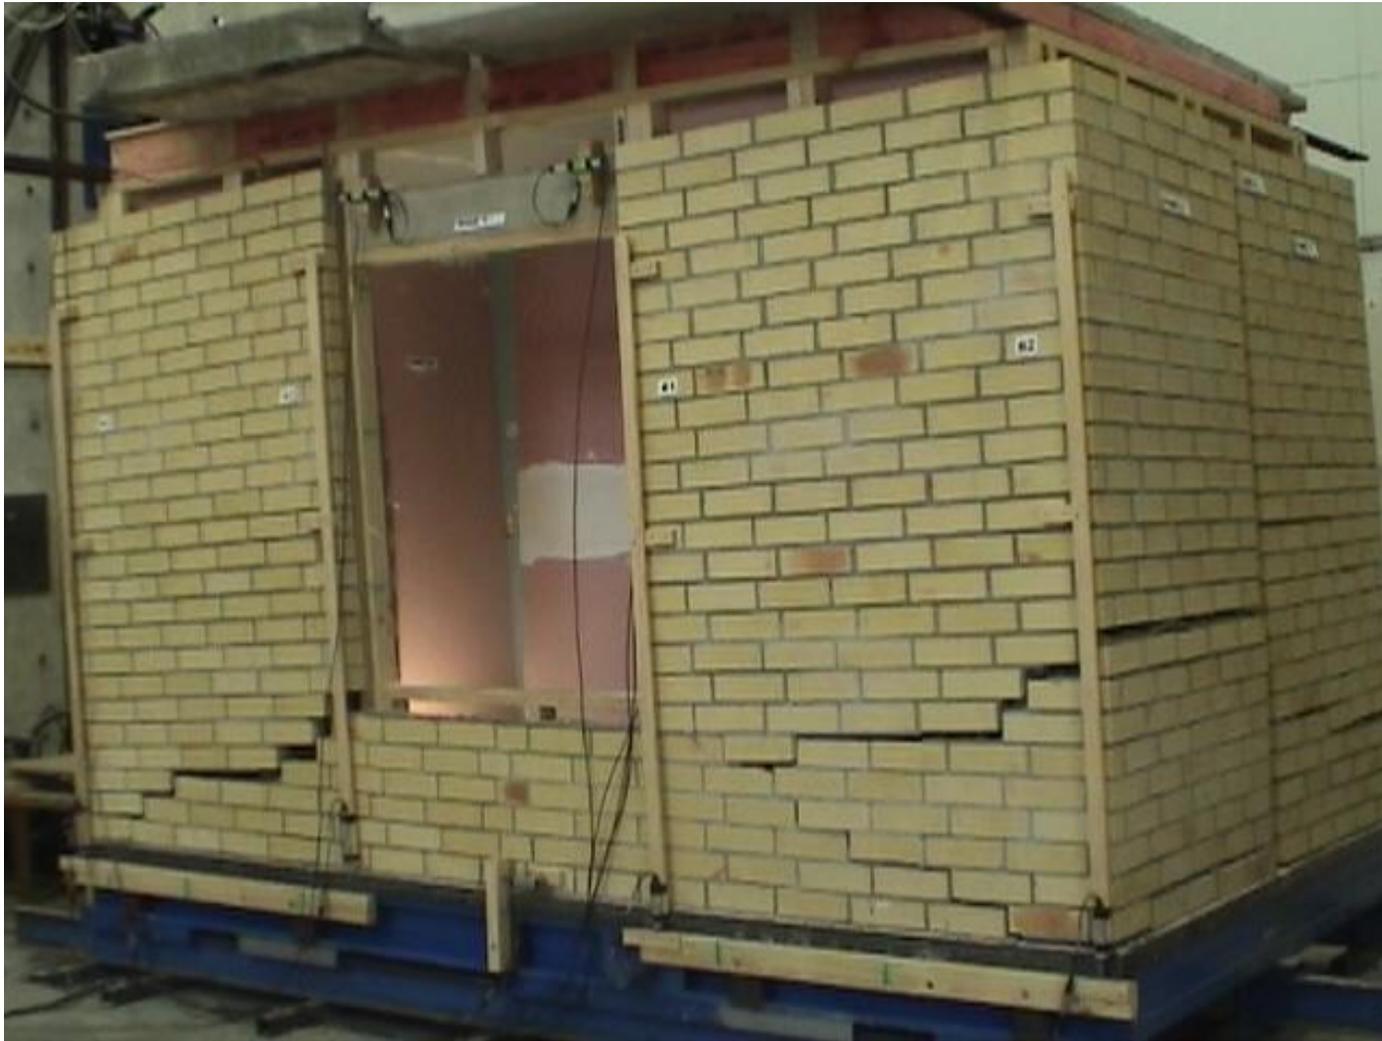
Figure 20. Cracks on Side 1 at peak backward deflection in Test 31

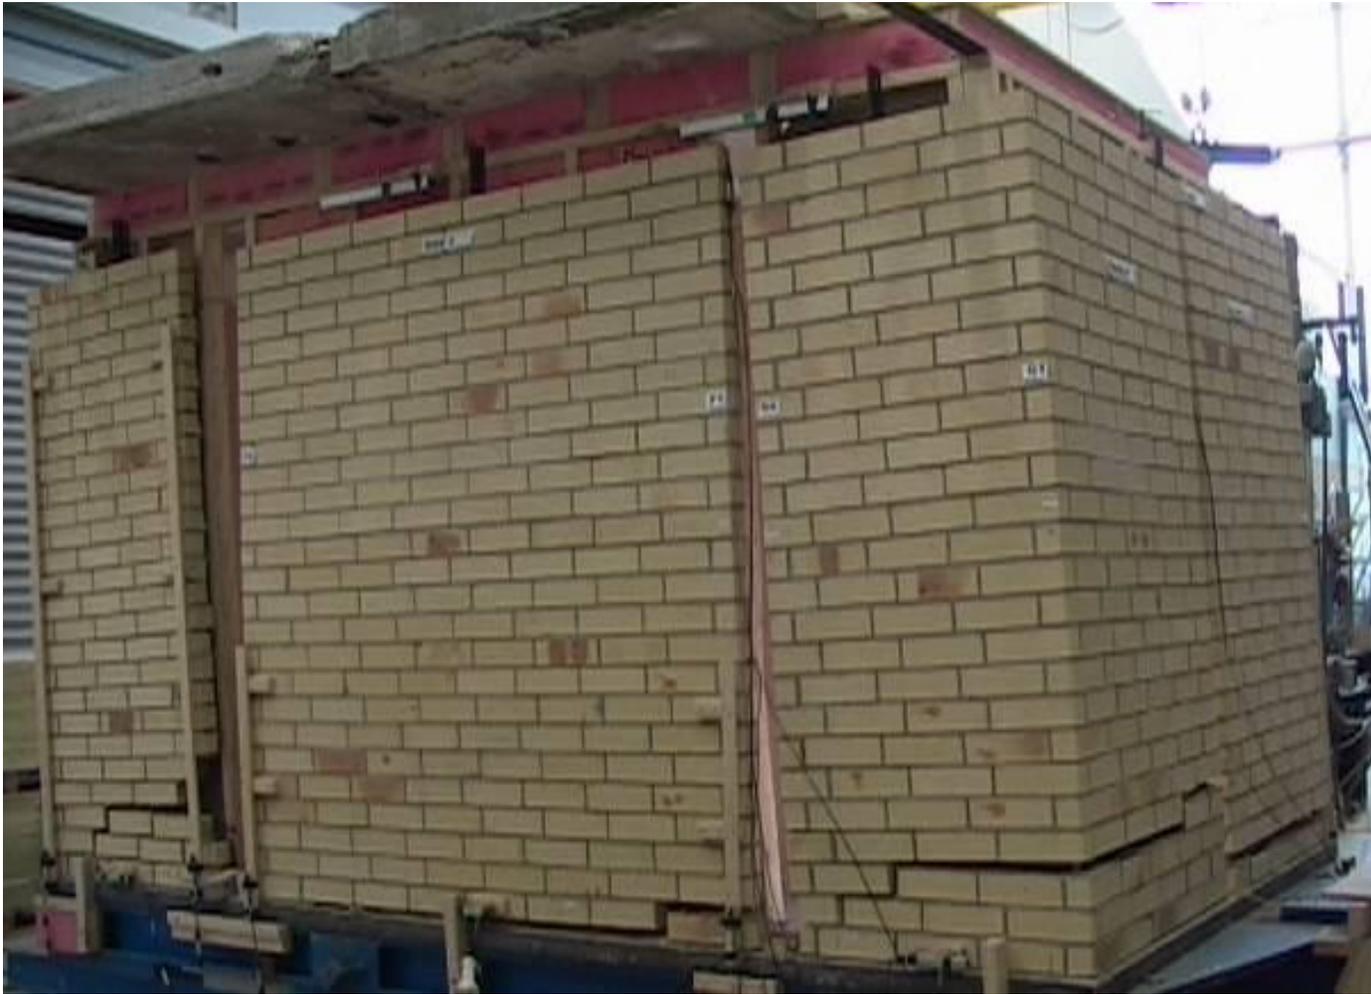
Figure 21. Cracks on Side 2 at peak forward deflection in Test 31

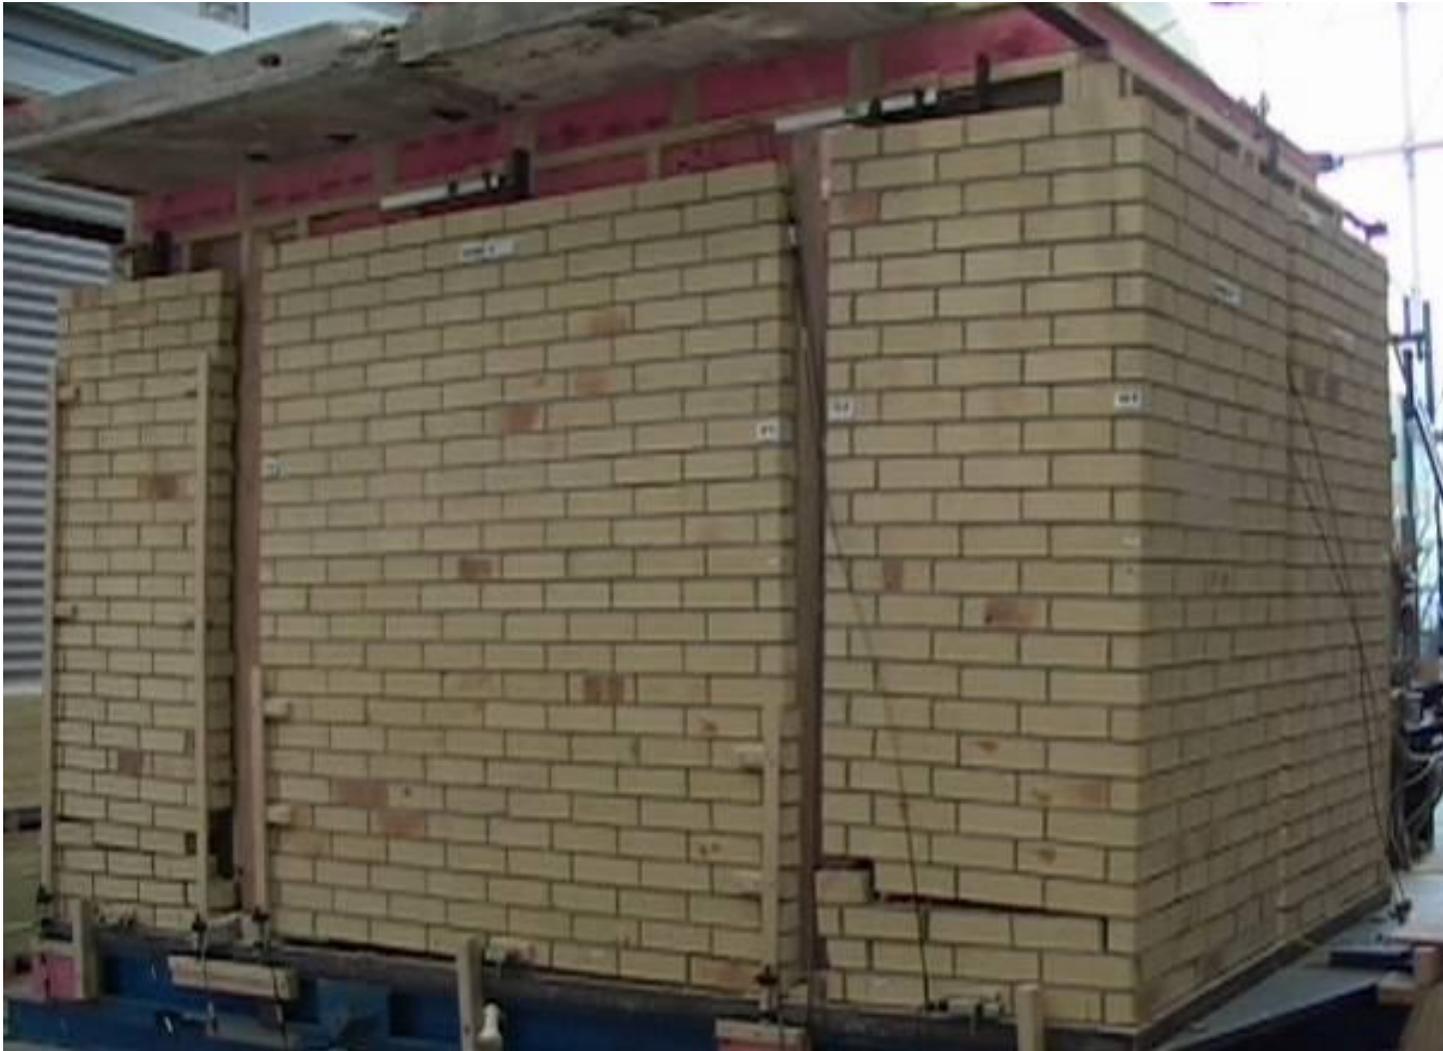
Figure 22. Cracks on Side 2 at peak backward deflection in Test 31

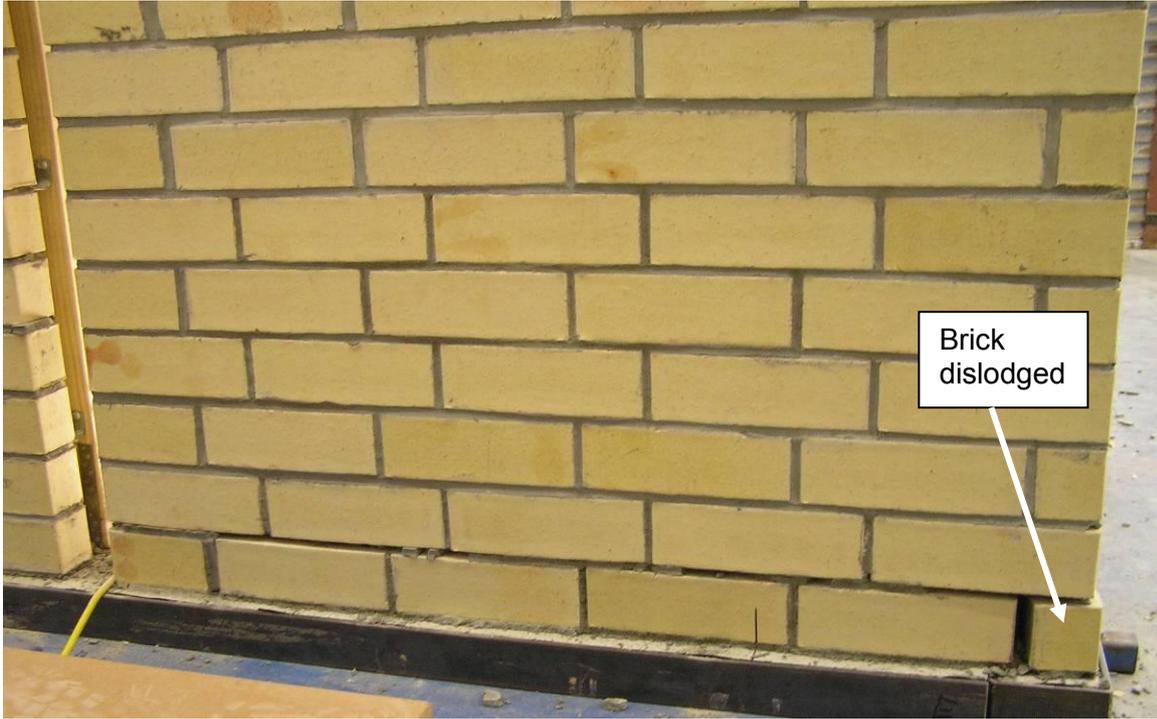
Brick dislodged

Figure 23. Typical condition of brick veneer at room ends at test completion (face-loaded panels)

Figure 23 to Figure 31 show the condition of the veneer at the end of all shake testing. All panels finished close to their initial uncracked positions. Although some of the cracks were unsightly they could all be re-pointed. Many ties had failed or had fatigue cracks, but this was because of the very large number on large deflection cycles imposed (as was noted for Panel F above).

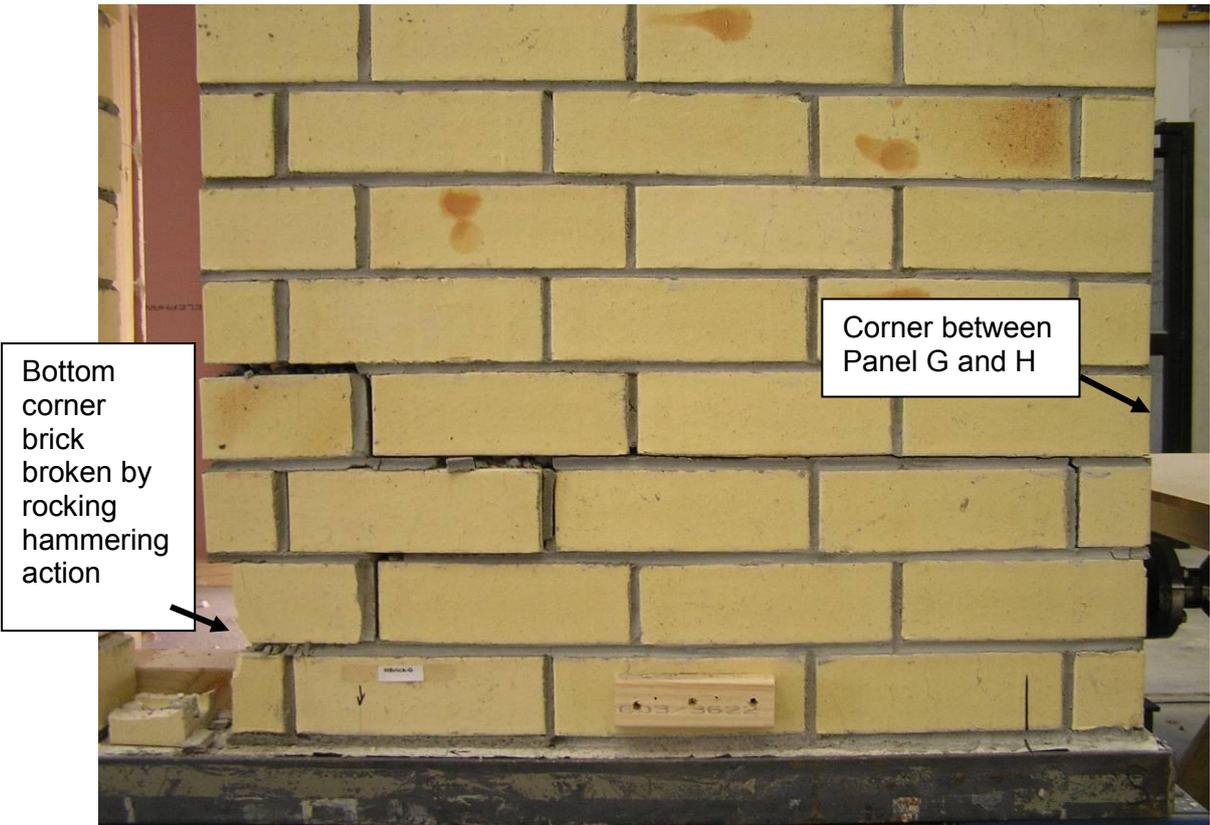
Bottom corner brick broken by rocking hammering action

Corner between Panel G and H

Figure 24. Condition of Panel G at test completion (in-plane-loaded panel)
