STUDY REPORT

No. 190 (2008)

Seismic performance of brick veneer houses

**Phase 2. Shake table tests on
a clay brick veneer specimen**

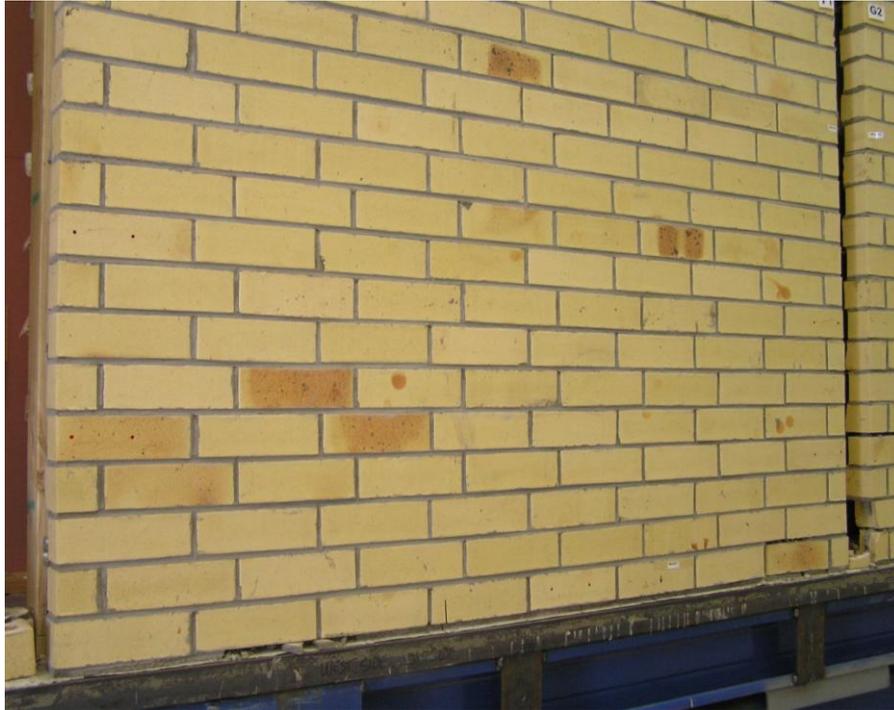
Figure 25. Condition of Panel F at test completion (loaded in-plane)

In Test T31, Panel F initially rocked but then this action stopped as the ties fatigued near the top of this panel because of the large number of large displacement cycles that had been applied, and the panel stopped following the ceiling deflection.

Figure 23 to Figure 31 show the condition of the veneer at the end of all shake testing. All panels finished close to their initial uncracked positions. Although some of the cracks were unsightly they could all be re-pointed. Many ties had failed or had fatigue cracks, but this was because of the very large number on large deflection cycles imposed (as was noted for Panel F above).

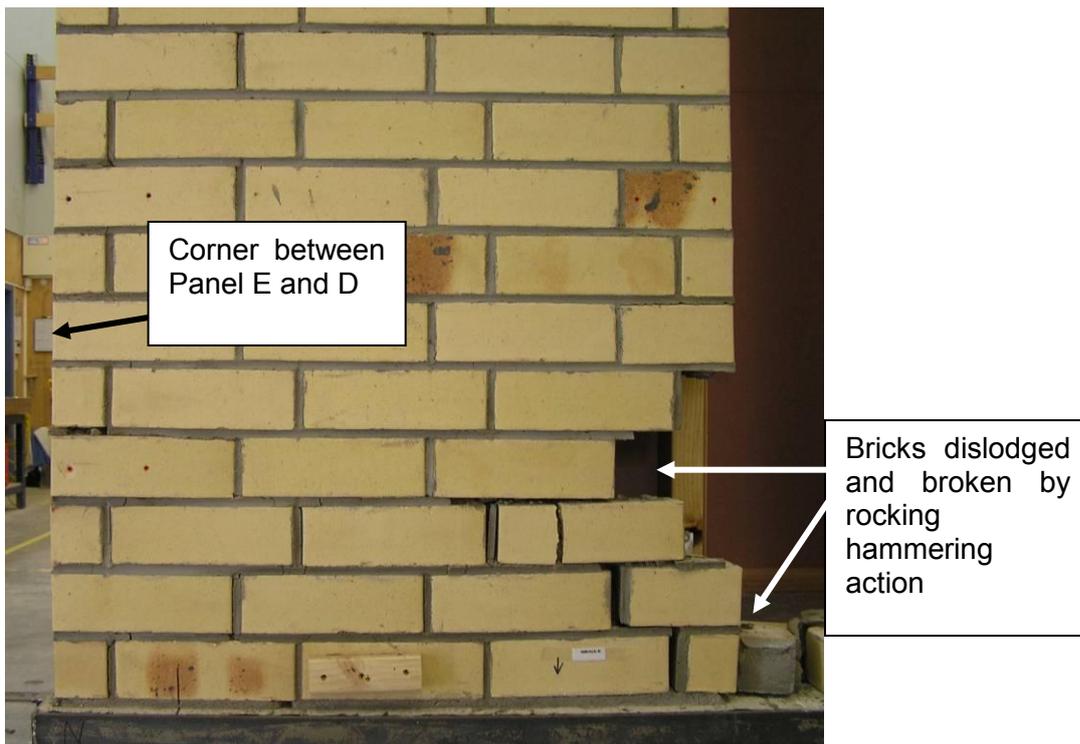
Figure 26. Condition of Panel E at test completion (loaded in-plane)

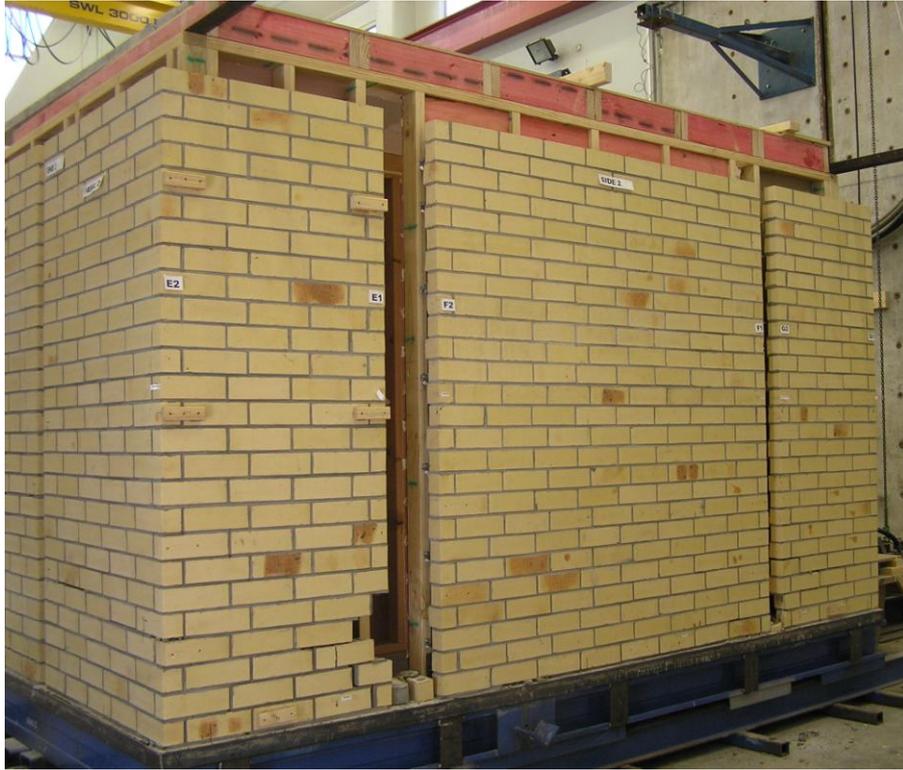
Figure 27. Condition of Side 2 and End 1 at test completion

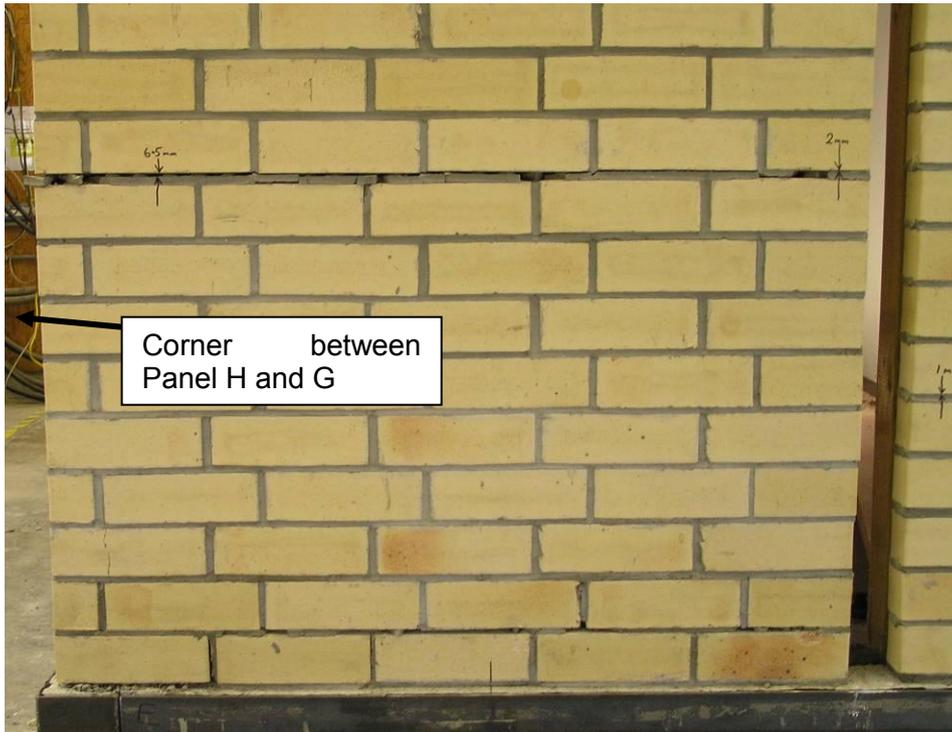
Figure 28. Condition of Panel H End 1 at test completion (face-loaded)

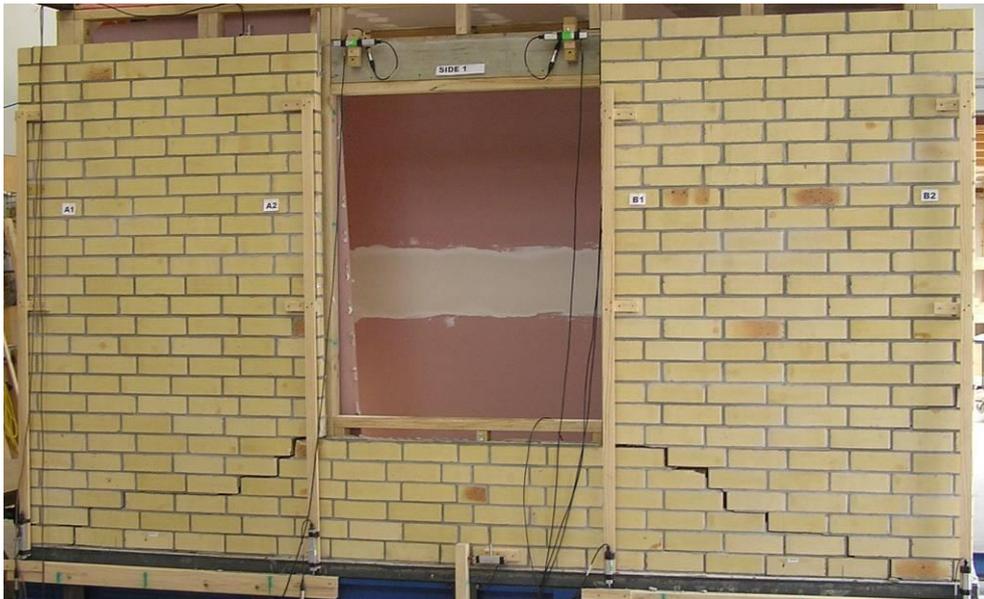
Figure 29. Condition of Side 1 (Panels A and B) at test completion (loaded in-plane)

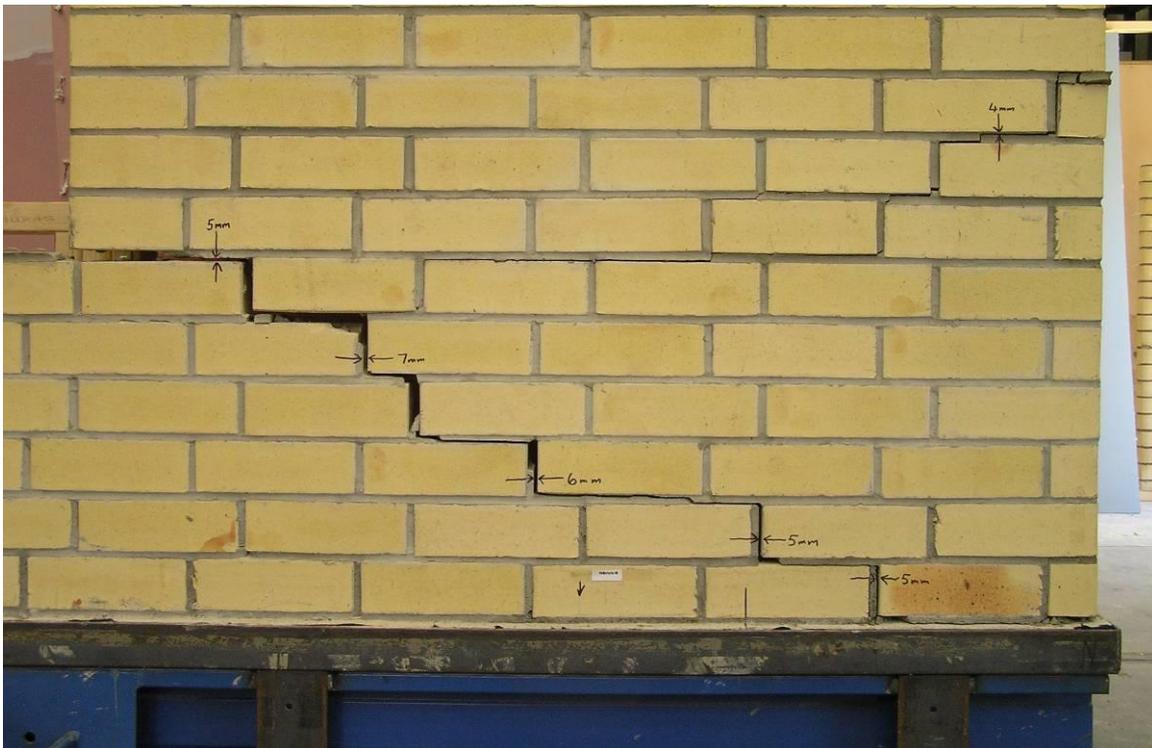
Figure 30. Condition of Panel B at test completion (loaded in-plane)

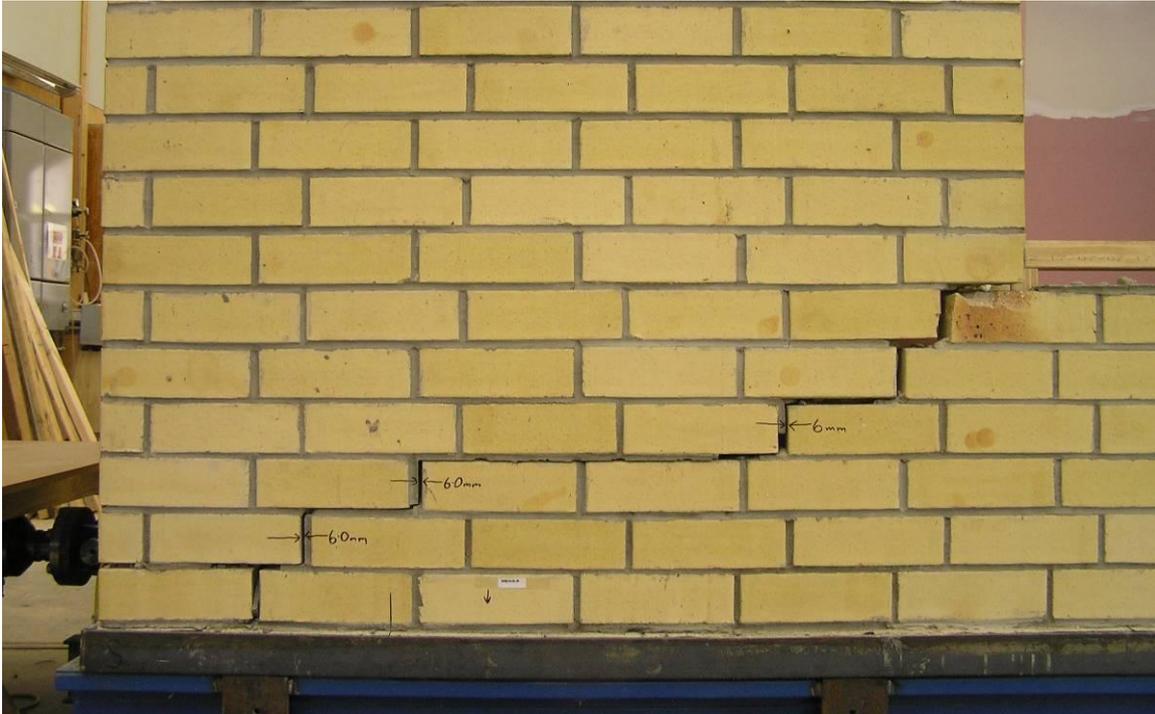
Figure 31. Condition of Panel A at test completion (loaded in-plane)

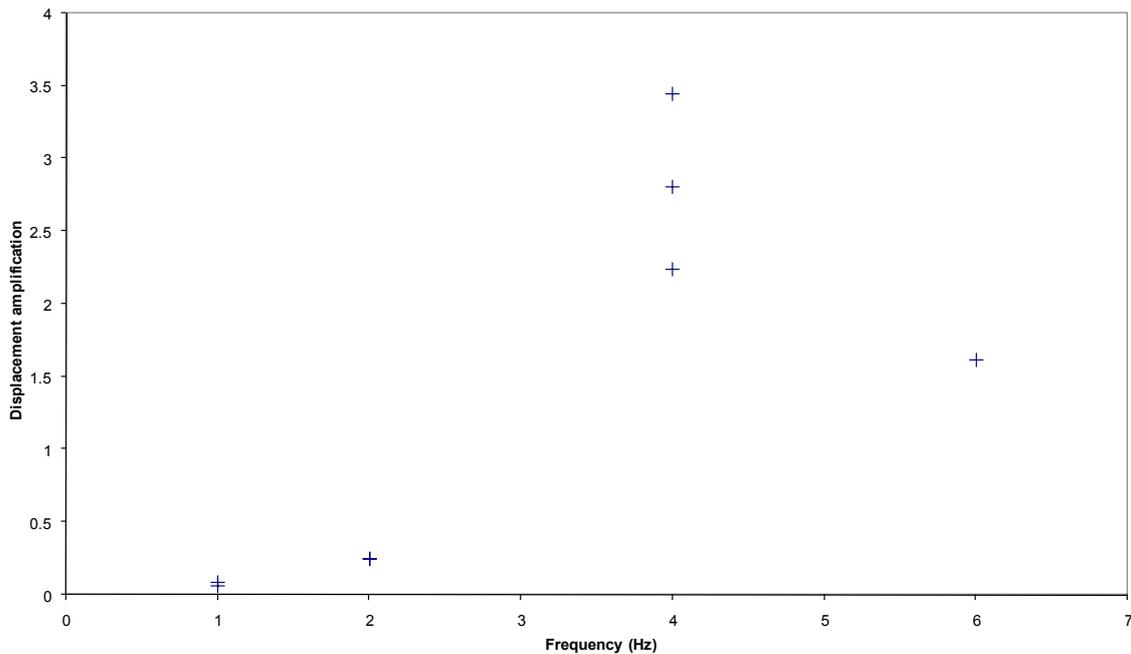
Figure 32. Natural frequency of room when linings were firmly fixed

Figure 32 plots the amplification ratio (= measured ceiling displacement relative to table divided by the table displacement amplitude) versus table displacement frequency for tests where the lining was still well attached and where the ceiling displacement was sufficient that it could be accurately measured. Peak values in Figure 32 are at 4 Hz, whereas the natural frequency found in Section 9 from the measurements of decay vibrations was 7.5 Hz. However, the peak in Figure 32 is not well defined as insufficient runs were performed to create an accurate curve. There are three peak points plotted at 4 Hz with the two lower values being from Tests T23 and T24, where the lining fixing had softened and ceiling displacements had reached 13.2 and 17.3 mm. It is concluded that the natural frequency of the room with lining is sensitive to the preceding loading.

As most of the analysis in this report using the natural frequency for the case of the lining in place uses data from tests where the ceiling displacement amplitude varied between 7–17 mm, the natural frequency for this state is taken as 4–5 Hz.

It is concluded that the natural frequency of the room was approximately 4–5 Hz when the lining was well attached and was experiencing displacement amplitudes in the order of 7–17 mm.

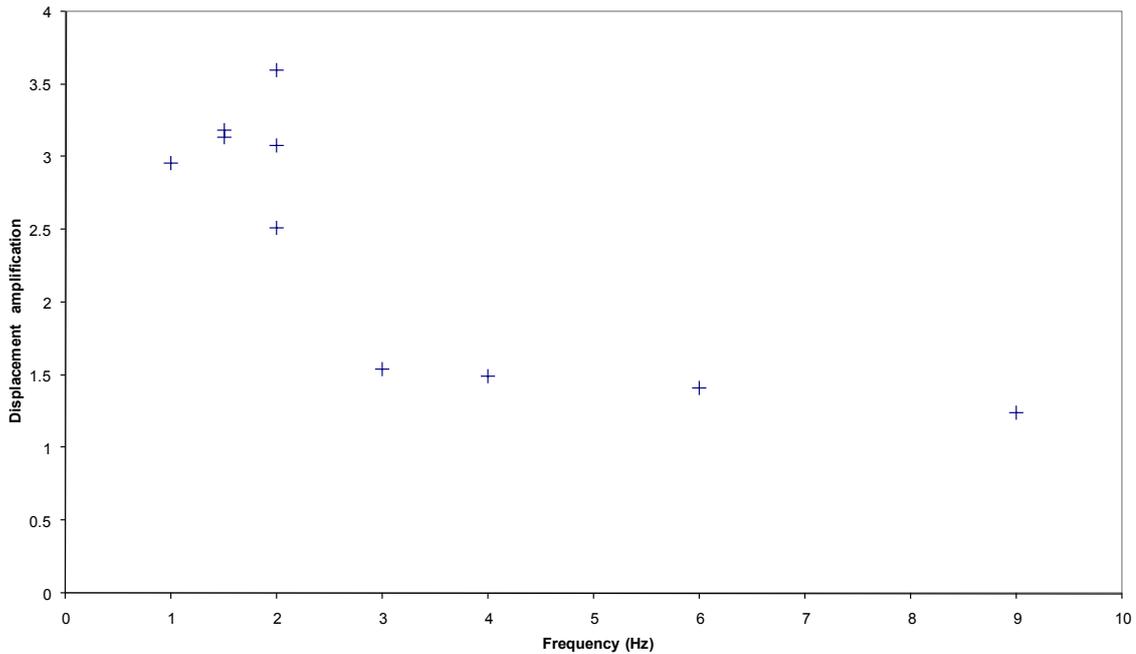
Figure 33. Natural frequency of room when linings effectively not fixed

Figure 33 plots the amplification ratio for tests where the wall lining was effectively detached from the framing. The resistance is then due only to the brick veneer. As there were many lengths of veneer, and as veneer panels have a non-linear force/displacement relationship, a simple natural frequency is not expected. From Figure 33 the best estimate of natural frequency is approximately 1.5 Hz. Three ratios are plotted at 2 Hz. The highest ratio occurs in Test T17 where the linings first came loose in Stage I and the linings may still have had some influence and increased the natural frequency. The next highest ratio occurs in Test T25 where the linings first came loose in Stage II and the same conclusion applies. Thus, the lowest point is expected to be the most reliable indication for the detached lining situation and this fits the curve of the other data best.

It is further concluded that the room natural frequency was between 1.25 and 1.75 Hz when the lining was effectively detached. However, unlike an elastic system, it did not display a sharp increase in displacements at the natural frequency, but rather shaking in the 1 to 2 Hz range gave similar displacement amplifications.

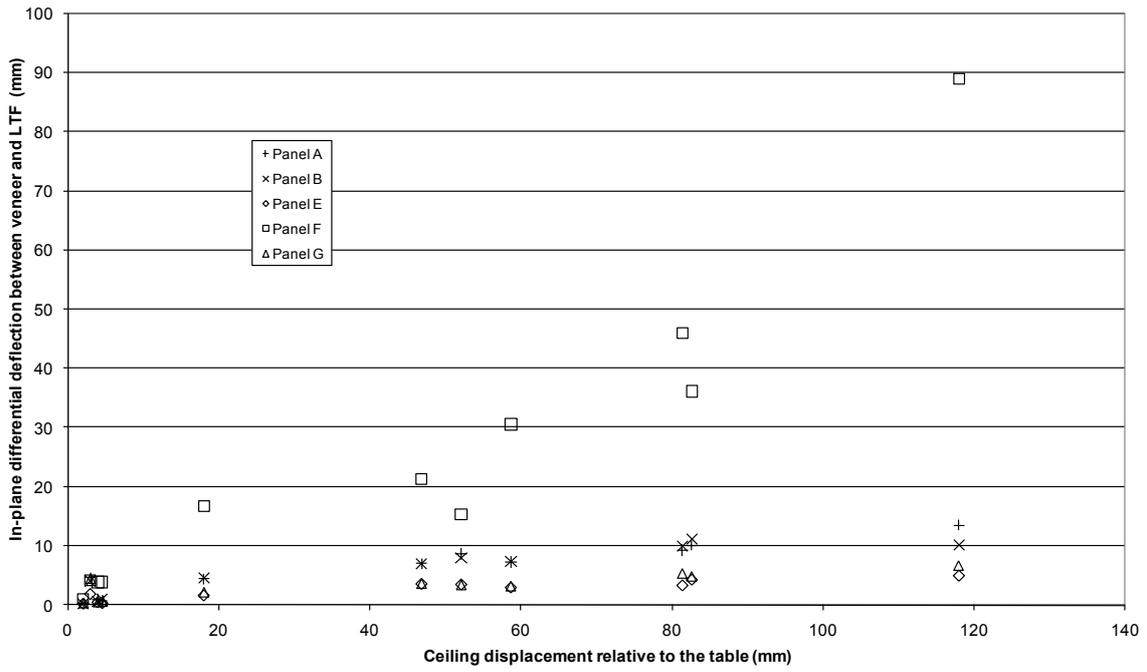
Figure 34. Tie deflection versus ceiling displacement

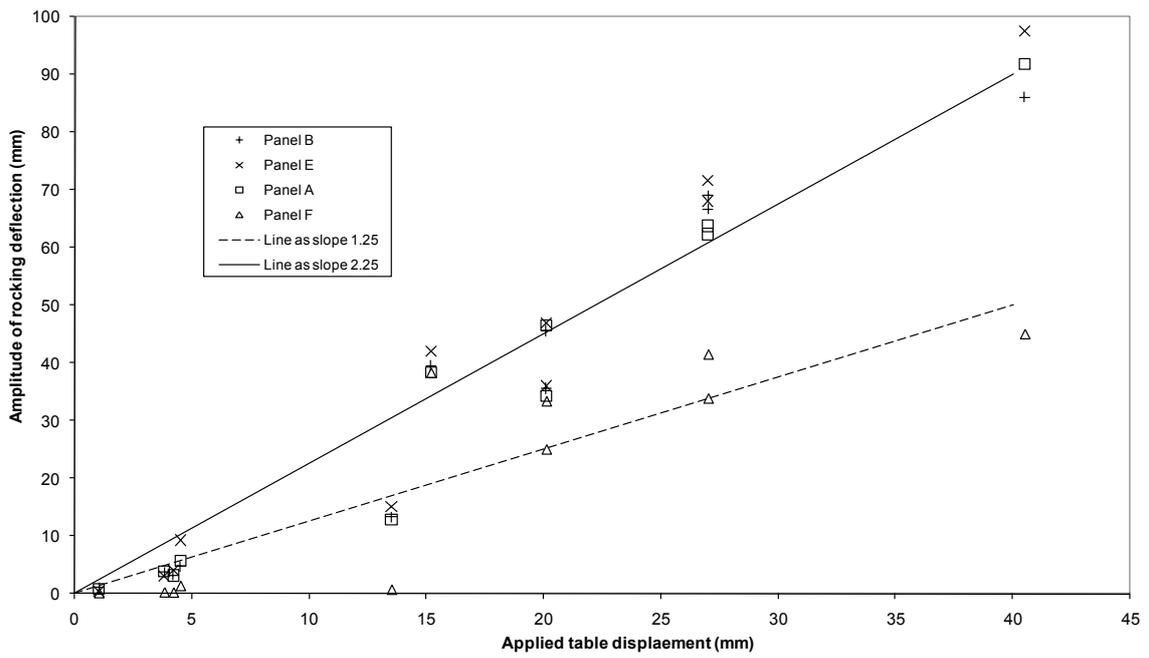
Figure 35. Panel rocking deflection versus applied table displacement

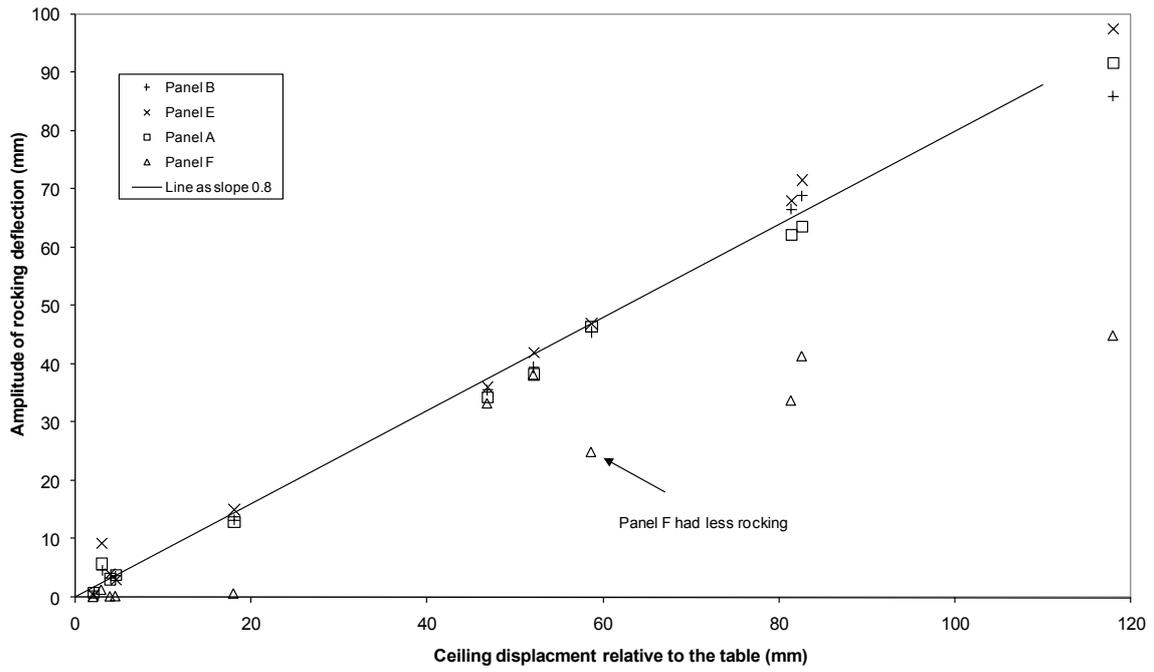
Figure 36. Panel rocking deflection versus ceiling displacement

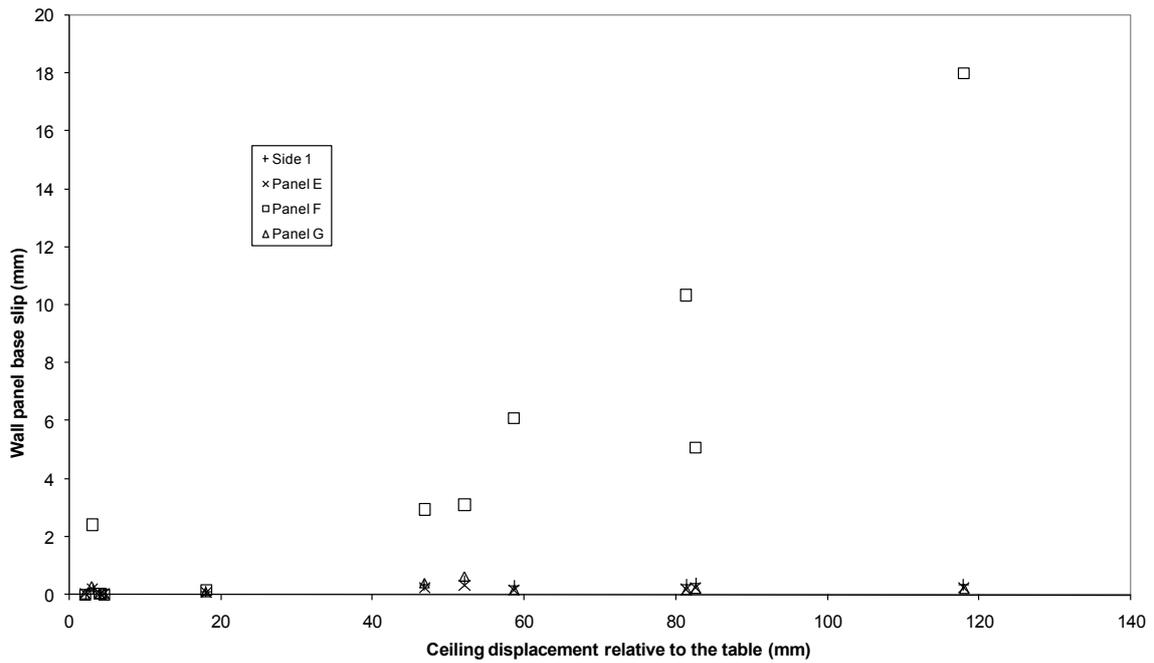
Figure 37. Panel base slip versus ceiling displacement

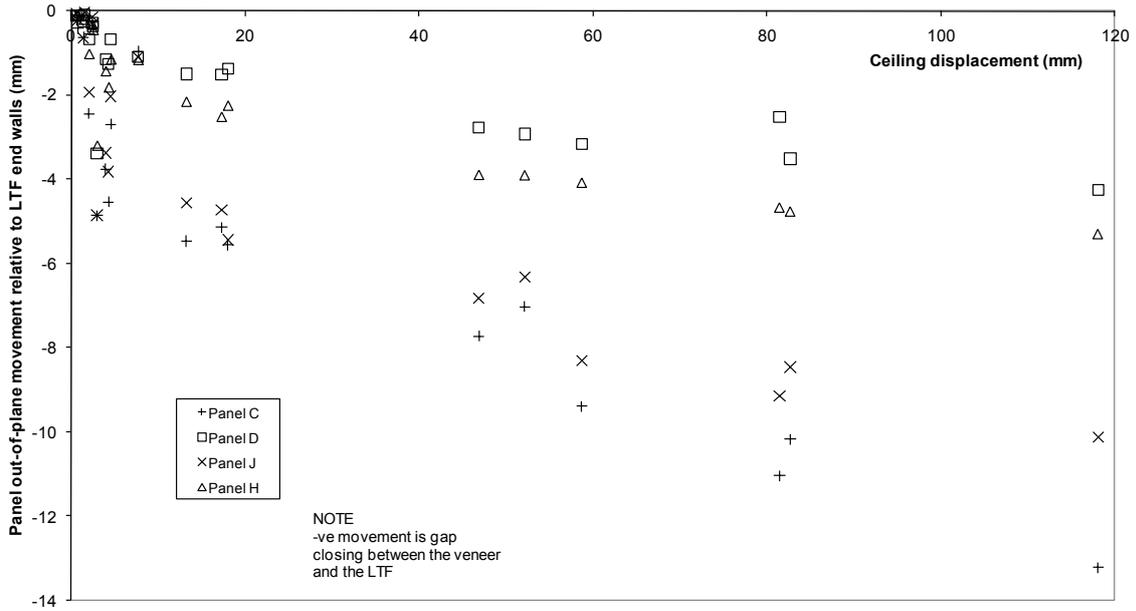
Figure 38. Maximum veneer panel out-of-plane displacement relative to LTF

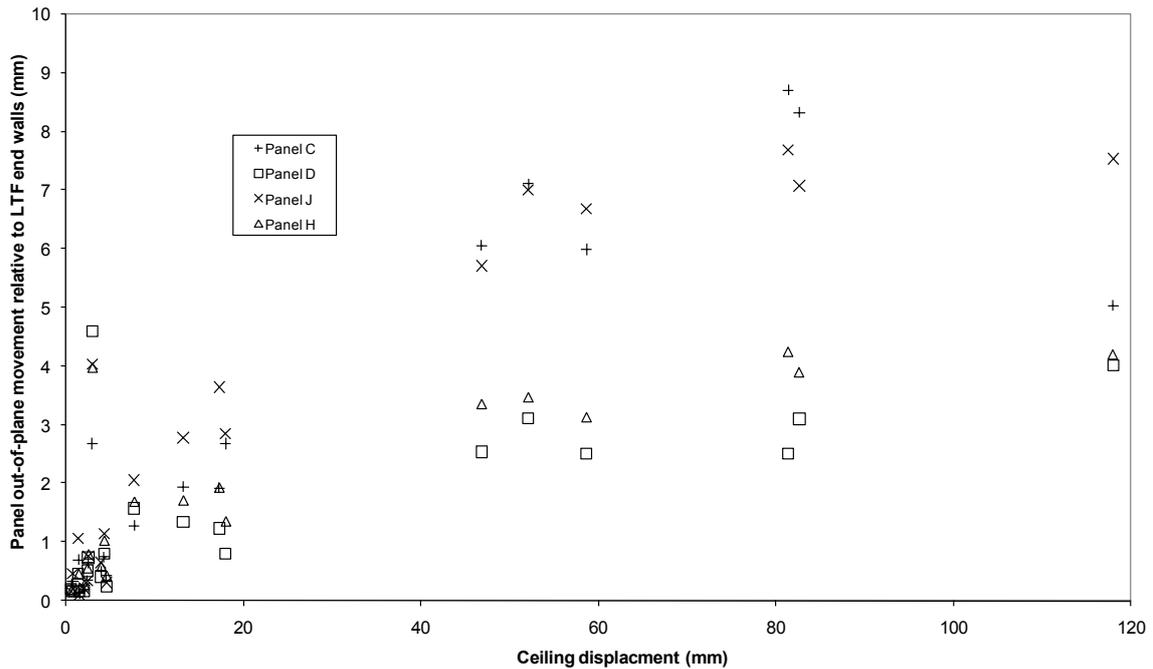
Figure 39. Range of veneer panel out-of-plane displacement relative to LTF in each test

The range of movement in each test is plotted in Figure 39. For example, in Test T31 the top of Panel C End 2 was closer to the LTF by between 8.19 and 13.27 mm during the test. Thus, a point at -13.27 mm is plotted in Figure 38 at the ceiling displacement of 118 mm and a point at $(13.27 - 8.19 =) 5.04$ mm is plotted in Figure 39 at the ceiling displacement of 118 mm. The measured gap between the walls did not increase by more than 1 mm in any of the tests. A comparison of the plots in Figure 38 and Figure 39 shows that the ties never fully straightened after buckling.

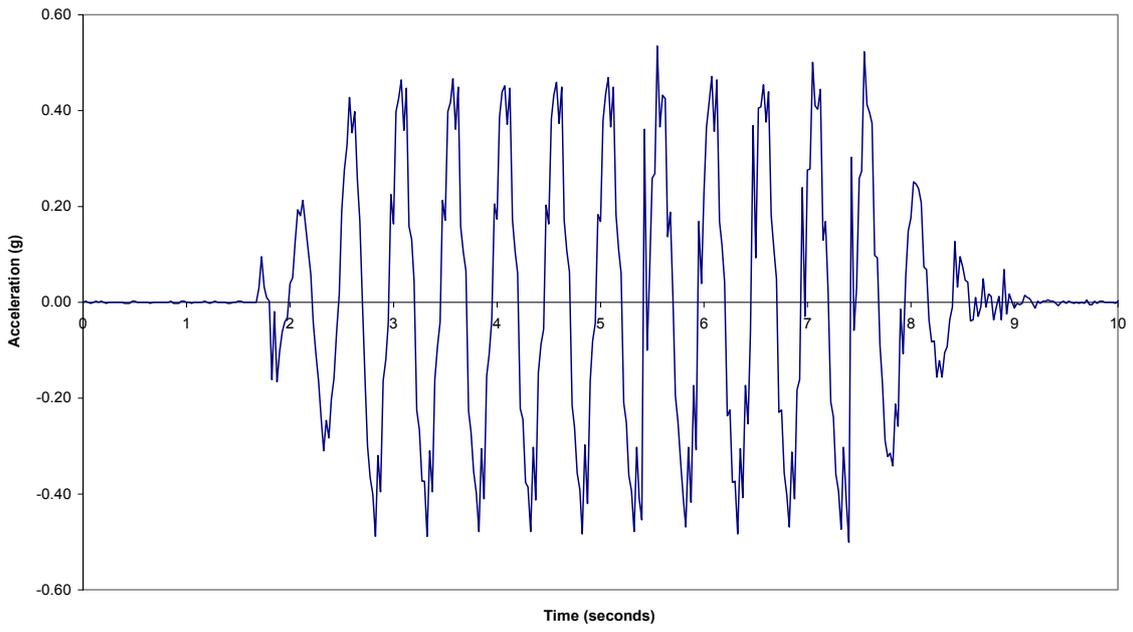
Figure 40. Measured table acceleration in Test 17

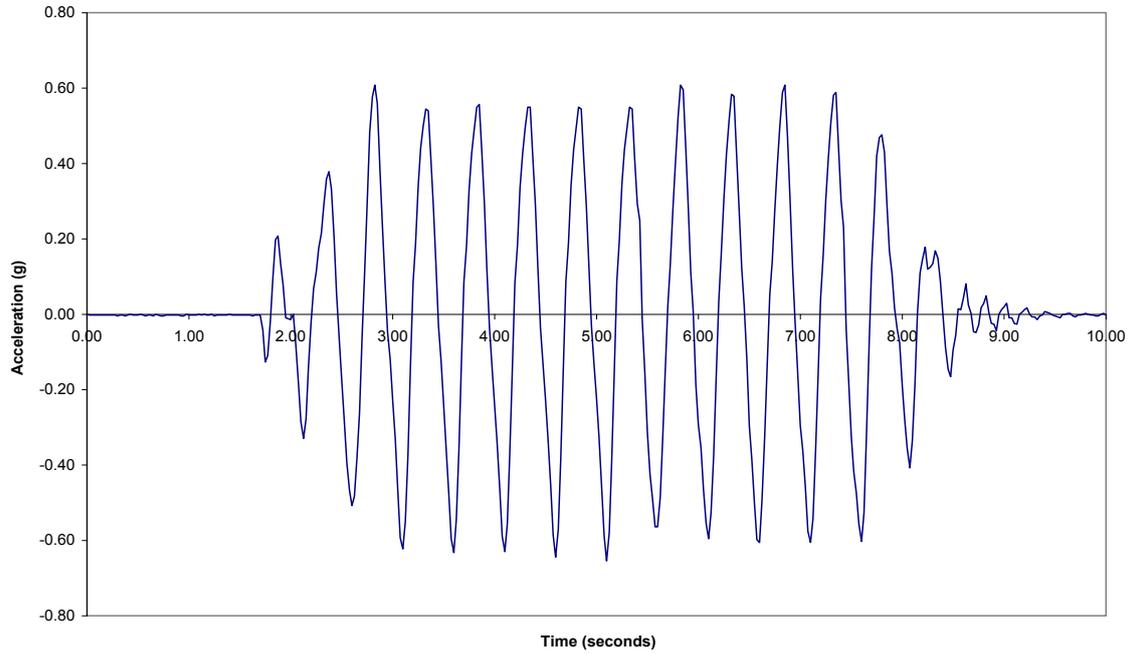
Figure 41. Measured ceiling acceleration in Test 17

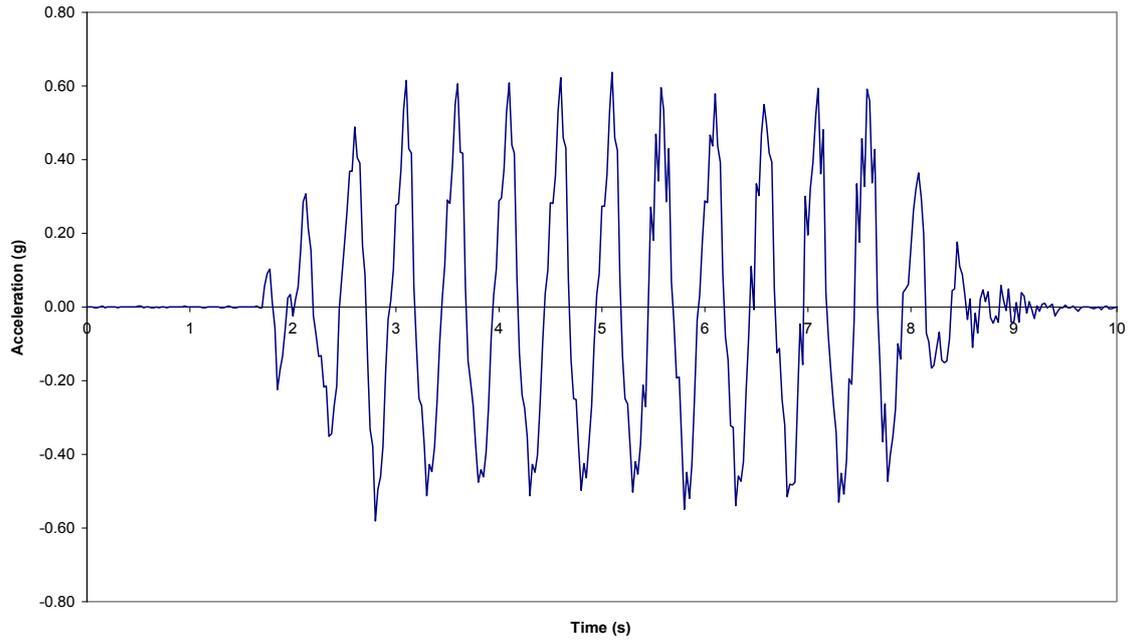
Figure 42. Measured acceleration at the top of Side 1 veneer in Test 17

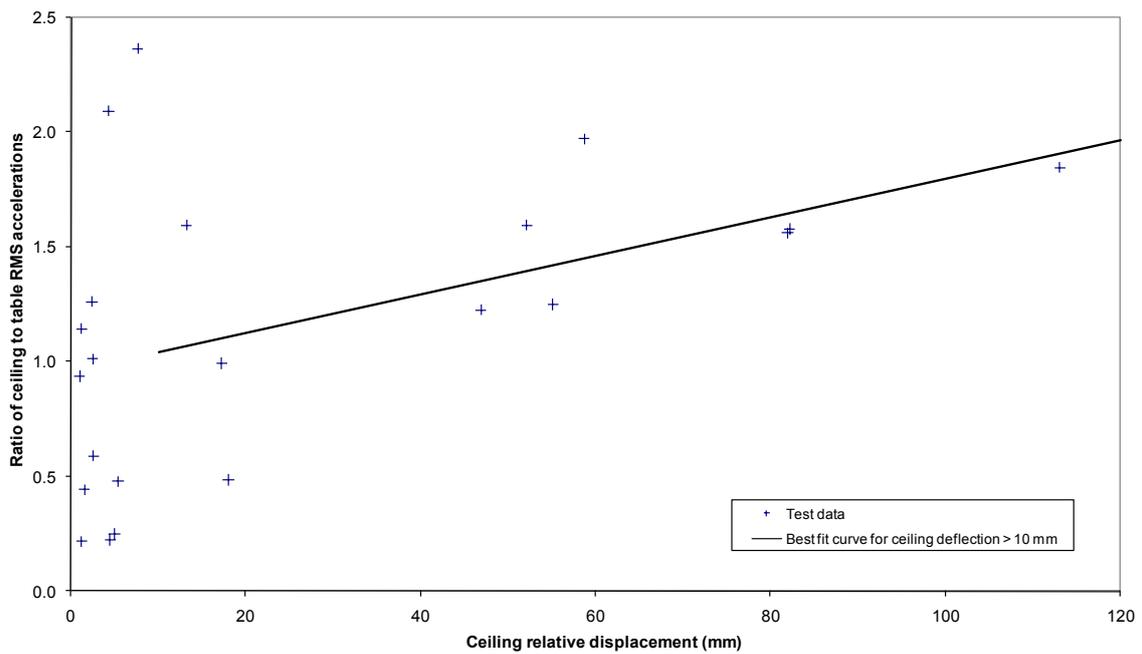
Figure 43. Ratio of ceiling RMS acceleration to table RMS acceleration versus ceiling displacement

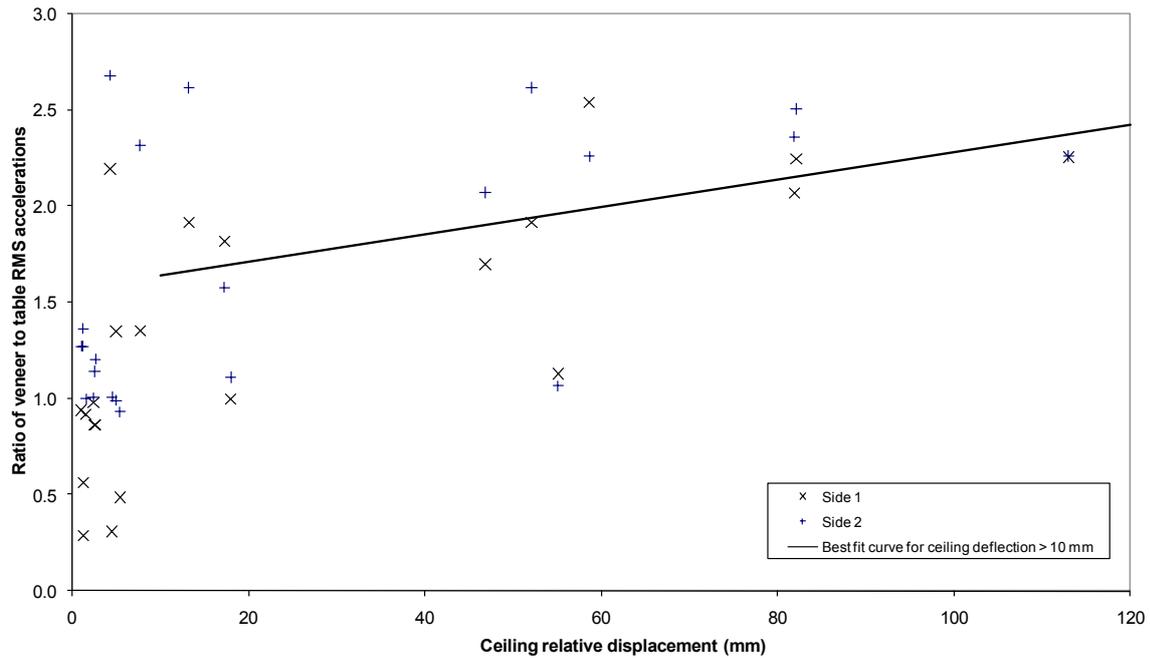
Figure 44. Ratio of veneer RMS acceleration to table RMS acceleration versus ceiling displacement

Figure 44 plots the ratio of the RMS acceleration at the top of the veneer to table RMS acceleration versus ceiling displacement. Again it can be seen that there is a considerable scatter of results. For ceiling displacements greater than 10 mm, a best fit straight line gave a ratio of approximately 1.6 for 10 mm ceiling deflection and approximately 2.4 for 120 mm ceiling deflection.

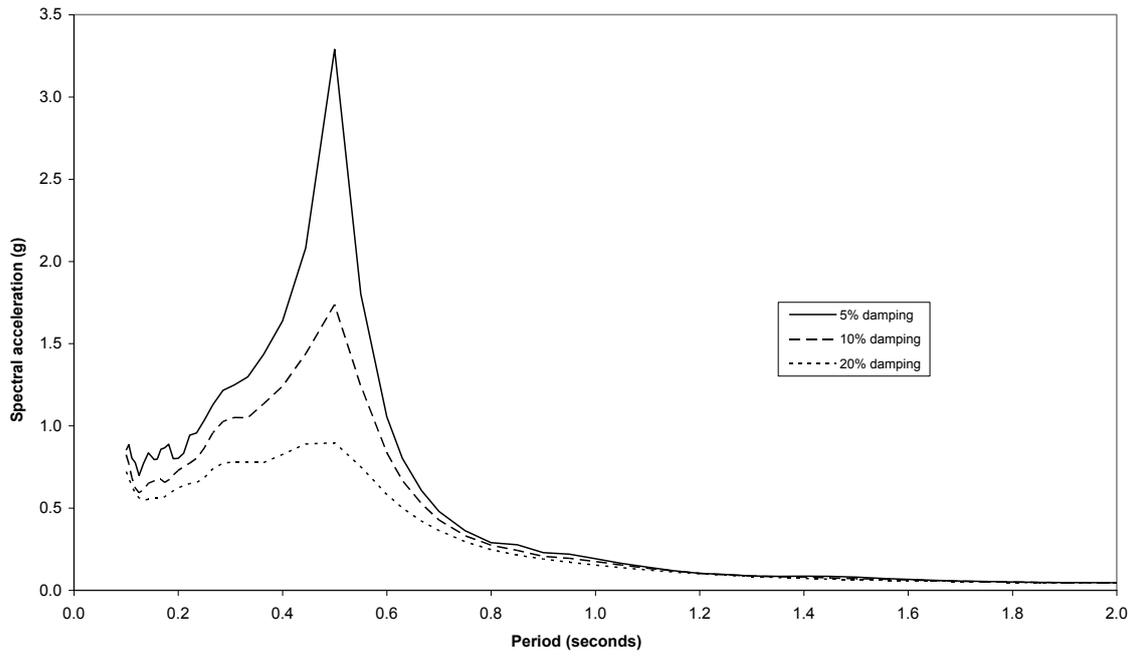
Figure 45. Response spectra from shaking of Test T22

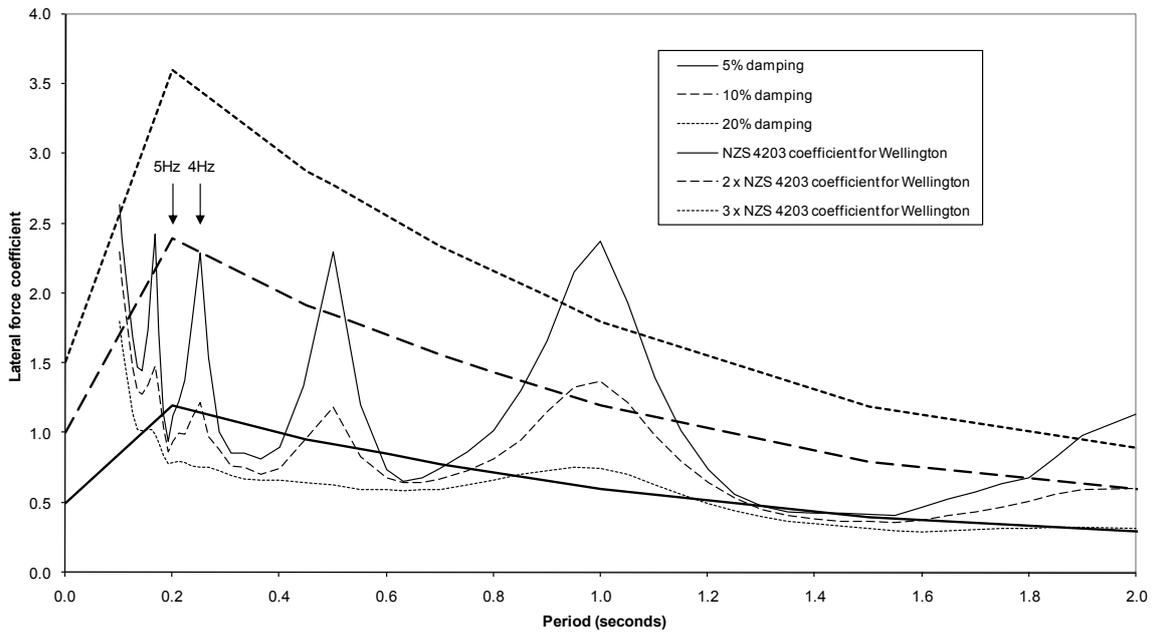
Figure 46. Summation of response spectra before significant veneer cracking in Stage I

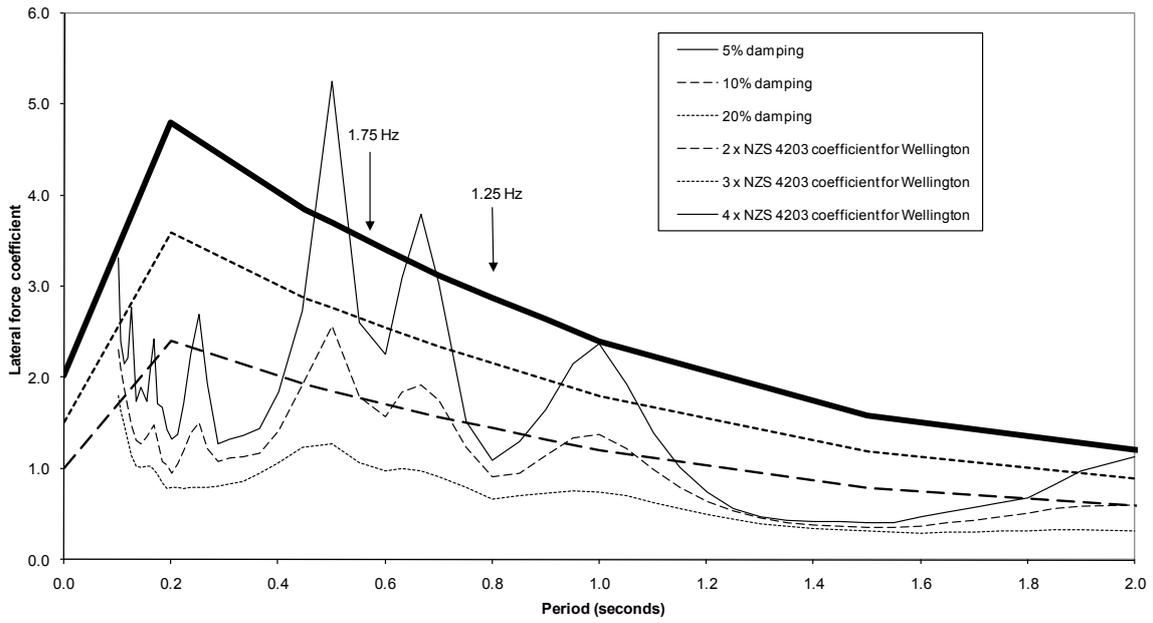
Figure 47. Summation of response spectra in Stage I

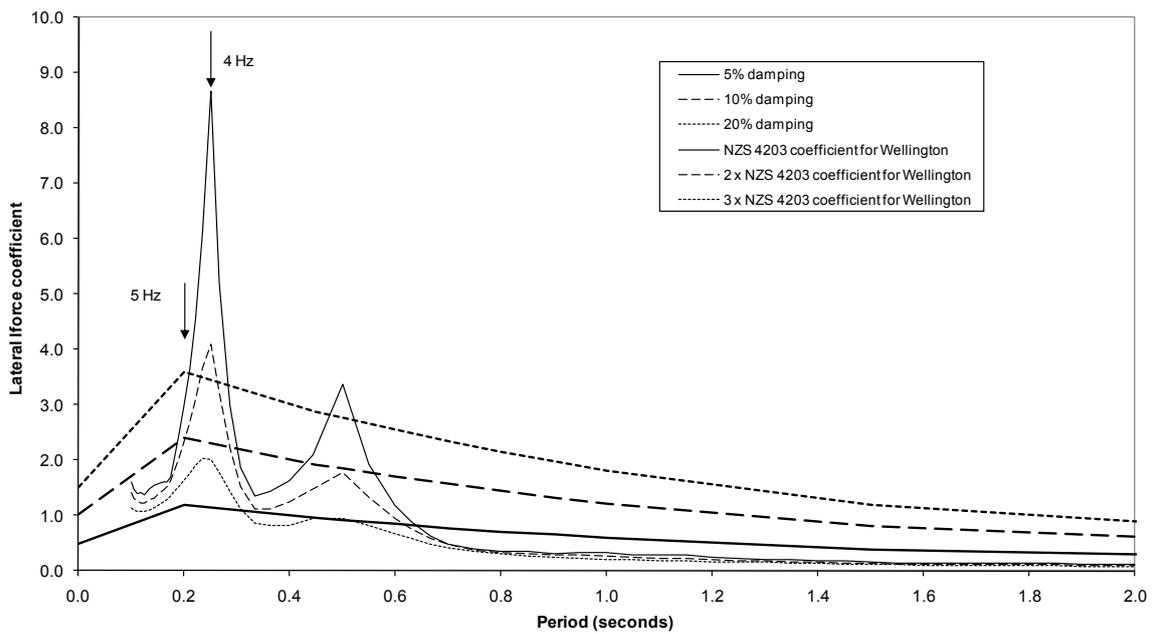
Figure 48. Summation of response spectra in Stage II before significant veneer cracking

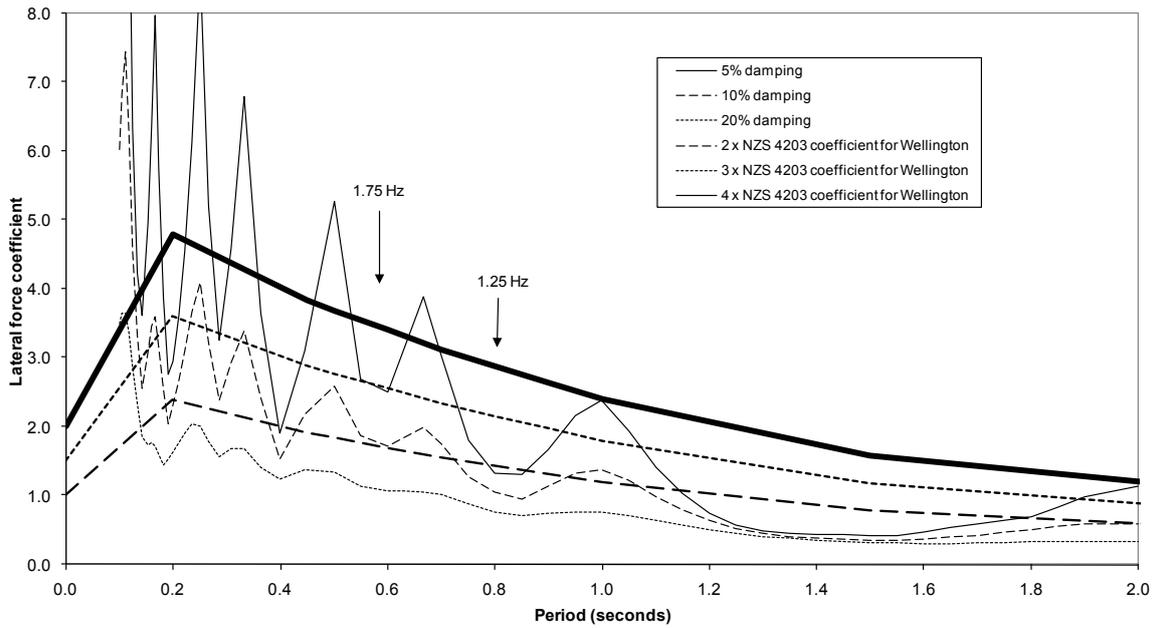
Figure 49. Summation of response spectra in Stages I and II before ties fatigued

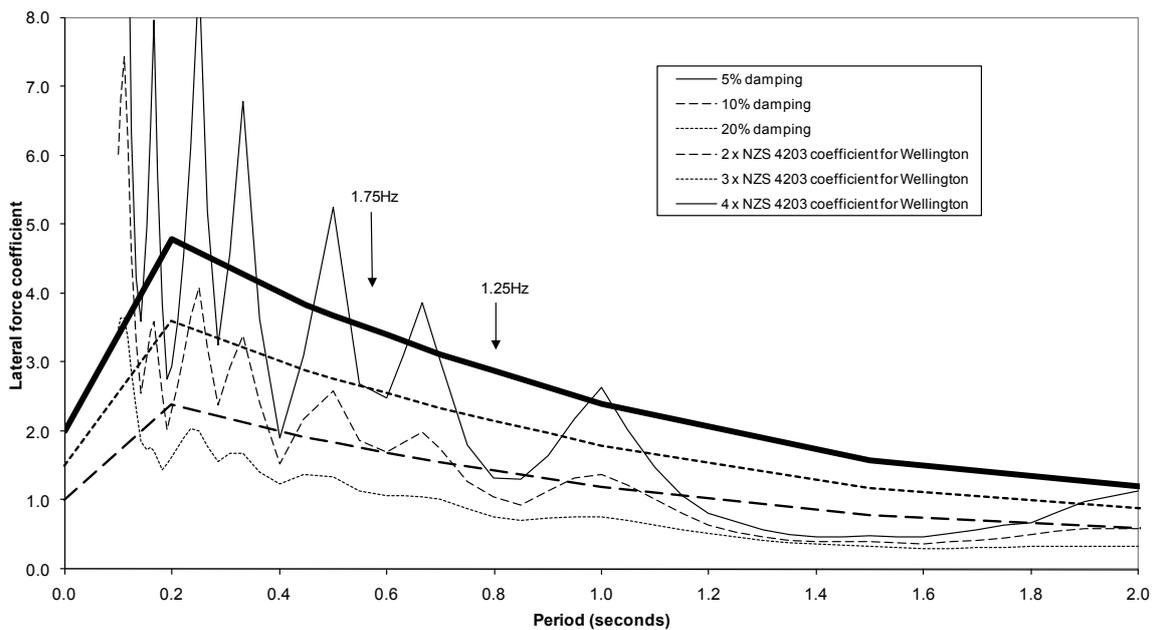
Figure 50. Summation of response spectra in Stages I and II

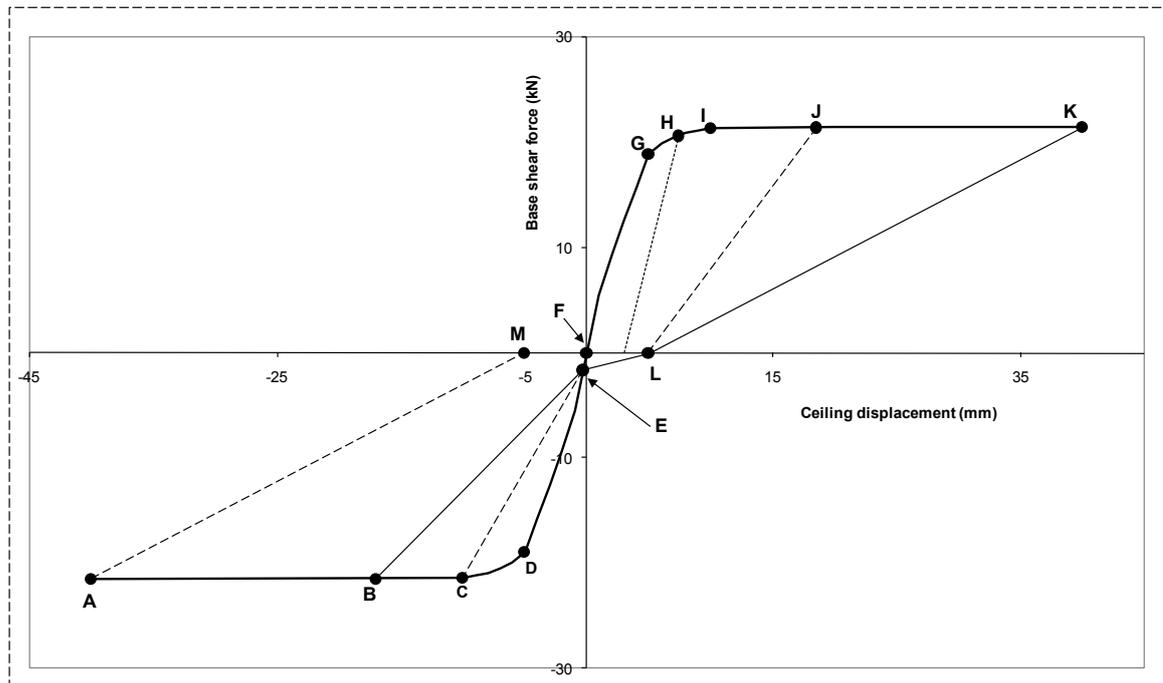
Figure 51. Hysteresis shape used in the computer model for predicting brick veneer panel response

Beattie (2008a), and for the test room it is the backbone curve shown as a bold line in Figure 51.

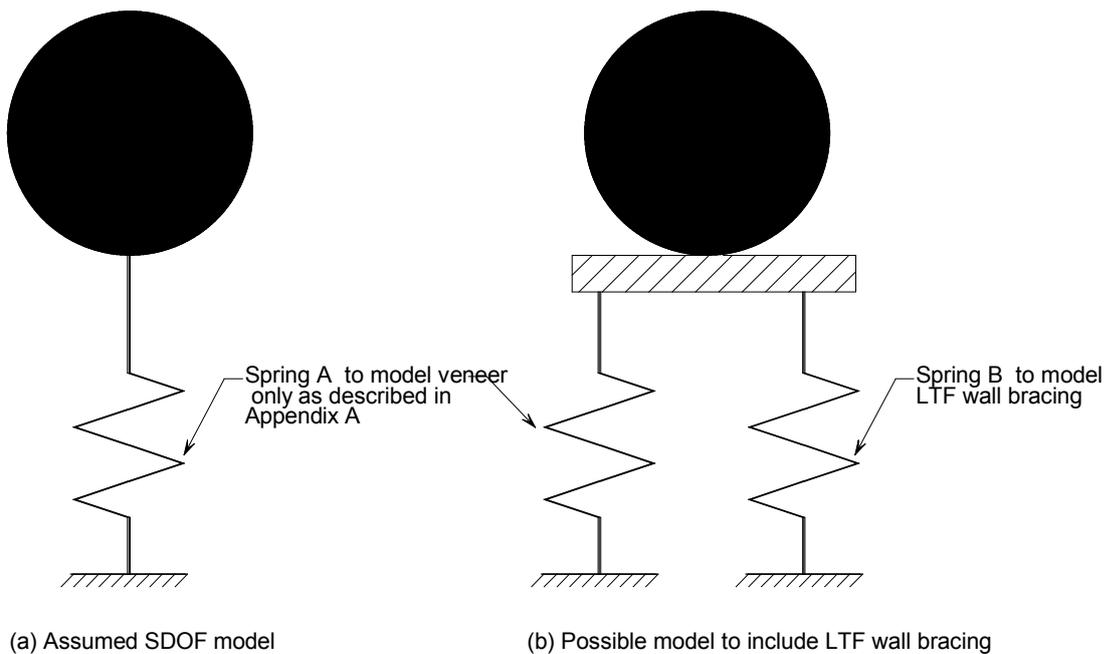
Figure 52. Schematic view of computer model

The room was considered to be a SDOF oscillator with a mass on top, as shown in Figure 52. This mass was taken as the mass corresponding to the effective weight, W_T , at the top of the room. W_T was taken to be half the estimated weight of the walls (LTF and veneer) plus the room ceiling weight, W_c , calculated in Section 4.3, plus the added 34.88 kN weight of the concrete slabs. W_T was calculated to be 58.3 kN.
