STUDY REPORT

No. 190 (2008)

Seismic performance of brick veneer houses

**Phase 2. Shake table tests on
a clay brick veneer specimen**

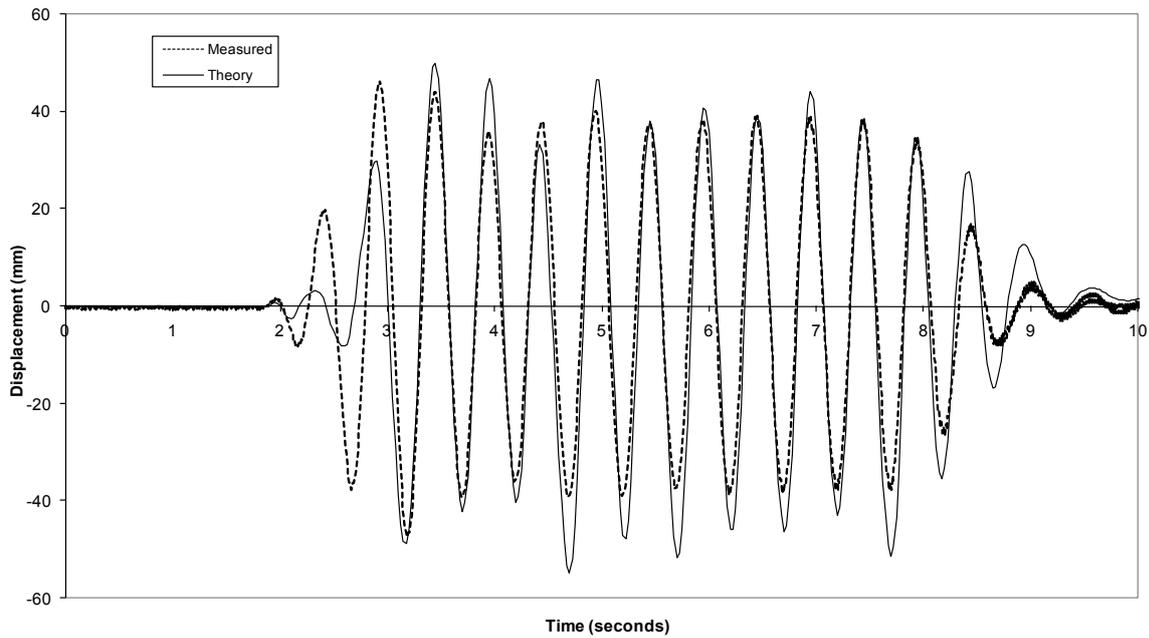
Figure 53. Comparison of measured and theoretical ceiling displacement time history for Test T20

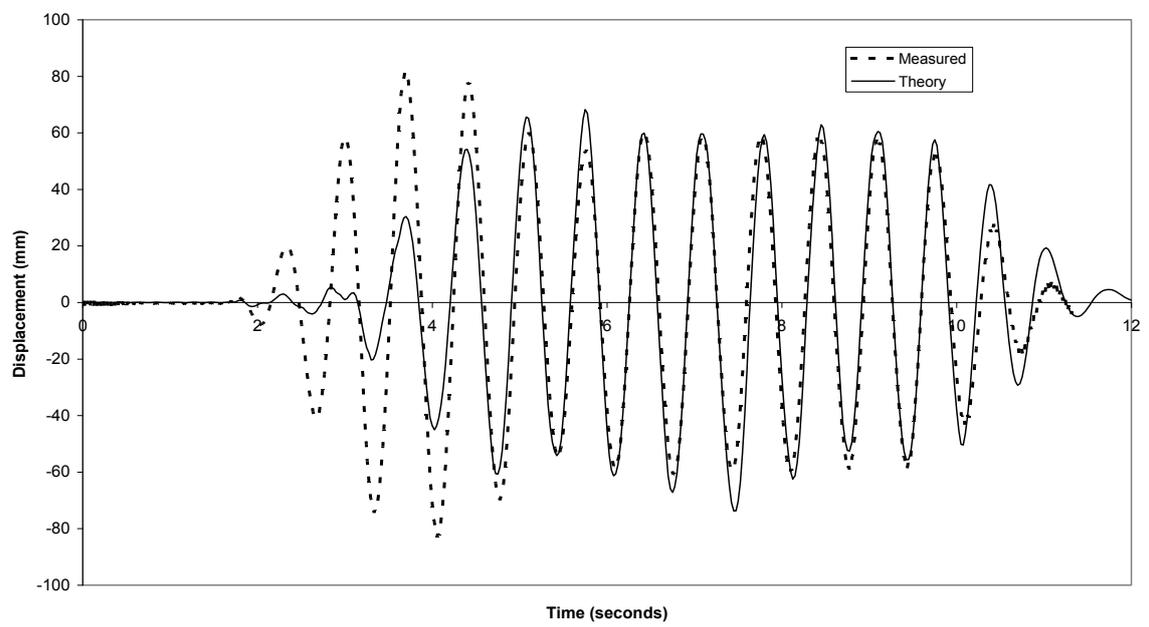
Figure 54. Comparison of measured and theoretical ceiling displacement time history for Test T21

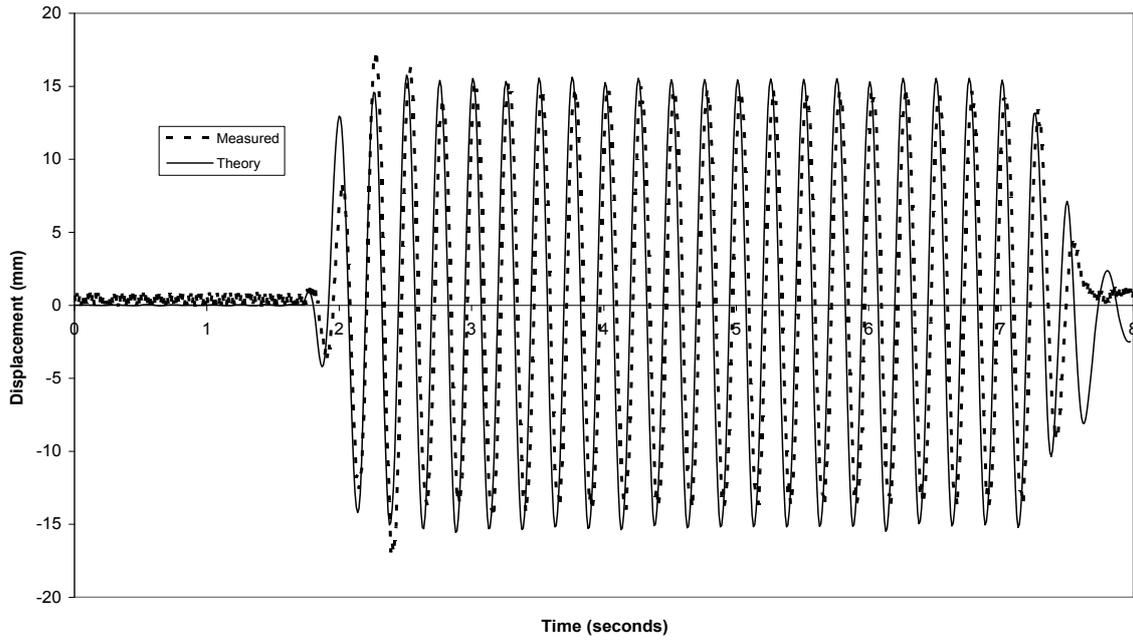
Figure 55. Comparison of measured and theoretical ceiling displacement time history for Test T24

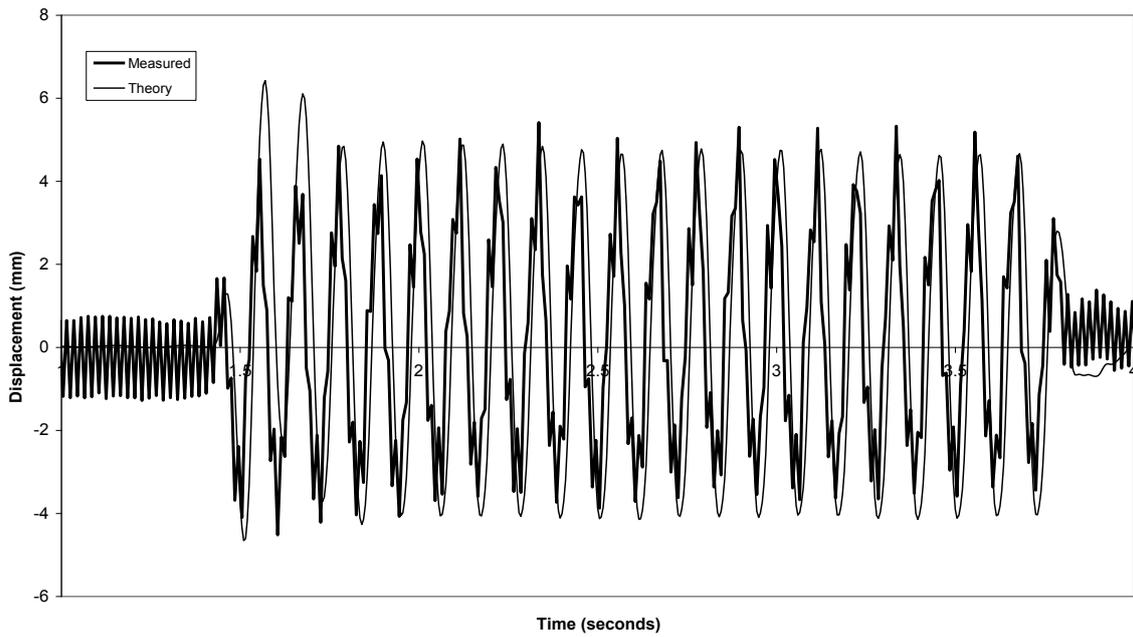
Figure 56. Comparison of measured and theoretical ceiling displacement time history for Test T29

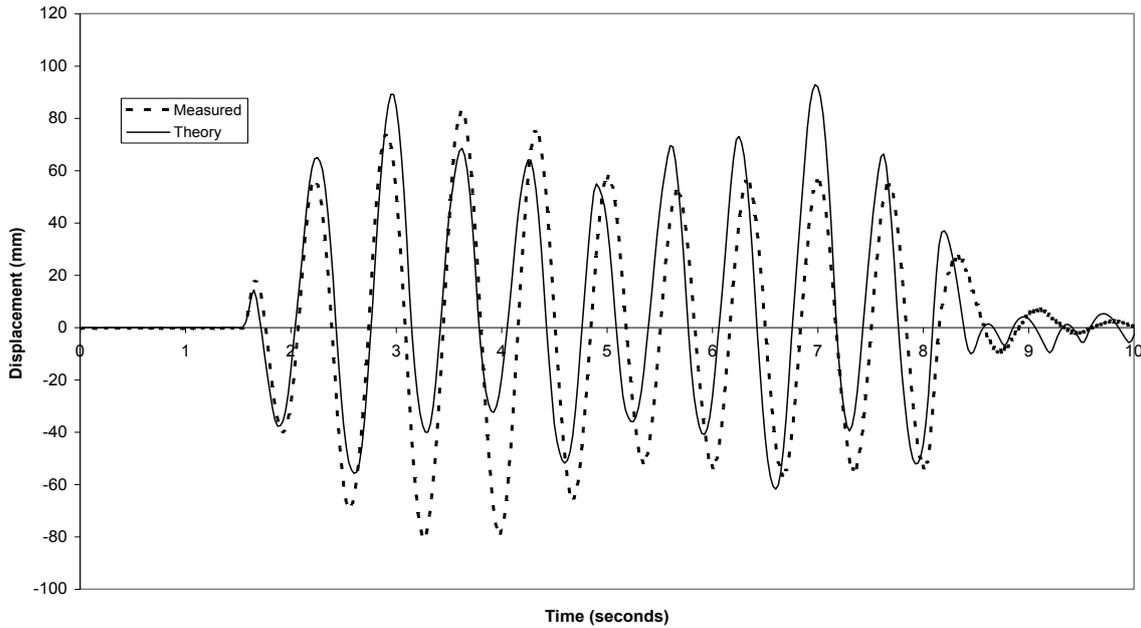
Figure 57. Comparison of measured and theoretical ceiling displacement time history for Test T30

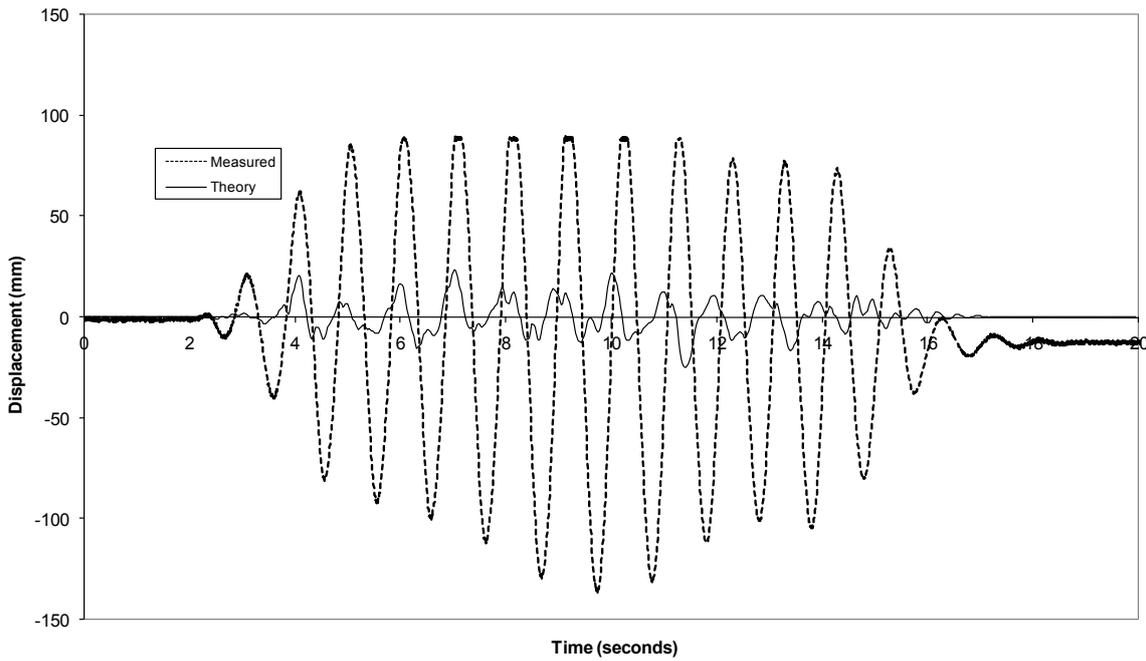
Figure 58. Comparison of measured and theoretical ceiling displacement time history for Test T31

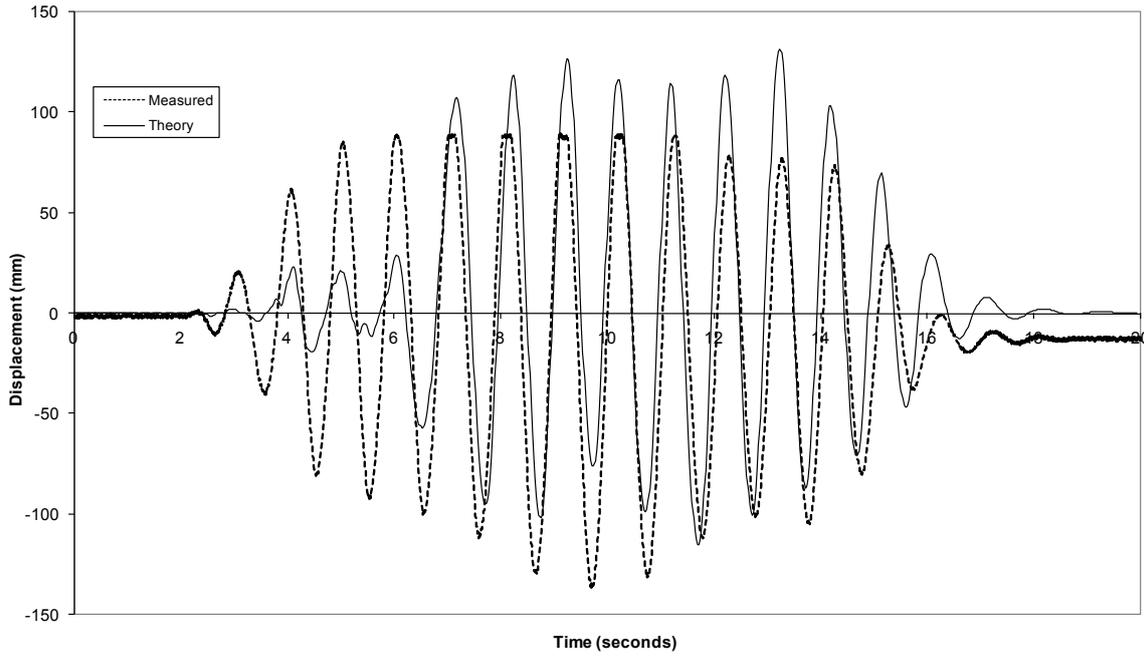
Figure 59. Comparison of measured and theoretical ceiling displacement time history for Test T31 with lateral resistance factored by 0.9

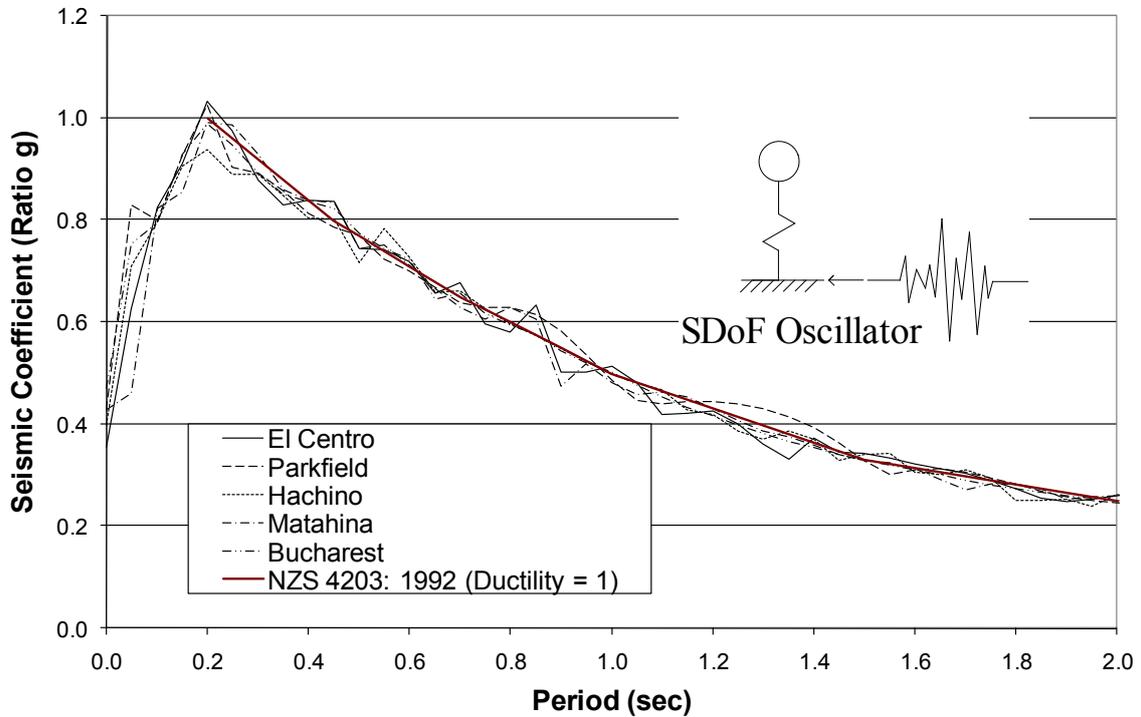
Figure 60. Comparison of acceleration response spectra from NZS 4203 and five earthquakes

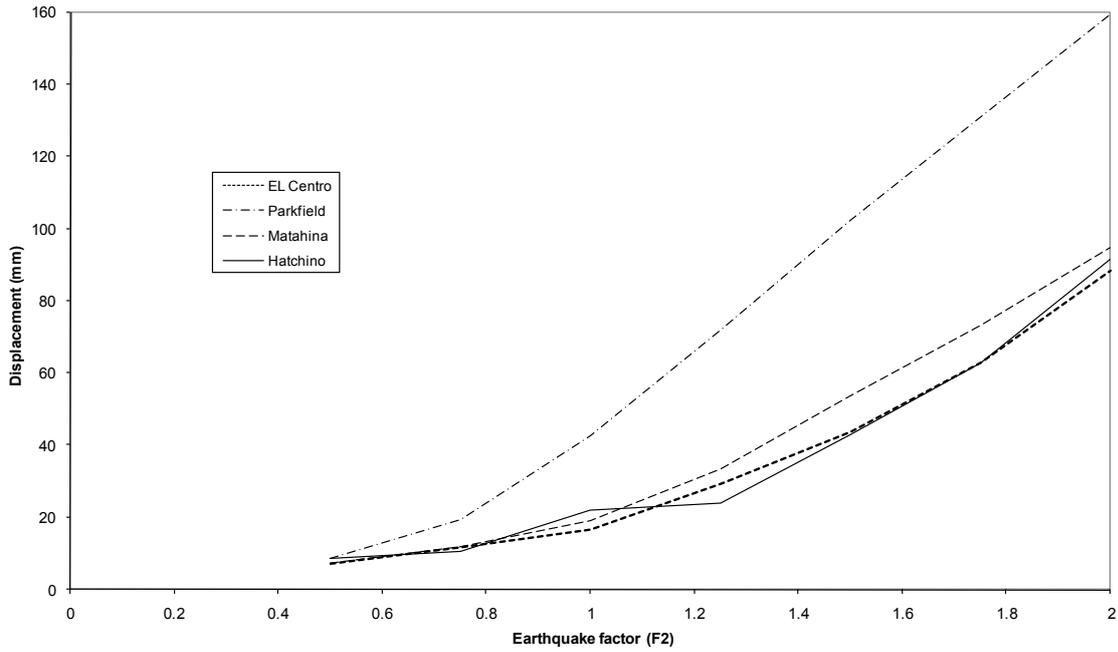
Figure 61. Predicted displacement of ceiling if room subjected to various earthquakes modified to fit the NZS 4203 Sp=1.0 Wellington design spectra

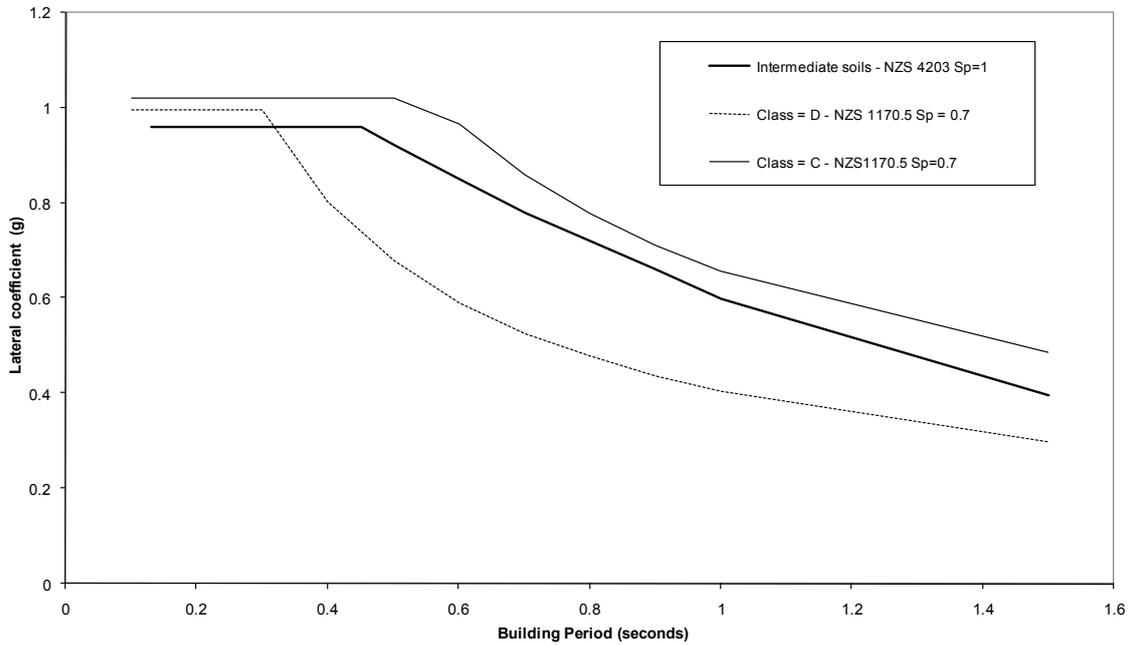
Figure 62. Comparison of target acceleration response spectra from NZS 4203 and NZS 1170.5 for matching earthquakes for time history analysis

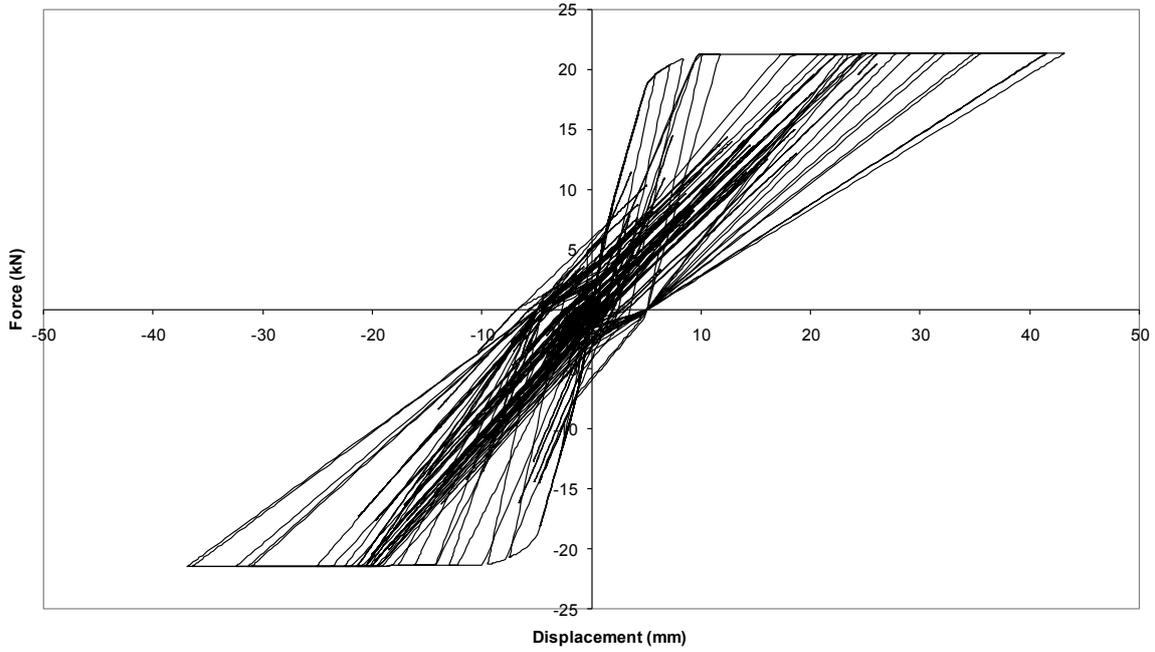
Figure 63. Total hysteresis from modified Hachino earthquake with factor of 1.5

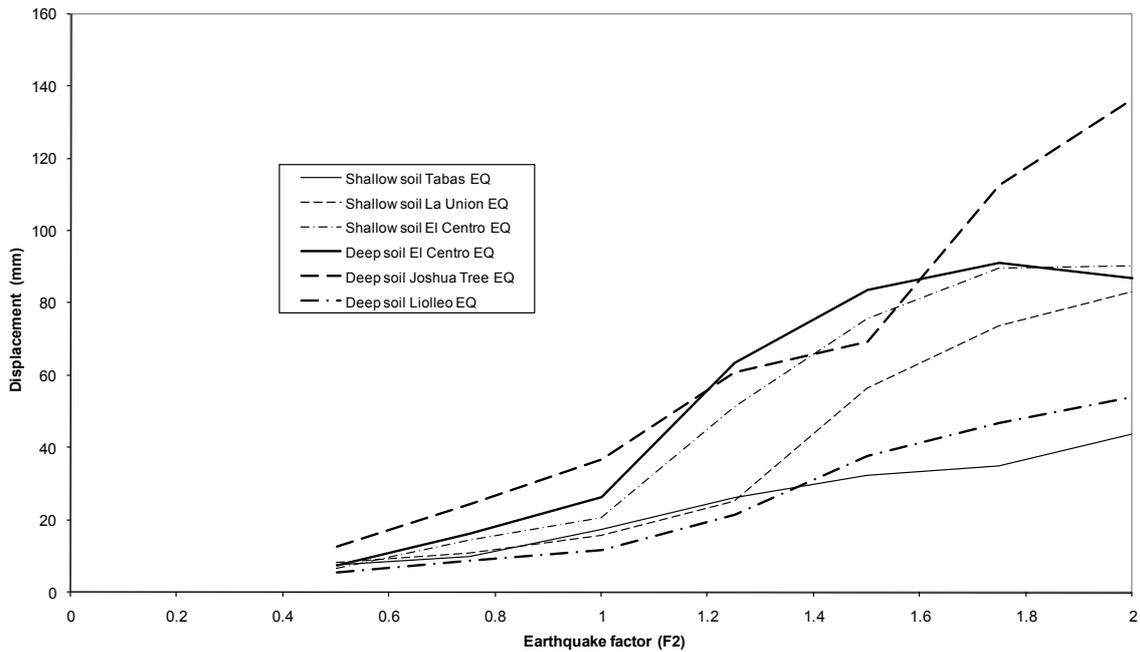
Figure 64. Predicted displacement of ceiling if room subjected to various earthquakes modified to fit the NZS 1170.5 $S_p=0.7$ Wellington design spectra

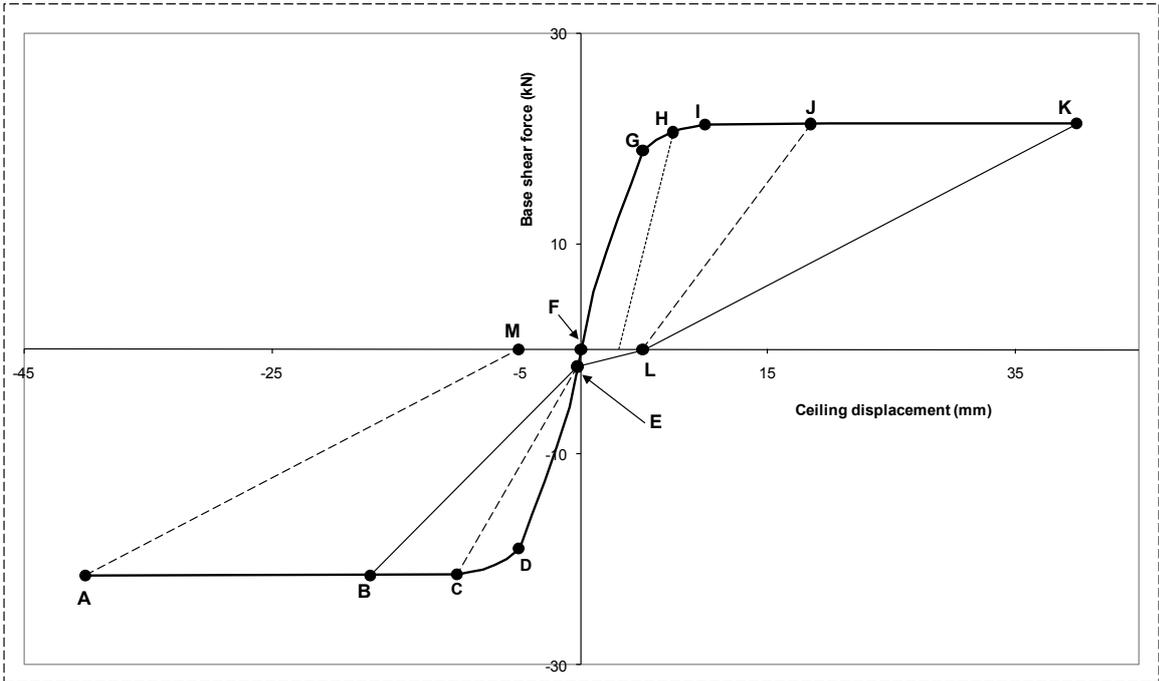
Figure 65. Hysteresis shape used in the computer model for predicting brick veneer panel response

LoopCase 5, 6 and 7 correspond to LoopCase 2, 3 and 4 above but on the inverted mirror side of the hysteresis loop. LoadCase +5 is ABCD, LoadCase 6 is AM, LoadCase 7 starts from M but is not drawn.
