STUDY REPORT

A PILOT STUDY TO CHARACTERISE THE BIOCONTAMINANT CLOUD WHILE DECLADDING “LEAKY BUILDINGS”

SR296 (2013)

November 2013

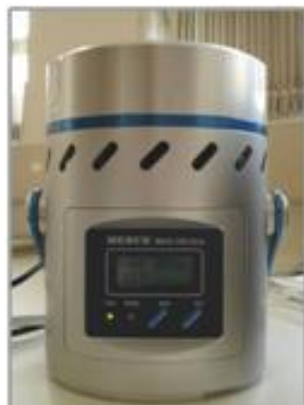
Figure 1: MERCK MAS-100 Eco sampler.

starting with DG18. Each 100 L sample took approximately 1 minute to collect. Indoor and outdoor samples were collected with the units simultaneously, before remediation had started and during remediation.

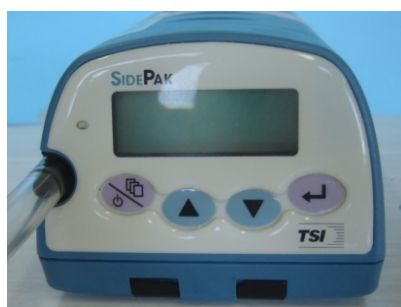
Figure 2: SidePak AM510 sampler

The second type of air sampler used in the study was a TSI SidePak AM510 laser photometer, see Figure 2. This measures aerosol mass concentrations of $PM_{2.5}$ and PM_{10} in real time by drawing a sample of air across a laser and closely estimating particulate mass concentrations. These samplers are widely used in industrial workplaces to assess human exposure to particulates, specifically those of a respiratory and thoracic size. $PM_{2.5}$ or PM_{10} levels were taken every 2 seconds and averaged over 10 seconds over the recording time period. Zero calibrations were conducted prior to each sampling day, and a background level of particulates were collected for at least 15 minutes prior to remediation or building activity began on site.

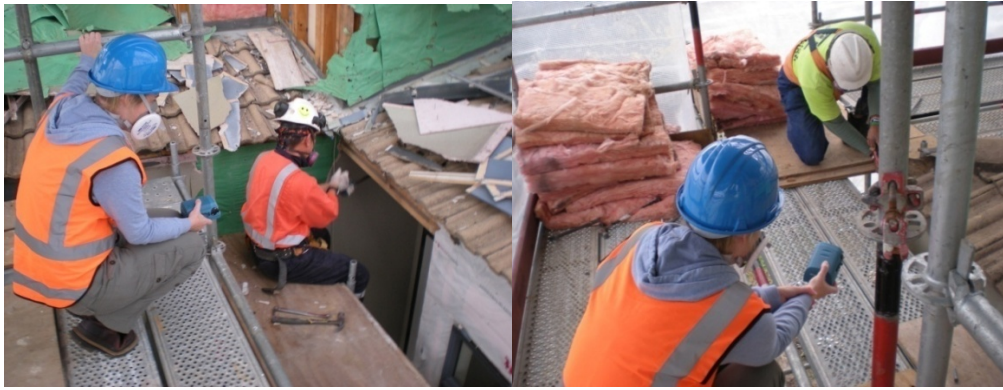
Figure 3: SidePak sampler held near the working space of the building remediators

During the initial sampling phase the MAS-100 eco and AM510 samplers were set up on tripods so the sampling inlets were at a height of 1.5 m outside the dwelling. However, in the second phase of sampling the units were carried by hand by the researchers, so that they could be held closer to the remediators work zone and could more easily follow the remediators around the building, see Figure 3.

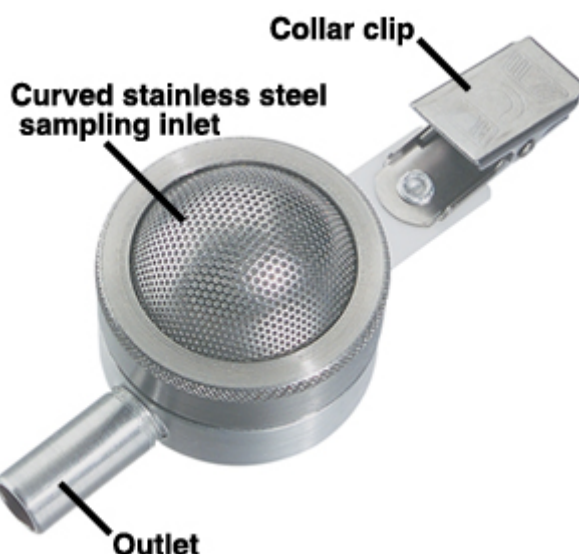
Figure 4: SKC button aerosol sampler (SKCinc.com)

Additionally in Unit 1 and 2 samples were taken during remediation, one inside the Unit, and one outside. These samplers were left running while remediation activities were carried out, taking 4 L and 3 L samples of air respectively. Due to the short sampling time available for remediation in Unit 3, airborne mycotoxin samples were not taken during remediation. Samples of contaminated building paper and gypsum board were also taken for analysis of mycotoxin content. Samples were also taken from the gloves of a researcher who had been handling the building material, by touching the gloves to a cellulose filter. All samples were stored frozen until analysis could be conducted (-20°C). ELISA analysis of trichothenes were conducted at the Wellington School of Medicine by Rob Siebers using methods outlined previously (Park et al. 1996). Several dilution levels were chosen to measure both air, building and glove samples.

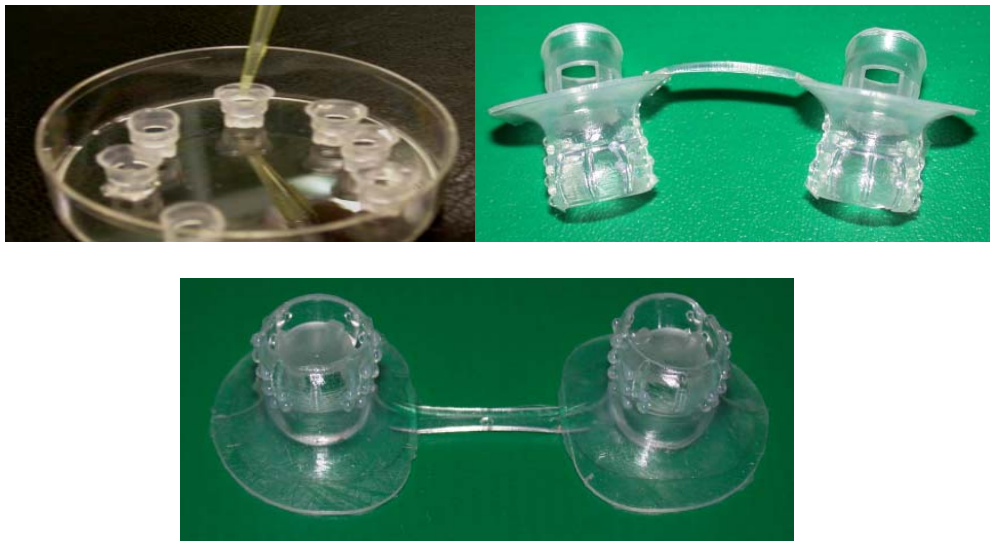
Figure 5: The nasal sampler

Maggie Nasal Samplers (supplied and designed by Dr Euan Tovey, University of NSW) were worn to assess levels of inhaled spores. For the remediation of Unit 1 the sampling, shown in Figure 5, were filled with 15 µl of melted Vaseline. Two nasal

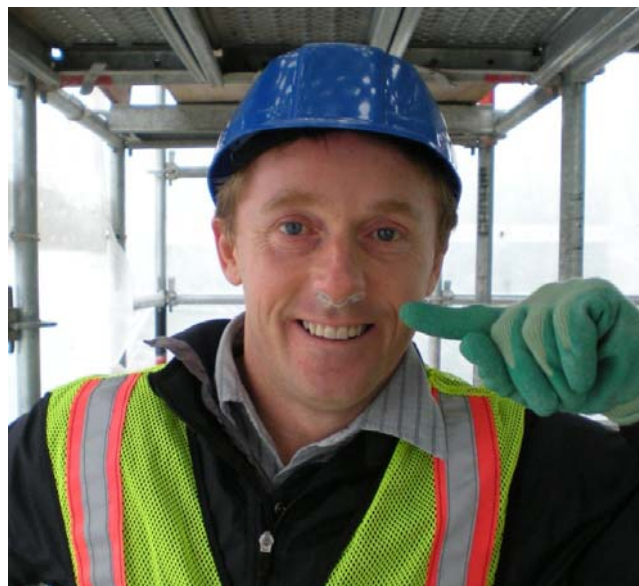
Figure 6: Nasal Samplers being worn onsite

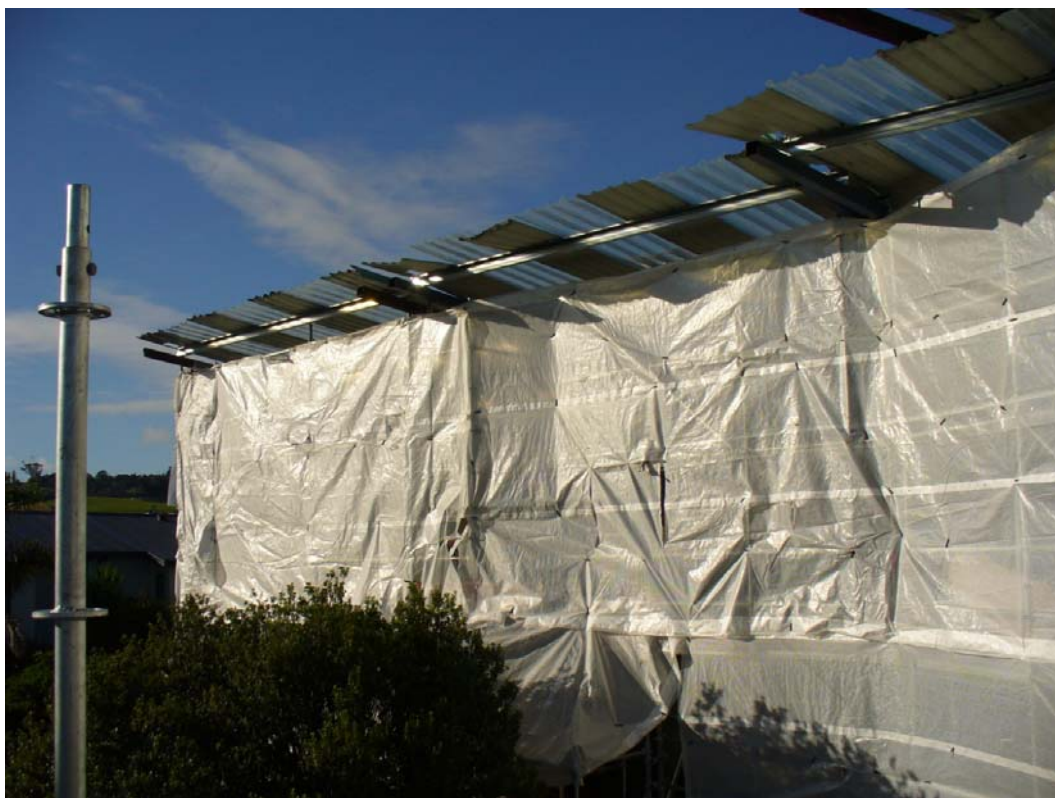
Figure 7: View of the temporary canopy of long run metal and translucent plastic sheets and plastic curtain surrounding the building being remediated

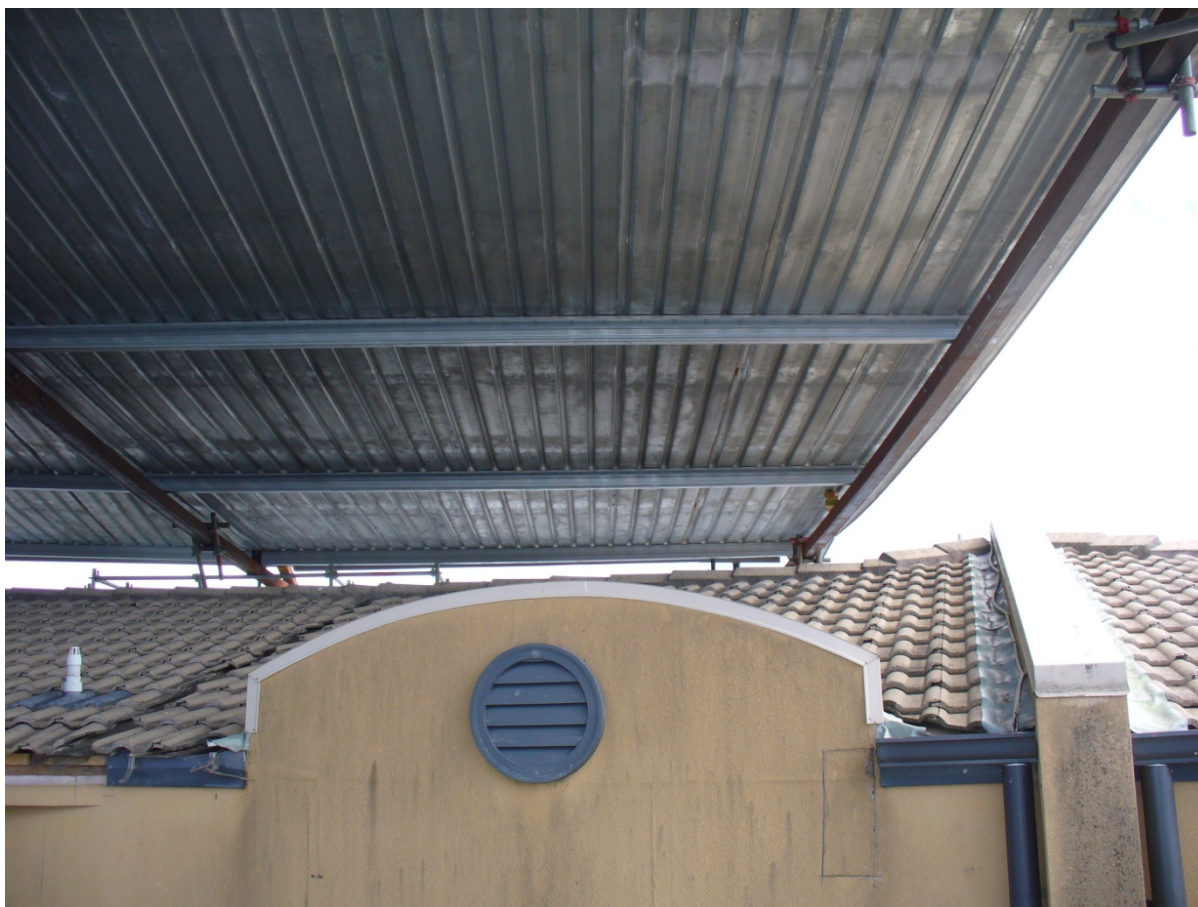
Figure 8: View of underside of the canopy

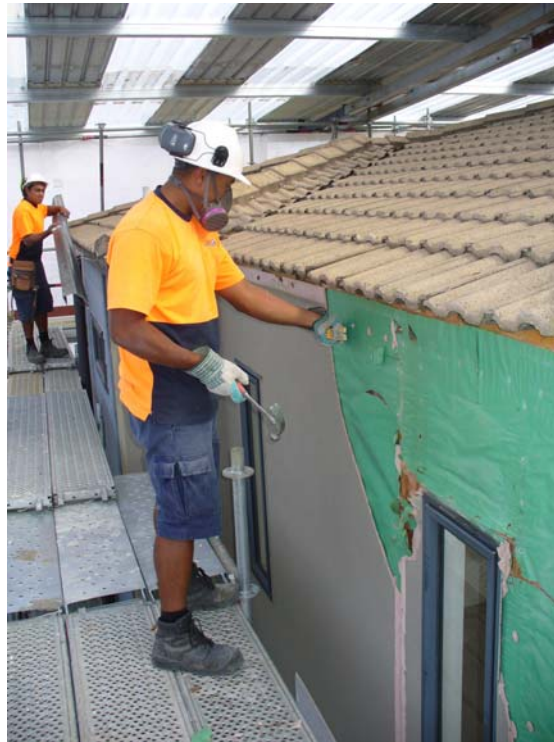
Figure 9: Interior view from the upper level scaffolding of the canopy and curtaining

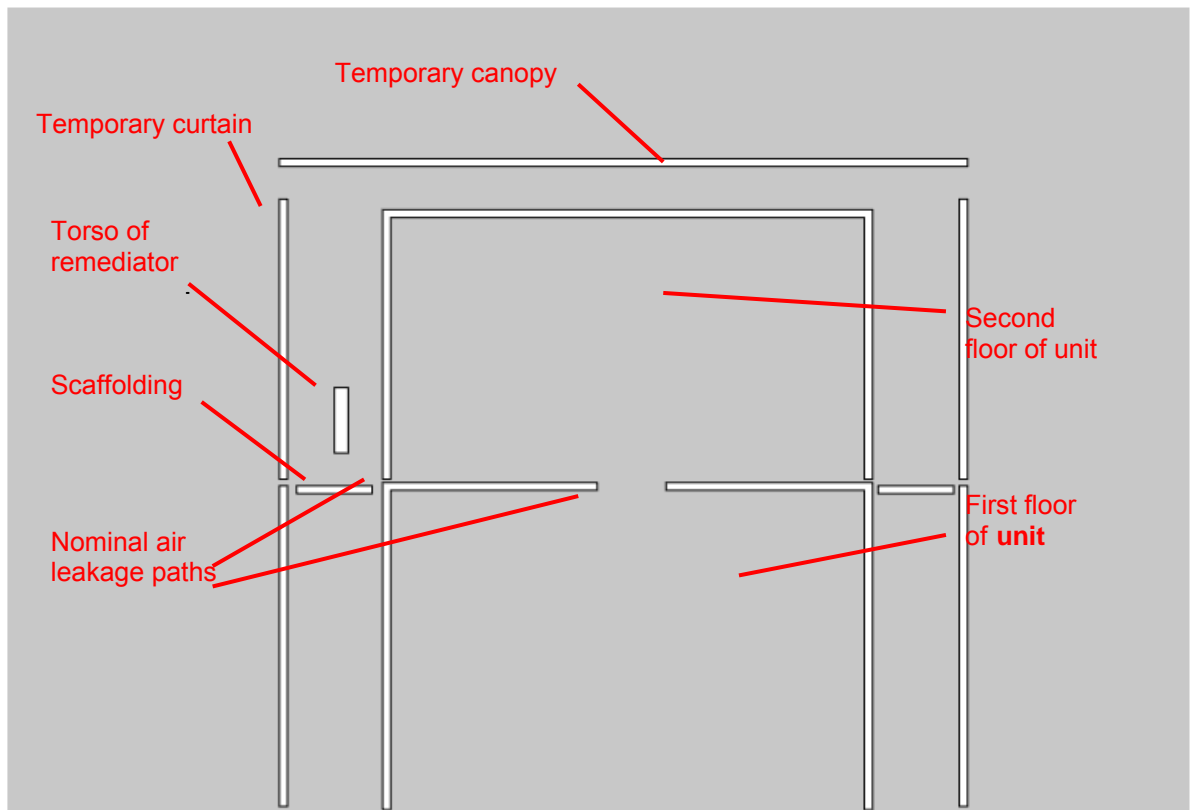
Figure 10: Two dimensional model of the building, canopy and curtaining, and torso of the remediator

The building, canopy and curtain, and remediator are modelled two dimensionally with gaps left between these elements to provide an approximation to air flow paths between them, see Figure 10.

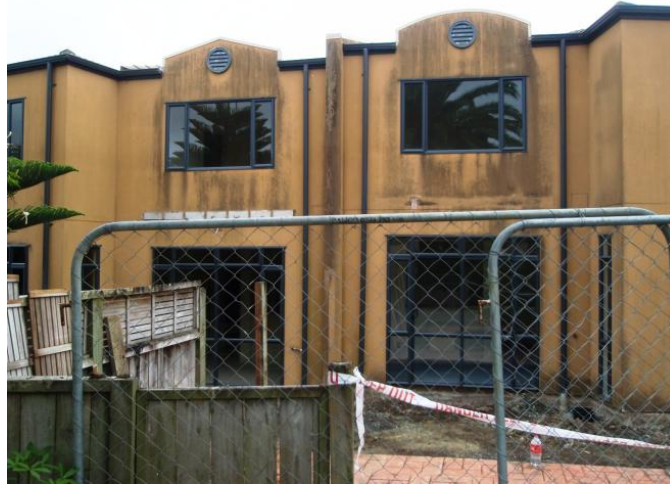
Figure 11: (Photo 1) Units in Complex 1 prior to remediation and scaffolding – dark areas of water damage are clearly visible as dark areas on the monolithic cladding

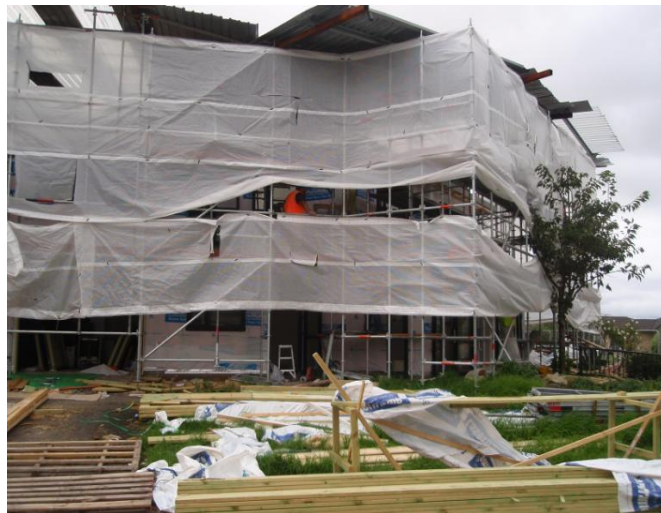
Figure 12: (Photo 2) Units during remediation phase in Complex 1 with scaffolding, temporary roof and screens attached

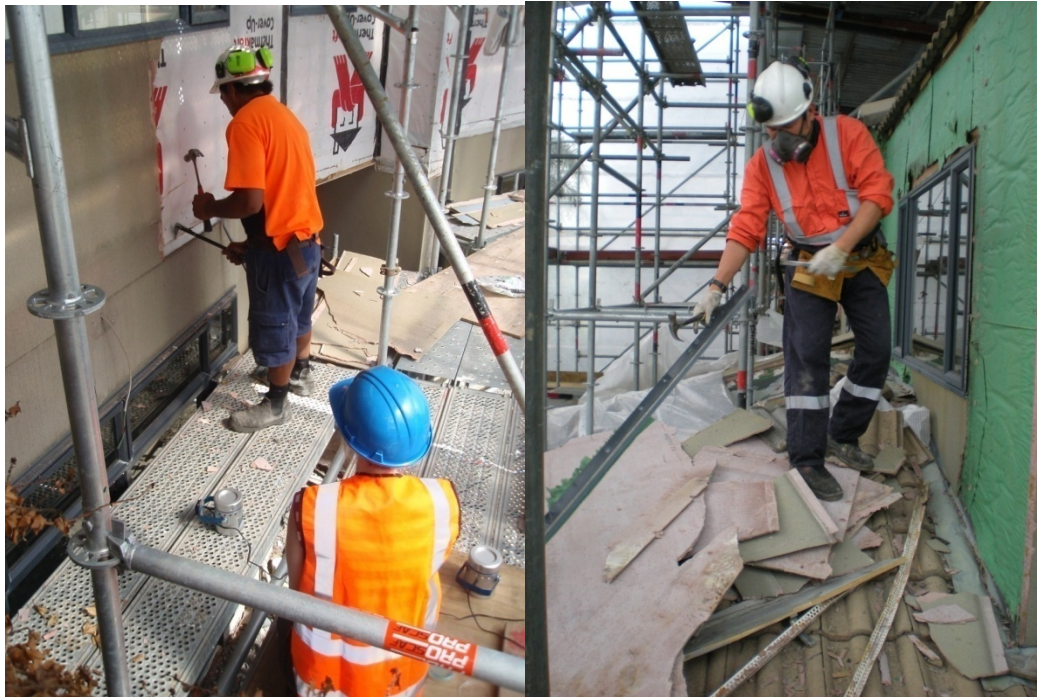
Figure 13: (Photo 3 & 4) The decladding process in Complex 1 – boards of cladding are pulled from the buildings by the remediators. This is thought to be a time of possible high spore exposure. Sampling machines can be seen in the foreground.

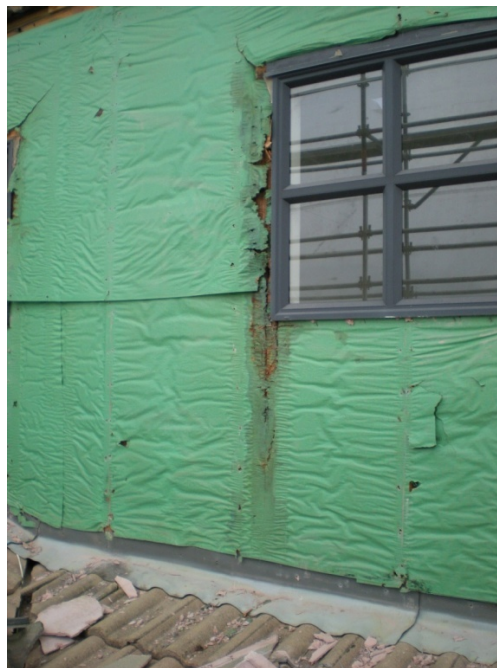
Figure 14: (Photo 5) Once cladding is removed water damage is often seen with the disintegration of building paper

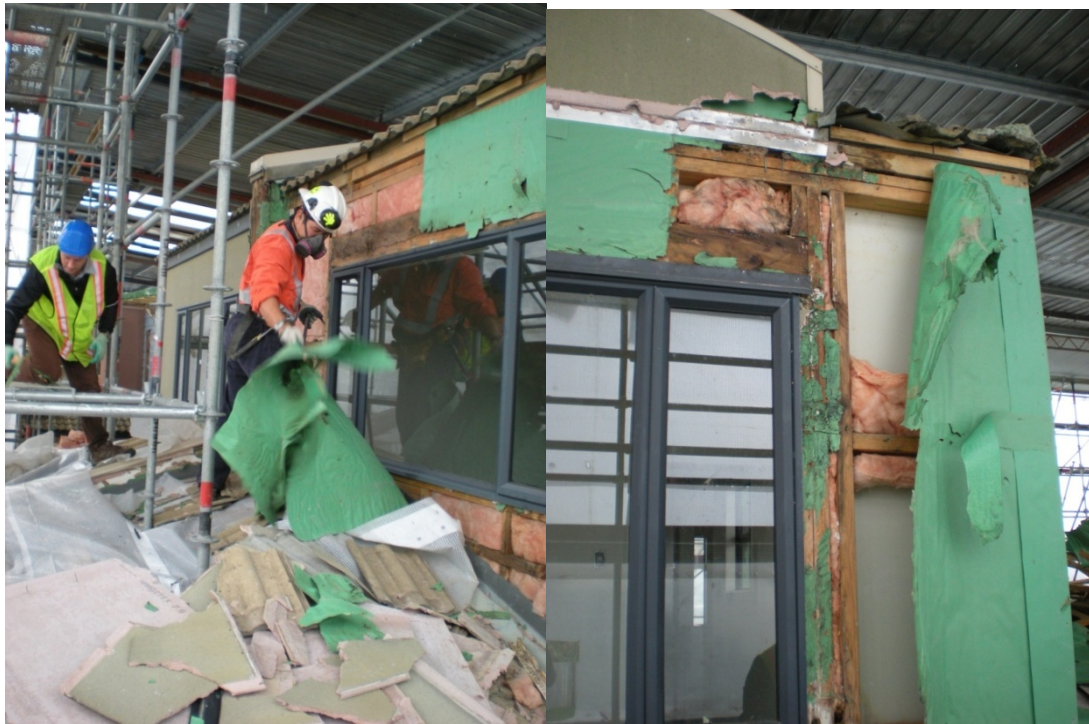
Figure 15: (Photo 6 & 7) Building paper and insulation layers are also removed.

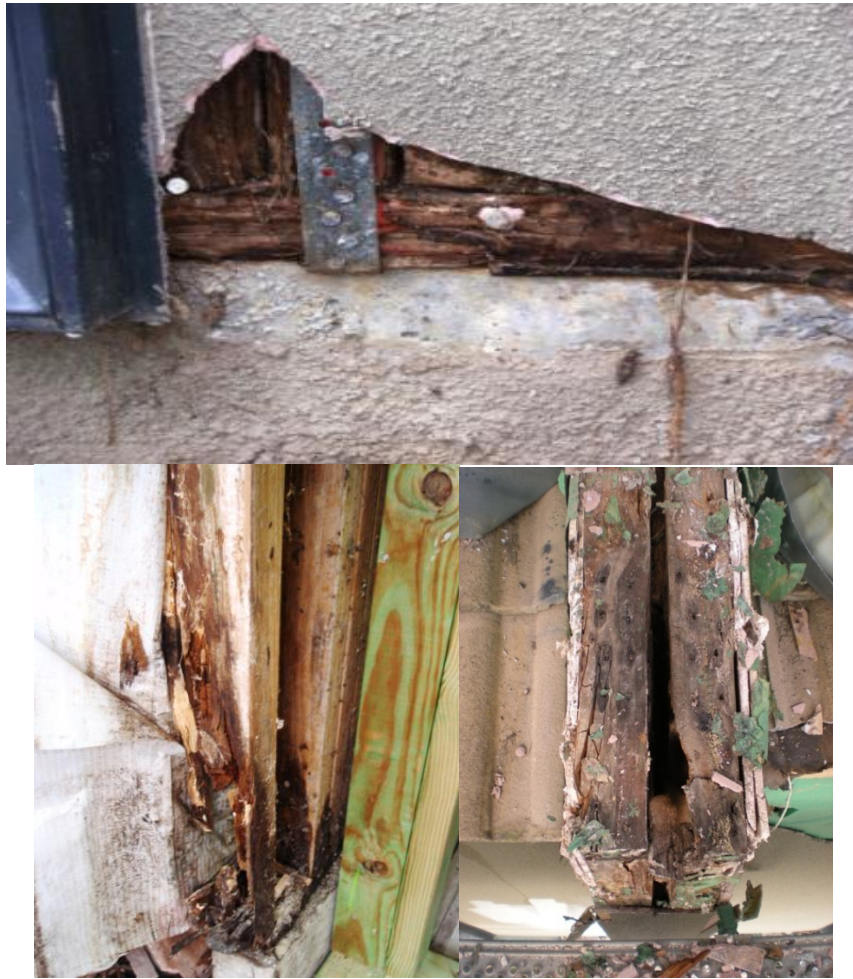
Figure 16: (Photo 8 – 10) Cladding removal also shows biodeterioration of the wooden structure of the Unit

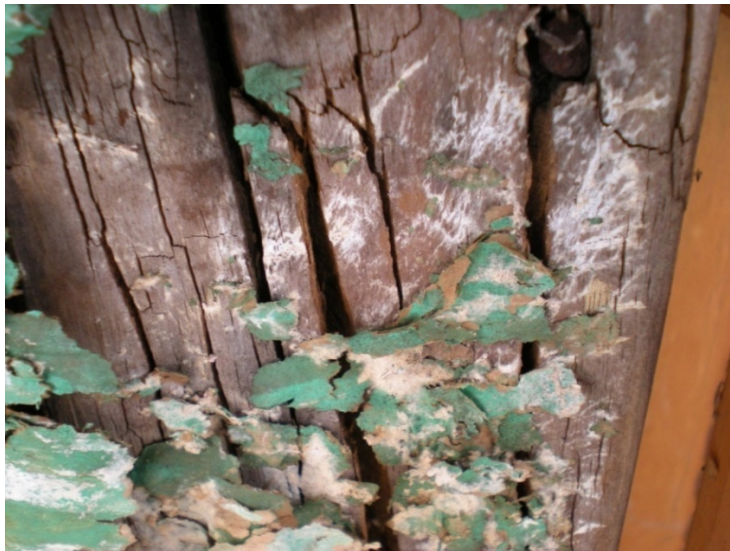
Figure 17: (Photo 11) Sometimes this deterioration is sometimes quite severe

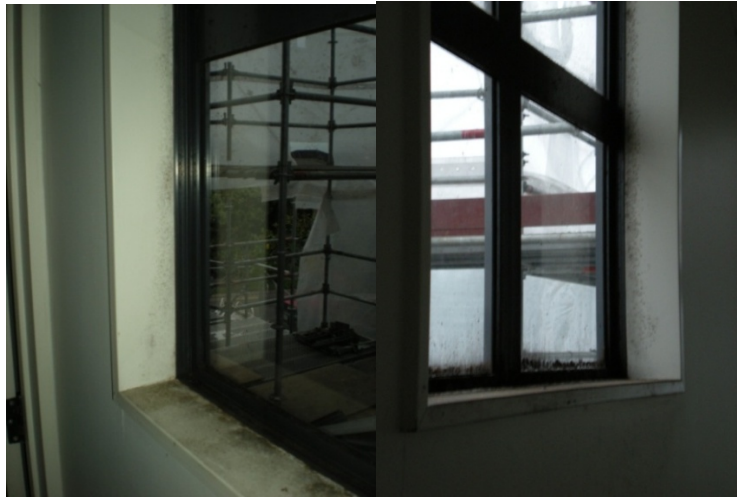
Figure 18: (Photo 12 & 13) Inside units fungal, biocontamination from water damage is apparent, particularly around windows

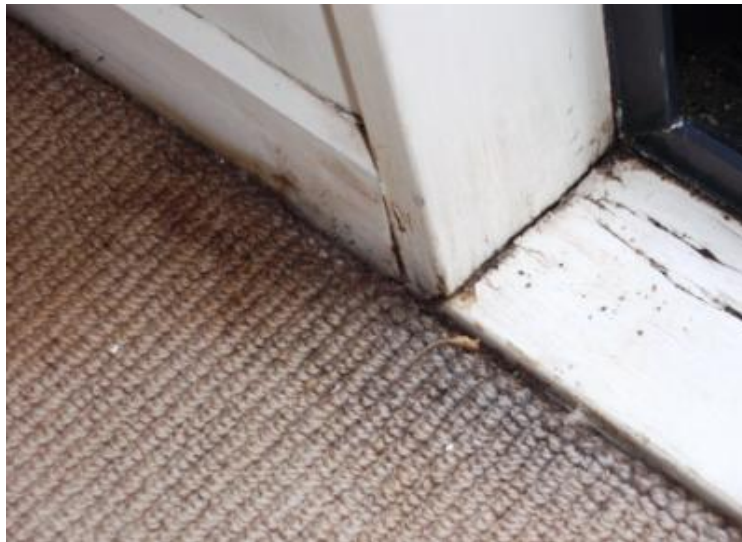
Figure 19: (Photo 14) Fungal contamination from water damage is also apparent on skirting boards and carpets.

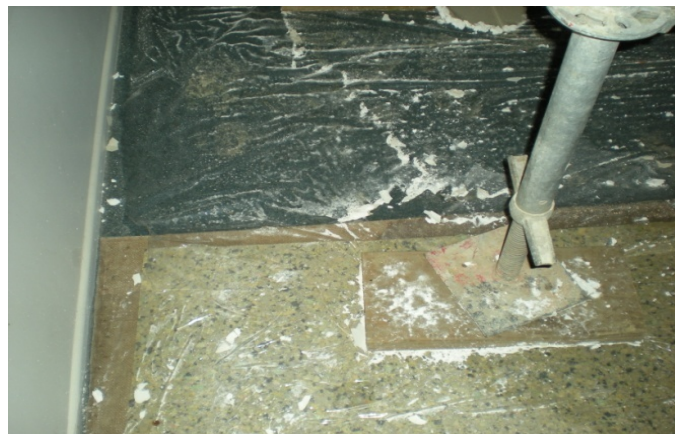
Figure 20: (Photo 15) Plastic wrapped carpets. Some owners opt to retain original carpets after remediation to cut down on repair costs.

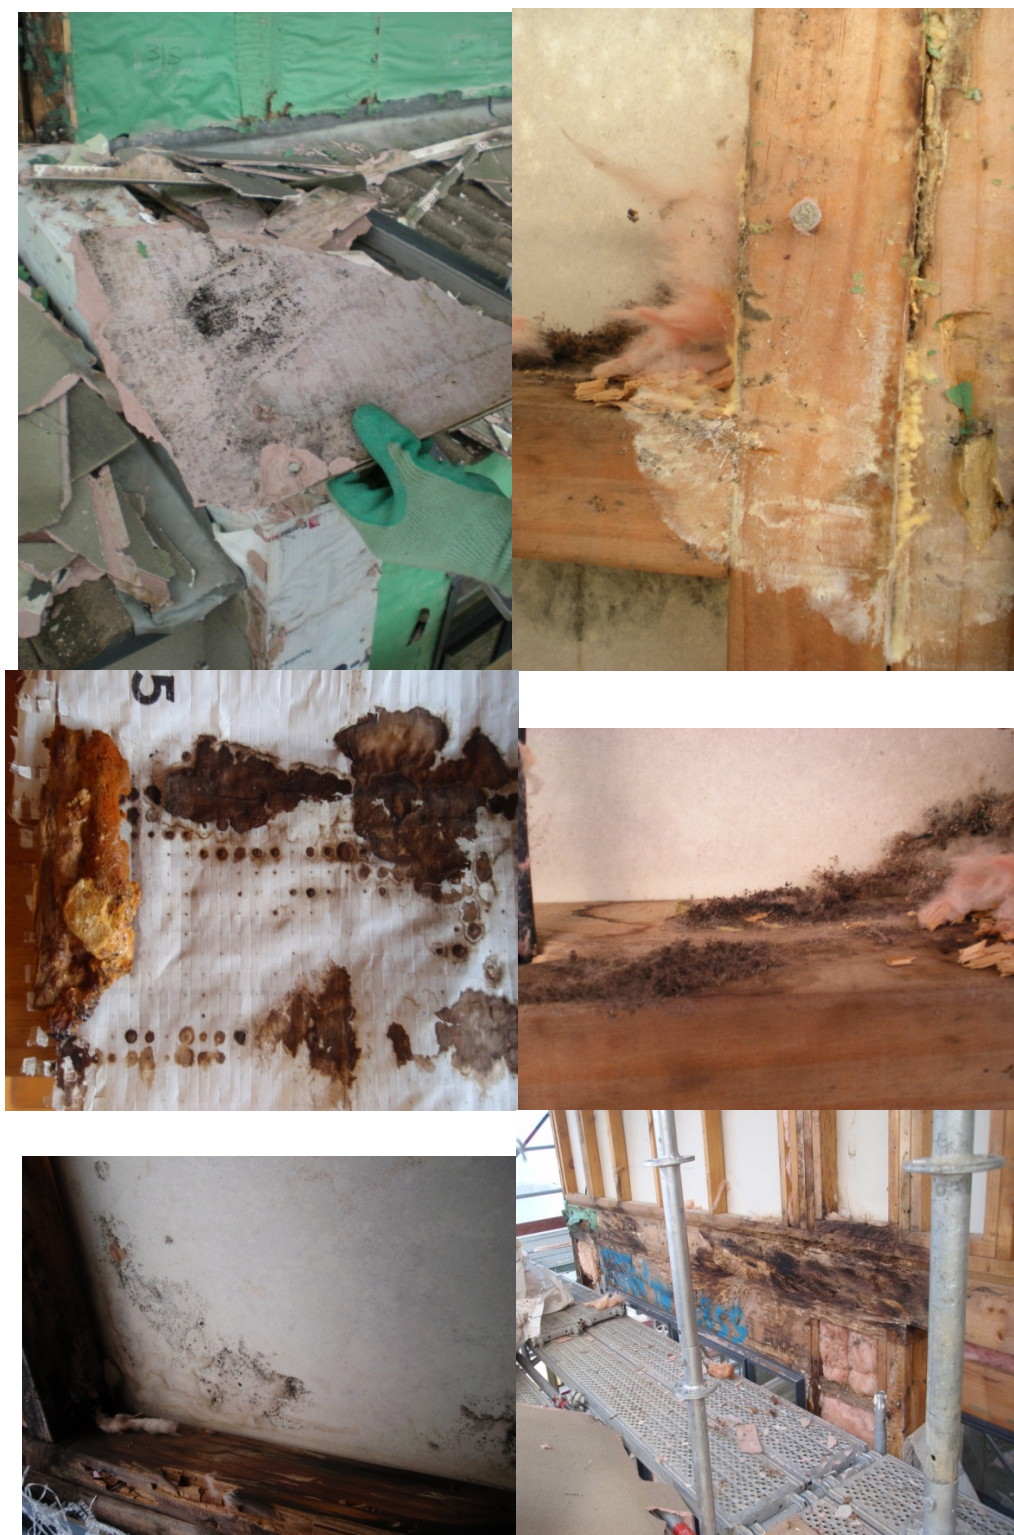
Figure 22: (Photo 17 – 22) All of the building materials damaged by water can support fungal and microbial growth. These pictures demonstrate fungal colonies seen on some of these materials.

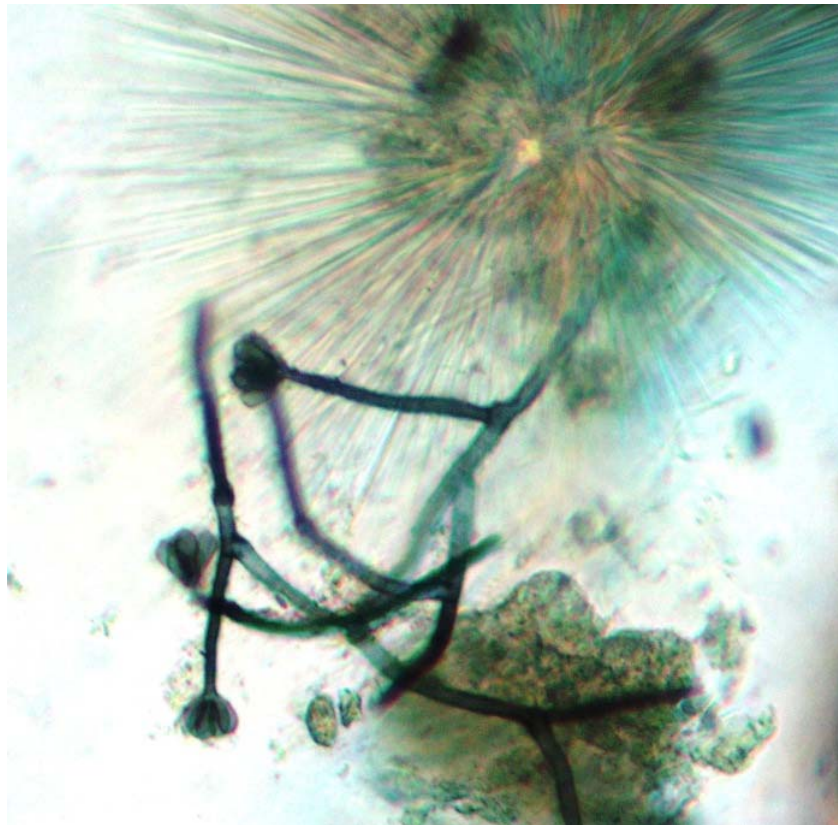
Figure 23: (Photo 23) An example of water-damaged fibre cement abundantly colonised by *Stachybotrys chartarum*.

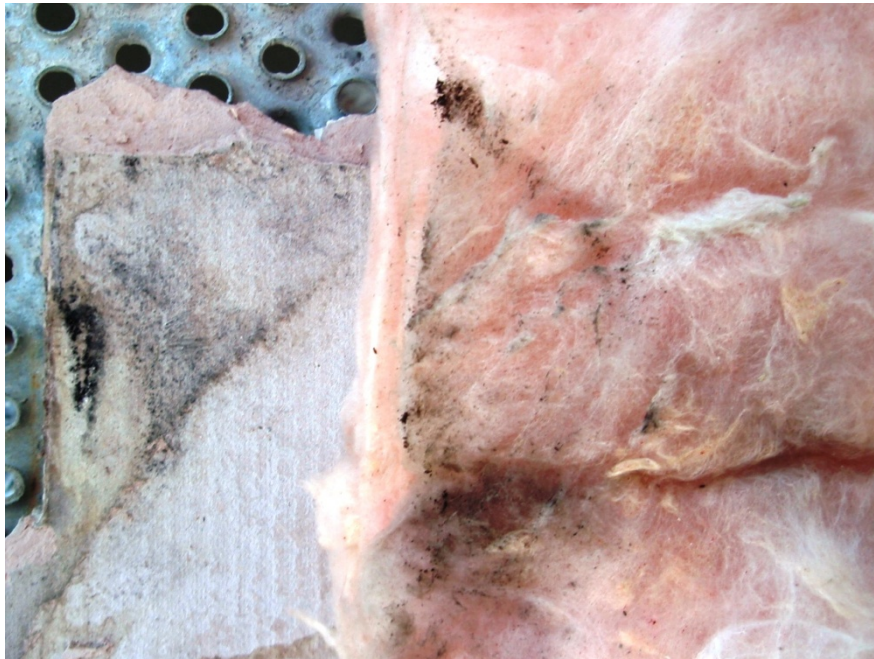
Figure 24: (Photo 24) Visible 'soot-like' biocontamination of fibre cement (left) and insulation batts (right) by toxigenic fungus *Stachybotrys chartarum*.

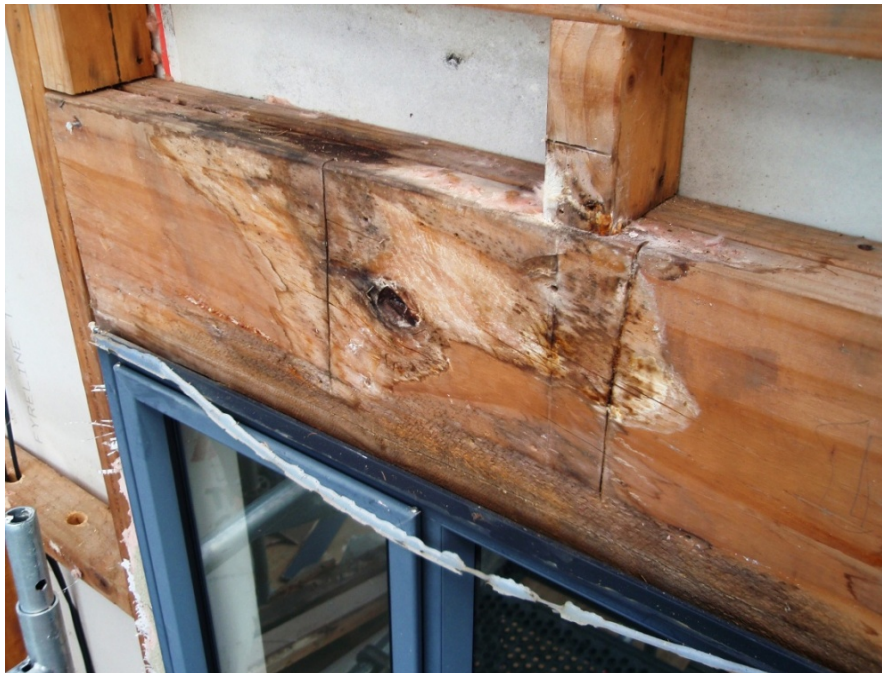
Figure 25: (Photo 25) Rhizomorphs of a basidiomycete wood decay fungus causing destructive brown rot on timber framing

Rhizomorphs and mycelium wood-rotting decay fungi, mostly basidiomycetes, were observed to be associated with severe biodegradation of structural building timbers (Photo 25). Significant to extreme loss of strength was noted for many of these timber samples with advanced brown rot decay and or occasional fungal soft rot being present. Such brown rots are very destructive and can occur on both treated and untreated building timbers, as was observed in this project. A deteriorogenic Ascomycetous species *Nodulisporium* was also recovered from brittle rotting timber.

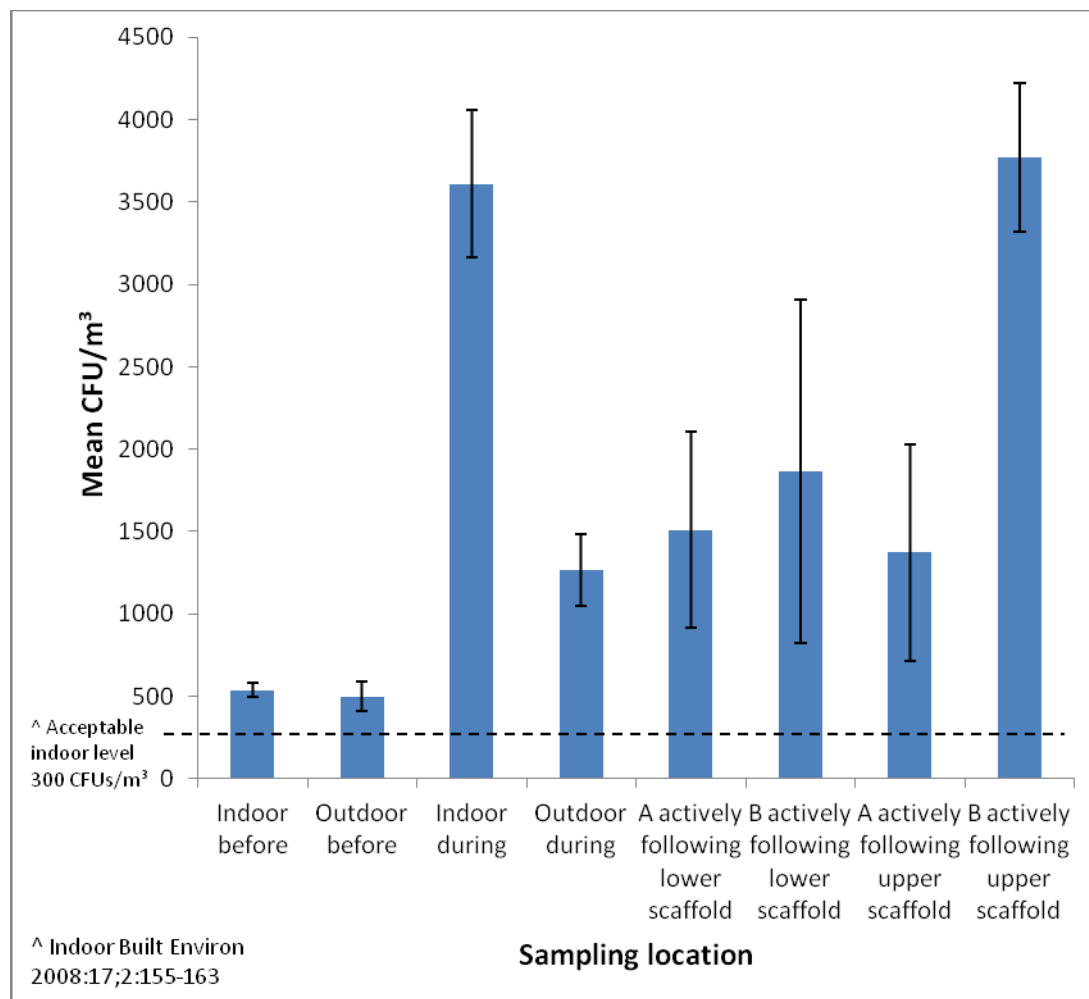
Figure 26: Mean CFU levels taken during remediation of Unit 1 (error bars = $\pm 1.96 \times \text{std error around the mean}$)

Levels of viable spores were measured at several time points during the remediation process. In Unit 1 colony forming unit levels taken shortly before remediation activities started indicated that spore levels were approximately equal indoors and outdoors (538 CFU/m³ indoors versus 498 CFU/m³ outdoors, see Figure 26. Samples taken 30 minutes later, during initial remediation, which started on the lower level of the Unit, show a 7 fold increase in spore levels inside, with 3610 CFU/m³, and a 2.5 fold increase outside with 1264 CFU/m³. These static samples were taken from fixed positions, inside the home on the kitchen bench (1.2 m height), and outside 2 metres away from the walls of the Unit, on a tripod (1.5 m height). Actively following the builders with the samplers outside (approx 1 – 2 m from where they were working), also showed high mean levels of spores, between 1264.5 – 3770 CFU/m³. The error bars indicate that there were higher levels of variability between replicates during remediation activities, suggesting that spore levels were highly variable during this time. Little variation was observed in the levels of spores before remediation began, see Figure 7.

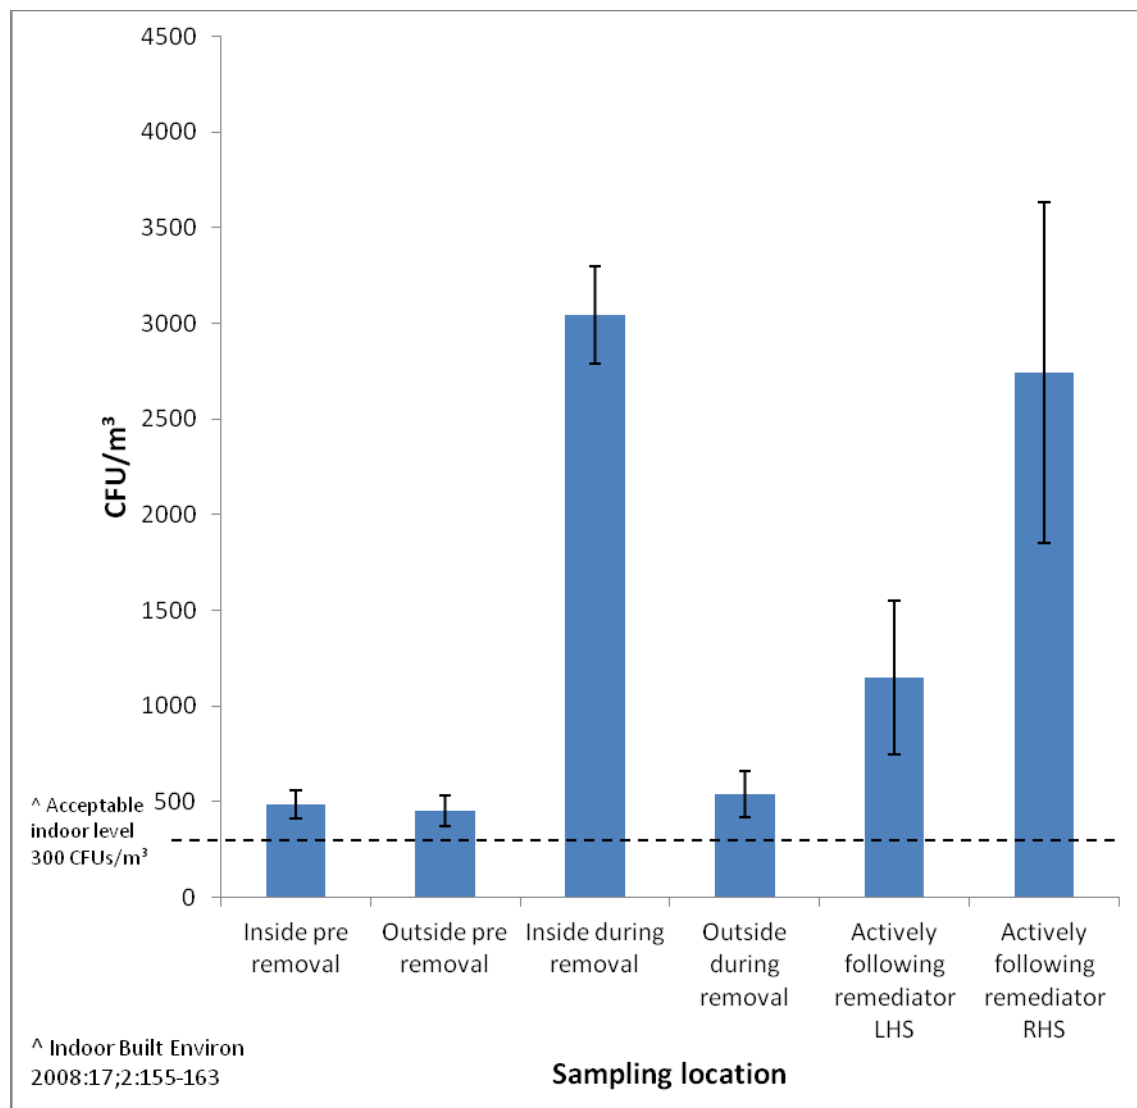
Figure 28: Mean CFU levels taken during remediation of Unit 3 (error bars = $\pm 1.96 \times \text{std error around the mean}$)

Background levels of spores taken prior to remediation activities began on Unit 3 were comparable between the indoors and outdoors (487 CFU/m³ versus 453 CFU/m³, see Figure 28, a similar pattern to Unit 1. During initial remediation activities on Unit 3, which being a 1 level home occurred next to the indoor and outdoor samplers, the indoor samples were 6 times higher compared to the indoor pre-remediation levels, indicating a rapid increase in spores had occurred through the vibration associated with cladding removal, see Figure 28.

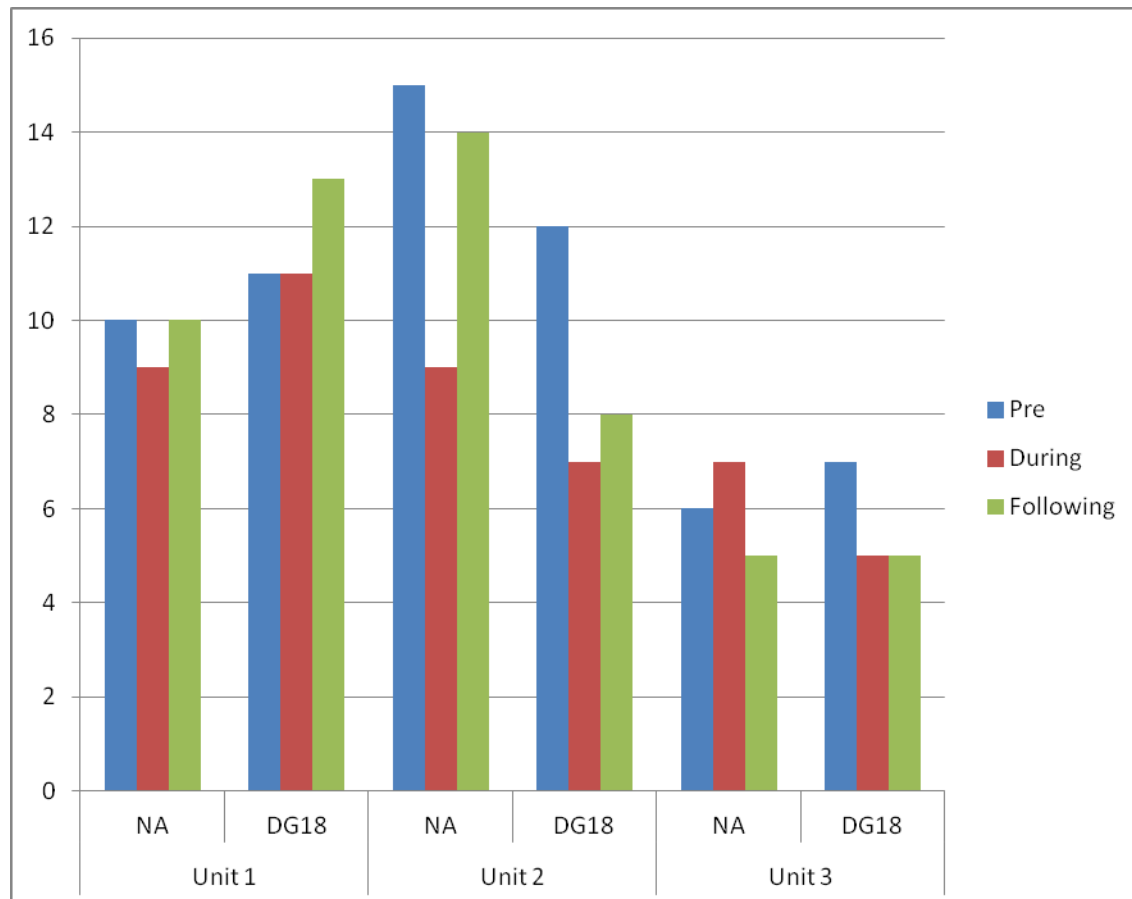
Figure 29: RTU Figure. Levels of common airborne fungi isolated onto Nutrient agar (NA) and DG18 agar pre remediation, during remediation and following workers, across the all three houses.

groups; *Aspergillus*, *Bacteria*, *Cladosporium*, *Penicillium* and yeasts were precluding the identification and isolation of other taxa which were more visible pre disturbance and without clouds of dislodged airborne propagules to mask their presence. Therefore the lower RTU numbers was likely an artefact of plating rather than remediation activity itself. Further monitoring and method development across a large sample size of houses is still required to fully determine RTU levels and subsequent worker exposures.

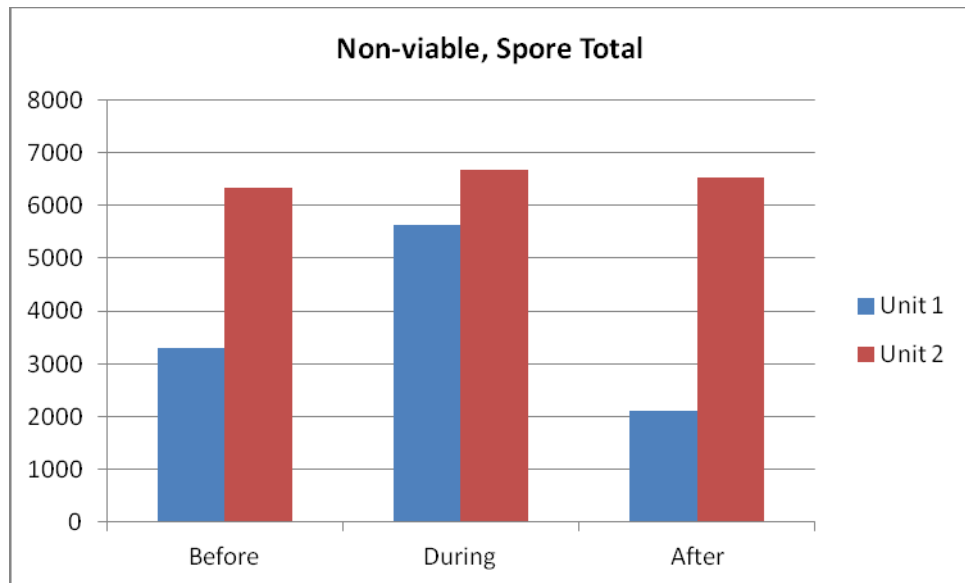
Figure 30: Indoor non-viable spore total counts before, during and after remediation

For Unit 1 and 2 we collected data before, during and after remediation. Figure 30 to Figure 39 compare between Unit 1 and 2 the way in which various biocontaminant levels changed before during and after remediation.

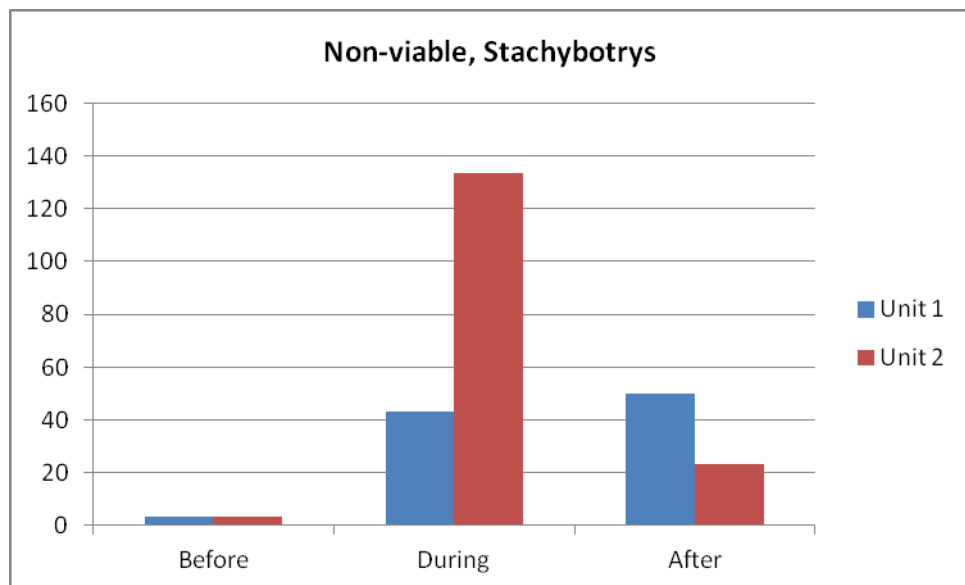
Figure 31: Indoor non-viable *Stachybotrys* counts before, during and after remediation

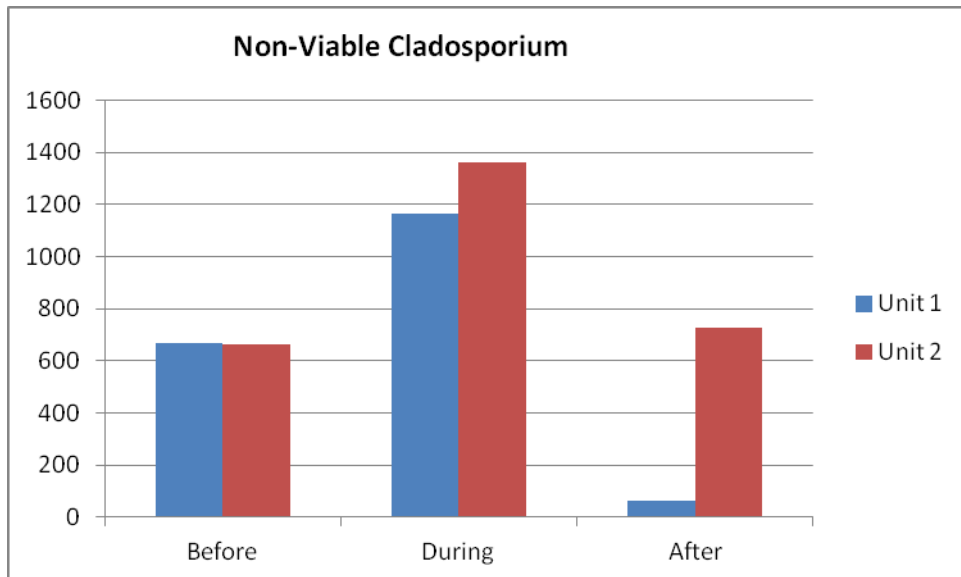
Figure 32: Indoor non-viable *Cladosporium* counts before, during and after remediation

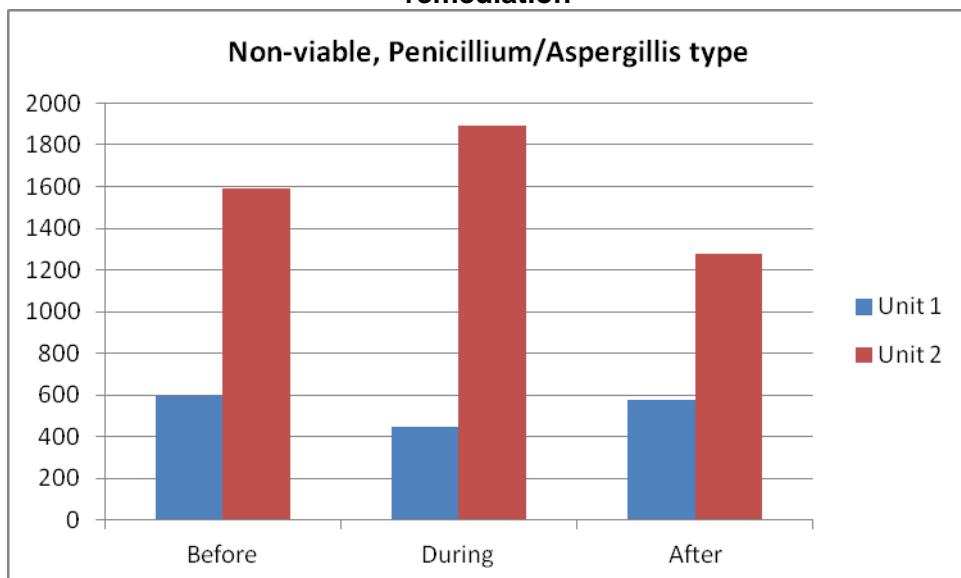
Figure 33: Indoor non-viable *Penicillium/Aspergillus* type counts before, during and after remediation

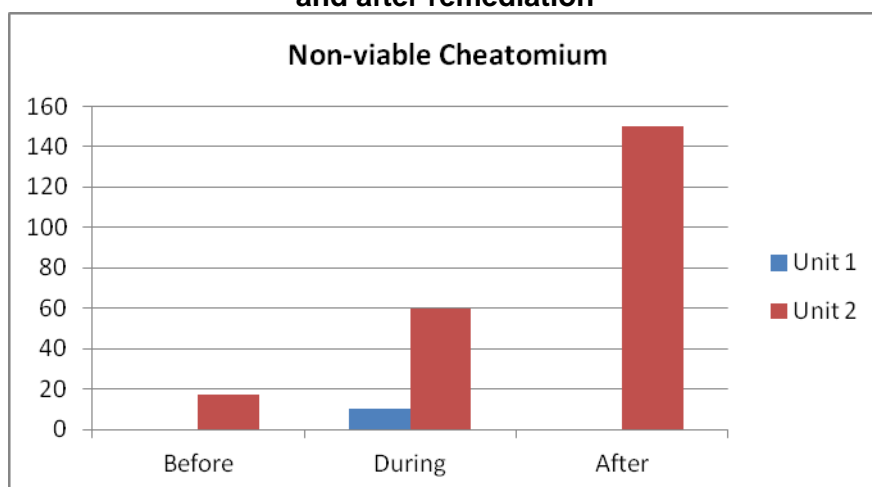
Figure 34: Indoor non-viable *Chaetomium* counts, before, during and after remediation

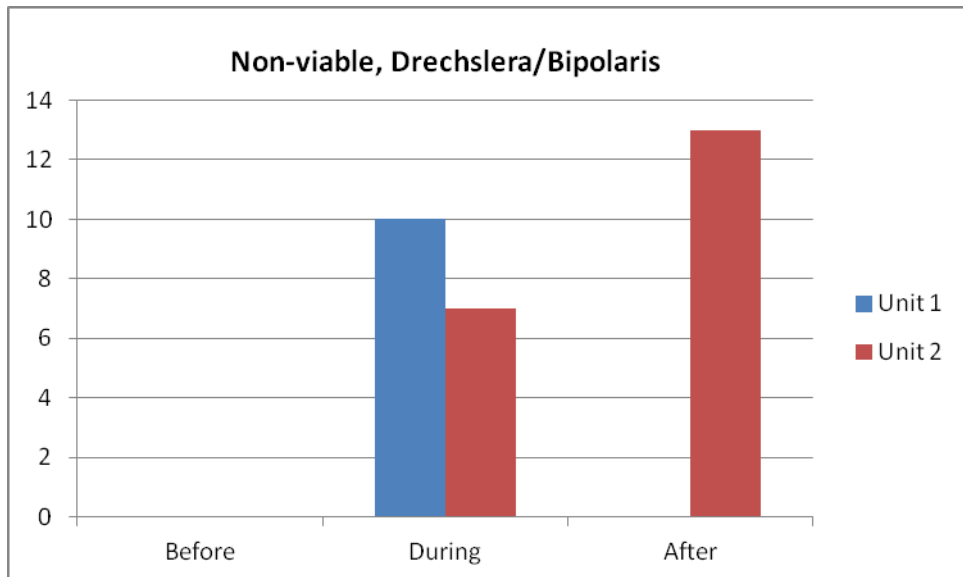
Figure 35: Indoor non-viable *Drechslera/Bipolaris* type counts, before, during and after remediation
