STUDY REPORT

A PILOT STUDY TO CHARACTERISE THE BIOCONTAMINANT CLOUD WHILE DECLADDING “LEAKY BUILDINGS”

SR296 (2013)

November 2013

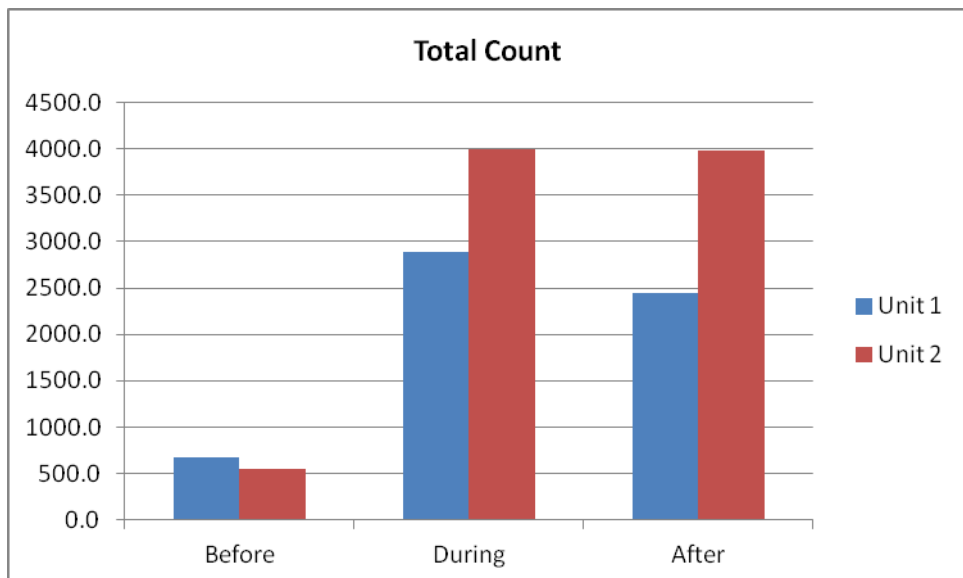
Figure 36: Indoor viable total count, before, during and after remediation

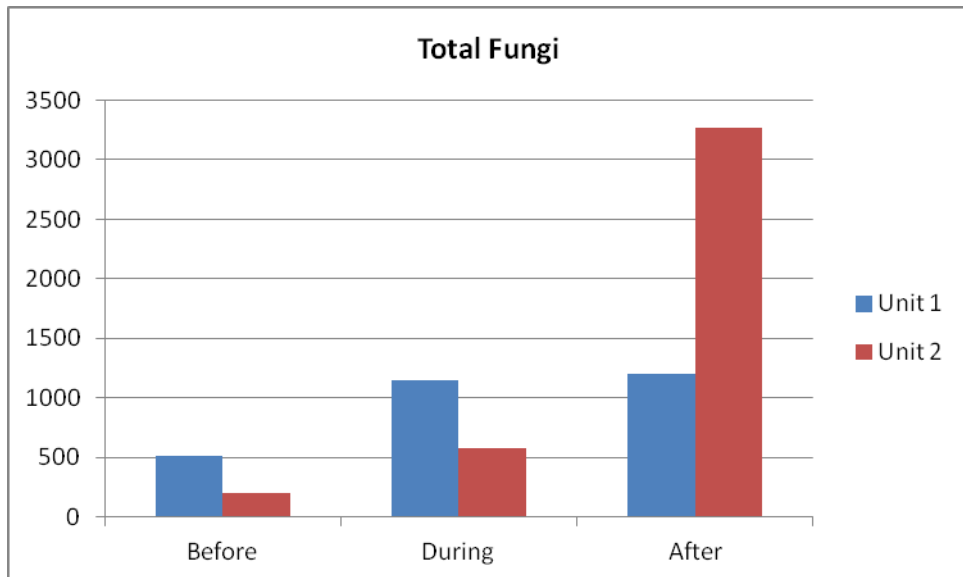
Figure 37: Indoor viable total fungi count, before, during and after remediation

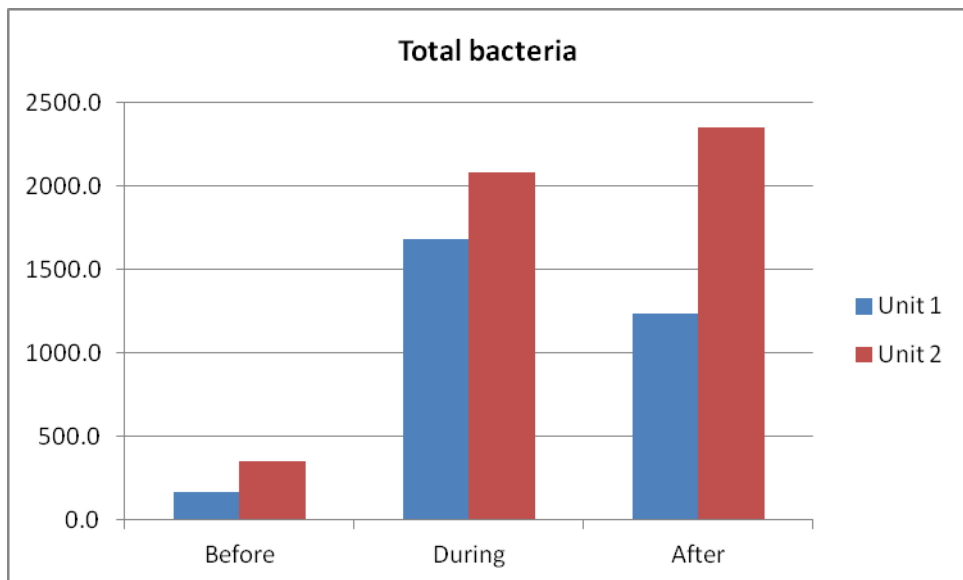
Figure 38: Indoor viable total bacteria count, before, during and after remediation

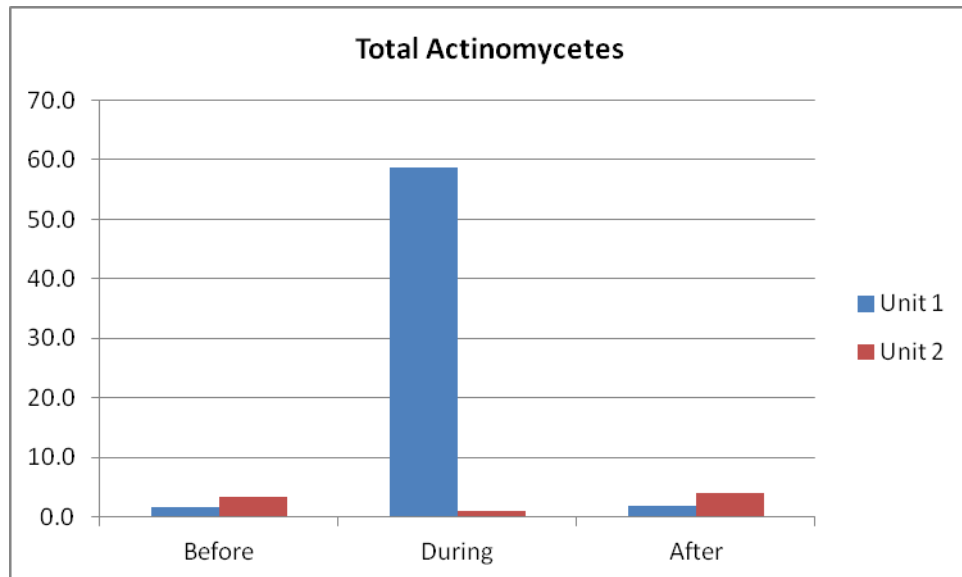
Figure 39: Indoor viable total *Actinomycetes* count, before, during and after remediation

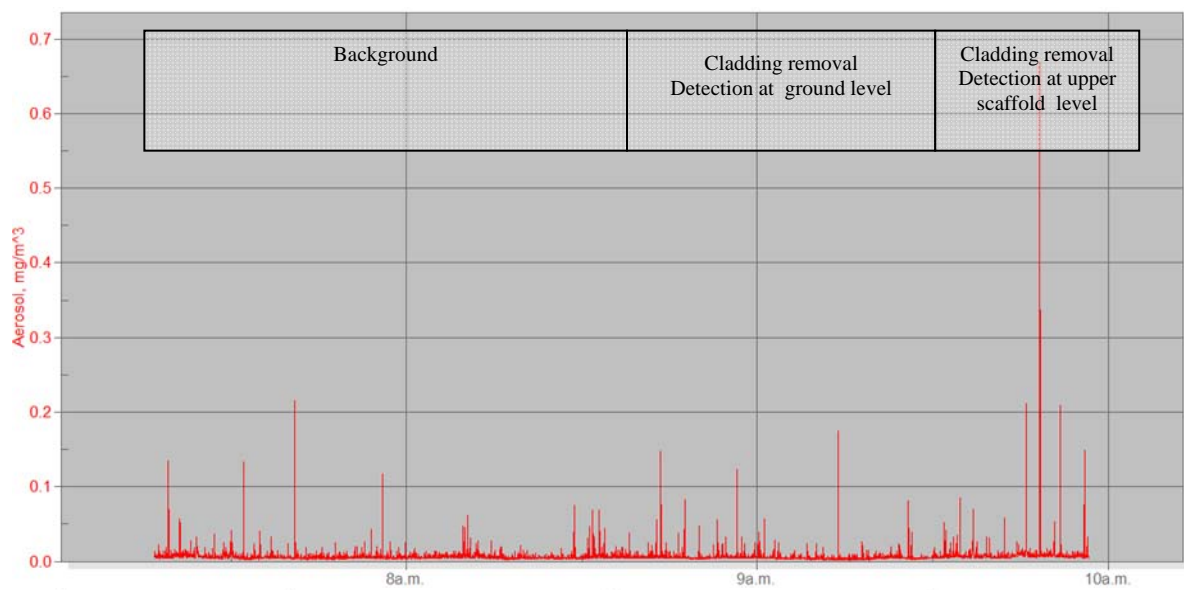
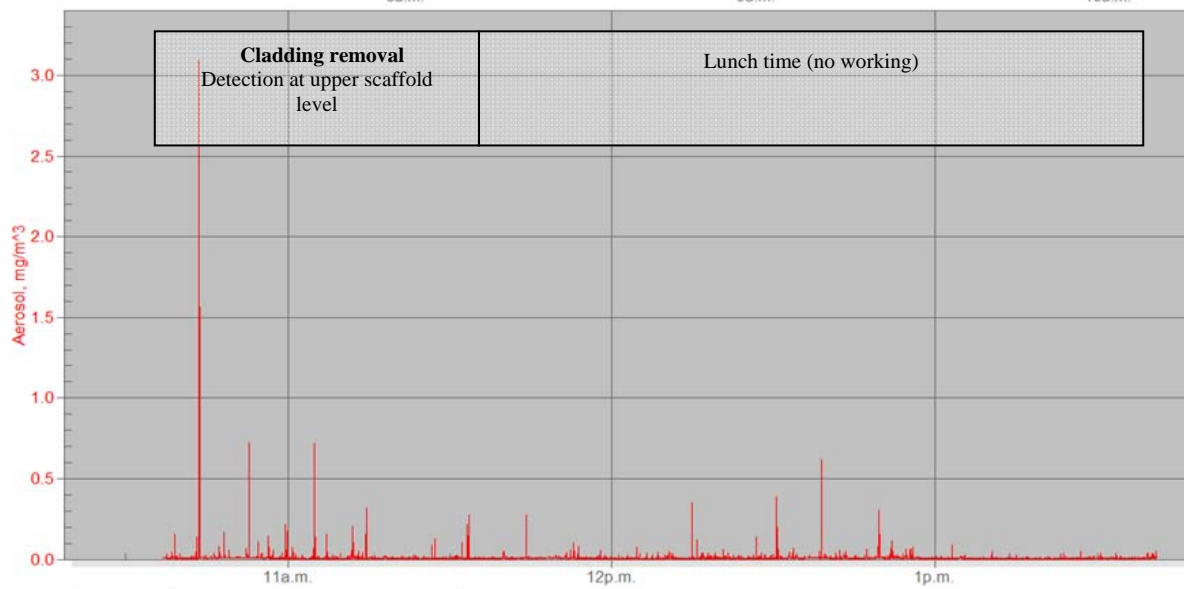
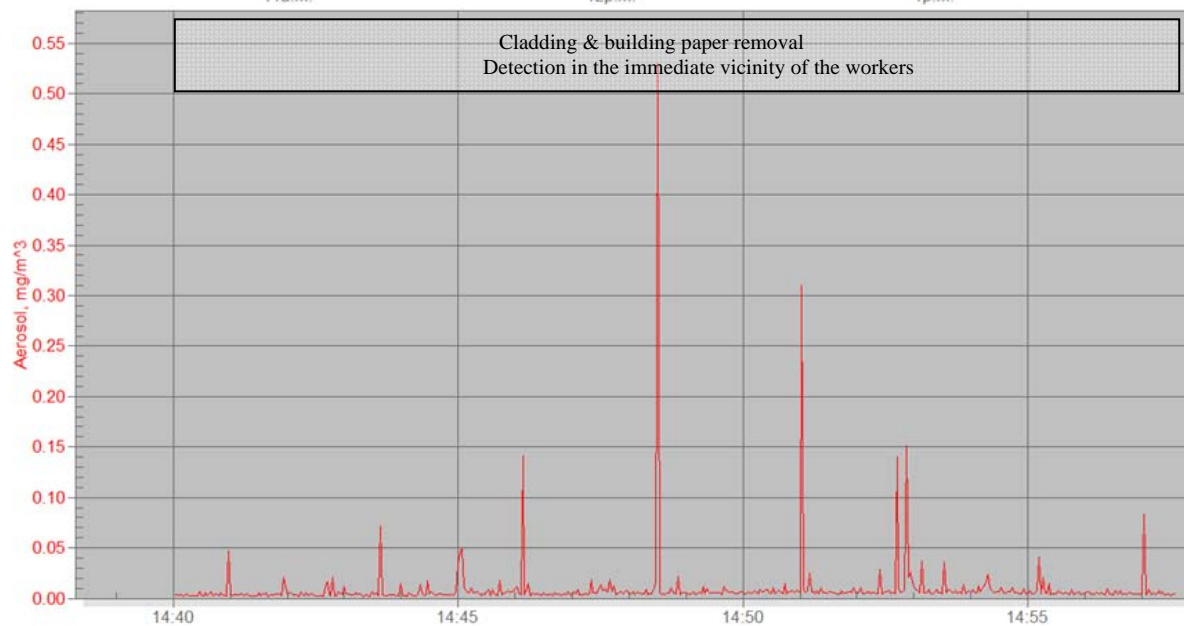
Figure 40: Unit 1 PM10 measured with various activities (NB: scale differs on each graph)

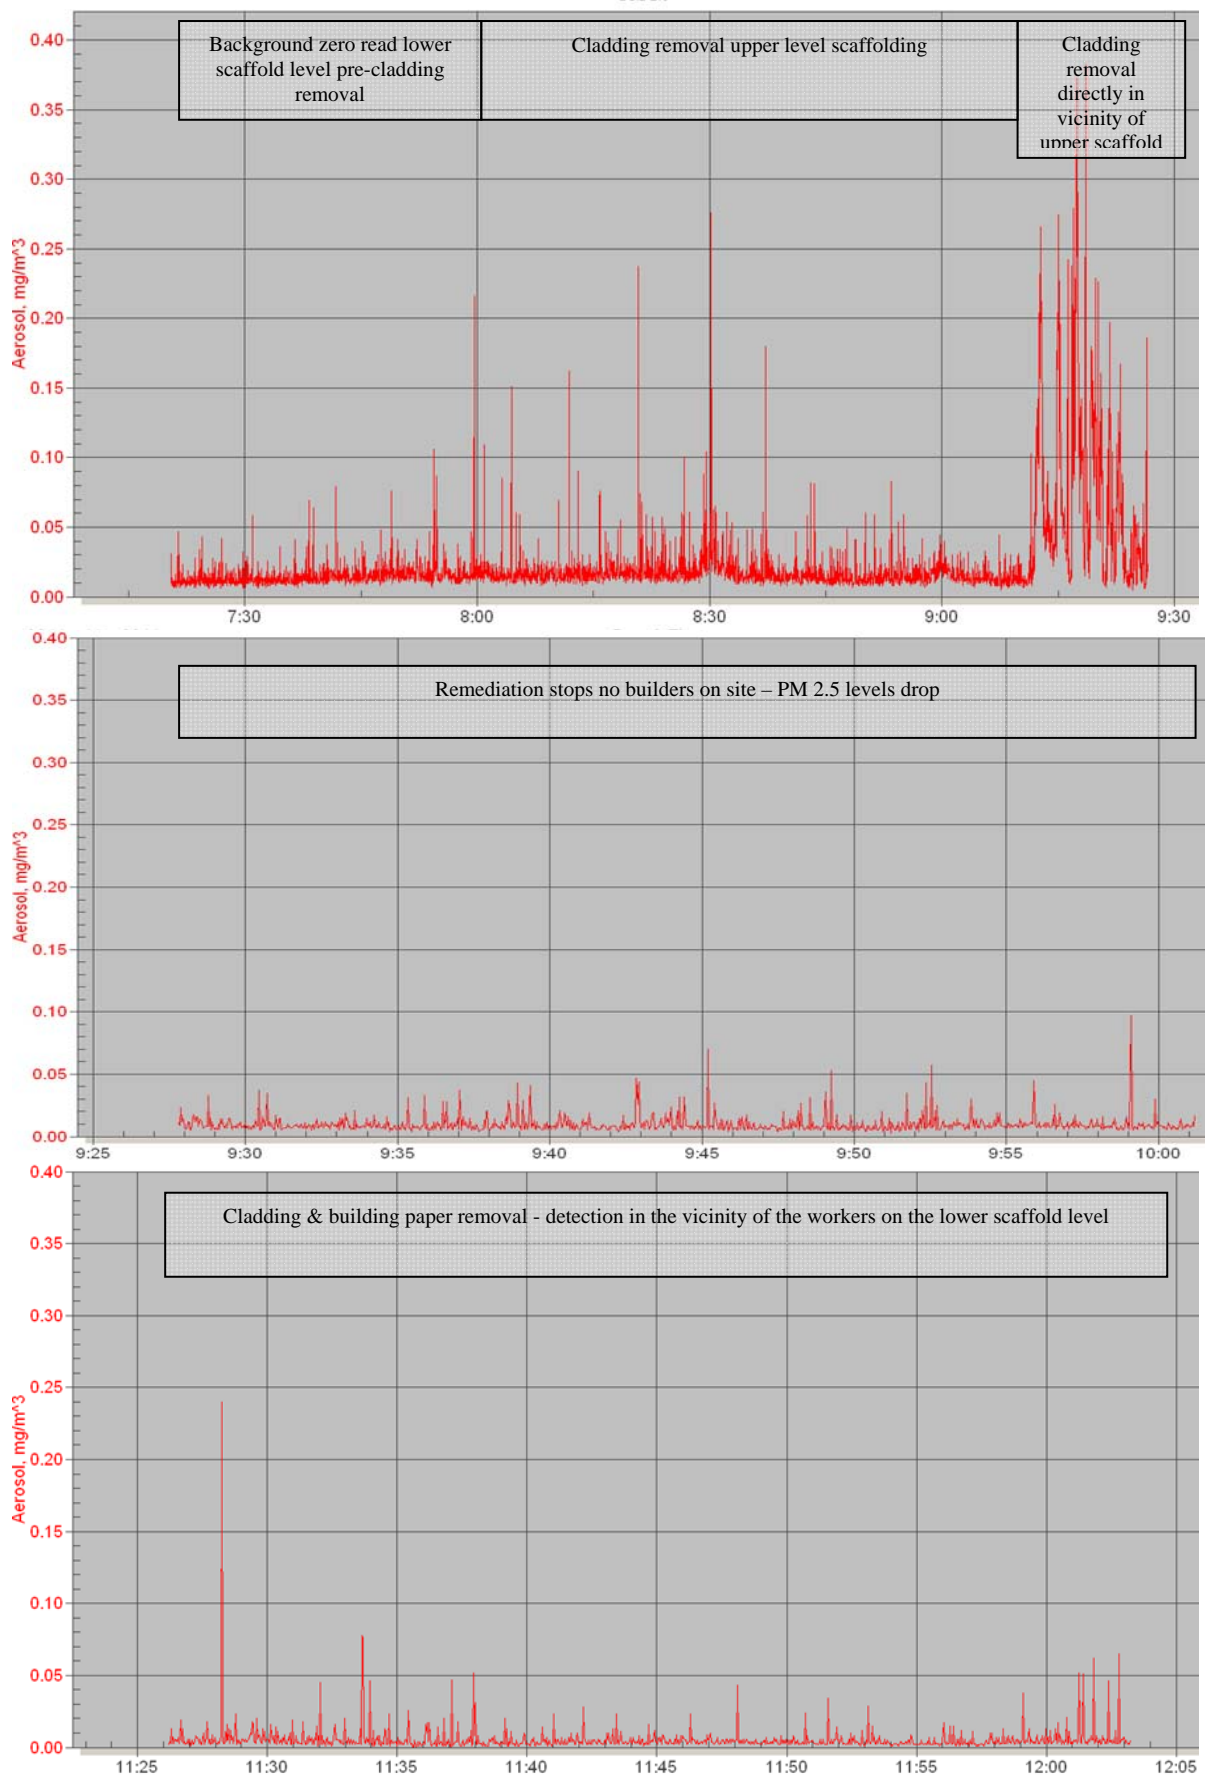
Figure 41: Unit 2 PM2.5 measured with various activities

During remediation of Unit 2, the background levels prior to any activity commencing on the building site of PM_{2.5} were found to generally be low, being below 0.05 mg/m³, with just one peak observed over 0.1 mg/m³ see Figure 41 and Table 4. When remediation activity started on the upper levels of the housing, the sampler on the ground did pick up increased PM_{2.5} concentration, with 33 peaks above 0.1 mg/m³, and a maximum of 0.18 see Table 4. When the sampler was moved to be in the immediate vicinity of the remediators on the upper scaffolding (9:15 – 9:26 am, Table), PM_{2.5} concentrations rapidly increased and 98 peaks were observed over a level of 0.1 mg/m³ during this time. Again, as with Unit 1, when activity stopped on the site, the outdoor particulate matter concentration fell rapidly back to low levels. Interestingly when work restarted on the lower level of the Unit (11:26 – 12:03 pm, Table 4), and the sampler was moved to follow the remediators, only one peak over 0.1 mg/m³ was observed, indicating that the location of the workers on the building may be important for exposure, potentially in relation to the temporary roof on the remediation building skin.

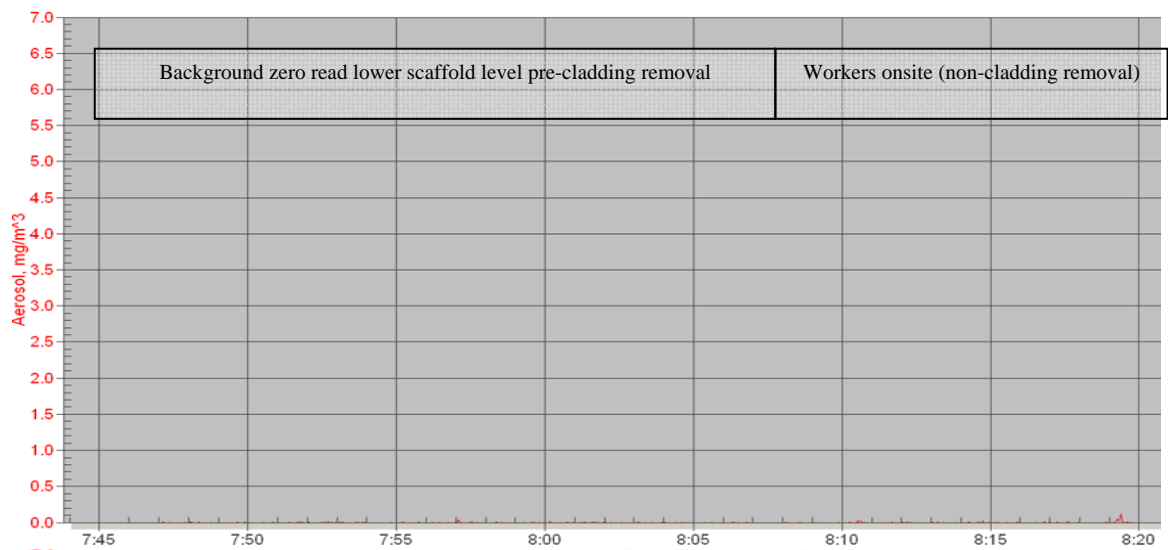
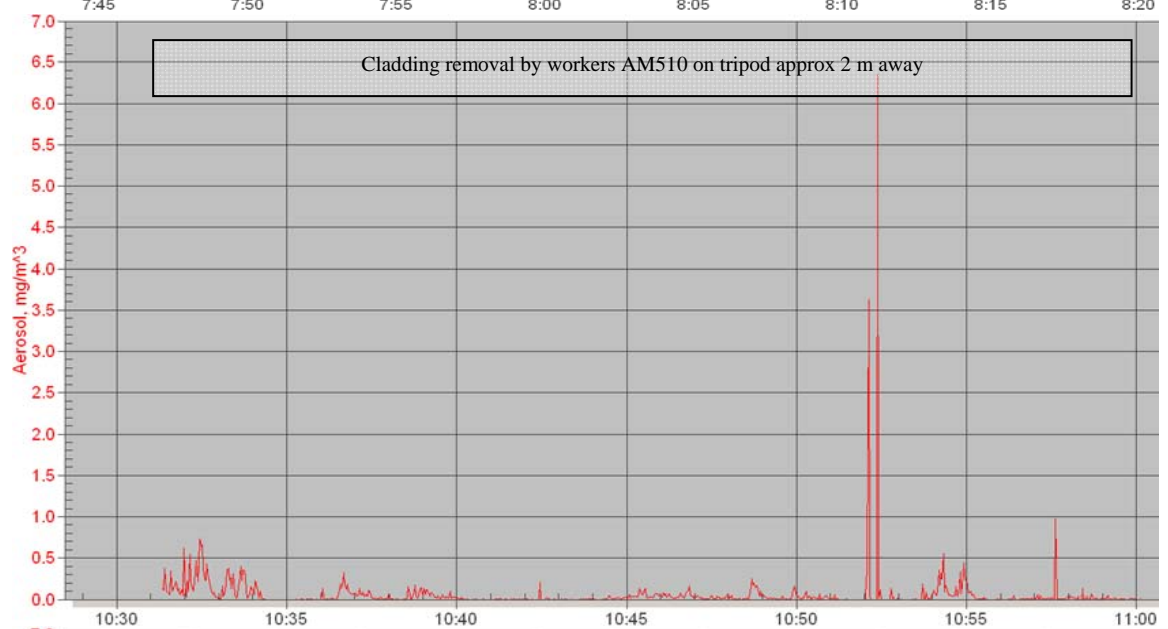
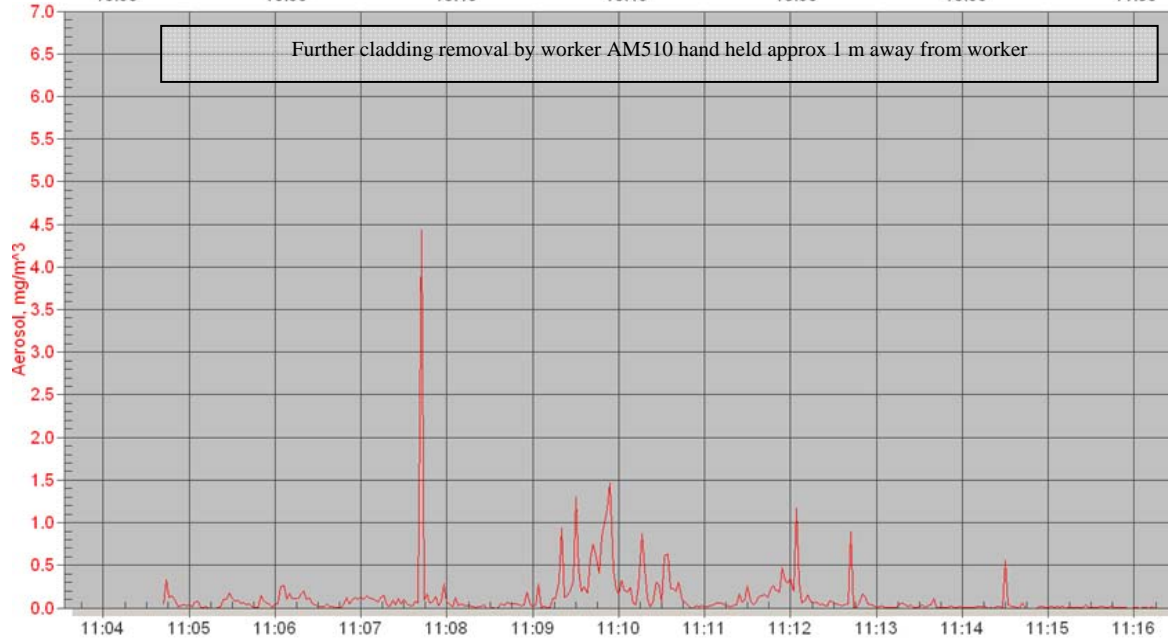
Figure 42: Unit 3 PM2.5 measured with various activities

Background concentrations of PM_{2.5} prior to workers being on site on Unit 3 were again, as with Units 1 and 2, very low, with a peak of 0.126 mg/m³, the only peak above 0.1. When builders first arrived on site the levels continued to be low, and activities were mainly based inside of the building around the far side of the apartment block, and did not involve any decladding (temporary internal walls were being erected inside the buildings). When the decladding process started concentrations of PM_{2.5} rapidly increased for the static sampler (10:31 – 11:00 am), with 116 peaks recorded over 0.1 mg/m³ and a maximum concentration of 6.36 recorded. Cladding removal in the immediate vicinity of the workers between 11:04 – 11:16 am also showed high levels of particulate matter over 0.1, with 97 peaks observed, and the maximum value of 4.43 mg/m³. It must be noted however, that some of these particulates may have also been generated by the use of a metal grinder around the other side of the building, with the potential for the wind to move it around the building and into the vicinity of our samplers, and so may not be solely contributable to the cladding removal process.

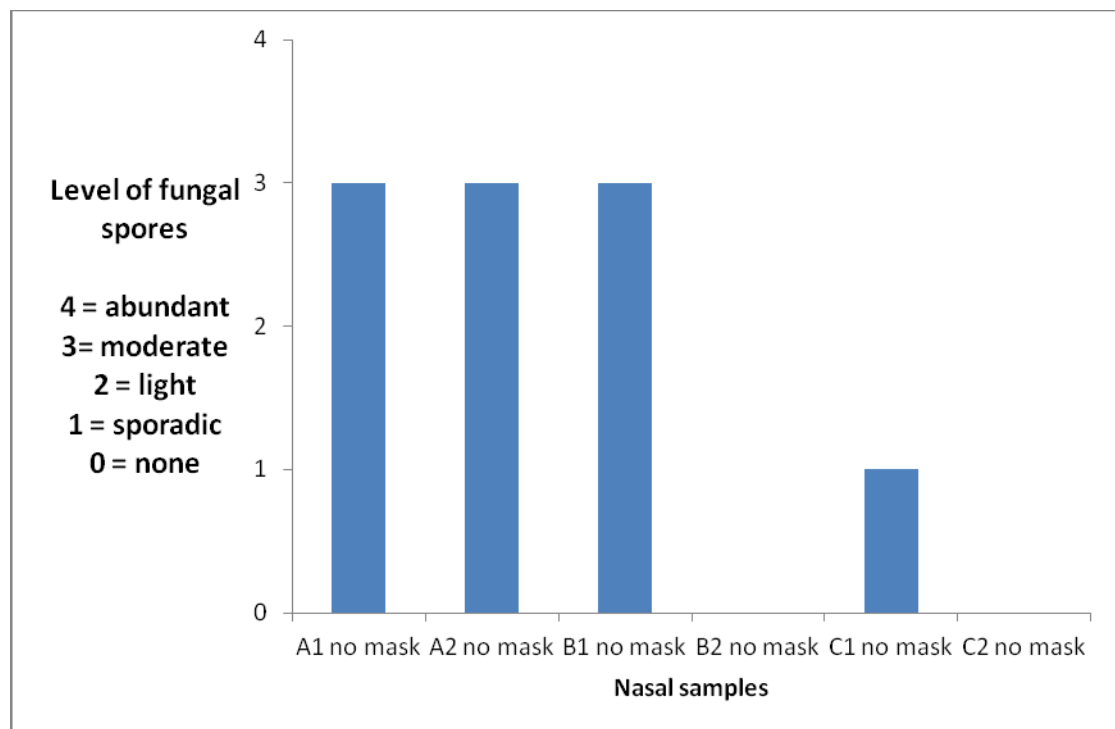
Figure 43: Levels of fungal spores observed in Vaseline coated nasal samplers during remediation of Unit 1, for person A, B and C, wearing no safety masks.

Levels of spores were recorded from the Vaseline coated nasal samplers worn during the remediation of Unit 1 on a 0 – 4 scale, see Figure 43. No masks were worn during this sampling period, after observations of workers on site indicated very few worn respirators. Person A had moderate levels of spores in both nostrils, Person B just in nostril 1, and Person C had sporadic levels in nostril 1. No spores were observed in nostril 2 for Person B or Person C. A large amount of fibres and anomorphous material were also collected in the Vaseline filled nasal sample cups, making spore counting difficult. Additionally the nasal samplers were difficult to wear for Person C and Person D (results not able to be read due to sample preparation problems), as those with larger nostrils found it difficult to keep the samplers in place. Therefore for Unit 2 and Unit 3 samplers were worn by smaller nostrilled researchers, and were also attached to an elasticated band attached to the mask which went around the back of the head, to help keep the samplers in place, particularly as the addition of a respirator was observed to sometimes dislodge the nasal samplers. After advice from Biodet the coating of the samplers in Vaseline was abandoned for Unit 2 and Unit 3, and instead a double sided layer of adhesive tape was applied to the cups, for easier identification of spores under the microscope.

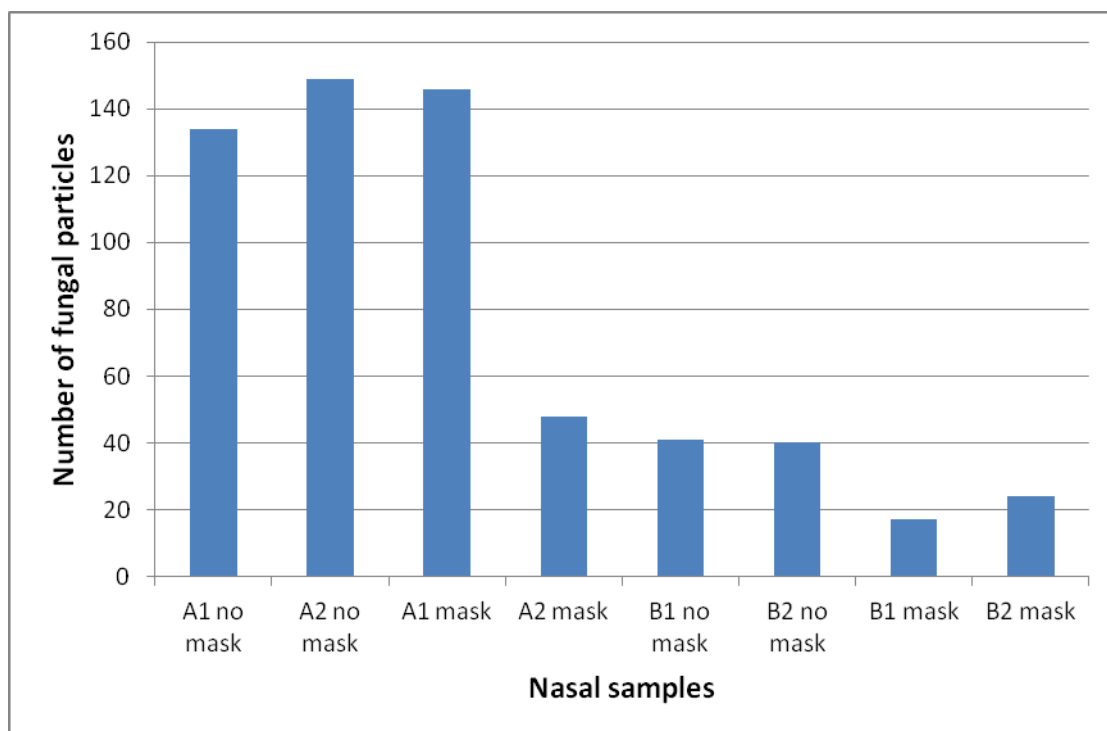
Figure 44: Number of fungal particles found in each sellotape nasal sample during remediation of Unit 2, with and without masks. Person A (respirator) and Person B (disposable mask).

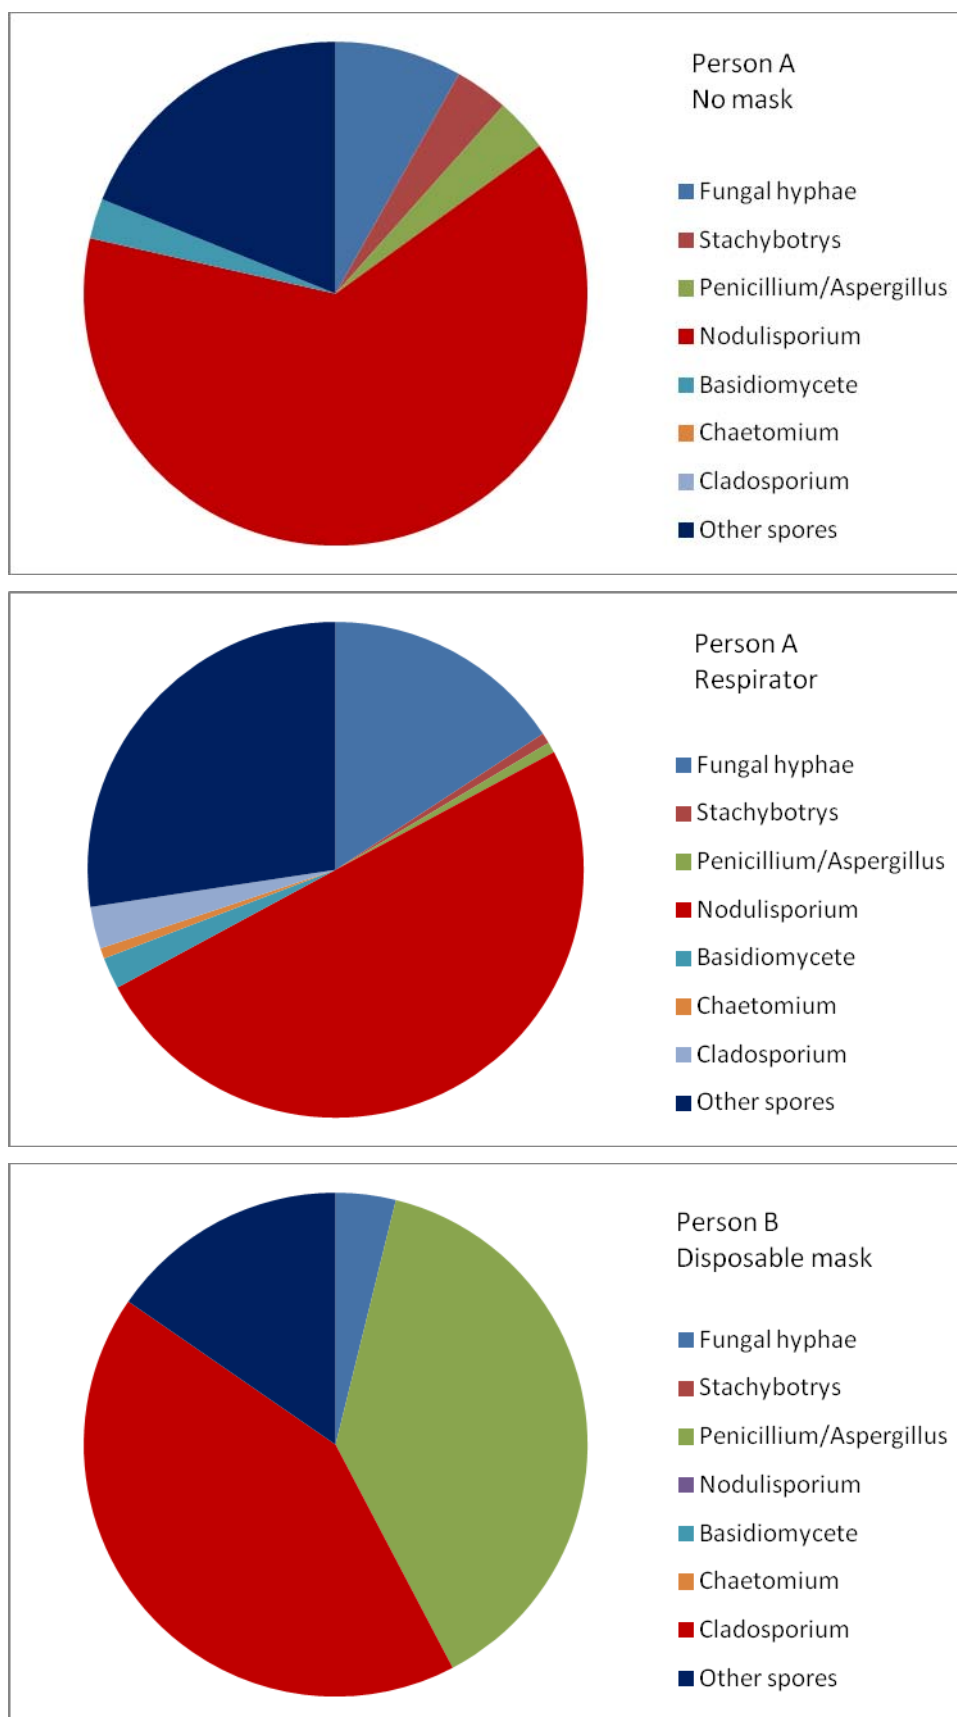
Figure 45: Types of fungal particles found in sellotape nasal samples during remediation of Unit 2, with and without a respirator for Person A and with a disposable mask for Person B

With the addition of a respirator there were no *Stachybotrys* spores observed in one nasal sample for Person A. However, one *Stachybotrys* spore was observed in the other nasal sample, suggesting that the respirator was not preventing all spores from entering the breathing cavities.

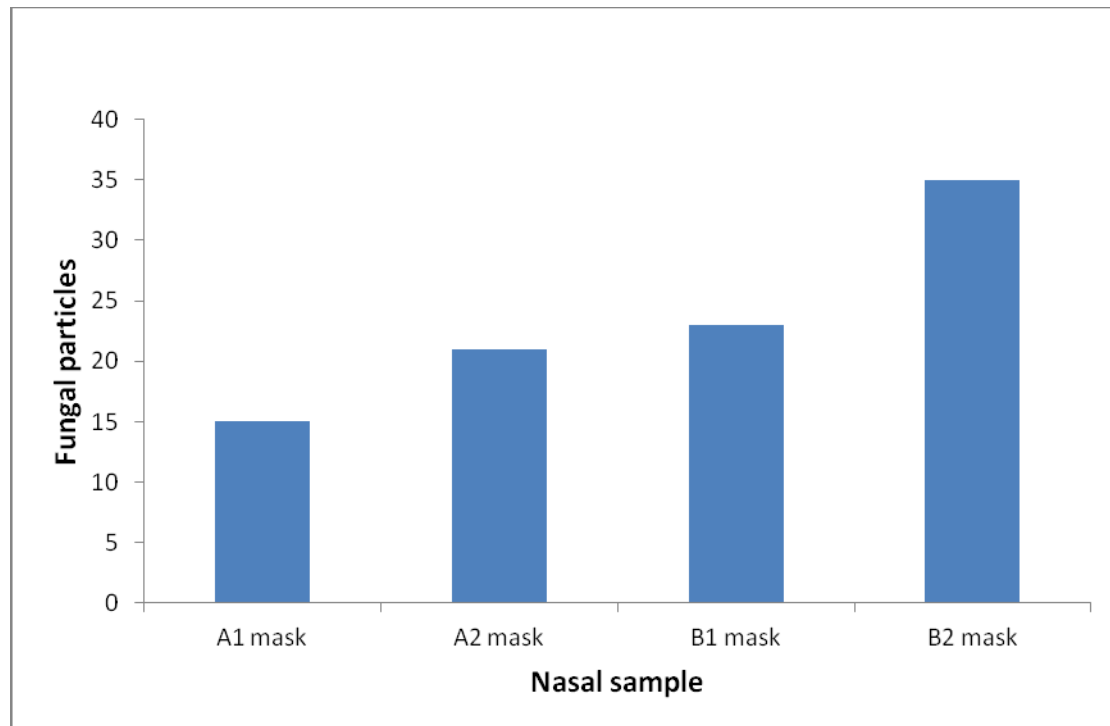
Figure 46: Number of fungal particles found in each sellotape nasal sample during remediation of Unit 3, for person A and person B, both with respirators

In Unit 3 only a short sampling time became available and only one period of nasal sampling could be conducted. The decision was made to carry out the sampling with respirators, and miss out the no mask samples. Fungal particles were present on the nasal samplers even while using respirators, for both Person A and Person B, see Figure 46. Levels were lower than those observed for Unit 2, and consisted entirely of fungal hyphae and a few *Penicillium phialides* spores. No *Stachybotrys* spores were picked up by any of the nasal samplers on Unit 3, even though they were observed to be present on site on the building materials.

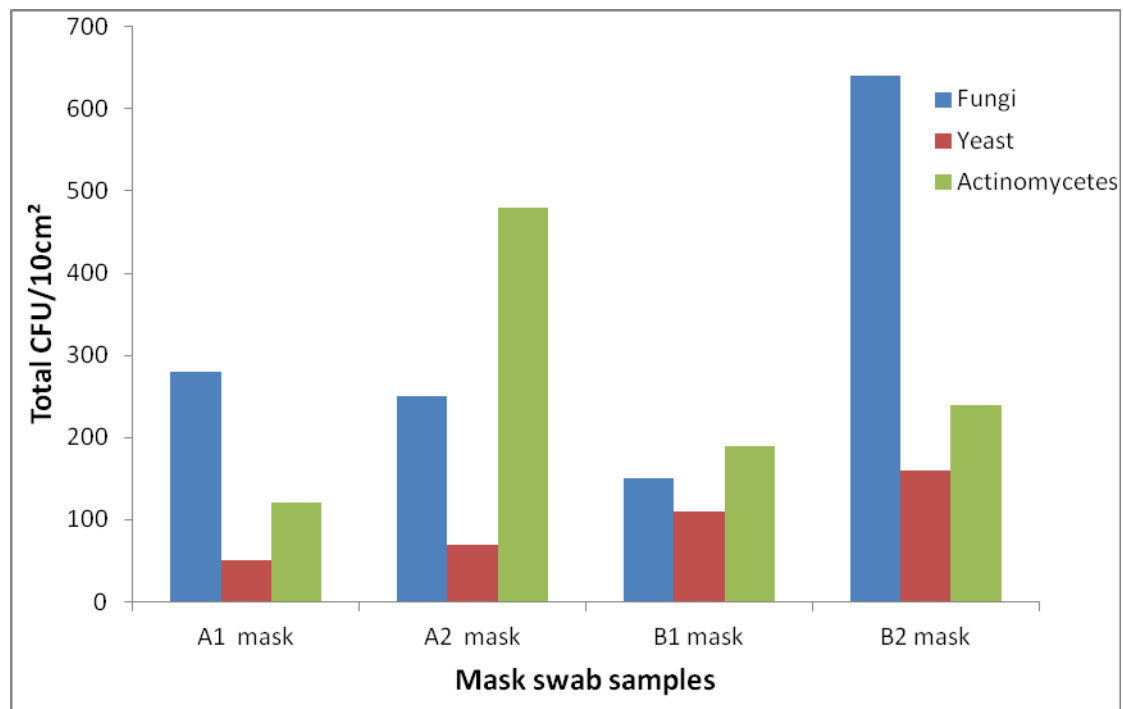
Figure 47: Levels of biocontaminants from swab samples taken inside the masks after being worn during remediation activities in Unit 2

Fungal spores and fragments were observed on the inside of both the respirator (Person A) and the disposable mask (Person B), as were yeasts, Actinomycetes and other bacteria, see Figure 47 and Figure 49. This would suggest that these contaminants were able to breach the both types of masks.

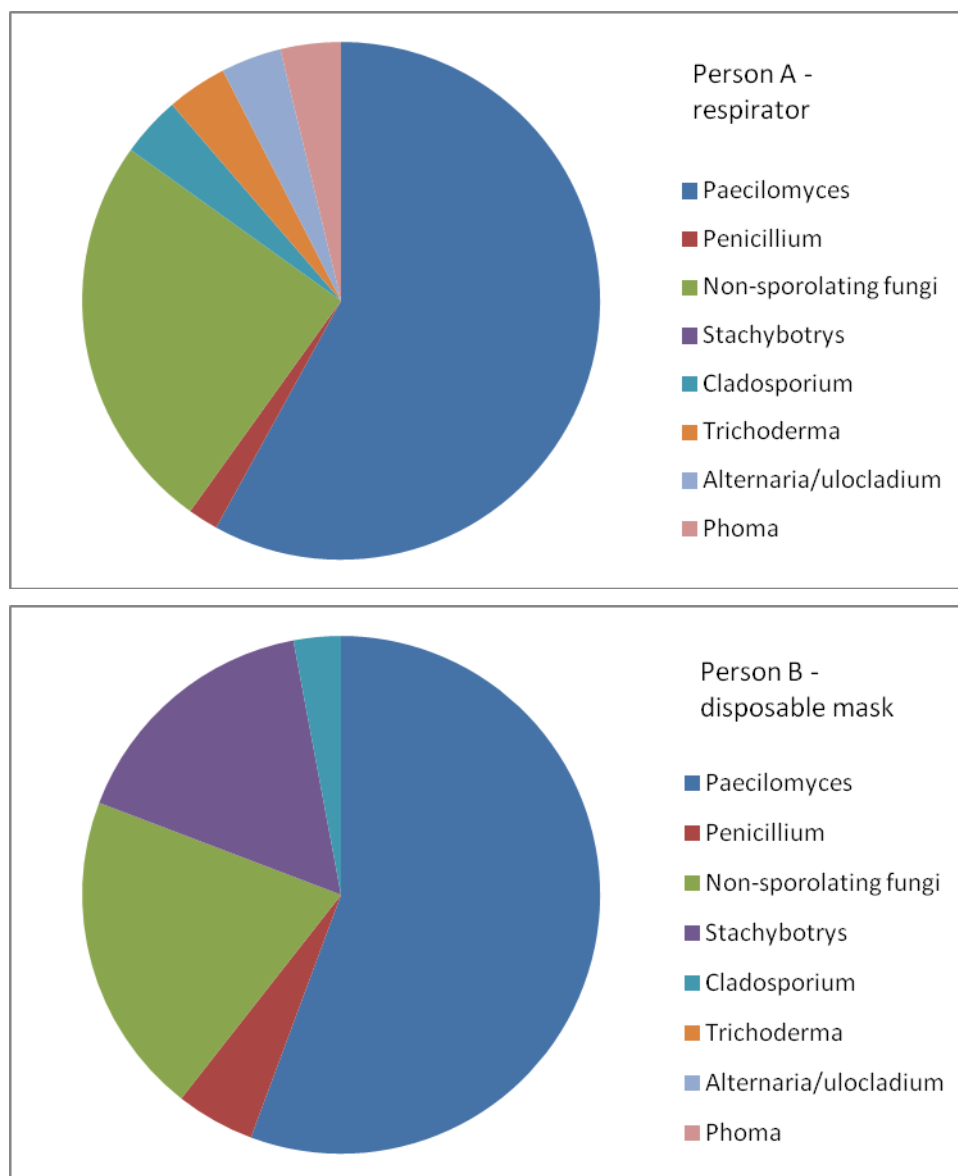
Figure 48: Types of fungi found on swabs of the interior of masks after remediation activities.

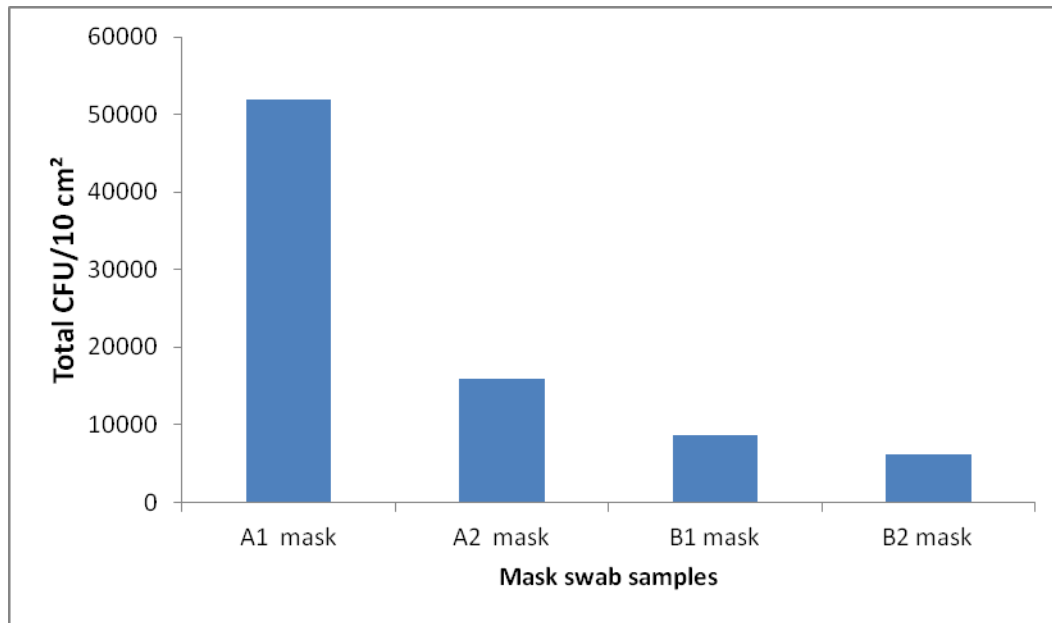
Figure 49: Levels of bacteria from swab samples taken inside face masks after being worn during remediation activities in Unit 2

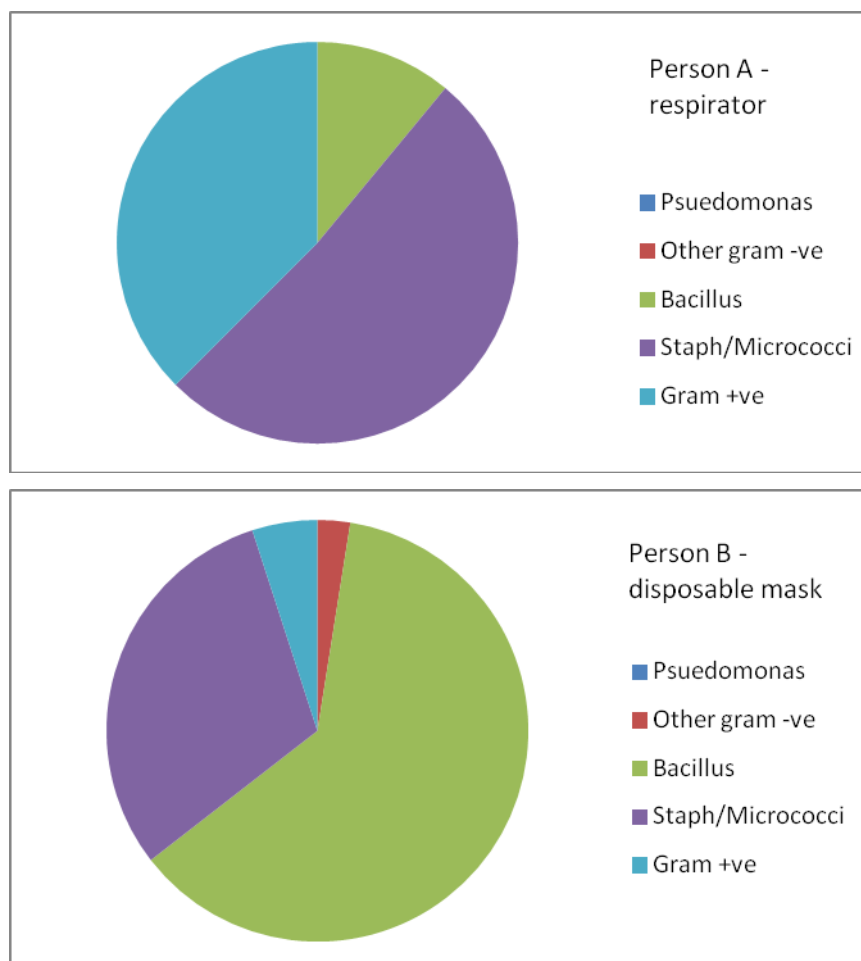
Figure 50: Types of bacteria found on swabs of the interior of masks after remediation activities

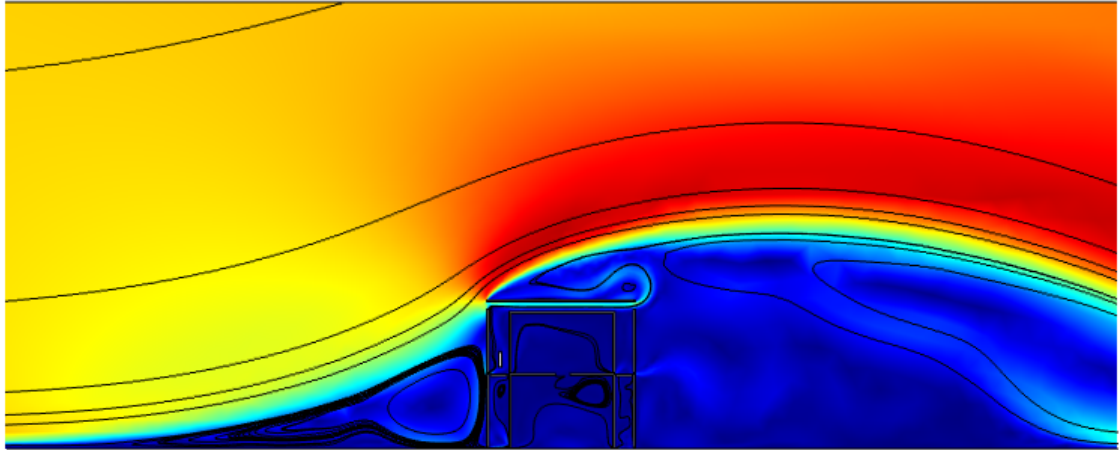
Figure 51: Airflow over the building with a wind of 2 m/s

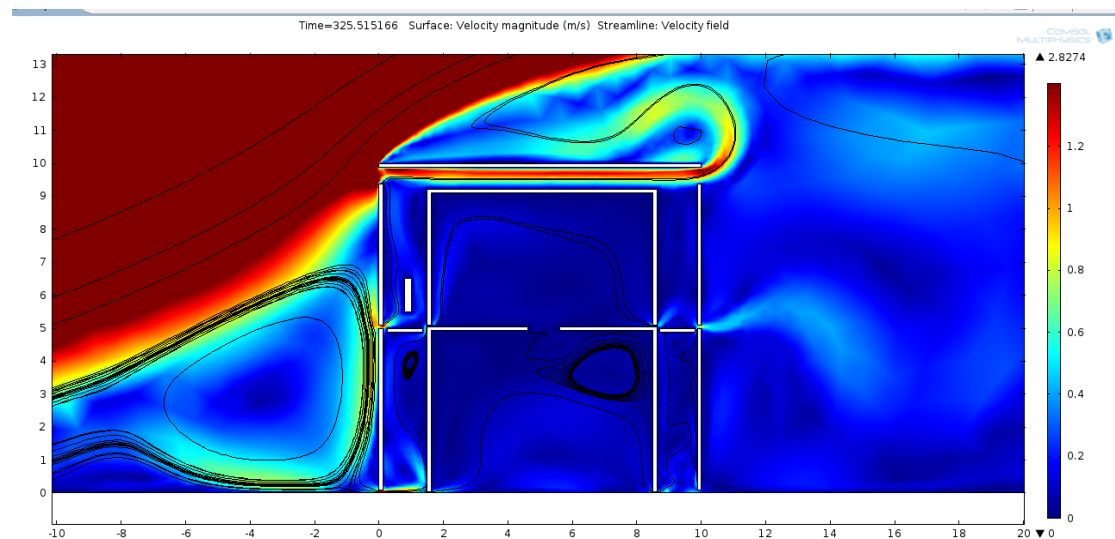
Figure 52: Airflow within building and protective surrounds with a wind velocity of 2 m/s

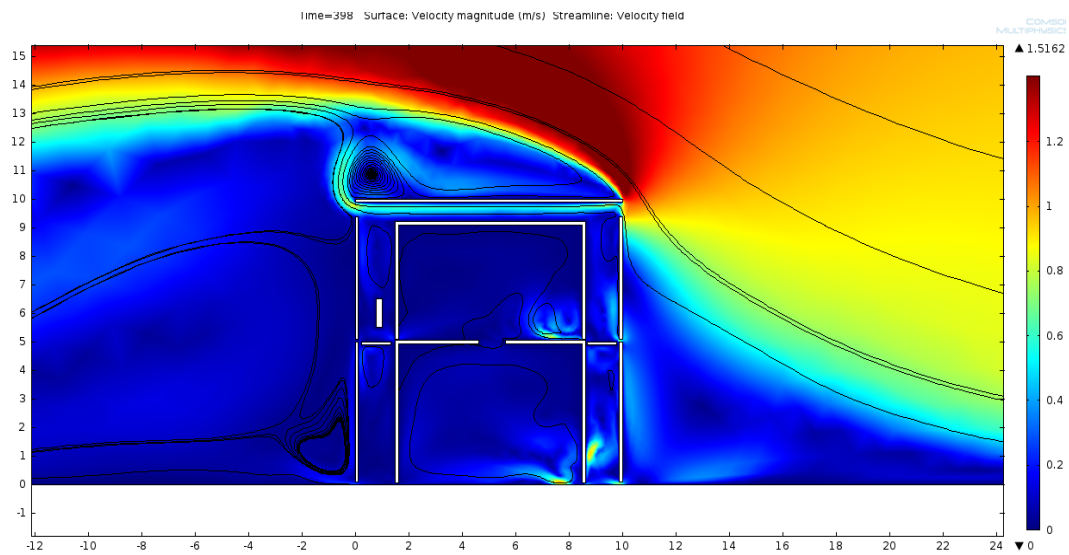
Figure 53: Airflow within building and protective surrounds with a wind velocity of – 1 m/s

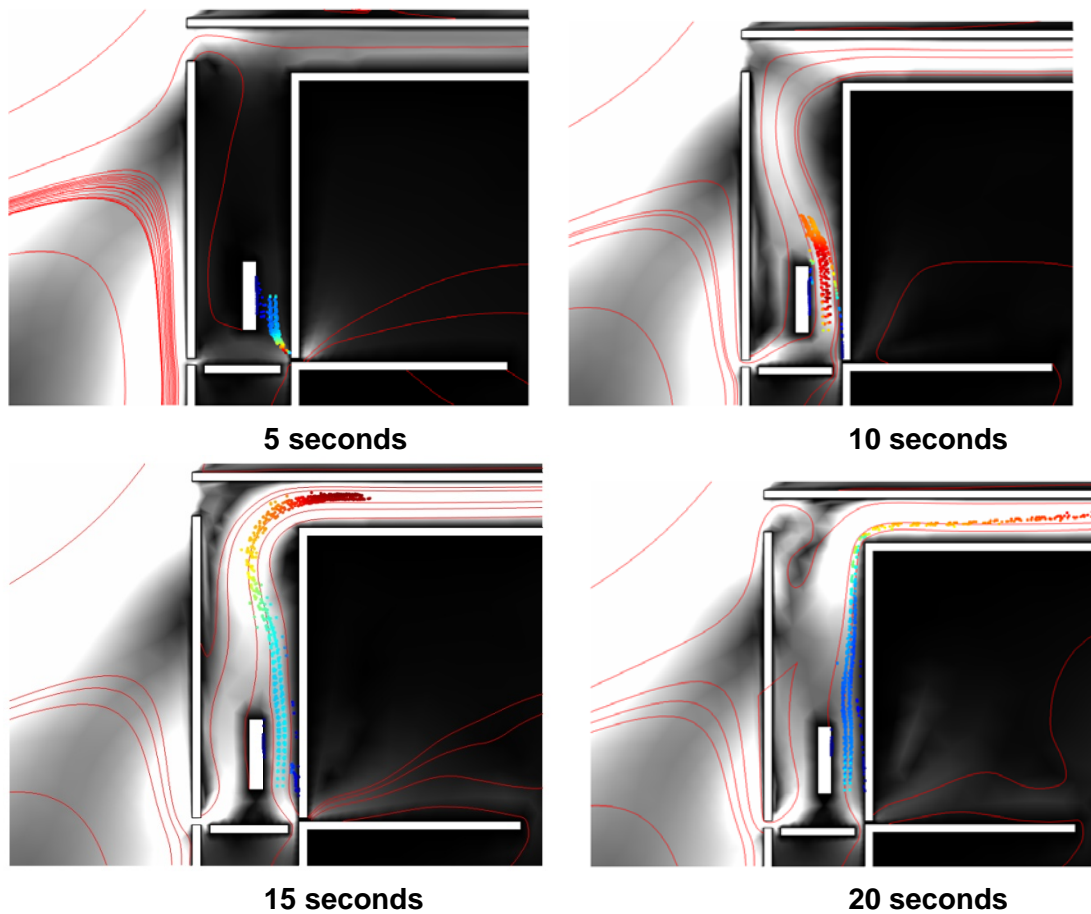
Figure 54: Trajectory of biocontaminant cloud with wind velocity of 2 m/s

Figure 54 and Figure 55 and show the resulting trajectory of the biocontaminant cloud for the external velocities of 2 m/s and -1 m/s respectively.

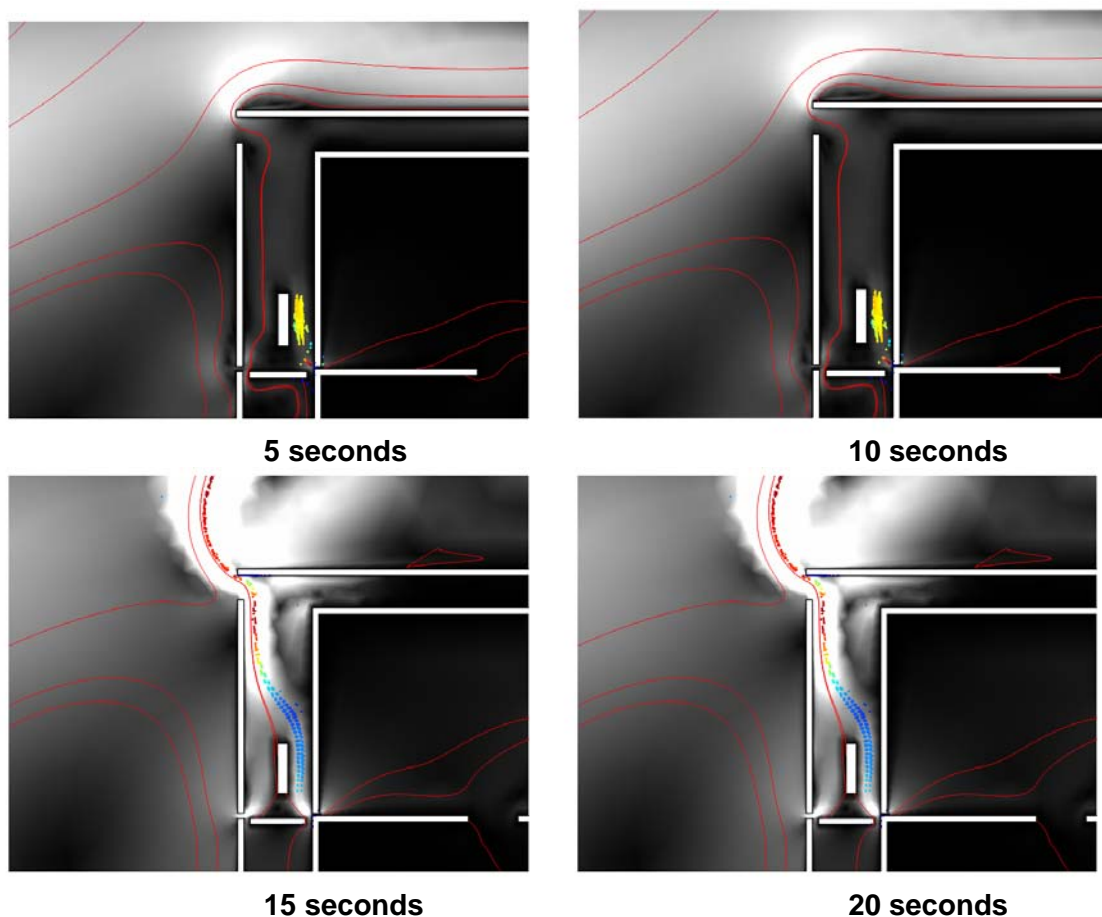
Figure 55: Trajectory of biocontaminant cloud with wind velocity of -1 m/s

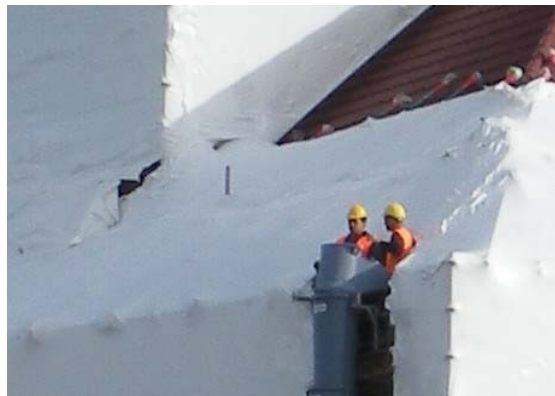
Figure 56: (Photo 23) Workers place building materials at top of rubbish shoot without respirators
