STUDY REPORT

No. 110 (2001)

Calibration Studies for Landslide Quantitative Risk Assessment

**Prepared by: Golder Associates (NZ) Ltd
 PO Box 2281
 Christchurch**

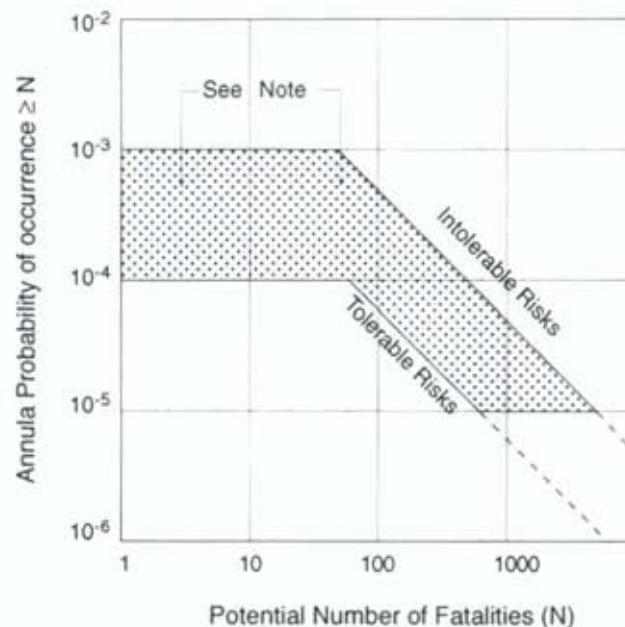
Figure 2: Proposed guidelines for assessing risks to life from naturally occurring slope hazards (from Morgan, 1997)

Note: Risks should be reduced in accordance with the ALARP principle with emphasis on those risks falling within the shaded area. The expected annual fatalities should not exceed 5×10^{-3} without justification.

The shaded area on Figure 2 is representative of a risk which is undertaken or accepted only if a benefit is desired. This requires the risk to be reduced to a level when most (but not all) of the public are satisfied (Health and Safety Executive, 1988), considered to be as low as reasonably practicable (ALARP).

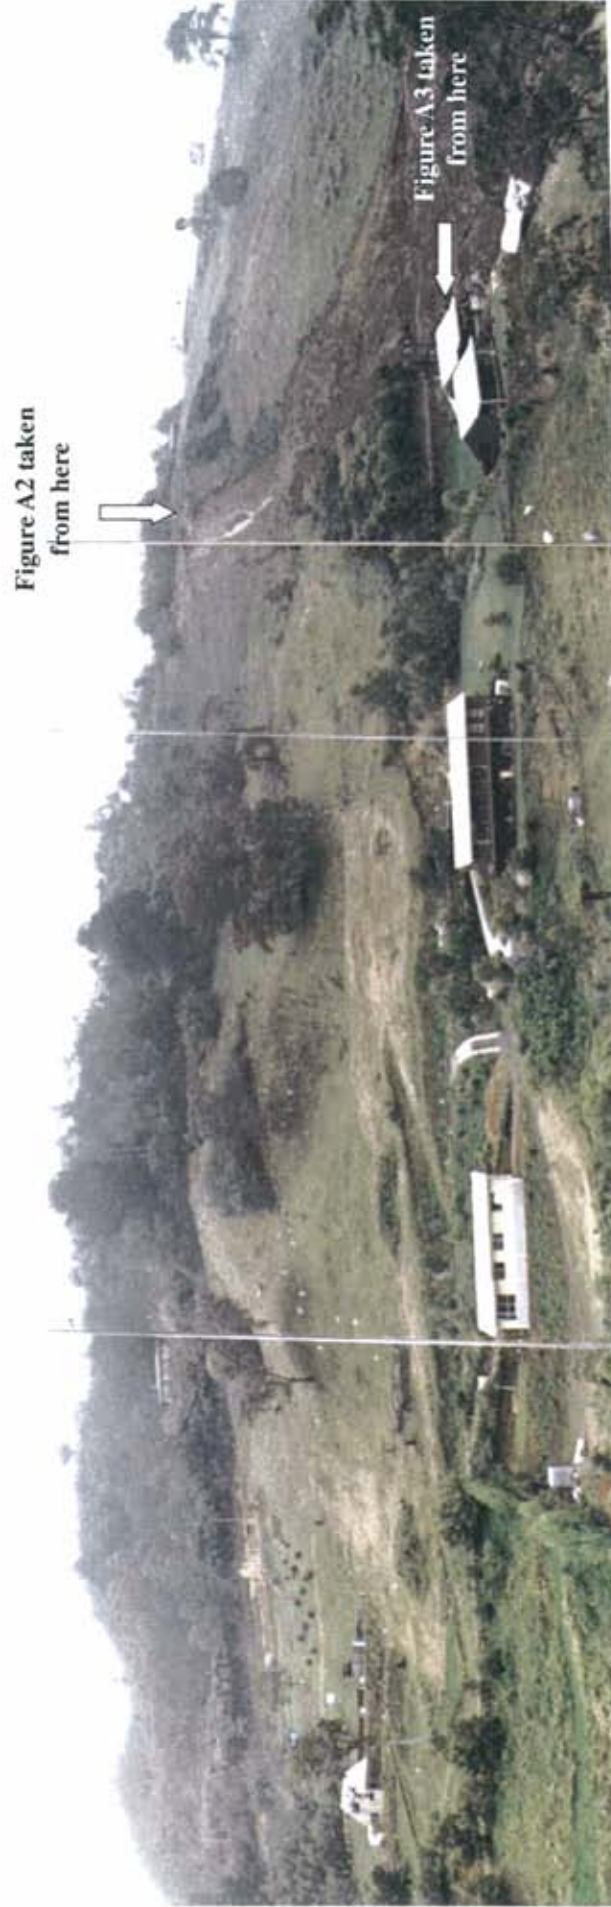
Figure A1: Landslide of 7th December 1983, damaged house on right of photo (view looking southwest)

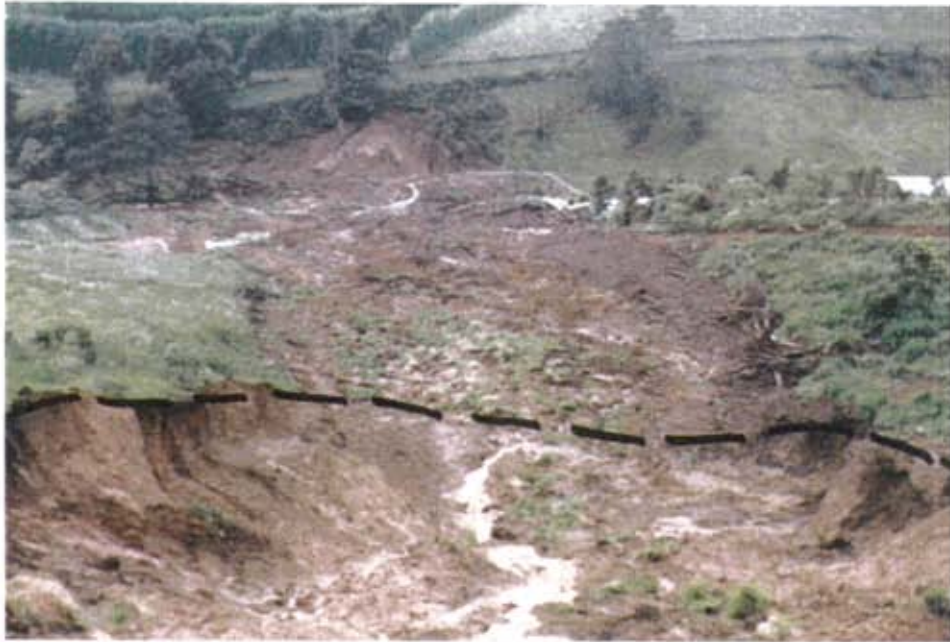
Figure A2: View to northeast from top of landslide. Dashed line shows the boundary between the lost ground and the landslide debris

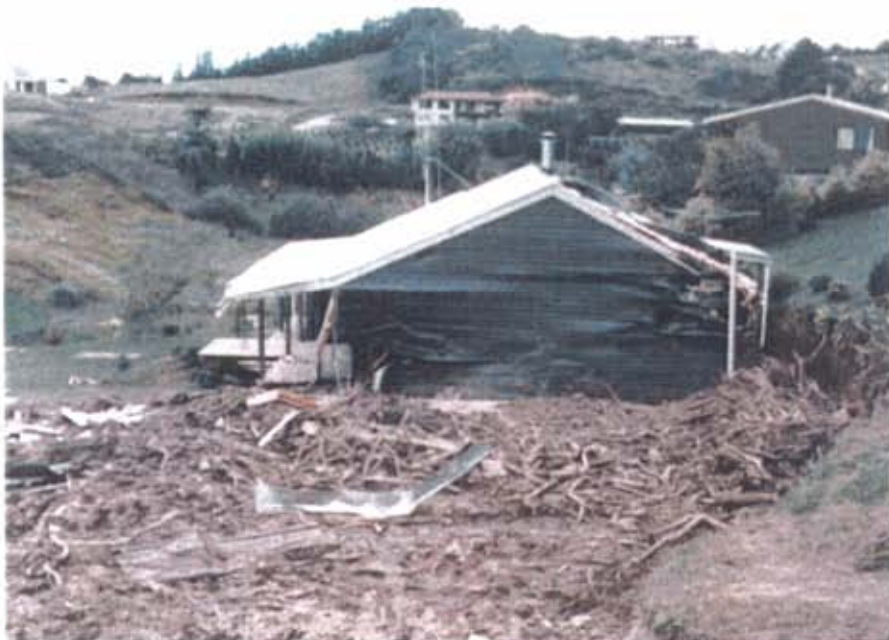
Figure A3: View to east showing damage to house and landslide debris

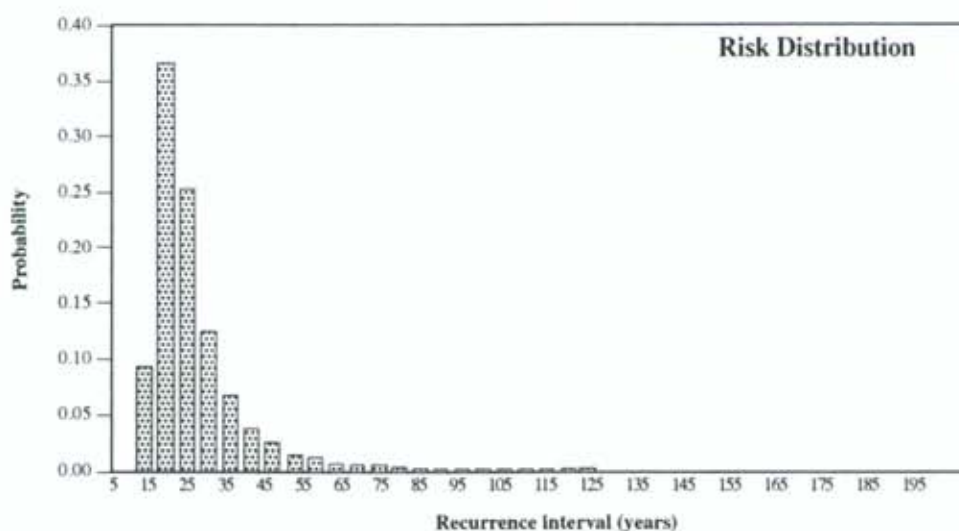
| | Min | Most Likely | Max |
|---|---|---|---|
| Maximum risk | 0.09 | Maximum frequency of occurrence | 11 years |
| Average risk | 0.03 | Average frequency of occurrence | 33 years |

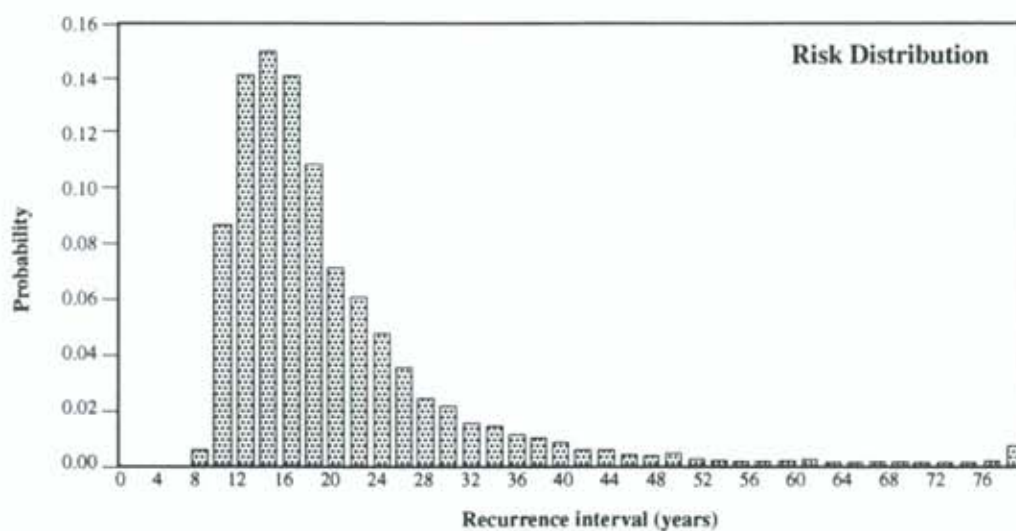
**Table A6: Risk of Damage to dwelling due to Landslip**

| | Min | Most Likely | Max |
|---|---|---|---|
| Maximum risk | 0.15 | Maximum frequency of occurrence | 7 years |
| Average risk | 0.06 | Average frequency of occurrence | 16 years |

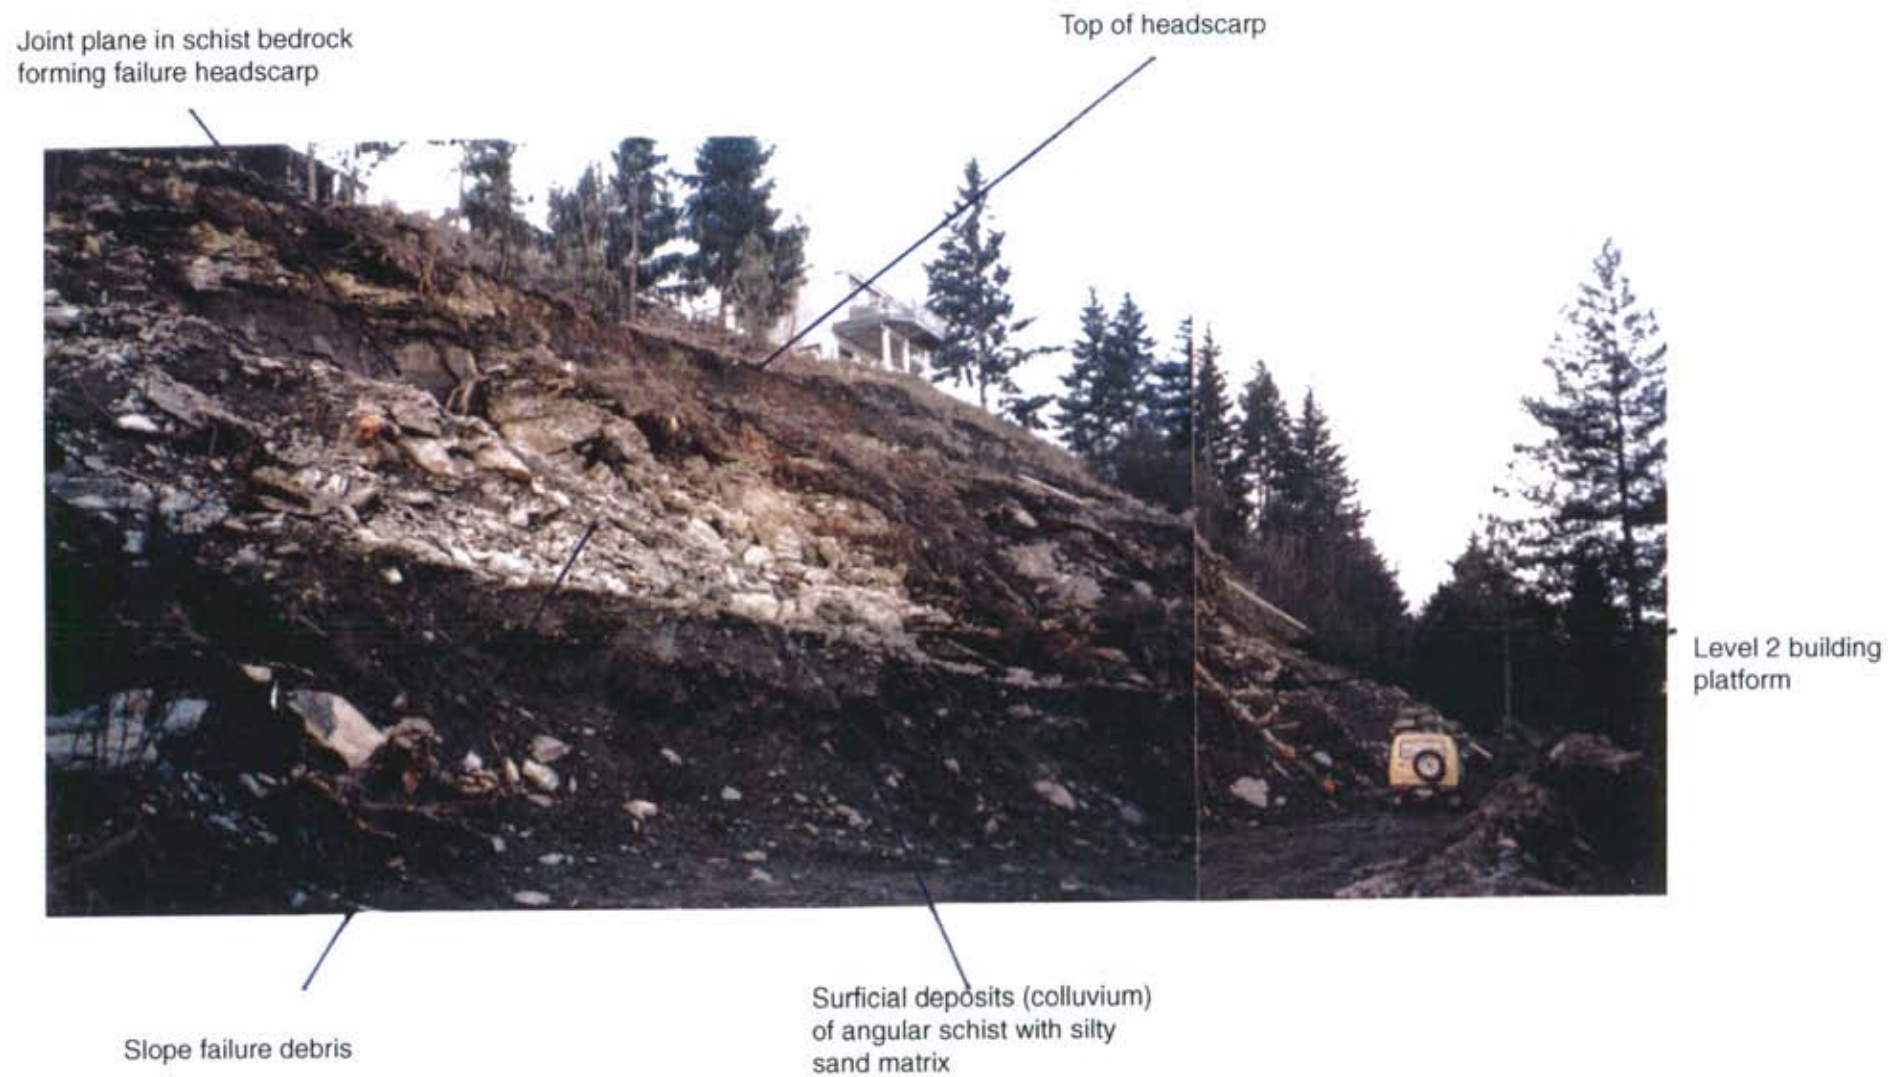
Figure B1: Oblique view of slope failure

A number of steeply inclined joints striking up/down slope were also observed at the margins of the failure, which may have acted as lateral release surfaces for the block slide.

Slight seepage of groundwater was visible at the site inspection following failure down the head scarp originating from the contact between the surficial deposits and the bedrock, and also at the base of the closely fractured schist at the west end of the scarp. The water source was believed to be from a thin

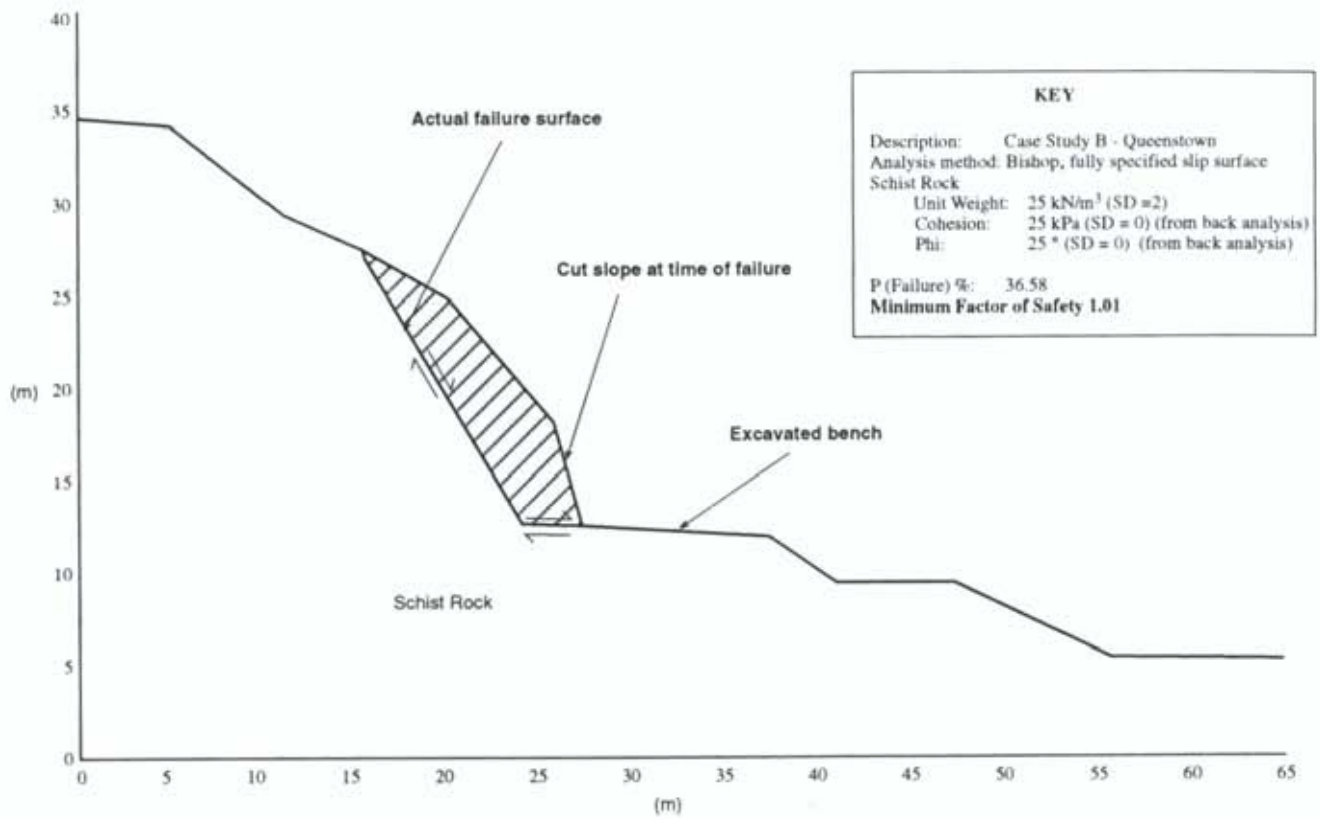
Figure B4: Results of stability analysis assuming typical strength parameters for discontinuities in Otago Schist

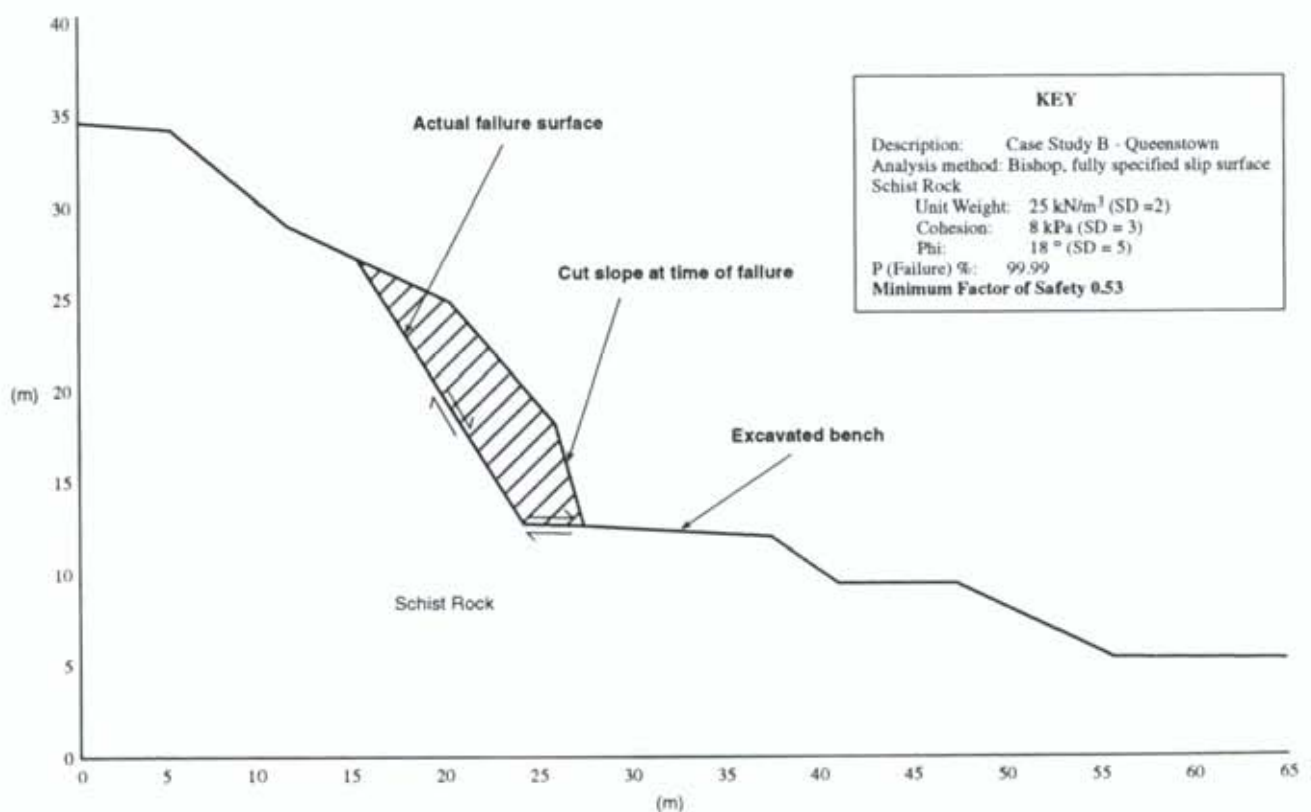
Figure B5: Results of back analysis showing actual strength parameters

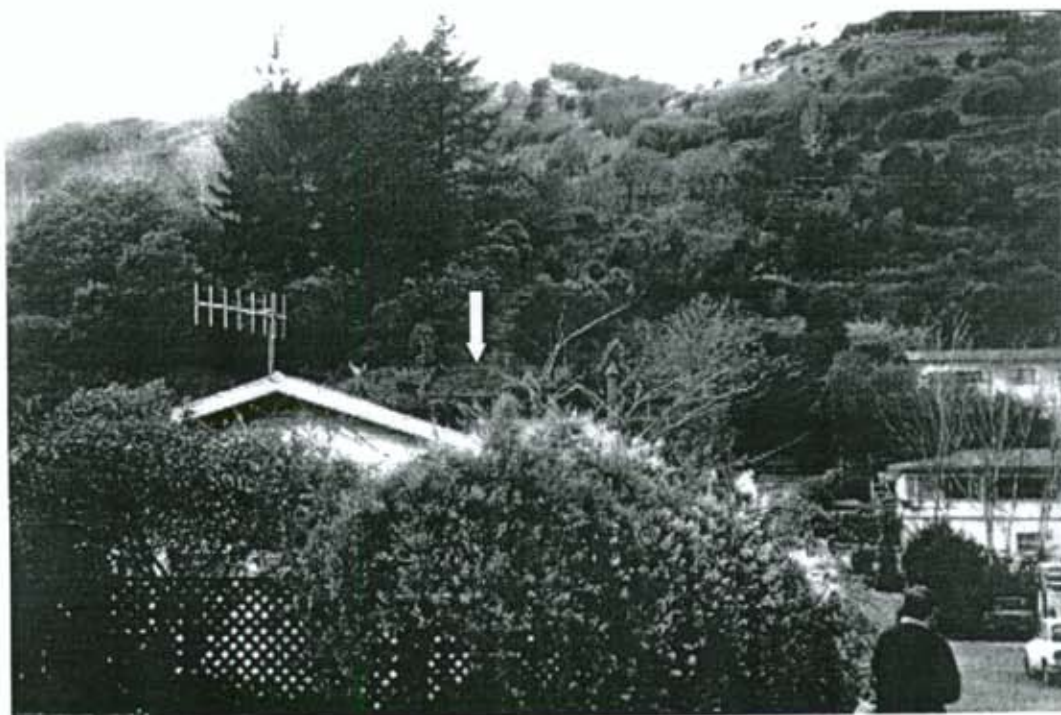
Figure C3: Slope viewed from below. Former house site arrowed

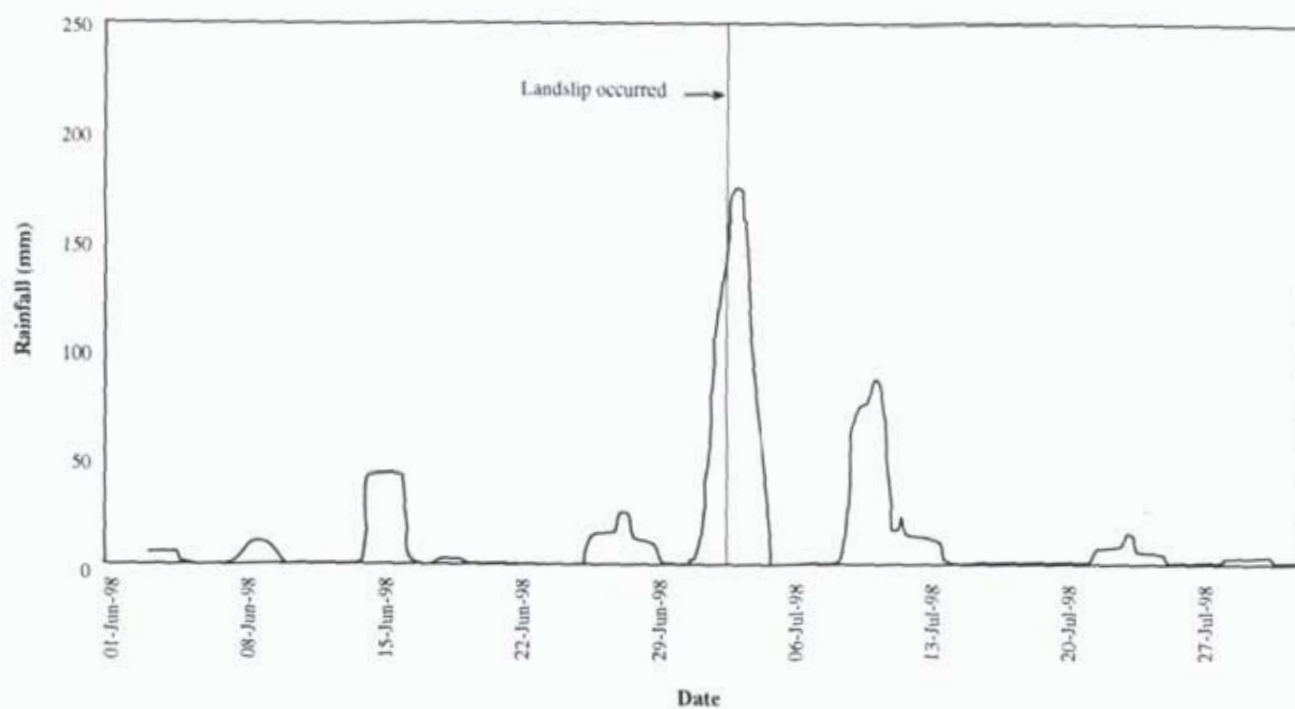
Figure C4: 24 hour antecedent rainfall, Nelson Airport

A high intensity rainfall initiated the failure of 2 July 1998. Records obtained for the Nelson Airport rain gauge indicates 173 mm of rain fell in the 48 hours preceding the landslide of July 1998 (Figure C4). Comparison with NIWA's High Intensity Rainfall Design System (HIRDS) database indicates an event of this magnitude to have a recurrence interval of approximately 14 years (Figure C5). By assuming that, on average, a rainfall event of this magnitude will always result in a slope failure of similar size to the 1998 event, a failure probability of 0.05 to 0.25 (i.e. 1 in 4 to 1 in 20 years) appears reasonable.

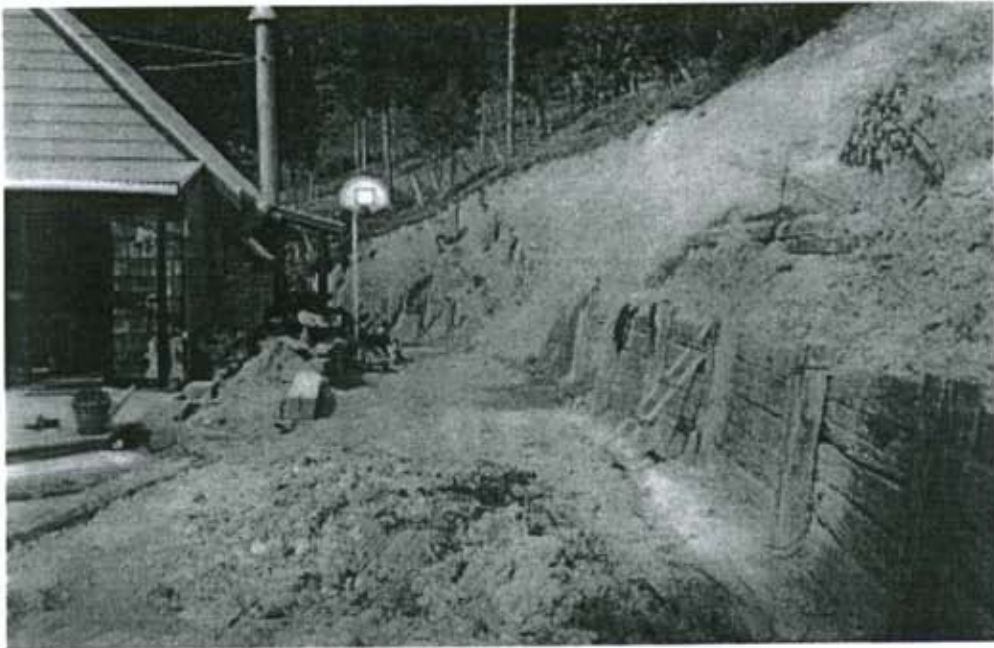
Figure D1: View showing slip debris against house

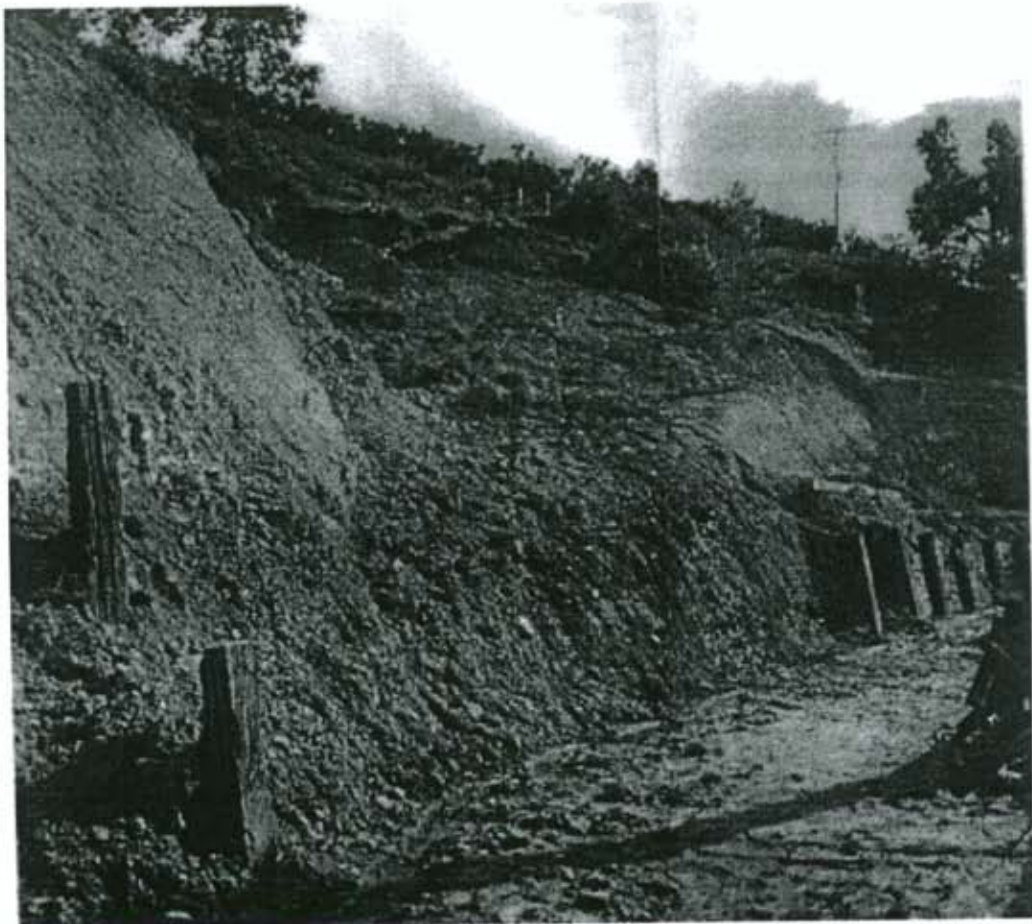
Figure D2: View showing slip
