STUDY REPORT

No. 182 (2007)

Weathering of Polymeric Materials in New Zealand

BRANZ Study Report SR 182 (2007)

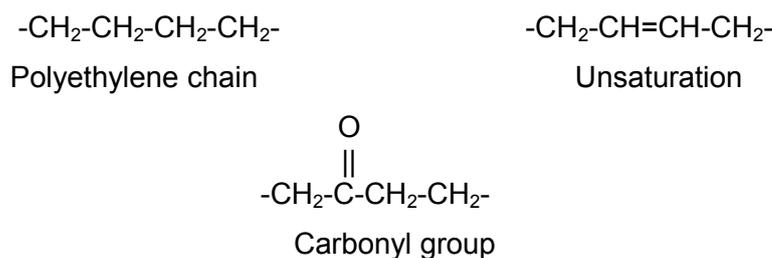
Figure 1. Structure of the polyethylene chain and chromophoric groups

This is the situation with the polyolefins, polyethylene (PE) and polypropylene (PP), which are severely affected by the presence of UV radiation. Although they have no carbonyl or C=C bonds within their regular structure, the chromophoric moieties are introduced into the backbone or side groups through the high temperature injection moulding and extrusion processes involved in producing the plastic building products. It is also understood that the metal-based additives contained within the polyolefins catalyse oxidation reactions resulting in photo-oxidative and thermo-oxidative degradation. Initiation of the photo-chemical degradation reactions can occur via free radical mechanisms, leading to the formation of hydroperoxides and chain scission as shown schematically in Figure 2, which eventually cause catastrophic failure of building components. However, it is important to note that the careful selection of UV

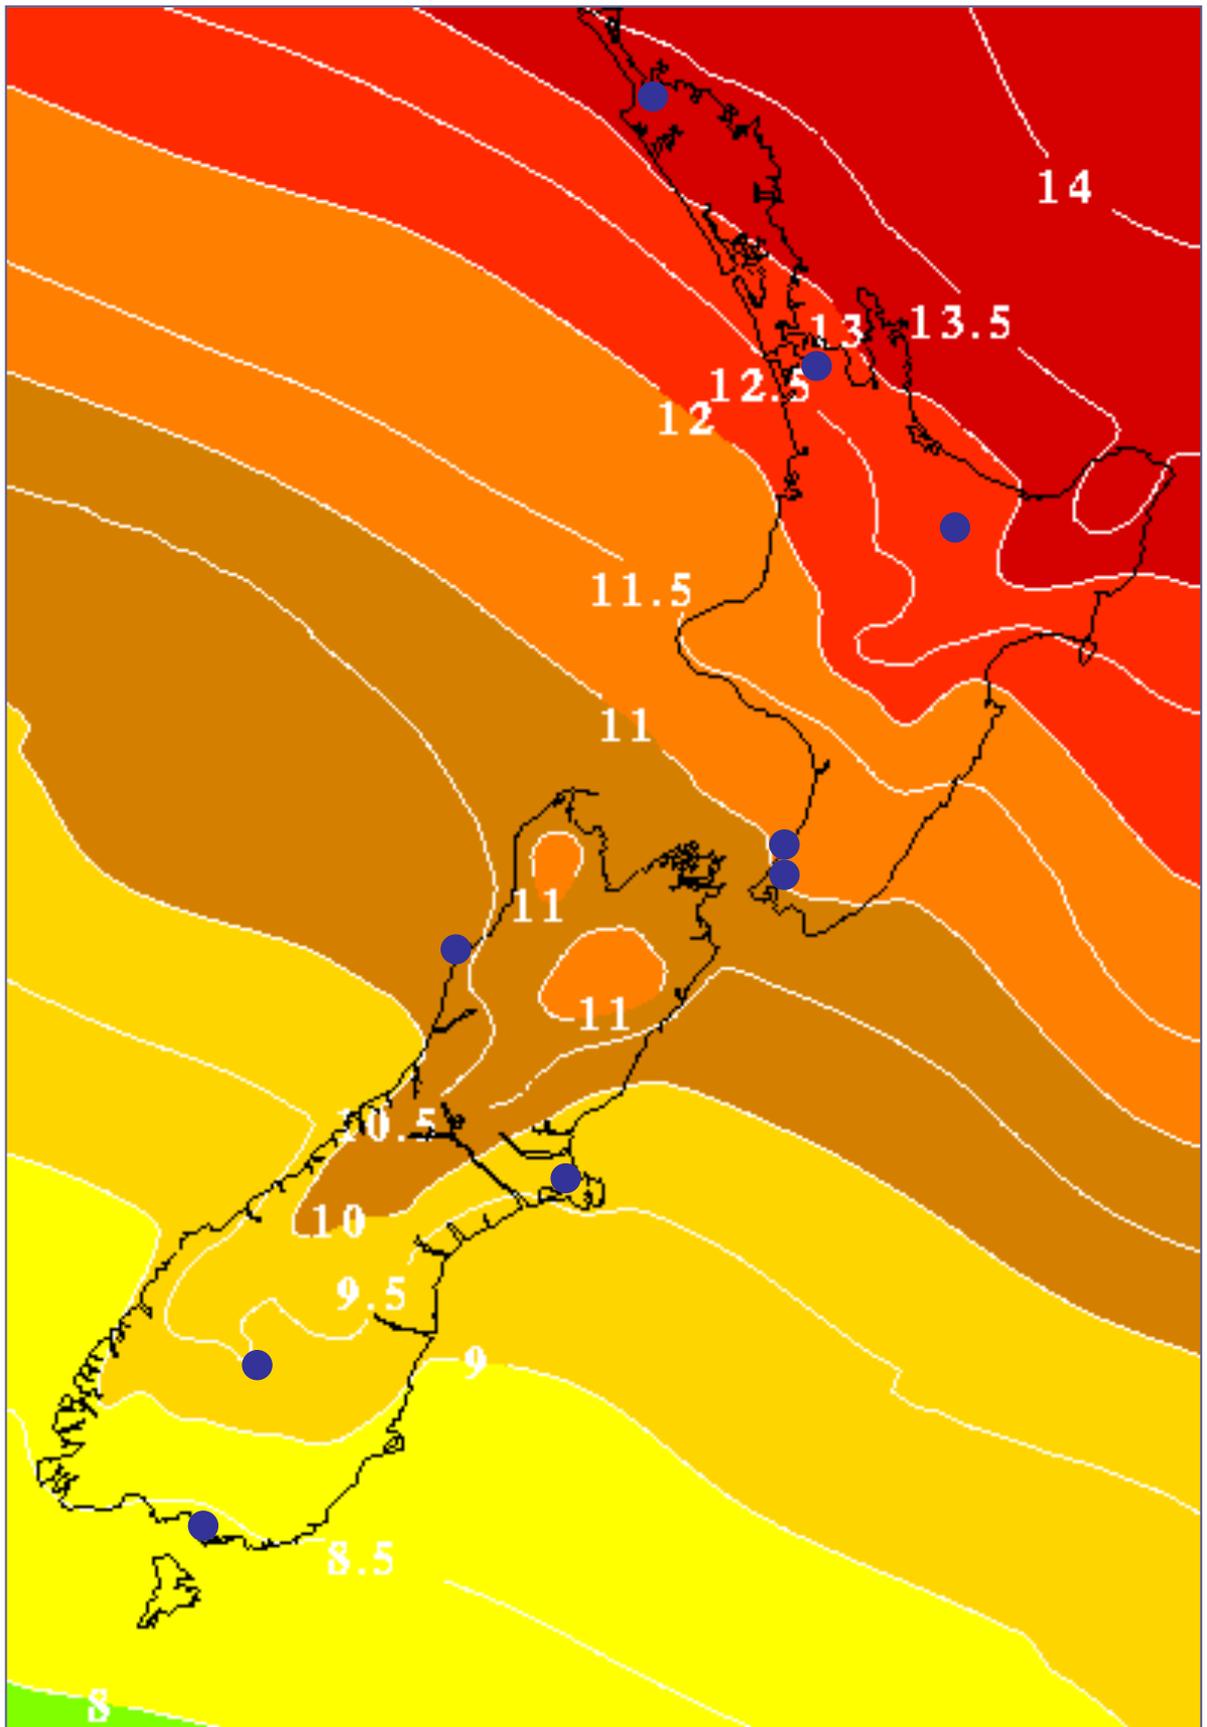
Figure 3. Maximum annual UV index at BRANZ exposure sites (UV index map provided by NIWA)

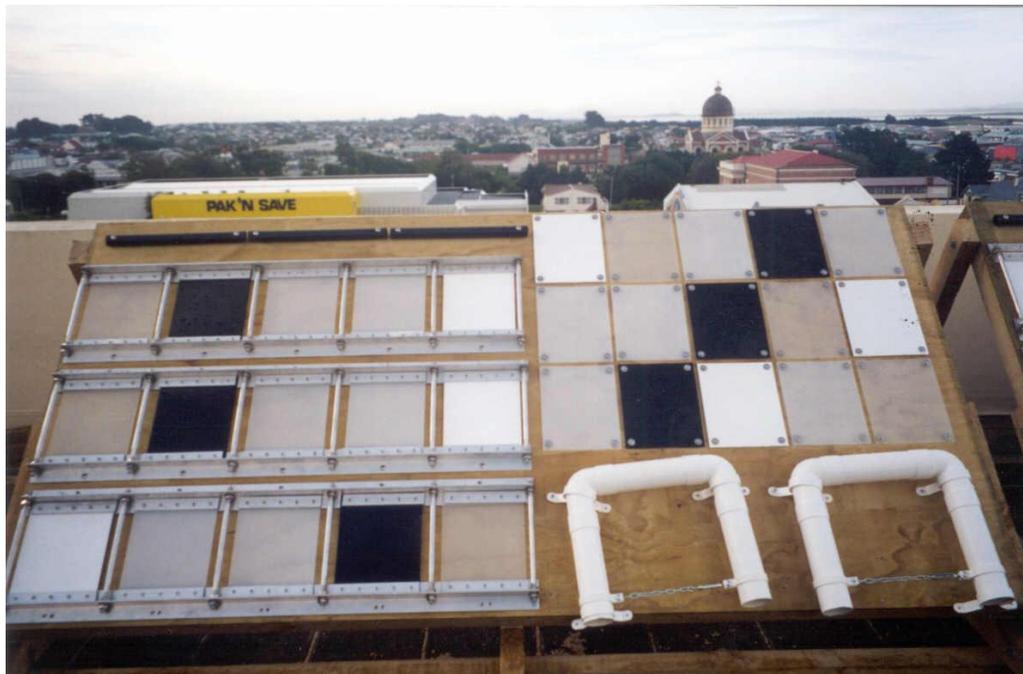
A typical arrangement of the samples during exposure is shown in Figure 7. The un-stressed plastic sheet samples fill the three rows on the right of the sample rack. On the left side are the multiple aluminium stress racks with each of the polymer sheets held under tension. The PE and uPVC pipe products can also be seen at the top and bottom of the rack respectively.

Figure 7. BRANZ exposure rack configuration

Exposure racks were constructed to allow exposure of the samples at 45° to the horizontal facing the equator, as prescribed in ASTM G7 Clause 4.2.2. However, rack construction varied from the manner of construction described by ASTM G7 Clause 5.2 in that stainless steel screws were used to secure the corners of the samples. This construction method could prevent expansion and contraction of the samples and will need to be considered in interpretation of the results obtained.

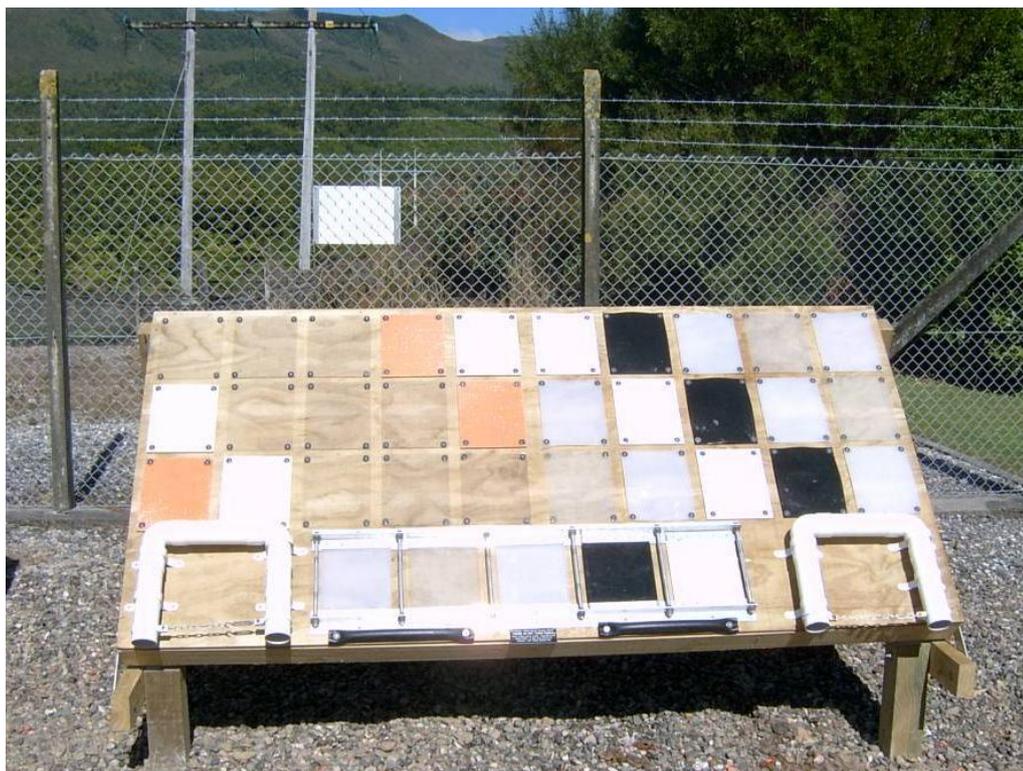
A more compact rack design was employed for the additional sites. These contained the sample types used in the original sites (sheets from the same batches of materials were used), but a reduced number of samples were exposed. The un-stressed plastic sheet samples fill the top three rows on the typical sample rack shown in Figure 8. Below these, in the centre, is the aluminium stress rack with each of the un-reinforced polymer sheets held under tension. The uPVC and PE pipe products can also be seen at the bottom of the rack.

Figure 8. Exposure rack configuration used on the additional exposure sites

In each exposure location the exposure racks were aligned with magnetic north, i.e. facing the equator, to maximise solar radiation exposure (ASTM G7).

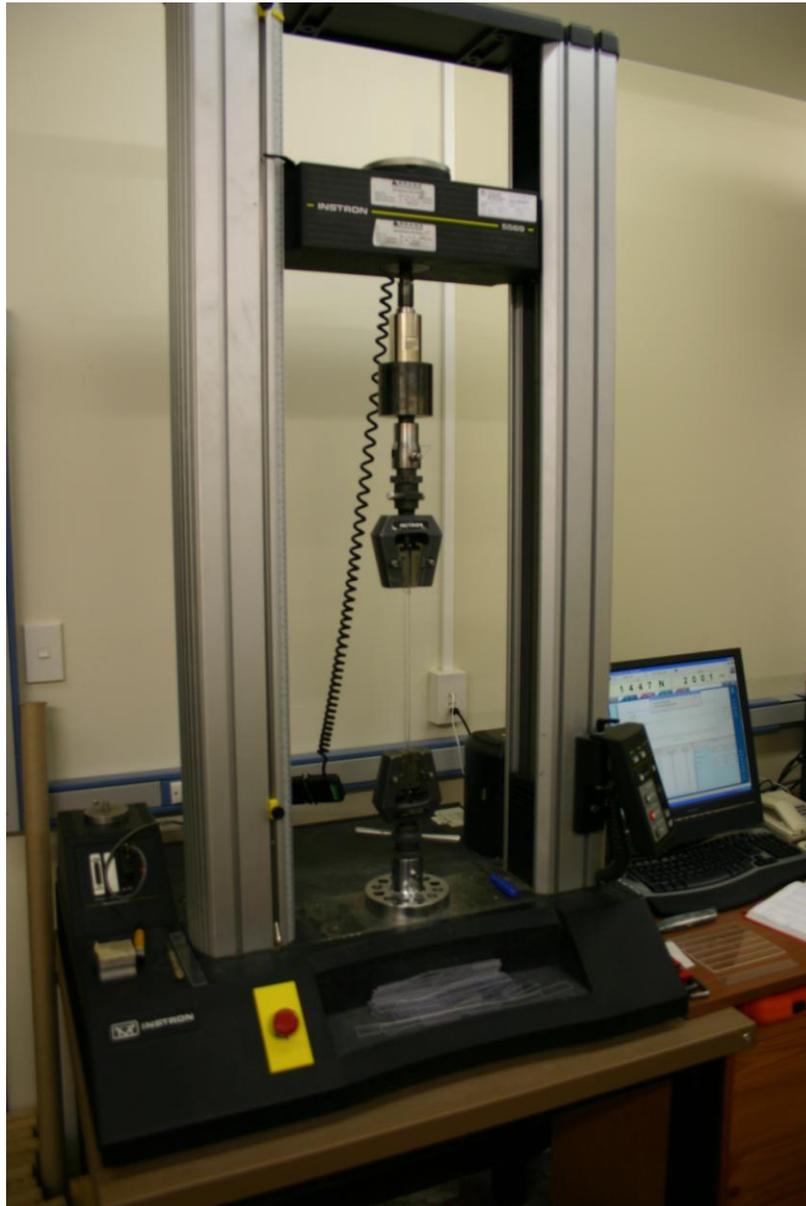
Testing was carried out on a calibrated Instron Universal Testing Machine with a 10kN load cell. Testing of a sheet sample in progress is shown in Figure 9.

Figure 9. Tensile property testing

Post-conditioning, the test pieces were subjected to tensile strength testing. The tensile strength was determined over a gauge length of 100 mm with a cross-head rate of 10 mm/min.

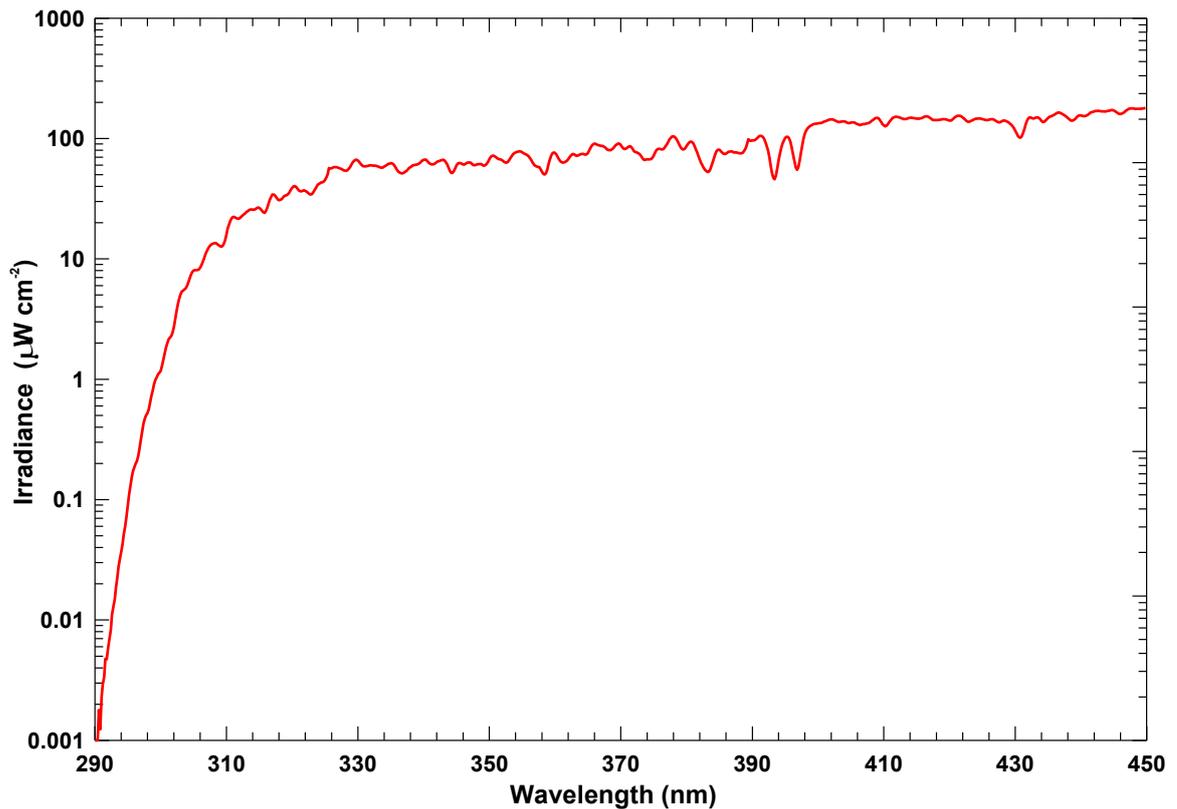
The principal component of sunlight that causes damage to polymeric materials is ultraviolet light (UV). A typical intensity spectrum of incoming UV radiation is shown in Figure 10.

Figure 10. Typical spectra of the UV region of New Zealand sunlight (NIWA 1991)

The UV is the most energetic part of sunlight and does the most damage, even though it comprises only about 5% of light reaching the earth's surface.

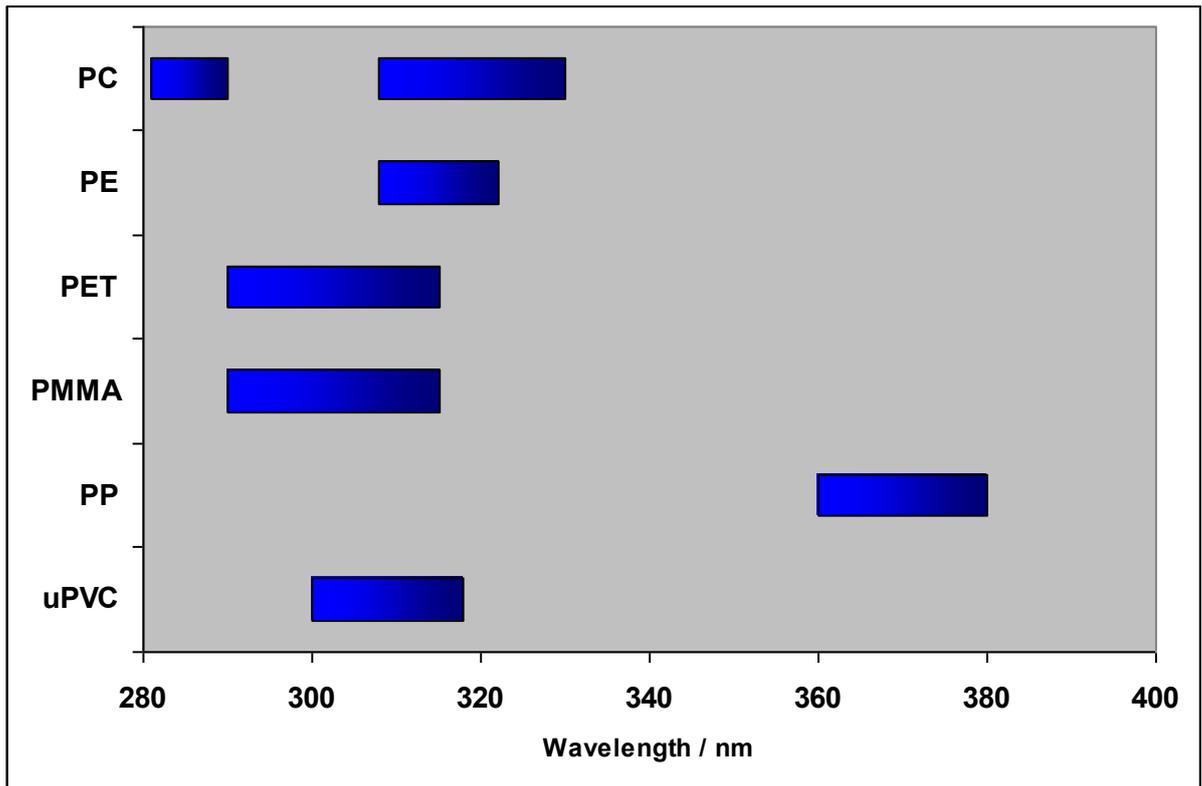
Different polymers are most sensitive to damage from different wavelengths of UV radiation, known as the activation spectra (Andrady 1997, Andrady 2002, Andrady 2003), as detailed in Table 3 and shown schematically in Figure 11.

Figure 11. Reported activation spectra for polymers on exposure to UV radiation

The potential for a polymer to degrade due to incident radiation is controlled by the ability of the material to absorb photons of suitable energy and by the availability of photochemical pathways to allow chemical reactions using the absorbed energy (Andrady 1997). Only radiation absorbed by a system is effective in producing chemical changes. Polymers exhibit marked different wavelength sensitivity in their photo-degradation behaviour since different polymer types consist of different chemical structures. Additionally, photons of different wavelengths have different energies, photon energy increasing with decreasing wavelength.

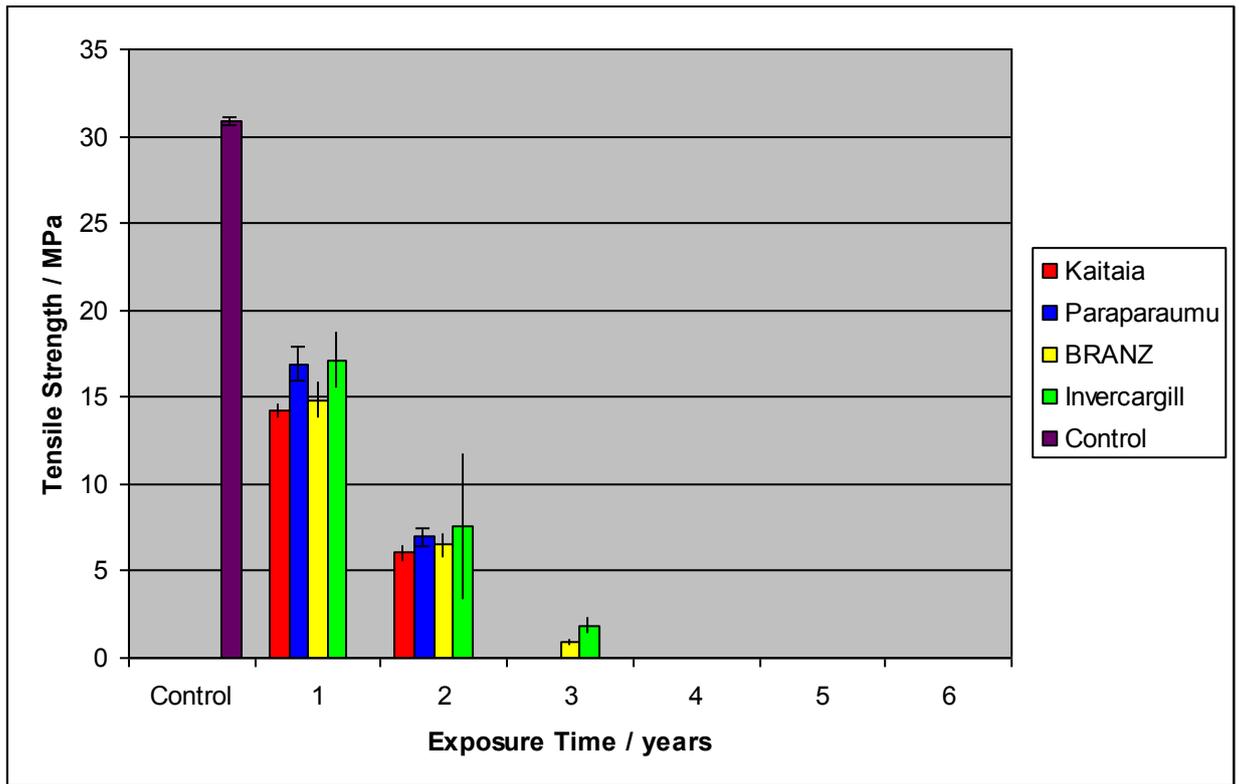
Figure 12 presents the tensile strength results for the un-stressed 2 mm PP from the original exposure sites.

Figure 12. Tensile strength of un-stressed 2 mm PP sheet as a function of time and location

Statistical analysis of the clear 2 mm PP samples showed strong effects of exposure time, smaller effects of location, and a weak effect of direction. No statistically significant effect for stressing of the samples was found. Samples exposed at the Kaitaia site had lower strength than at the BRANZ site, while samples at the Paraparaumu and Invercargill sites had a higher strength. The weak effect of direction manifested in that when tested in the cross-direction tensile strength was uniformly higher by 1.1 ± 0.7 MPa.

Over 50% of tensile strength had been lost in the first year of exposure. This observation is in line with results and trends reported by other workers (Manson 1976, Davis 1983) and this rapid degradation has been clearly attributed to reactions with oxygen (Winslow 1967). It is also well known that embrittlement is typically a precursor to visible changes (Winslow 1967).

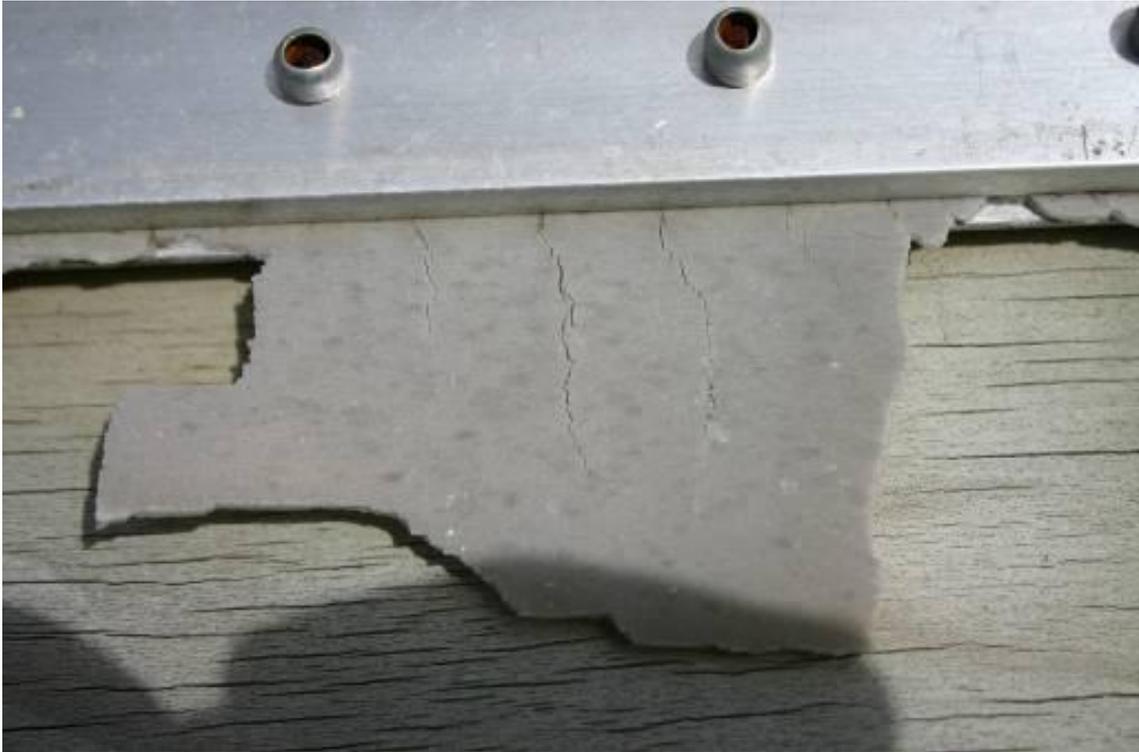
By the end of three years of exposure the materials had undergone extensive micro-cracking, were visibly completely degraded, and had lost all mechanical strength as is clear from Figure 12 and as exemplified by the photo in Figure 13. After four years no intact samples were found on any of the original exposure sites.

Figure 13. Typical appearance of the PP sheet after three years of outdoor exposure

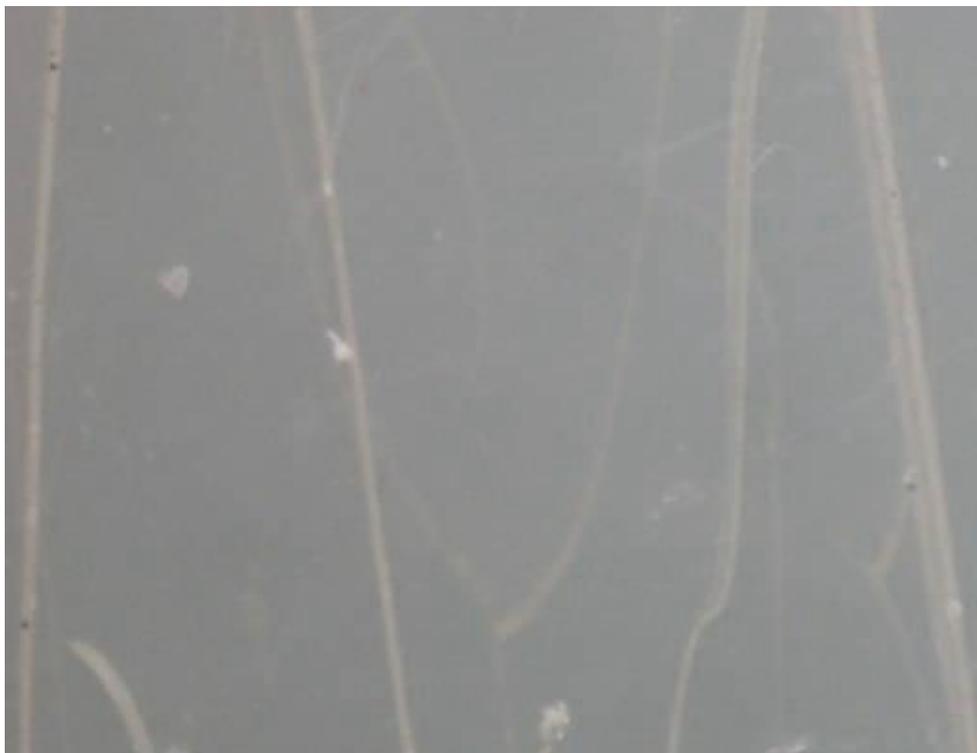
Microscopic examination of the surface of the PP material allowed visualisation of the individual micro-cracks as shown in Figure 14.

Figure 14. Optical microscope image of micro-cracks in PP sheet after three years of exposure

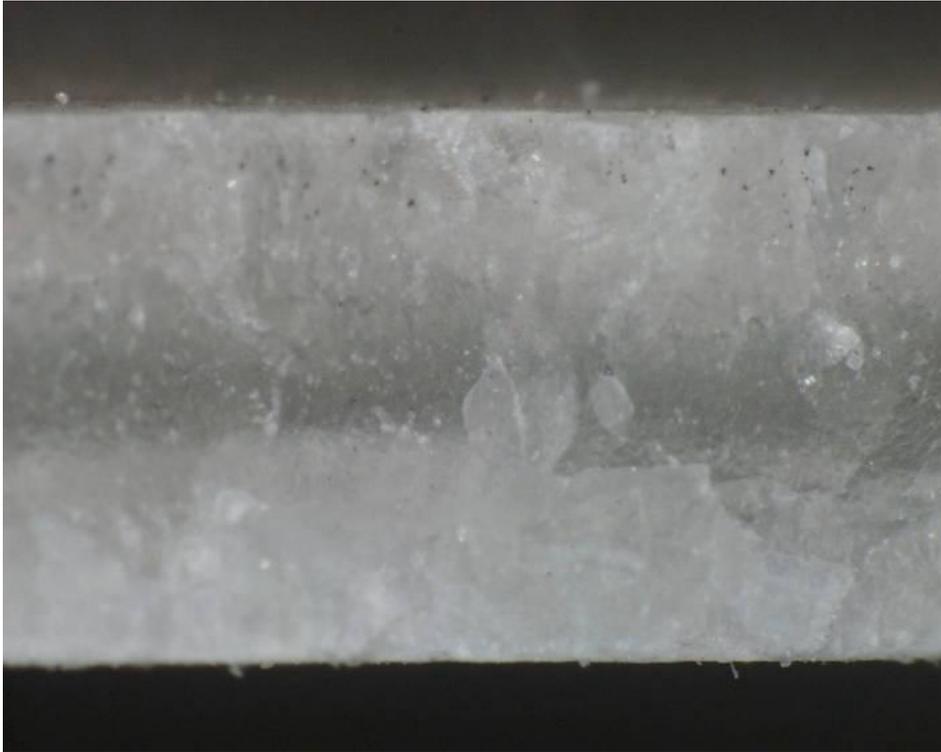
When viewed from the sheet edge the extent of the penetration of the cracks into the material and the explanation for the loss of strength was clear (see Figure 15).

Figure 15. Optical microscope image of PP sheet edge showing penetration of the microcracks into the sheet after three years of exposure

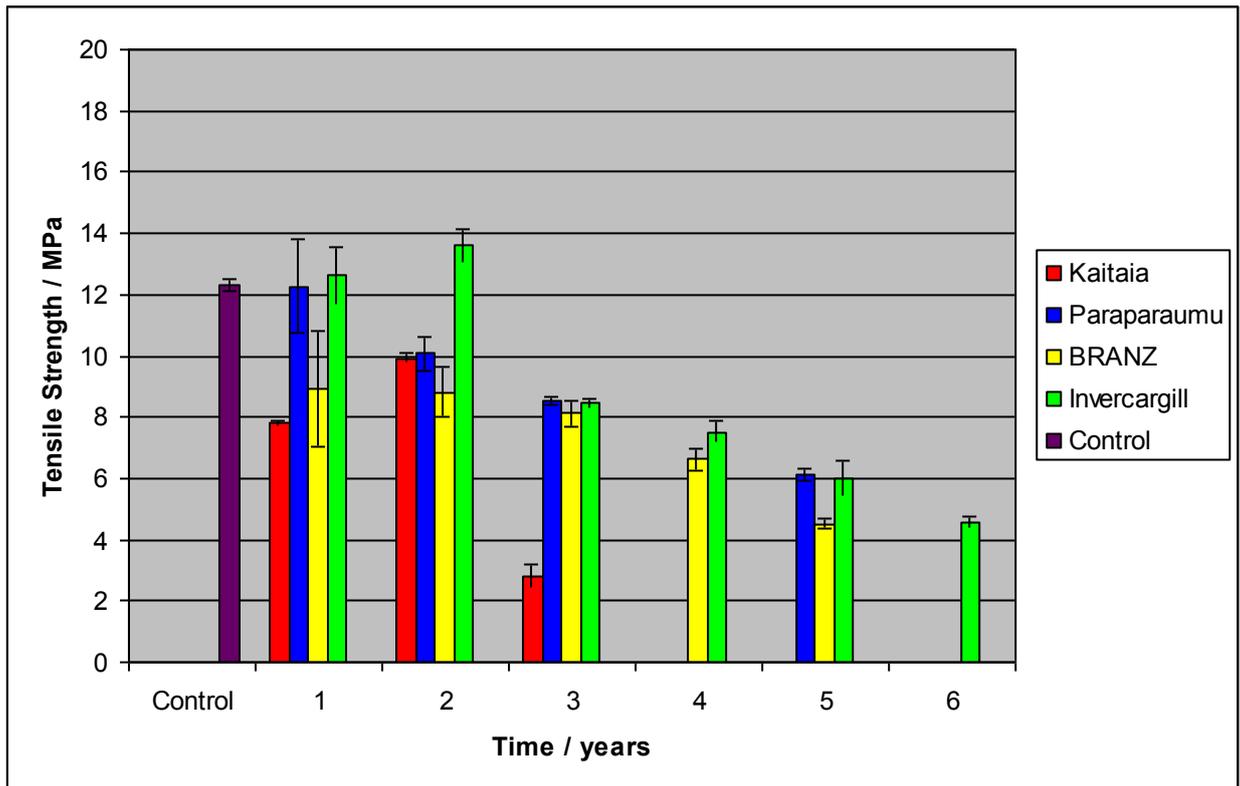
The tensile strength results for the un-stressed 2 mm clear PE from the original exposure sites are shown in Figure 16.

Figure 16. Tensile strength of un-stressed 2 mm PE sheet as a function of time and location

Statistical analysis of the clear 2 mm PE data showed strong effects for exposure time and for location, and a weak effect of direction and no effect of stress. The strength decreased with exposure time. This result is in line with results found by other workers (Manson 1976). Samples in the Kaitaia site had a strength on average 4 ± 0.4 MPa lower than the BRANZ site samples. Samples at the Invercargill and Paraparaumu sites were slightly stronger on average than those at the BRANZ site. Strength in the cross-direction was 0.7 ± 0.4 MPa higher.

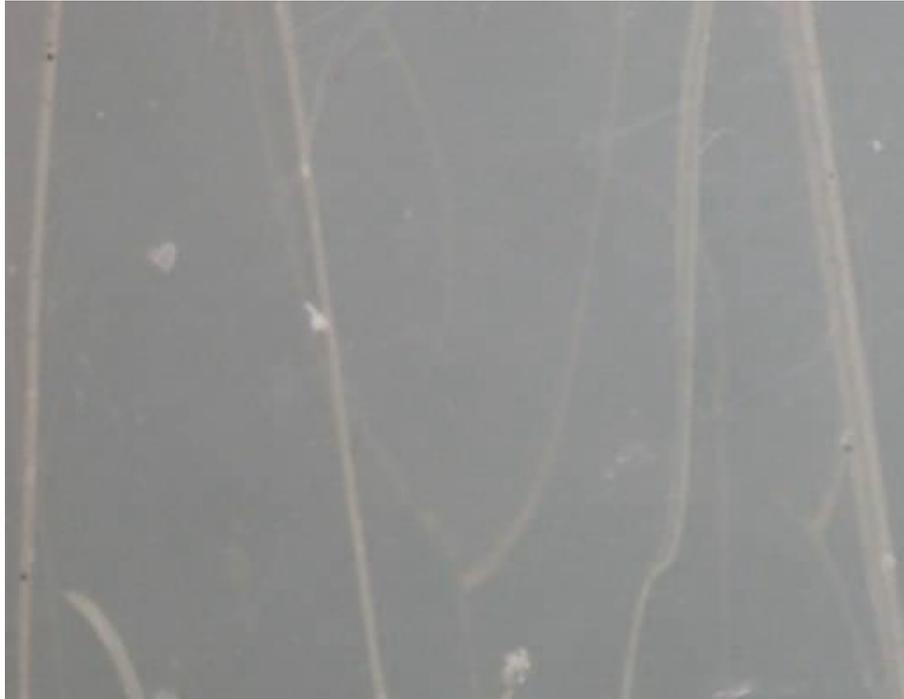
Surface micro-cracks in a PE sheet are shown in Figure 17.

Figure 17. Optical microscope image of micro-cracks in PE sheet after three years of exposure

The optical microscope image shown in Figure 17 is the same scale as that for PP shown in Figure 14. It exemplifies that the micro-cracks in the PE, made visible using blue dye, are further apart than for the PP sheet. However, the cracks in the PE were found, with time, to propagate deeper into the sheet and this is demonstrated in Figure 18 below.

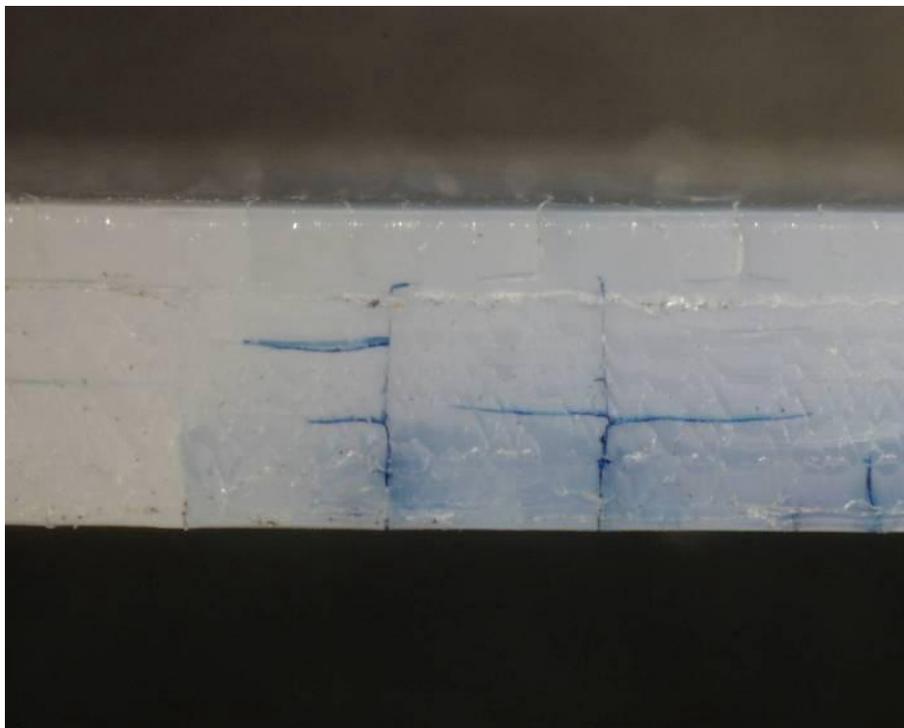
Figure 18. Optical microscope image of PE sheet edge showing penetration of the micro-cracks into the sheet after three years of exposure (dye has been used to make the cracks easier to see)

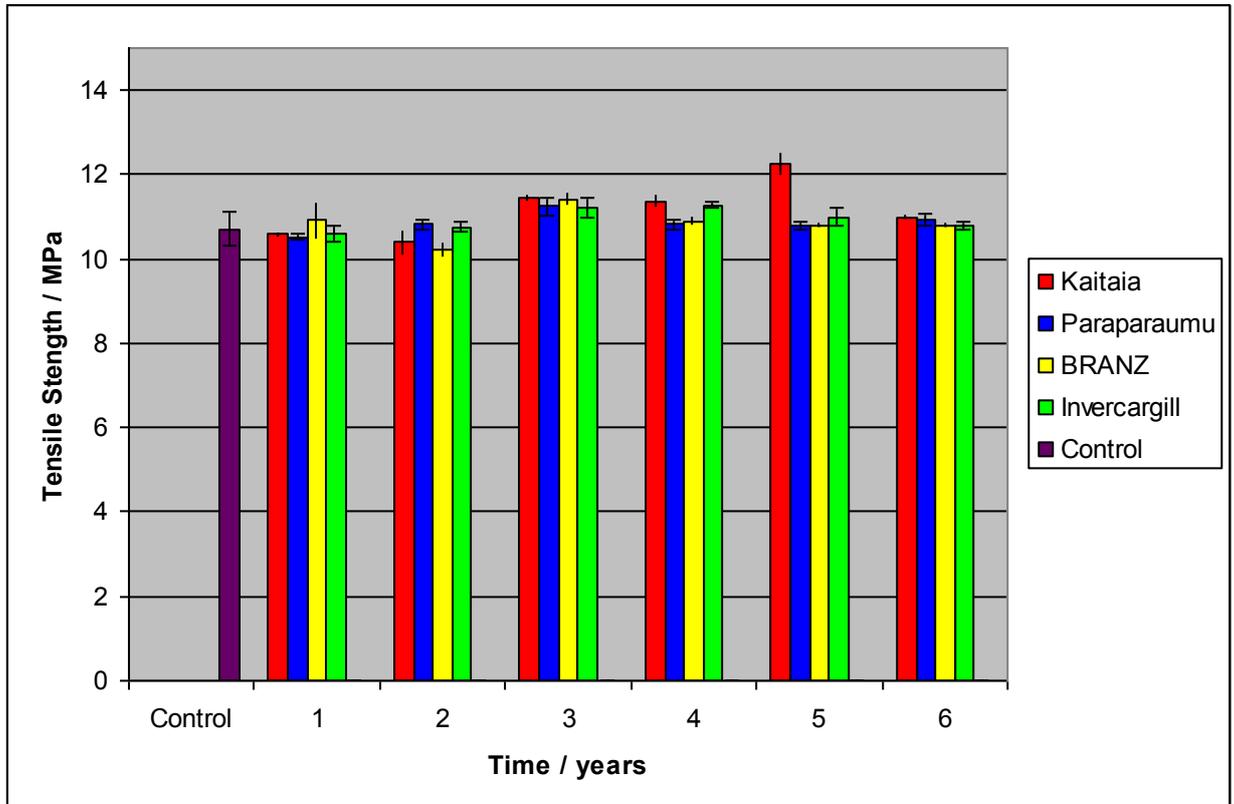
The tensile strength results for the un-stressed 3 mm black PE from the original exposure sites are shown in Figure 19.

Figure 19. Tensile strength of un-stressed 3 mm black PE sheet as a function of time and location

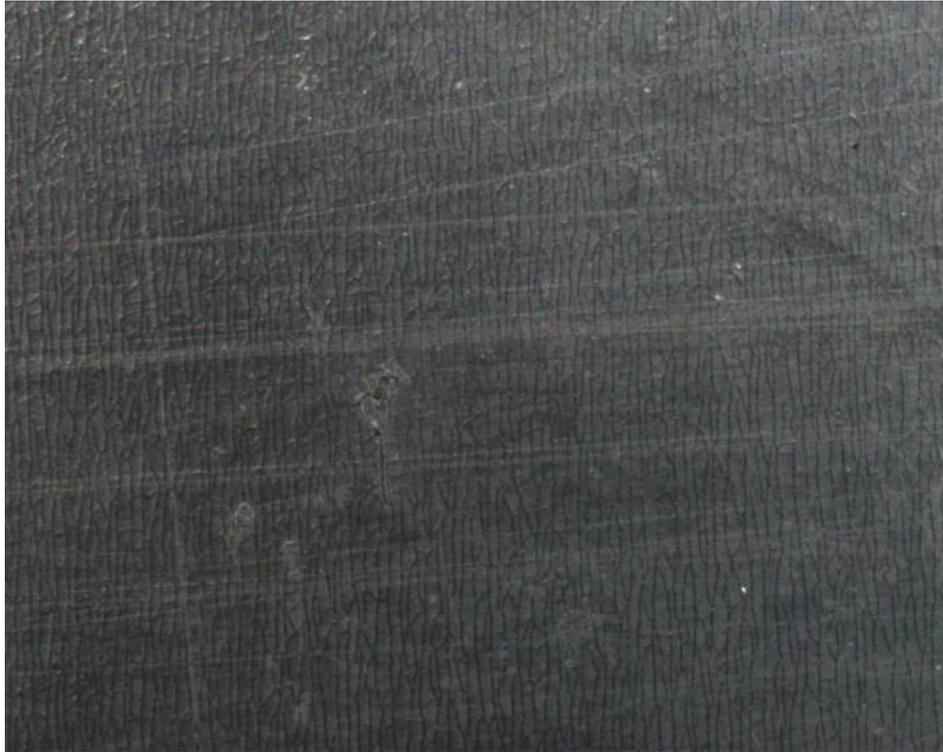
Publications by other authors have indicated that correctly formulated and pigmented PE can have a life of 20–30 years, dependent on climate (Gilroy 1979). However, the sample surfaces studied here exhibited extensive, very fine, micro-cracking as shown in Figure 20. Again this image is to the same scale as Figure 14 and Figure 17.

Figure 20. Optical microscope image of micro-cracks in black PE sheet

It is believed that the carbon black pigment has limited the size of these micro-cracks. Carbon black is a very effective stabiliser for PE. Typical additions, in the range 2–4% by weight, result in both light screening and antioxidant effects (Wypych 1990).

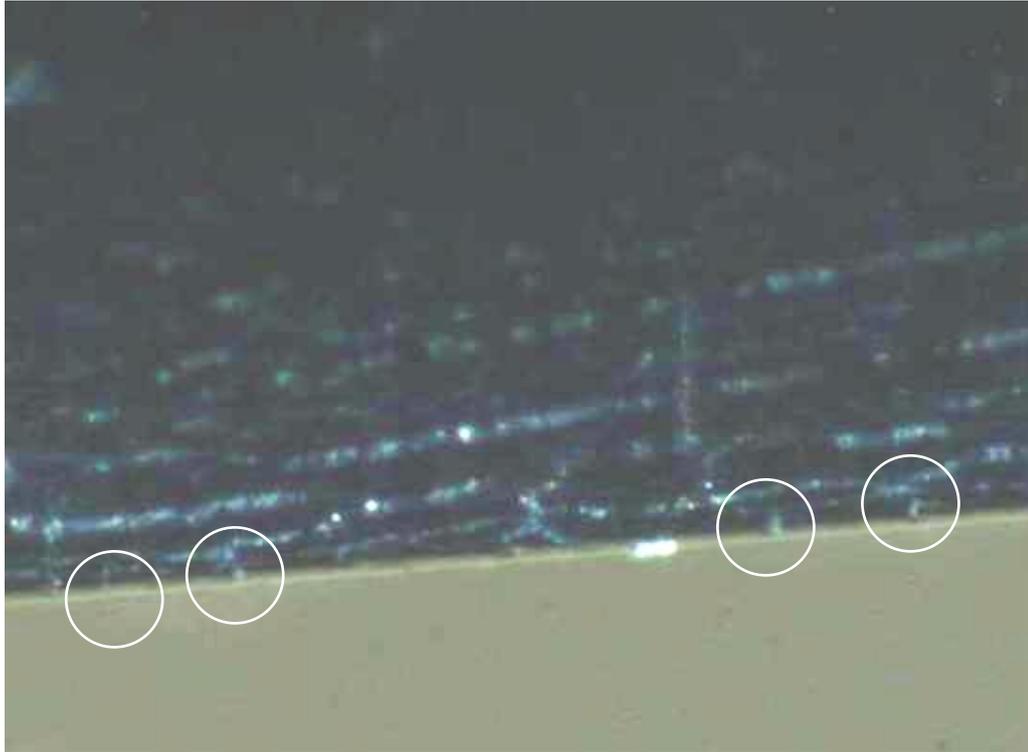
While white pigments reflect incoming radiation, coloured pigments absorb selective wavelengths. This affects their influence on the material's surface layers. Carbon black is highly UV absorbing, is capable of giving excellent UV opacity in very thin layers, and hence effectively limits UV damage to the very surface of the material (Davis 1983). The carbon black particles also have highly condensed aromatic ring structures and impurities at their surfaces that endow radical scavenging and antioxidant abilities (Scott 1965, Liu 2002). These mechanisms will tend to restrict the micro-cracking to the very surface of the material and prevent the extensive cracks seen in the more transparent polyolefin (PE and PP) samples. When viewed from the sheet edge (see Figure 21), it is clear that the extent of the penetration of the cracks into the sheet was small.

Figure 21. Optical microscope image of black PE sheet edge showing the limited penetration of the micro-cracks into the sheet after three years of exposure (some of the micro-cracks present are circled for clarity)

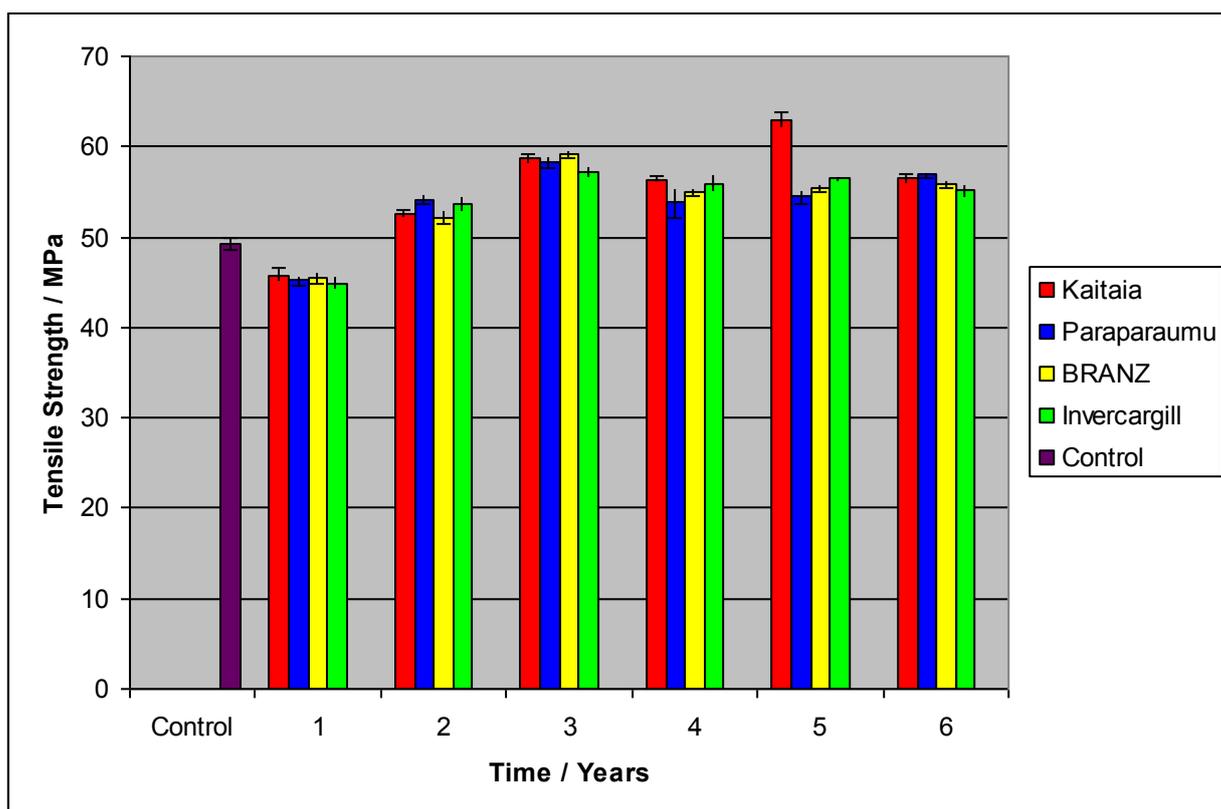
The tensile strength results for the un-stressed 2 mm white uPVC from the original exposure sites are shown in Figure 22.

Figure 22. Tensile strength of un-stressed 2 mm white uPVC sheet as a function of time and location

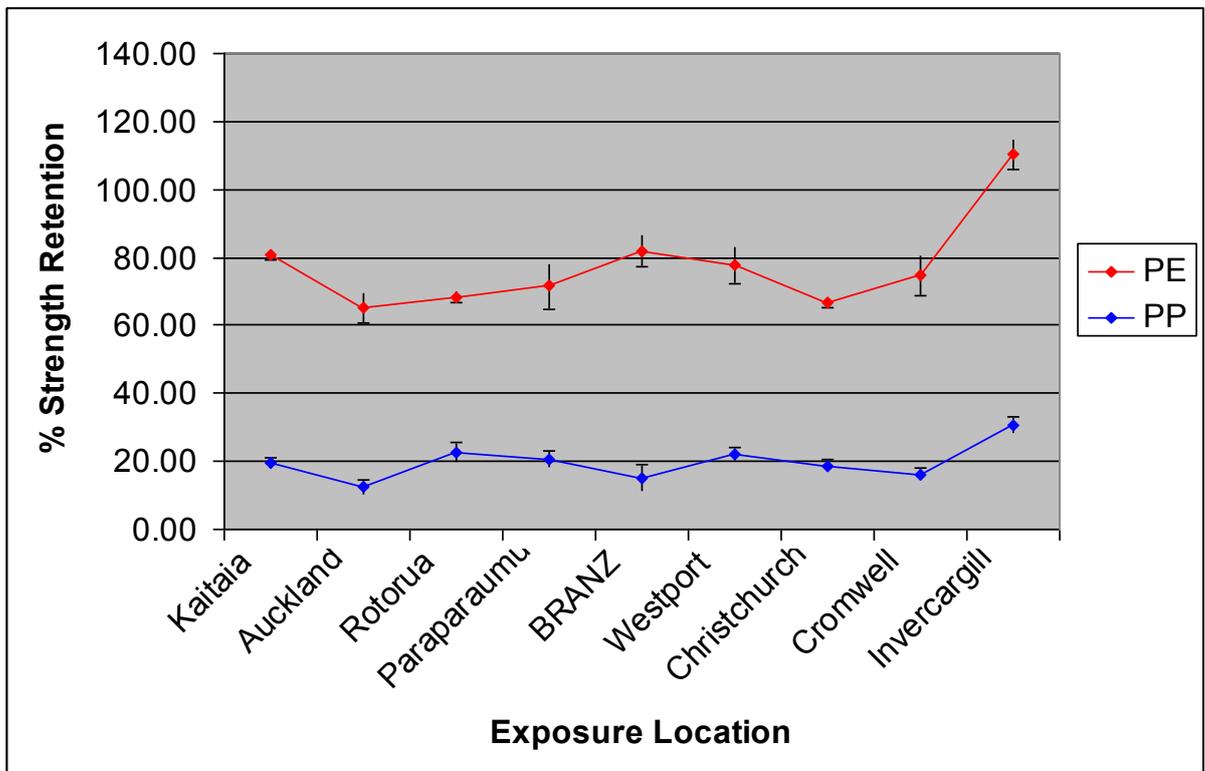
The % tensile strength retention for the polyolefins after two years of exposure on the five recently established exposure sites, compared to results after the same exposure time on the original sites, is shown in Figure 23.

Figure 23. % tensile strength retention of un-stressed 2 mm PE and PP sheet after two years of exposure as a function of location

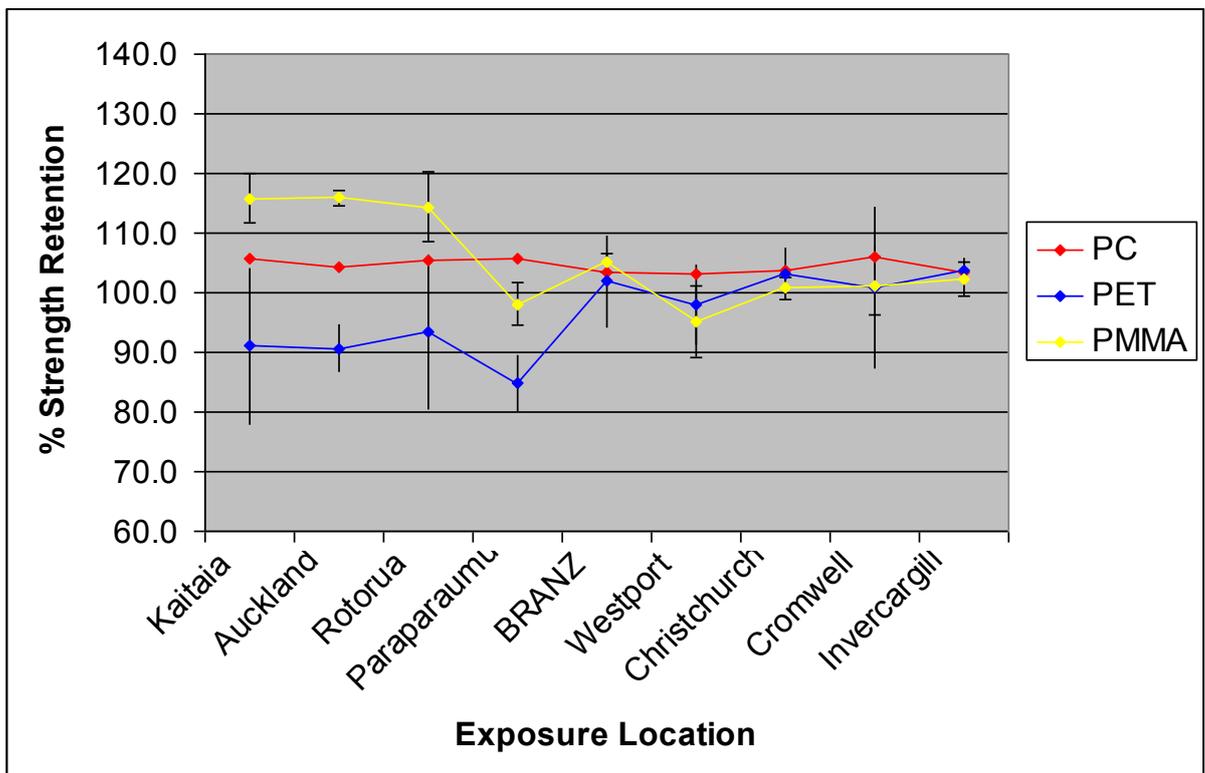
The % tensile strength retention for the clear PC, PET and PMMA samples, after two years of exposure on all exposure sites, is shown in Figure 24.

Figure 24. % tensile strength retention of un-stressed PC, PET and PMMA sheet after two years of exposure as a function of location

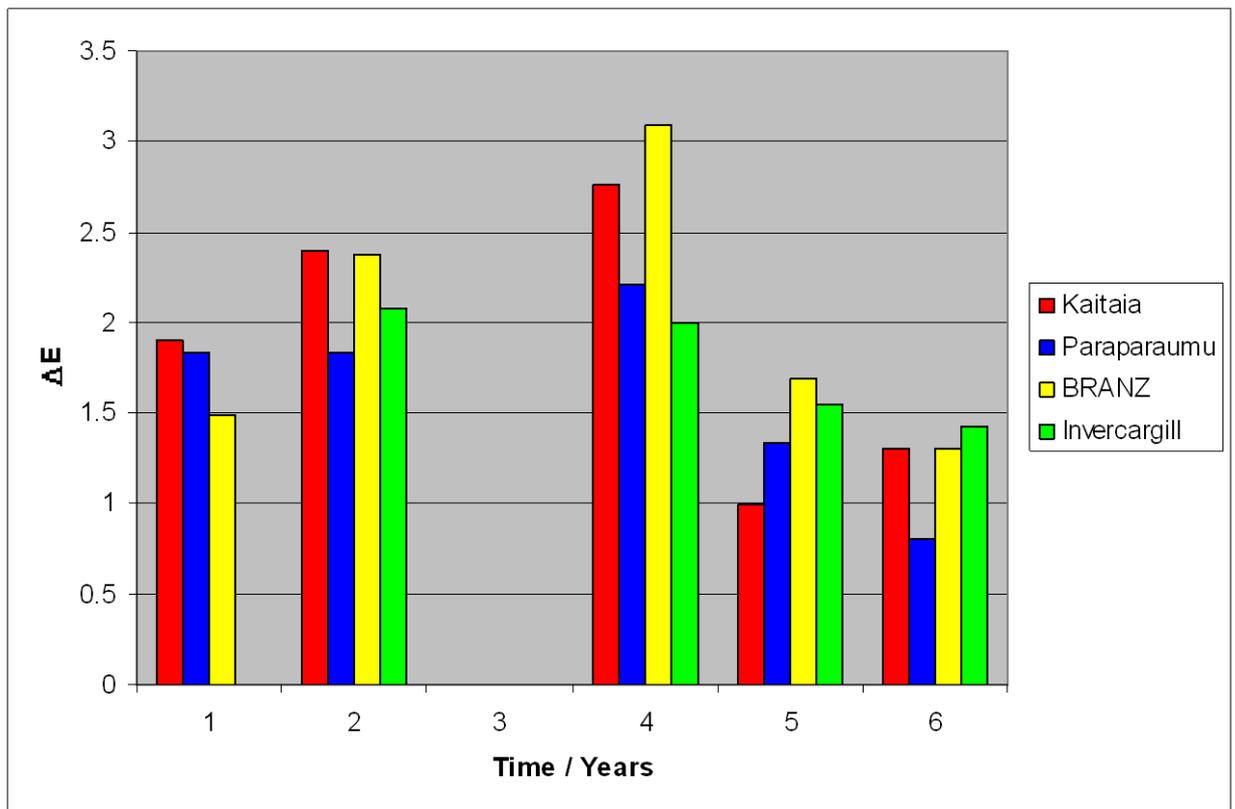
Colour shift, ΔE , data obtained for black PE from the original exposure sites, as the years passed, is shown in Figure 25.

Figure 25. Colour shift, ΔE , data for black PE on the four original exposure sites

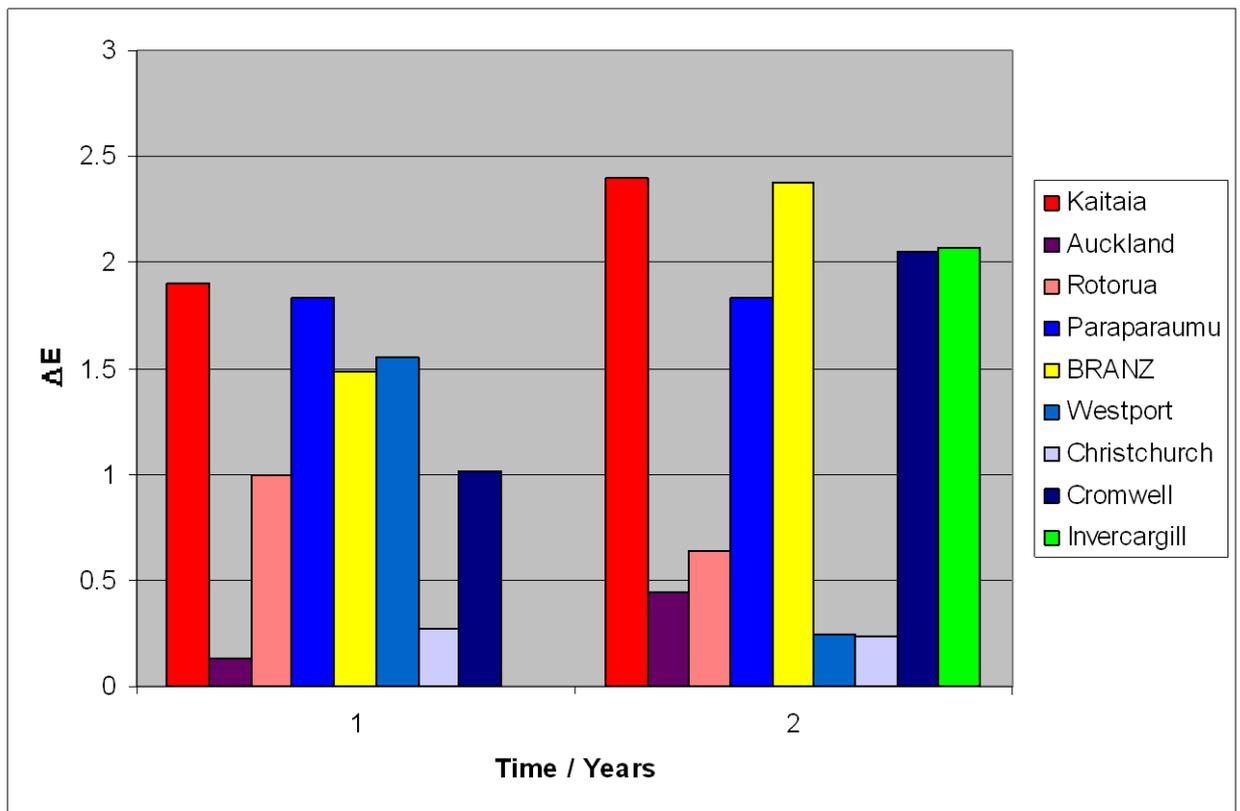
The colour shift, ΔE , data obtained for black PE for the all exposure sites over the first two years of exposure is shown in Figure 26.

Figure 26. Colour shift, ΔE , data for black PE on all exposure sites during the first two years of exposure
