STUDY REPORT

No. 182 (2007)

Weathering of Polymeric Materials in New Zealand

BRANZ Study Report SR 182 (2007)

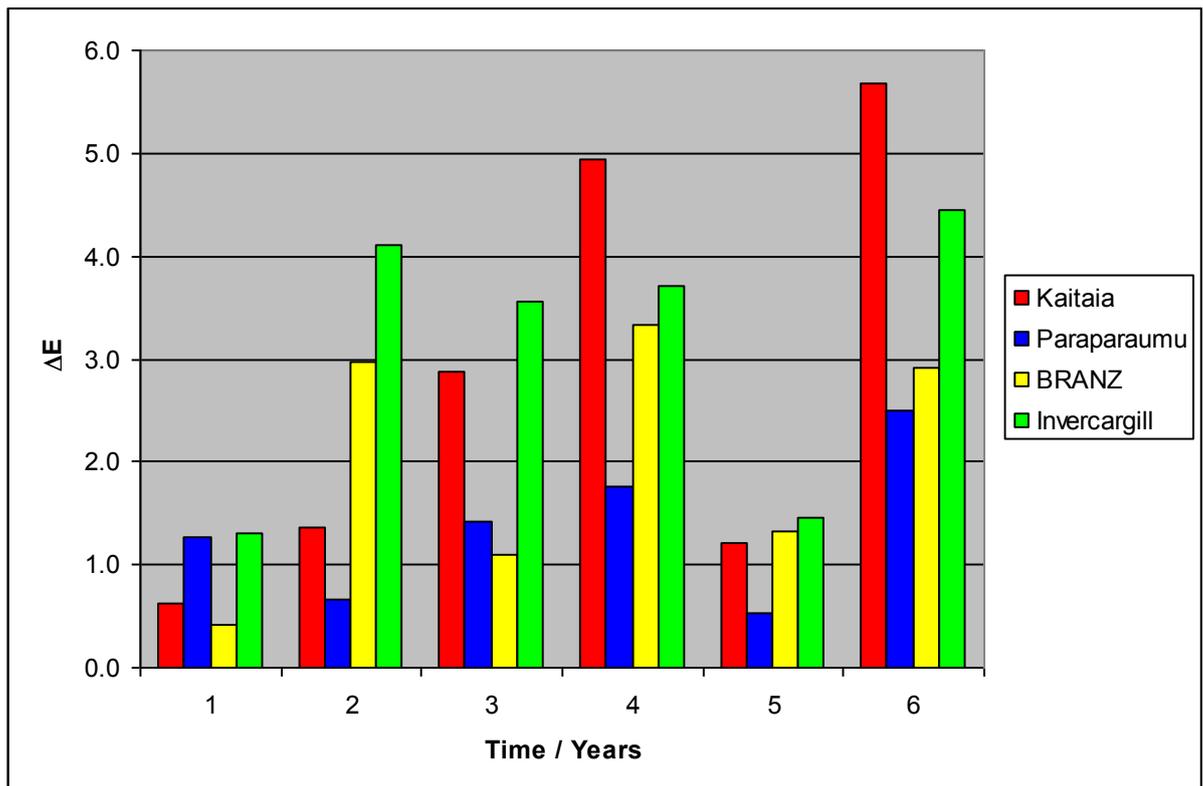
Colour shift, ΔE , data obtained for white uPVC from the original exposure sites, as the years passed, is shown in Figure 27.

Figure 27. Colour shift, ΔE , data for white uPVC on the four original exposure sites

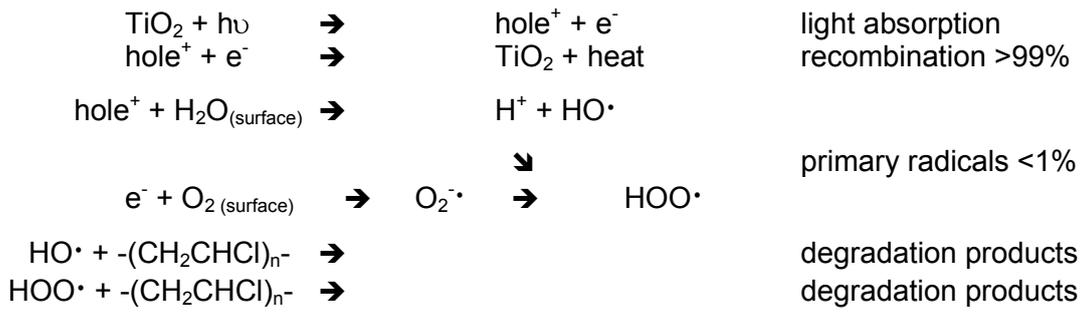
The absorption of light by TiO_2 results in dissociation to release an electron as detailed in the equations below. The free electron usually recombines to reform TiO_2 , but it can react with water or oxygen present in the uPVC to form reactive species. These in turn attack the uPVC as shown in the last two equations (Archema 2005).

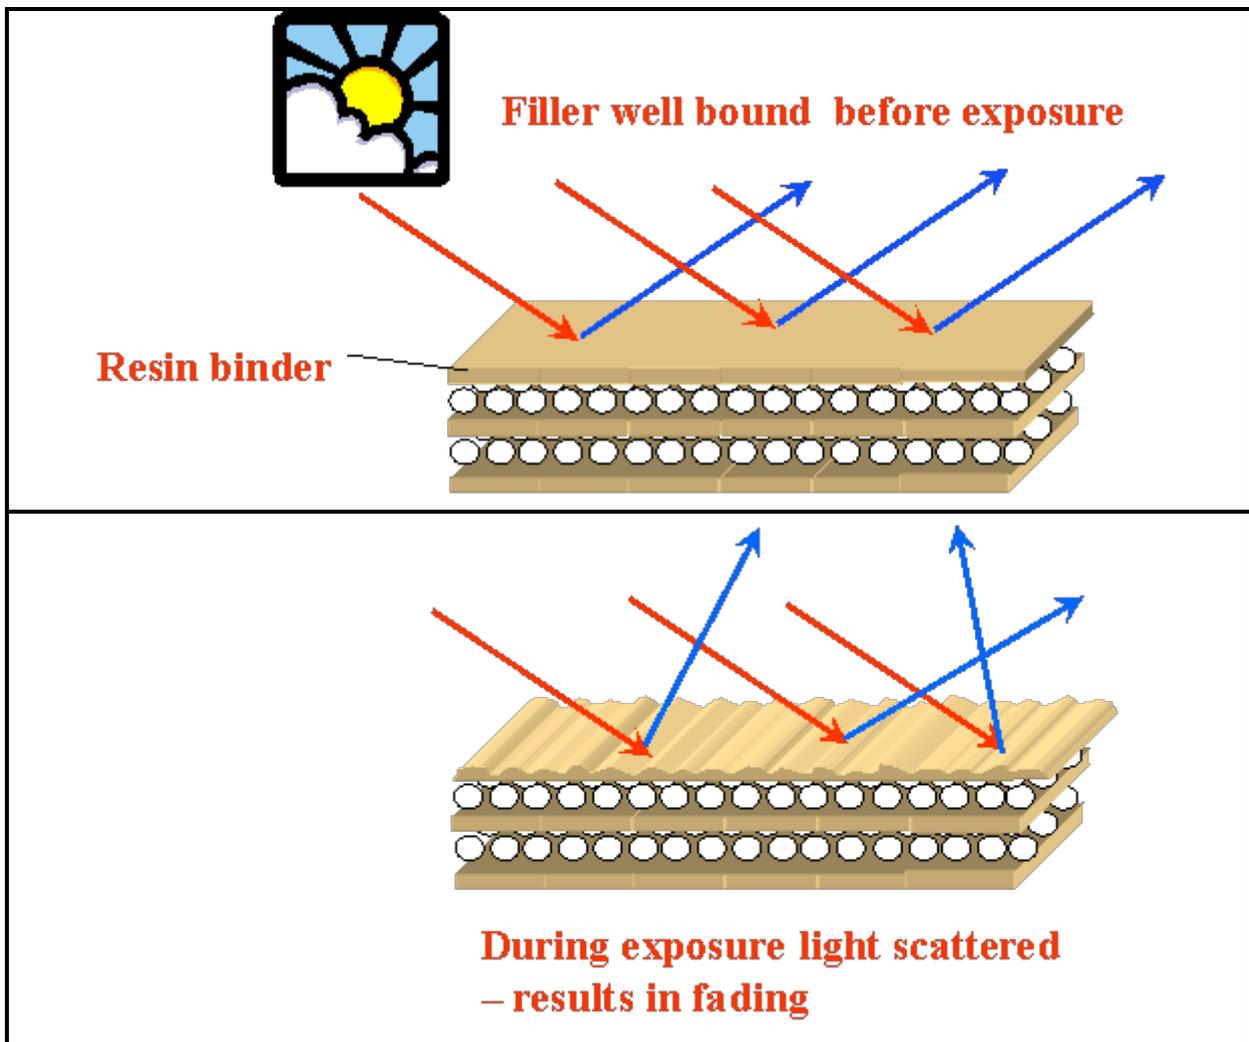
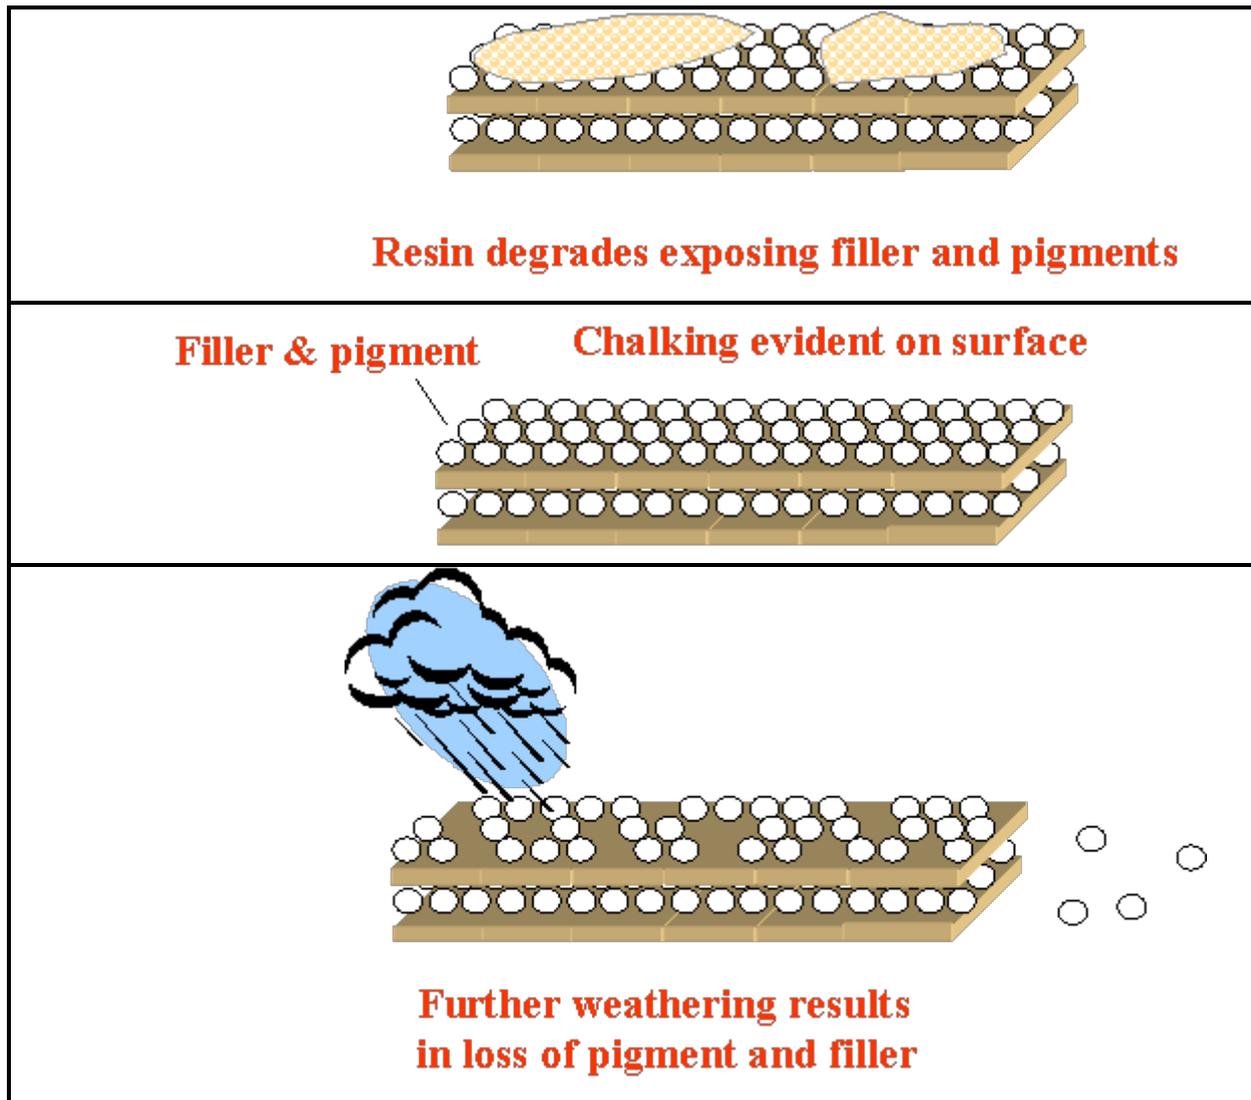
This attack on the uPVC manifests as loss of material adjacent to the pigment particles. This phenomenon is described as chalking and a schematic of this mechanism is shown in Figure 28. An example electron microscope image for a chalked uPVC surface showing the degradation of the resin and exposure of the filler and pigments is shown in Figure 29.

Figure 28. Schematic of the uPVC chalking mechanism

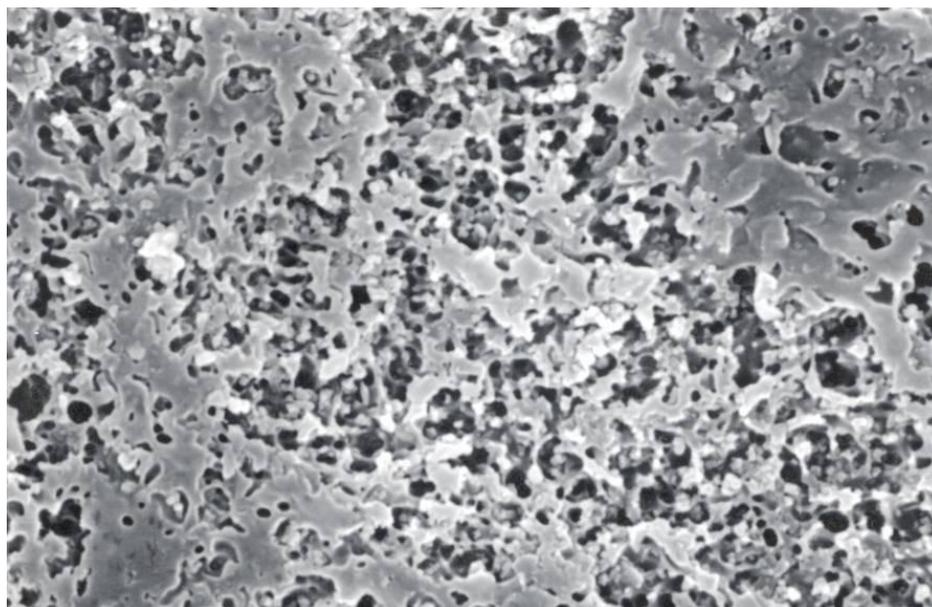
Figure 29. Electron microscope image showing uPVC chalking

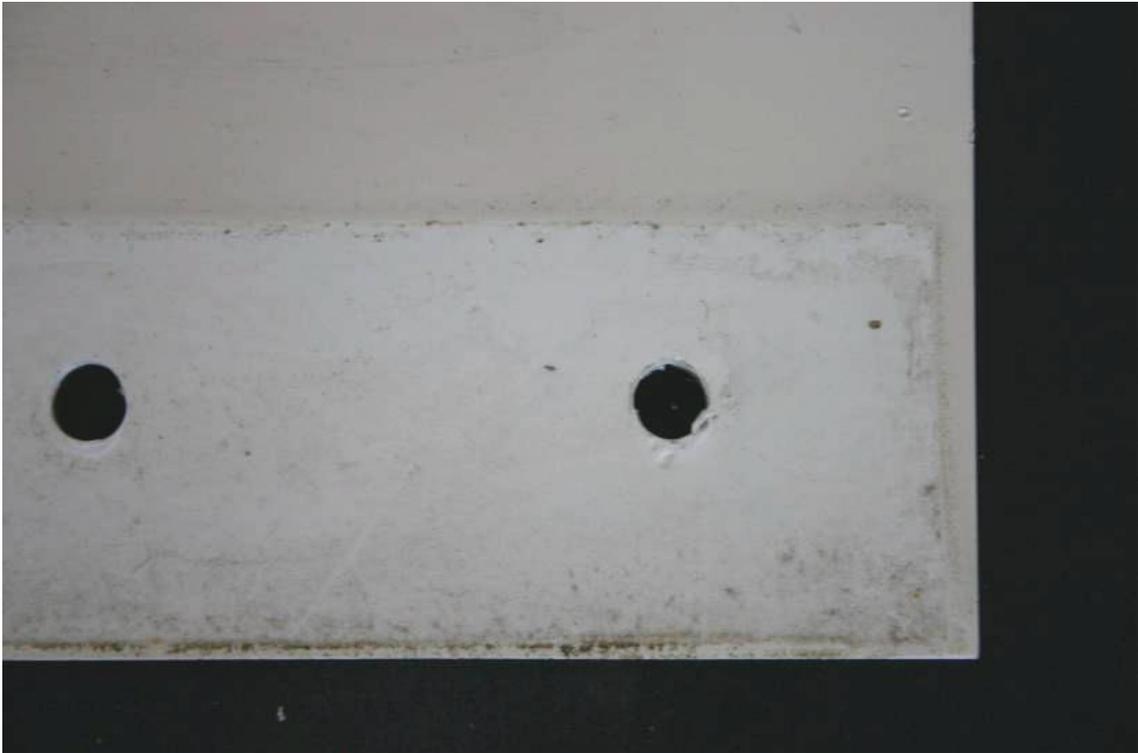
Figure 30. uPVC sample from the Kaitaia exposure site collected in 2005 – the bottom of the sample was covered by the stress rack clamp during exposure and is markedly lighter than the exposed area of the sample

Onset of the chalking mechanism is characterised by a gradual increase of colour shift as the surface resin degrades, followed by a relatively rapid reduction as the resin and pigment are lost and a fresh resin surface is exposed. This trend is clear in Figure 27 between the fourth and fifth years for the exposed samples. Photographs of uPVC samples collected in the fourth and fifth years exemplifying this are shown in Figure 30 and Figure 31.

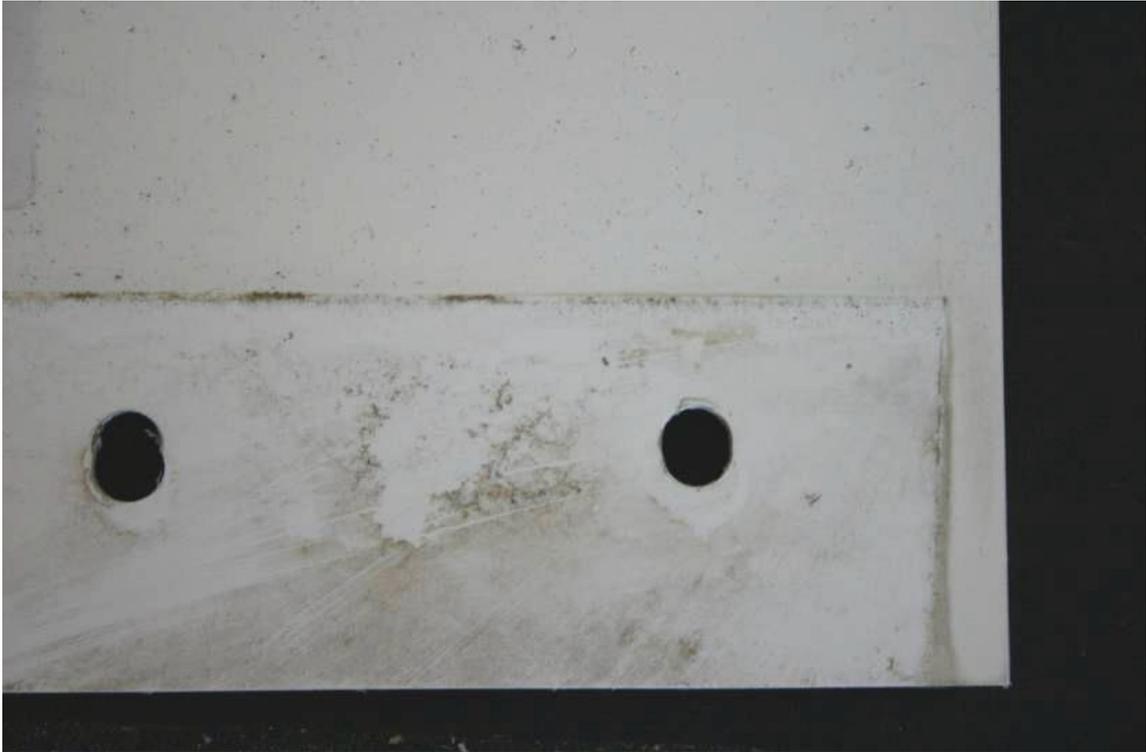
Figure 31. uPVC sample from the Kaitaia exposure site collected in 2006 – the bottom of the sample, covered by the stress rack clamp during exposure, is now much more similar in appearance to the exposed area of the sample

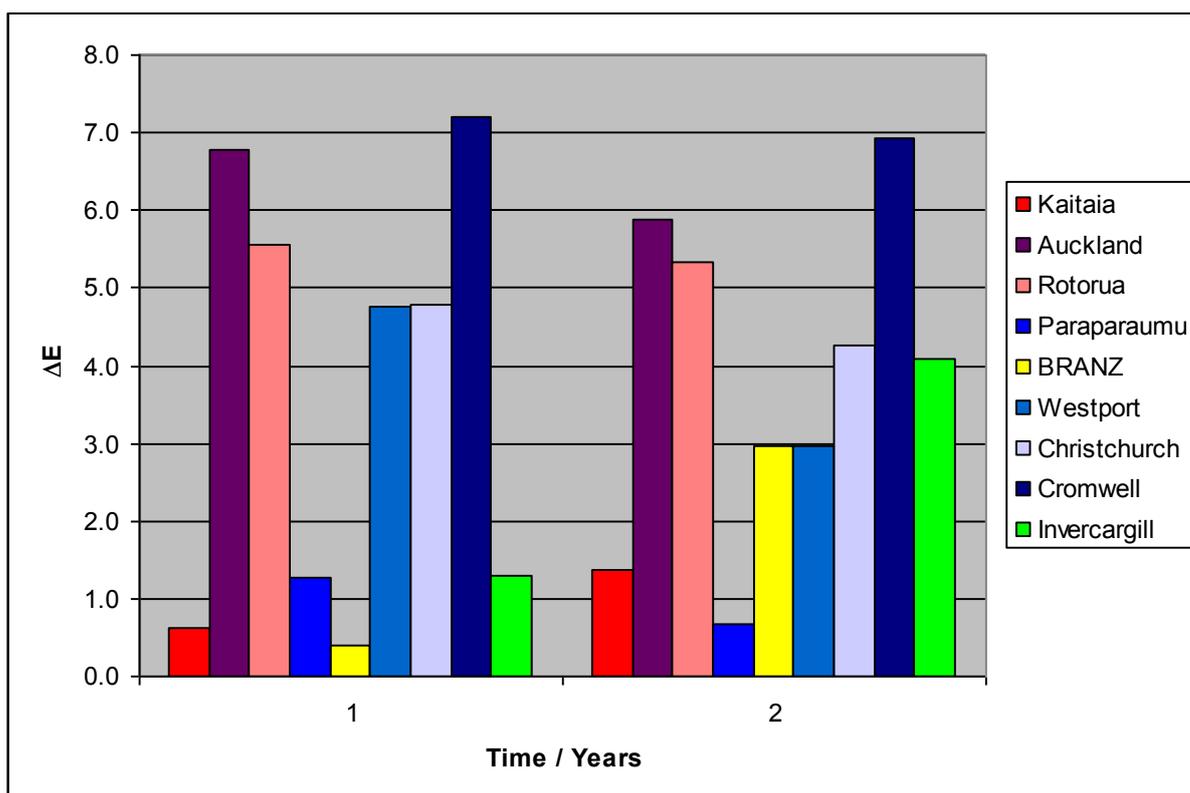
The results obtained after two years of exposure on the five recent exposure sites, compared to results after the same exposure time on the original sites, are shown in Figure 32.

Figure 32. Colour shift, ΔE , data for white uPVC on all exposure sites after two years of exposure

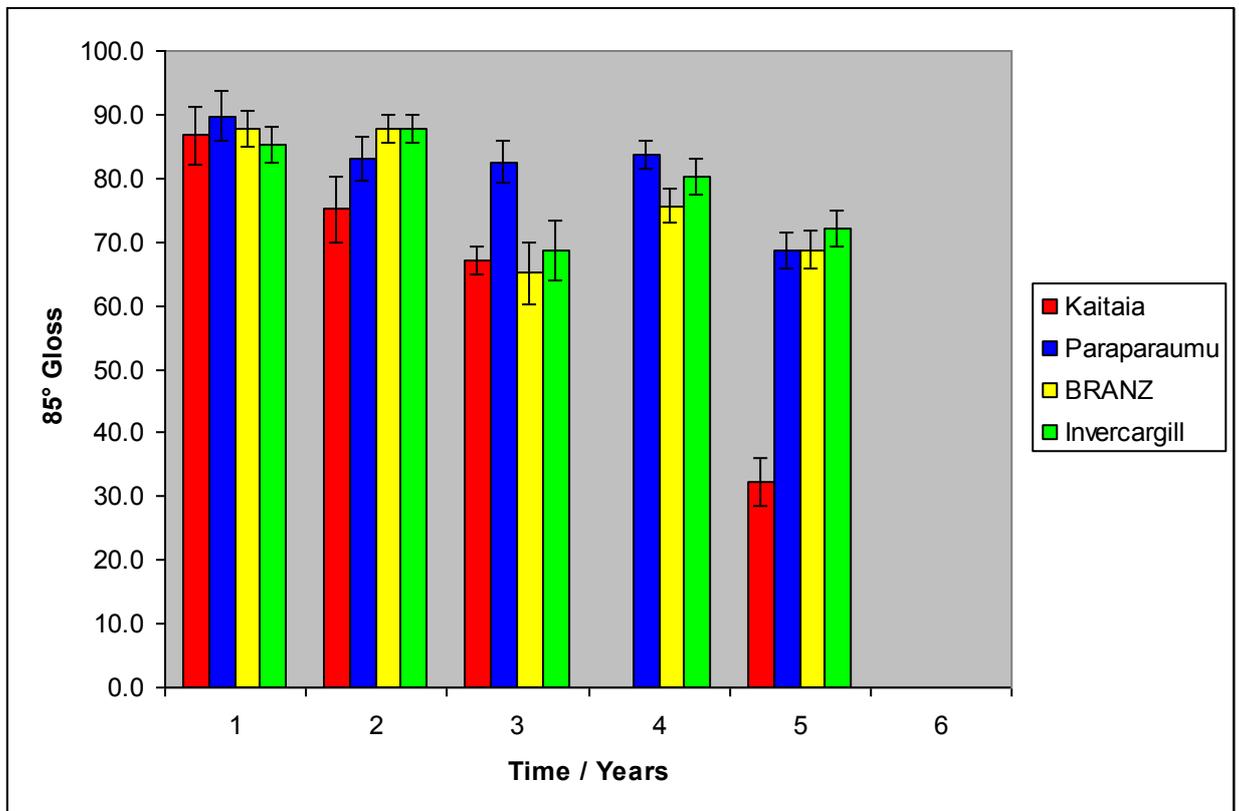
The surface gloss data obtained for clear PE from the original exposure sites, as the years passed, is shown in Figure 33.

Figure 33. Surface gloss data for clear PE on the four original exposure sites

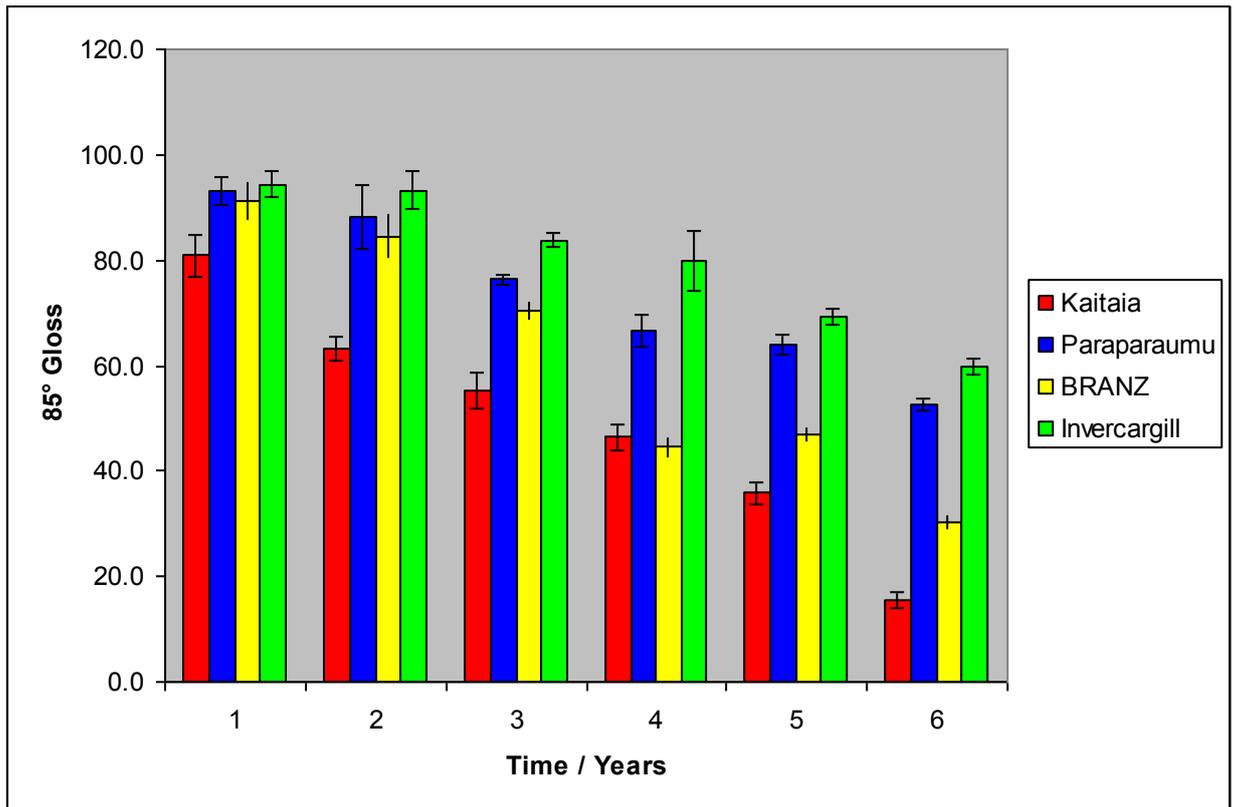
The surface gloss data obtained for black PE from the original exposure sites, as the years passed, is shown in Figure 34.

Figure 34. Surface gloss data for black PE on the four original exposure sites

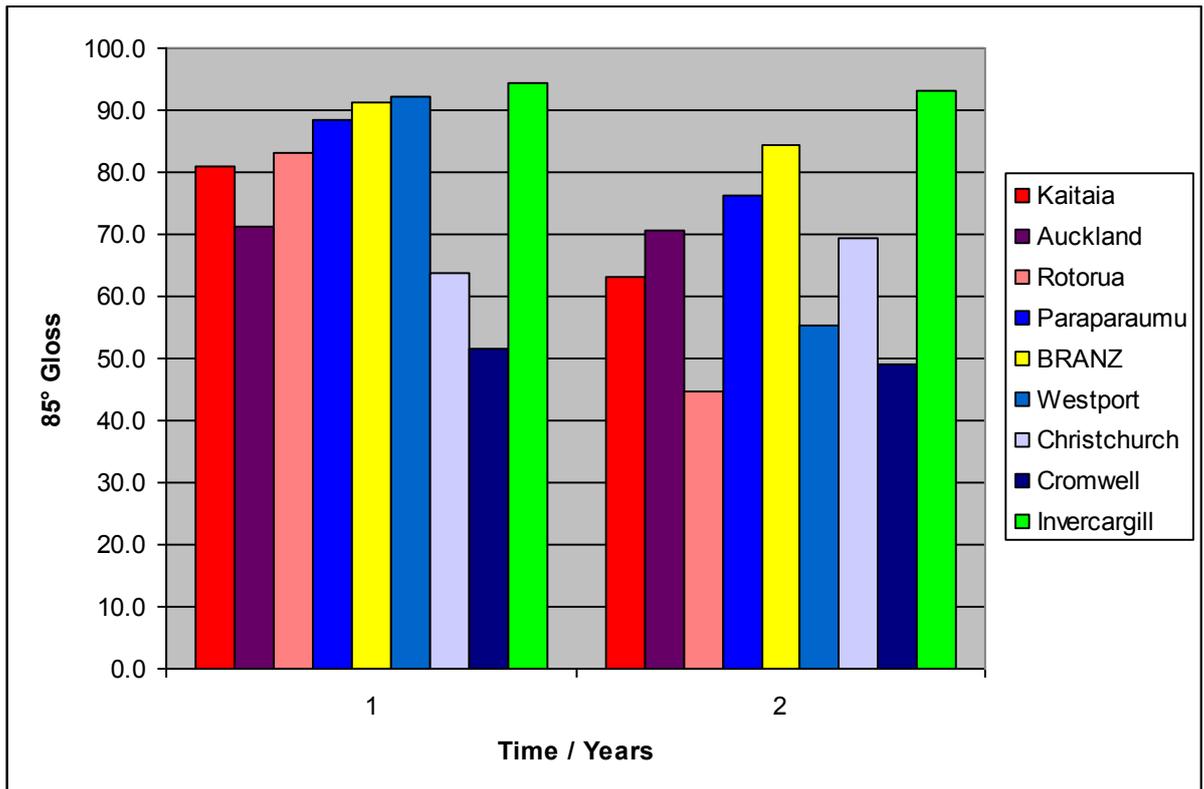
The gloss data obtained for black PE for the five recent exposure sites, and the results obtained for the first two years of exposure on the original sites, are shown in Figure 35.

Figure 35. Surface gloss data for black PE on the five recent exposure sites

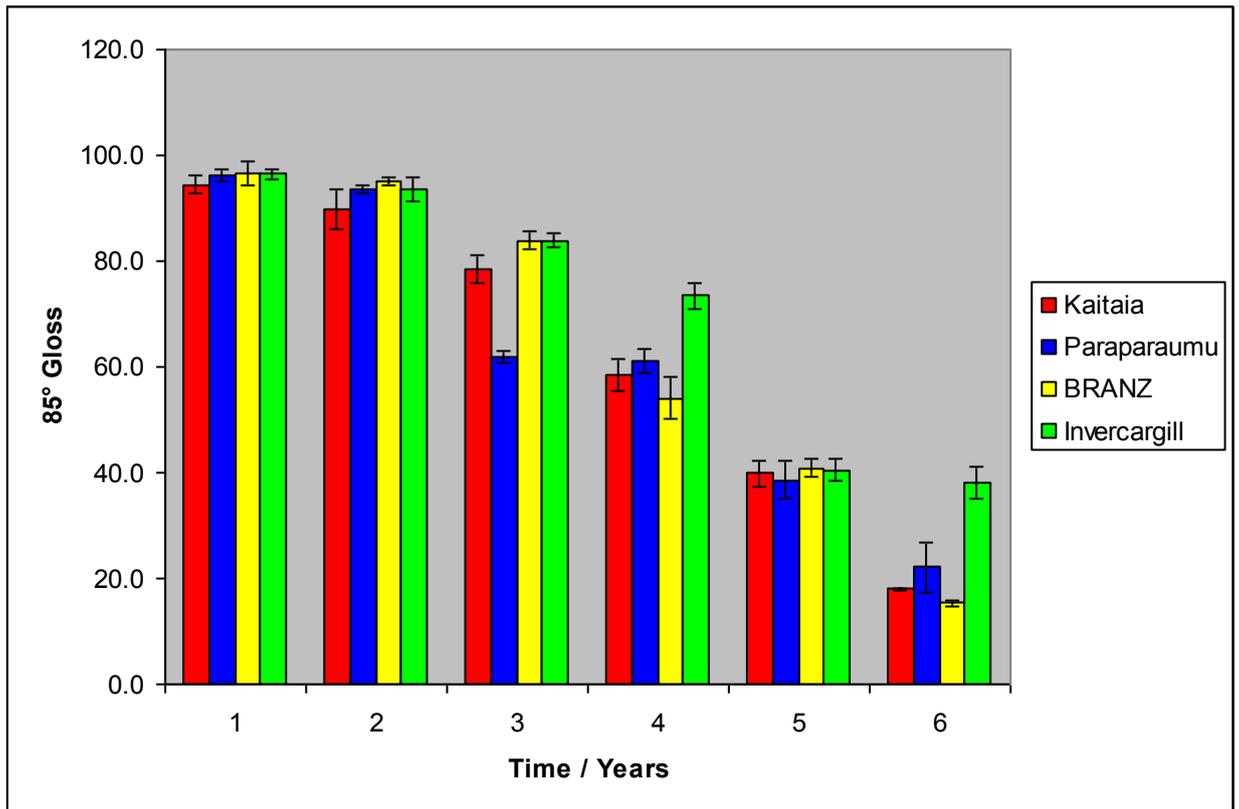
The surface gloss data obtained for white uPVC from the original exposure sites is shown in Figure 36.

Figure 36. Surface gloss data for white uPVC on the four original exposure sites

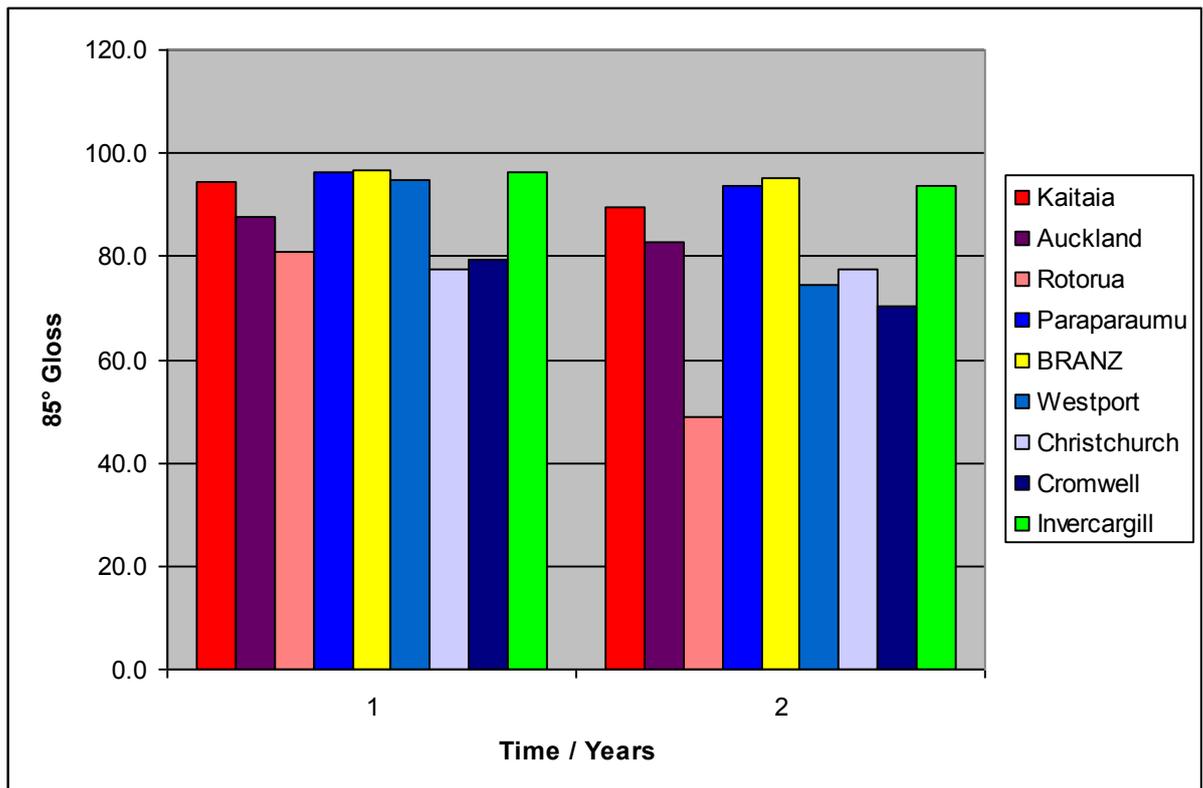
The gloss data obtained for uPVC for the five recent exposure sites, and the results obtained for the first two years of exposure on the original sites, are shown in Figure 37.

Figure 37. Surface gloss data for white uPVC on the five later exposure sites

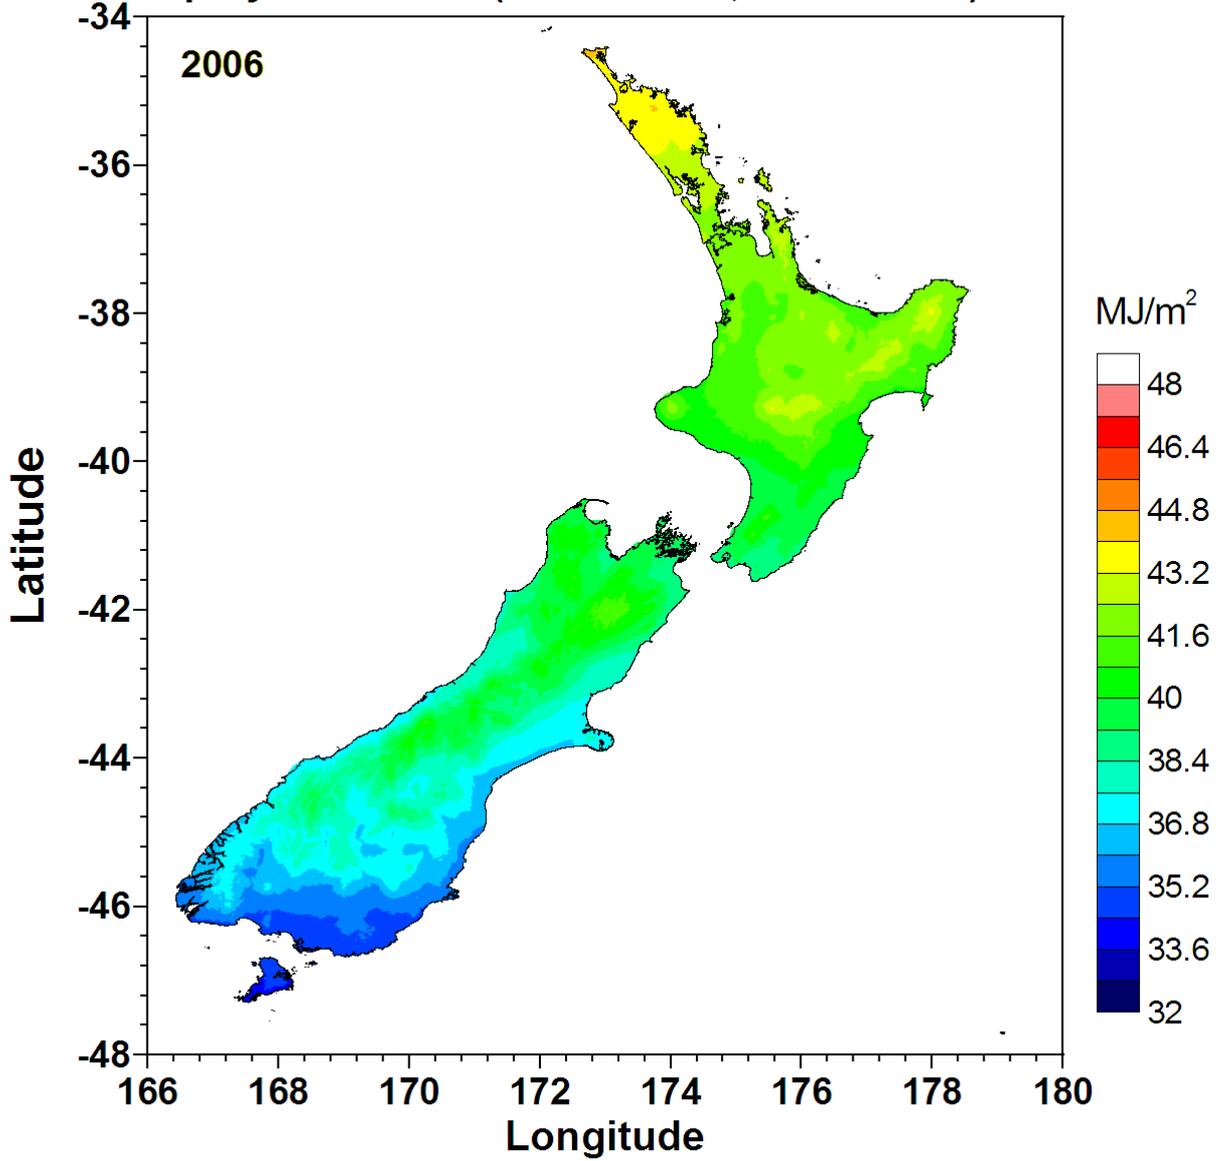
Figure 38. PC energy dose map based on NIWA 2006 broadband radiation data

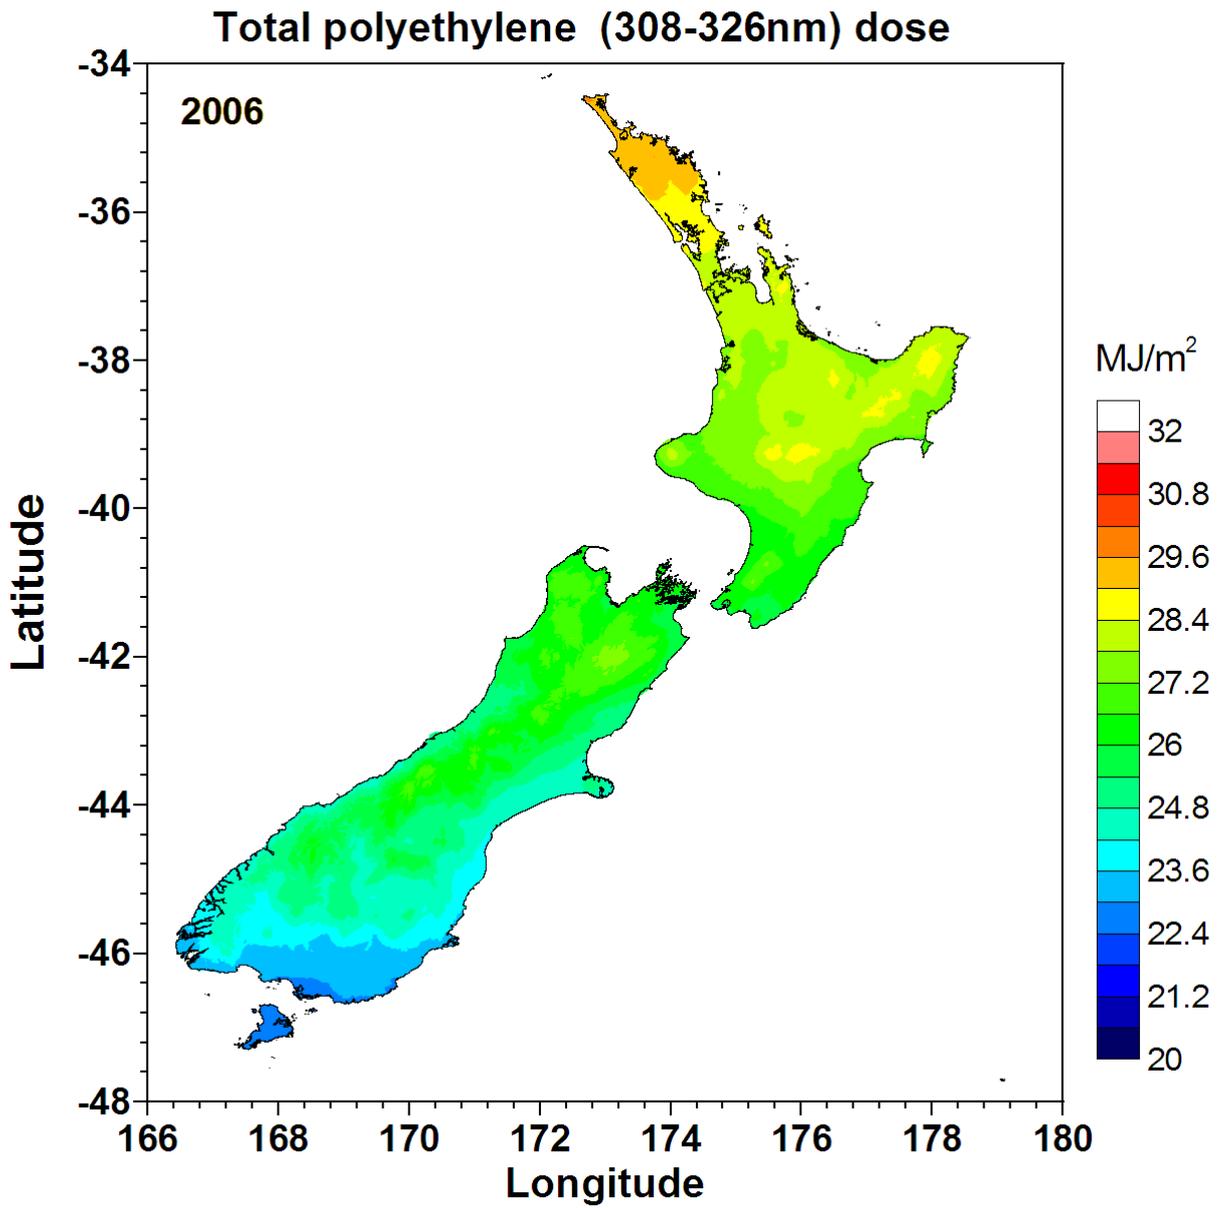
Figure 39. PE energy dose map based on NIWA 2006 broadband radiation data

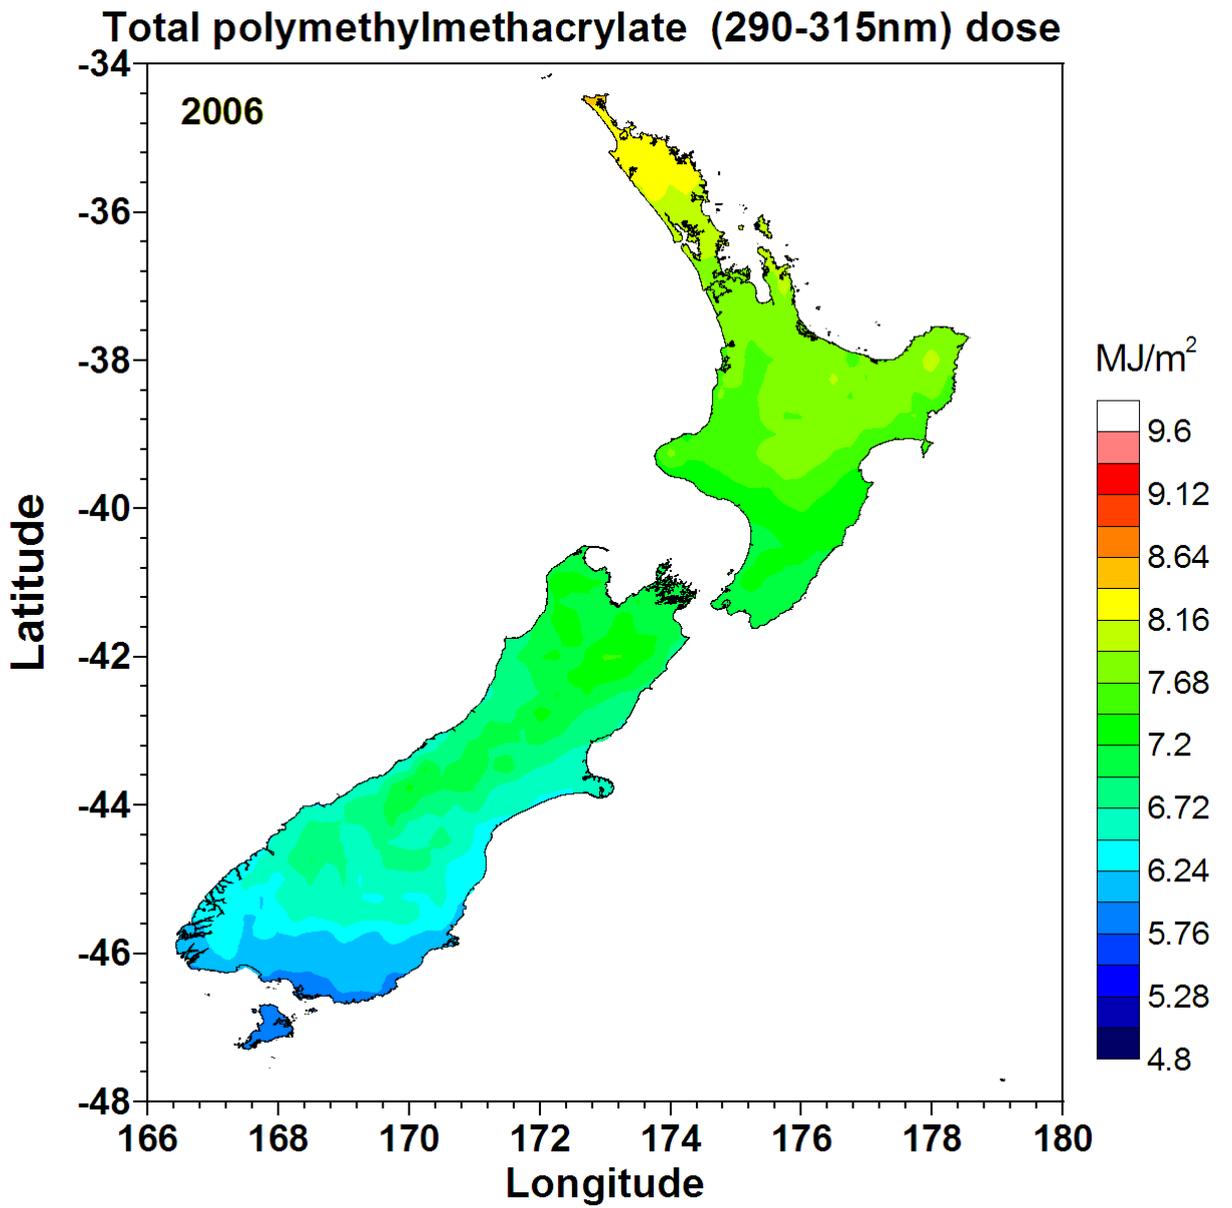
Figure 40. PMMA energy dose map based on NIWA 2006 broadband radiation data

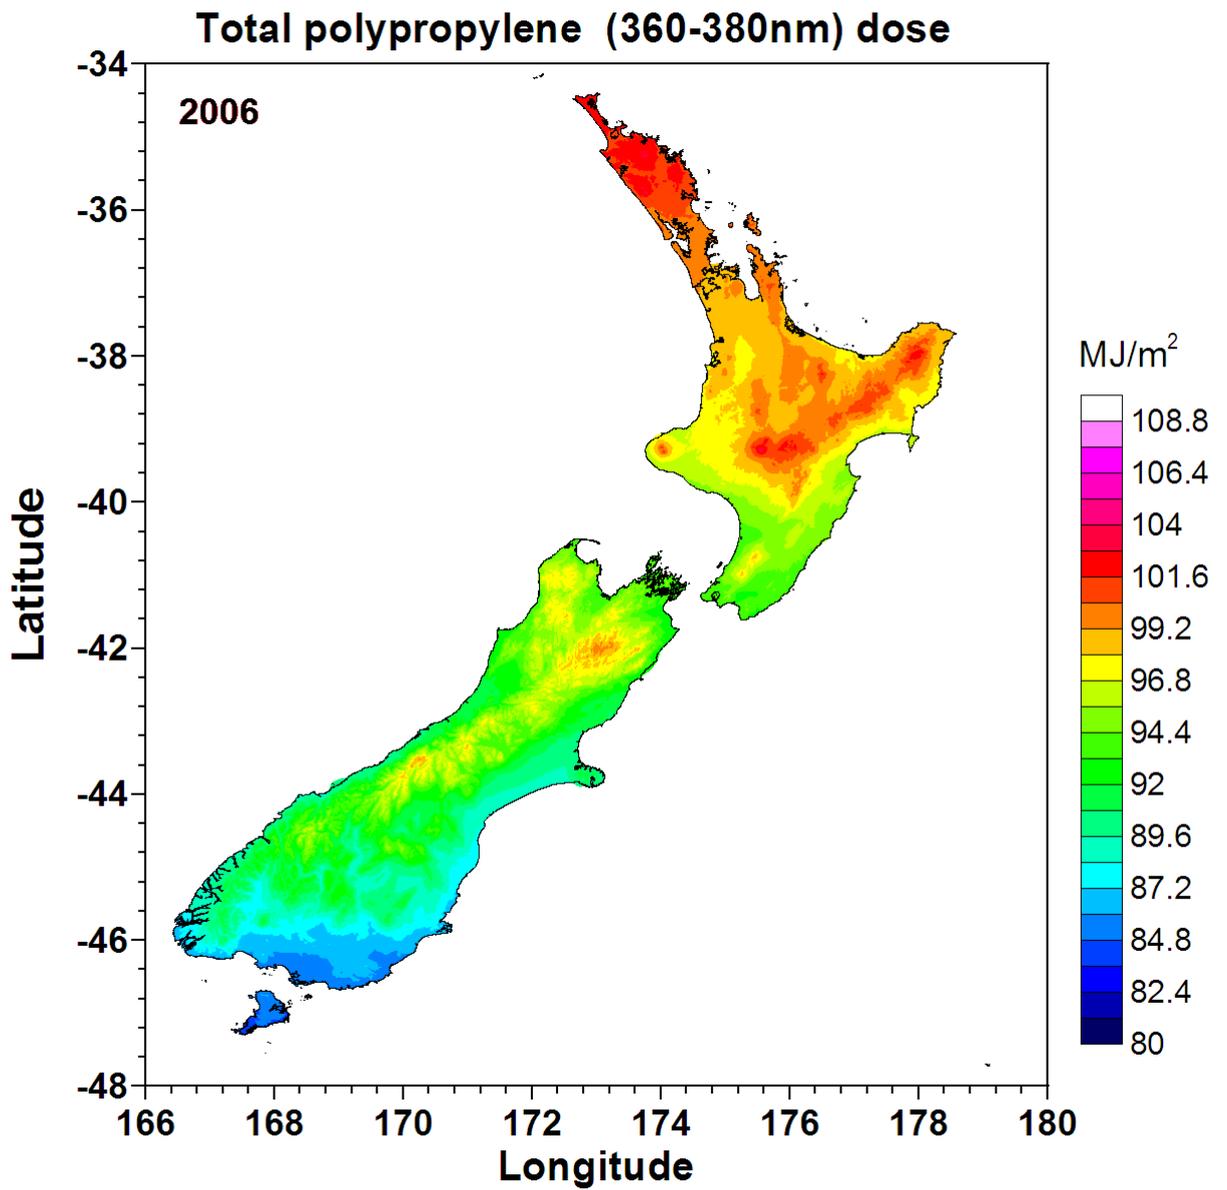
Figure 41. PP energy dose map based on NIWA 2006 broadband radiation data

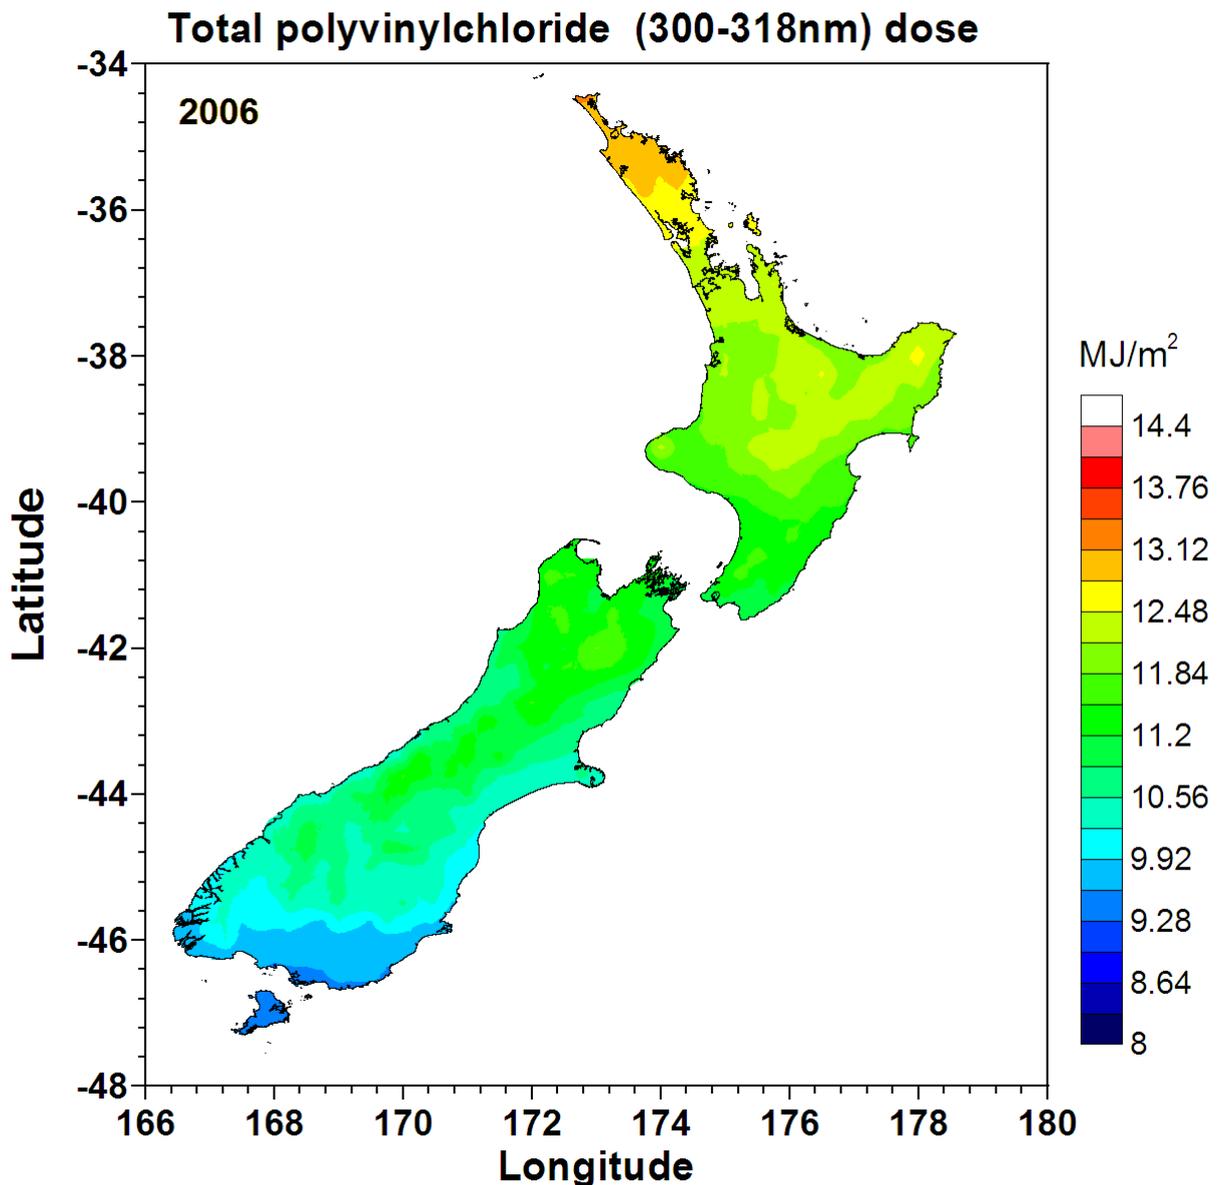
Figure 42. uPVC energy dose map based on NIWA 2006 broadband radiation data

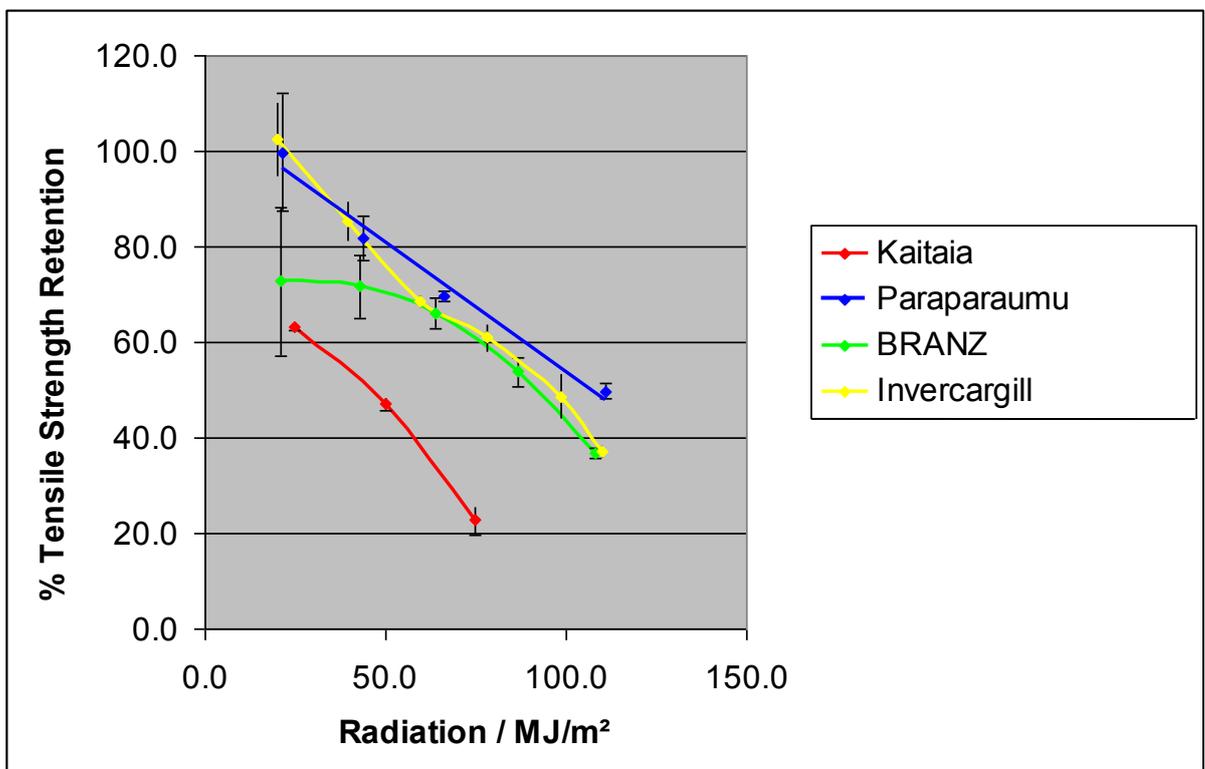
It was then possible to plot the change of tensile strength of the PE and PP sheets (shown in Figure 12 and Figure 16) against the cumulative harmful radiation dose at each of the original four exposure sites. The resulting plots are shown in Figure 43 and Figure 44. The data for the PE and PP are then combined in Figure 45.

Figure 43. PE tensile strength retention as a function of cumulative harmful radiation dose

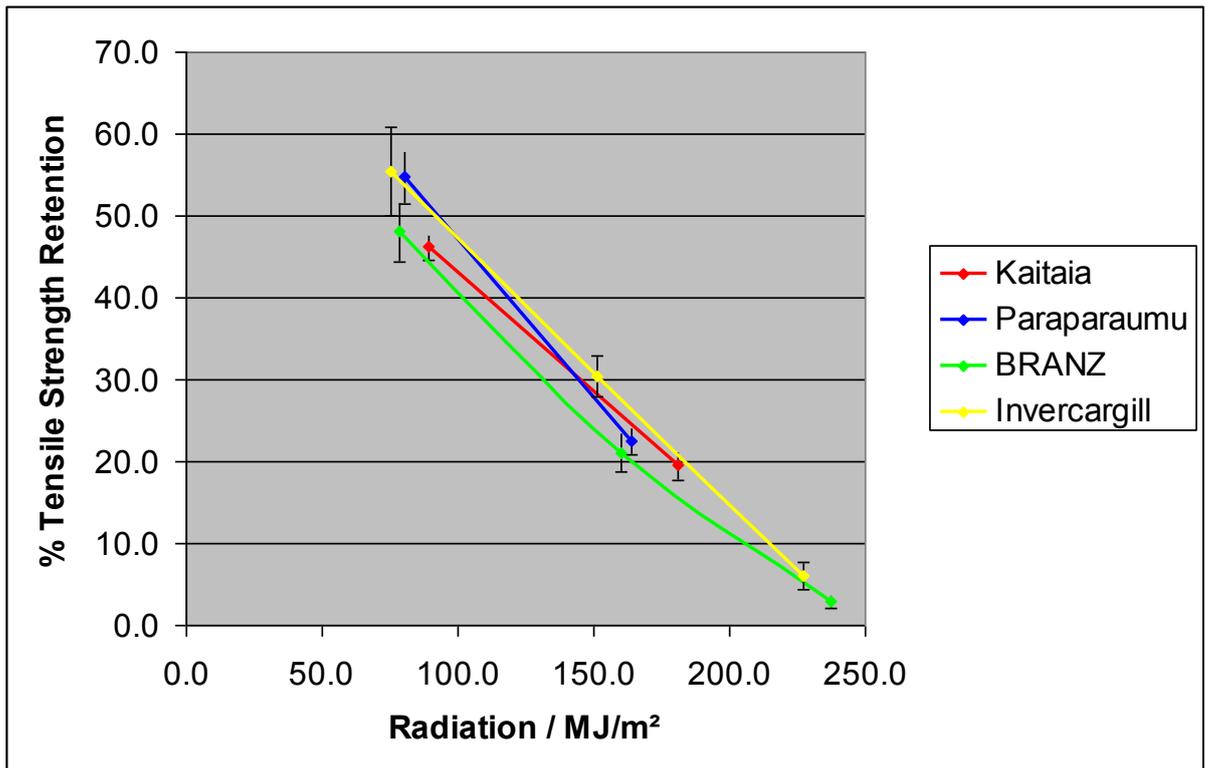
Figure 44. PP tensile strength retention as a function of cumulative harmful radiation dose
