STUDY REPORT

No. 182 (2007)

Weathering of Polymeric Materials in New Zealand

BRANZ Study Report SR 182 (2007)

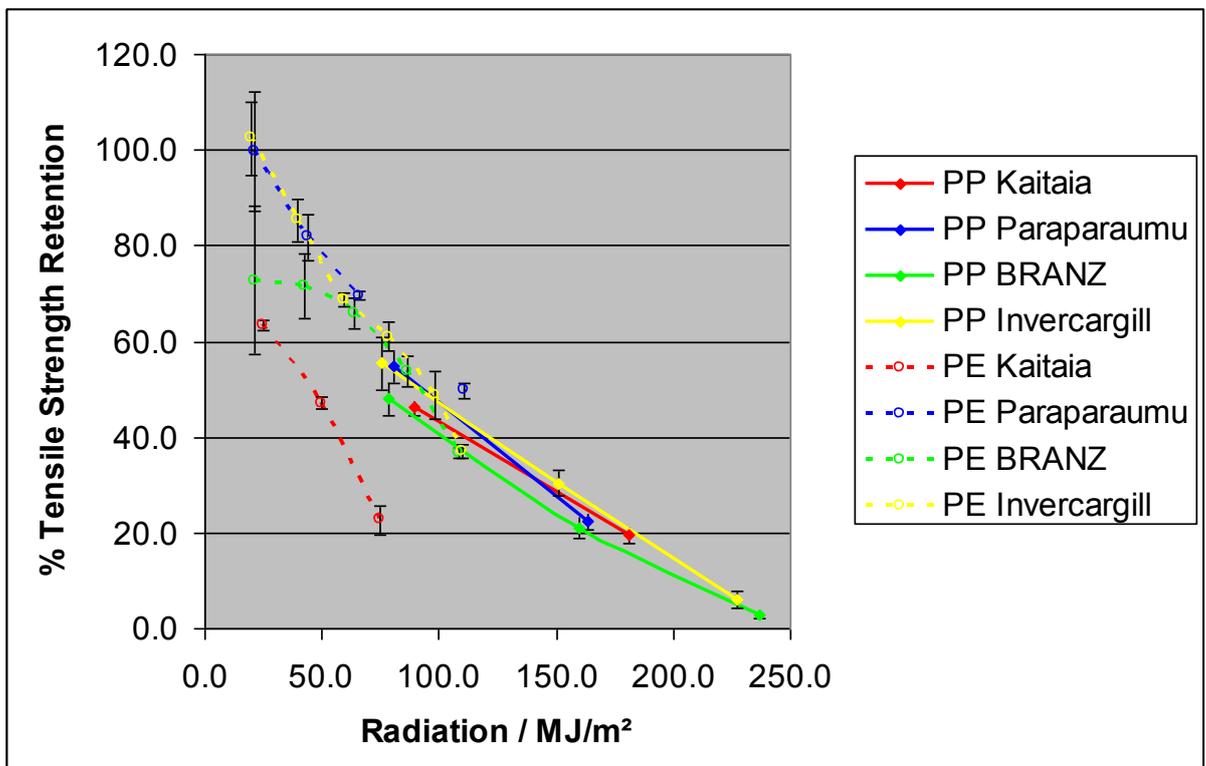
It was then possible to plot the change of tensile strength of the PE and PP sheets (shown in Figure 12 and Figure 16) against the cumulative harmful radiation dose at each of the original four exposure sites. The resulting plots are shown in Figure 43 and Figure 44. The data for the PE and PP are then combined in Figure 45.

Figure 45. Combined tensile strength retention as a function of cumulative harmful radiation dose for PE and PP

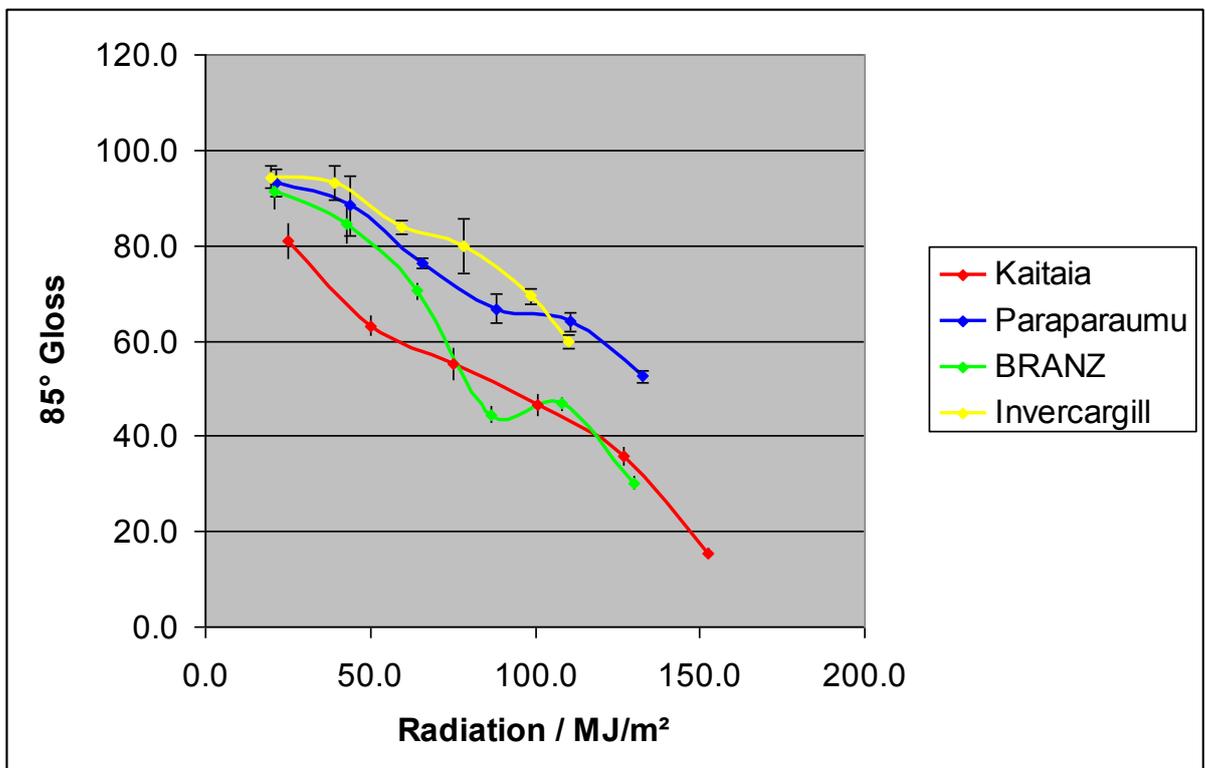
The black PE and white uPVC materials did not lose mechanical strength over the first six years of exposure, so analogous plots against cumulative harmful radiation dose at each of the exposure sites are not useful. However, it is instructive to plot the surface gloss of these materials against the cumulative harmful radiation dose as shown in Figure 46 and Figure 47.

Figure 46. Black PE gloss data as a function of cumulative harmful radiation dose

4.4.2). The clarification of the trend towards higher gloss reduction per unit harmful incident radiation (implying more micro-cracking at the surface) in Kaitaia also seems to support the interpretation of the clear and black PE mechanical property trends in Section 4.2.3.

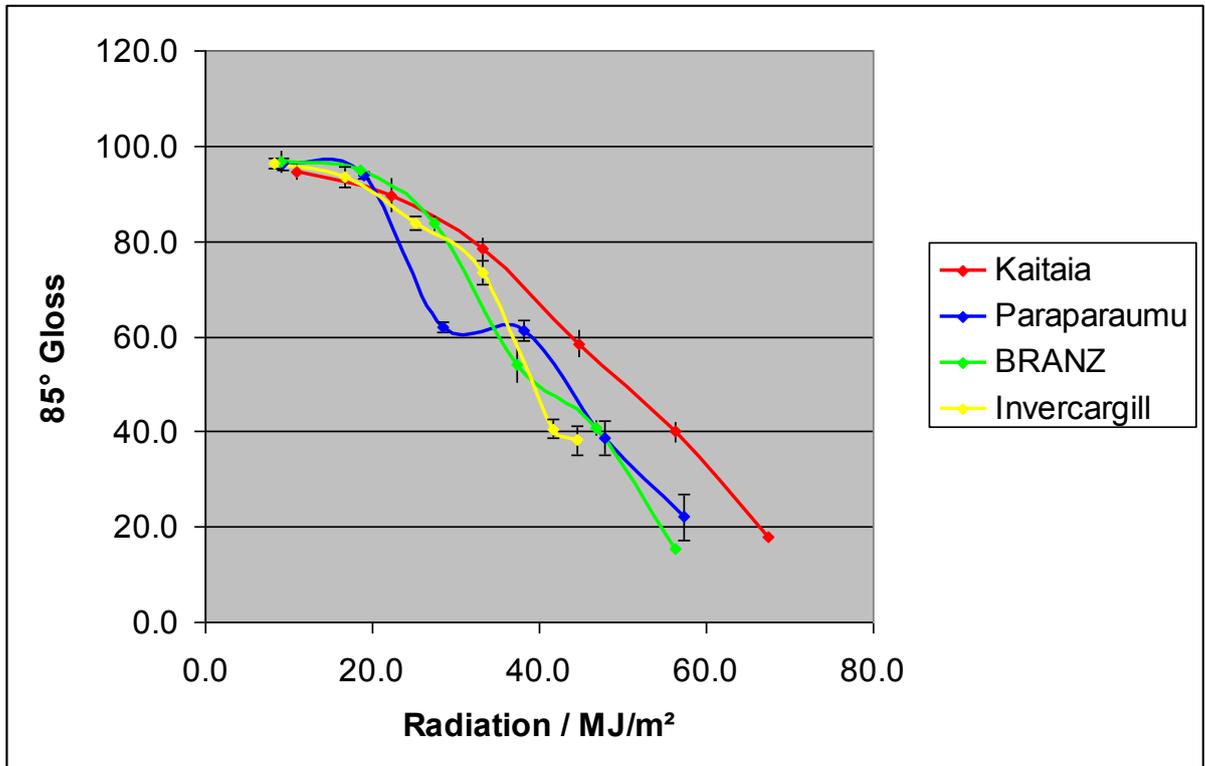
Figure 47. uPVC gloss data as a function of cumulative harmful radiation dose

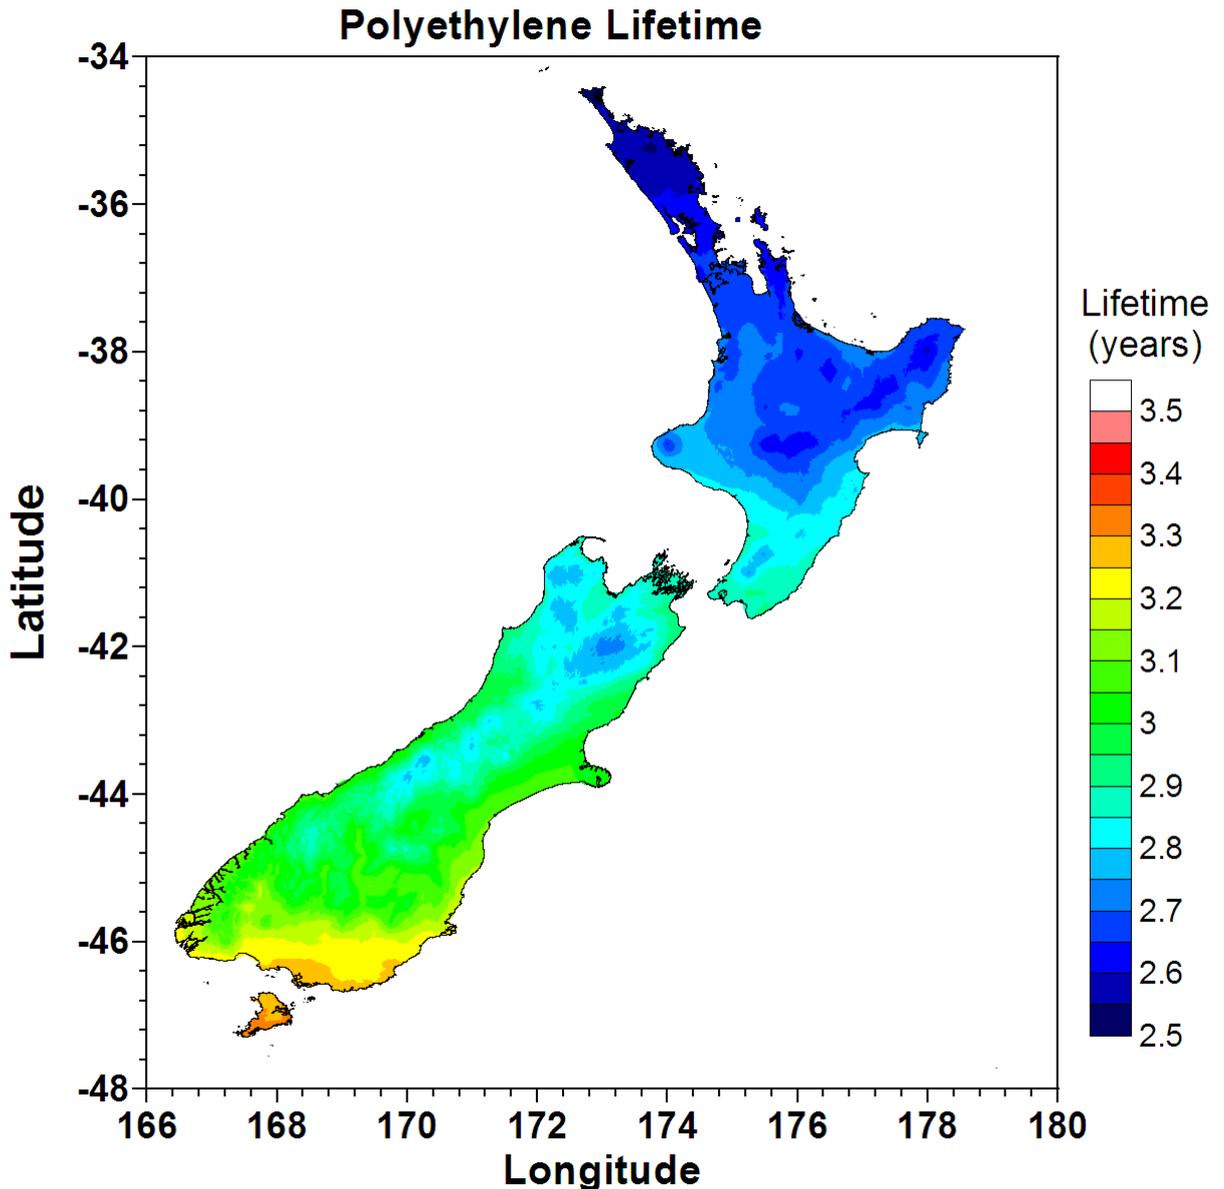
The predicted lifetime for the non-UV stabilised PE sheet used in this study is shown in Figure 48. The map was derived by taking a worst case harmful radiation dose for PE (radiation of wavelengths 308–326 nm – see Table 3) for the year 2006 by examination of data from each of the NIWA’s broadband monitoring sites across New Zealand. An extrapolation was then made to produce the map showing how many years it would take to reach a cumulative harmful radiation dose for PE of 75 MJ/m², based upon data from each of NIWA’s broadband monitoring sites across New Zealand.

Figure 48. Predicted lifetime for the PE sheet used in this study derived using NIWA 2006 broadband radiation data

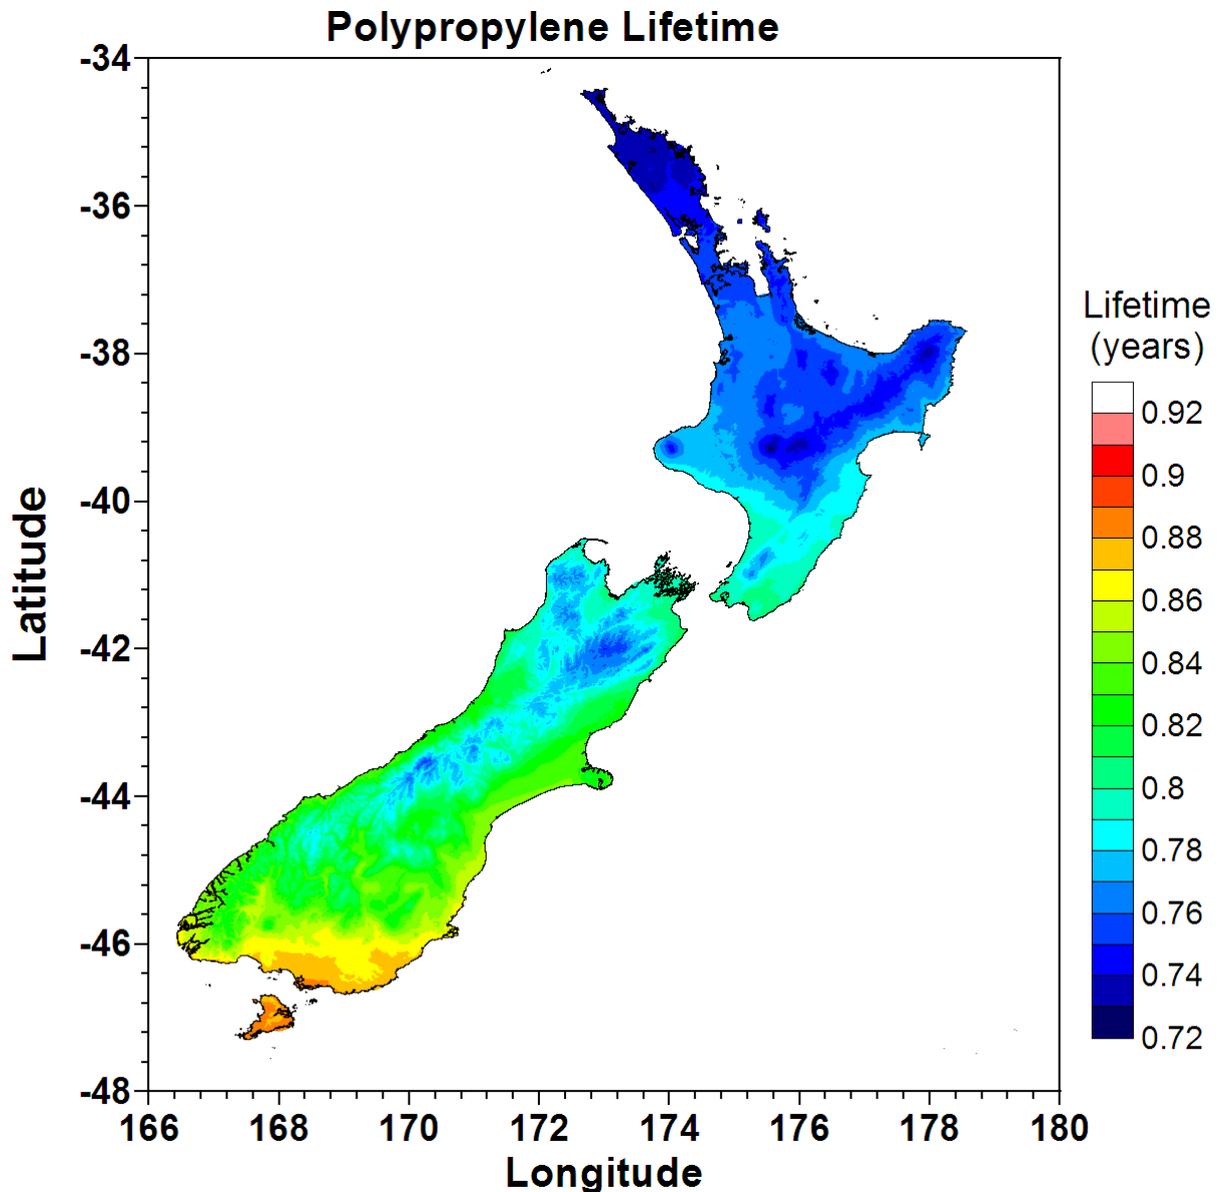
Figure 49. Predicted lifetime for the PP sheet used in this study derived using NIWA 2006 broadband radiation data
