# **STUDY REPORT**

**SR 211 (2009)**

## **Installed Performance of Ceiling Insulation**

**Ian Cox-Smith**

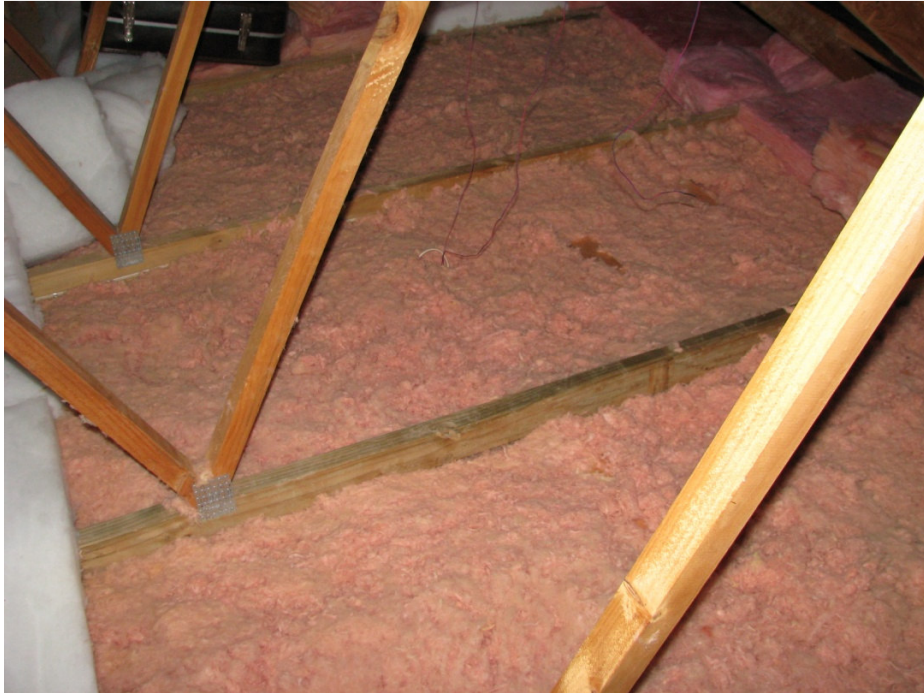
**Figure 1: Ceiling A – area 1, batten only.**

The first ceiling (Ceiling A) was in a late 1980s house and had been insulated at the time of construction with loose-fill glasswool. The insulation was approximately 50–70 mm thick. Two HFTs were installed – one directly under an area containing just a batten (Figure 1) and the other under an area containing both a batten and a joist (Figure 2).

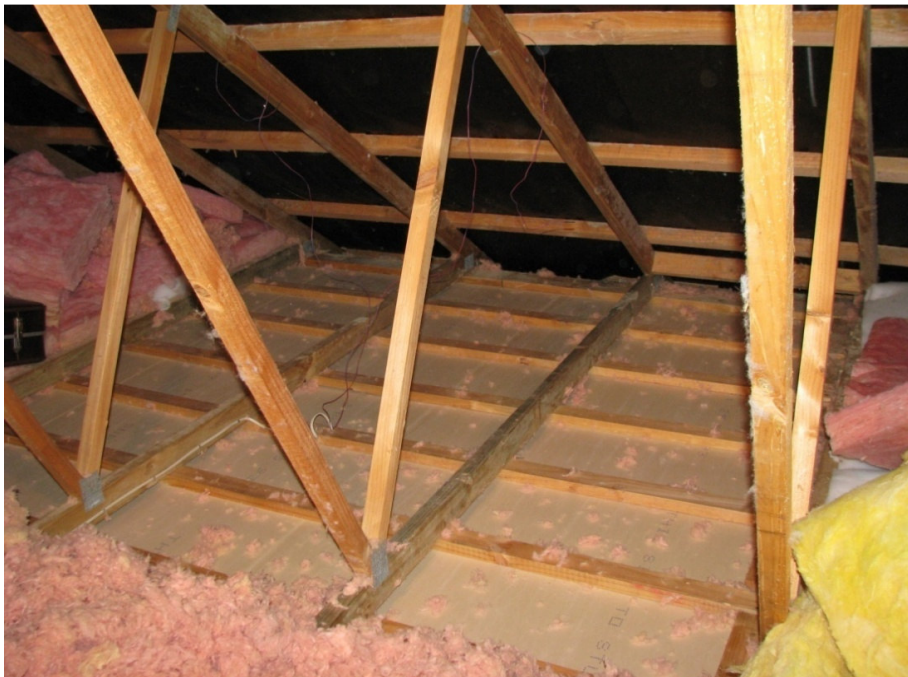
**Figure 2: Ceiling A – area 2, batten and joist.**

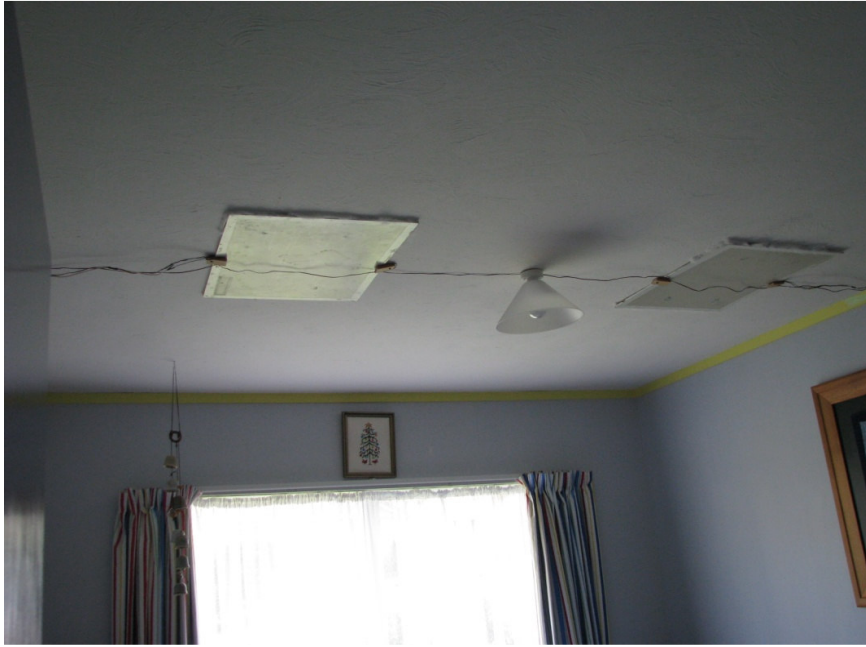
**Figure 3: Ceiling A – heat flux transducers in position.**

The thermocouple to measure the air temperature above the insulation was passed through the light fitting to avoid drilling holes through the ceiling (Figure 3). (The same technique was used at the other two test sites.) The panels were attached with clips rather being held in place with stands, and the loggers were wired to the panels but are not visible in the picture. For the measurements with insulation only over the top of the framing, the area near the outer edge of the ceiling was insulated with an extra piece of insulation added between the framing to eliminate ventilation through that area.

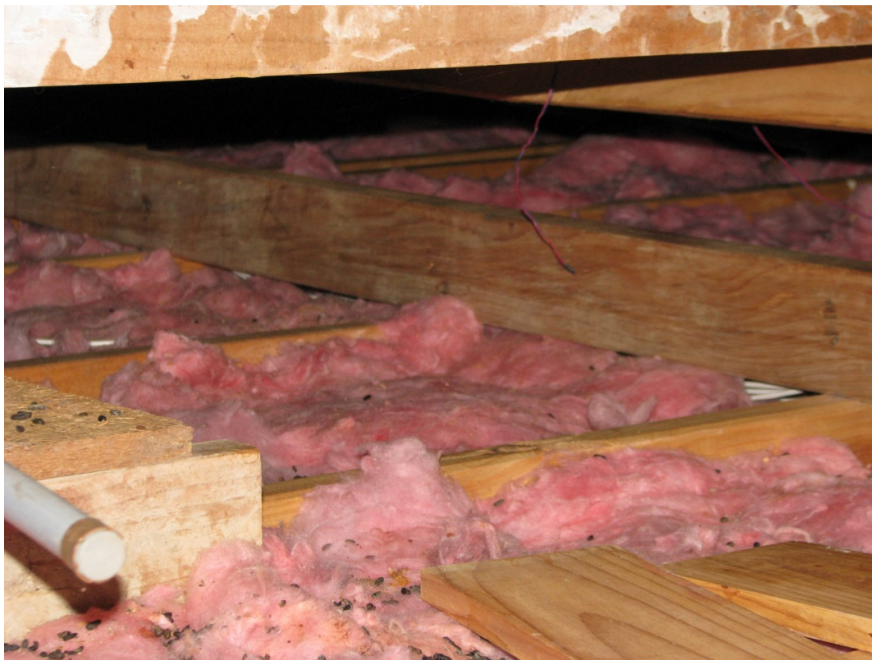
**Figure 4: Ceiling B – original insulation poorly installed.**

The second ceiling (Ceiling B) was in an early 1970s house that had been retrofitted in the 1980s with glasswool insulation segments. The insulation segments were approximately 70 mm thick and poorly installed, with the widespread presence of tucking and folding (Figure 4). The single HFT was installed directly under an area containing a joist but no dwangs, and the panel was held in place with a purpose-designed stand (Figure 5). The logger was placed on the stand just underneath the HFT panel.

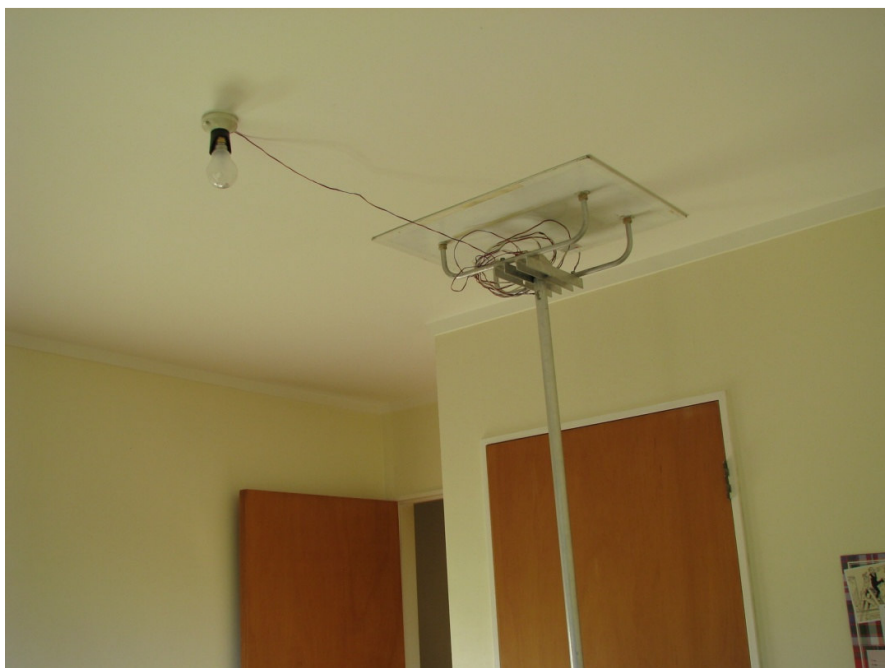
**Figure 5: Ceiling B – heat flux transducer in position.**

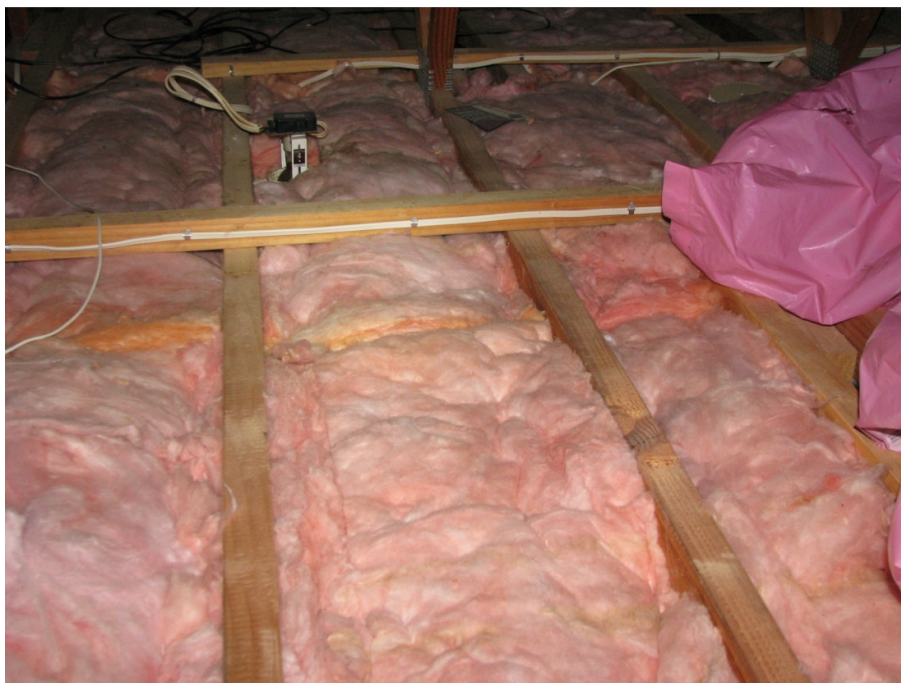
**Figure 6: Ceiling C – plastic bags from the original insulation had been left in the ceiling.**

The third ceiling (Ceiling C) was in an early 1990s house insulated at the time of construction with nominal R 2.4 glasswool insulation segments – the plastic bags from the insulation had been left in the ceiling (Figure 6). While the installation was better than that of Ceiling B, there was some tucking present. The segments were approximately 90 mm thick. Only one HFT was installed, was placed directly under an area containing both a batten and a joist (Figure 7).

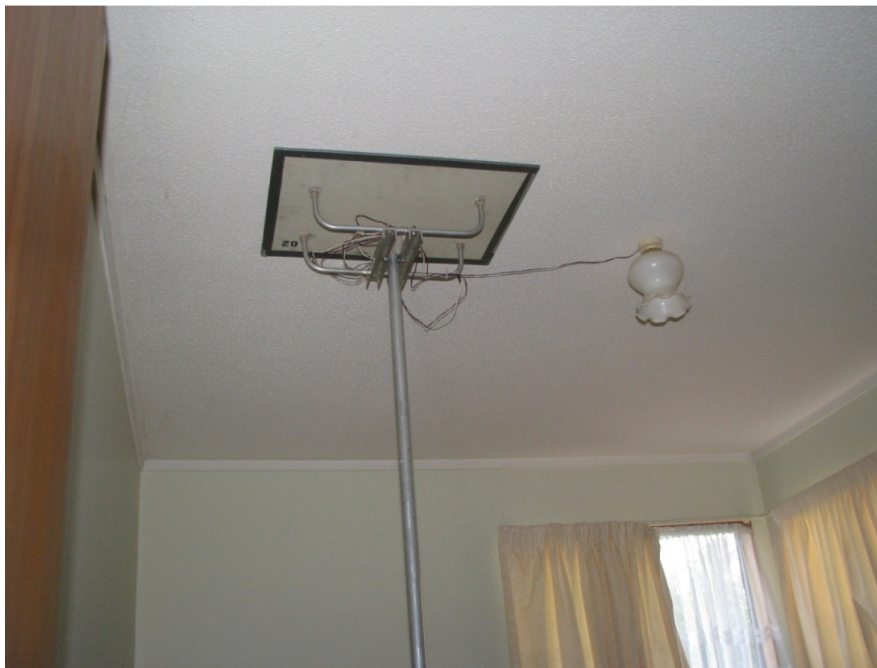
Figure 7: Ceiling C – heat flux transducer in position.

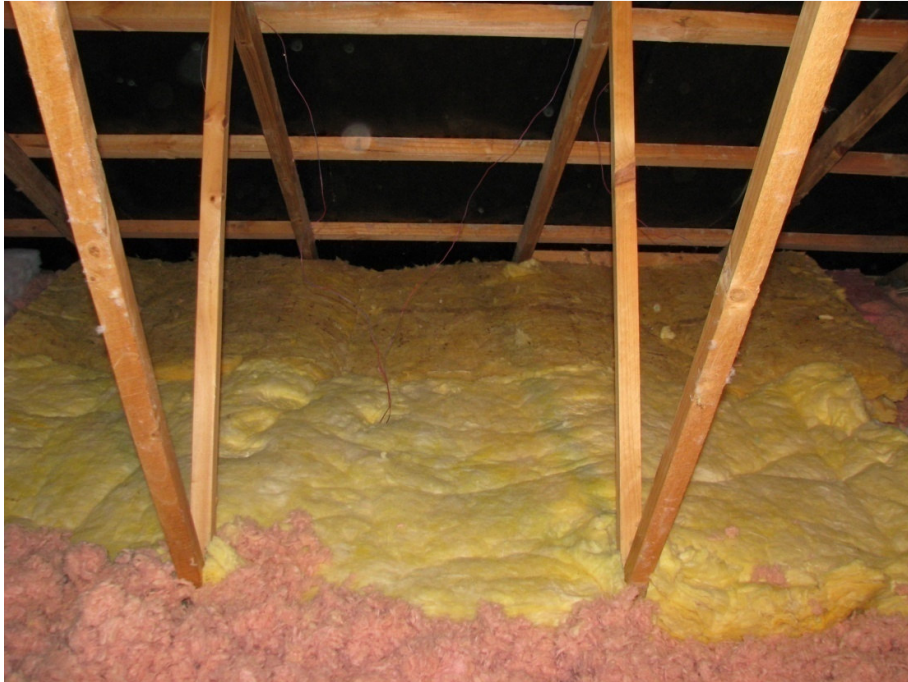
**Figure 8: Ceiling A – 120 mm thick R 3.2 glasswool insulation product (roll form) installed over the top of the framing.**

After first measuring the thermal resistance of the ceiling at two locations with the existing loose-fill insulation, the insulation was removed from the test area and replaced with 120 mm thick R 3.2 glasswool insulation product (roll form) installed over the top of the framing (Figure 8). The thermal resistance was then remeasured.

For Ceiling A and the situation with insulation only over the the top of the framing, the initial R-value result was surprisingly low, despite taking considerable care with installation. A revisit to the test site revealed that small gaps (5 mm) had opened up at some of the joints between the sections of insulation. The insulation was carefully moved so as to close these gaps, and the R-value was then remeasured and found to be close to what would be expected if there were no ventilation losses occurring.

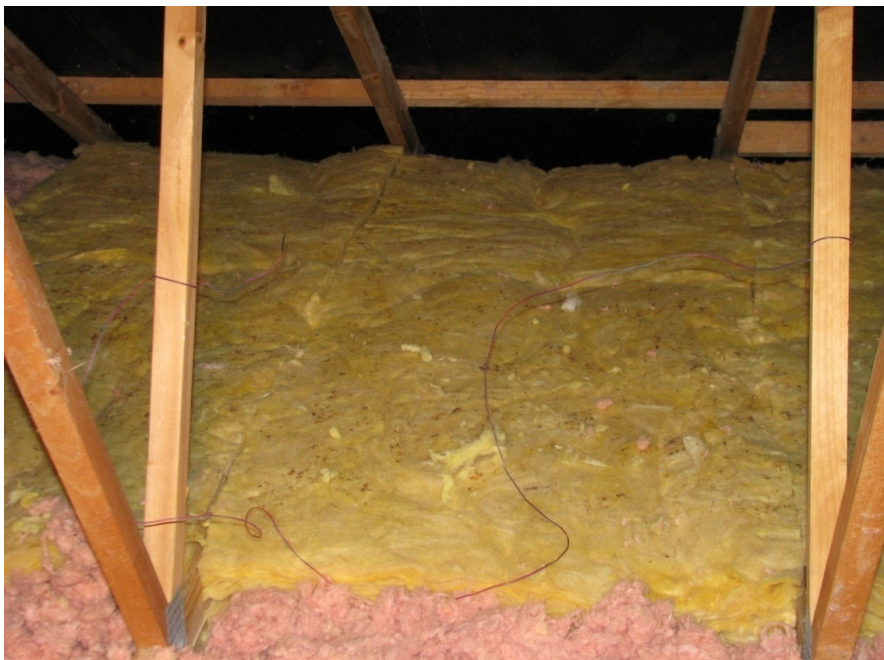
**Figure 9: Ceiling A – pieces of insulation friction-fitted between the framing.**

Next, the same pieces of insulation were cut down in size and friction-fitted between the framing. Care was taken to cut the insulation width to ensure that the insulation was able to bulge over the top of the framing and conceal (insulate) it (Figure 9).

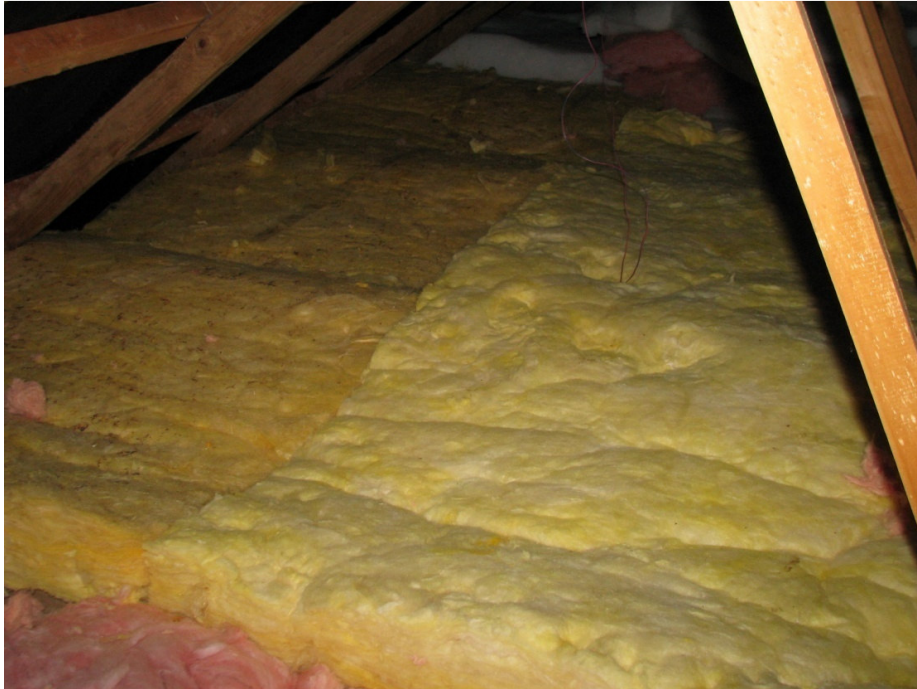
**Figure 10: Ceiling A – layer of insulation over framing and second layer between framing**

A fourth set of measurements was made with more of the same insulation material installed over the top of the framing in addition to the material already friction-fitted between the framing (Figure 10).

For Ceiling A with two layers of the R 3.2 insulation, it was only possible to determine that the thermal resistance was significantly above R 5. This happened because the temperature difference was insufficient to produce a significant heat flow through the heat flux transducer.

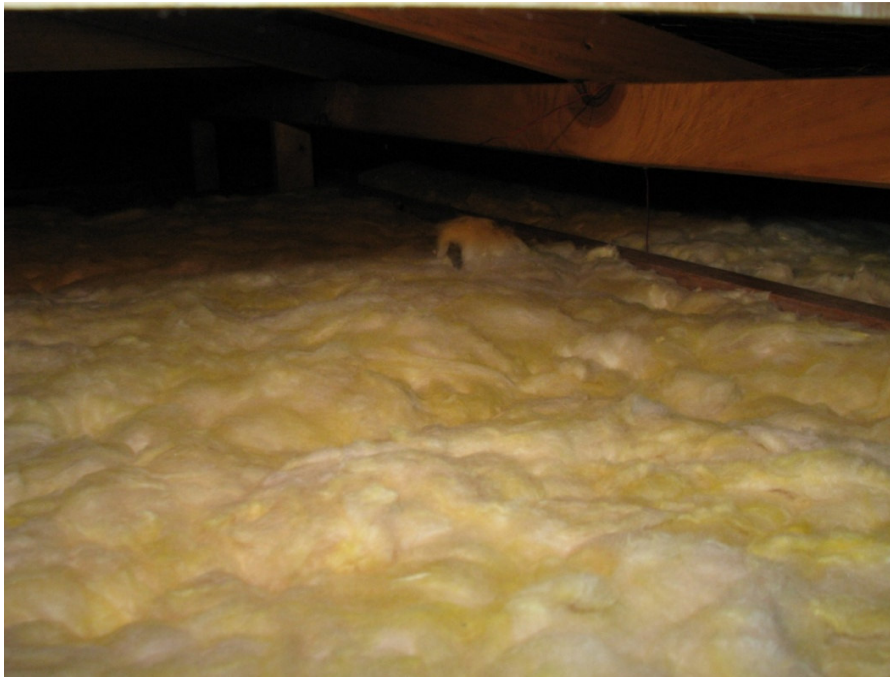
**Figure 11: Ceiling B – 120 mm thick R 3.2 glasswool insulation product (roll form) installed over the top of the framing and existing insulation.**

After first measuring the thermal resistance of the ceiling with the existing retrofitted insulation segments, the thermal resistance was remeasured with 120 mm thick R 3.2 glasswool insulation product (roll form) installed over the top of the framing and existing insulation (Figure 11).

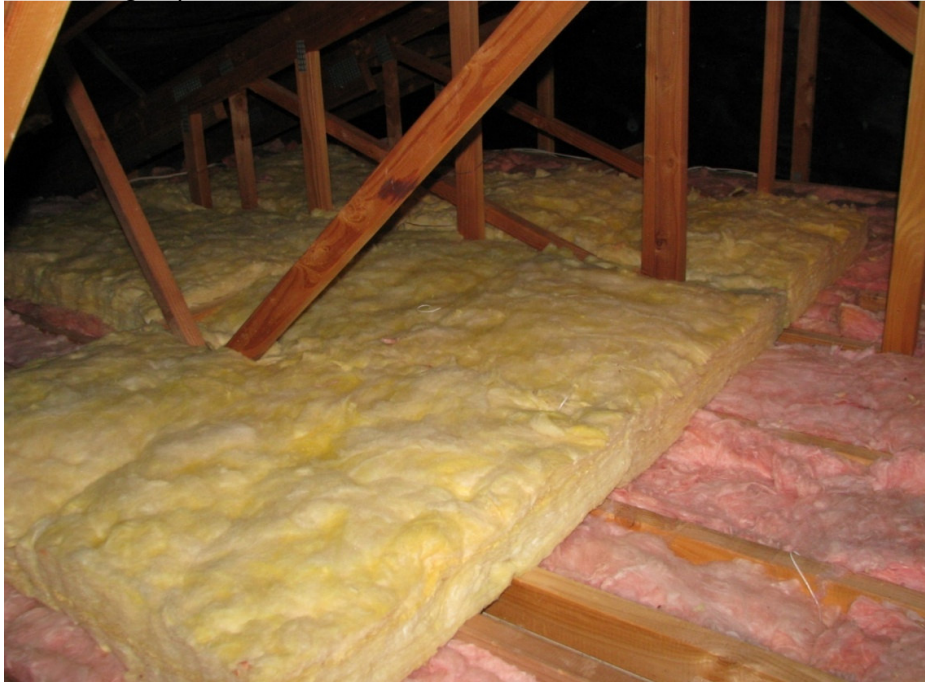
**Figure 12: Ceiling C – 120 mm thick R 3.2 glasswool insulation product (roll form) installed over the top of the framing.**

After first measuring the thermal resistance of the ceiling with the existing nominal R 2.4 insulation segments, the insulation was removed from the test area and replaced with 120 mm thick R 3.2 glasswool insulation product (roll form) installed over the top of the framing (Figure 12). The thermal resistance was then remeasured. As with Ceiling A, the area near the outer edge of the ceiling contained additional insulation between the framing to prevent ventilation.

For Ceiling C, the thermal resistance was also very low for the case of insulation installed over the top of the framing, but because of nature of the framing, it was not possible to apply a better fit to the insulation.

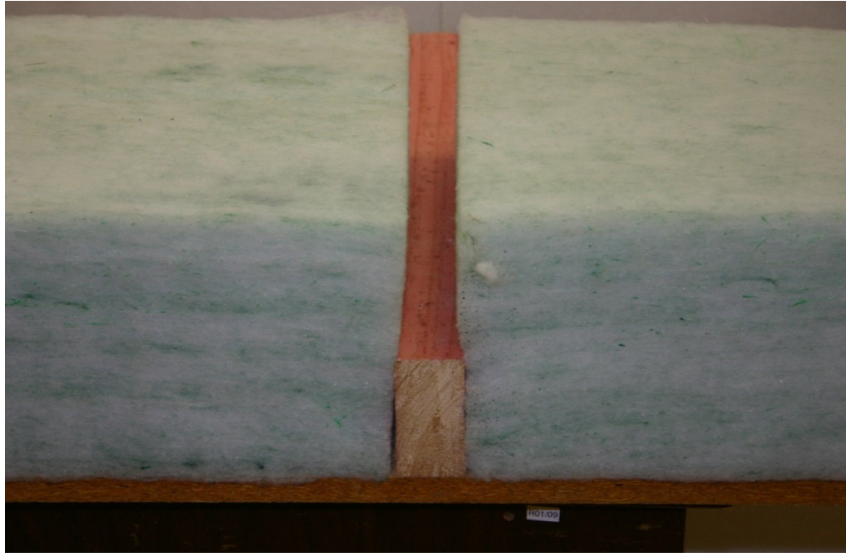
**Figure 15: Polyester insulation fitted against framing in the way the R-value has traditionally been calculated using 1-dimensional calculation methods such as NZS 4214.**

Figure 15 shows a representation of polyester insulation fitted between framing in the way that the R-value has traditionally been calculated using 1-dimensional calculation methods such as NZS 4214. It assumes incorrectly that insulation is cut exactly to the width of the spaces between framing. The assumption therefore is that there is no insulation over the top of the framing, and increasing the thickness of the insulation will not reduce the thermal bridging from the framing.

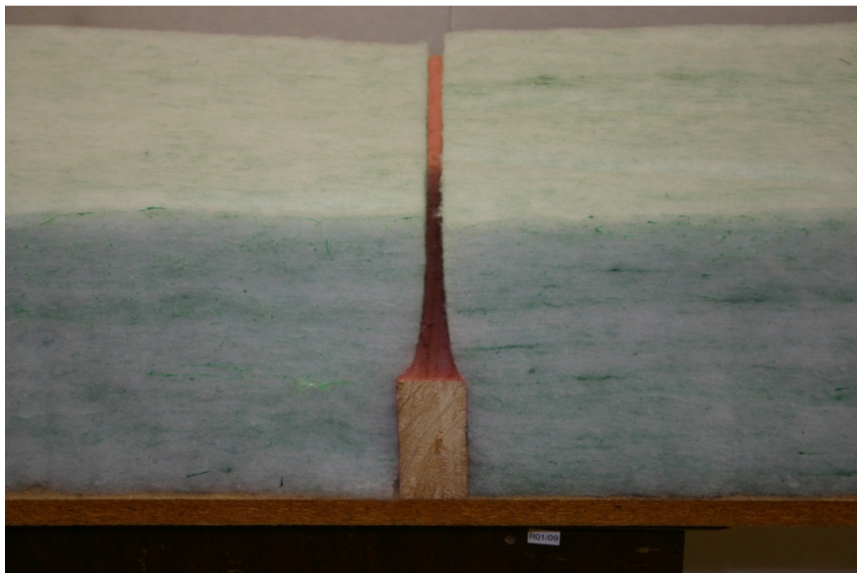
**Figure 16: Insulation cut to friction-fit the frame spacing.**

Figure 16 represents the reality of insulation cut to friction-fit the frame spacing. The width of the insulation is then the width of the space between the framing plus the width of the framing (usually 45 mm). This results in the insulation partially covering over the framing and produces a reduction in thermal bridging from the framing. The thermal bridging from the framing would be expected to be reduced if the insulation thickness is increased, but since there is still a gap in the insulation above the framing, there will still be some convective heat transfer into the ceiling space above the insulation.

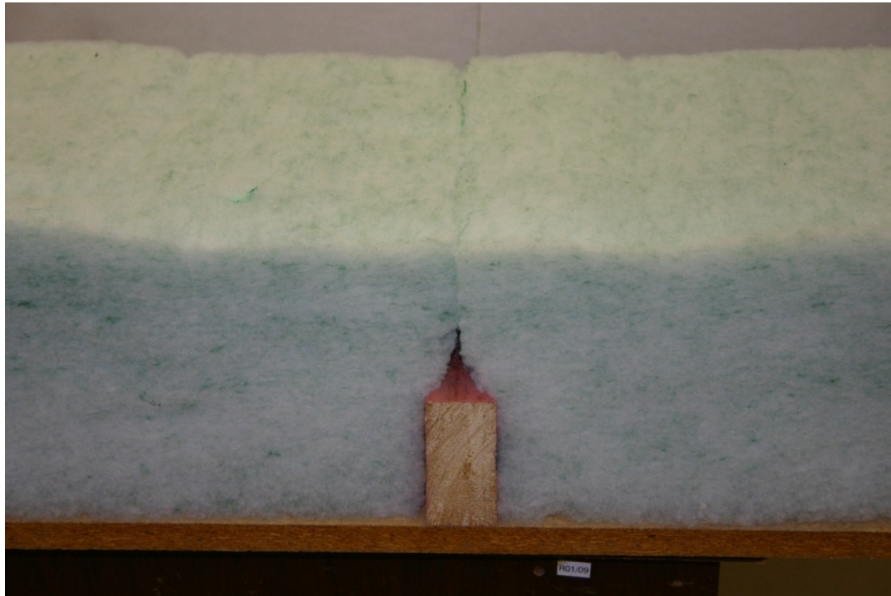
**Figure 17: Insulation cut to the width of the space between framing plus twice the width of the frame (2 x 45 mm) and installed with the segments end on to the framing.**

Cutting the insulation slightly wider enables the insulation to close up over the top of the framing, minimising the convective heat transfer. Figure 17 shows insulation cut to the width of the space between framing plus twice the width of the frame (2 x 45 mm)

In both cases, the insulation closes up very effectively over the top of the framing, and the thermal resistance would be expected to be very close to what would be achieved if the insulation was installed as two layers. For this particular insulation product, these two examples are indistinguishable but because some fibrous insulation products, particular polyester ones, can have a significant polarity in fibre rigidity, this may not always be the case. In one direction, the material may not close over the top of the framing as well as it does when oriented the other way.

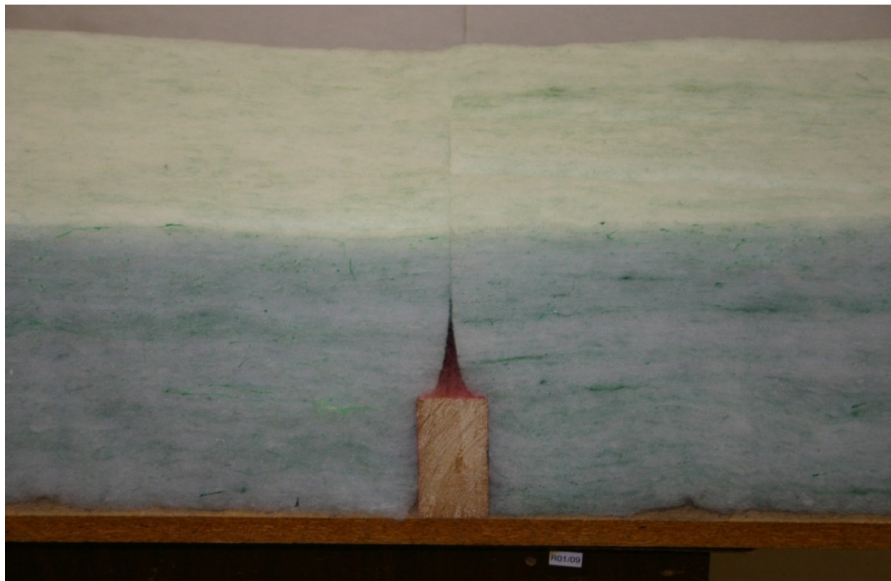
**Figure 18: Insulation cut to the width of the space between framing plus twice the width of the frame (2 x 45 mm) and installed with the segments side on to the framing.**

and installed with the segments end on to the framing. Figure 18 shows insulation cut to the same width but installed with the segments side on to the framing.
