STUDY REPORT

SR 268 (2012)

Drainage Planes and their Applicability in New Zealand

BRANZ Study Report SR 268

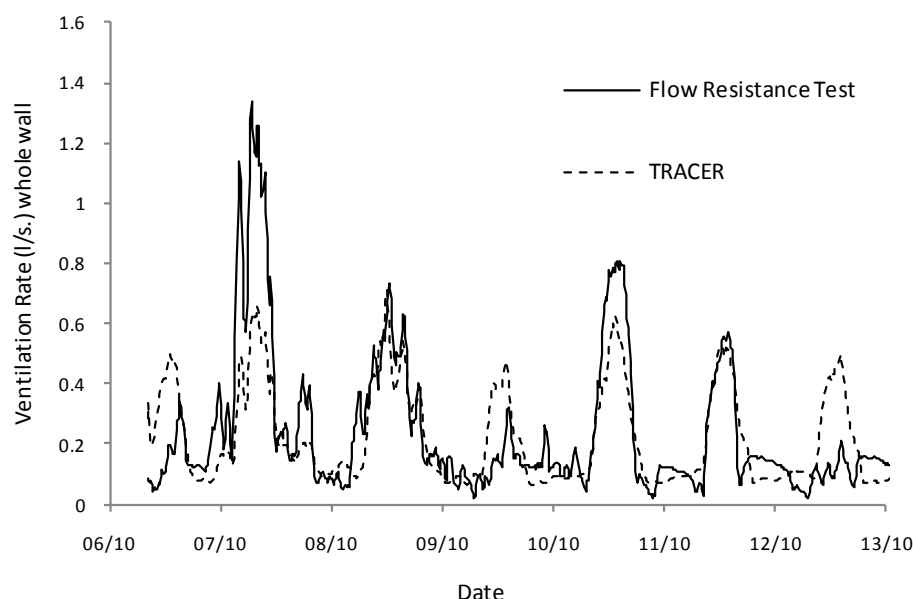
Figure 7 provides an example of comparing the measured ventilation rate (tracer) with that predicted by the airflow resistance, in this instance for Wall 23 (mesh mat).

Figure 7 Measured and Predicted Ventilation Rates for Wall 23

The consistent alignment between the measured and predicted ventilation rates validates using the power law relationships (refer to 5.2.1) to calculate ventilation rates.

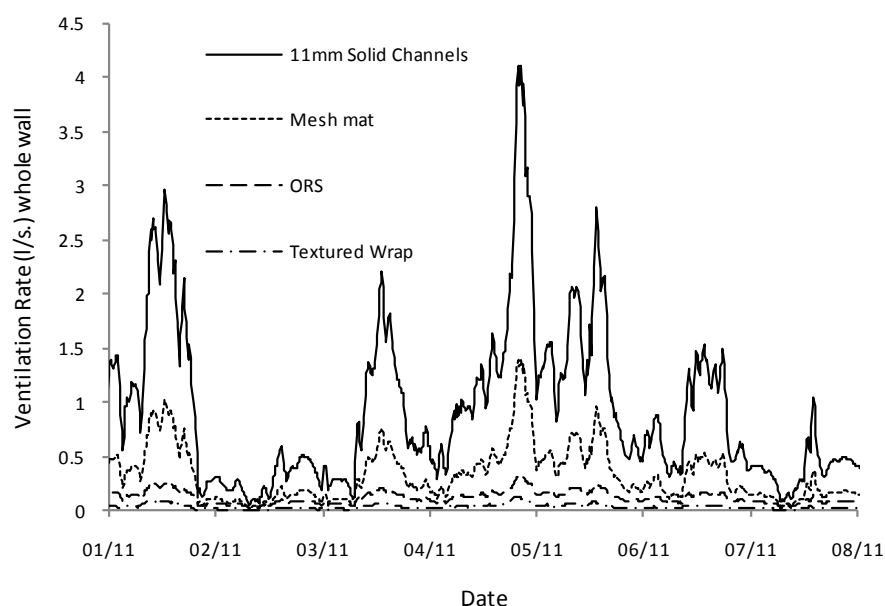
Figure 8 shows the predicted ventilation rate for a range of walls with different types of drainage plane. It can be seen that drainage plane walls generally have higher ventilation levels than an ORS with a full 20mm cavity.

Figure 8 Predicted Ventilation Rates for Different Types of Drainage Plane

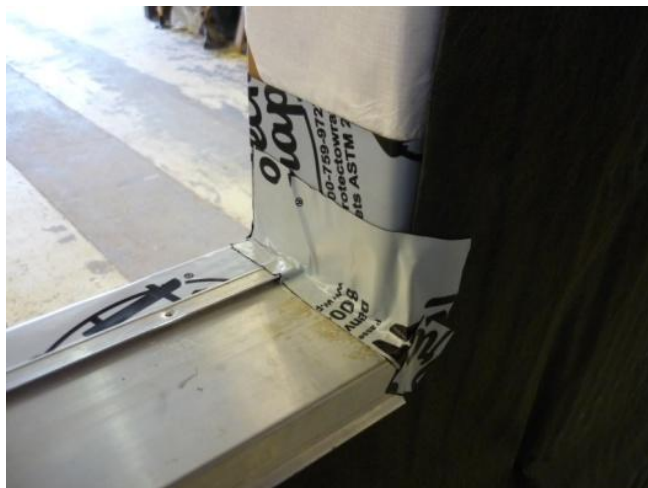
To install a window in a drainage plane wall the following was typically required to pass E2/VM1:

- A conventional head flashing.
- A sill tray (following E2/AS1:2005).
- The sill tray must be sealed to the jambs.

Figure 9 Window Sill Tray Details for Drainage Planes

If the sill tray is not sealed to the jamb, the specimens tend to fail E2/VM1 during the wetwall test.

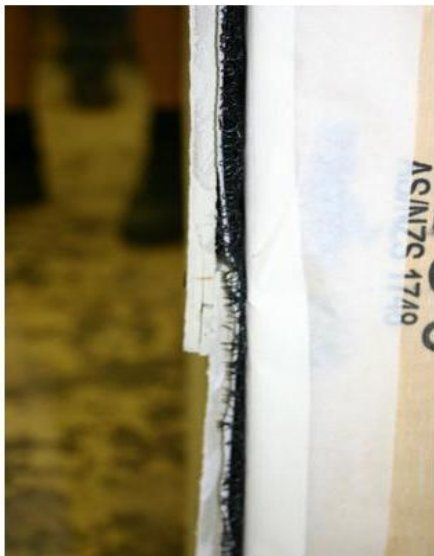
During the modified E2/VM1 test, no water penetrated the filter fabric. Therefore the “drainage” mesh performed no function other than holding the filter fabric against the cladding which is very different to how a “normal” cavity wall works. In a “normal” cavity wall, water that breaches the cladding enters a drainage space (the cavity) and can then drain

under gravity or be dried by airflow in the cavity. In the case of this particular drainage plane, the drainage path is ad-hoc like a direct-fix wall (albeit removed from the framing line) and is not as exposed to the ventilation in the mesh.

Figure 11 E2/VM1 Test 2 Specimen

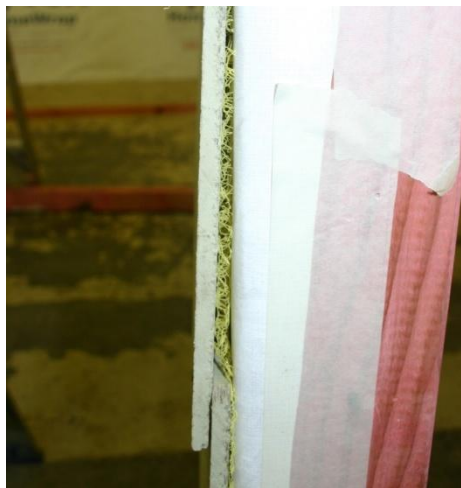
Test 1 involved a drainage product with no filter fabric. In this case the specimen failed because water reached the wrap during the water management part of the modified E2/VM1 test. Looking at the wall side-on it is easy to see the reason – the weatherboards completely compressed the product so that any water that penetrated had to touch the wrap. Incidentally, this particular product is marketed for use specifically with weatherboards, but it is debatable whether it altered the drainage gap naturally found behind most weatherboards.

Figure 12 E2/VM1 Test 1 Specimen

The importance of compressibility for drainage can be observed in Figure 12. If a 10mm cavity depth is chosen this should represent a “finished” cavity, not the nominal thickness of the drainage plane.

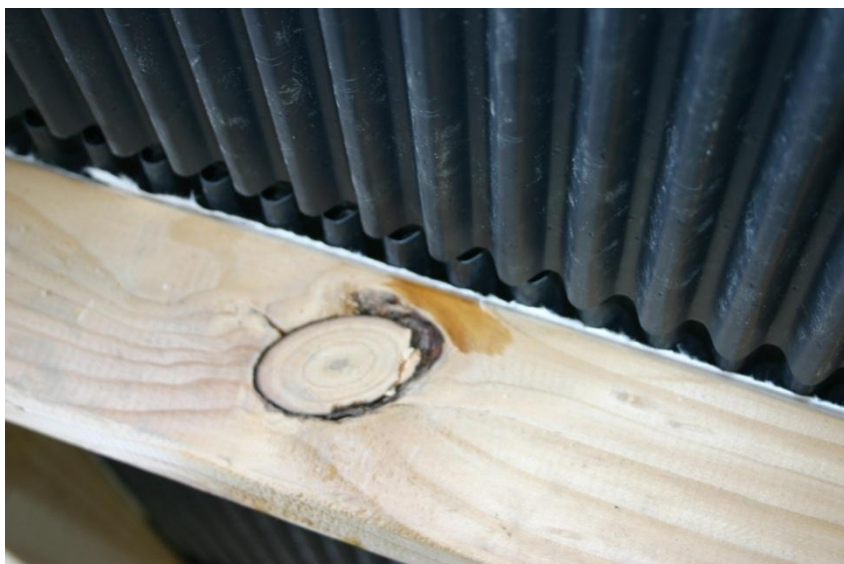
In Test 3 the drainage product consisted of relatively solid plastic channels. While this type of product functions most like a normal cavity wall (see Section 5.4), in this instance the product failed the modified E2/VM1 procedure during the wetwall test, but mainly because of a technicality. The upper course of the drainage product was simply butted up against the lower course (in line with manufacturer’s instructions). Therefore water that ran down the upper course dripped onto the inner face of the lower course and hit the framing.

Figure 13 E2/VM1 Test 3 Specimen

Note that the system had not failed until this point; the lining, insulation and wall underlay had “pressed” the courses of material against the cladding so that water dripped from the upper to the lower course. If the product had been lapped shingle fashion, the specimen would have passed the tests in E2/VM1.

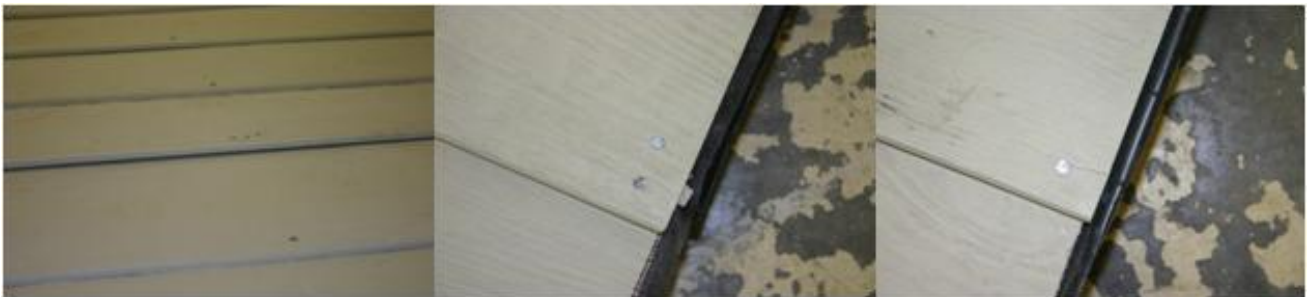
- Bulge in weatherboards.
- Nailthrough (over-nailing).
- Cracking of weatherboards.

Figure 17 Bulging, Nailthrough and Cracking of Claddings

These issues may be because of the particular combination of cladding and drainage plane but should be investigated as part of a thorough product appraisal.

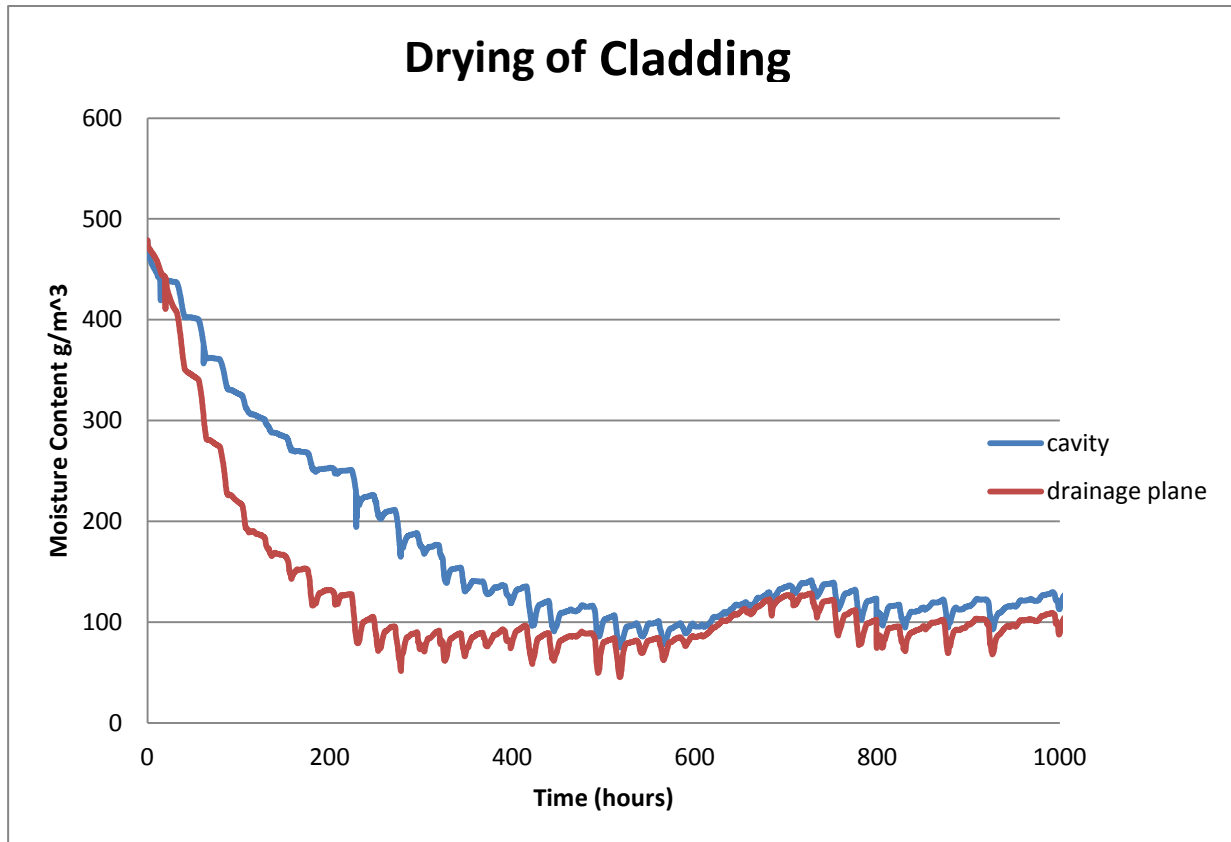
Figure A.6 Comparison of Drying Times

Figure A.6 shows that WUFI calculates the drying time for the cavity wall to be longer than that of the drainage plane wall.

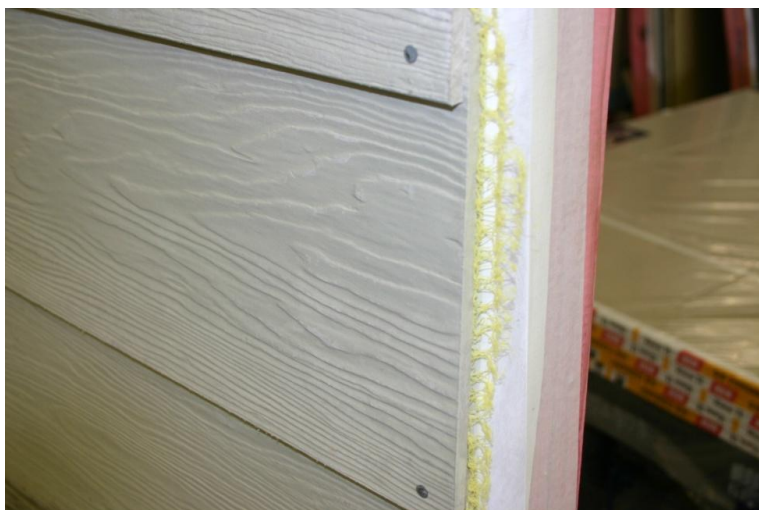
Figure A.8 Face Nailing of Weatherboards

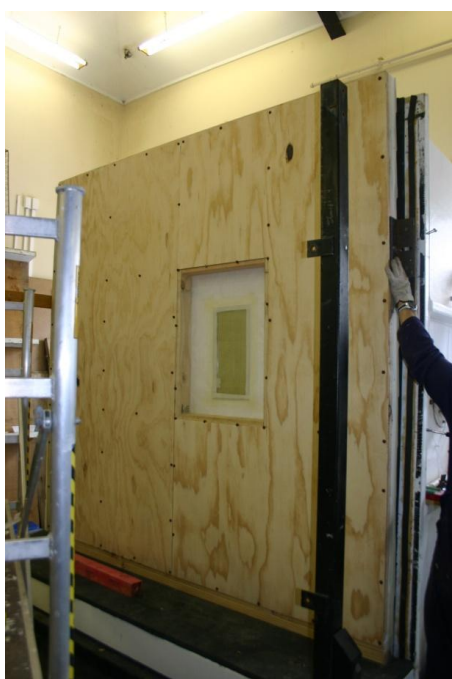
Figure A.9 Perspex Panels in Line with Underlay and Plywood Interior Linings

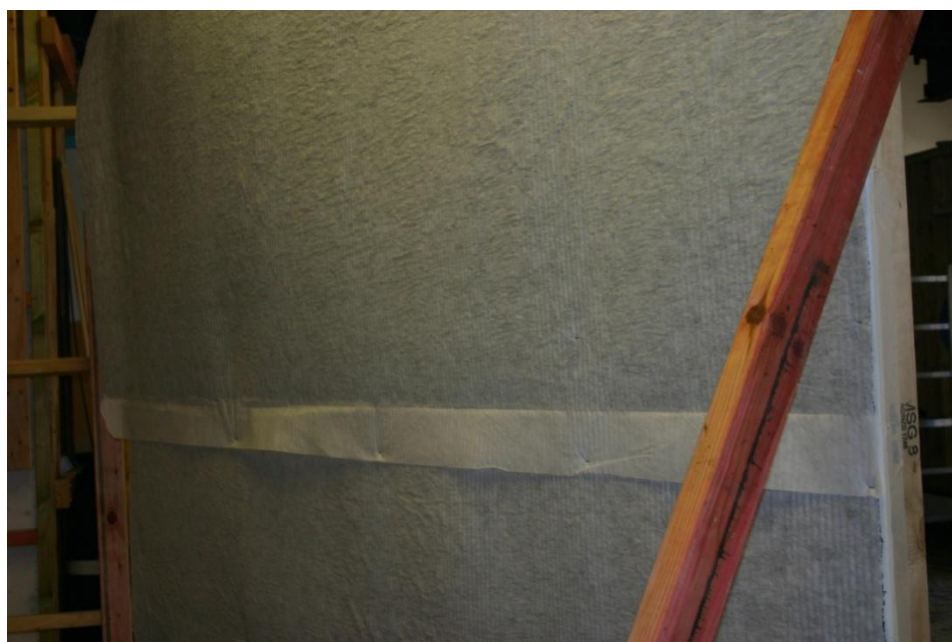
Figure A.10 Detail Showing Lapping of Drainage Product Filter Fabric

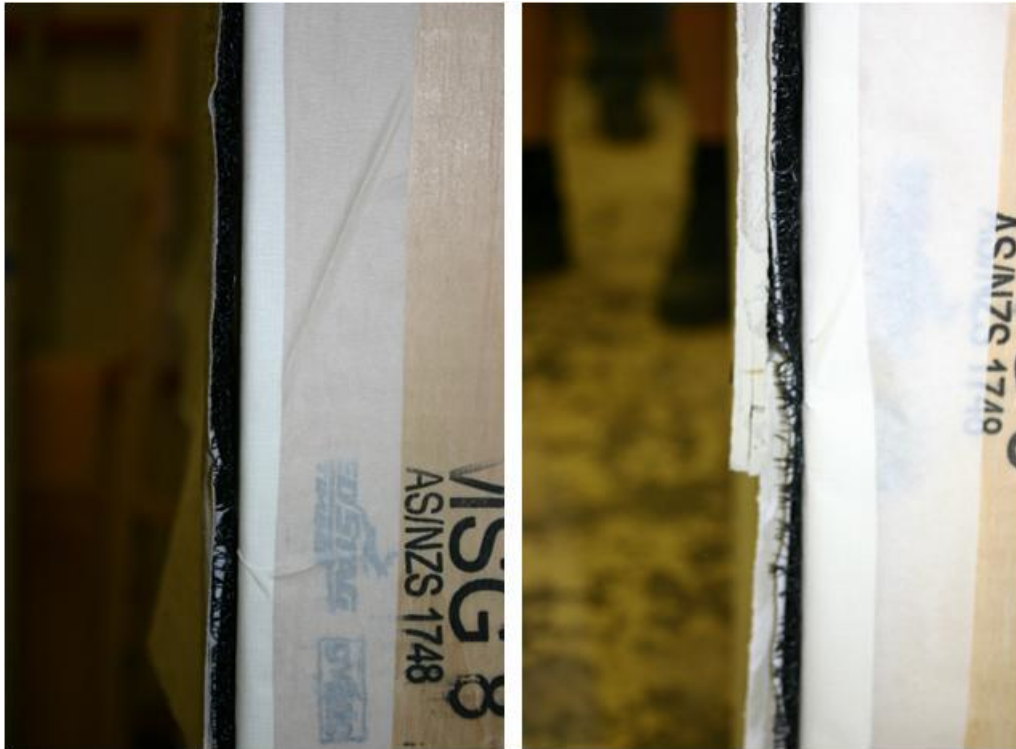
Figure A.11 Compression of Drainage Product after Cladding is Applied

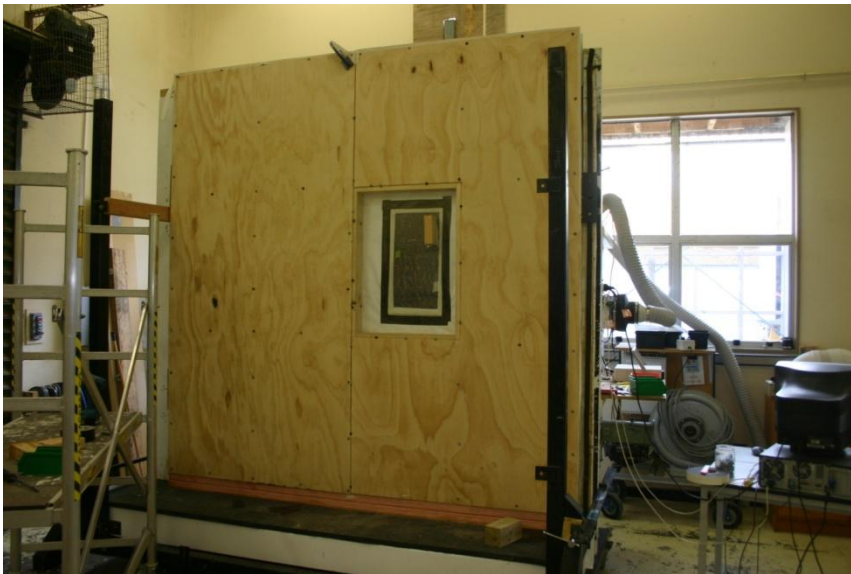
Figure A.12 Perspex Panels in Line with Underlay and Plywood Interior Linings

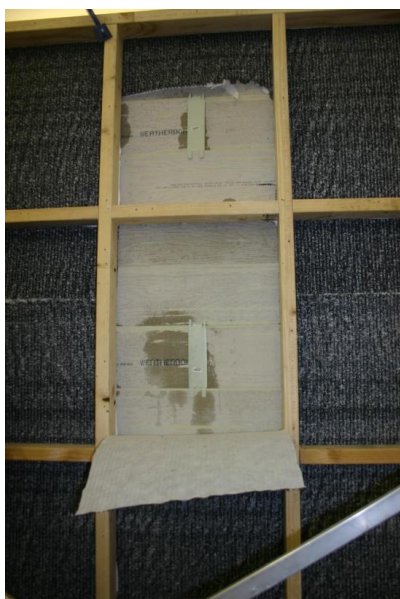
After completion of the wetwall test the pressure was ramped up to 150Pa. Water percolated through the larger gaps in the vicinity of the jointers. This gap was formed by the jointer itself and would have been present even if the butt joint between boards was sealed. Water that did penetrate at the butt joints was deflected by the jointer and drained back out (see Figure A.13).

Figure A.13 Water Penetration Through Boards

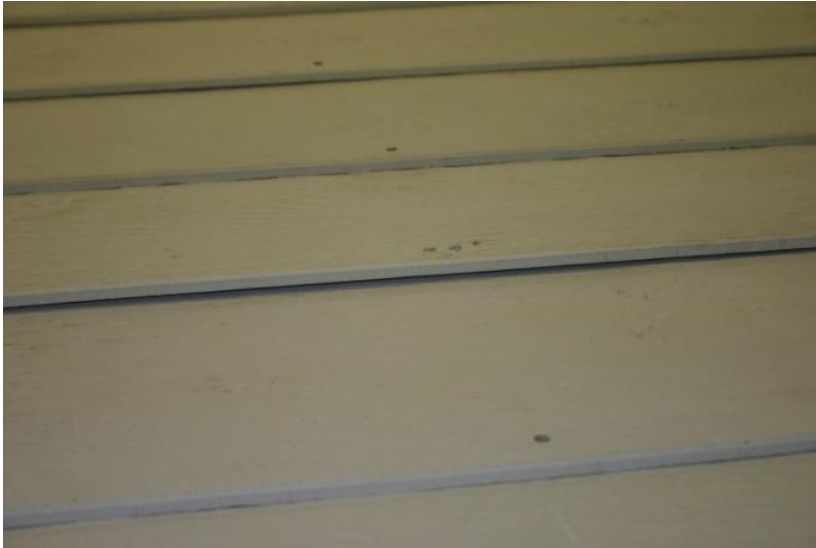
Figure A.14 Bulge in Weatherboards

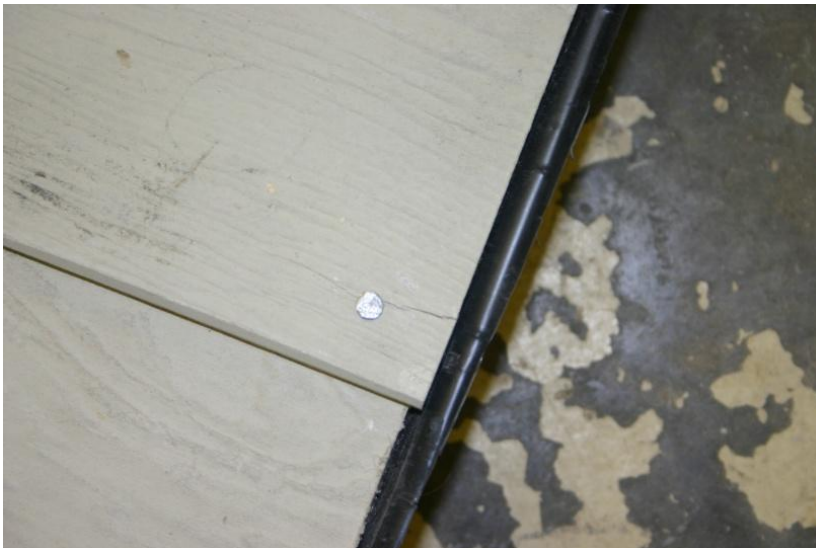
Figure A.15 Cracking of Weatherboards

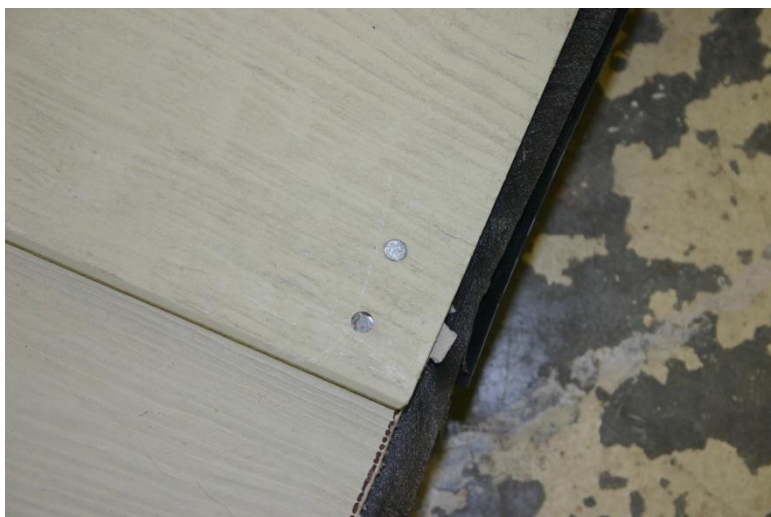
Figure A.16 Nailthrough Required a Second Nail to be Used Here

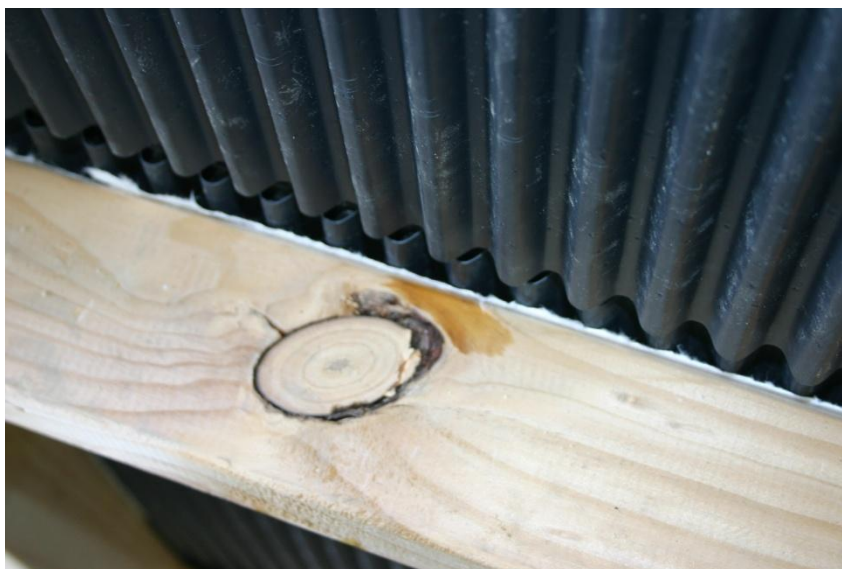
Water was thought to penetrate through the larger gaps near the jointer. The amount of water coming through the cladding would have been highest in the wetwall test. During the other parts of E2/VM1 a higher degree of pressure equalisation across the cladding should have occurred due to the relatively large vent areas (at the bottom of the wall and between the boards) and low leakage (a single piece of underlay with no lap joints). This equalisation would lead to less of a pressure drop across the cladding and hence less water penetration than during the wetwall test. When this water was incident on the upper course of the drainage product, it drained down the surface. When water reached the bottom of the upper course, it dripped down and since the lower course was not lapped under the upper course and the channels were not perfectly aligned, water was able to drip on to the framing (see Figure A.17).

Figure A.17 Frame Wetting During the Wetwall Test Due to Product Not Lapping
