# Retrofit performance measurement of Kotuku Apartments

This is the second of a series of three BRANZ study reports prepared on the upgrading of Wellington City Council's four low-rise Kotuku Apartments, located in the suburb of Kilbirnie, Wellington, New Zealand. This report's focus is on the actual building performance transformation via a suite of in situ experiments executed to quantify aspects related to comfort, cost and liveability.

## BRANZ Study Report SR369

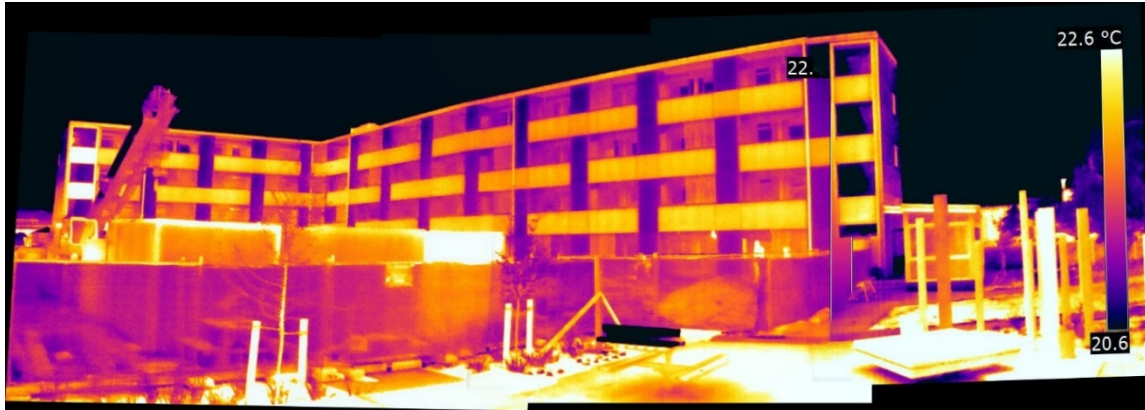
**Figure 2. Apartment Blocks A and B in early 2016 during renovation.**

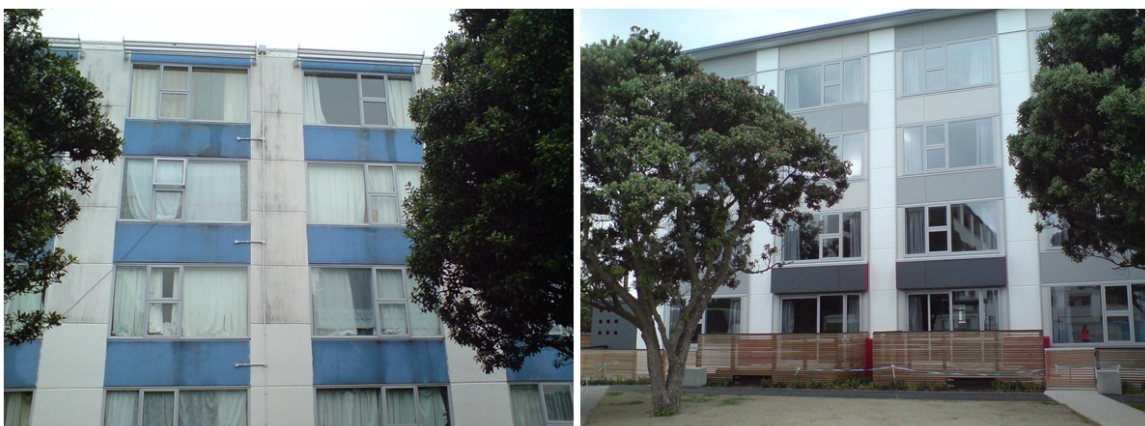
A FLIR P640 thermal imaging camera was used for the Kotuku Apartments field experiments. The FLIR camera has a 640 x 480 image resolution and a sensitivity of 30 mK. Both BRANZ camera operators had specialist thermal imaging training (i.e. Level 2 ASNT equivalent certification or higher) to ensure competent usage. The initial thermal images were taken in September and October 2013 before Kotuku Apartments were renovated. The second set of images, post-renovation, were taken in mid May 2016 around noon. The weather targeted was close to ideal for thermographic examination – overcast, with low contrast to reduce reflection, and no surface moisture for both field visits. A more regular picture of an external wall façade is shown in Figure 3 .

**Figure 3. Kotuku Apartments (left: pre-renovation and right: post-renovation).**

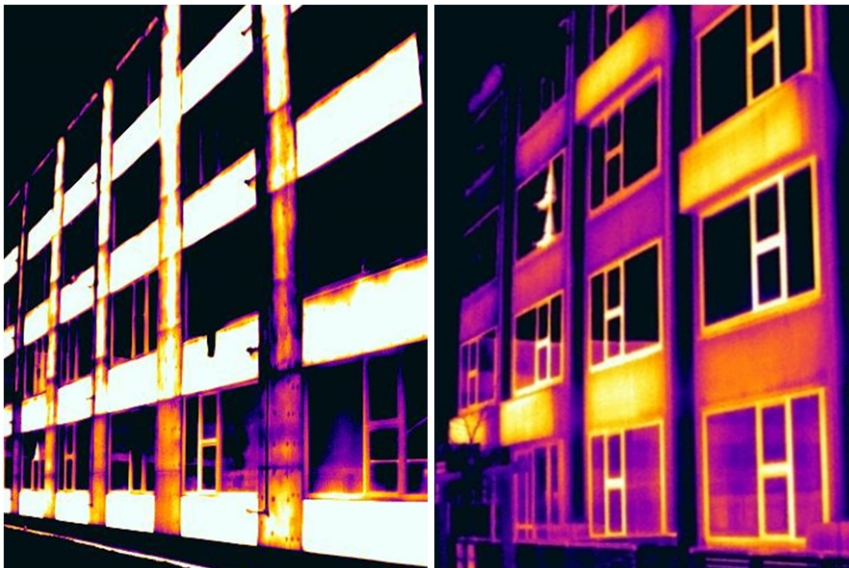
Note that the 'before' colours (and therefore temperatures) do not match the 'after' colours in these and all the remaining pictures. Thus, the rate of heat loss can only be compared within a picture rather than between pictures.

**Figure 4. Polystyrene wall panels (left: pre-renovation and right: post-renovation).**

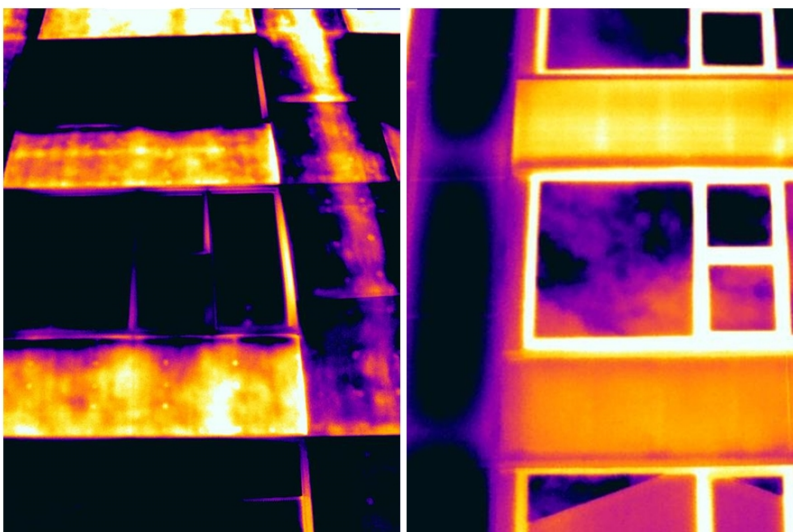
**Figure 5. Water ingress in exterior wall panels (left: pre-renovation and right: post-renovation).**

Saturated insulation is far less effective than dry insulation in providing thermal resistance. It was estimated that the compromised polystyrene sheet insulation shown would be approximately half as effective than if it was dry (I. Cox-Smith, personal communication, 20 April 2014). Since the saturated spandrel panels were replaced as part of the renovation, the resulting thermal performance of the wall system should have been significantly improved. This expectation was confirmed by the results from the in situ R-value measurements using heat flux transducers.

The Figure 5 'after' image shows the saturated insulation panels have been replaced, demonstrated by the even colour tones. The invisible spectrum (infrared) surface temperature difference between the panels is due to the visible spectrum colour of the newly painted panel surface. Some were painted with dark colour and therefore absorbed more heat and were warmer than the others painted in lighter colours (see Figure 3 post-renovation). Insulation has also been added in the soffit to reduce heat loss (see Figure 6). However, there was still some heat loss through the base of the wall where the cladding meets the concrete floor (see the arrow in Figure 7).

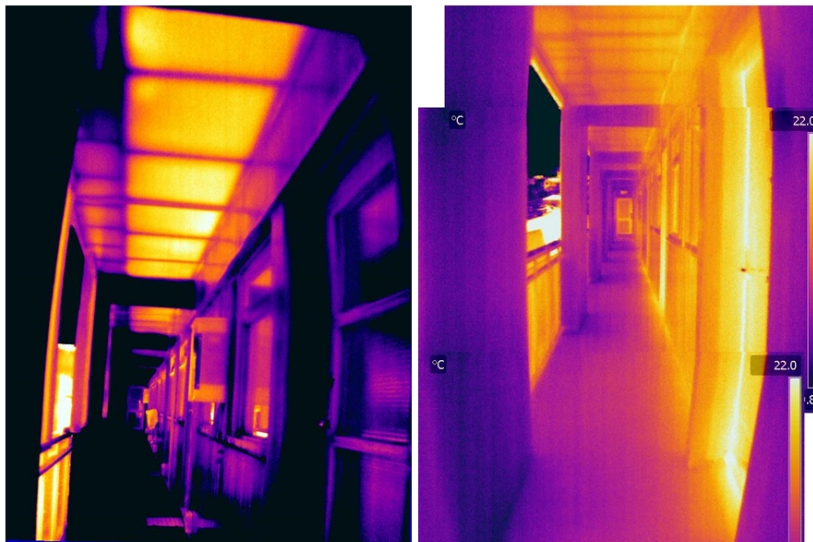
**Figure 6. Heat loss through soffits above open walkways (left: pre-renovation and right: post-renovation).**

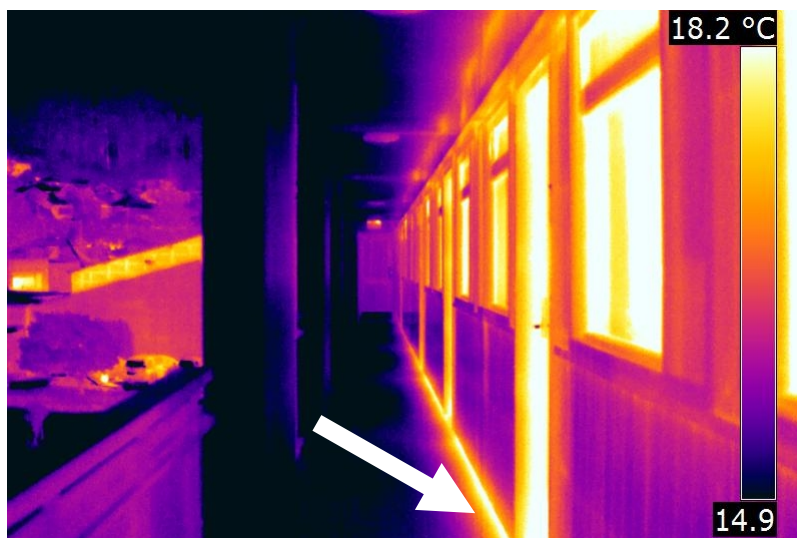
**Figure 7. Post-renovation heat loss through wall adjoining open walkway.**

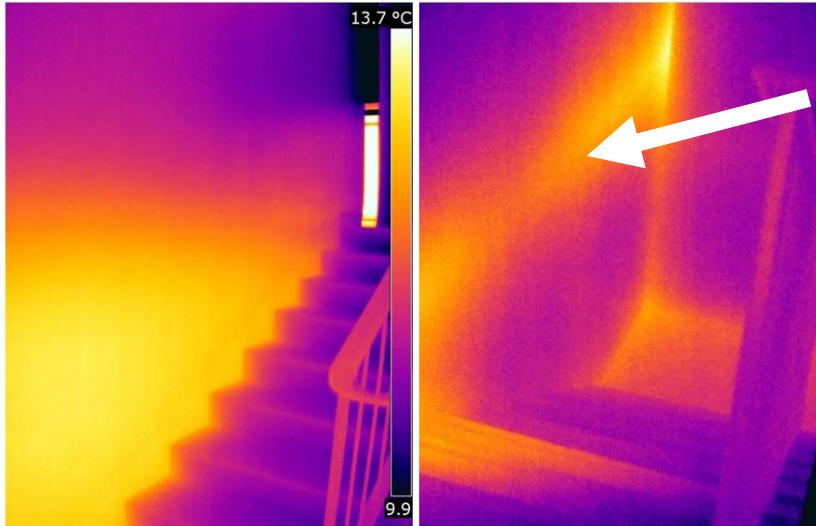
Figure 8 shows the impact of insulating the wall adjacent to a staircase, in terms of reducing heat loss, post-renovation. The renovated wall shows dark pink (i.e. a cooler temperature) over most of the wall apart from the floor-wall intersection (arrowed). This shows that the installed wall insulation has been effective at minimising the heat transfer through the wall. This is true for everywhere apart from the junction, which acts as a thermal bridge and cannot be easily thermally rectified using this type of renovation.

**Figure 8. Heat loss in stairwell (left: pre-renovation and right: post-renovation).**

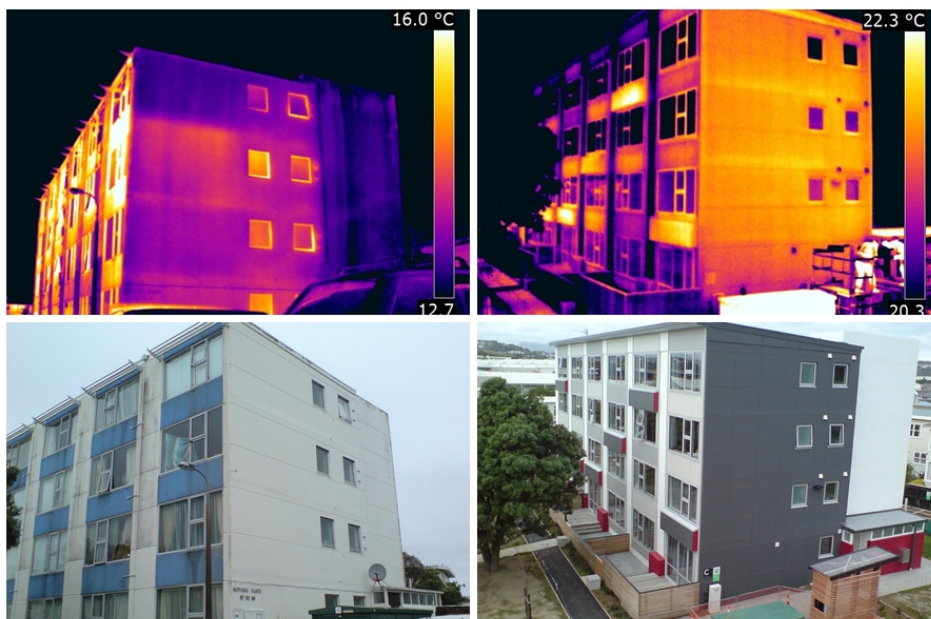
Before renovation, the top floor unit appeared to be cooler because of lack of insulation (Figure 9). Previous thermal simulation parametric studies (Buckett & Jaques, 2016) have shown that the top floor in this building was especially vulnerable thermally. This is due to its lack of any significant ceiling roof insulation, not having the potential benefits from heated apartments above it to minimise heat losses and receiving the strongest wind effect of all the levels. Post-renovation, this situation has changed dramatically, as demonstrated by the considerably more even thermal gradients between floors.

**Figure 9. Slab junction bridging (left: pre-renovation and right: post-renovation).**

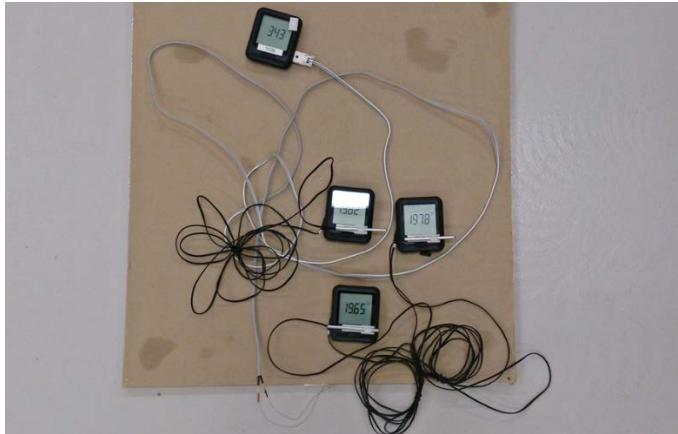
- a 600 x 600 mm main panel
- four 150 mm wide surround edge panels of similar R-value to minimise edge errors
- a data acquisition unit or wireless Wi-Fi logger to record HFT output, and
- either type-T thermocouples or wireless Wi-Fi temperature loggers to measure concurrent indoor and outdoor temperatures (see Figure 10).

**Figure 10. The BRANZ 600 x 600mm HFT panel (light brown) and Wi-Fi loggers.**

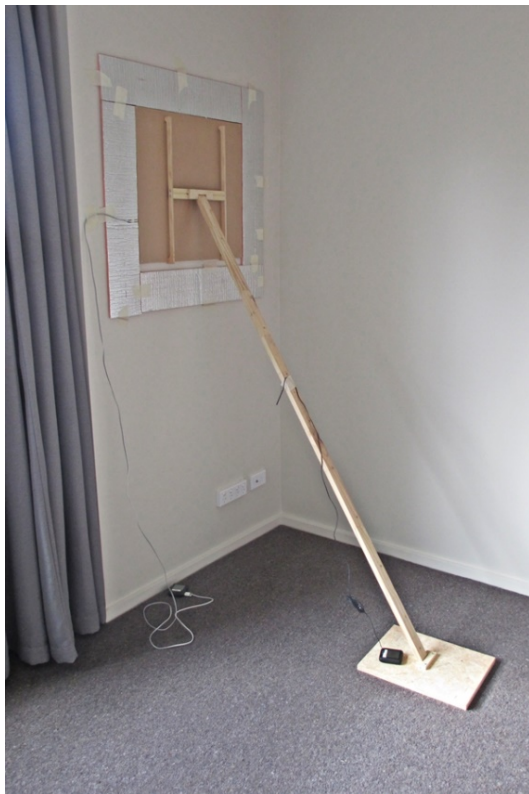
Three to four calibrated HFTs were set up in the end units in Block D on Level 1 and 3 for several days in May/April 2014 and then again in May 2016 to compare the thermal performance before/after renovation (see Figure 11). In 2014, type-T thermocouples were utilised. These were replaced in 2016 with Wi-Fi temperature loggers and a data acquisition unit to record HFT output to bypass the need to drill the steel entry door for cabling.

**Figure 11. Set-up in the apartment, showing physical supporting mechanism.**

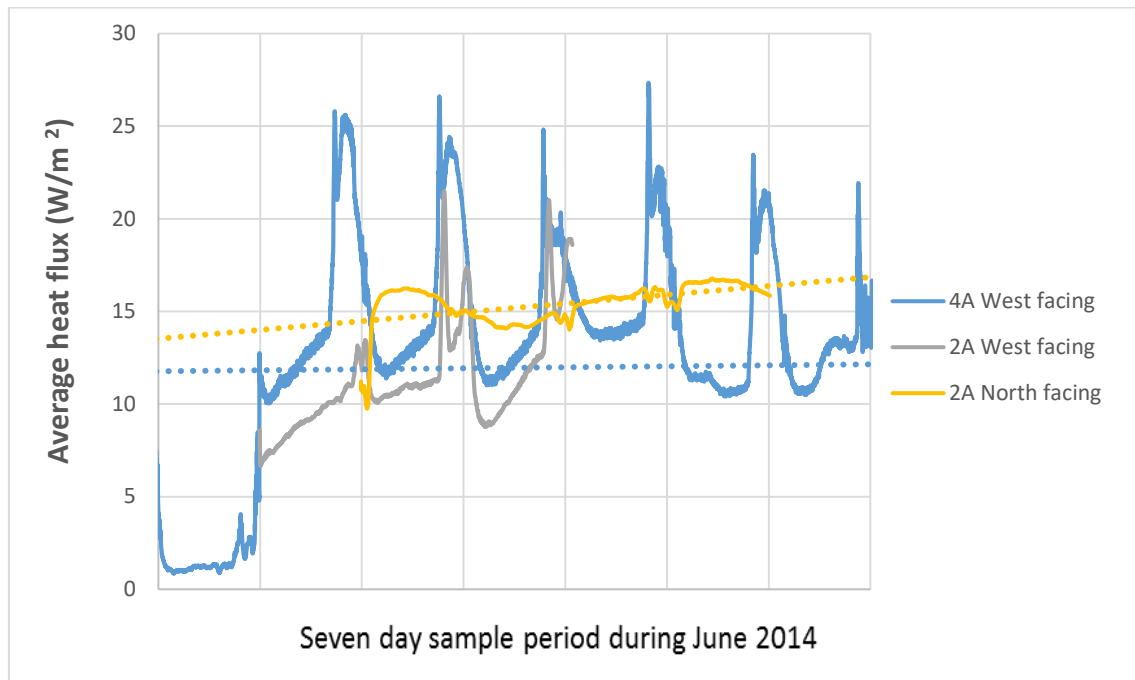
The average heat flux (i.e. rate of heat flow for an area) of the wall system in 2014 was approximately 10–15 W/m<sup>2</sup> (see Figure 12). This is shown by the dotted lines in each of the graphs. In 2016, after renovation, the average heat flux of the wall system was decreased to approximately 10 W/m<sup>2</sup> (see Figure 13).

**Figure 12. Hourly average heat flux (W/m<sup>2</sup>) before renovation.**

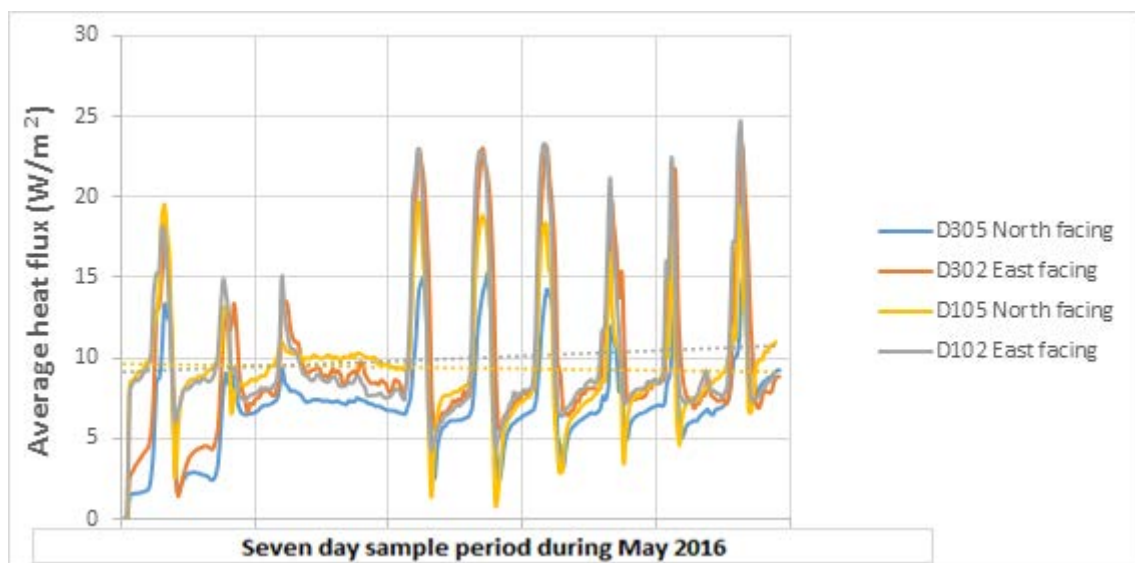
**Figure 13. Hourly average heat flux (W/m<sup>2</sup>) after renovation.**

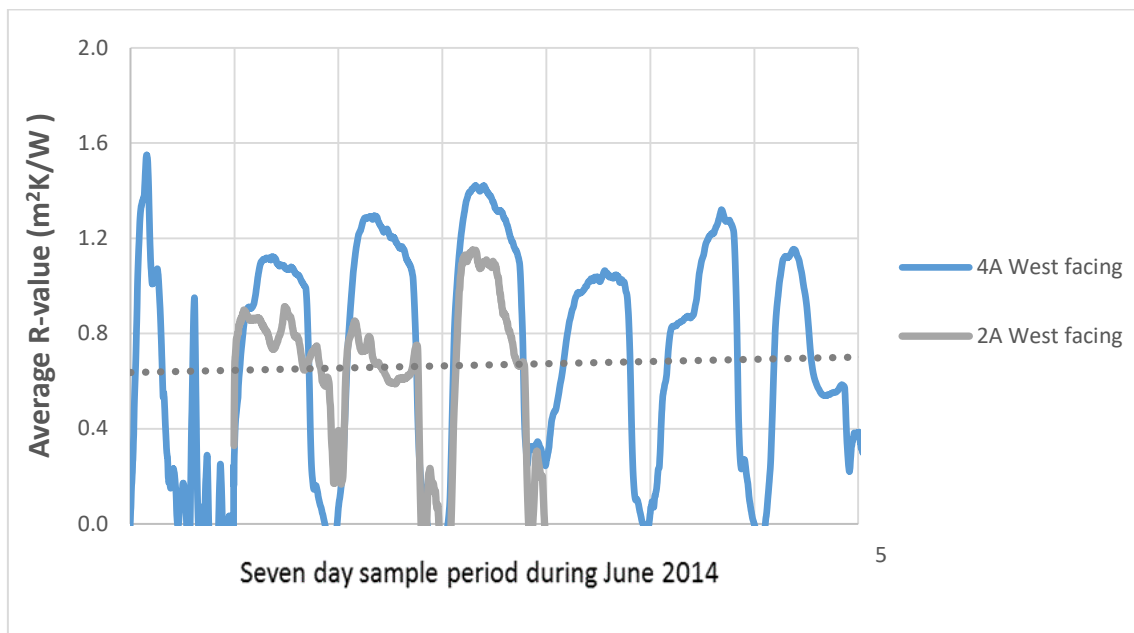
The average R-value of the walls in 2014 was approximately 0.6 m<sup>2</sup>K/W (see Figure 14). After the renovation in 2016, the average R-value of the walls increased to approximately 1.0 m<sup>2</sup>K/W for heated apartment units (i.e. east-facing walls) and approximately 1.1 m<sup>2</sup>K/W for unheated apartment units (i.e. north-facing walls) (see Figure 15).

**Figure 14. Average hourly R-value (m<sup>2</sup>K/W) before renovation.**

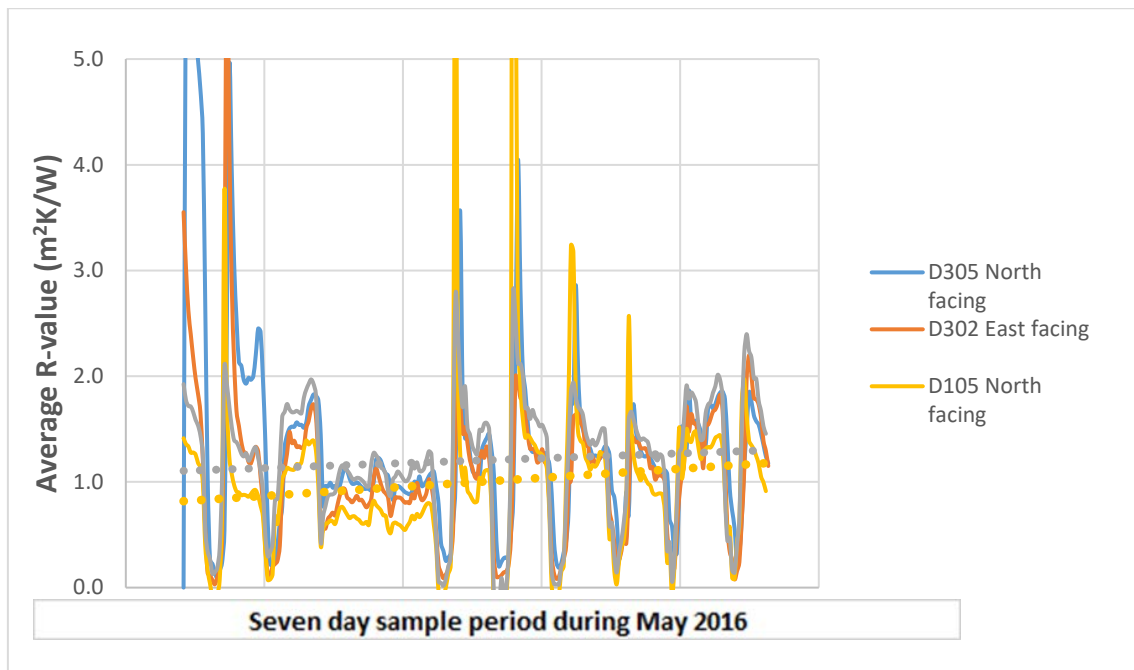
**Figure 15. Average hourly R-value (m<sup>2</sup>K/W) after renovation.**

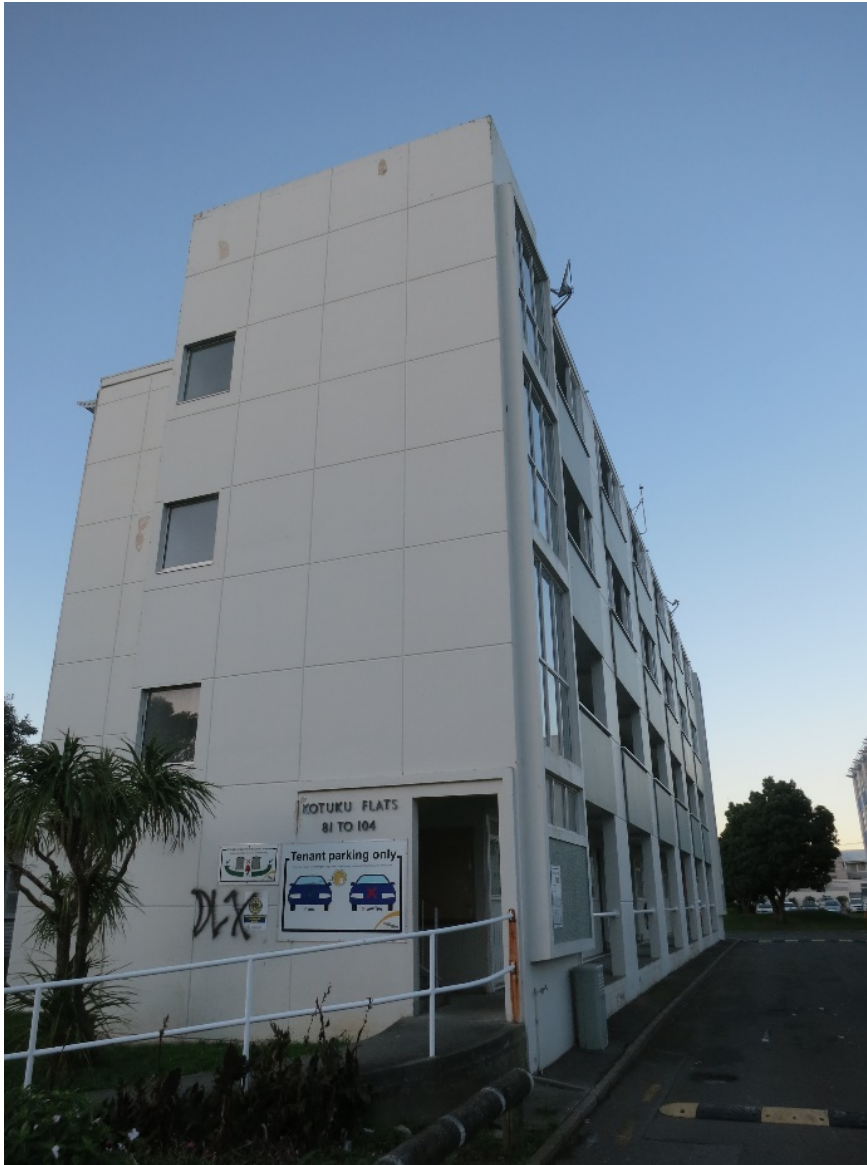
**Figure 16. Apartment Block D, prior to renovations, looking east.**

Block D was used as a proxy for the co-heating testing, being essentially very similar in construction to the other three blocks (see Figure 16). In addition, it had the advantage of being the first block scheduled to be renovated and then reinhabited, so testing could be completed sooner than the other apartments. It is the westernmost block, having by far the bulk of its glazing north-facing, and four storeys high. The co-heating tests were conducted during complete vacancy for 2 weeks before the start of renovations (in June 2014) and then again for 2 weeks after the renovations rehabilitation (in May 2016).

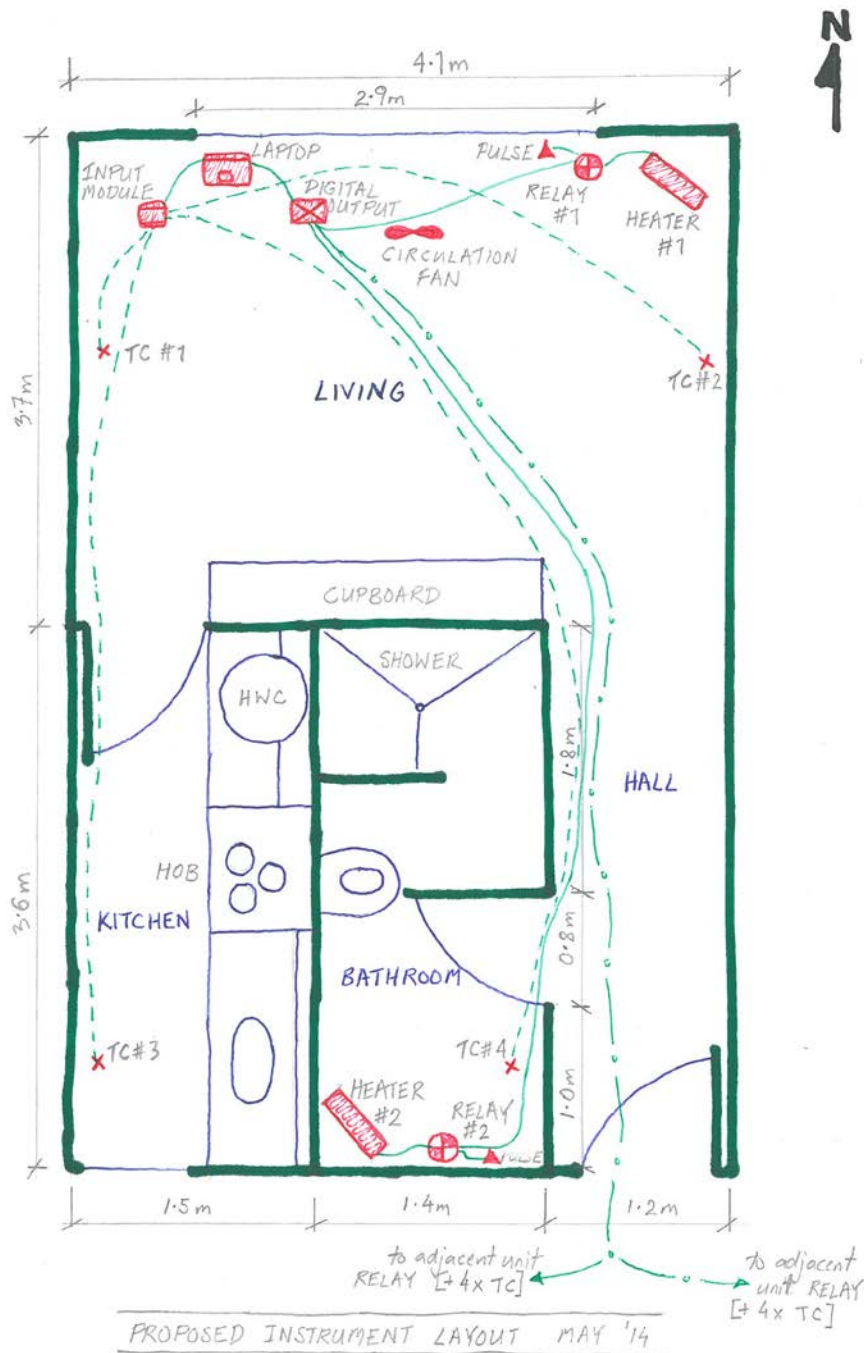
Both the before and after experimental set-ups comprised the internal temperature stabilising of three adjacent apartments (by floor) for over a week. Multi-floors were set up this way so that a vertical central core would be effectively thermally cocooned by the adjacent apartments. Each unit consisted of two space heaters, an air circulation fan and several temperature/humidity data loggers. The central unit also contained various extra switching controls and loggers. A schematic of the central unit equipment layout is shown in Figure 17. (Key: pulse = pulse logger, TC = thermocouple wire stands, heater = convection-type space heater, fan = standard oscillating mixing fan). Not shown are the two temperature and humidity loggers located on the eastern living room wall and on the kitchen door.

**Figure 17. Typical instrument set-up (pre-renovation) for central apartment co-heating layout.**

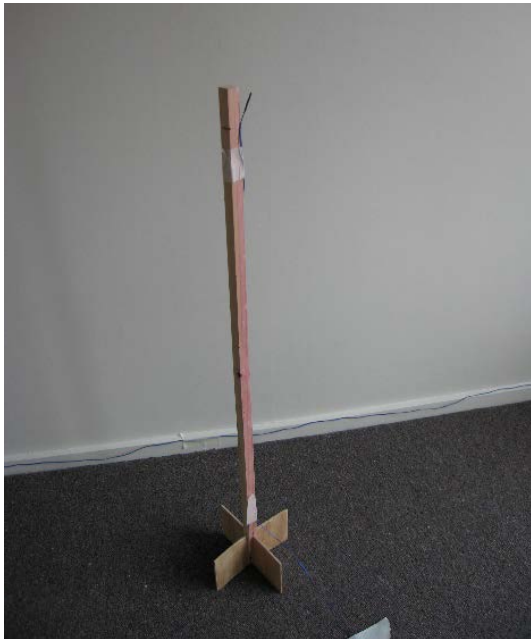
**Figure 18. Typical thermocouple wire at 0.85 m height supported by timber stand.**

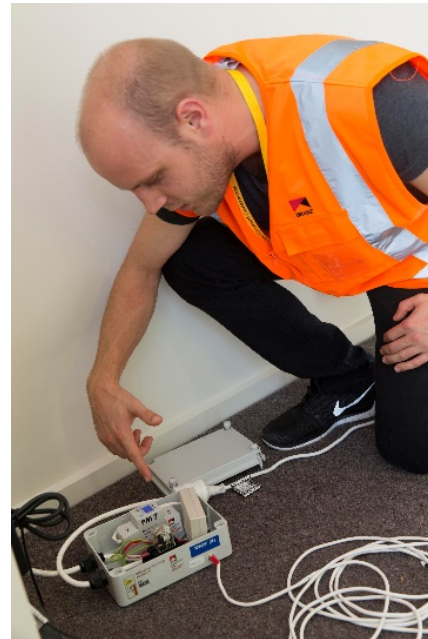
Pulse loggers attached to the heaters tracked the on-off switching necessary for long-term indoor temperature stabilisation, therefore enabling the calculation of total energy requirements (see Figure 19).

**Figure 19. Heater relay and pulse meter box. (Photography: Neil Price)**

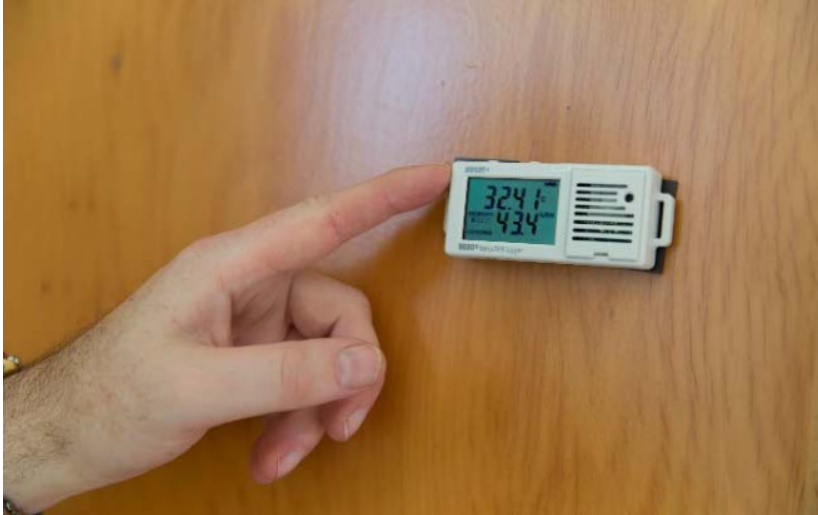
Space heaters were logged at 1 minute intervals while temperature and humidity were also logged at 1 minute intervals. In the post-renovation set-up, all the space heater-related logged data was pushed via a cellular connection to a database server at BRANZ for back-up, remote access and dynamic troubleshooting.

**Figure 20. Temperature and relative humidity sensor/logger on kitchen door. (Photography: WCC)**

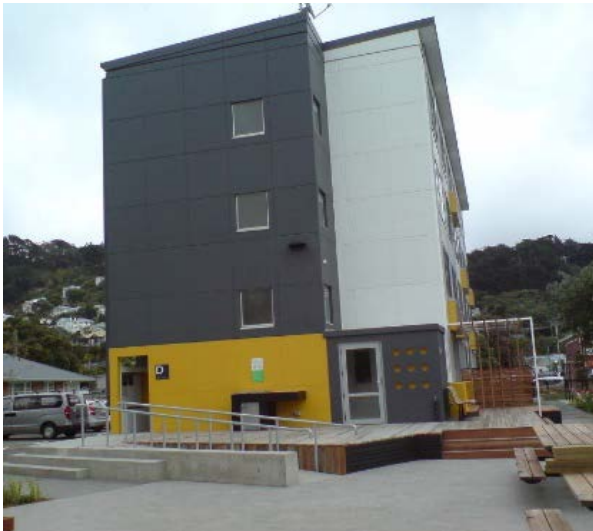
**Figure 21. Block D post-renovation, looking west.**

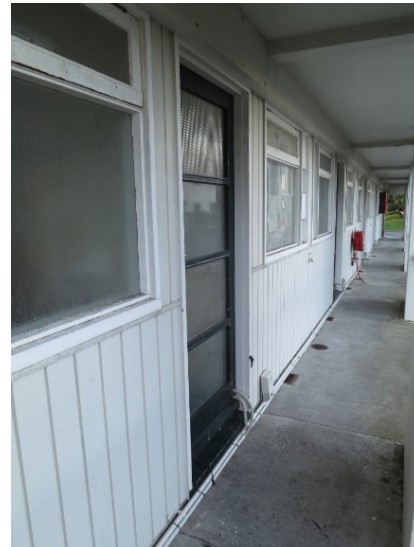
**Figure 22. Cable runs (in plastic conduits) from base of central unit door to adjacent units.**

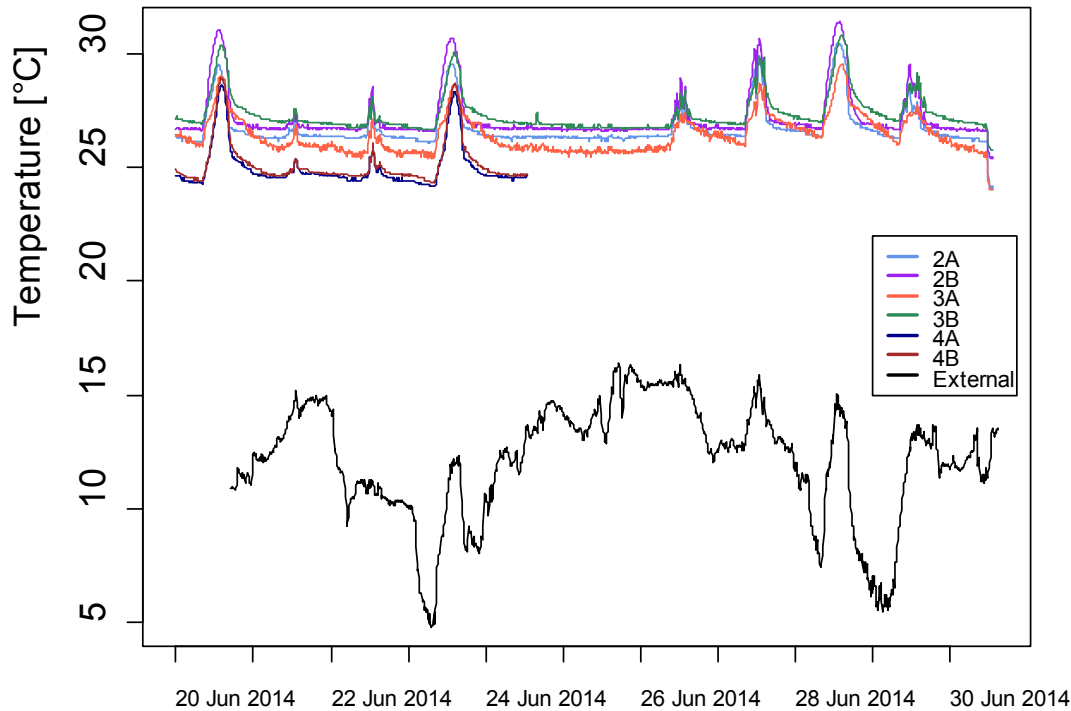
Figure 23 gives the temperatures within each of the apartments as well as the outside temperature (measured on site) during the 2-week pre-renovation period (June 2014). Owing to equipment limitations, the three edge apartments and those on the ground floor were not able to be temperature controlled very accurately using computers. Instead, these apartment heaters were reliant on their (less-accurate) space heater thermostats.

**Figure 23. Outside temperature and temperatures within each apartment under test during the pre-renovation period (June 2014).**

The intent was to stabilise the temperatures within each apartment to 27°C. However, some apartments struggled to achieve this pre-renovation. Despite their small size (at around 30m<sup>2</sup>) and the use of 4 kW of heating, the externally exposed apartments (on the top level and at the end of the block) struggled to achieve this temperature continuously. This was due to these apartments having large, poorly insulated surfaces exposed to outside conditions. The two core units (3B and 2B) that were surrounded by conditioned apartments can be seen in Figure 23 to be the closest to the 27°C set point temperature.

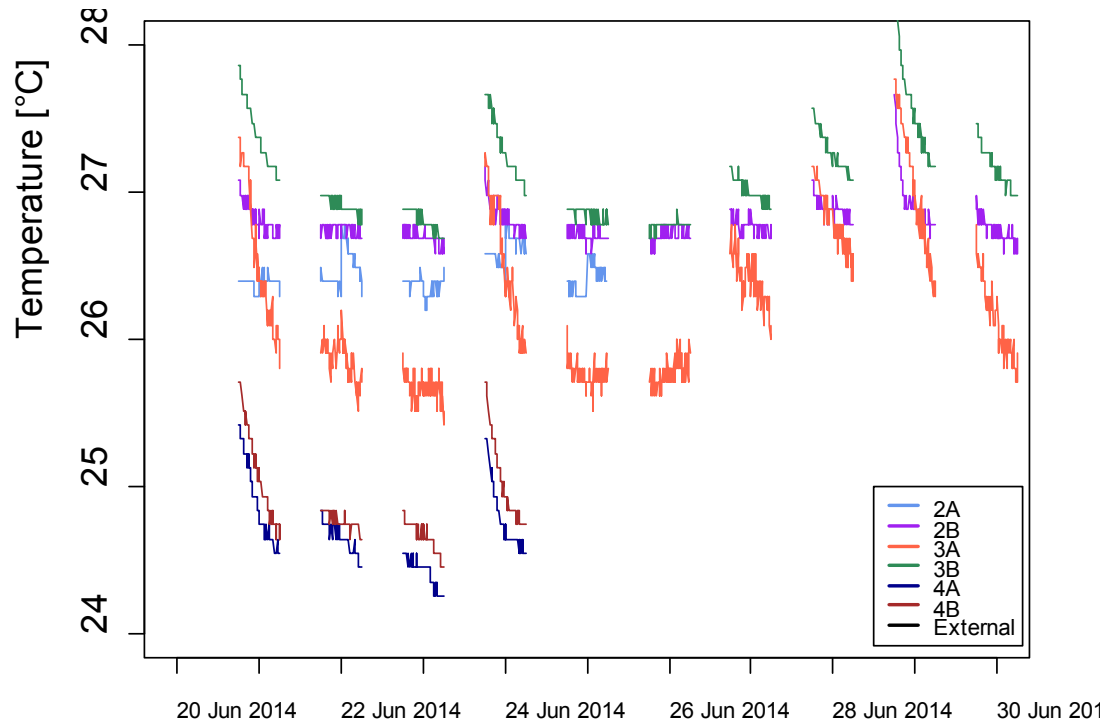
To artificially remove the influence of the solar gains, only overnight data (i.e. 6pm–6am) was examined. Figure 24 shows a close-up of the overnight temperatures in each of the monitored apartments. Rather than being flat for the duration of the overnight period, many apartments show a steady reduction in temperature throughout the night. By comparing Figure 24 and Figure 23, this effect is particularly pronounced when the preceding daytime temperature was high. This response is what would be expected when there is an interplay between the thermal mass of the building and the air temperature within the apartments. Heat from the day charges the thermal mass within the room to be later released at night-time when the room cools down.

**Figure 24. Temperatures within the monitored apartments showing only the overnight (6pm–6am) temperatures.**

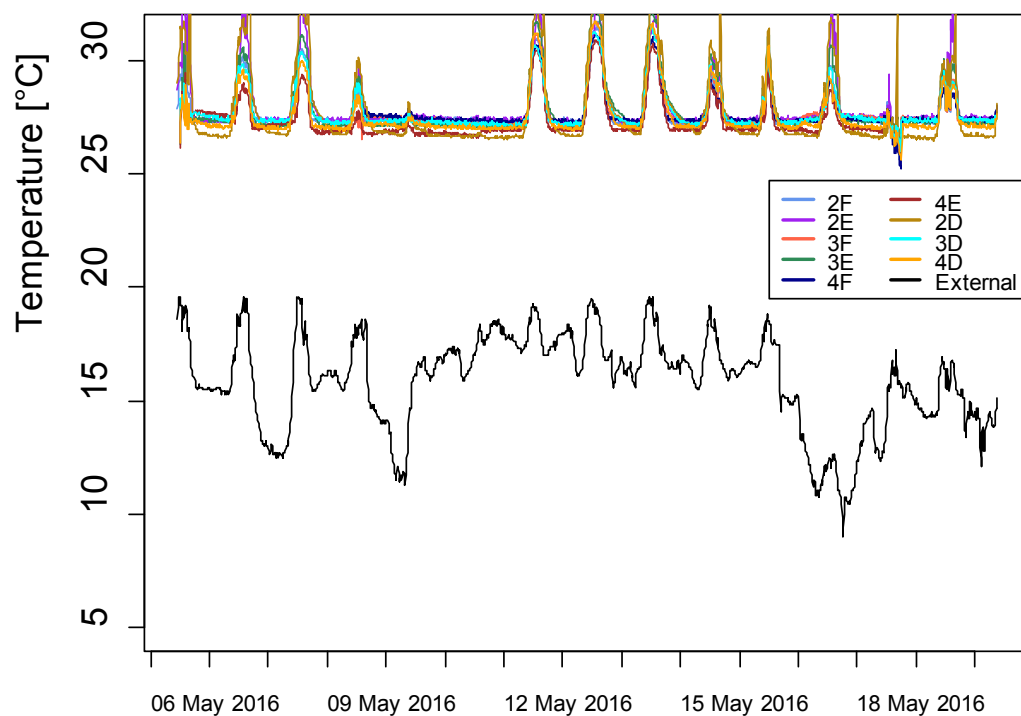
Figure 25 shows the outside temperature as well as the temperatures in the equivalent apartments after the renovations during the monitored period of May 2016. The average outside temperature during the pre-renovation was considerably colder (at 11.7°C) than the post-renovation period (at 15.4°C).

**Figure 25. Post-renovation temperatures.**

The achieved indoor temperatures in the apartments during the 2016 monitoring period are much more consistent than those achieved in 2014. This is reflected in the smaller overnight temperature range. Although daytime solar gains still result in temperatures peaking over 32°C, the overnight temperatures are considerably more stable – in most cases almost flatlining (see Figure 25). The required space heating for the overnight periods is shown in Figure 26 and Figure 27.

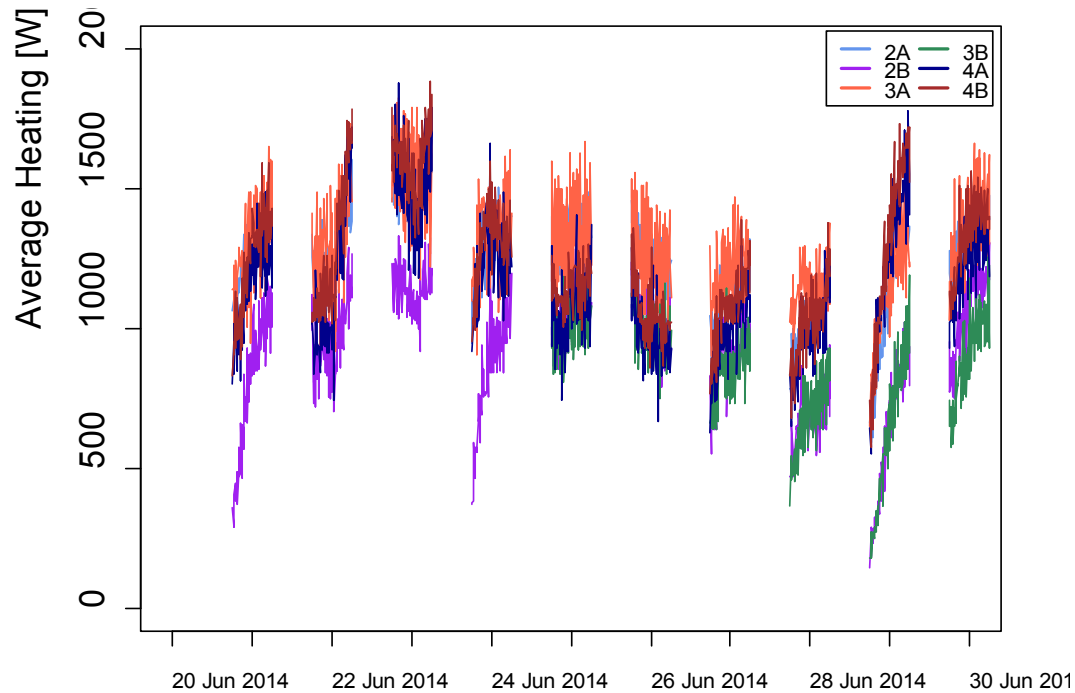
**Figure 26. Overnight heating (averaged over 10-minute periods) before the renovations.**

The average overnight heating from the external side apartments before the renovations was 1121 W per apartment and 725 W per apartment after the renovations. The two primary factors influencing this post-renovation space heating reduction are the upgraded thermal insulation and the higher outside temperatures experienced. It is not possible to determine the proportional influence of each from this data alone due to the unknown contributions of mass and solar irradiation.

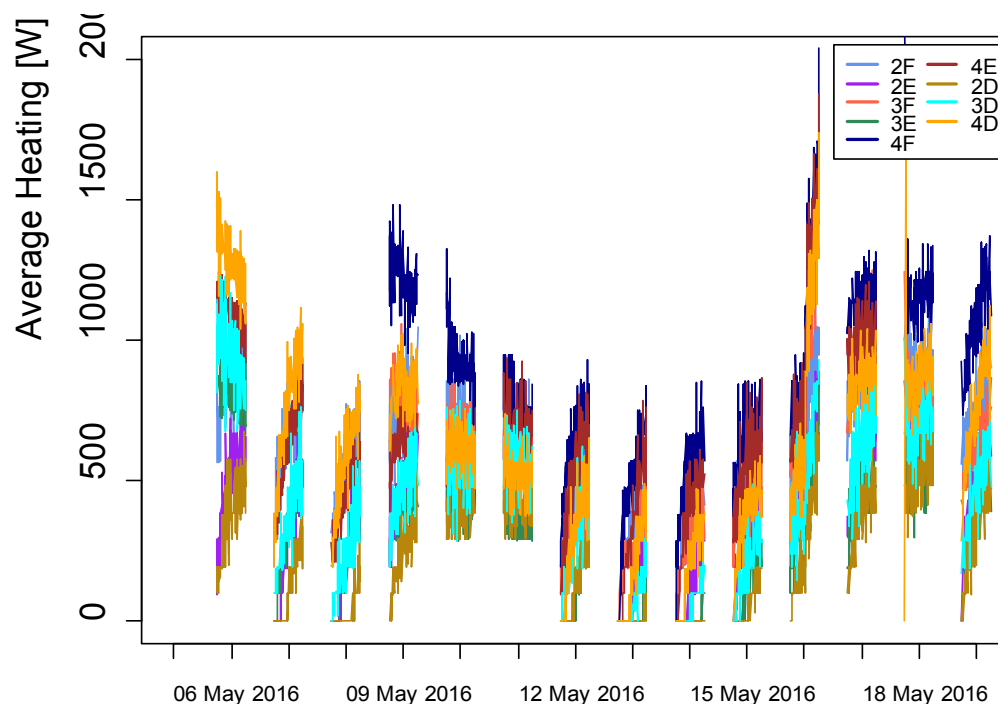
**Figure 27. Overnight heating (averaged over 10-minute periods) after the renovations.**

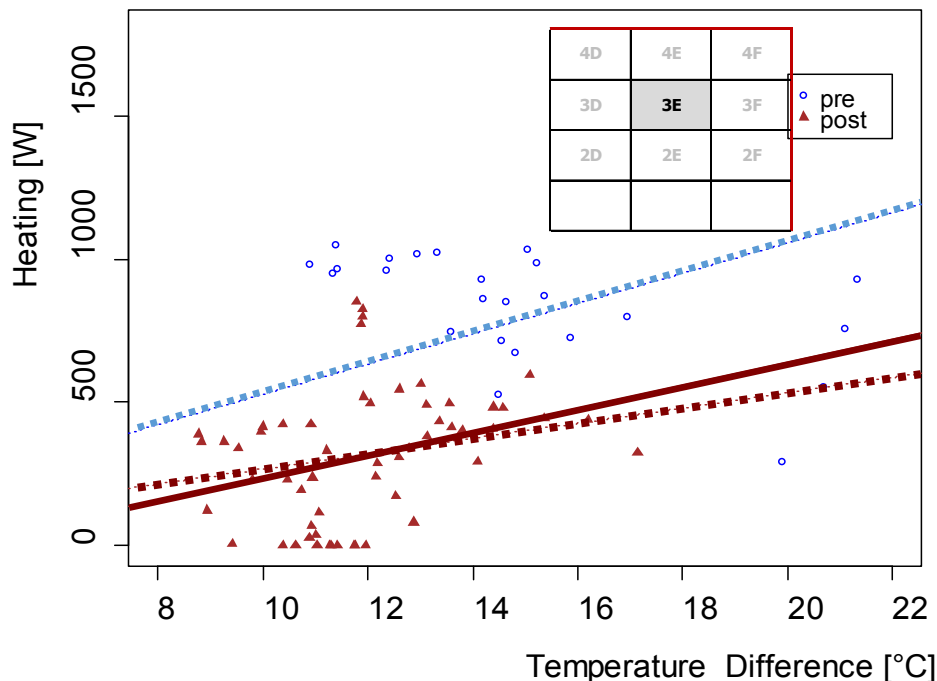
Figure 28 shows the comparison of the space heating and temperature difference from the core apartment on level 3. The pre-renovation data (for 3B) is shown as blue circles, while the post-renovation data (for 3E) is shown with filled red triangles. This core apartment (3B or 3E) is surrounded by heated apartments above, below and to the sides. As these other apartments are heated to the same level, there should be minimal heat flow through the walls, floors and roof. The renovation changed the north elevation by including double glazing as well as internally insulated plasterboard for the remaining wall area. The south elevation had fibreglass insulation added to the framing and a new security door, while the single glazing was retained.

**Figure 28. The space heating requirements for the central (core) level 3 apartment (3B pre-renovation  $\equiv$  3E post-renovation). The solid red line is the least squares fit through the post-renovation data. The blue dotted line and the red dotted line are**

**least squares fitted lines that also go through the origin for the pre-renovation and post-renovation cases respectively.**

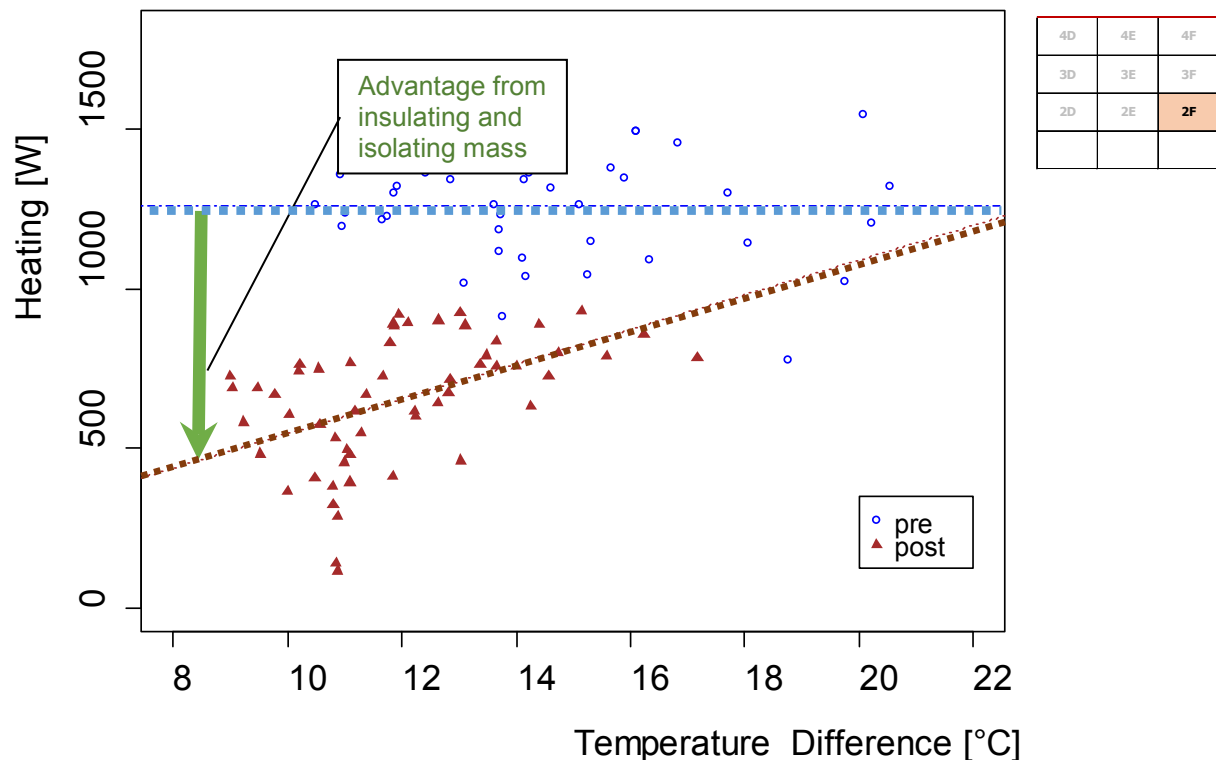
Figure 29 illustrates this using the data from the level 2 side apartment as an example. Here, the pre-renovation period is shown by the flat blue line, and the post-renovation requirements are shown by the brown line. Thus, the positive benefits of the thermal improvements from the renovations can be seen, being especially useful when the temperature differences are small.

**Figure 29. Level 2 side apartment (2A pre-renovation  $\equiv$  2F post-renovation). The blue line is the average value of the heating for the pre-renovation data while the brown line is least squares fit forced through the origin.**

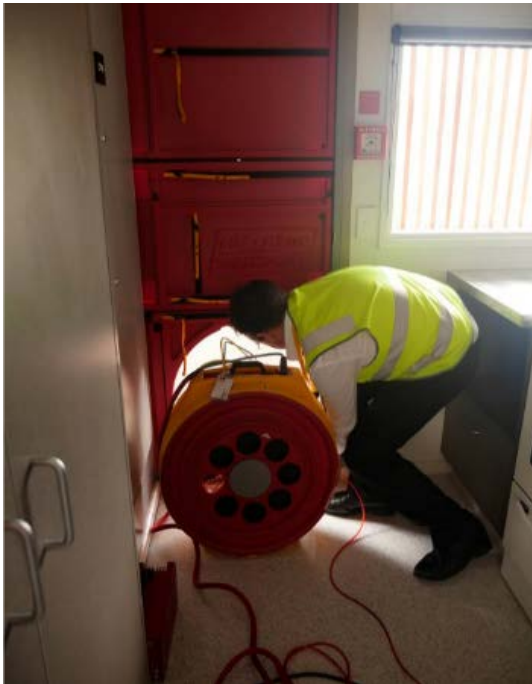
**Figure 30. BRANZ scientist installing blower unit in the base of entry door.**

The panels and the fan are placed within the door frame, ensuring a tight fit to minimise the likelihood of extra air leaks (see Figure 30).

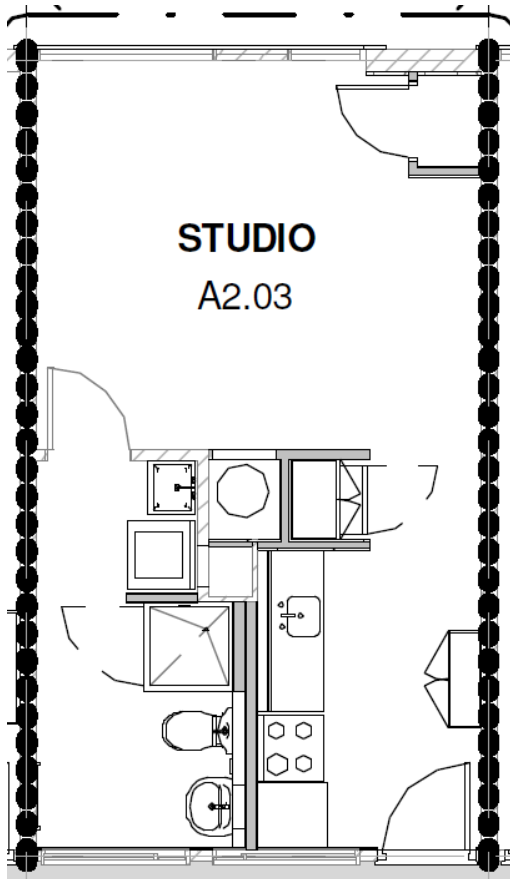
**Figure 31. Post-renovation apartment layout, showing bathroom-kitchen swap.**
