# Airtightness of roof cavities

## BRANZ Study Report SR401

We have introduced and trialled a measurement procedure to estimate the airtightness of residential roof spaces. By using a dual fan approach, it is possible to distinguish between the leakage through the roof envelope and the air permeability of the ceiling. Using this method, an effective leakage area for three residential dwellings with and without mould growth in the attic space is calculated and compared to international standards.

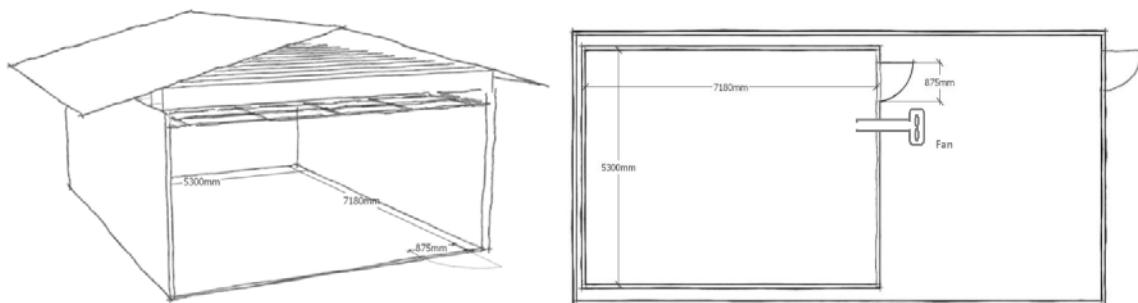
**Figure 1. Test facility for air permeability of ceilings. Left: sketch of the test room with airtight walls and timber rafters for convenient installation of different ceiling types. Right: layout of the test facility within the roof ventilation test building.**

In order to evaluate the air permeability of different, common ceiling linings a special test facility (Figure 1) was designed and constructed within one of our experimental buildings on the BRANZ site in Judgeford. Efforts were made to seal the wall linings and the entry door of the 38.1 m<sup>2</sup> room within a room as best as possible. The area is deemed large enough to account for variations in material and workmanship. A design of timber ceiling rafters was chosen to allow for an easy and flexible installation of the different ceiling types to be tested.

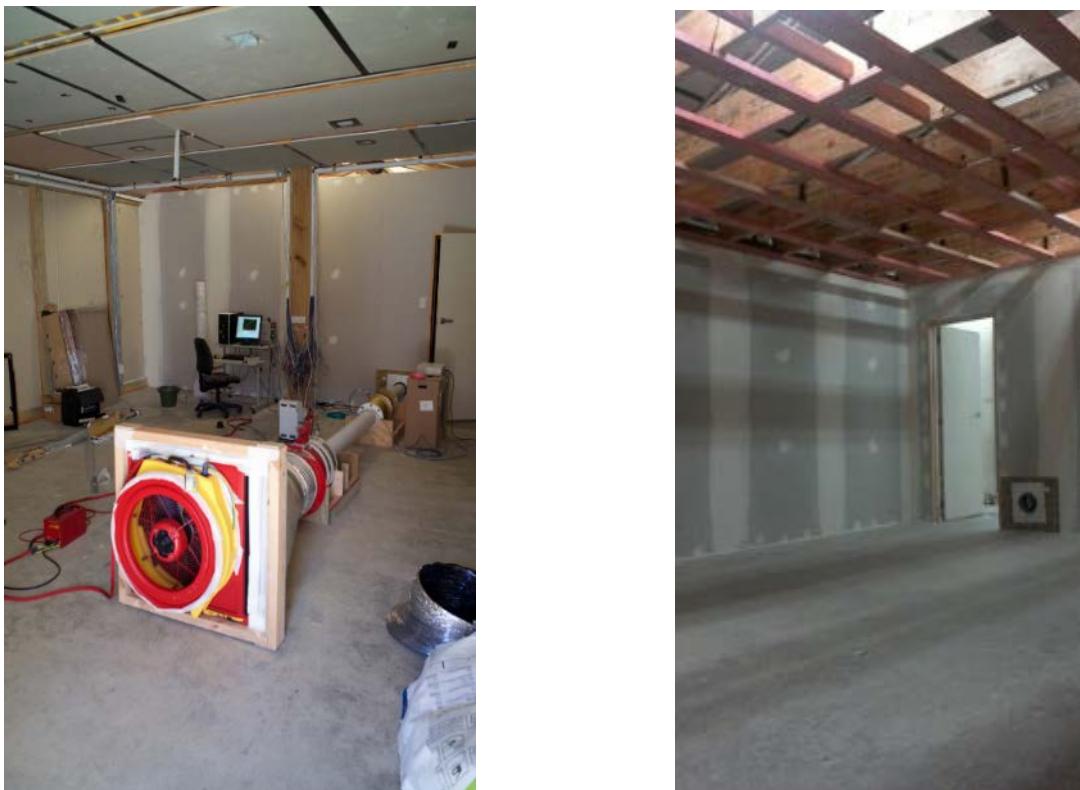
**Figure 2. Left:** front wall and entry door of the ceiling test facility. The fan used to pressurise the room is attached to a laminar-flow element (cylindrical device in the background), which measures the volumetric airflow into the room. **Right:** view from the inside with no ceiling installed

To obtain the characteristic material properties  $c$  and  $n$  for a specific ceiling, the following test procedure is performed. Using a fan, air is forced into the room at a constant rate (parameter  $Q$  in the above formula). This volumetric airflow measurement is achieved using a Laminar Flow Element (LFE)<sup>1</sup> (Figure 2).

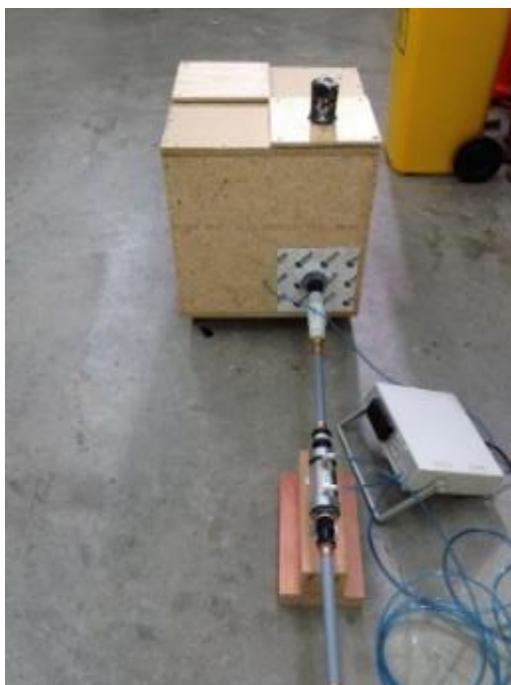
**Figure 3. Set-up to characterise small device for its airflow characteristics.**

The characterisation of ceiling penetrations such as light fittings and roof access hatches works in a similar way but on a smaller scale. An airtight enclosure is used to house the device under test (Figure 3). The measurement procedure is otherwise the same as with the ceilings.

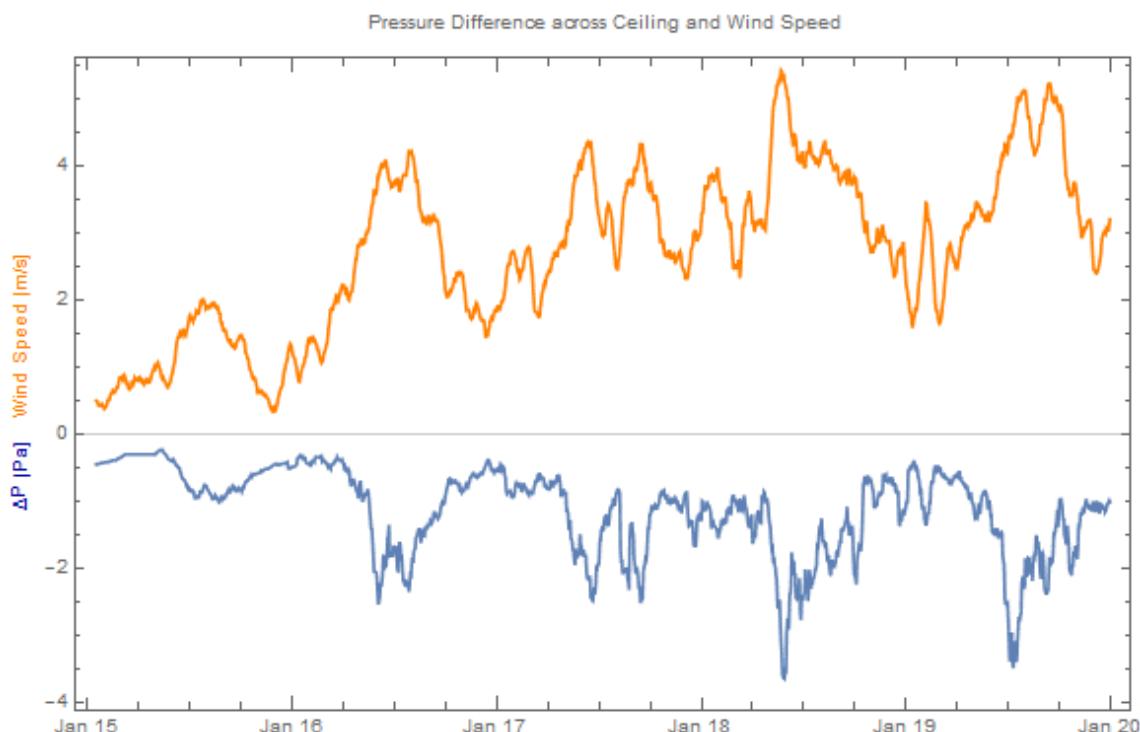
Figure 4 shows differential pressure measurements across a plasterboard ceiling on the single-storey BRANZ ventilation test building. Wind speed in close proximity to the test building at a height of 10 m is also plotted. The data was acquired over a period of 5 days with wind speeds close to zero and up to 6 m/s (~22 km/h). Windows and doors were kept shut during the experiment. While the sampling interval was 1 minute, the data displayed in Figure 4 has been smoothed by a moving average routine. The recorded pressure differences are exclusively such that the roof cavity has a negative pressure in comparison to the living space. Thus, the air transport will be predominantly in the direction from the living space to the attic space (Roppel, Norris & Lawton, 2013).

**Figure 4. Measured pressure difference across a residential ceiling (blue) and wind speed at 10 m height.**

A reasonably pronounced correlation of pressure difference  $\Delta p$  to the wind velocity can be seen (see also Figure 5). For the encountered wind conditions during our measurement period, the recorded pressures lie between 0.5 and 4 Pascals. The wind direction and internal temperature differences will play a role in the pressure gradient across the ceiling but have been neglected here.

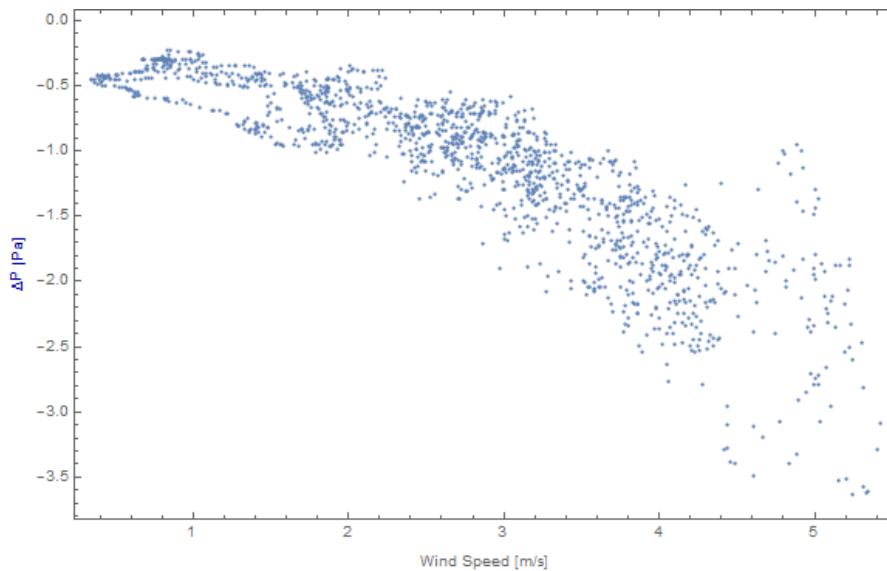
**Figure 5. Correlation between pressure difference and wind speed.**

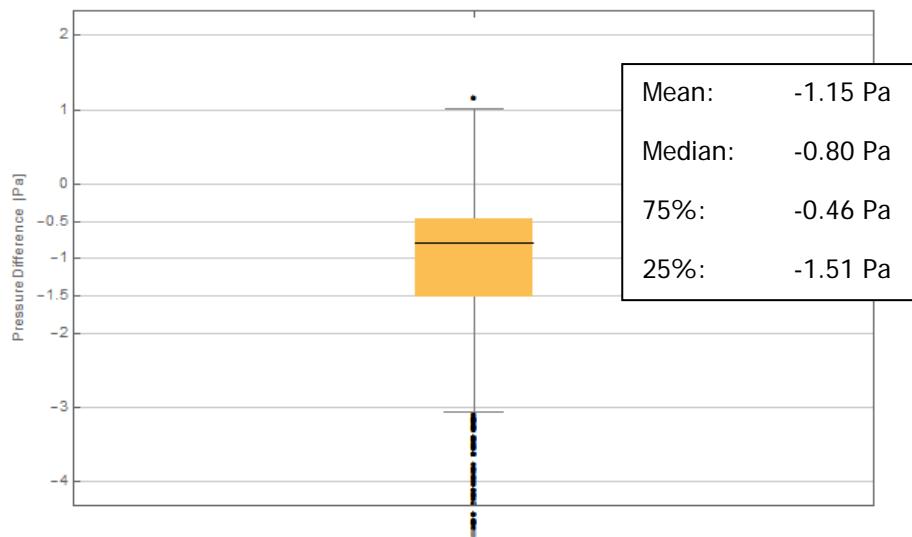
Figure 6 displays the measured pressure data as a box whisker plot indicating the key statistical parameters.

**Figure 6. Statistical box plot of the pressure data  $\Delta p$  from Figure 4. 25% and 75% quartiles (yellow box), median (black line), 5% and 95% whiskers and outliers (points) are plotted.**

For this experiment with average wind speeds of 2.7 m/s (~10 km/h), approximately half of all measured pressure values fall with an interval between  $-0.5 > \Delta p > -1.5$  Pascals. The mean value is  $\Delta p_{\text{mean}} = -1.2$  Pascals. This is also the pressure that is used in the following sample calculations.

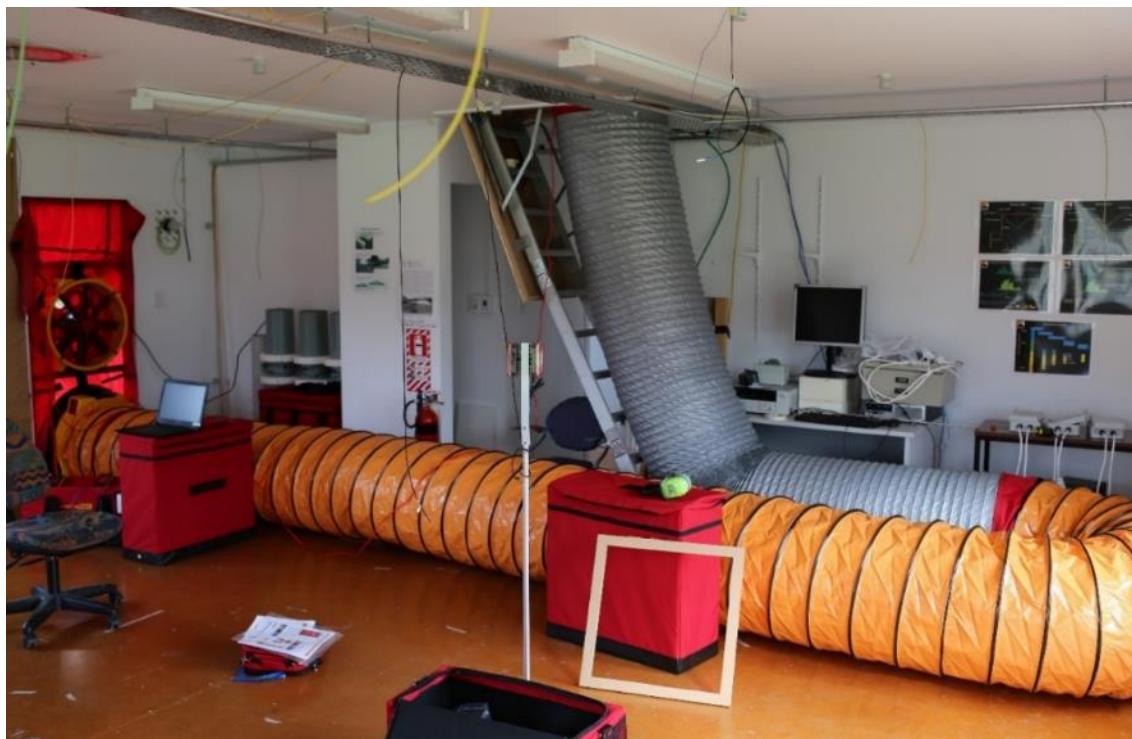
Figure 7 shows the dual blower door fan<sup>3</sup> set-up in the BRANZ ventilation test building, which has been developed to characterise the airtightness of residential roof cavities. Fan 1 is used to pressurise the living space, while fan 2 is channelling outside air via ducting into the roof space.

**Figure 7. Dual fan method to characterise the airtightness of a roof cavity.**

This set-up is chosen so that the leakage area of only the roof envelope can be determined. If both the living space and the roof space are pressurised to the same value, there will be no airflow across the ceiling lining.

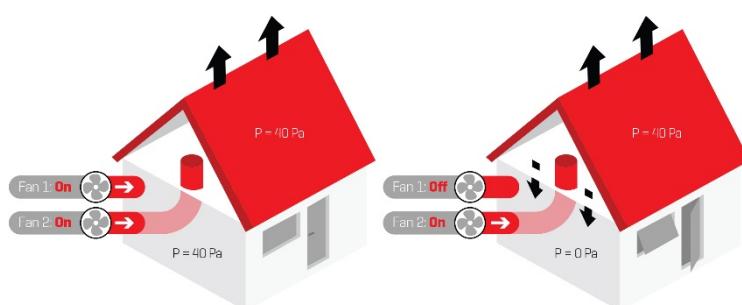
This situation is depicted on the left in Figure 8, where both the roof cavity and the living space are pressurised to 40 Pascals. Windows and doors are shut for this measurement mode.

**Figure 8. Dual fan set-up to characterise the airtightness of a roof cavity. Left: no pressure difference across the ceiling lining as both spaces are pressurised to the same value. Right: with fan 1 switched off, resulting in air flowing down.**

With fan 1 turned off, the ceiling lining will be exposed to a pressure drop across it, and air will be forced downstairs through any cracks and openings. Windows and doors should be opened to ensure that the building is at ambient pressure.

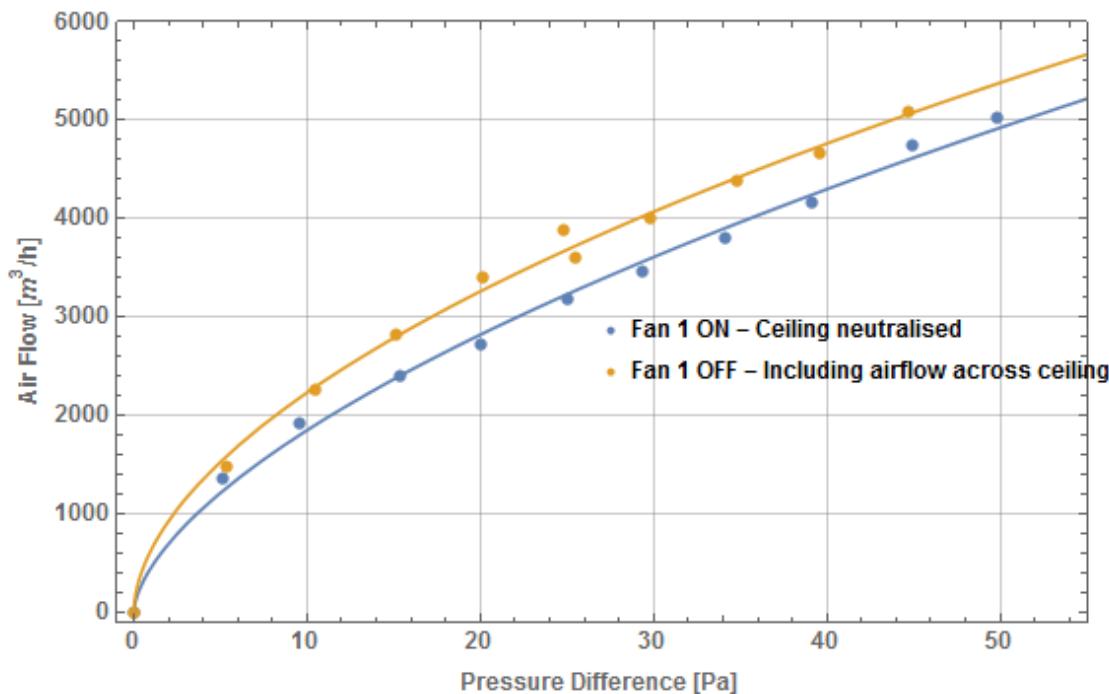
Figure 9 shows these two measurement configurations performed on a residential building in Titirangi, Auckland. The measured data (dots) is fitted using Equation 1, yielding a good result. While the blue curve represents the airflow through and around the roof cladding only, the difference between the two curves can be attributed to an additional airflow through the ceiling lining and penetrations.

**Figure 9. Airflow data with the ceiling neutralised (blue) and contributing to the airflow (orange) – data from the Titirangi residence.**

In this case, the roof cavity was reasonably tight, and for the balanced measurement, a pressure difference of close to 50 Pa was achieved. While this is a desired reference value for a standard blower door test on residential buildings, it is not always possible to reach this pressure in roof cavities due to their leaky nature. The analysis in section 3.2 is performed based on 40 Pascals.

Figure 9 shows the results for the blower door pressurisation measurements for this Titirangi property. The orange curve represents the data including an airflow back through the ceiling into the living space. Using fan 1, the ceiling flow has been neutralised to a negligible pressure drop represented by the blue dataset. The data shows some scatter due to the wind conditions during the experiment.

The flow across the ceiling only can be estimated by subtracting the two curves in Figure 9 for a given pressure level. Assuming a pressure difference<sup>6</sup> of 1.2 Pascals, the airflow across the ceiling alone is calculated to be approximately  $Q_{ceiling} = 190 \text{ m}^3/\text{h}$  (52.7 litres/second). The contribution of 22 incandescent light fittings at 1.2 Pa would be  $135 \text{ m}^3/\text{h}$  (37.5 litres/second), which is in the right order of magnitude and points towards the downlights as the main conduit of downstairs air into the roof cavity. Additional leakage paths around the roof access hatch or extractor fans are likely to make up the difference.

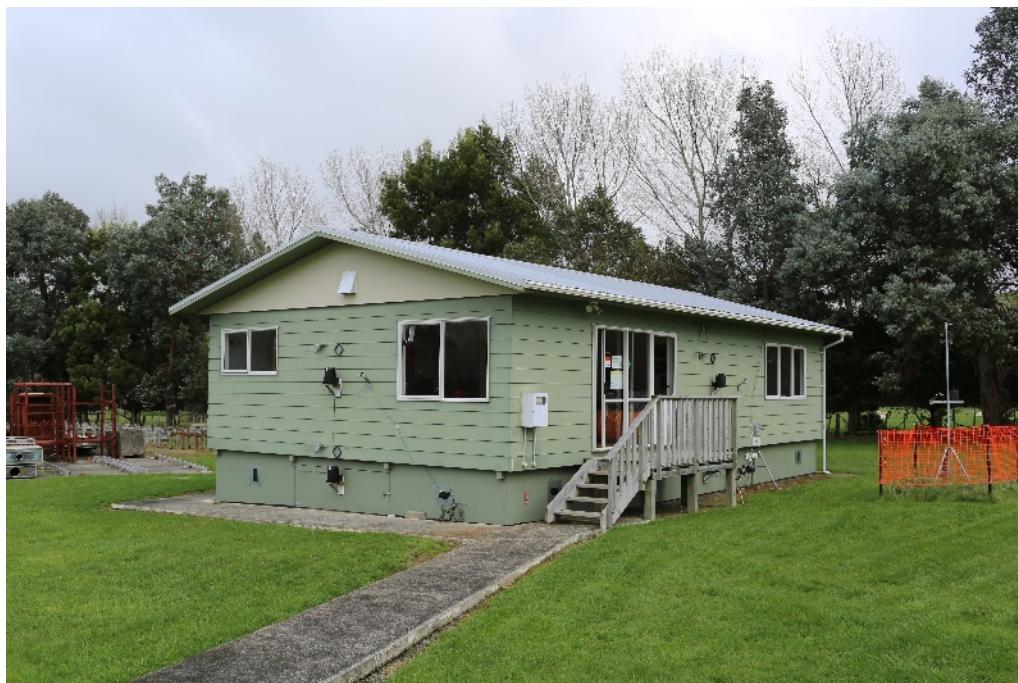
The method using a dual fan set-up was trialled on the BRANZ ventilation test building (Figure 10). In addition to the pressurisation experiments, a tracer gas approach was trialled to determine actual infiltration rates of the roof cavity under normal climatic conditions.

**Figure 10. BRANZ Ventilation test building in Judgeford.**

The gable-type construction has a standard corrugated iron cladding on building paper on mesh. The insulated ceiling area is approximately  $90 \text{ m}^2$ , yielding a roof cavity volume of around  $49 \text{ m}^3$ . No passive roof ventilation elements are installed in the building. The dwelling does not show any signs of mould in the roof space. While it is not inhabited and consequently does not have normal moisture sources, the building is frequently adjusted to high internal moisture levels for scientific purposes. The ceiling lining is standard plasterboard with square stopping. A number of artificial, controllable ventilation openings can provide an air exchange path from the living space to the roof cavity. For this experiment, these were shut.

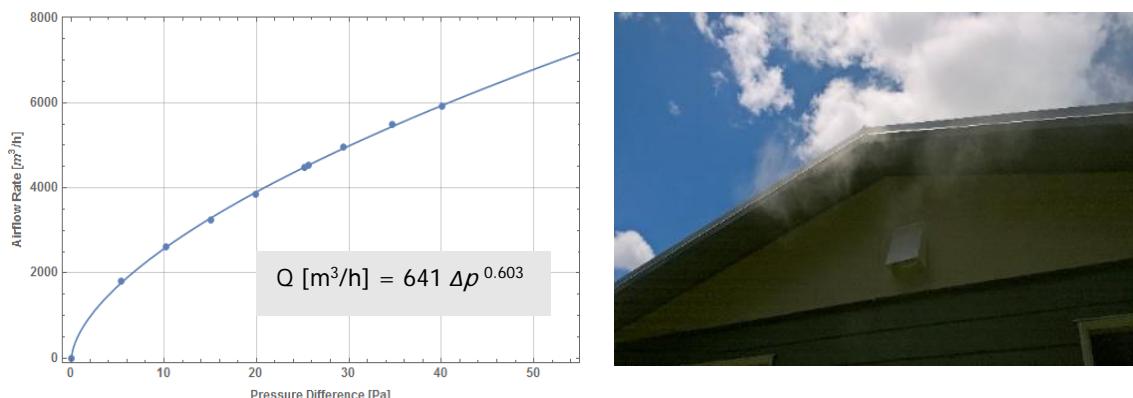
**Figure 11. Airflow versus pressure for the ventilation test building – ceiling balanced to 0 Pa. The curve fit using Equation 1 is given. Right: leakage paths visualised by a smoke generator in the attic.**

The air leakage through the roof envelope can be visualised using a smoke generator.<sup>4</sup> The battery-operated device was placed in the roof cavity, with a moderate pressure applied to the attic space. The main leakage paths were around the front and rear eaves, with lesser amounts coming from the soffit. No smoke could be detected exiting through the ridge cap from the overlap between iron sheets. These channels seem to be effectively blocked by the roofing underlay, at least for this crude visualisation method using smoke.

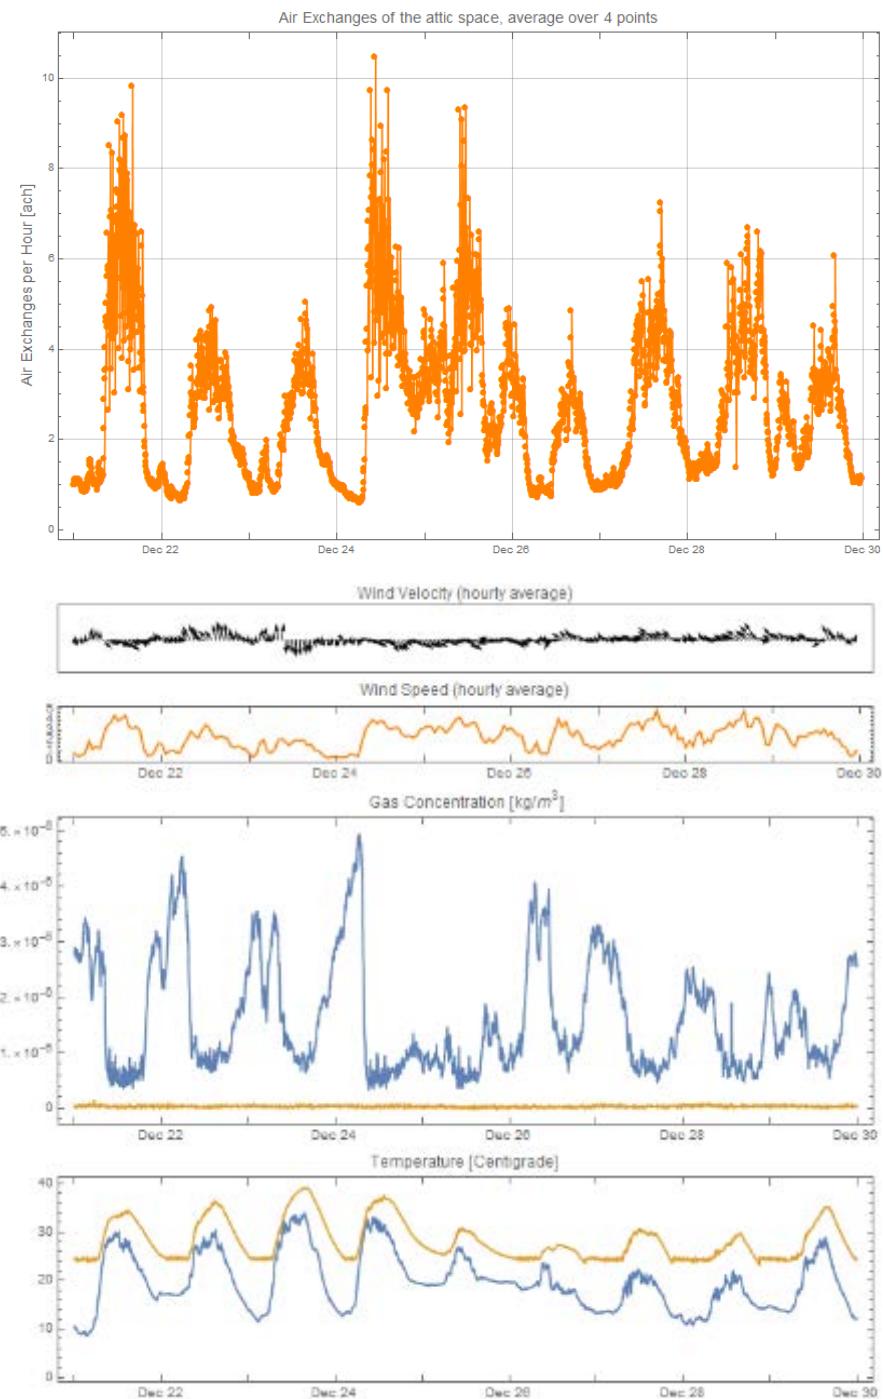
The calculated air exchange rate, measured gas concentrations as well as wind velocity and temperatures are given in Figure 12. The inverse correlation between gas concentration in the attic space and wind speed is as expected. Wind action is causing infiltration of outside air into the roof cavity, thus dilution of the tracer gas concentration.

**Figure 12. Top:** calculated air exchange rates for the attic space based on a tracer gas measurement. Climatic conditions and gas concentrations are also given.

The attic space of the building was dosed with 1% SF<sub>6</sub> in N<sub>2</sub> at a constant rate of 40 ml/min for a period of 9 days. The sampling of the gas was performed in the attic space as well as outside the building every 5 minutes. The wind velocity was recorded at 10 metres above ground in close proximity to the dwelling. The measured gas concentration is used to calculate an infiltration rate (Sherman, 1990). Using the roof cavity volume, the latter can be expressed as air exchanges per hour (ach).

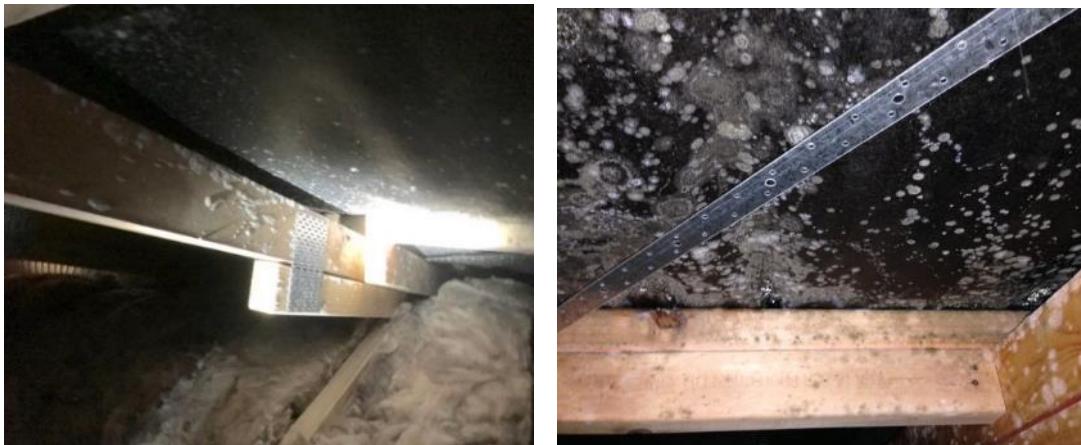
This 2-storey residential building in close proximity to the sea showed signs of extensive mould growth on the roofing paper as well as on the structural timber (Figure 13). The hilly surroundings are covered in tall vegetation shading the house, especially in the morning. The northern half of the building has a gable-type roof construction with a 75 m<sup>2</sup> area of insulated ceiling area. The front part of the building is covered by a skillion-type roof construction which is decoupled from the main roof cavity. The skillion part of the roof is not accessible and was not part of these measurements.

**Figure 13. Examples of mould growth on roofing paper and timber.**

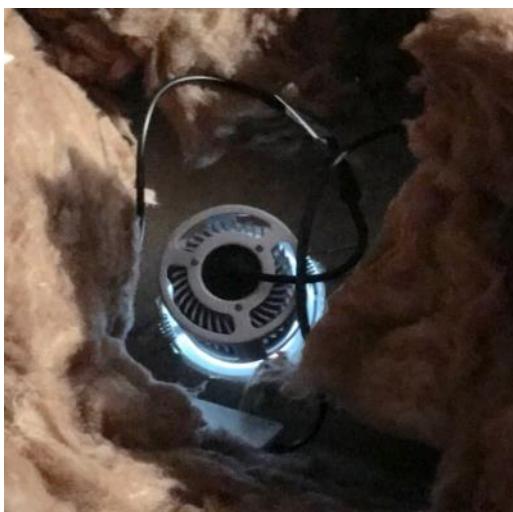
The ceiling is lined with square-stopped plasterboard, which ordinarily would represent a good air barrier. However, 22 downlights installed through the top level provide an easy path for moisture from the living space into the attic. Although, the lights are of LED-type, the design is such that a gap exists between the main part and the mounting bracket (Figure 14). The individual light fitting could not be characterised as one of the elements in Table 2. Given the size of the opening, however, it is anticipated that the flow characteristic is in the same category as the very loose incandescent, old-style light fitting.

**Figure 14. Downlight as viewed from the attic space. The large opening around the main body is visible.**

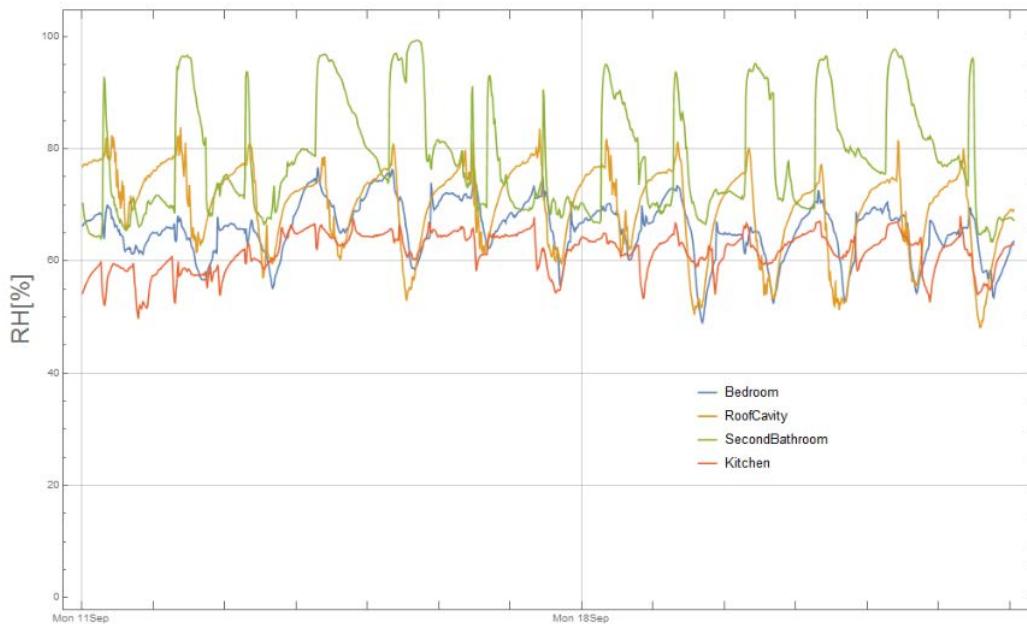
**Figure 15. Relative humidity in the main bedroom, attic space, bathroom and kitchen of the Titirangi dwelling.**

Immediately noticeable are the prolonged periods of time when the relative humidity exceeds 90% in the bathroom. The moisture, probably generated by showers in the morning, is not effectively removed by passive (opening windows) or active (extractor fans) ventilation and remains at a high level for most of the day.

While the extensive level of mould growth certainly underlines the need for the moisture level in the attic space to be reduced, it is important to point out that there are a number of factors that play an important role in creating and maintaining a healthy building climate. Having established an airtight roof cavity and a ceiling providing easy access for air into the attic, the moisture level of the living spaces is another relevant parameter. To evaluate the indoor climate, temperature and relative humidity were recorded at various points throughout the building over several weeks in 2017. Figure 15 shows the relative humidity (RH) in the roof cavity, kitchen, bathroom and main bedroom for 2 weeks in September.

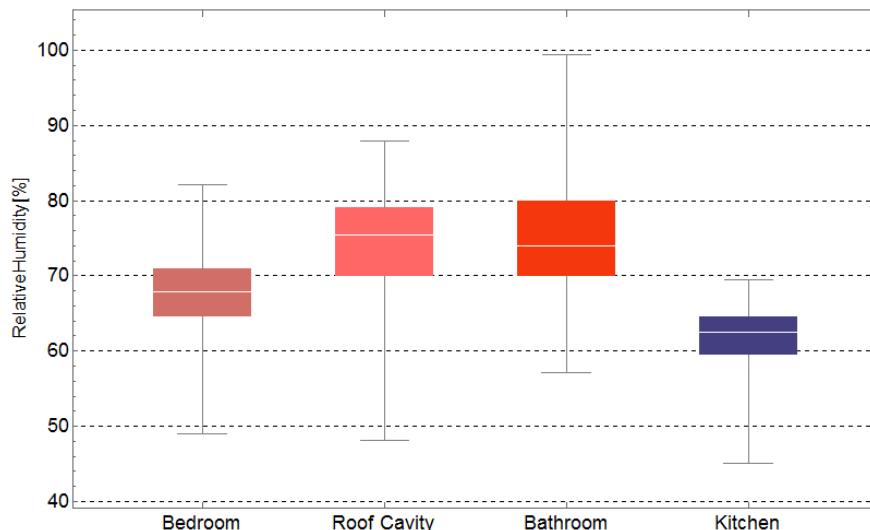
Looking at the statistical distribution in the form of a box-plot (Figure 16), the following median values for the relative humidity are found: 74% in the bathroom, 75% in the attic, 68% in the bedroom and 63% in the kitchen.

**Figure 16. Statistical distribution of relative humidity for the Titirangi dwelling. The boundaries of the coloured boxes indicate the 25% and 75% quartile, the line represents the median, while the whiskers give the maximum and minimum values.**

Especially the bathroom exhibits high moisture levels. For a quarter of the time, the relative humidity level lies above 80%. If these measurements are representative the occupant behaviour – inadequate ventilation of the living spaces – excessive amounts of moisture will have been transported through the air-leaky ceiling into the attic to accumulate there.

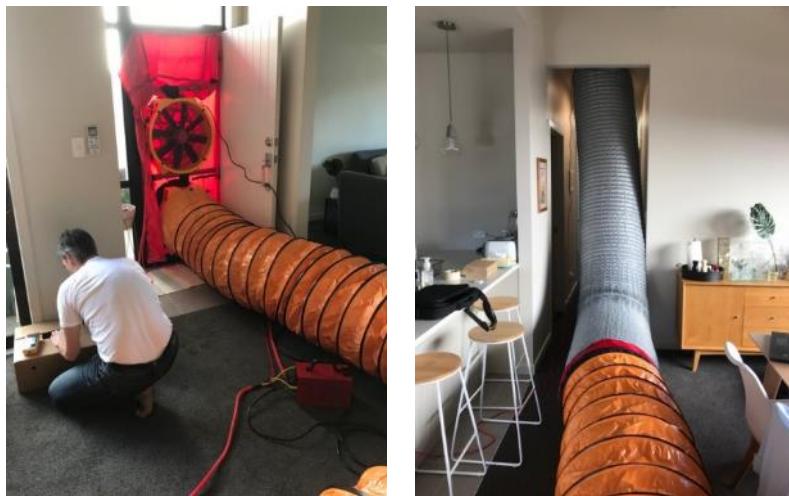
The same measurement procedure – including the dual fan blower door pressurisation tests and indoor climate recording – was performed at this dwelling (Figure 17).

**Figure 17. Measurement set-up with dual fan blower door (left) and ducting into the roof cavity (right).**

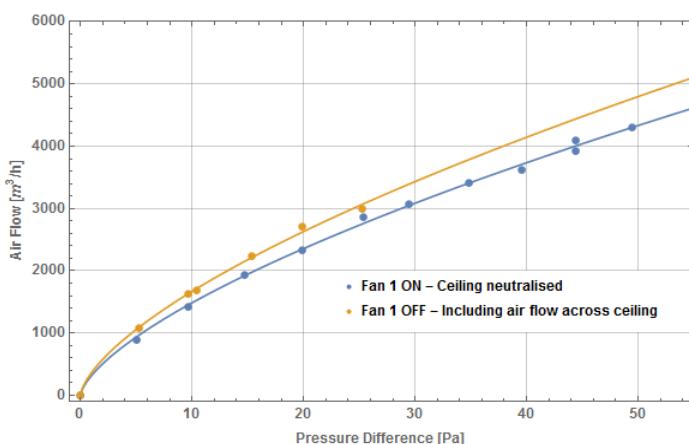
The results with and without an airflow across the ceiling are depicted in Figure 18. The roof cavity appeared very airtight, and a pressure of 50 Pa was easily achieved. For the run with fan 1 turned off, instrumental issues prevent any data points being acquired above 25 Pa. At 40 Pascals, the roof envelope alone exhibits an airflow of  $3737 \text{ m}^3/\text{h}$  ( $n50: 4,334 \text{ m}^3/\text{h}$ ), translating to an air exchange rate of 81 ach ( $n50: 94$  ach). Again, using Equation 2, an effective leakage area can be calculated (Table 3). Using the insulated ceiling area and the 1:300 roof ventilation area rule, a benchmark can be established. For this property, the ventilation opening to ceiling area ratio is 45% and even lower than in the Titirangi dwelling. The graphs of the two measurement modes in Figure 18 are closer together than the Titirangi building, pointing towards a more airtight ceiling level and confirming the visual inspection. Extracting the airflow across the ceiling only, by subtracting the two graphs at the reference pressure of 1.2 Pascals, an airflow of  $Q_{\text{ceiling}}(1.2 \text{ Pa}) = 53 \text{ m}^3/\text{h}$  (14.7 litres/second) is estimated.<sup>7</sup> Possible leakage paths have been identified around the roof access hatch, extractor fans and holes for the heat pump services.

**Figure 18. Airflow results for the Papakura dwelling. The measured data points are fitted using Equation 1.**

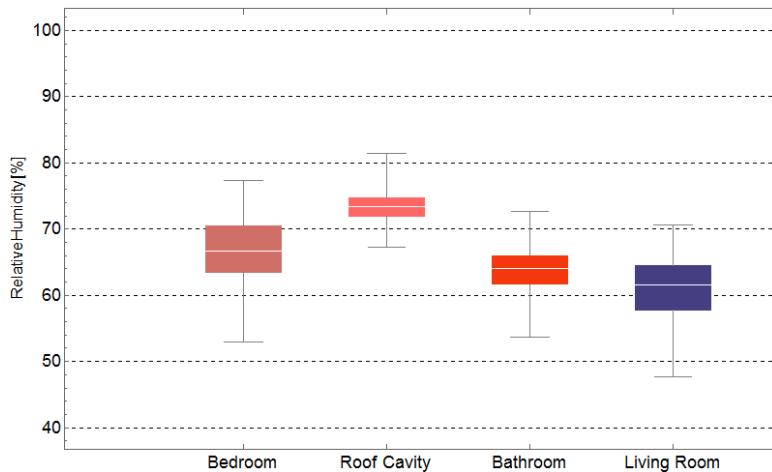
the relative humidity are given in Figure 19. Noticeable is the much lower humidity levels in the bathroom compared to that of the Titirangi dwelling, which, according to the occupants, is achieved by consistent usage of the extractor fan. The relative humidity in the roof space is very similar to the Titirangi building with a median value of 73%. The distribution of measured values is, however, narrower, mainly due to less extreme temperature variations due to the north-facing aspect of the roof.

**Figure 19. Statistical distribution of relative humidity for the Papakura dwelling. The boundaries of the coloured boxes indicate the 25% and 75% quartile, the line represents the median, while the whiskers give the maximum and minimum values.**

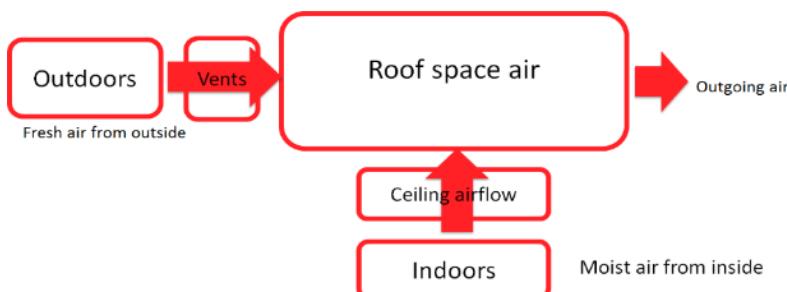
The calculation is based on the idea that a certain amount of fresh, drier outside air is required to mix with the moist airflow upwards from the living spaces for the attic moisture content to stay below a predefined moisture threshold (Figure 20).

**Figure 20. Sketch of airflows for the mass balance calculation.**

The mass-flow balance is expressed in Equation 3. Here,  $VP$  stands for vapour pressure, which is calculated from temperature and relative humidity.<sup>8</sup> For instance, a climatic condition of  $T=20^\circ\text{C}$  and  $\text{RH}=65\%$  would translate to a vapour pressure of  $VP=1,520 \text{ Pa}$ .

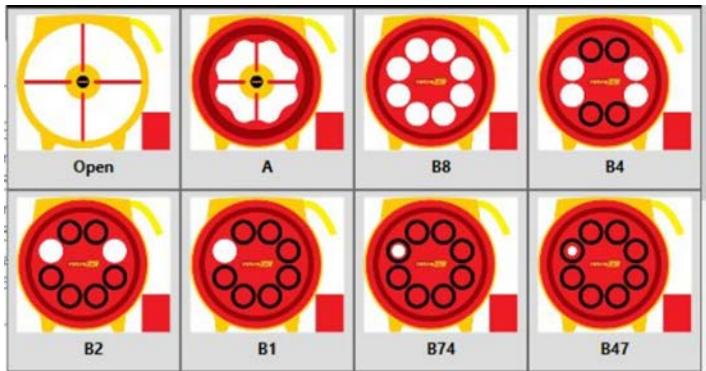
The airflow rate through the fan for its different fan speeds is obtained by measuring the pressure difference across the nacelle. This fan pressure is calibrated against an airflow rate. The measured fan pressure must be high enough to get a good signal-to-noise ratio, which can be difficult to achieve for an airtight dwelling with a low airflow rate into the building. To increase the fan pressure for a given airflow rate, restrictor plates can be mounted to the fan. The possible configurations are depicted in Figure 21.

**Figure 21. Restrictor plate configurations for the Retrotec fans.**

Essentially, the airflow rate through the fan is obtained by a calibration of the measured pressure difference across the nacelle. The fan opening and thus the airflow rate can be adjusted by a number of restrictor plates. It was found that removing all restrictor plates in combination with the ducting leads to significant errors. This operating mode was avoided for the experiments in this study.
