Report ER3

Seismic Improvement of Loadbearing Unreinforced Masonry Cavity Walls

Dmytro Dizhur and Jason Ingham

Project LR0458

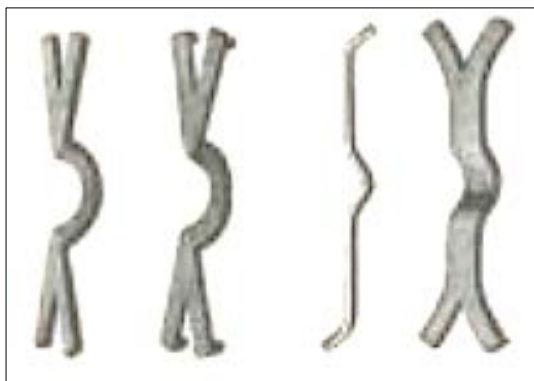
(a) Cast iron (left 2) and wrought iron (right 2) ties (reproduced from Hamilton, 1958)

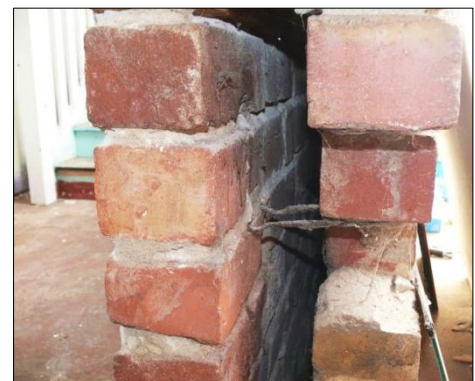
(b) Typical cavity wall cross-section showing metal ties

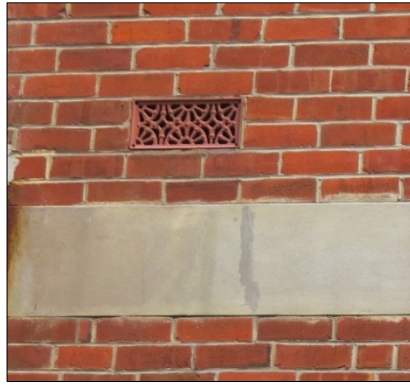
Figure 9 - Air bricks (vents) and DPC layers

(b) Typical cavity wall air vents

Some cavity walls were built with a damp proof course (DPC) layer (see **Figure 9**) above ground level and often with weep-holes to allow water that penetrated the outer layer to drain outwards (Adams, 1908). In the early days of cavity construction there was much debate about whether or not the cavity should be ventilated. However, by the end of the 19th century a prevailing consensus had developed that there should be a small amount of ventilation, similar to that provided under floors, but that the cavity should be effectively sealed at openings and above the foundation (see **Figure 9a,b**). This detail provided a degree of ventilation to help any penetrating moisture evaporate away (Pickles et al., 2010).

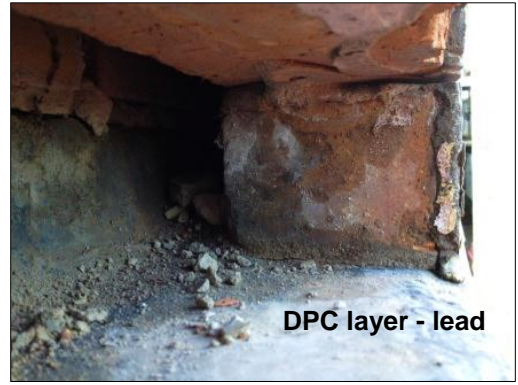
(c) Exterior cavity wall with brick removed, exposing the lead damp-proof course and air gap cavity

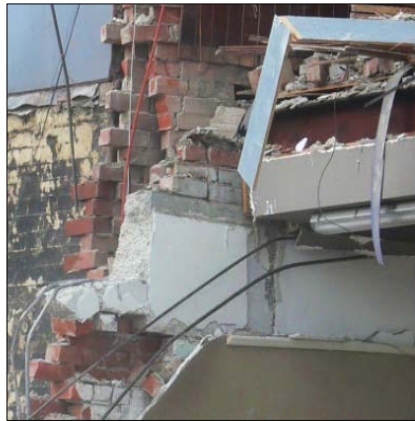
Figure 10 - Floor diaphragm-to-wall connection Type-1

(a) RC beam on inner wall layer

The type-1 diaphragm-to-wall seating arrangement (see **Figure 10**) consists of a concrete beam (reinforced with steel bars in most cases) resting on the inner loadbearing layer of the cavity wall. The outer layer of the wall extends continuously and is interconnected to the loadbearing inner layer using steel cavity ties. Timber floor joists are supported on the ledge that is typically formed due to a reduction of wall thickness with increasing floor height. This seating arrangement is prone to a cantilever type failure when subjected to earthquake induced shaking because the only connection between the two masonry layers is from the wall ties, which cannot develop flexural and shear resistance. Flexible floor or roof diaphragms, observed in most cases, can also contribute to the susceptibility of a cavity wall to fail in the out-of-plane direction due to excessive diaphragm displacement.

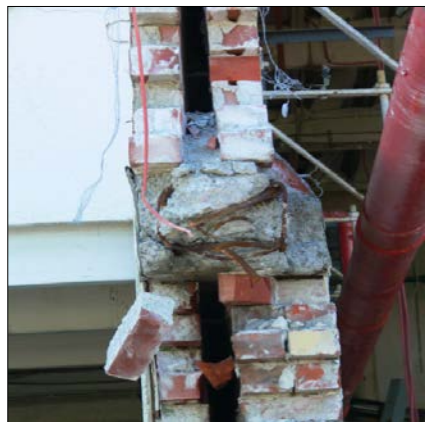
Figure 11 – Floor diaphragm-to-wall connection Type-2

(a) RC beam extending across both inner and outer wall layer

The type-2 seating arrangement shown in **Figure 11** has similar details to Type-1, with the concrete beam extending over the inner and outer layer of the cavity wall. The external layer of the wall is then continued from above the concrete beam for the subsequent storeys. In a typical two-storey cavity wall building, the concrete ring beam that usually sits at first floor level can be considered a fixed restraint for the cavity wall underneath. Due to the presence of a concrete ring beam, the two masonry layers underneath remain undamaged in most cases because the extra axial load from the weight of the concrete beam significantly reduces the risk of out-of-plane collapse plus the benefits of arching action that can develop when a rigid boundary restraint is

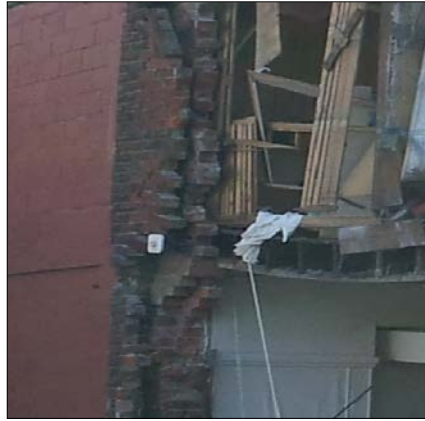
(a) Continuous outer and inner wall layer

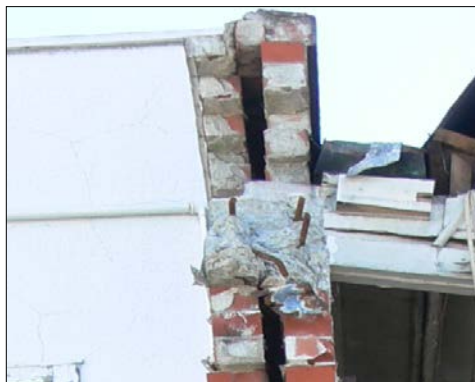
(a) Photograph showing detail

A solid wall type parapet over a cavity wall is shown in **Figure 14**, where the roof framing seating arrangement is located at the transition from cavity to solid construction, and a continuous cavity type parapet is shown in **Figure 15**, where the cavity construction is full height, including the parapet with capping and flashing over the top part of the wall. The roof framing seating is typically pocketed into the interior layer of the wall. A cavity type parapet on top of a concrete beam and roof seating arrangement can be observed in **Figure 16**.

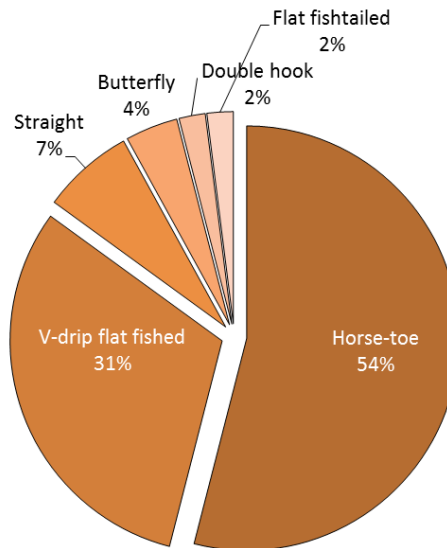
Figure 19 - Type of cavity wall ties (see **Figure 5**) from 47 buildings that were damaged during the Canterbury earthquakes

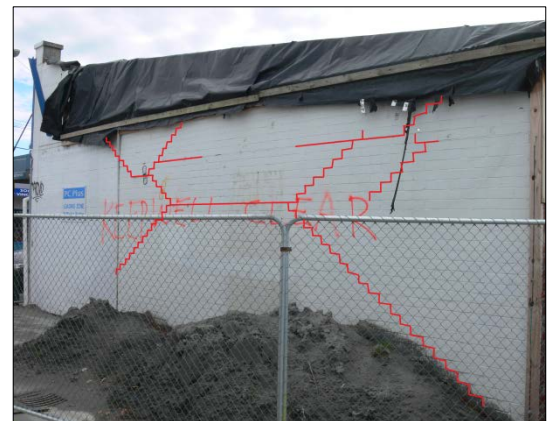
Figure 23 – Out-of-plane two-way bending type failure

(a) Schematic example of two-way bending type failure

(b) Two-way typical cracking pattern (highlighted in red for clarity)

Two-way out-of-plane bending type failure is frequently encountered in URM walls that are subjected to earthquake induced shaking. Due to a combination of factors including boundary conditions and weak mortar strength, a typical U-shaped failure plane typically forms in the top portion of the wall (see **Figure 23** and **Figure 26** for more examples).

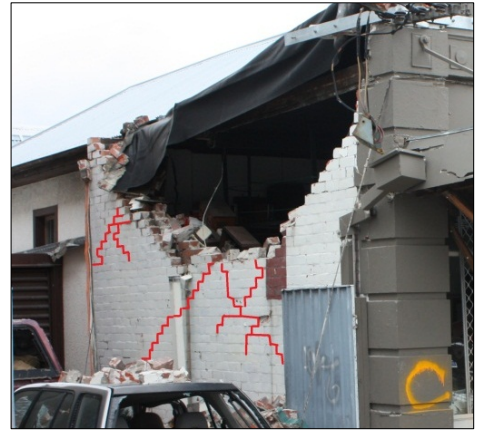
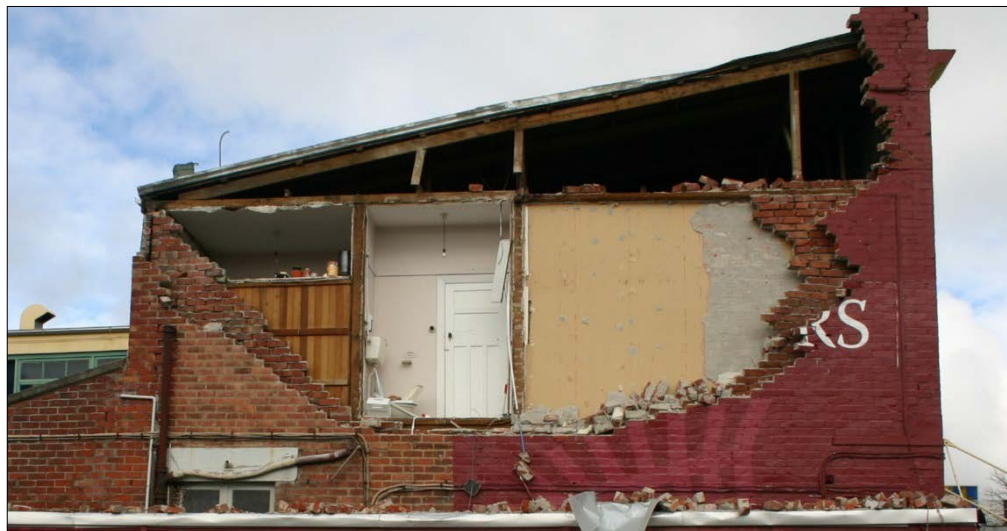
Figure 24 – Out-of-plane cantilever U-type wall failure

(a) Schematic example of shorter spanning wall with unrestrained top boundary support

(b) Short spanning cavity walls with unrestrained top boundary support (highlighted in red for clarity)

(c) Schematic example of cantilever U-type wall failure for long spanning walls

(d) Example of cantilever U-type wall failure for long spanning walls

Depending on the support conditions at the top and bottom of a wall, the failure mode may be a cantilever type (for example **Figure 24**) with the entire top section of a wall collapsing. For long spanning walls with an unrestrained top portion of the wall, a U-type wall failure typically occurred extending the full height of the wall as shown in **Figure 24c,d**. When the top section is well connected to the diaphragm, failure may occur in vertical or two-way bending.

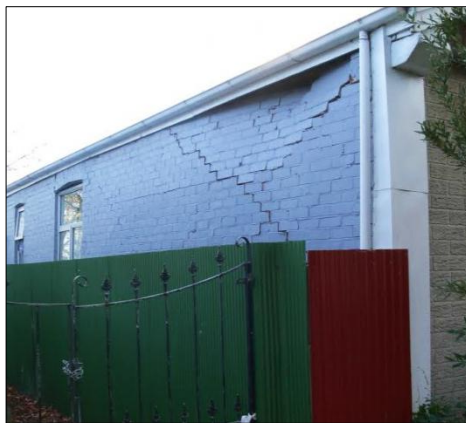
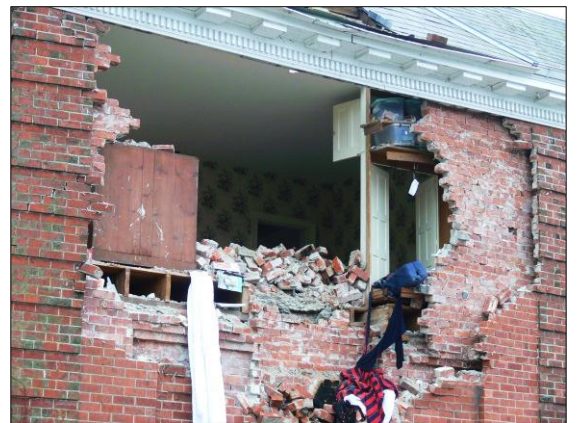
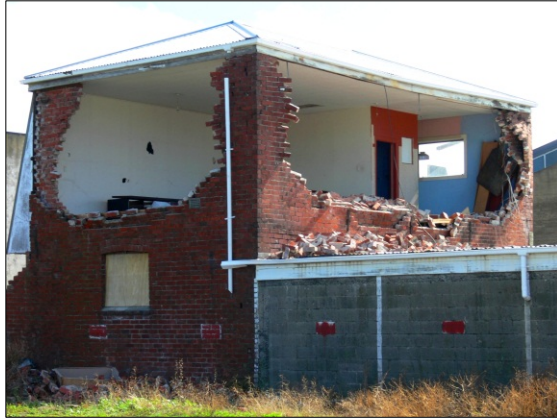
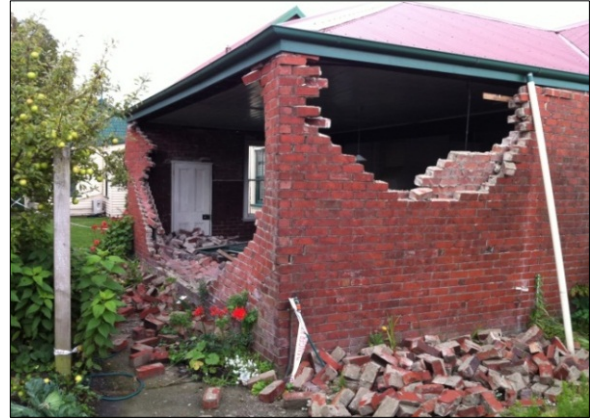
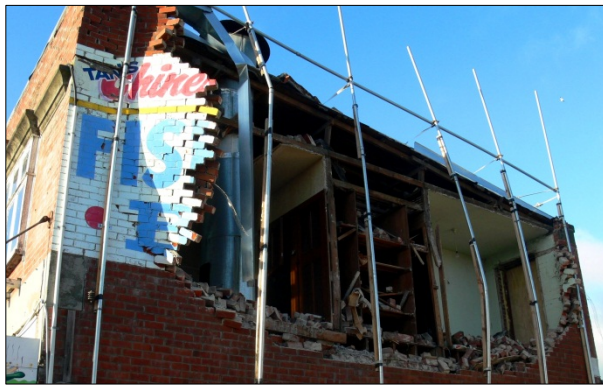
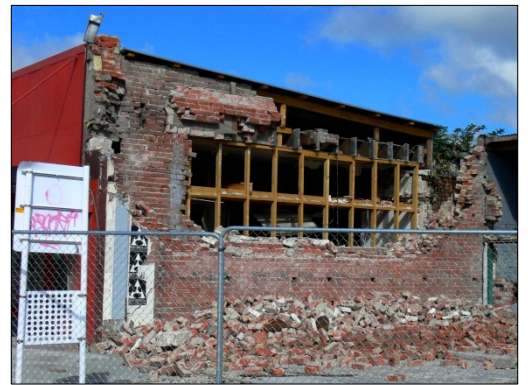
Figure 26 - U-shape two-way bending failure

(a) Typical two-way cracking pattern - onset of collapse of top portion

(b) Collapse in two-way bending of a cavity wall of two single leafs

(f) Example of combined failure modes

(g) Collapse in two-way bending of a wall with two single leafs - 1

(h) Two-way bending collapse of wall having two single leafs- 2

(i) Two-way bending collapse of wall having two single leafs - 3

More examples of out-of-plane failures observed following the 2010/2011 Canterbury earthquakes are illustrated in **Figure 25**, **Figure 26** and **Figure 27**.

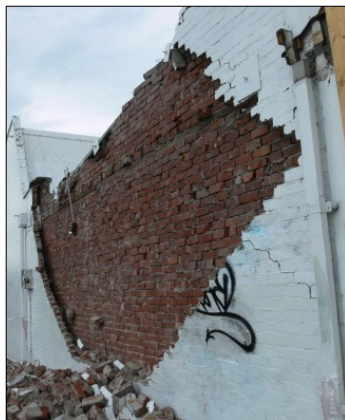
(c) Typical two-way bending collapse of outer layer

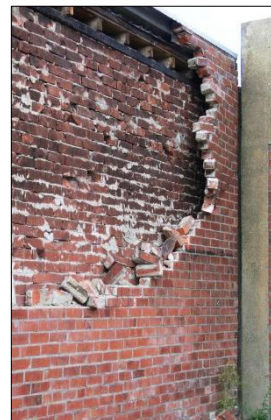
(d) Side view of wall displacement - 1

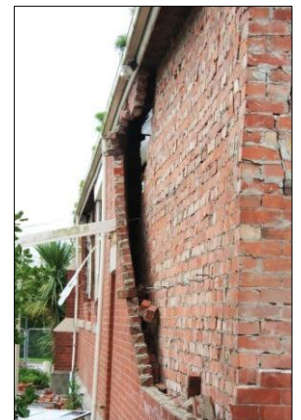
(e) Side view of wall displacement - 2

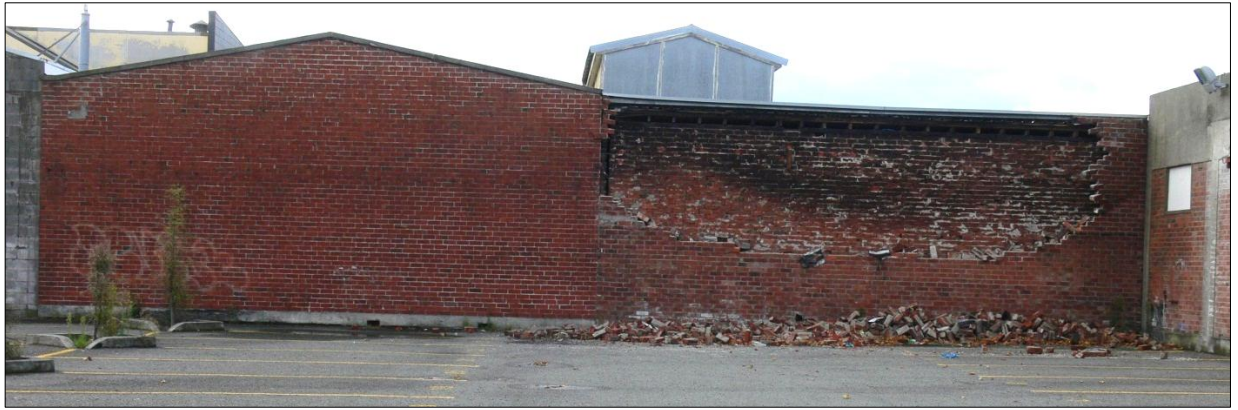
Figure 27 – Comparison of two cavity walls. Weak lime mortar with badly corrode cavity ties and poor top restraint (right), cement mortar and adequate top support, cavity tie condition unknown (left)

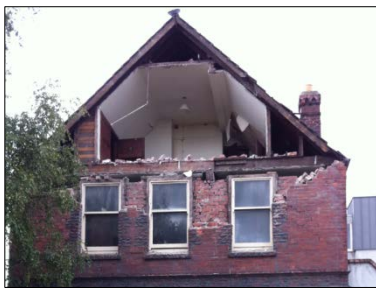
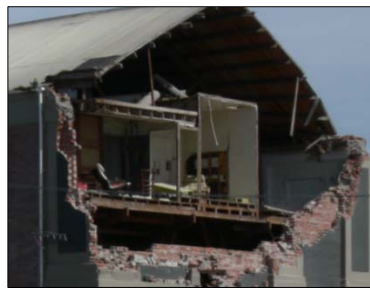
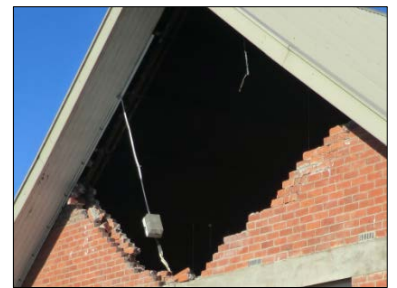
Figure 29 - Gable end wall failures

(a) Gable end walls – cantilever failure (no top restraint)

(b) Gable end walls - full collapse cantilever failure (no top restraint)

(c) Gable end walls – partial collapse (perimeter top restraint)

The difference in seismic performance of gable end cavity walls is illustrated through a comparison between **Figure 29a** and **Figure 29c**. In **Figure 29b** the top of the cavity wall was poorly restrained, resulting in complete collapse of the gable end wall with failure being initiated from the top of the wall as indicated by the absence of bricks attached to roof purlins. In contrast, a more effective restraint condition is shown in **Figure 29c**, where the gable end wall suffered only partial collapse. Both ends of the gable end wall remained undamaged whilst the middle section failed, possibly due to an increasingly high slenderness ratio towards the centre for a gable end wall.

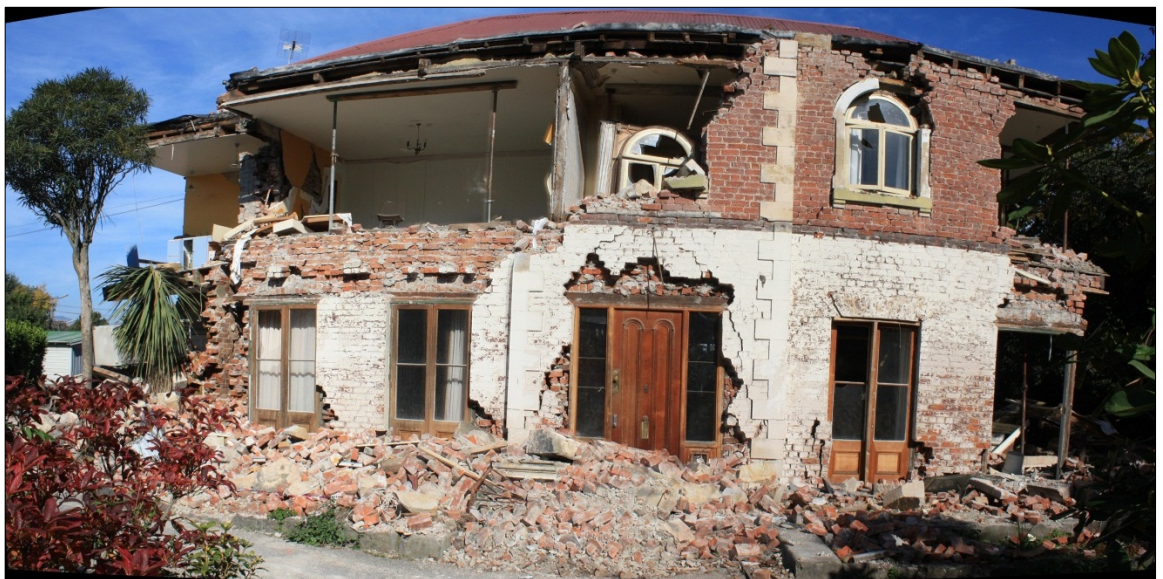
Figure 31 - Mixture of observed failure modes

It was observed that some URM cavity type buildings sustained a wide range of failure modes including a mixture of in-plane damage to walls, piers and spandrels, out-of-plane and corner failures (**Figure 31**).

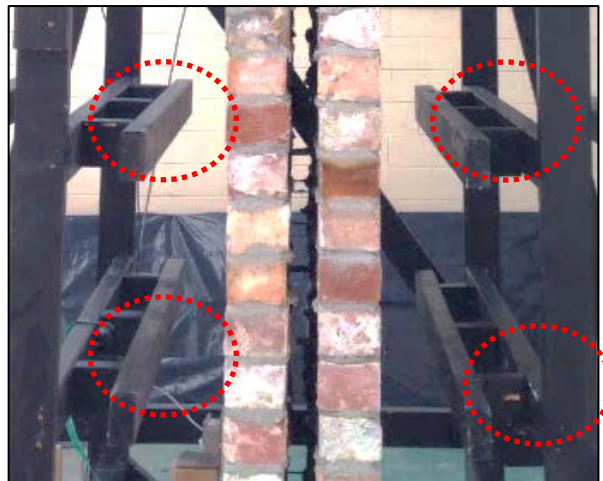
Figure 41 – Wall collapse prevention stoppers (highlighted in red)

Wall collapse prevention stoppers were designed and installed onto the protection frames to prevent excessive wall displacements that would have led to complete collapse of the tested wall. Wall collapse was prevented to avoid possible damage of the equipment and instrumentation (see **Figure 41**).

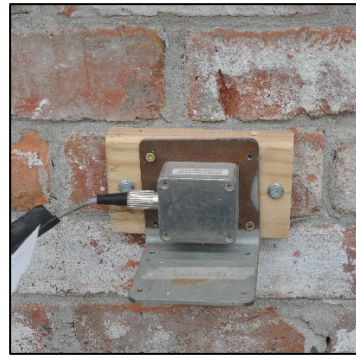
Figure 42 – Instrumentation used

(a) Typical accelerometer

Figure 42 show different types of instruments that were used for the shake table experimental testing. Four accelerometers were installed in specified positions to measure the accelerations of the cavity wall and shake table, and three draw wires were attached to measure the differential displacement of the wall when subjected to horizontal motion. The draw wires were attached to an independent instrumentation frame positioned away from the shaking platform. The instruments were located horizontally at the centre of the test walls and shake table platform, and the vertical positions of the instrumentation relative to the base of the wall are shown in **Table 5**.
