STUDY REPORT

No. 117 (2003)

Behaviour of Light Timber-Framed Floors Subjected to Fire Attack From Above

P. N. Whiting

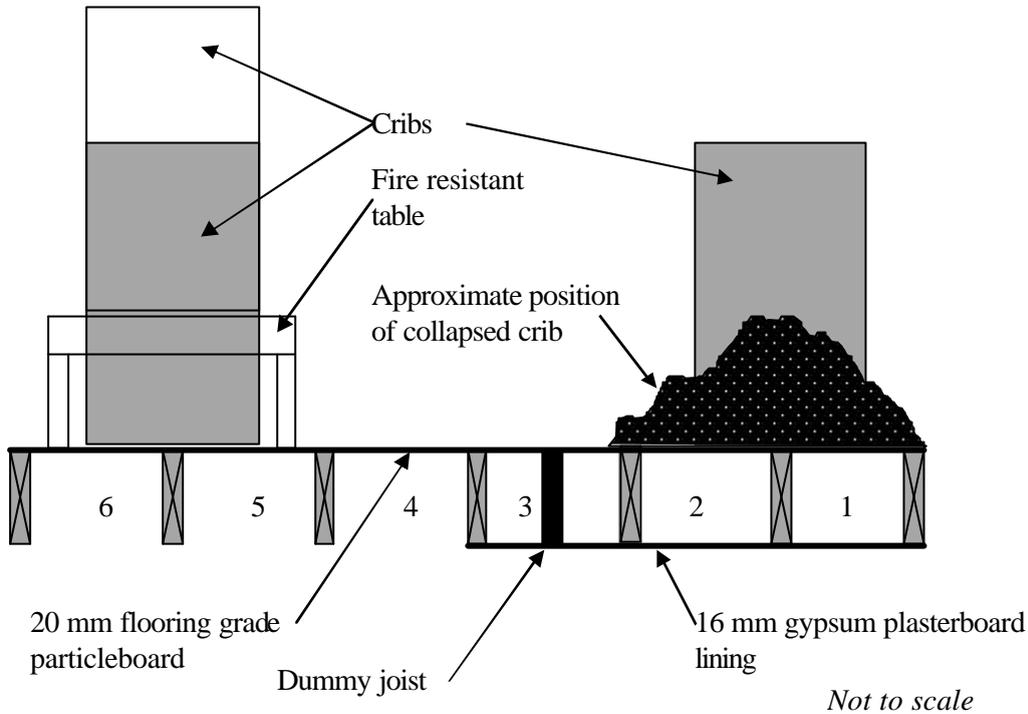
Figure 12: Diagrammatic section through room

As observed in the crib tests, when the structure of a crib failed due to the degree of its consumption by fire, the collapsed material protected the floor very effectively. At the conclusion of the full-scale experiment, after some 80 minutes, the particleboard directly under the cribs (over cavities 1 and 2, Figure 12) was charred to an average depth of 15 mm.

There was no evidence of flaming within floor cavity No. 1, which showed no evidence of flaming having entered. The particleboard still retained some residual strength, the depth of charring varying from 5mm at the wall to 15mm over the joist separating cavity No. 1 from No. 2. There was some evidence of flaming having entered cavity No. 2, with the joist separating floor cavity No. 2 from No. 3 only slightly charred on the side facing into cavity No. 2, while the other joist showed considerable damage. Cavity No. 3 was significantly damaged. From both observation and the thermocouple recordings from the dummy joist, the particleboard floor over this cavity charred completely in little more than 30 minutes from the start of the experiment. The joists were significantly charred with an average of less than 10% good material remaining. The joists between cavity Nos. 4, 5, and 6 were likewise charred, resulting in the collapse of floor sections.

The first stage of failure of the flooring was recorded by the thermocouples located within in the lined section of floor (cavity No.2, Figure 12). After 31 minutes from the start of the experiment, the temperatures recorded by all thermocouples within the one floor cavity section increased rapidly to over 500°C. In reviewing what remained of the floor after the test, it is believed that the sudden temperature rise can be attributed to a small localised failure of the particleboard between collapsed mounds of cribs. The collapsed cribs continued to protect large sections of particleboard over cavity Nos. 1 and 2 (refer Figure 12).

The timing is consistent with the recorded observations made during the test. After approximately 31 minutes, embers were observed falling from the unlined section of floor (cavity Nos. 4 and 5, Figure 12). Embers continued to fall in increasing quantities from the unlined section of floor for the following four minutes. During this time the fire resistant table fell through the floor, between the remains of the floor joists. At 35 minutes, a large section of this half of the floor collapsed completely. The collapse of the floor modified the fire environment, significantly altering the ventilation conditions.

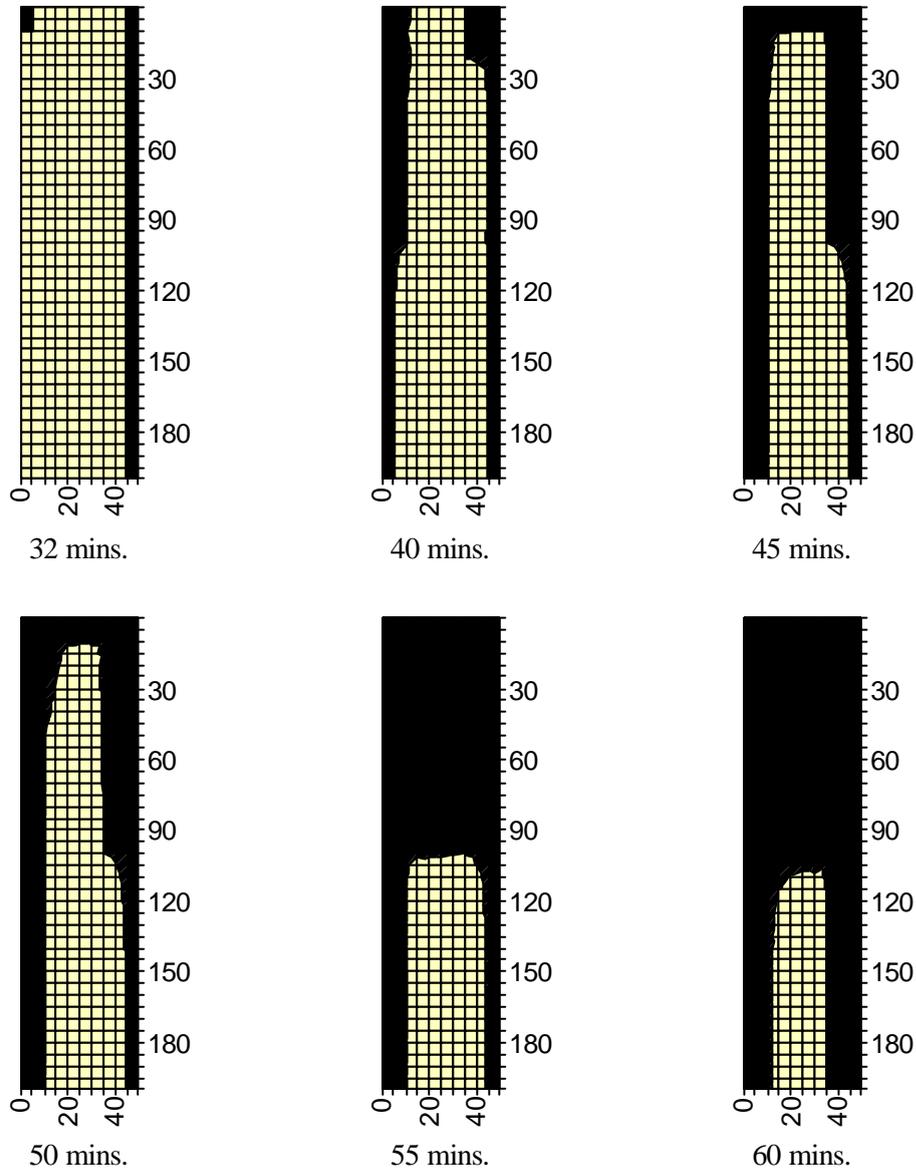
Figure 13: Dummy joist char diagrams

The second stage of failure that of the floor structural elements, was recorded by the dummy joist. The joist began to char significantly from approximately 32 minutes, as the diagrams in Figure 13 illustrate.

It is clear from Figure 13 that the structure of the floor was seriously compromised long before the 60 minute fire resistance rating of the floor/ceiling system was reached. It is also likely that had the floor been loaded with a larger fire resistant object, it would have failed more convincingly.

It is significant to note that the dummy joist was located within a lined floor cavity not covered with a crib set, (cavity No. 3, Figure 12). This section of floor did not become covered with

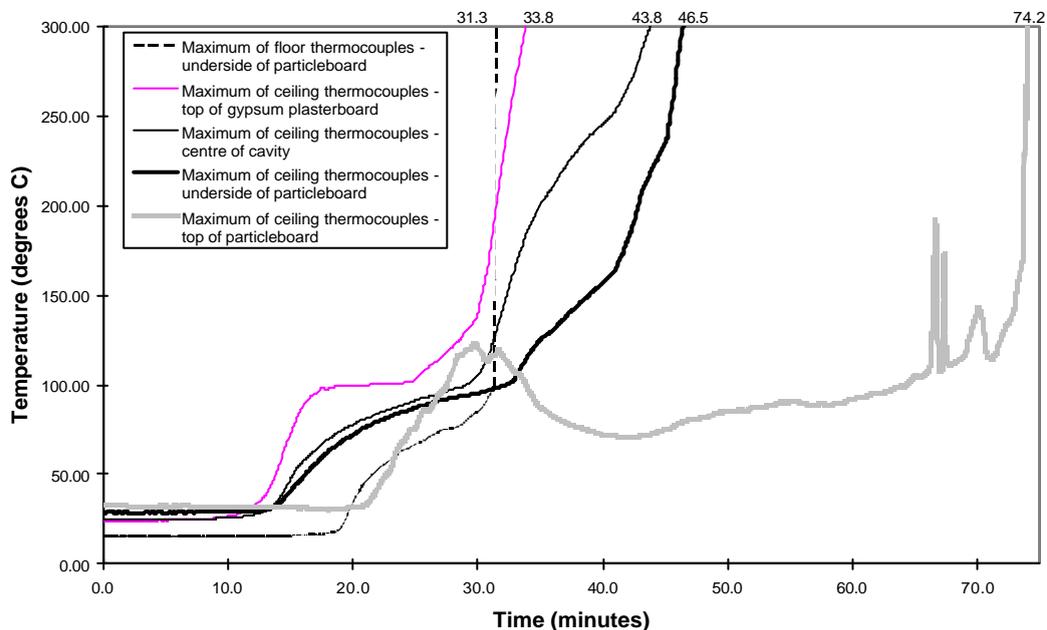
Figure 14: Maximum thermocouple readings, time to exceed 300°C

The charring of the particleboard on the floor of the test room occurred while the ventilation conditions remained unchanged. The charring of both the dummy joist and the particleboard on top of the ceiling assembly occurred after the ventilation conditions for the room as a whole
