Study Report SR410 [2018]

Assessing the risk of non-compliant firestopping and smokestopping in New Zealand residential buildings undergoing alterations

Kevin Frank, Greg Baker and Jonathon MacIntyre

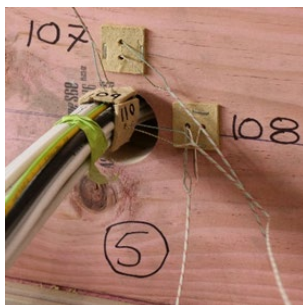
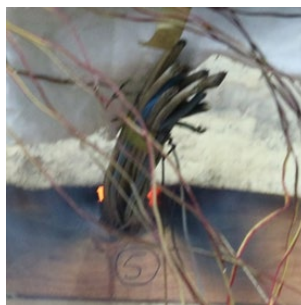
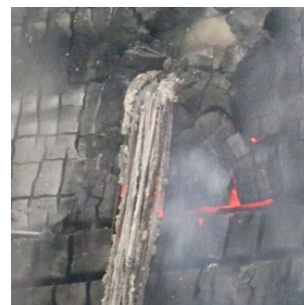
Figure 24. Test TV: 12-cable bundle, 52 mm diameter penetration.

Two 12-cable bundle penetrations were installed without firestopping, one without plasterboard pattresses (Figure 24) and one with (Figure 25). The 52 mm diameter hole size for these penetrations was almost large enough for the penetrations to fail based on the gap gauge before the test started. Both of these penetrations failed insulation quickly, at 3 and 5 minutes respectively. The penetration without a plasterboard pattress reached a peak temperature rise of 625 K on the unexposed side and the one with reached 603 K. Both penetrations also failed integrity before 30 minutes, at 19 and 21 minutes respectively. However, the plasterboard pattress kept the substrate temperature on the unexposed side well below 180 K temperature rise.

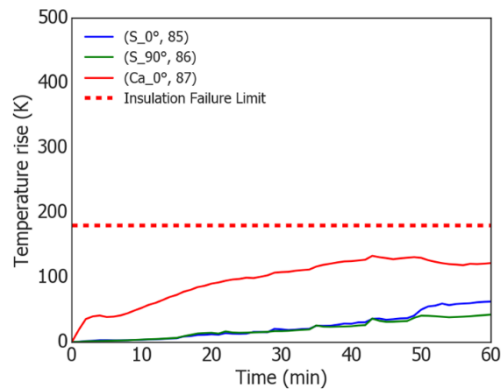
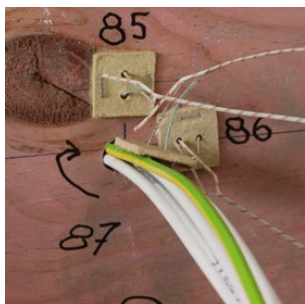
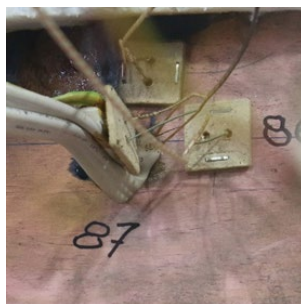
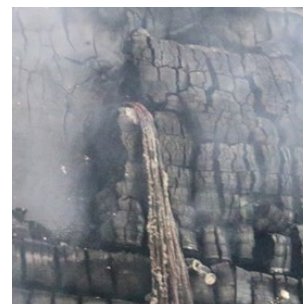
Figure 26. Test TV: 3-cable bundle, 16 mm diameter penetration.

None of the 3-cable or 1-cable unsealed penetrations (Figure 26–Figure 29) failed insulation or integrity prior to 60 minutes in this substrate. Very little charring was observed on the unexposed side of these penetrations as well.

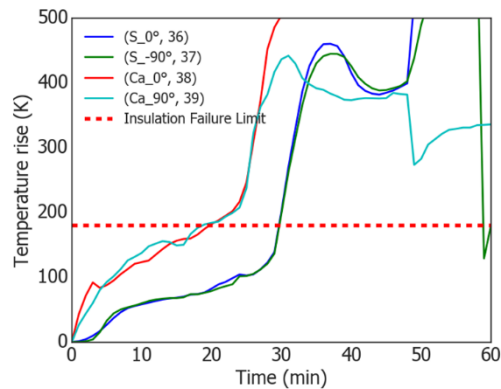
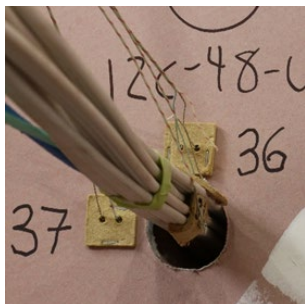
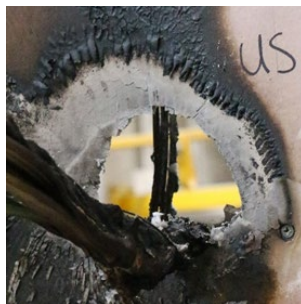
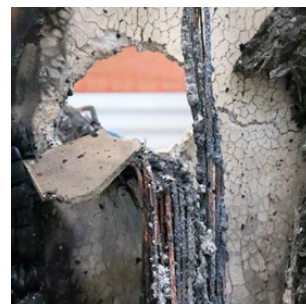
Figure 30. Test CV: 12-cable bundle, 48 mm diameter penetration.

One 12-cable bundle penetration was installed in the fibre-cement board wall without firestopping (Figure 30). It failed insulation at 19 minutes and integrity at 27 minutes, with one thermocouple recording a maximum temperature rise of 786 K. The substrate was severely damaged on both sides, and the cable insulation on the unexposed side was severely charred.

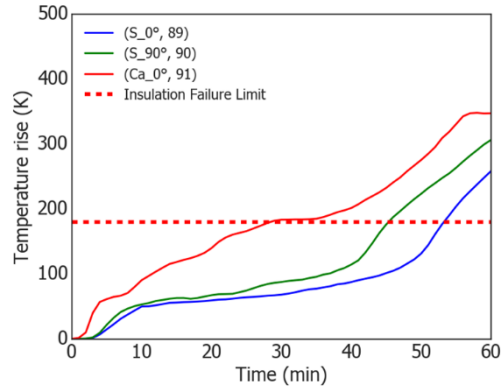
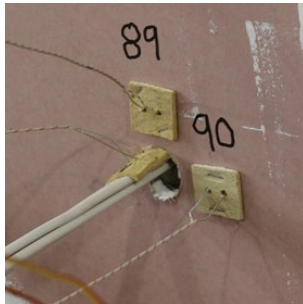
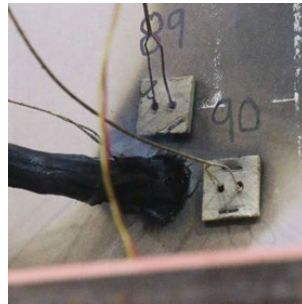
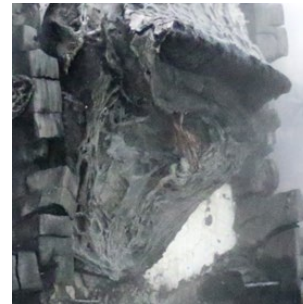
Figure 31. Test CV: 3-cable bundle, 25 mm diameter penetration.

3-cable bundles were installed with penetration diameters of 25 mm, 18 mm and 16 mm (Figure 31–Figure 33). All failed insulation at 29, 48 and 49 minutes respectively. Maximum temperature rises of 348 K, 278 K and 373 K were recorded, respectively. None of these penetrations failed integrity, and the 25 mm and 18 mm penetrations were particularly charred.

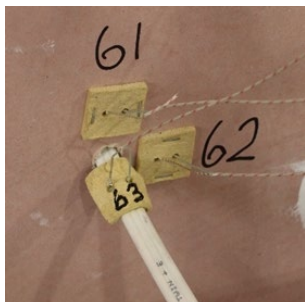
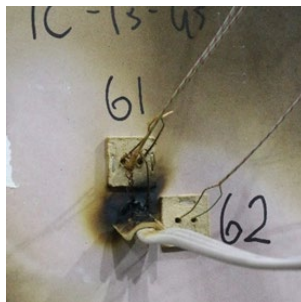
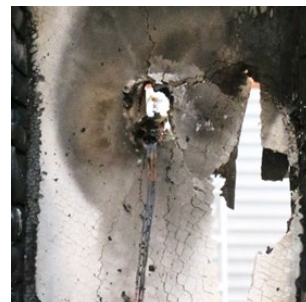
One 1-cable penetration with a penetration diameter of 13 mm was installed in the fibre-cement board wall. It failed insulation at 58 minutes and did not fail integrity. Some charring was noted (Figure 34).

Figure 34. Test CV: 1-cable, 13 mm diameter penetration.

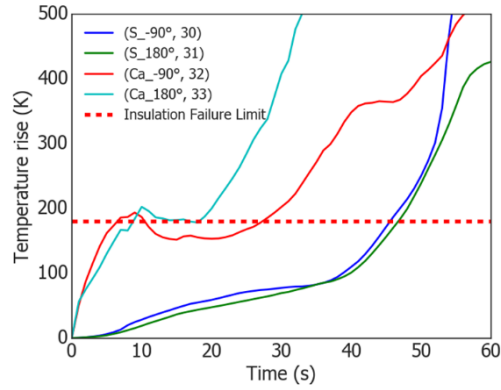
The single unsealed 12-cable bundle installed in a 44 mm diameter penetration (Figure 35) failed insulation at 7 minutes and integrity at 55 minutes. The peak temperature rise recorded was 676 K. The unexposed side was substantially charred.

Figure 35. Test PH: 12-cable bundle, 44 mm diameter penetration.

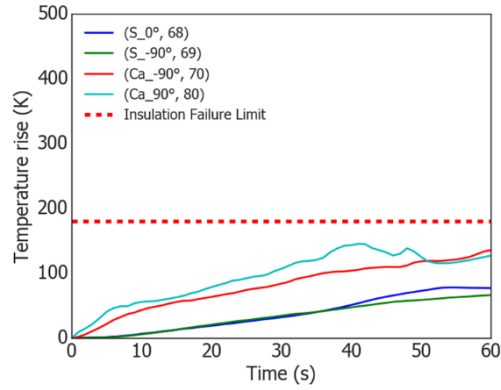
Of the three 3-cable bundles installed in 25 mm, 18 mm and 16 mm diameter penetrations (Figure 36–Figure 38) only the 25 mm penetration failed insulation before the test completed, at 48 minutes. The peak temperature rise recorded for this penetration was 272 K. No integrity failures were observed for these penetrations. Substantial charring was observed near the 25 mm diameter penetration, light charring was noted near the 18 mm diameter penetration and nearly no charring was noted around the 16 mm penetration.

Figure 37. Test PH: 3-cable bundle, 18 mm diameter penetration.

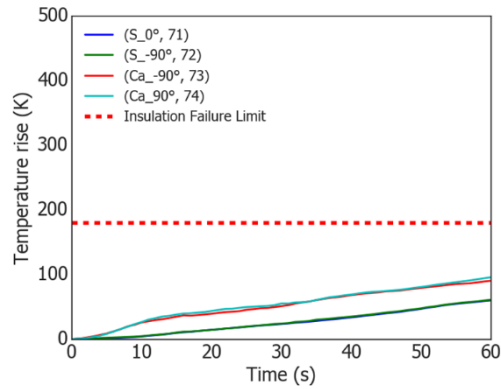
Figure 38. Test PH: 3-cable bundle, 16 mm diameter penetration.

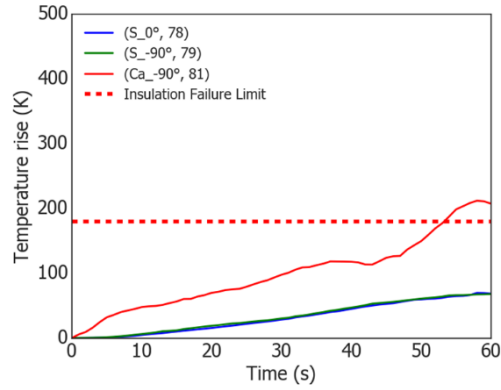
Single cables were installed in 16 mm and 13 mm diameter unsealed penetrations (Figure 39 and Figure 40). The 16 mm diameter penetration failed insulation at 54 minutes, with a peak temperature rise measured of 212 K. The 13 mm diameter penetration did not fail on insulation. Neither 1-cable penetration failed integrity prior to the end of the test. The cable insulation on the unexposed side of the 16 mm diameter penetration was substantially charred.

Figure 39. Test PH: 1-cable, 16 mm diameter penetration.

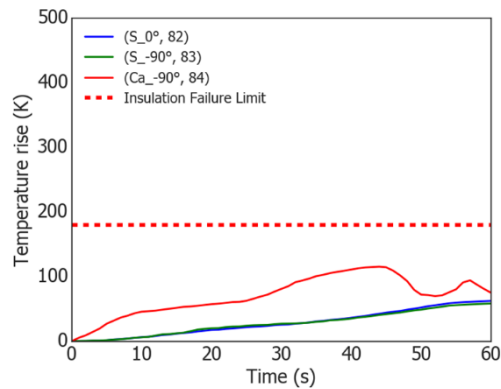
Figure 40. Test PH: 1-cable, 13 mm diameter penetration.

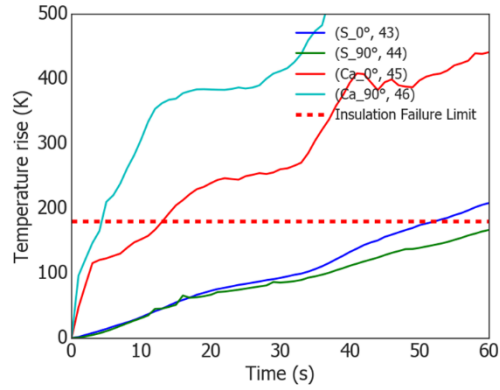
A 12-cable bundle in a 47 mm diameter unsealed penetration (Figure 41) failed on insulation at 5 minutes, with a peak temperature rise of 702 K. It failed on integrity at 33 minutes, and the unexposed side cable insulation was substantially charred.

Figure 41. Test CH: 12-cable bundle, 47 mm diameter penetration.

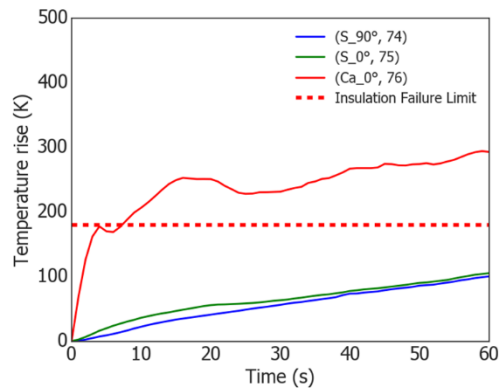
3-cable bundles were installed in 24, 18 and 16 mm diameter penetrations (Figure 42–Figure 44). The 24 mm diameter penetration was the only one that failed on insulation, at 8 minutes. The maximum temperature rise recorded on this penetration was 294 K. None of the 3-cable bundle penetrations in this substrate failed integrity before the end of the test. The cable insulation was substantially charred on the unexposed side of the 24 mm diameter penetration, while charring was minimal on the unexposed side of the 18 mm and 16 mm diameter penetrations.

Figure 42. Test CH: 3-cable bundle, 24 mm diameter penetration.

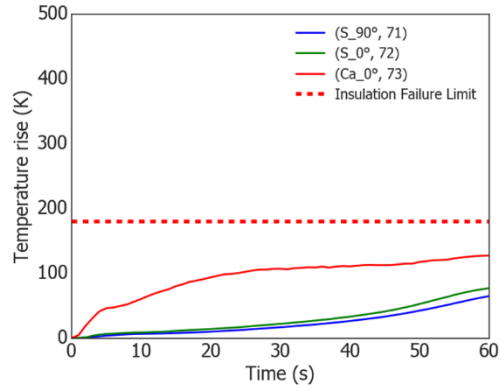
Figure 43. Test CH: 3-cable bundle, 18 mm diameter penetration.

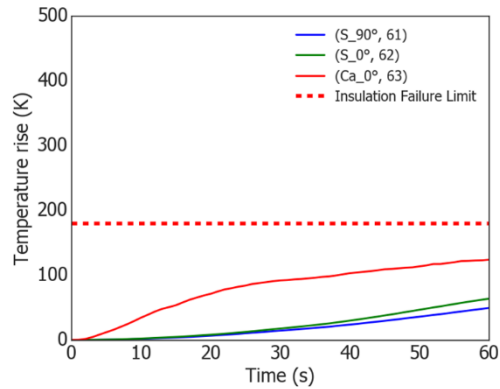
Figure 44. Test CH: 3-cable bundle, 16 mm diameter penetration.

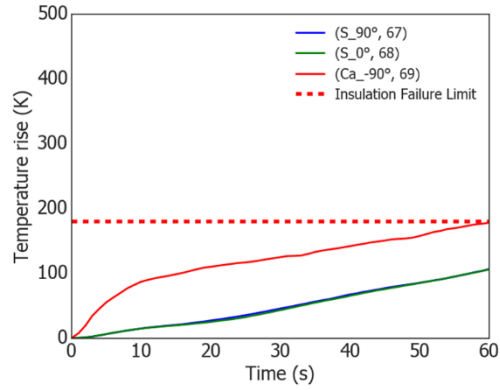
Neither the 16 mm or 12 mm diameter 1-cable penetrations failed either insulation or integrity in the timber infill floor substrate (Figure 45 and Figure 46). The cable insulation was charred on the unexposed side of the 16 mm diameter penetration.

Figure 45. Test CH: 1-cable, 16 mm diameter penetration.

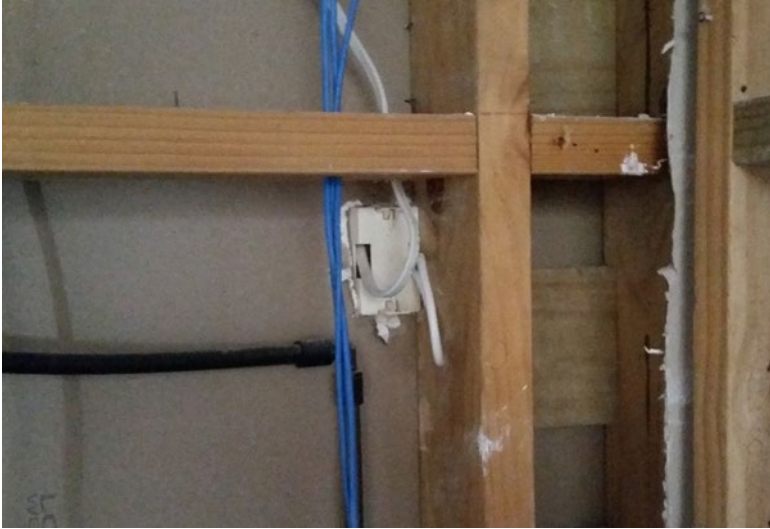
Figure 61. Unrated flush boxes in fire-rated walls.

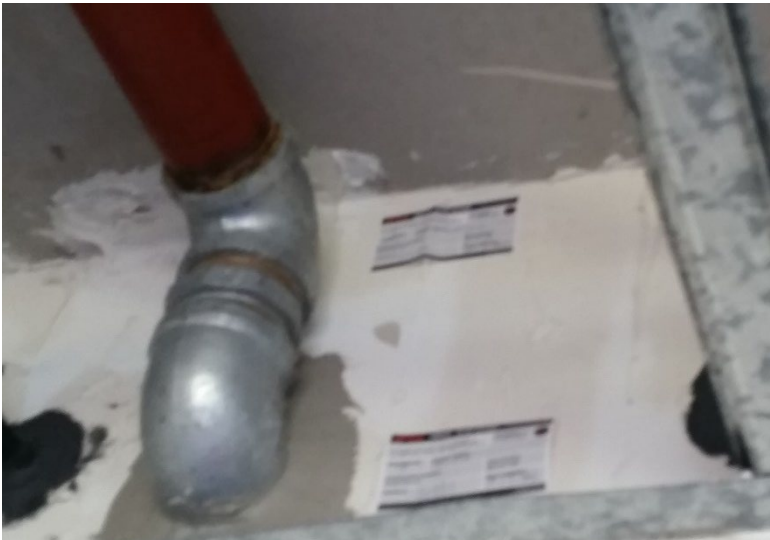
Figure 62. Penetrations through fire walls sealed with smoke seal only.

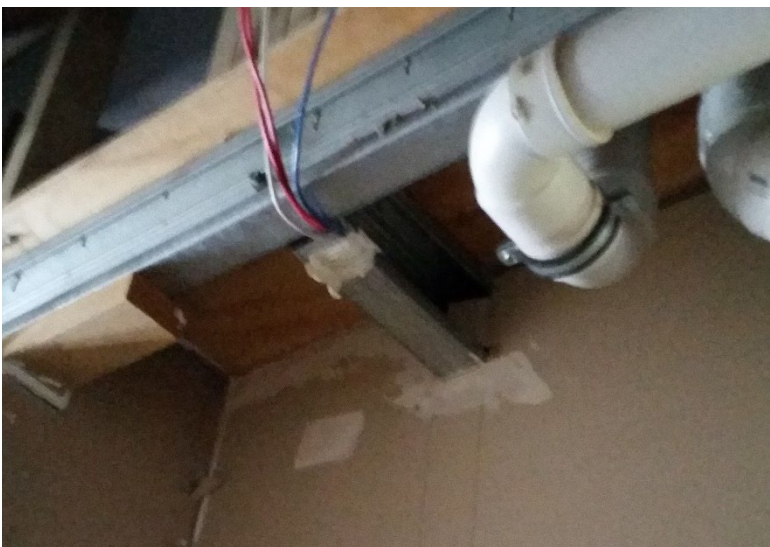
Figure 63. Non-sealed structural steel penetration of a fire-rated wall.

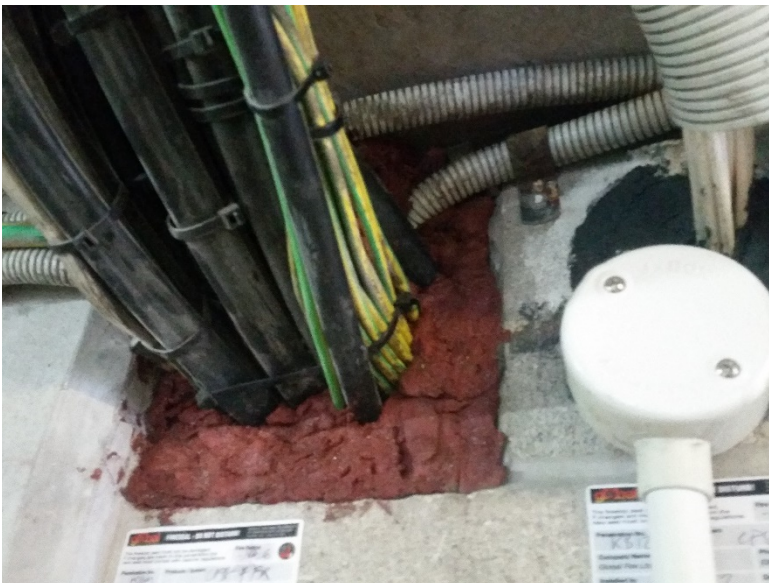
Figure 65. Multiple large cable bundles without stopping between bundles.

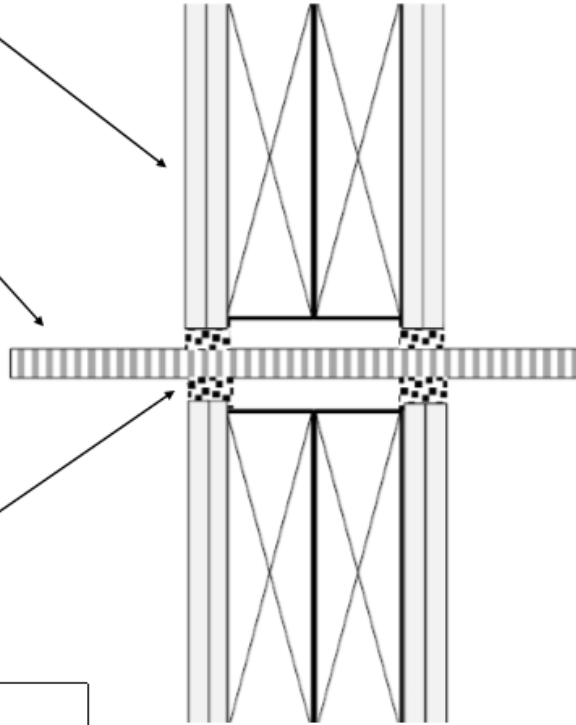
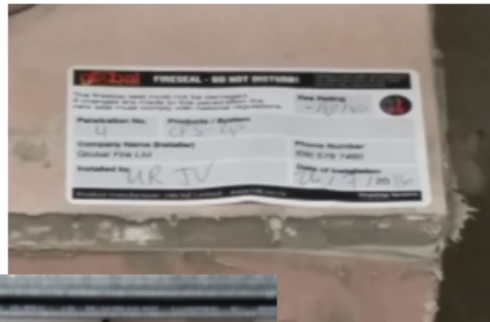
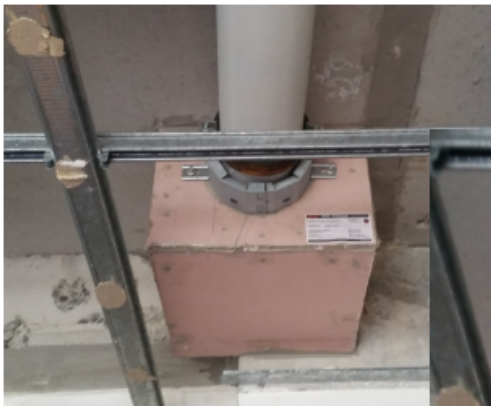
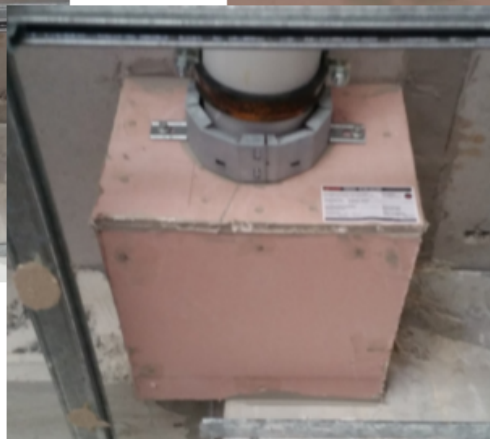
Sketch Number: 04
 Location: Kitchen—in apartment

Comments:
 Plasterboard bulkhead box attached to concrete wall

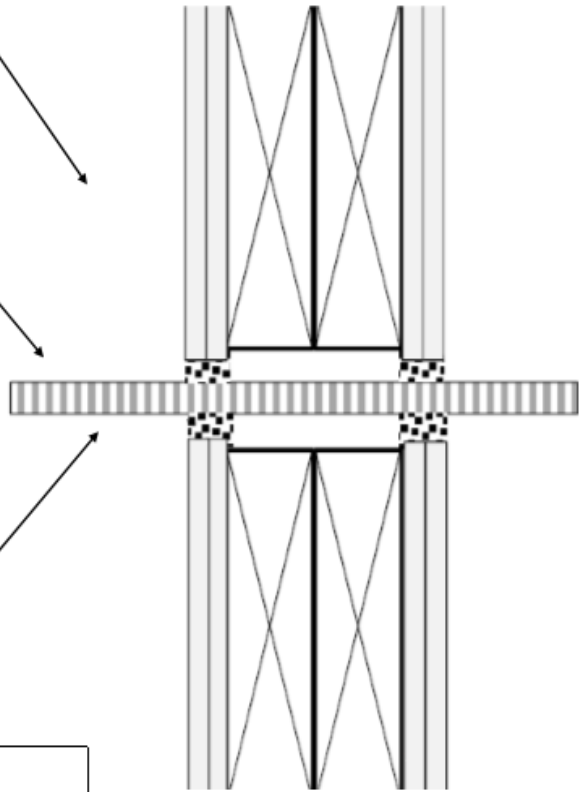
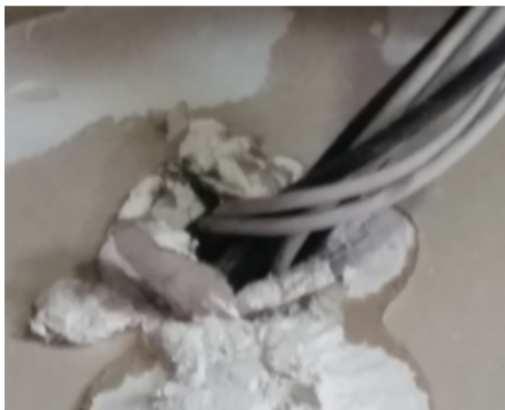
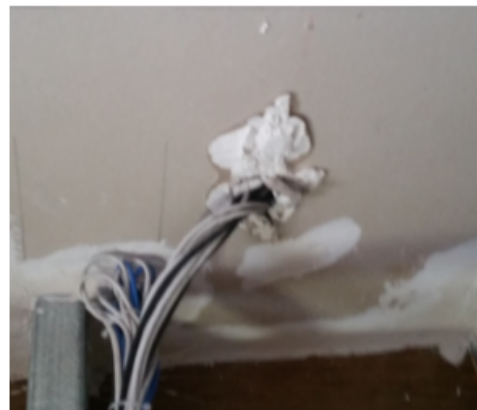
Sketch Number: 05
 Location: Lvl 7 Corridor (Means of Escape)

Comments:
 Corridor wall into apartment

Cavity Details:
 None Recorded/apparent
 Penetration in IT wall above ceiling height

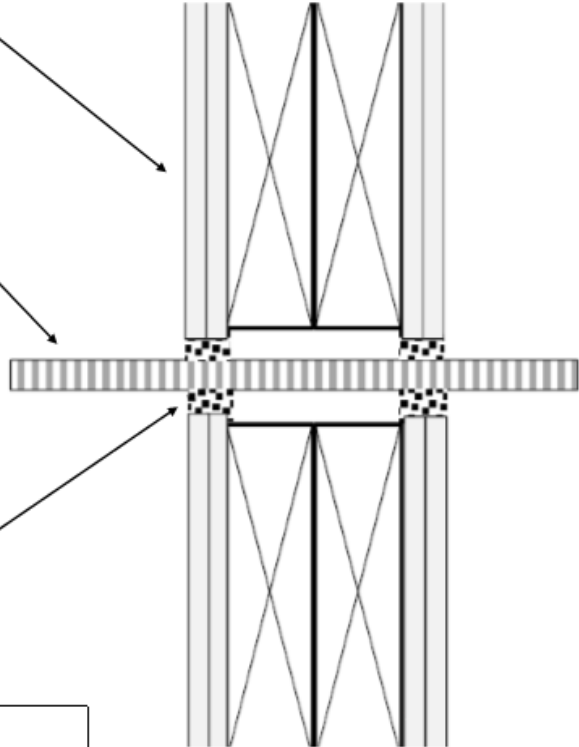
Comments:
 Corridor wall into apartment
 Pattress appears to end within 10-20 mm of top of penetration. Penetration on edge of sheet, join is not stopped

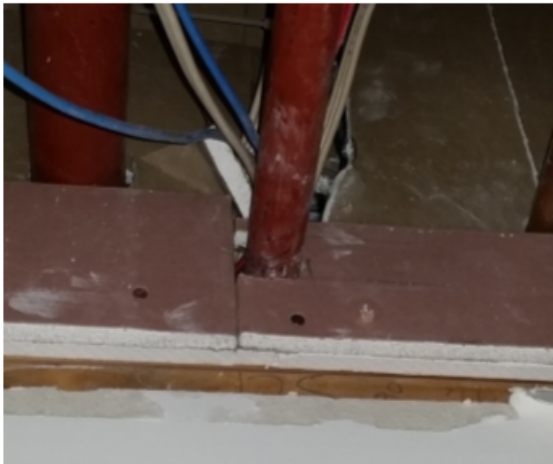
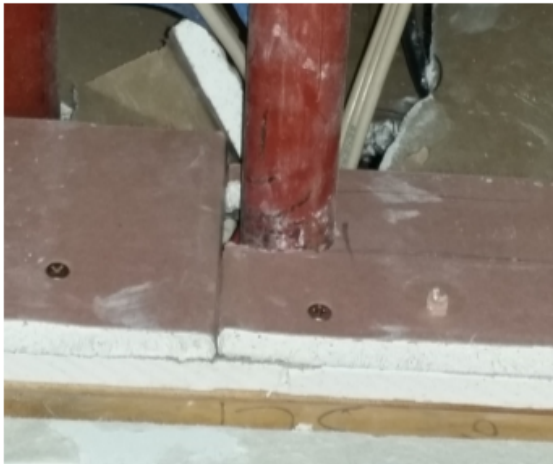
Sketch Number: 07a
 Location: Corridor (Means of Escape)

Comments:
 Corridor wall into apartment
 Plasterboard is broken and unstopped in surrounding area

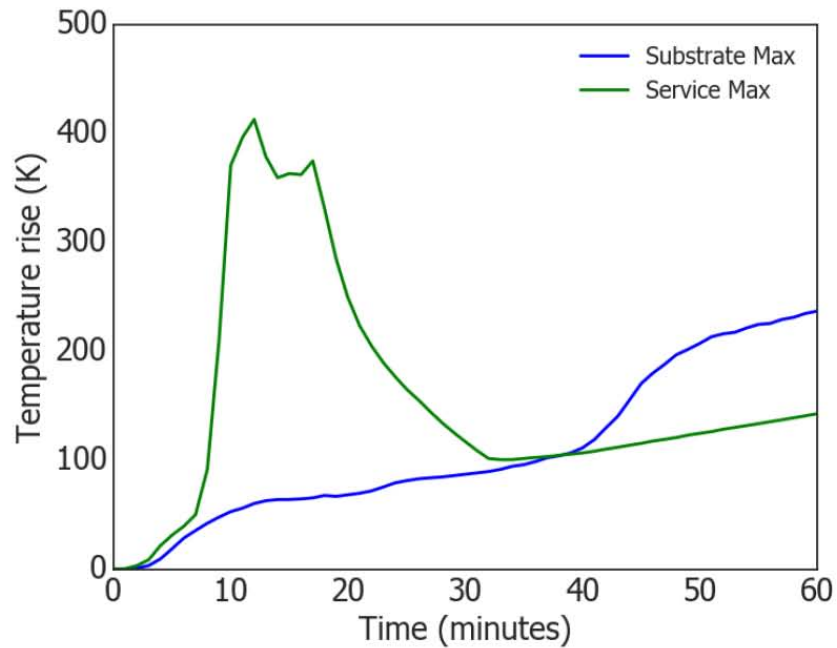
Figure 1: Penetration A thermocouple temperatures

Observations related to the integrity performance of the specimens were made during the test. A 25 mm gap gauge could be projected into the furnace through Penetration A at 14 minutes and a cotton pad was ignited at Penetration F at 10 minutes. No significant integrity observations were made during the test duration for the other penetrations.
