STUDY REPORT

SR234 (2010)

Investigation into the Performance of Brick Veneer Walls Installed with Urea Formaldehyde Foam Insulation – A Case Study

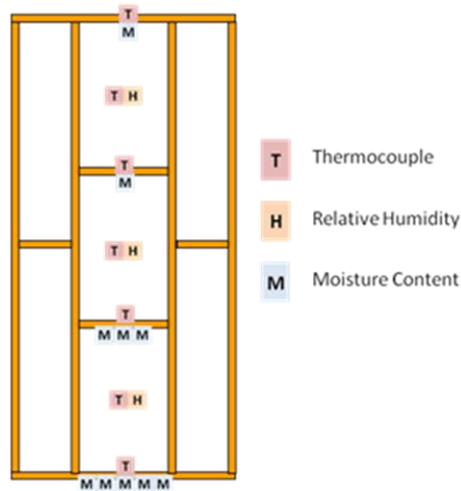
Figure 7: Framing and instrumentation layout for test building sample

The framing and instrumentation layout is shown in Figure 7. For the purposes of the current study the moisture content pins were all moved to the middle of their respective framing member, as shown in Figure 7. This was done in an attempt to look at the moisture distribution across the frame from the internal lining to the building wrap. The exposed ends of the moisture pins were coated with an adhesive in an attempt to

eliminate shorting of the pins through the wet foam. The humidity sensors were located in the stud space and were protected from liquid water by placing masking tape over the ends of their sheathing.
