STUDY REPORT

SR 304 (2013)

Post-Earthquake Performance of Passive Fire Protection Systems

P. C. R. Collier

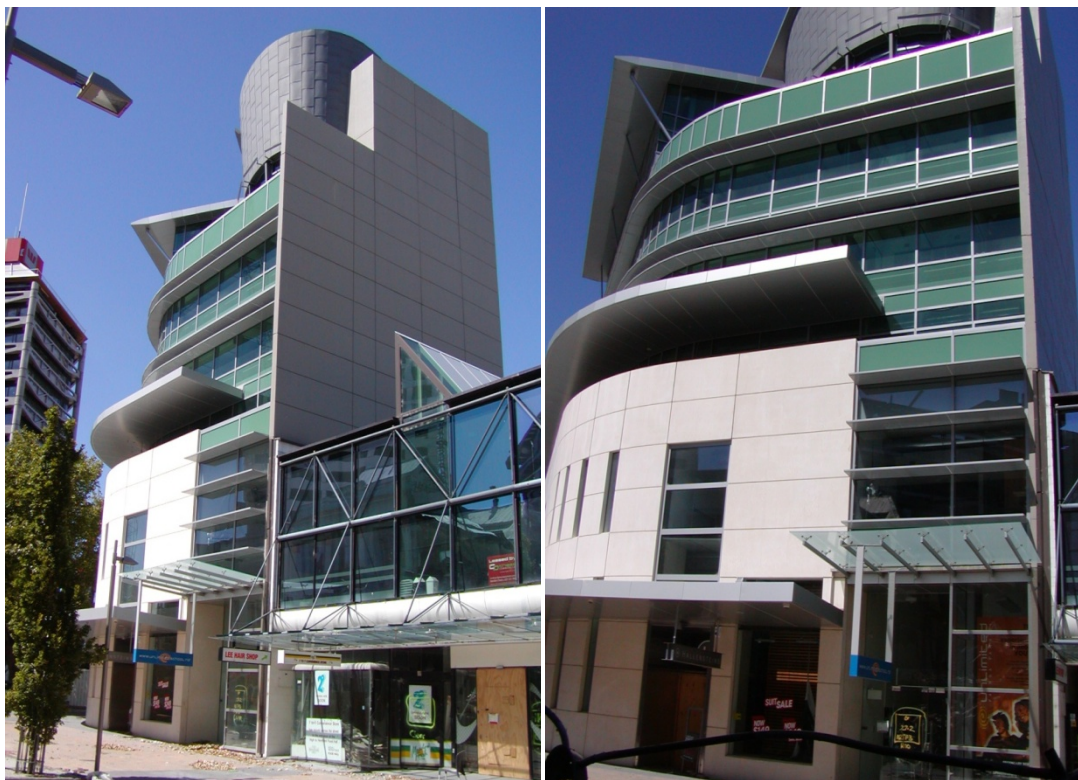
An example of a six-storey commercial building assessed in the building survey is shown in Figure 4. The ground floor comprised a retail outlet on the left side and an entrance lobby on the right, with an elevator and a stairwell servicing the five levels above that were open plan offices. A second stairwell servicing the upper five levels also connected to the ground level alley providing a second means of egress.

Figure 4: Six-storey office building surveyed

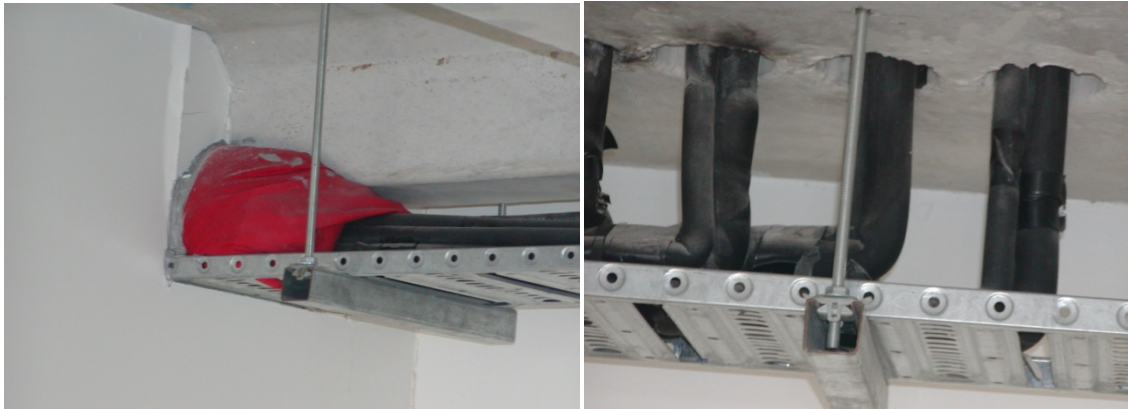
The service penetration carrying electrical cabling through the lobby wall shown in Figure 9 had some cracking between the rack and the ceiling and it is unknown whether the

ceiling-to-plasterboard interface or the penetration is the cause of the plasterboard cracking. In this case the degree of damage is relatively minor compared with other parts of the same wall, so it is most likely the first failure of fire resistance would be at the more severely damaged locations. The upper side of the cable penetrations through the concrete floor was not located to assess the level of any damage there.

Figure 9: Service penetration through lobby firewall and floor above

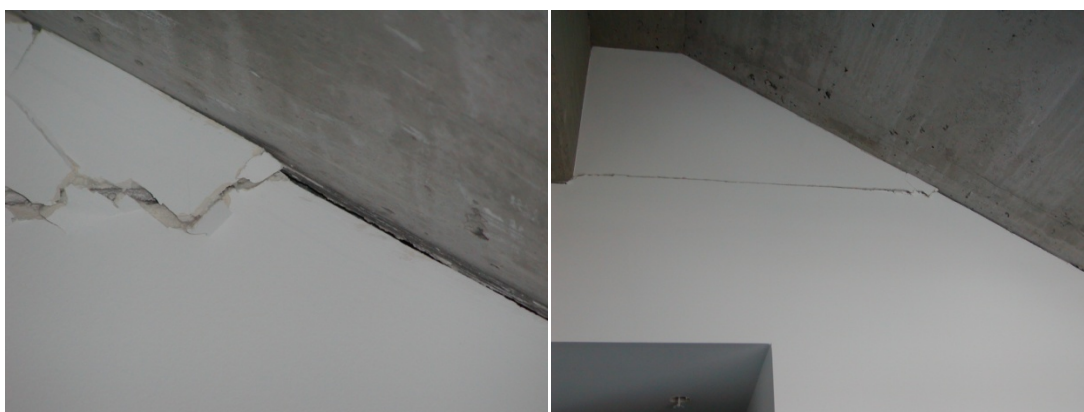
Figure 16: Plasterboard damage under scissor stair flight

Figure 16 shows the underside of a precast concrete stair where the junction to the fire-rated wall beneath has been crushed or displaced by earthquake-induced motion.

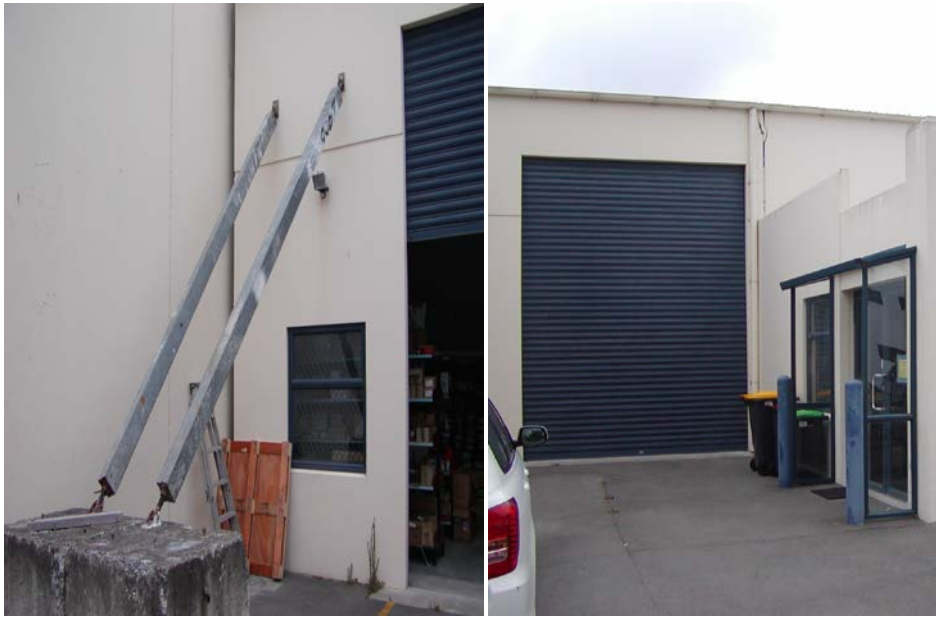
A broad and mainly external survey of low rise industrial buildings of predominantly concrete tilt slab construction in an industrial area south of the Christchurch CBD indicated that earthquake movement of the buildings and subsequent settlement due to liquefaction were jointly responsible for damage. The external view of a typical tilt slab building is shown in Figure 20 and a close up of the damaged joints in Figure 21 show an internal wall corner junction where the sealant has failed and the concrete fractured at the steel angle attachment. Also an external wall panel butt joint has opened, stretching the silicone sealant and causing it to tear, leaving an opening.

Figure 20: External view of typical concrete tilt slab building

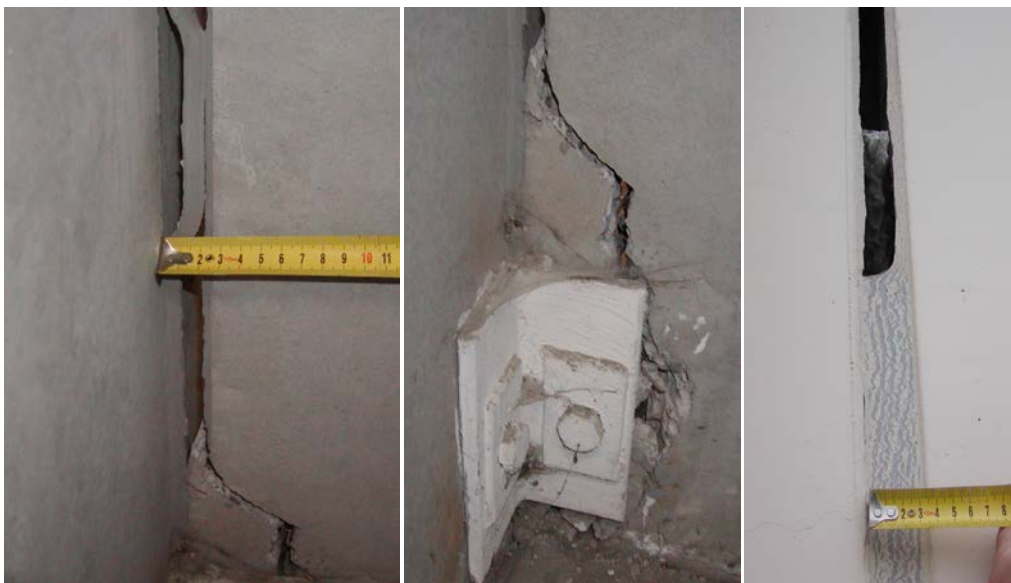
Figure 21: Internal corner and external butt joint

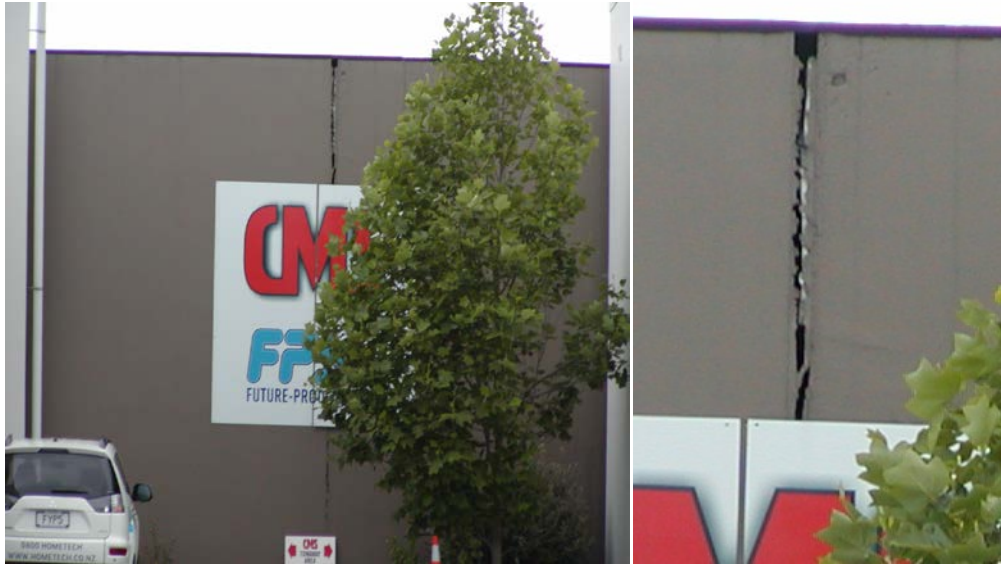
Surveying around the perimeter of the same city block showed that the damage in Figure 22 was fairly typical, with openings such as that shown but also some joints that were compressed as the ground settled unevenly as a result of liquefaction.

Figure 22: Typical opening of butt joints in concrete tilt slab panels

The implications are that the opening of gaps on the external walls represents an increased risk of fire spread to neighbouring buildings. Although fire spread along a street is unlikely, some of the buildings are very close to each other and if gaps or fractures in tilt panels were to match up, then it would be relatively easy for fire to spread to an adjacent premises.

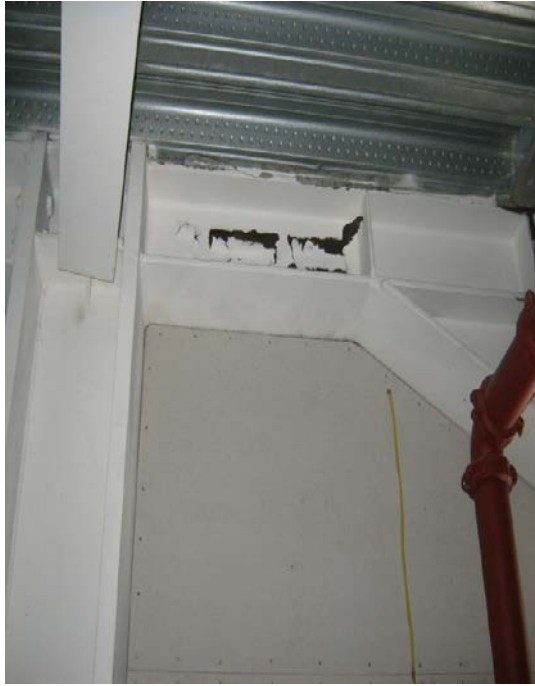
In a different multi-storey building that was not part of the BRANZ survey of PFP, the loss of intumescent paint was recorded in Figure 23. In this case paint had detached from the beam below the ceiling, most likely due to multiple cyclical deflections of the beam leading flaking of the relatively thick coating of brittle paint and potential exposure of unprotected steel in the event of a fire outbreak.

Figure 23: Loss of intumescent paint on steel beam post-earthquake

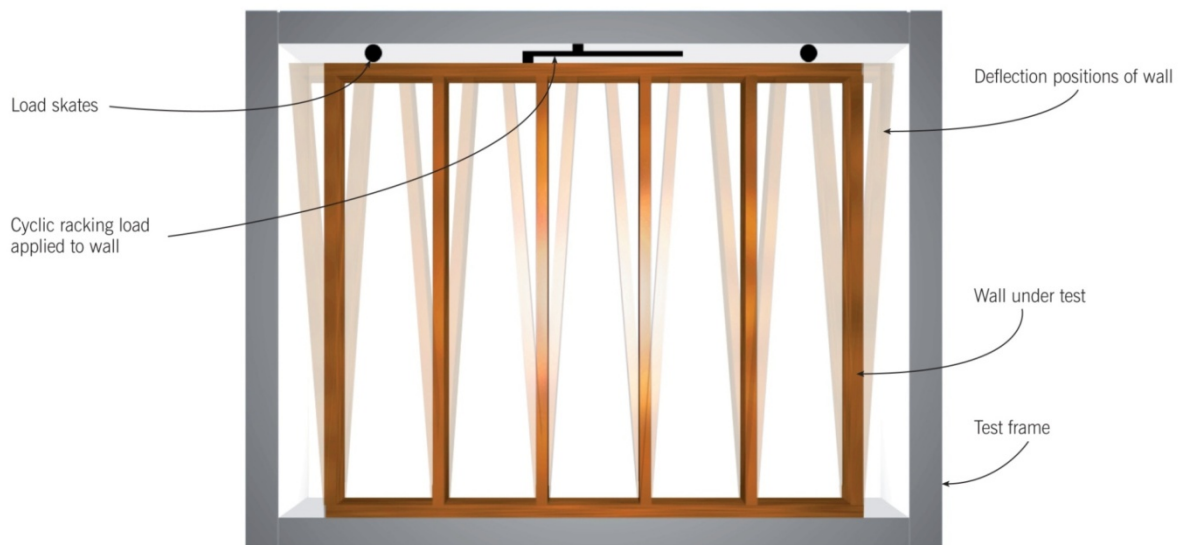
The earthquake damage was created by racking the test walls back and forth in a prescribed manner to simulate as closely as possible likely earthquake damage as shown in Figure 25. The walls were then subjected to a fire resistance test.

Figure 25: Racking of walls to simulate earthquake damage

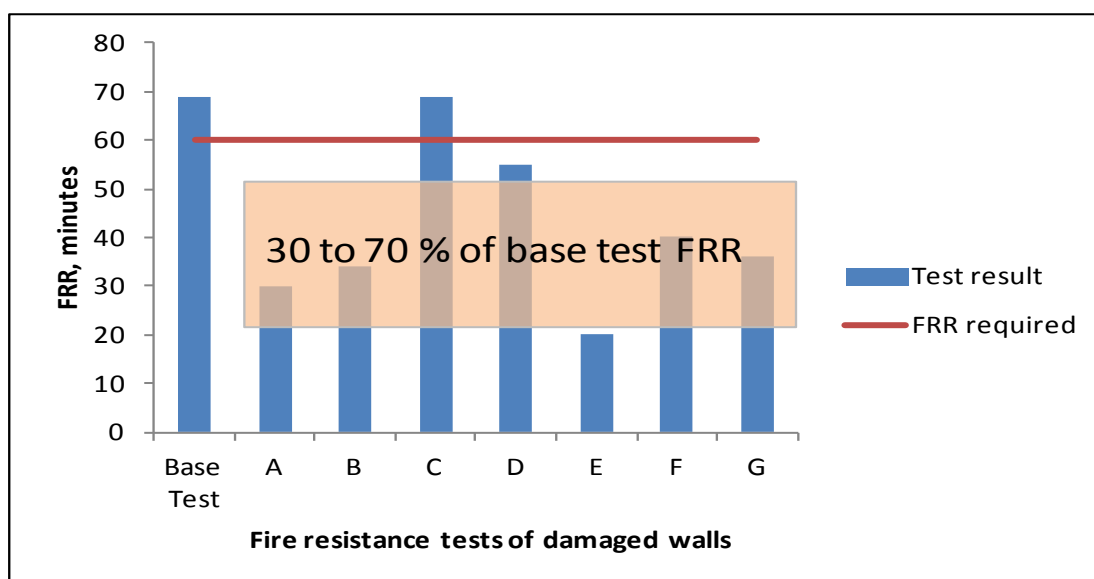
The reductions in fire resistance are shown in Figure 27, the majority of the reductions fall within a band of 30 to 70% of the base test fire resistance and in all of these tests the first mode of failure was Integrity. The only test not to fail by Integrity was Test C which failed by Insulation, in this case the lining remained attached to the framing after racking and throughout the fire test performing similarly to an undamaged test wall.

- Detachment of linings particularly around the perimeter of the test wall
- Cracks on corners and joints.

Figure 27: Comparing fire resistance of damaged walls

Restraining the lining around the perimeter with skirting boards, corner details and other junctions was shown to improve performance by preventing detachment of the lining.

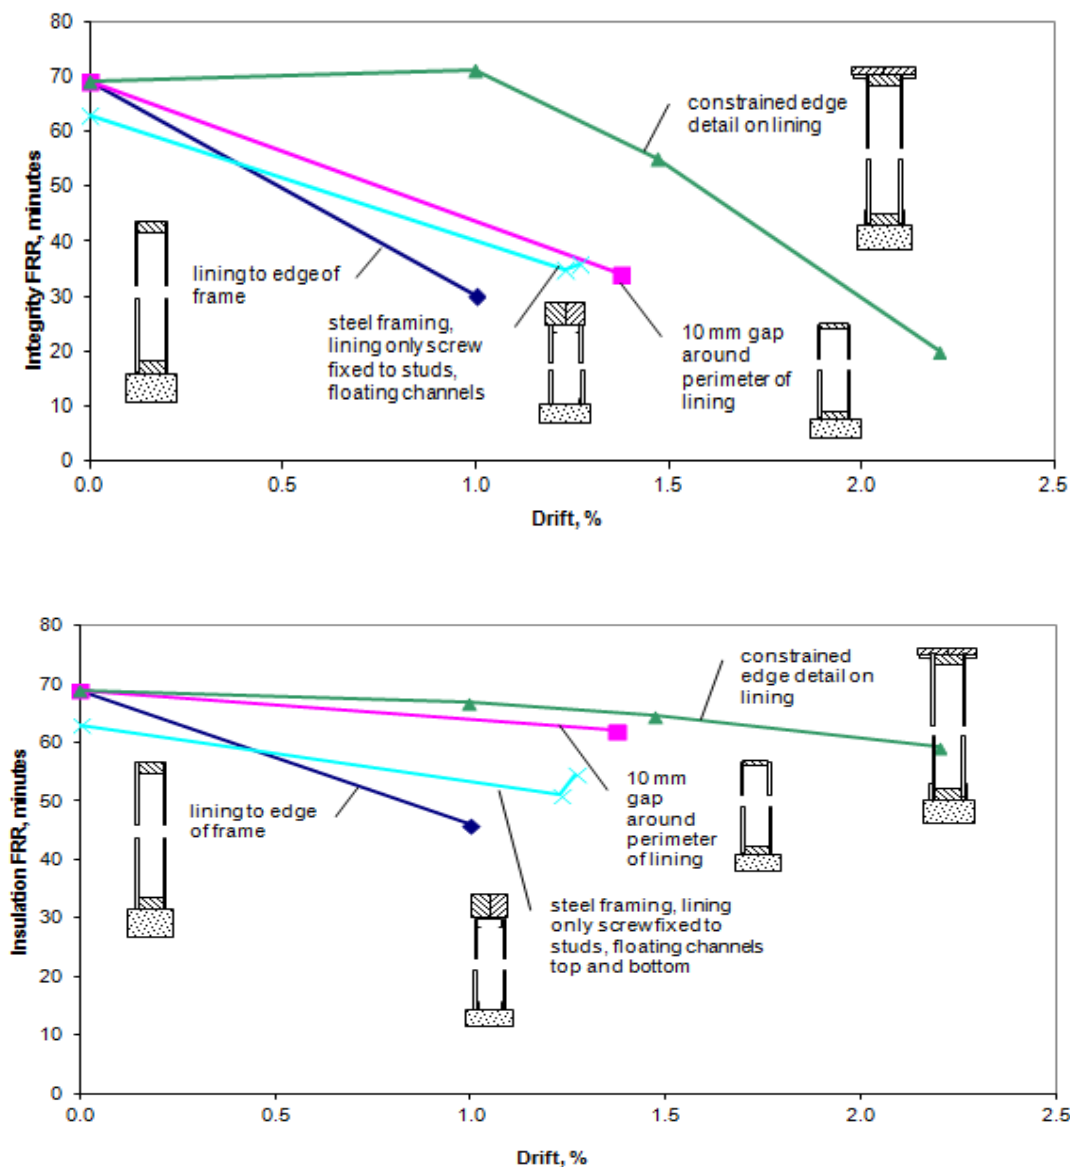
The Integrity and Insulation failure times for the test walls are compared in Figure 28 and Table 1. Clearly, Integrity predominates as the first failure and comparing Tests C, D and E where the perimeter of the lining was better secured with realistic detailing, there is clearly a “break point” after 1% drift in the racking process after which the fire resistance (Integrity) decreases rapidly.

Figure 28: Comparing Integrity (top) and Insulation (bottom) failures versus drift ratio

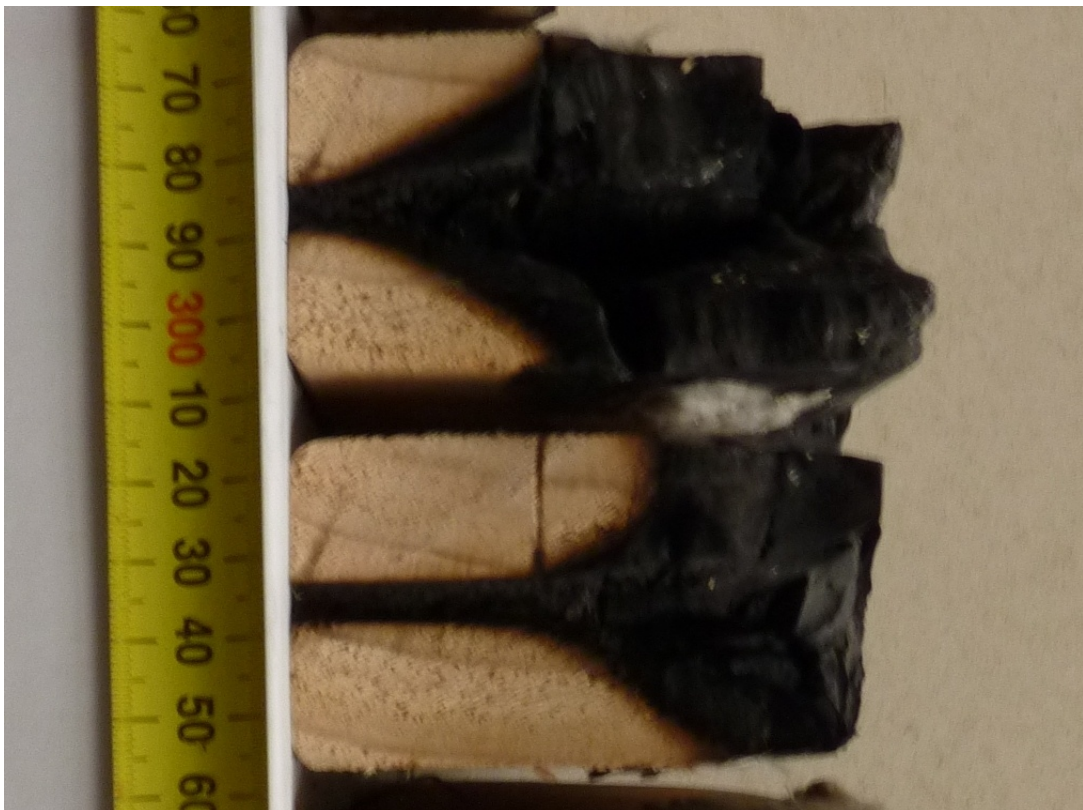
Figure 47: Cone-shaped charring profile in opposed-flame spread

The intention was that the thermocouples would provide some understanding as to what was happening. Figure 47 shows with two cross-sectioned 90 x 45 timber samples how the cone-shaped charring profile has developed against an opposing air flow. One of the thermocouple holes is visible in the bottom sample.

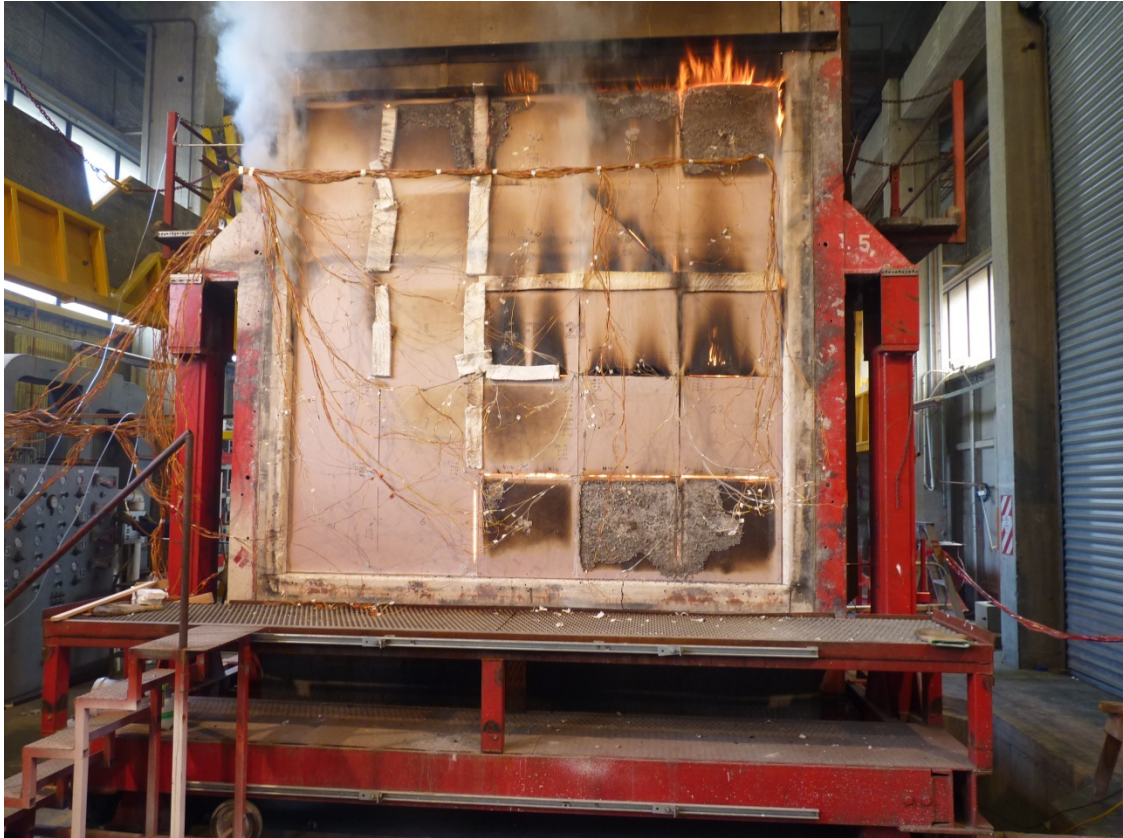
Figure 51: Test 2 at end of test

The end of test (Figure 51) at approximately 60 minutes shows where some of the Integrity failures have occurred, the gaps covered with ceramic fibre occurred well before 60 minutes and were covered over so that the test could continue and data was collected for as long as practicable.

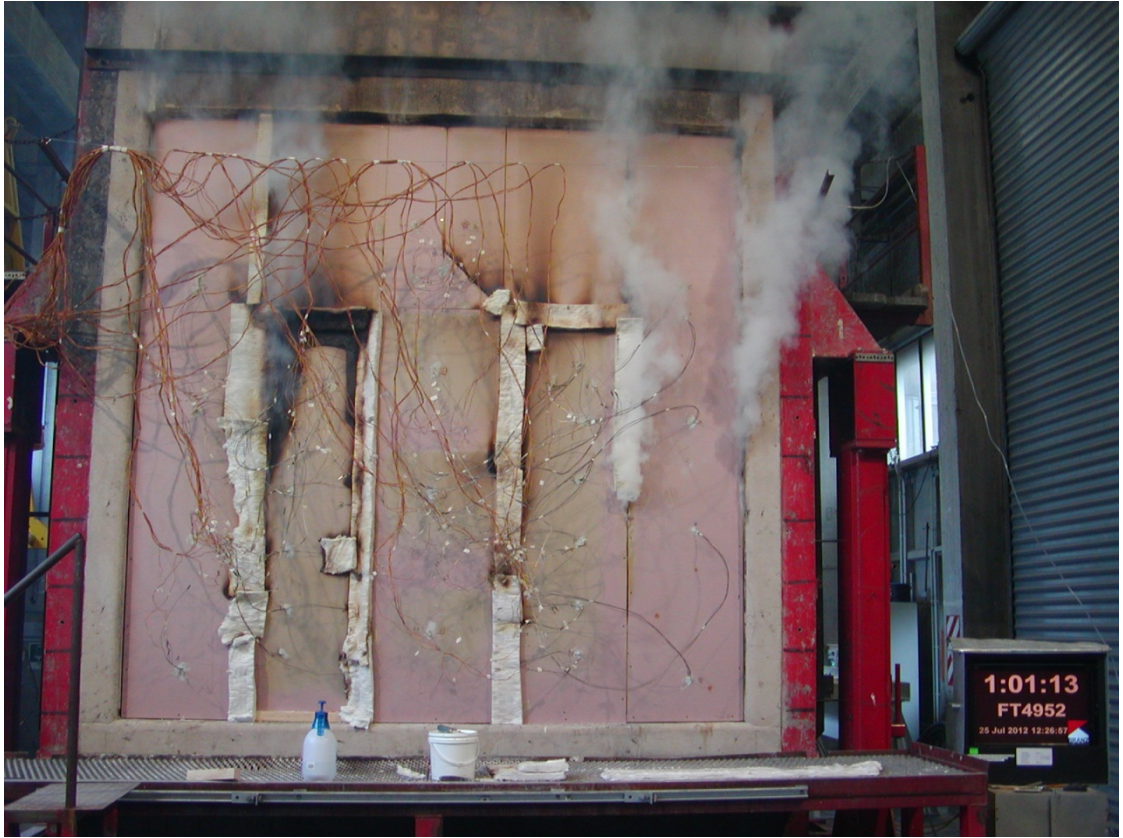
Figure 53: Test 3 at end of test

The end of test (Figure 53) at approximately 60 minutes shows where some of the Integrity failures have occurred, the gaps covered with ceramic fibre occurred well before 60 minutes and were covered over so that the test could continue and data was collected for as long as practicable.

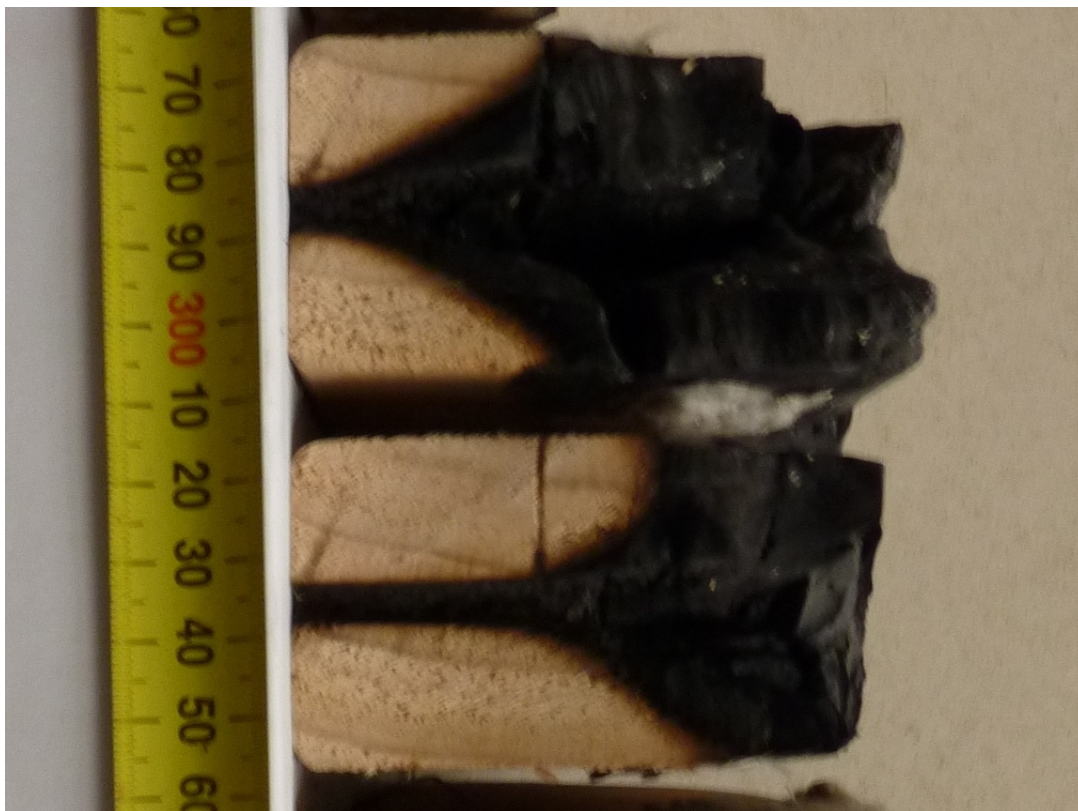
Figure 60: Extent of charring in 6 mm holes at 6.9 and 2.2 Pa furnace pressures

Comparisons of the actual sectioned holes are shown in Figure 60 after 118 minutes' fire exposure and it is evident that there is reasonable agreement with the final

temperature recordings in Figure 58 and Figure 59. The complete selection of photographs of sectioned holes that survived the test are included in Appendix B.

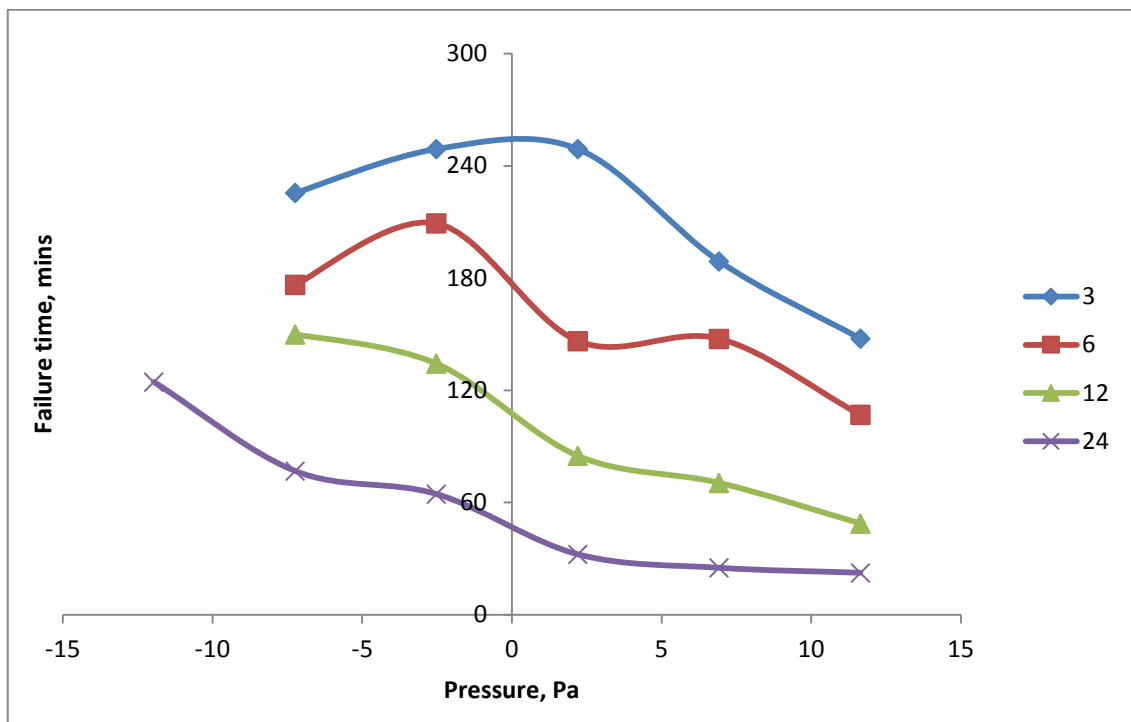
Figure 63: Integrity failures of circular holes

Integrity failures are shown in Figure 63. Although the test was stopped at 118 minutes without Integrity failures in some locations, the data at that time has been projected forward to a likely failure time. In a proportion of cases, an actual fire resistance wall will have failed by a mode other than Integrity, so the Integrity result predicted may not be relevant.

flame-through time (Integrity failure) around the point where the pressure is close to 0 Pa, offering evidence that pulsating or indeed oscillating flow in a gap has a detrimental effect. Alternatively it can be suggested that higher pressures are not proportionately detrimental to the fire resistance.

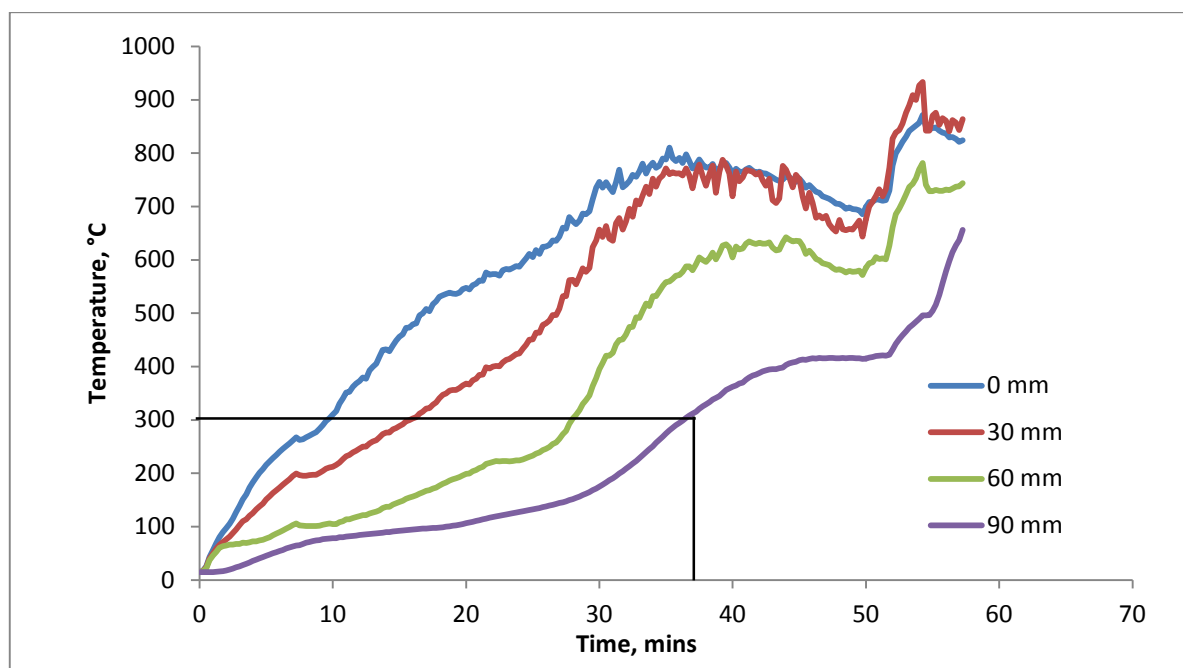
As an example, the four temperature recordings at 0, 30, 60 and 90 mm through a 2.6 mm wide vertical gap (approx 600 mm long vertically) subjected to a furnace pressure of approximately 4.9 Pa at a height of 1500 mm are graphed in Figure 64. The flame front progression is indicated by the times at which the temperature exceeds 300°C. Eventually, the temperature at the 90 mm thermocouple exceeds 300°C indicating flame-through and Integrity failure at approximately 38 minutes, also visually confirmed by flaming.

Figure 64: Typical results from thermocouples for 2.6 mm vertical gap at an average furnace pressure of 4.9 Pa

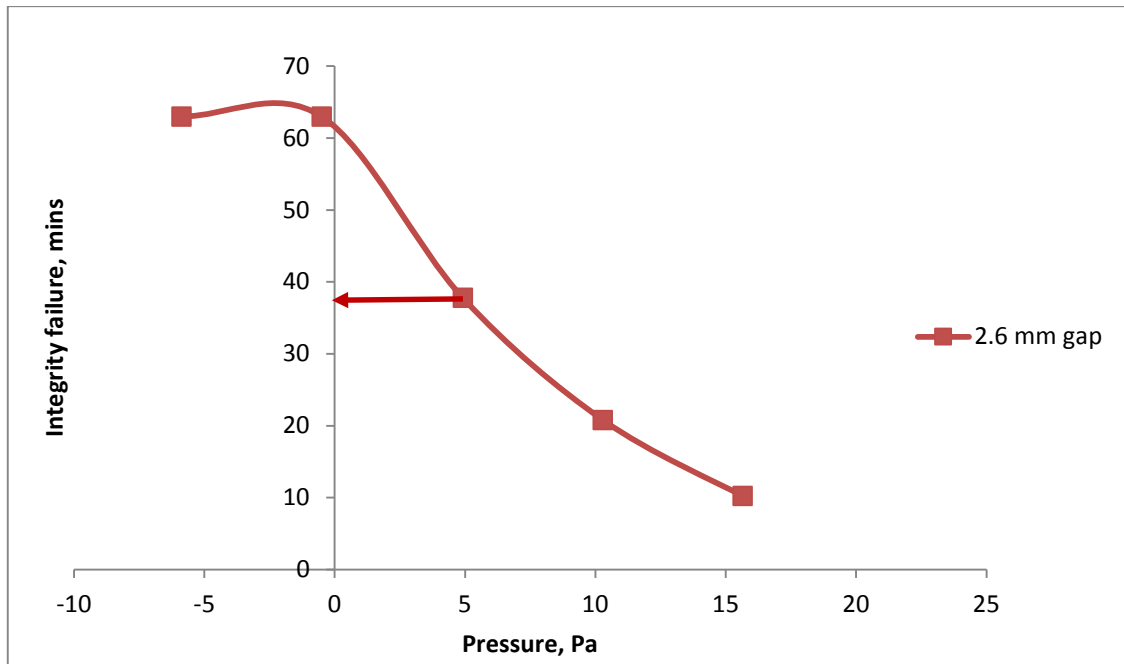
Figure 65: Typical reduction in Integrity FR with increasing pressure and elevation

In Figure 65 the Integrity fire resistance (FR) failure times from other elevations and pressures are determined from the temperature data in the same manner as that in Figure 64 to create a trend with increasing pressure. The results from a range of vertical gap sizes are added to the result in Figure 65 to produce Figure 66.

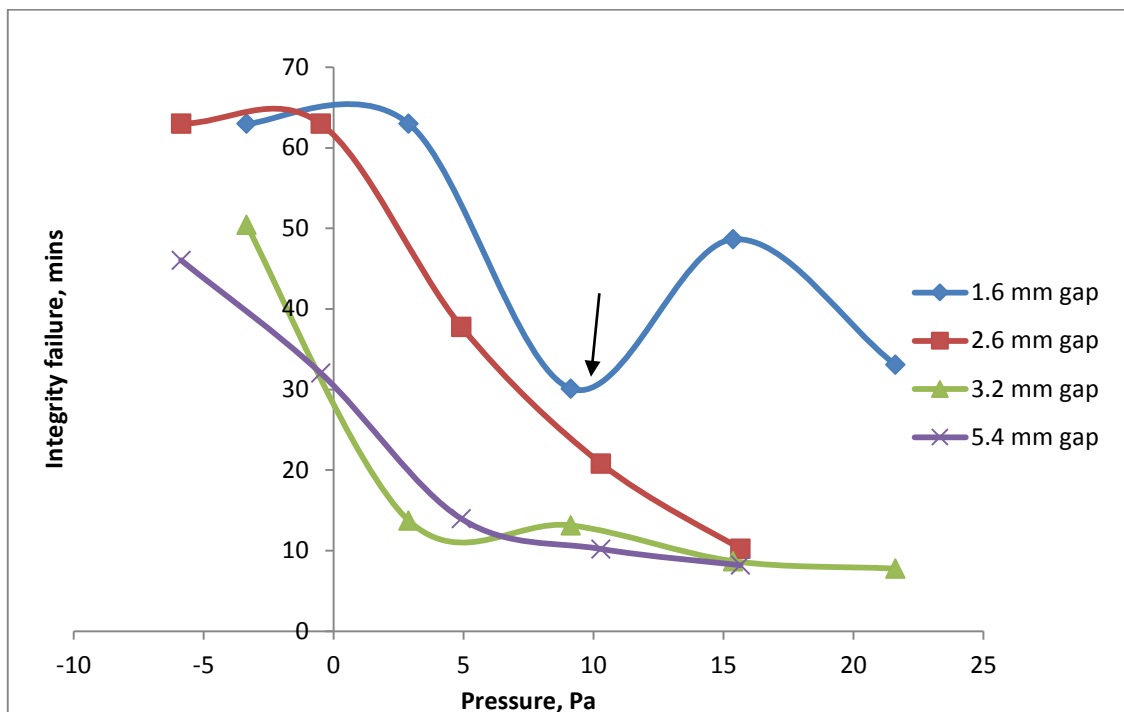
Figure 66: Reduction in Integrity FR with increasing pressure and elevation for a range of vertical gaps

For the vertical gaps in Figure 66, the reduction in Integrity to ten minutes occurs markedly with increasing furnace pressure. In the case of the wider gaps of 5.4 and 3.2 mm, the reduction occurs around the neutral pressure (0 Pa), whereas for the 2.6 mm gap, the Integrity reduction only occurs once a positive pressure is present but reduces to the same ten-minute fire resistance at 15 Pa. The wide difference in failure times between the small increase in gap from 2.6 mm to 3.2 mm in the range 0 to 10 Pa pressure possibly indicates some sensitivity due to gas flow changes over that narrow gap range.

With the narrow 1.6 mm gap, the Integrity trends similarly with the 2.6 mm gap result to a minimum at 10 Pa and then increases again. The local minimum at 10 Pa (marked by the arrow) is possibly an outlier – flaming at that location was confirmed by visual observations, the gap was covered with ceramic fibre and the test continued. Closer examination of the delay time (to reach 300°C) in Figure 67 shows a reduction from about 15 minutes to eight minutes for the initiation of the flame front at 0 mm and a corresponding increase in the rate of flame spread from 1 to 4 mm/min, the combination of which explains the reduction in failure time to 30 minutes. A possible explanation can be hypothesised that the gap (at an elevation of 10 Pa) was subject to a pulsating/oscillating flow, whereby the hot gases gently heating the gap are periodically replaced with cool 21% O₂ air that supports a glowing combustion on the timber surfaces, with increased heat input accelerating the failure. This is evidence of the earlier suggested whipsaw effect in Sections 5.1 and 7.2.

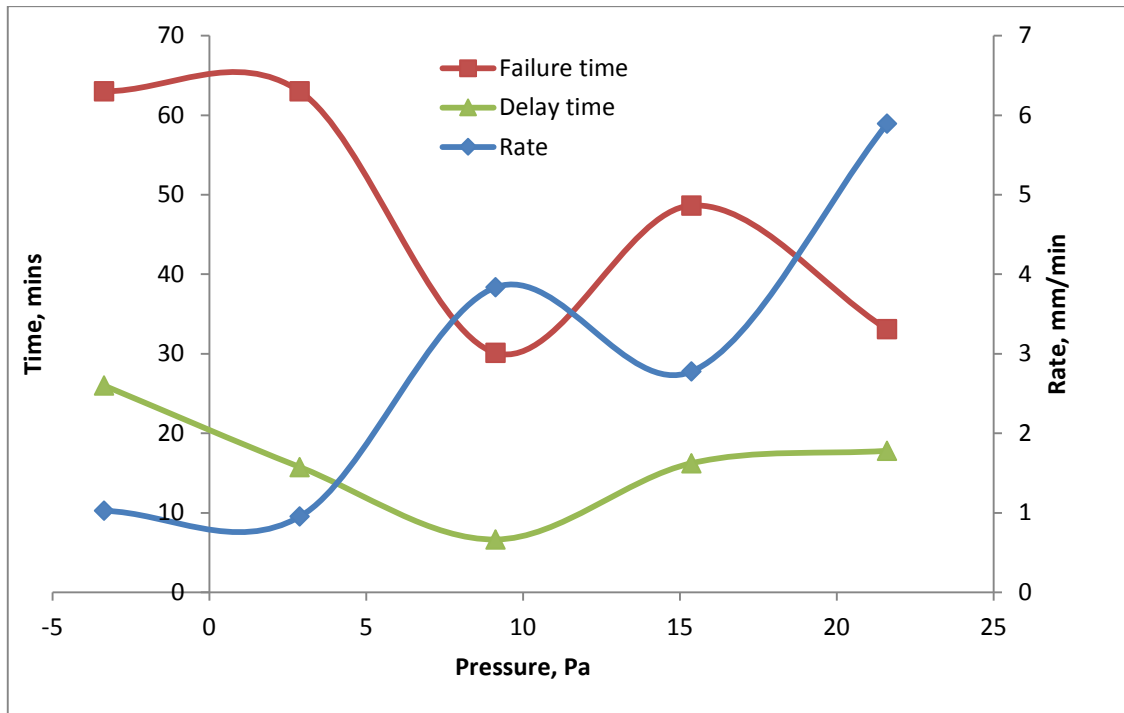
On further analysis, the increased Integrity failure time for the 1.6 mm gap at 15 Pa was found to be due to an increased delay time in establishment of the flame front in the gap at a pressure of 15 Pa as shown in Figure 67 and a reduced rate of flame spread. For pressure of 22 Pa the increased rate of flame spread is mainly responsible for the reduction in failure time.

Figure 67: Failure time compared with delay time and flame spread rate for the 1.6 mm vertical gap

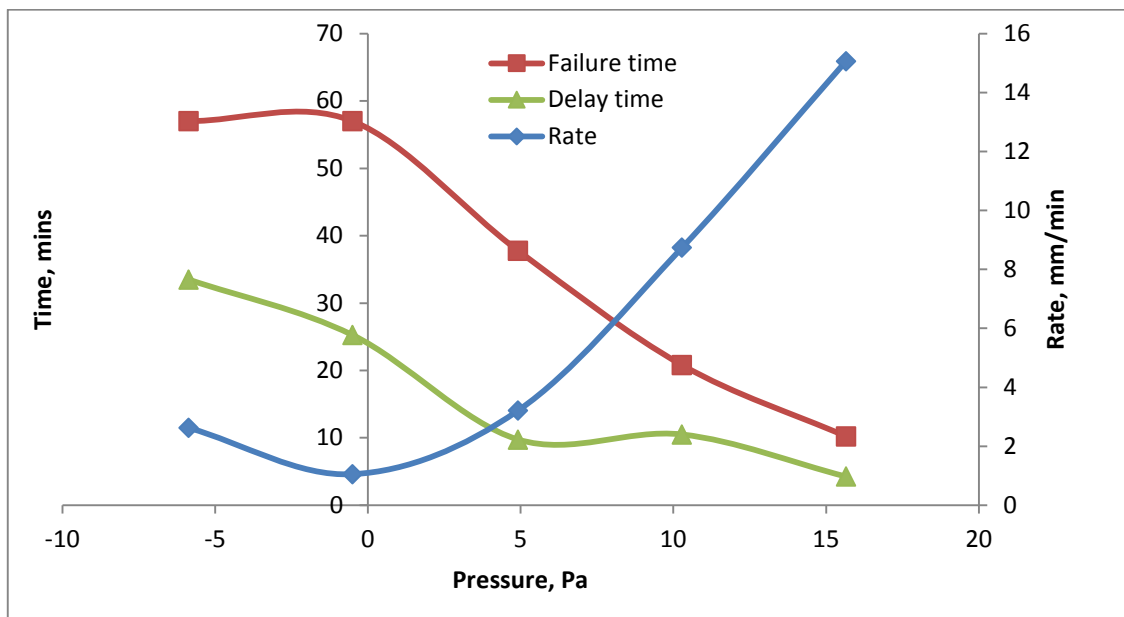
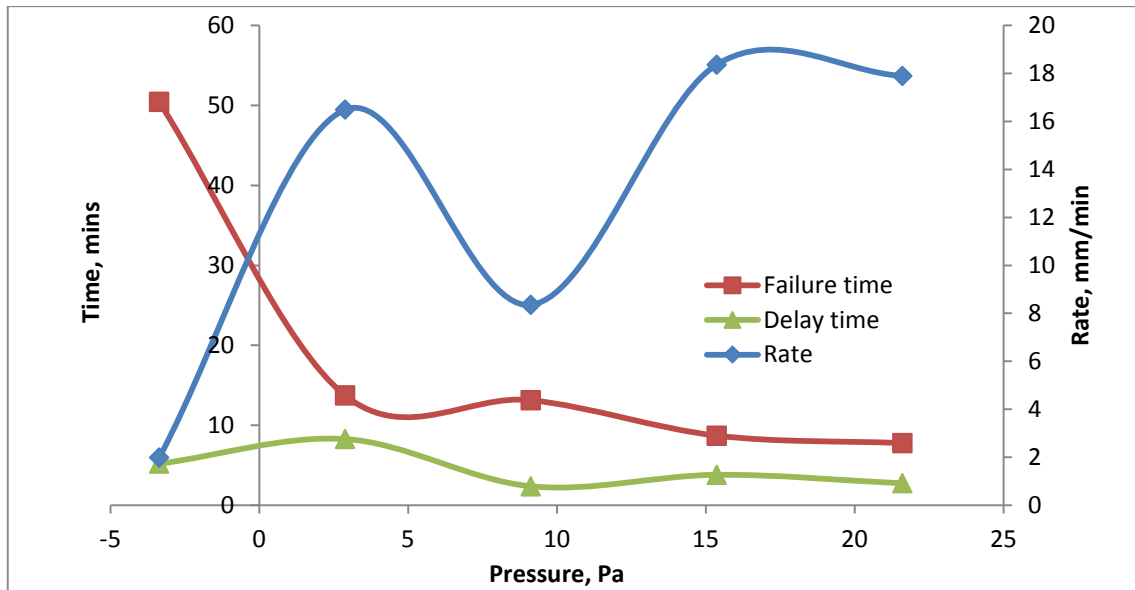
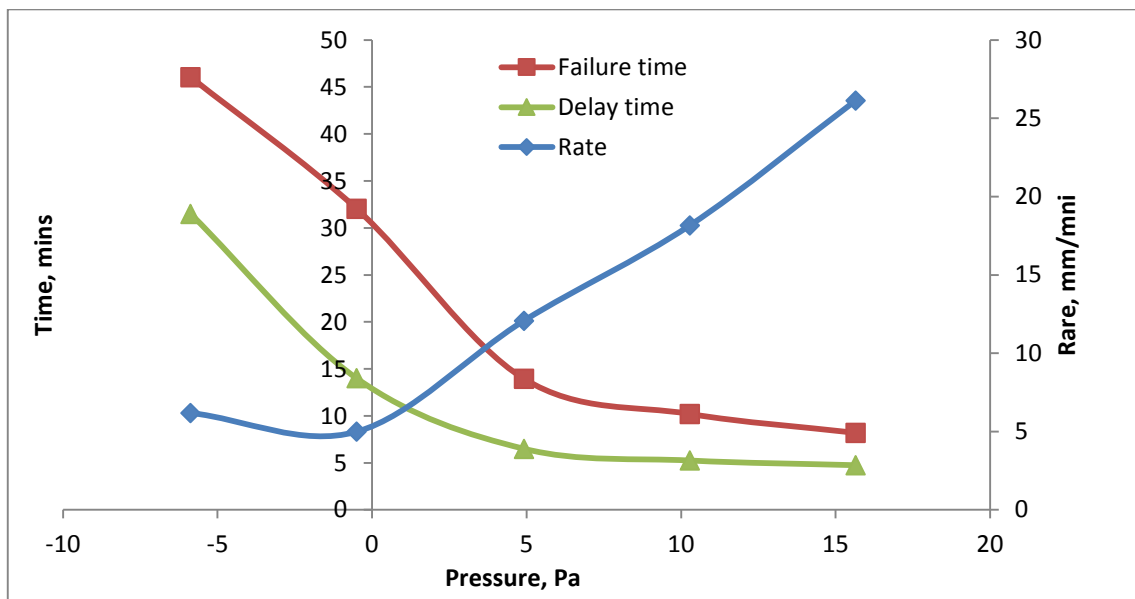
Similar analysis is presented in Figure 68, Figure 69 and Figure 70 for the 2.6, 3.2 and 5.4 mm vertical gaps. What is notable is how the flame spread rate dictates the overall failure time along with the delay time in the establishment of the flame front in the gap. Other factors are the presence of oscillating furnace pressure and the high gas temperature causing greater resistance to flow as indicated in Figure 30, all of which play a part in the overall fire resistance.

Figure 68: Failure time compared with delay time and flame spread rate for the 2.6 mm vertical gap

Figure 69: Failure time compared with delay time and flame spread rate for the 3.2 mm vertical gap

Figure 70: Failure time compared with delay time and flame spread rate for the 5.4 mm vertical gap

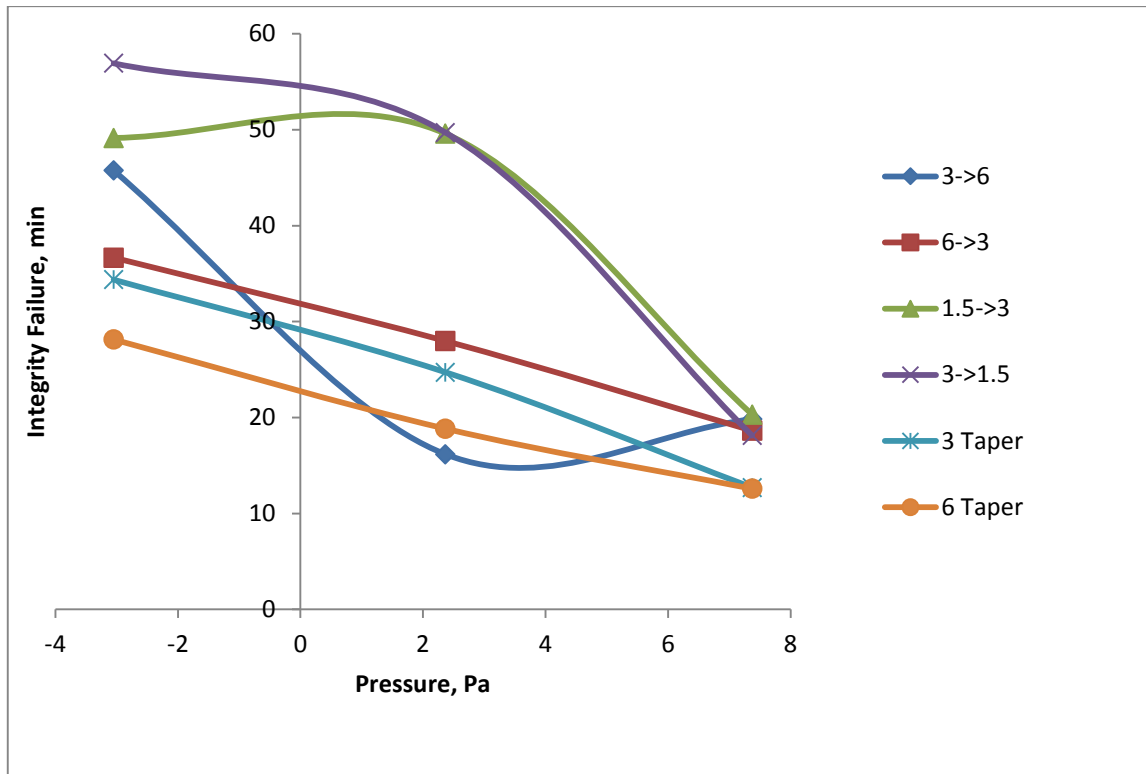
Horizontal gaps at three different elevations and a variety of gap profiles were included in the test walls, the trend is the same at the vertical gaps, as shown over a narrower pressure range in Figure 71.

Figure 71: Integrity failure of horizontal gaps

The parameters in the legend refer to the gap size in the direction of the fire to ambient sides, such that “3→6” means a 3 mm gap stepping to 6 mm gap at the midway point of the 90 mm depth. The legend “3 and 6 Taper” means a 600 mm wide tapered horizontal gap between timber nogs, that has 0 mm height at one end increasing to 6 mm height at the other and is instrumented with thermocouples at 3 and 6 mm gaps to measure flame spread through the 90 mm passage. At lower elevations and furnace pressure, the flow resistance makes a difference to the fire resistance but as the elevation and pressure increases, the Integrity fire resistance decreases to about the same level.

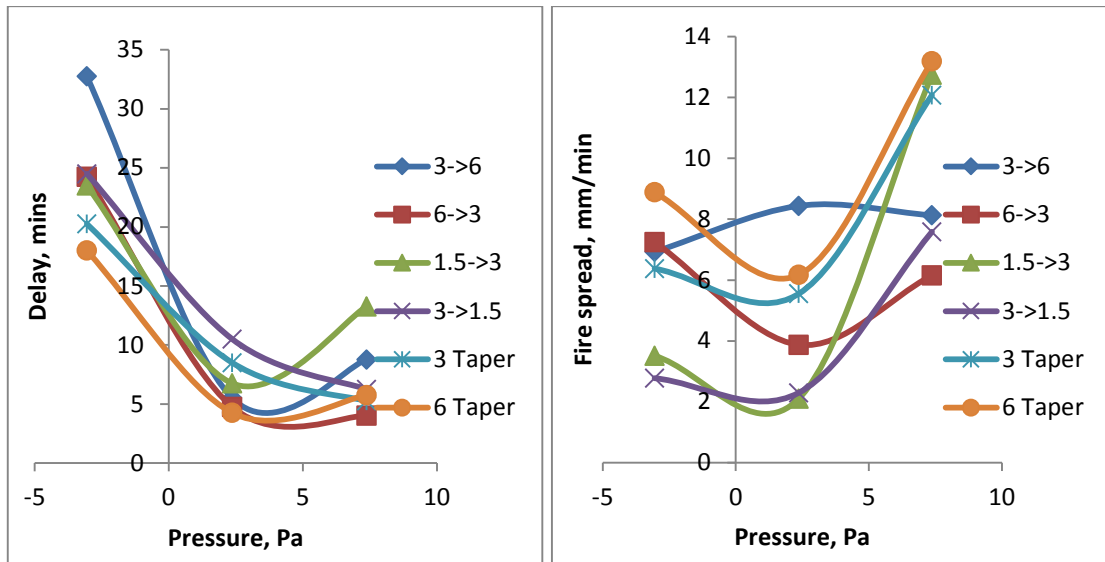
A separation of the components of delay time to the arrival of the flame front and rate of fire spread are shown in Figure 72. Comparisons with the vertical gap data is limited as the range of pressures is narrower because the gaps were only installed in the mid-height range of 600, 1200 and 1800 mm elevations instead of from 300 mm to 2700 mm. However, there is still some evidence of minimums for both the delay time and the flame front travel rate occurring at low positive pressures.

Figure 72: Delay time for arrival of flame front and rate of fire spread for horizontal gaps

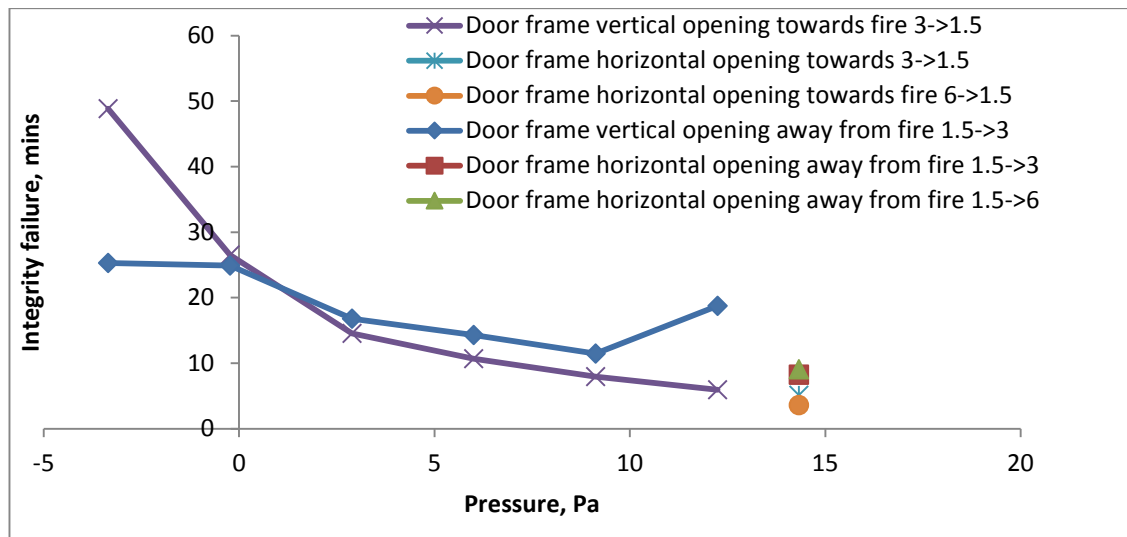
The relative Integrity fire resistance of simulated door leaf and frame assemblies (Figure 73) is shown in Figure 74. Similar trends are evident if compared with the trends above. In practice, a fire door would include intumescent seals in the frame designed to expand on heating and restrict the flow of hot gases for a sufficient period to permit the required fire resistance to be achieved. What the above trends have shown is the sensitivity of the Integrity fire resistance to small changes in gaps and flow direction. It follows that a fire door designed with specific clearances between the leaf and the frame that relies on intumescent seals to close the gaps has the potential to have its fire resistance compromised in the event of earthquake-induced deflections, and it may be very sensitive to even small changes given the indicated trends above.

Figure 74: Integrity failures through door frame

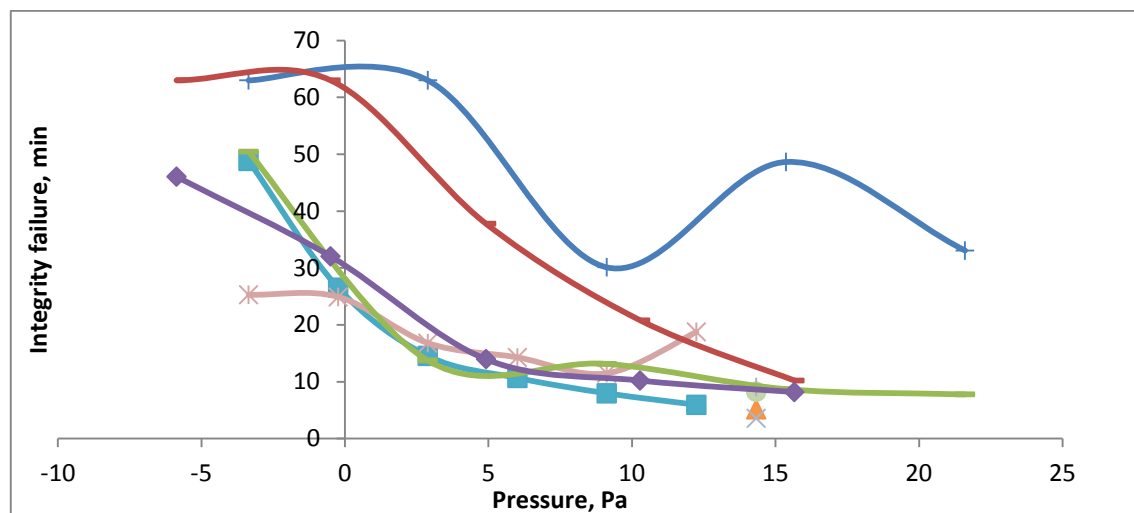
When all of the vertical and horizontal data is combined in one graph, as is shown in Figure 75, there is a clear trend showing a reduction in the Integrity failure time as the furnace pressure increases with elevation. What is less certain is what gap size and shape will occur as a result of earthquake damage, but it is clear that for anything but the narrowest of gaps (less than 1.5 mm), the reduction in fire resistance is quite significant. Therefore if gap sizes resulting from earthquake movements could be kept to a minimum, this represents a possible solution to preserving the fire resistance as much as possible.

Figure 75: Integrity failure for all gaps and shapes
