STUDY REPORT

SR 304 (2013)

Post-Earthquake Performance of Passive Fire Protection Systems

P. C. R. Collier

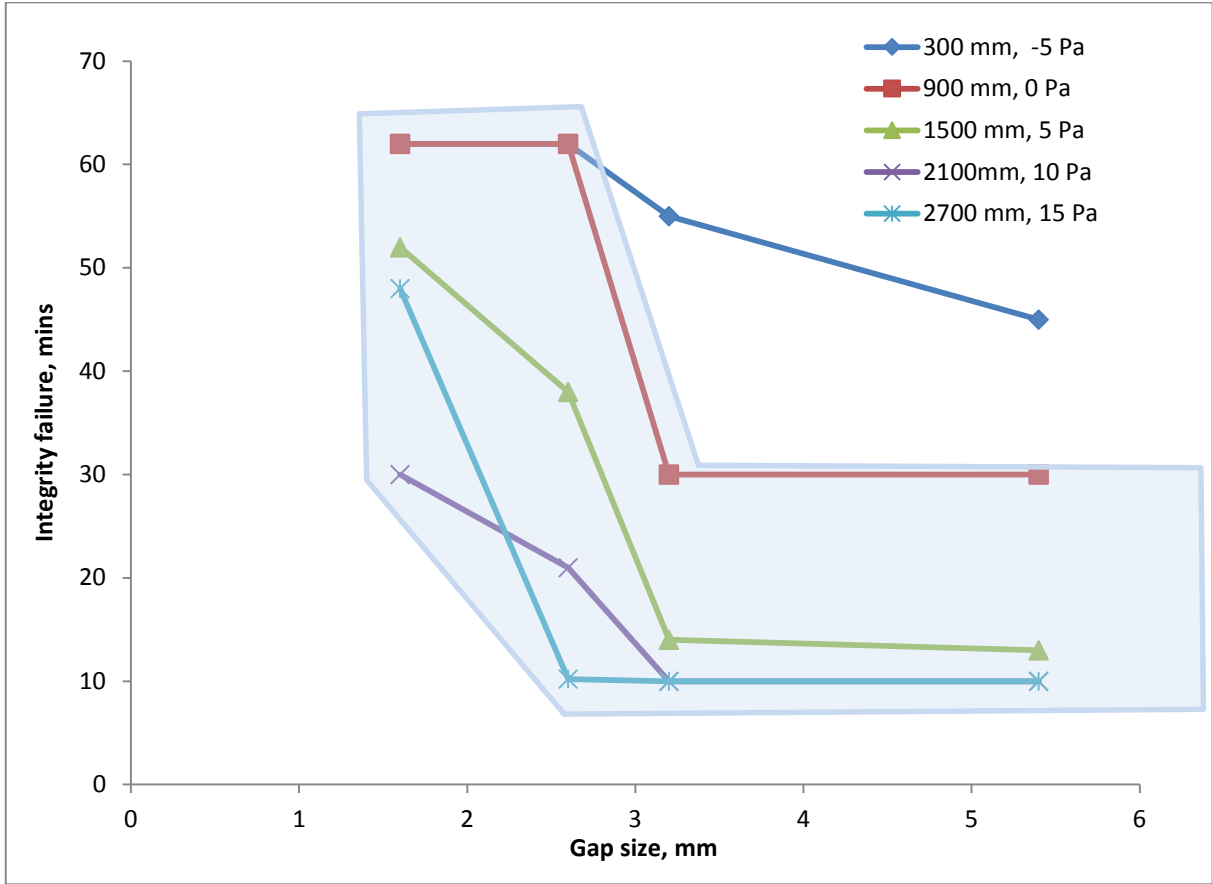
If the data in Figure 66 is replotted against gap size the results are shown in Figure 76. There is a marked reduction in Integrity failure times when the gap size increases from 1.5 mm to 3 mm for all pressures except -5 Pa. The shaded area represents the most

probable reductions in FRR whereby, for conservatism, the lower bound edge could be the preferred reduction acknowledged in a worst-case scenario.

Figure 76: Downward trend of Integrity failure for increasing gap sizes at various furnace heights and pressures

This trend supports the promotion of design methods to limit earthquake damage by isolation of PFP systems from the structure as a whole, with the additional benefit being that potential reduction in damage to PFP systems is also reduced.

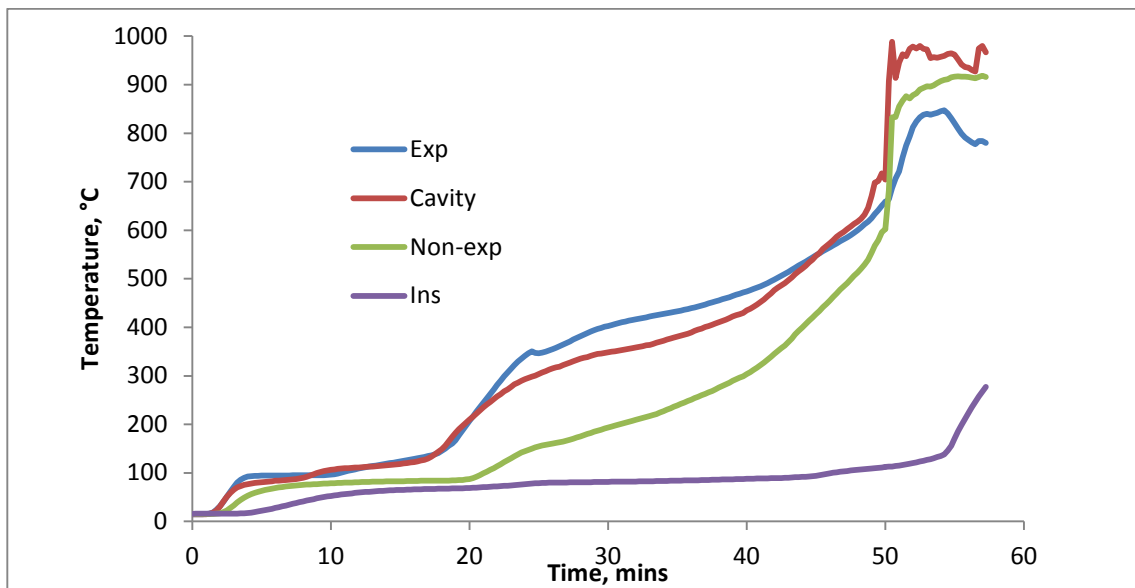
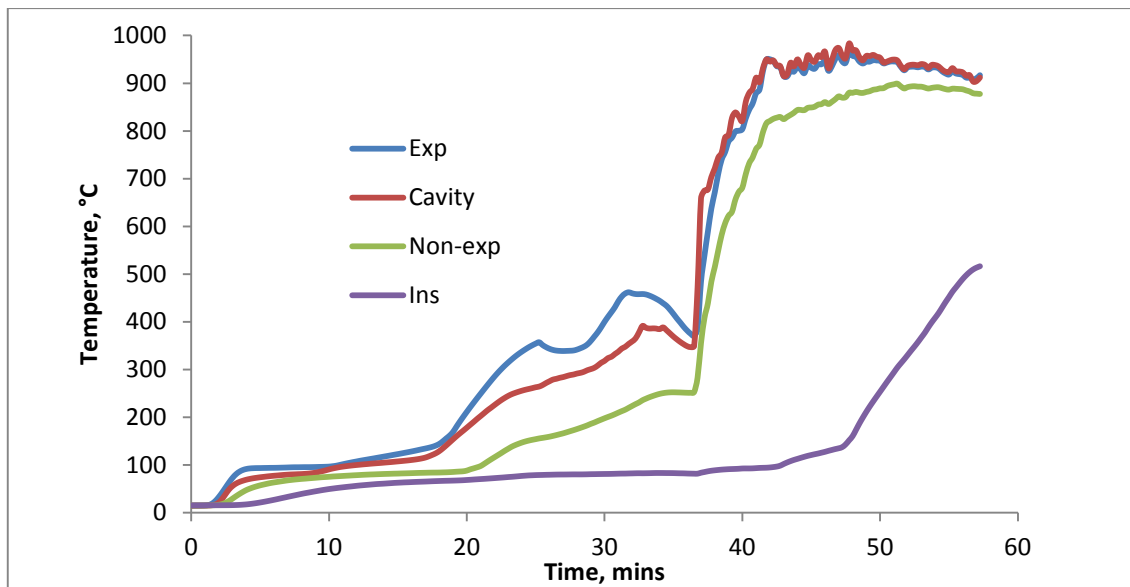
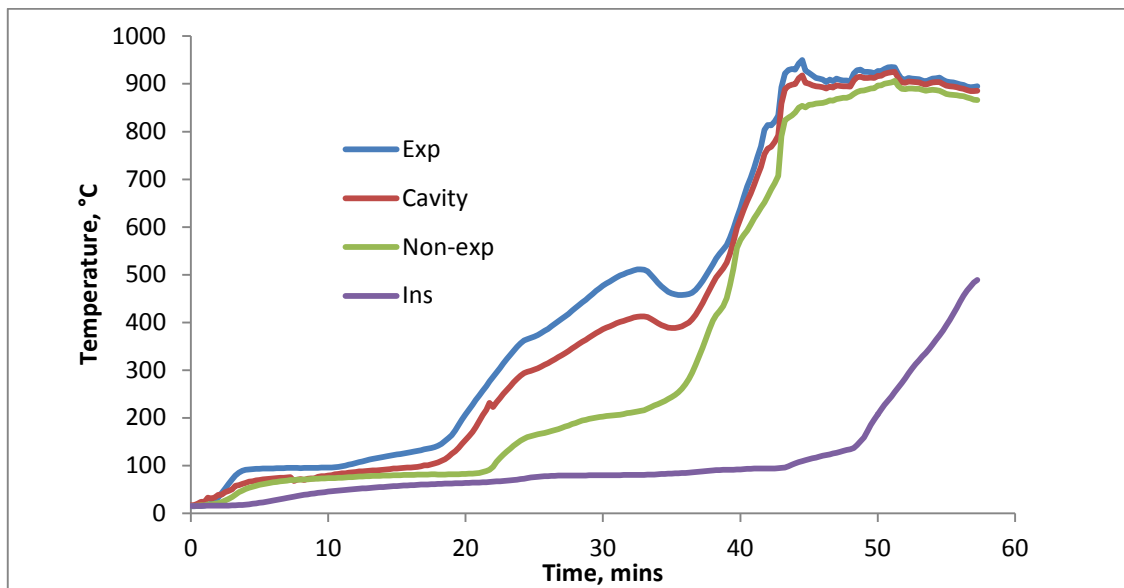
Figure 78: Loose lining with 3 mm gap bottom edge on fire-exposed side

Figure 79: Loose lining with 3 mm gap bottom edge on ambient side

Figure 80: Loose lining with 3 mm gap bottom edge on both sides

In all four locations the temperatures of the defect with the lining detached on the non-fire side rises first or performs the worst closely followed by the sample with the detachment on both sides. Unexpectedly, there is a considerable lag (~ten minutes) before the temperatures of the sample with the detached lining on the fire-exposed side similarly rises and for the control sample there is a further lag.

This result shows that lining defects on the fire side are not as detrimental to the fire resistance as on the non-fire side, but are still worse than no damage at all. Over this period no Integrity failures were recorded.

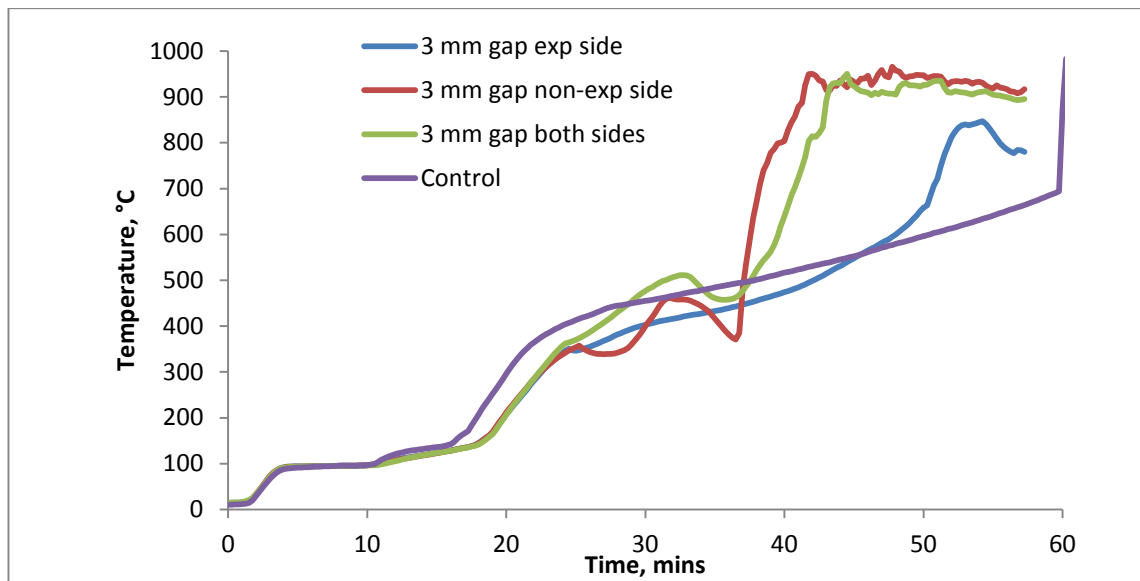
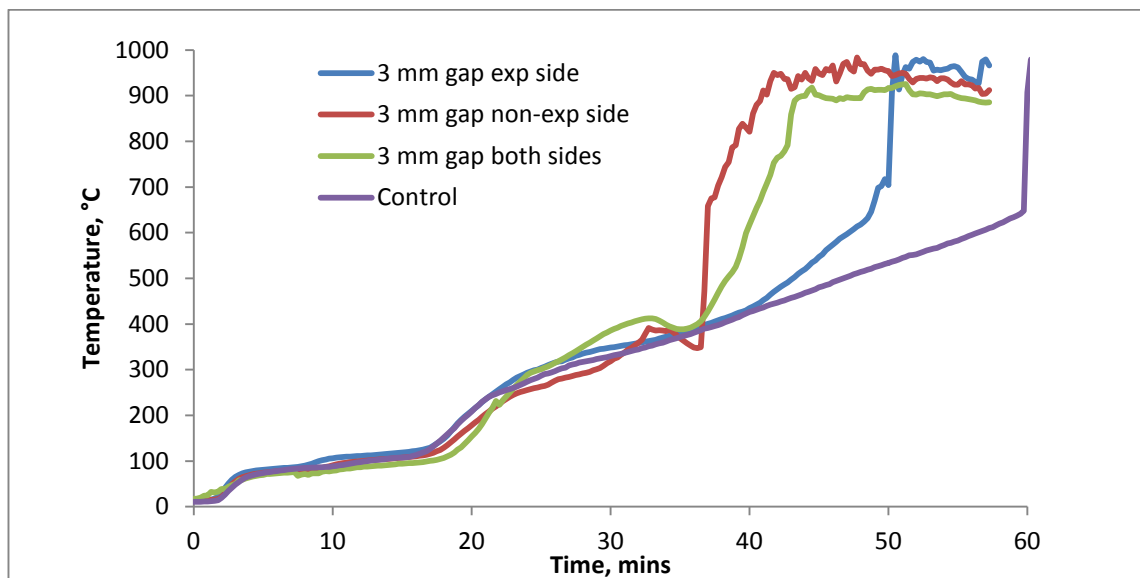
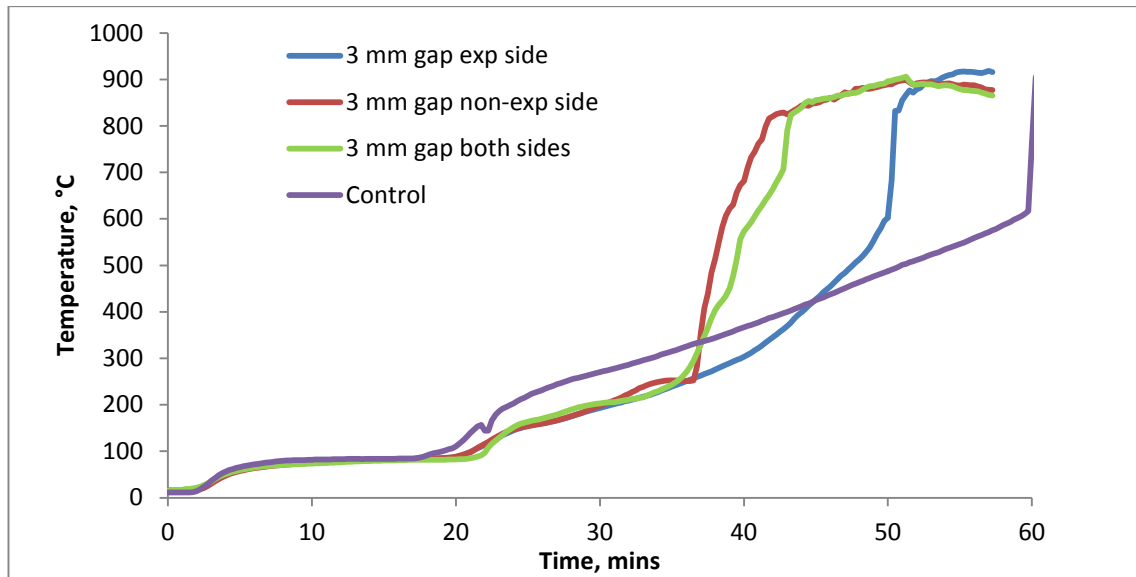
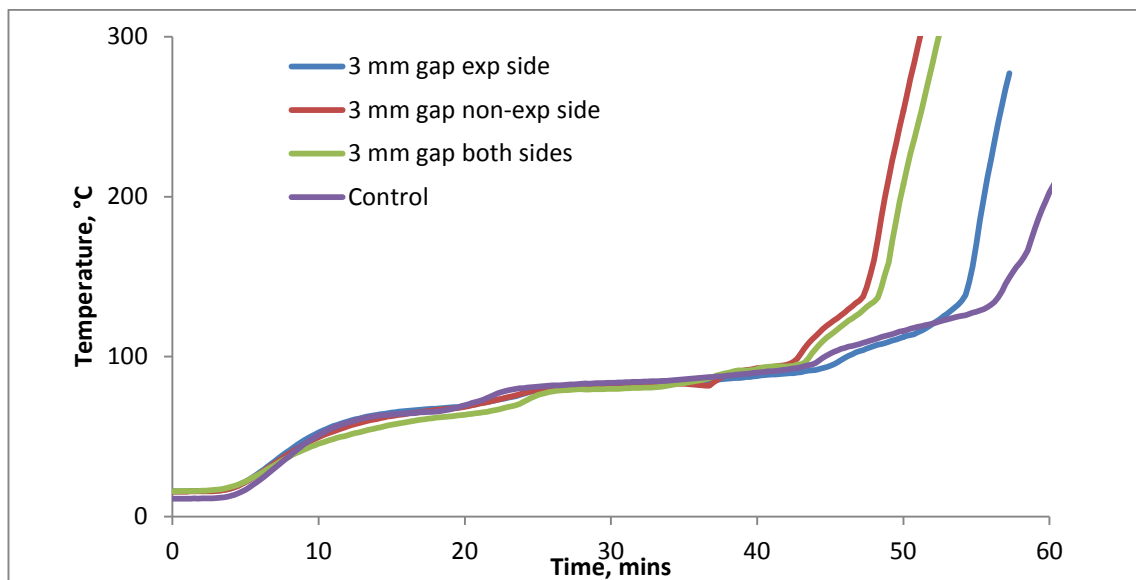
Figure 82: Comparing temperature of fire-exposed lining with gaps on bottom edge

Figure 83: Comparing temperature of cavity

Figure 84: Comparing temperature of non-fire-exposed lining on cavity side

Figure 85: Comparing temperatures on ambient side

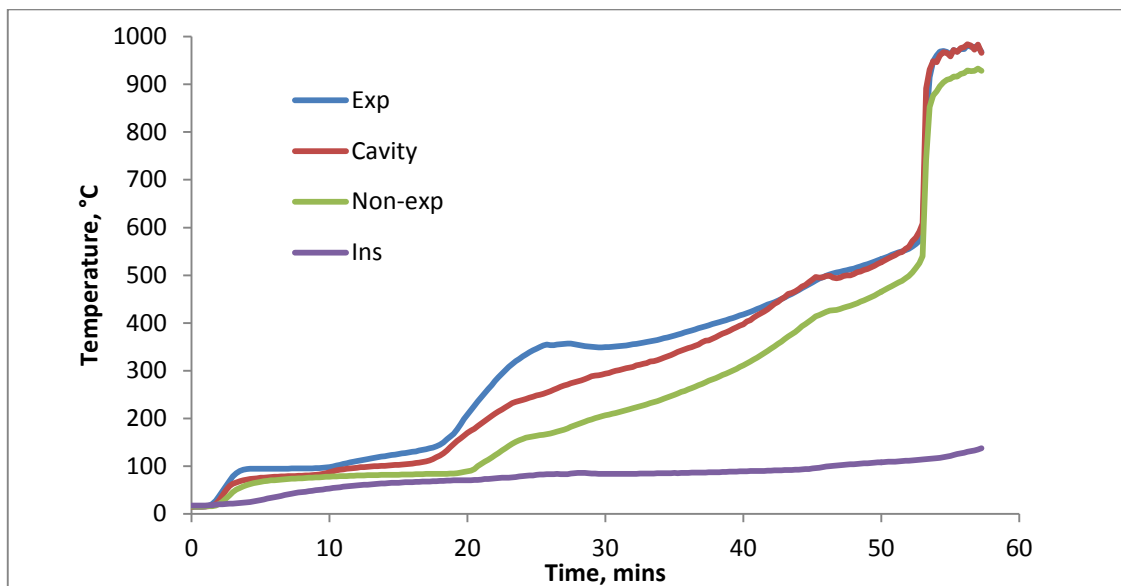
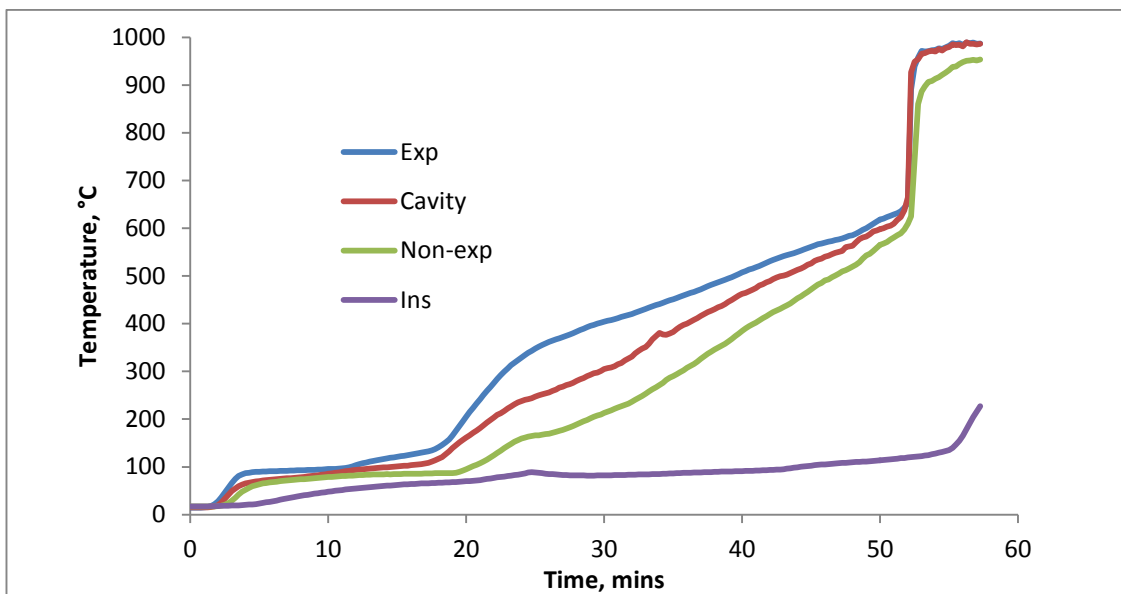
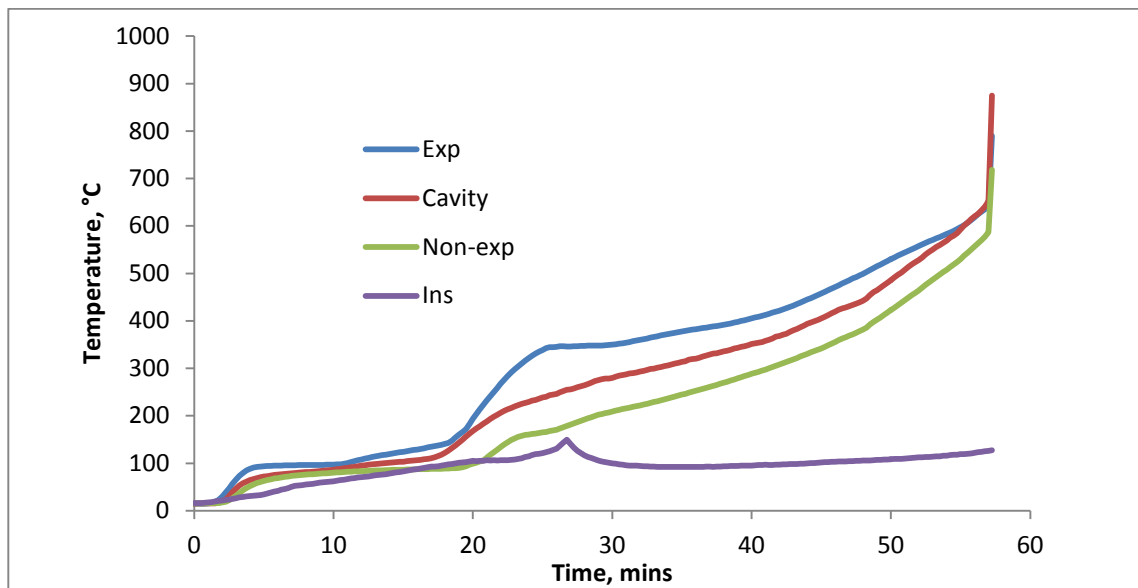
Figure 86: Loose lining with 3 mm gap top edge on fire-exposed side

Figure 87: Loose lining with 3 mm gap top edge on ambient side

Figure 88: Loose lining with 3 mm gap top edge on both sides

A noticeable difference when comparing Figure 86, Figure 87 and Figure 88 is the relatively earlier stage that the exposed lining and cavity temperatures equalise after 40 minutes for the sample with the exposed lining attached (Figure 86), contrasted with the two later samples indicating an exchange of hot furnace gas with cavity gas instead of convective heat transfer between the exposed lining and the cavity gas. This equalisation of temperature is not evident if there is a detachment of the lining on the ambient side whereby the exchange of cooler air (perhaps due to pulsating pressure at the top level) keeps the cavity temperature marginally lower (Figure 87 and Figure 88) or so it would be expected, except that the temperature of the cavity and non-fire-exposed lining is highest (Figure 90 and Figure 91) with just a gap on the ambient side of the wall. Comparing the fire-exposed lining in Figure 89, the wall with a gap on the ambient side also has a higher temperature as does the control sample, but less reliance should be placed on these measurements as they are relatively early on in the heat transfer path.

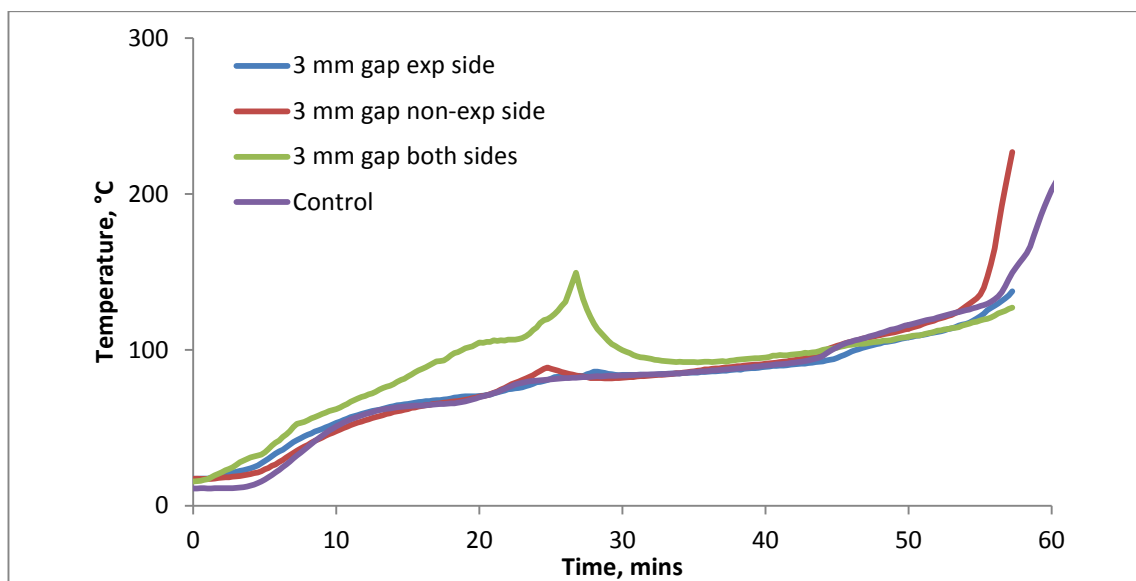
Figure 92: Comparing temperature of ambient side of non-fire-exposed lining with gaps on top edge

In Figure 92 the increase in temperature to a spike of the “3mm gap both sides” sample at about 28 minutes was caused by hot gases and flaming from a horizontal slot below heating the thermocouple measuring the temperature used for assessment of Insulation failure. The slot was covered with ceramic fibre at 28 minutes and the temperature then reduced to the same level as the other samples.

Once the ambient side temperatures settled beyond 40 minutes it is clearly evident that a 3 mm gap on the non-fire side is responsible for the first Insulation failure (140K rise) at 57 minutes with the control sample next to fail. However, this is academic only

because Integrity failure had occurred earlier at 49, 54 and 49 minutes respectively for the three damage conditions and the control sample exceeded 60 minutes.

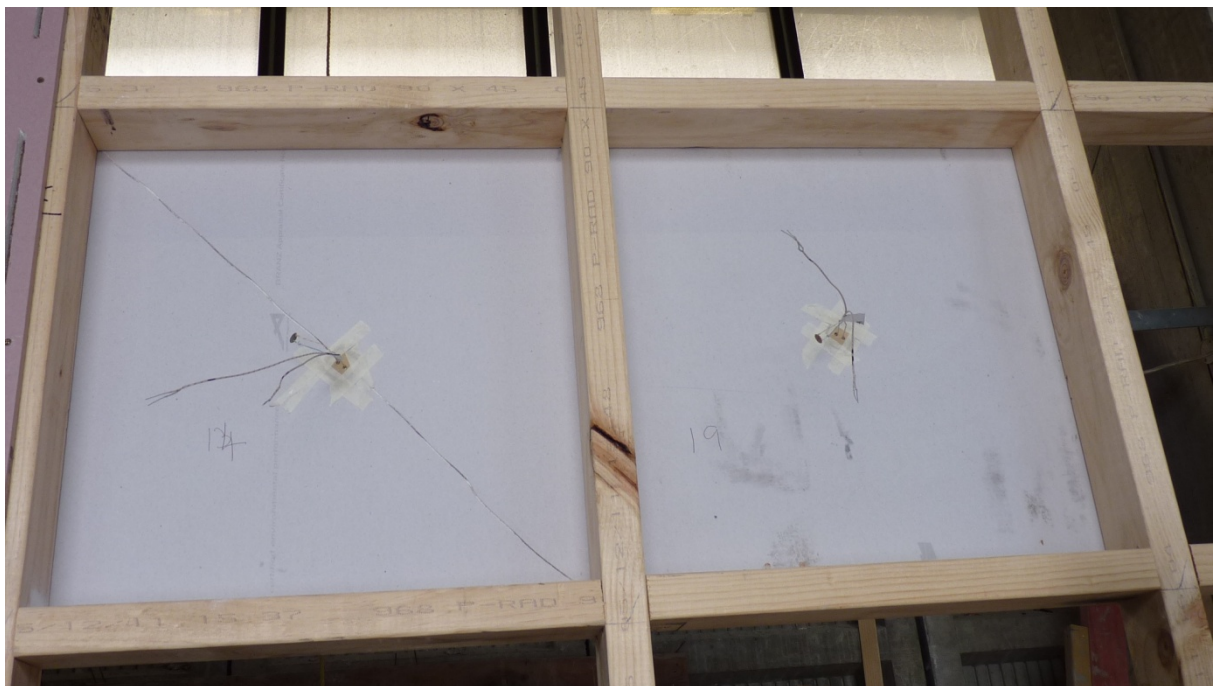
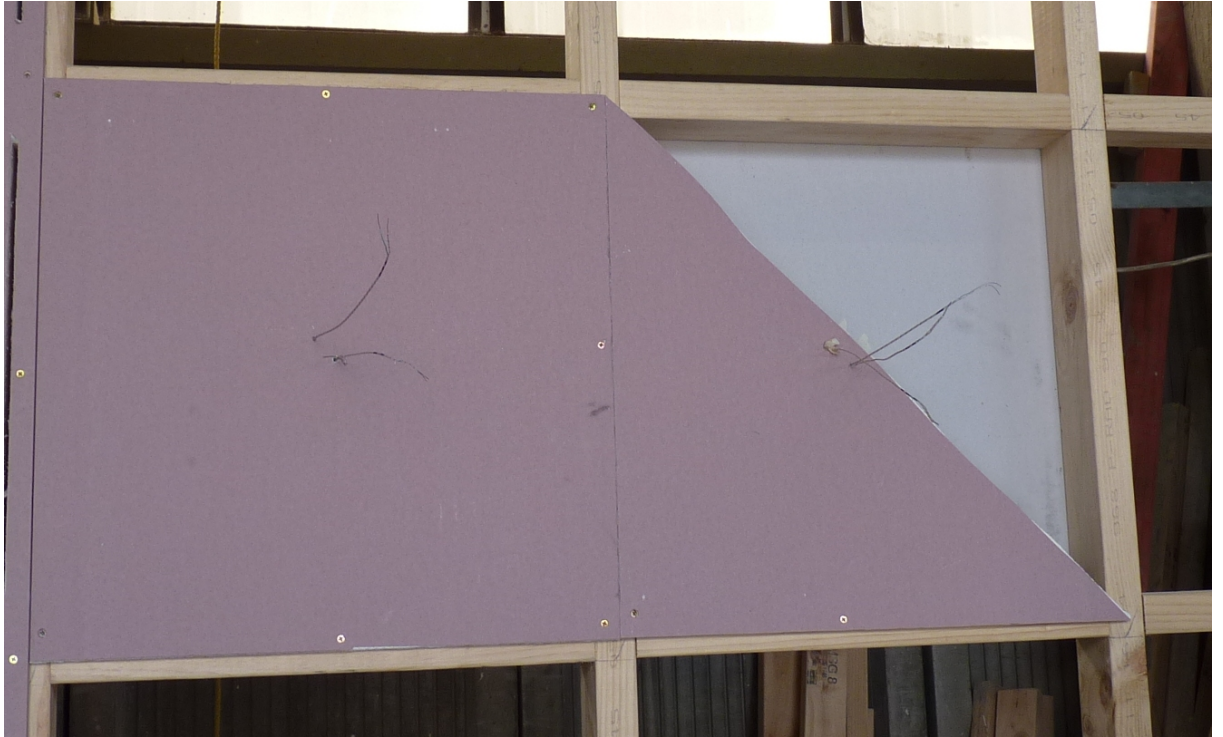
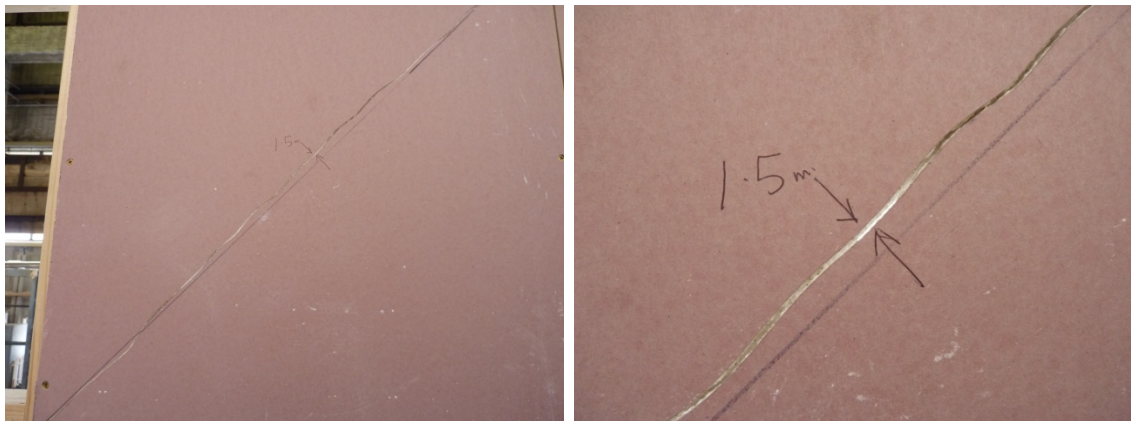
Figure 93: Left to right 1.5 mm crack on exposed lining and intact exposed lining

Figure 94: Left to right intact non-exposed lining and 1.5 mm crack in non-exposed lining

Figure 95: 1.5 mm crack on exposed side

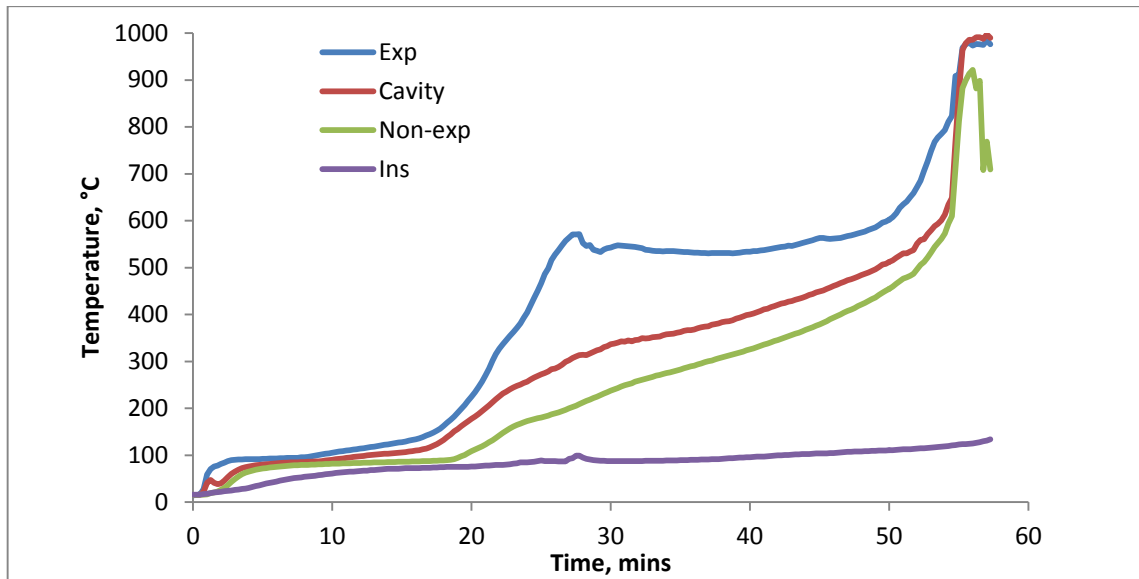
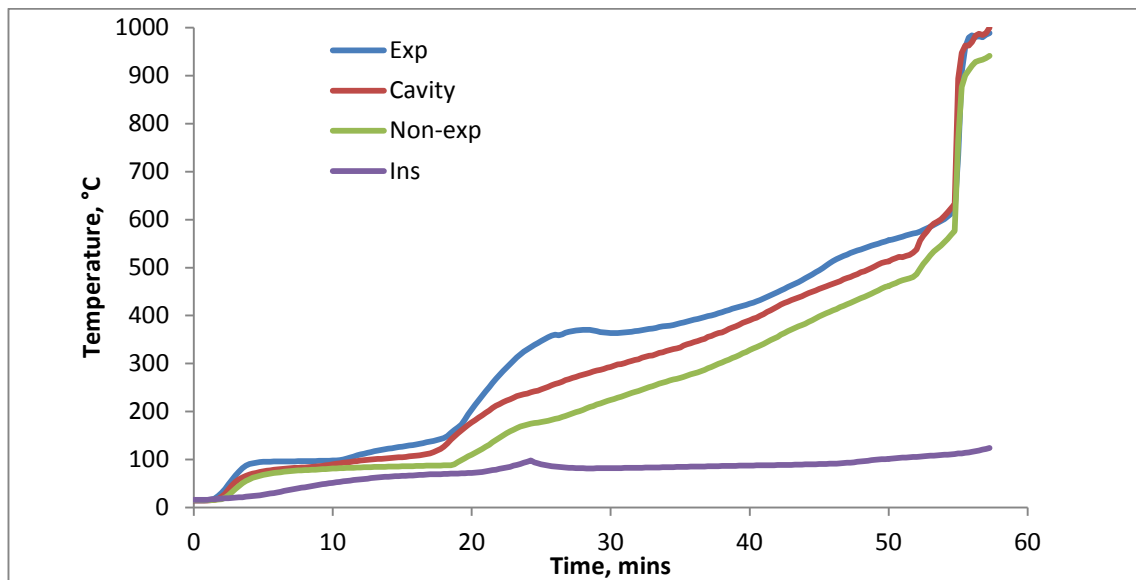
The temperature results are presented in Figure 96 to Figure 101. The wall temperatures with the 1.5 mm crack on the exposed side lining in Figure 96 show a rapid increase to a maximum and a plateau at about 550°C for the back of the exposed lining. Unfortunately the thermocouple measuring this temperature was placed over the crack as shown in Figure 91 which gives an unrealistic result and is ignored, but the remaining temperatures across the wall section are reliable. Comparing Figure 96 and Figure 97 there is not a great deal of apparent difference irrespective of which side of the wall contains the crack.

Figure 96: Temperatures in wall with 1.5 mm diagonal crack on exposed lining

Figure 97: Temperatures in wall with 1.5 mm diagonal crack on non-exposed lining

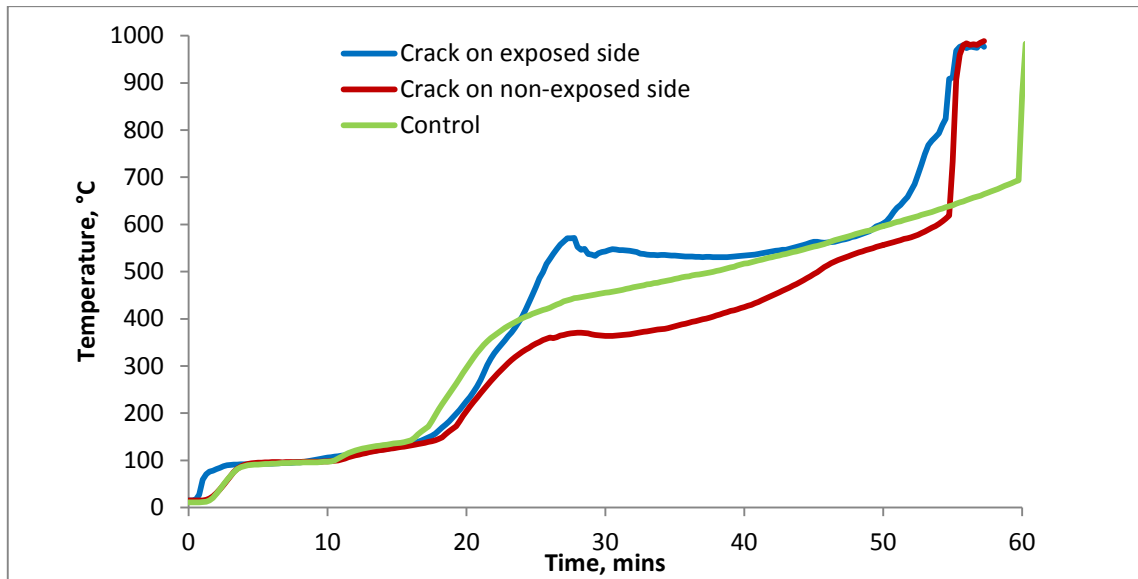
Figure 98: Comparing temperatures of exposed lining of wall with 1.5 mm diagonal cracks and control sample

The temperature comparisons in Figure 98 are of limited value given the artificially-higher reading due to the thermocouple being over the crack.

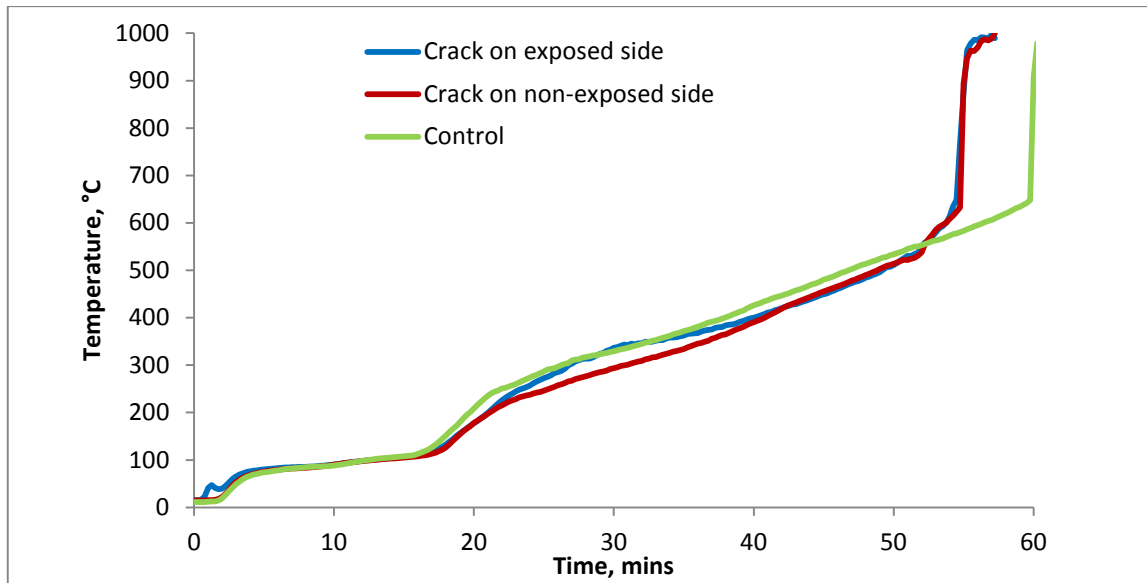
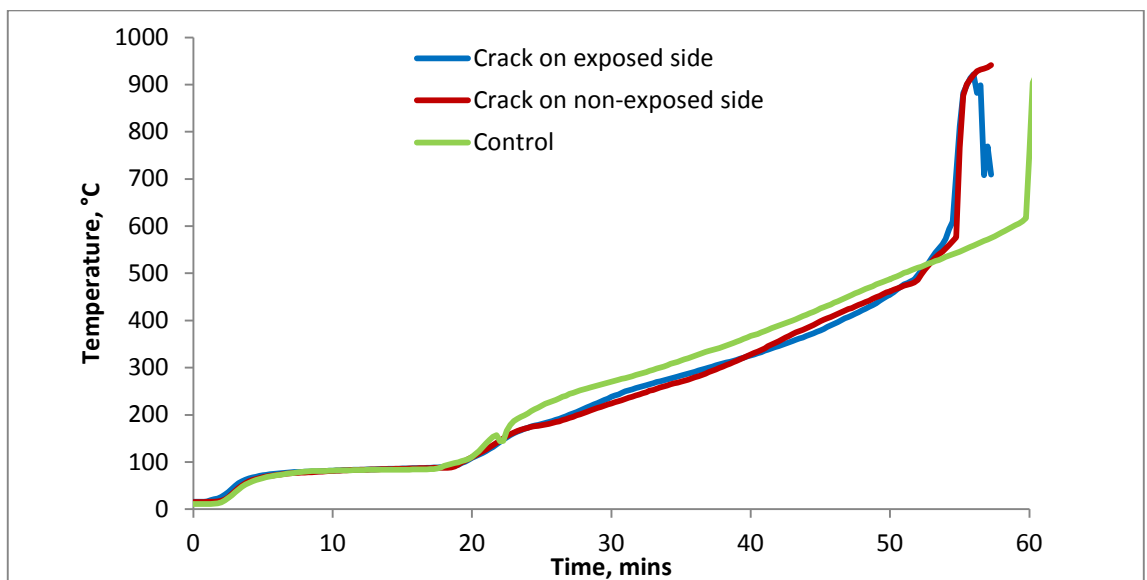
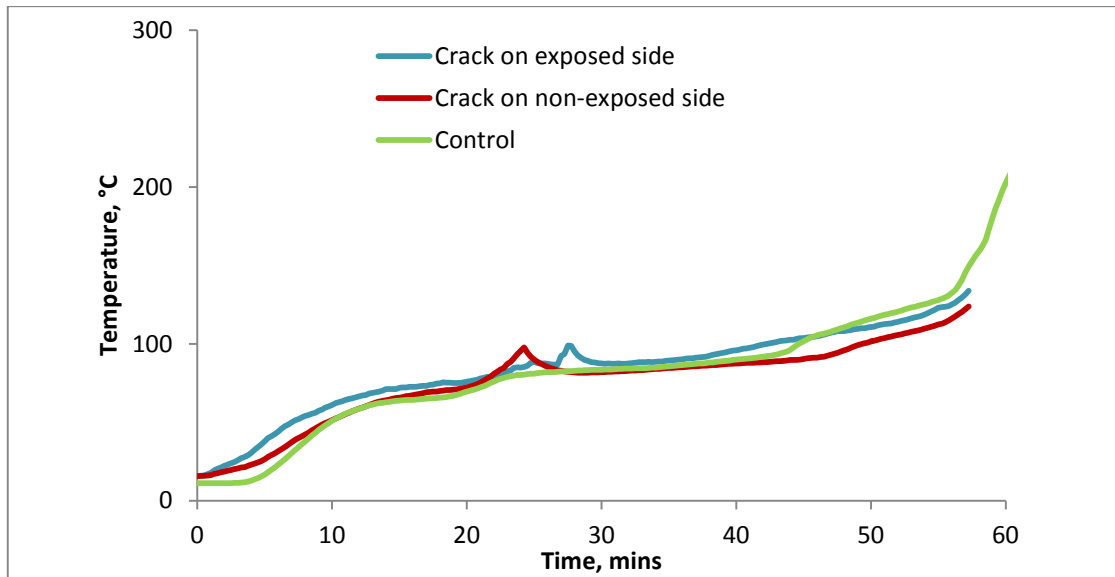
The subsequent comparisons for the cavity and both sides of the non-exposed lining in Figure 99, Figure 100 and Figure 101 indicate only minor differences due to the cracks compared with the control sample. The differences are so small that drawing conclusions about the deleterious effect of 1.5 mm cracks is probably not warranted, except to say that based on the Insulation criterion results in Figure 99, there does not appear to be any detrimental effect and perhaps a slight improvement in the fire resistance time would be realised due to the lower temperatures on the ambient side on the walls with a crack.

Incidentally the two spikes were due to flaming and hot gases from the horizontal gaps below which were covered with ceramic fibre prior to 30 minutes and the test continued with the two temperatures returning to the same rate of increase they would have had without being externally heated.

An Integrity failure at 55 minutes due to flaming from the 1.5 mm crack on the non-exposed (ambient) side was recorded and is the first failure mode for that sample.

Figure 99: Comparing temperatures in the cavity of wall with 1.5 mm diagonal cracks and control sample

Figure 100: Comparing temperatures of the cavity side of the non-exposed lining of a wall with 1.5 mm diagonal cracks and control sample

Figure 101: Comparing temperatures of the ambient side of the non-exposed lining of a wall with 1.5 mm diagonal cracks and control sample

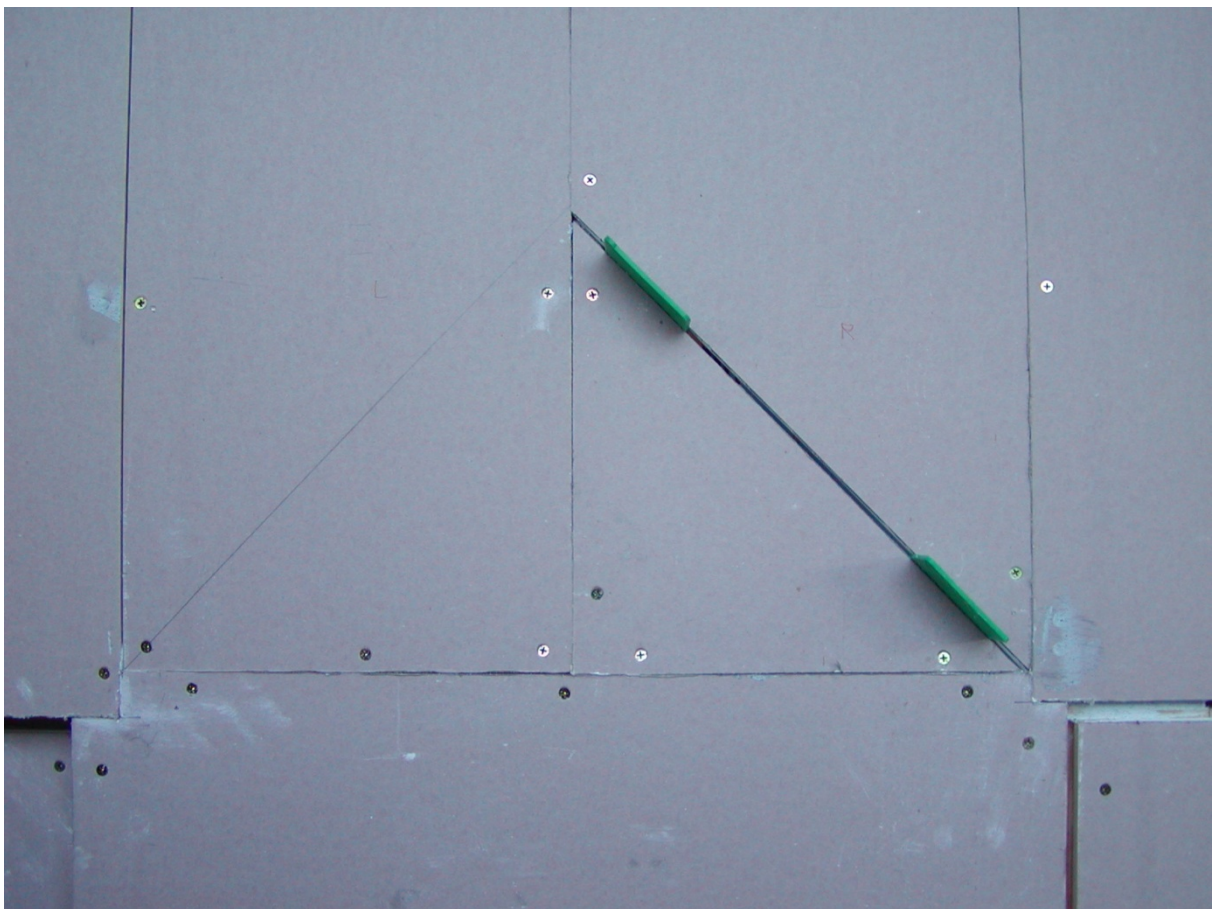
The same set scenarios as for the 1.5 mm diagonal crack above was repeated for a large 3 mm diagonal crack in the lining as shown in Figure 102.

Figure 102: Diagonal cracks 3 mm wide, one each side

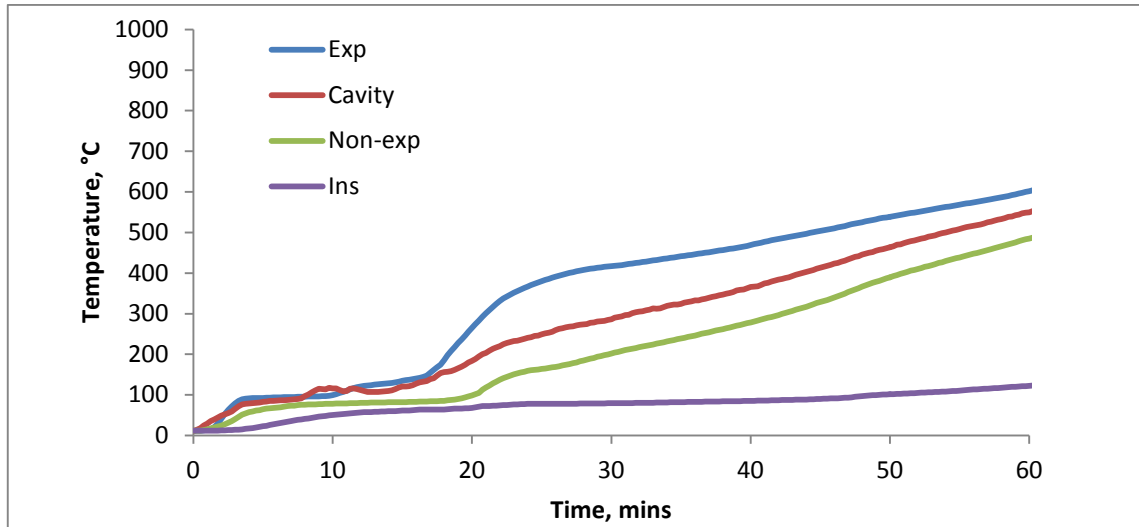
The temperature results are presented in Figure 103 to Figure 108. Comparing Figure 103 and Figure 104 there is not a great deal of difference that is apparent irrespective of which side of the wall the crack is.

Figure 103: Temperatures in wall with 3 mm diagonal crack on exposed lining

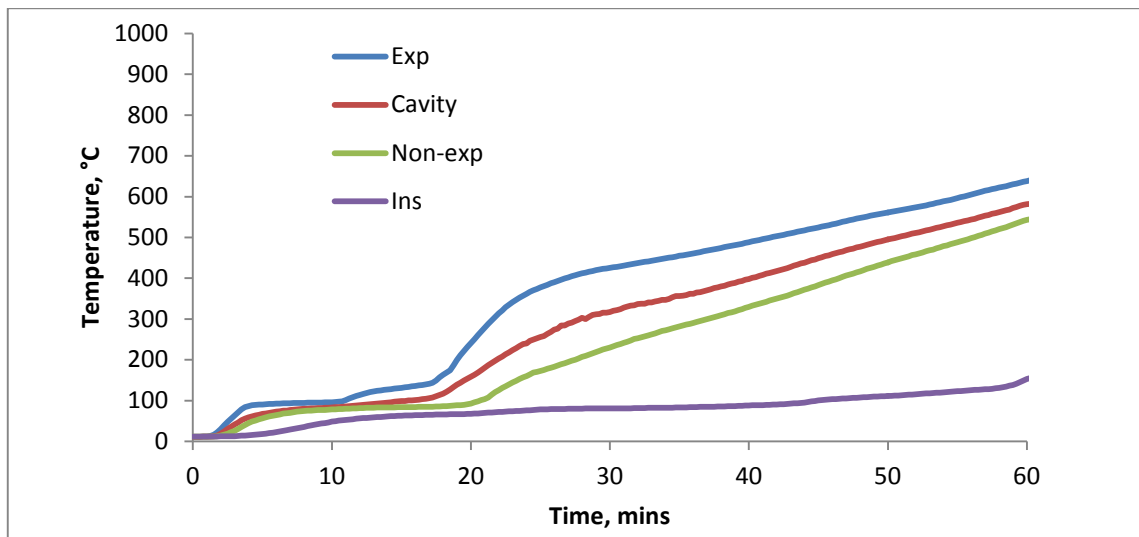
Figure 104: Temperatures in wall with 3 mm diagonal crack on non-exposed lining

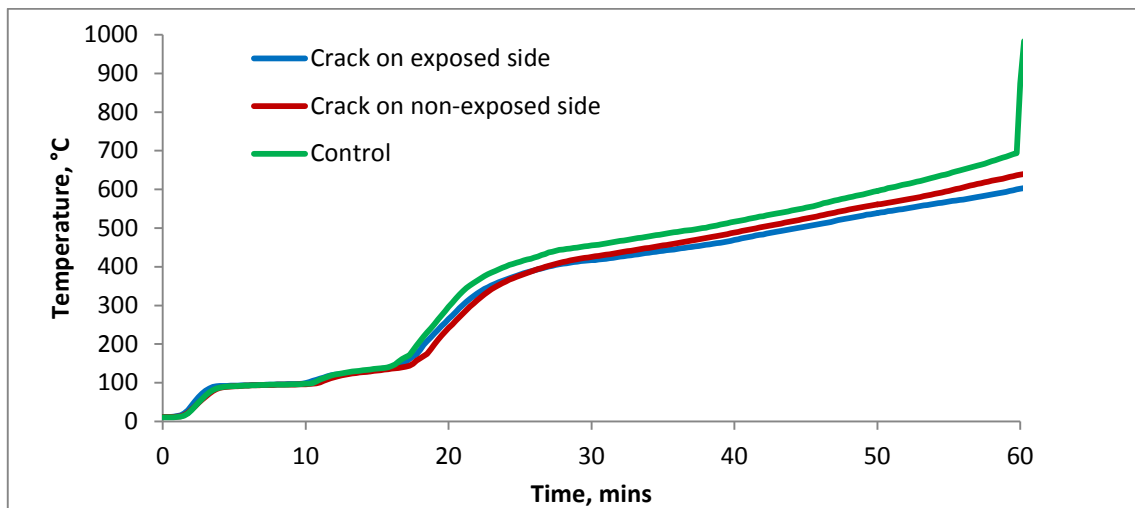
The subsequent comparisons for the cavity and both sides of the non-exposed lining in Figure 105, Figure 106, Figure 107 and Figure 108 indicate only minor differences due to the cracks compared with the control sample. The differences are marginally larger compared with the 1.5 mm cracks above and for all four thermocouple locations. In every case the temperature of the sample with the 3 mm crack on the non-exposed side lining is greater than those with the cracks on the fire-exposed side. Also, in every case the temperatures for the control sample with no damage were greater, leading to the conclusion that a 3 mm crack on either side does not appear to be detrimental to the Insulation fire resistance. However, an Integrity failure was recorded for the sample with the 3 mm crack on the non-exposed side with flaming from the crack at 57 minutes.

Figure 105: Comparing temperature of fire-exposed lining with 3 mm diagonal cracks

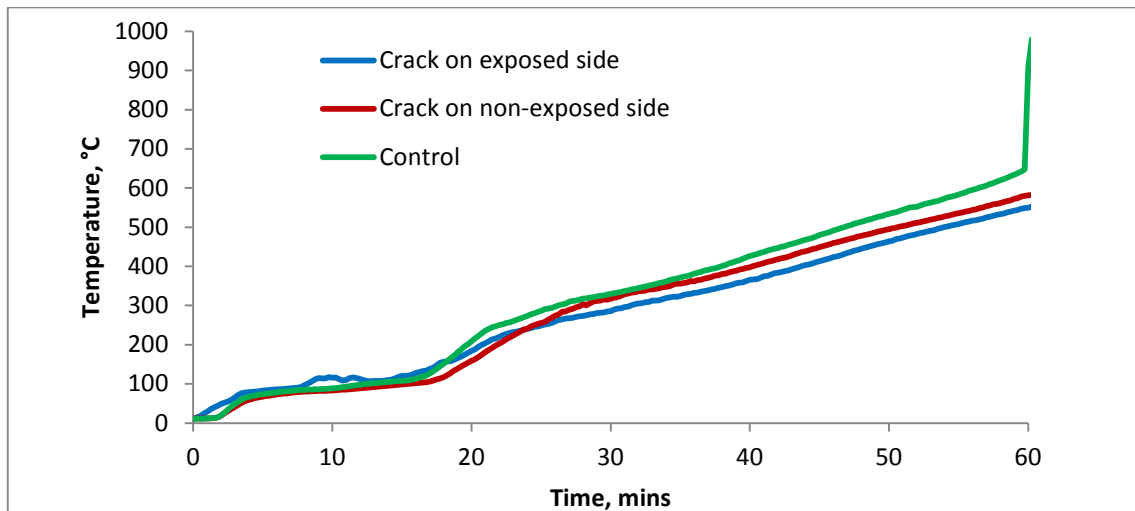
Figure 106: Comparing temperatures in cavity of wall with 3 mm diagonal cracks

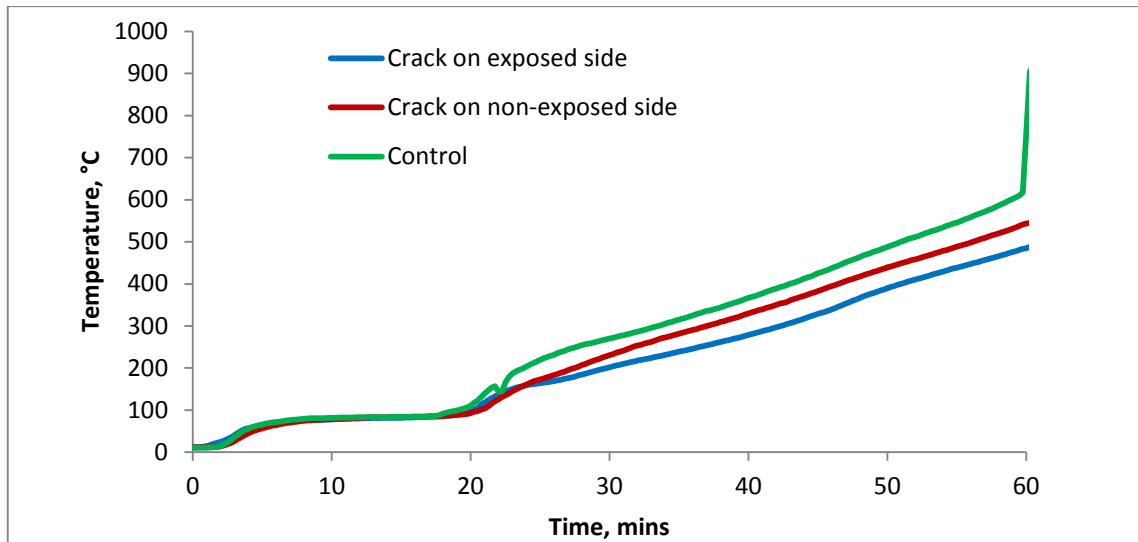
Figure 107: Comparing temperatures on cavity side of non-exposed lining in wall with 3 mm diagonal cracks

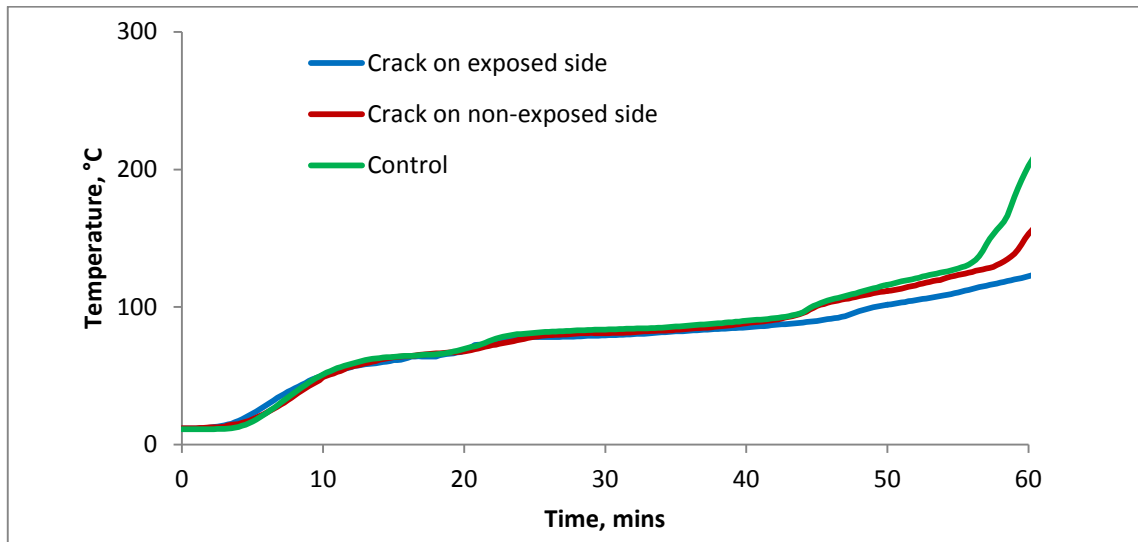
Figure 108: Comparing temperatures on ambient side of wall with 3 mm diagonal cracks

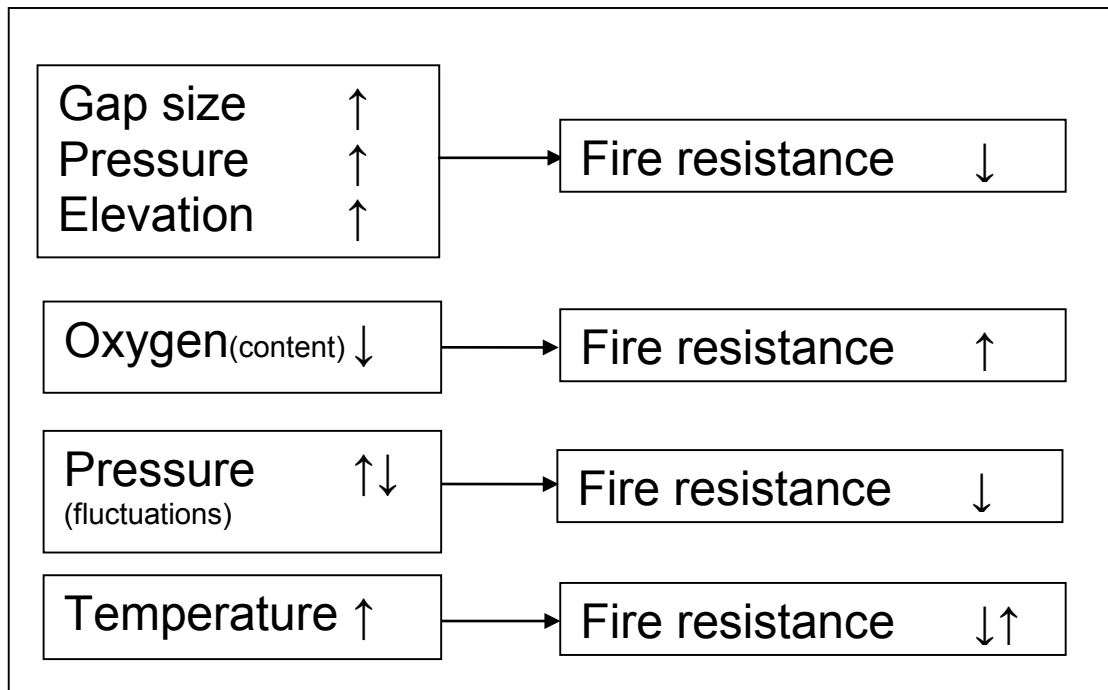
Some of the parameters affecting the fire resistance as discussed above are shown in Figure 109 and apply particularly for the Integrity criterion and also to Insulation, albeit indirectly. With the exception of the temperature of the furnace gases (or fire exposure), the influence of the parameters is clear cut, but for temperature the exact influence is complex. Although it is obvious that higher temperatures of hot flowing gases should be more damaging, the counter effects of density reducing and viscosity increasing with temperature reduce the heat-carrying potential of the hot gasses beyond 200°C. The effects of which were suggested as being responsible for a slightly reduced reduction in fire resistance.

Figure 109: Factors influencing fire resistance
