STUDY REPORT

SR 304 (2013)

Post-Earthquake Performance of Passive Fire Protection Systems

P. C. R. Collier

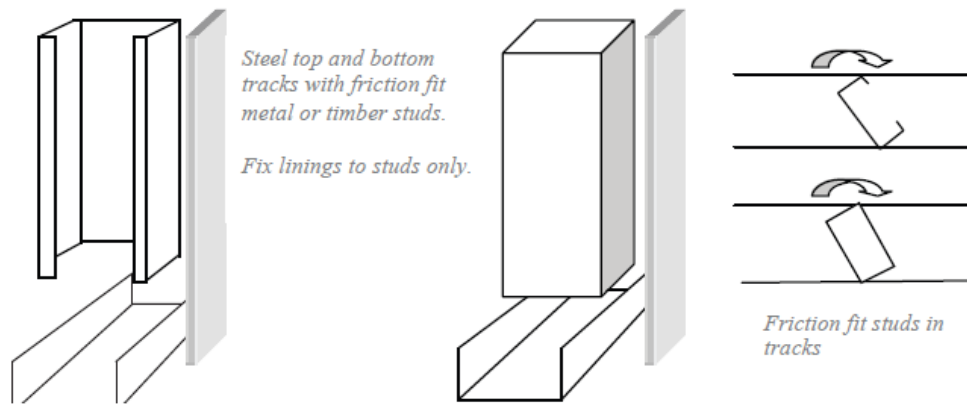
Figure 110: Framing details to minimise risk of post-earthquake damage

In order to protect plasterboard-lined partitions from damage, connections must be minimised and separation from the main structure must be provided so that seismic movements can be accommodated (Winstone Wallboards 2012). Figure 110 shows the principle of constructing partition framing. Metal top and bottom tracks are used with friction-fit metal or timber studs. A standard nominally 90 mm timber stud fits into a commonly-available 92 mm metal track. Plasterboard linings are fixed to studs but not to the top and bottom tracks.

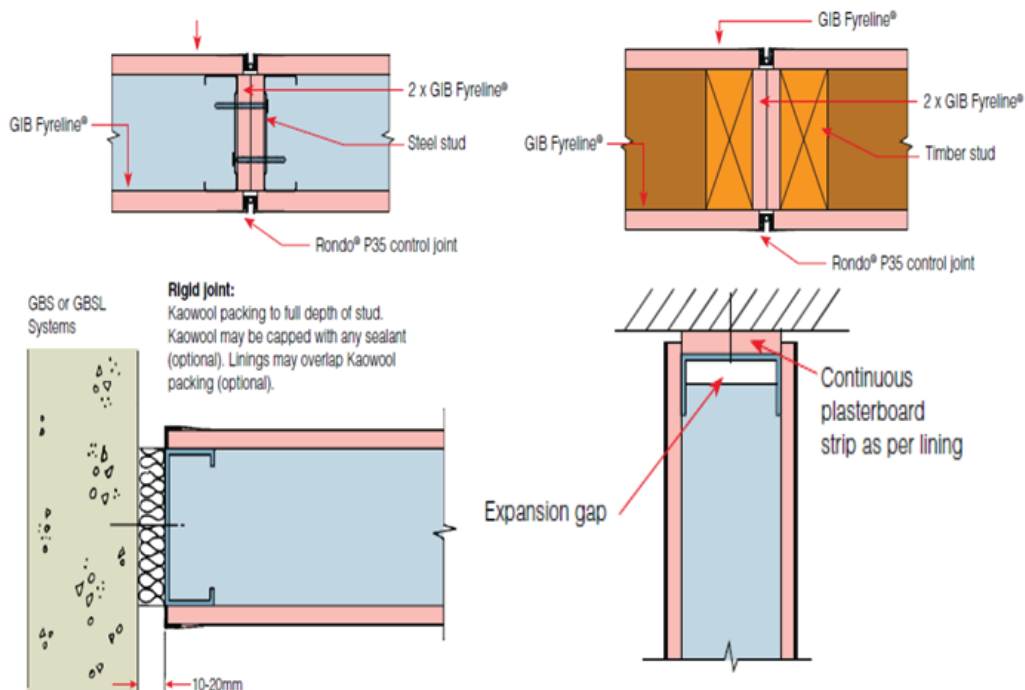
A series of possible details to provide freedom of movement and reduce earthquake damage to non structural linings

Figure 111: Simple plasterboard jointing details to minimise risk of post-earthquake damage

Figure 111 shows a sample of a number of already-available details (Winstone Wallboards 2006) that can eliminate or will significantly reduce earthquake damage to gypsum plasterboard-lined partitions in commercial construction. All details involve “disconnection” from the main structural elements and a regular pattern of intermediate control joints. Gypsum plasterboard packing strips can be provided behind joints to ensure ongoing integrity of fire or noise control separations. Proprietary trims and finishes exist to create clean shadow lines which can be left untouched, covered or sealant-filled depending on architectural preference.

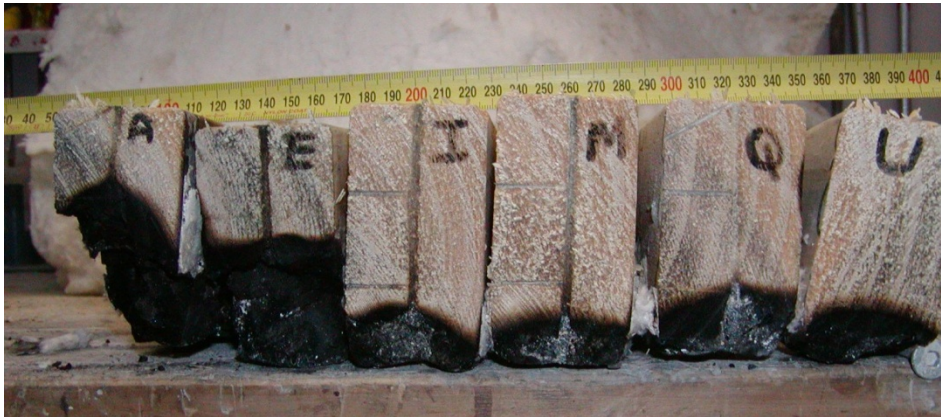
Figure 112: Charring in 3 mm holes after 120 minutes (left to right A, E, I, M, Q and U)

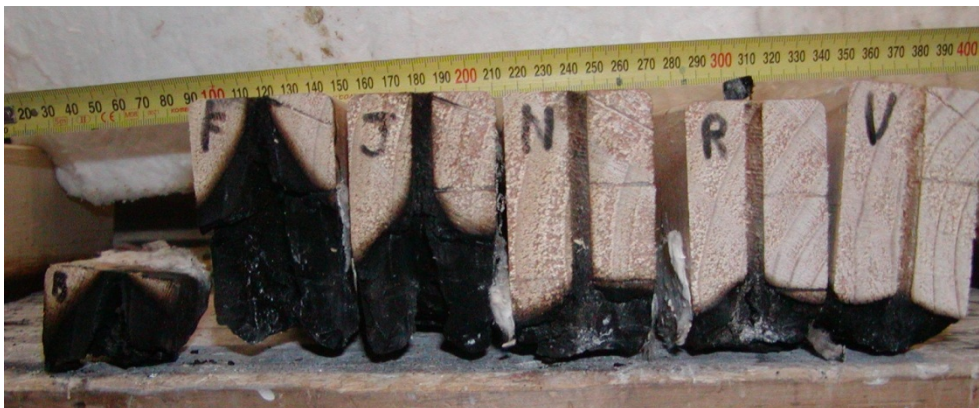
Figure 113: Charring in 6 mm holes after 120 minutes (left to right holes B, F, J, N, R and V)

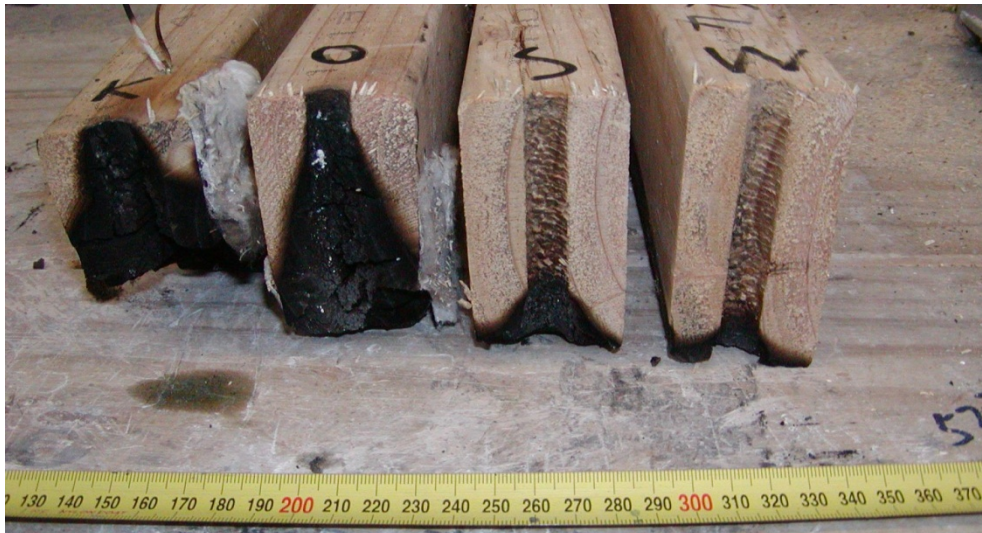
Figure 114: Charring in 12 mm holes after 120 minutes (left to right holes K, O, S and W)

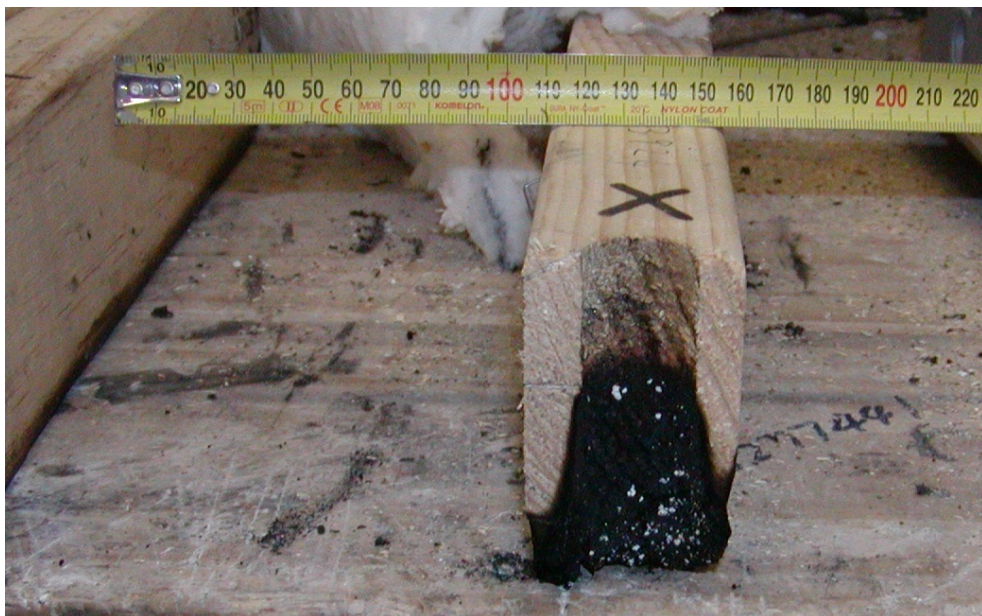
Figure 115: Charring in 24 mm hole after 120 minutes (X)

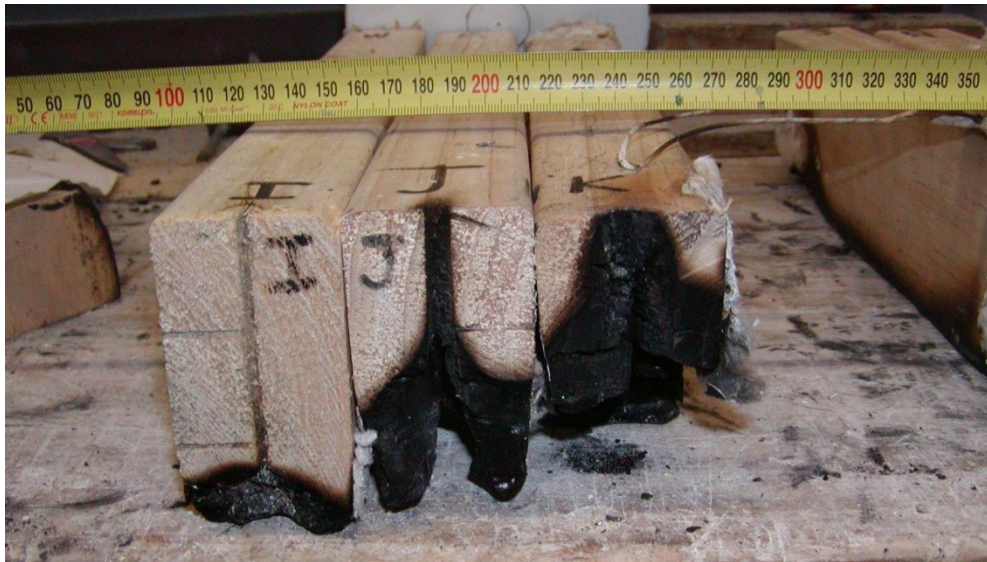
Figure 116: Charring in 3 to 12 mm holes at 2.2 Pa after 120 minutes (left to right I, J and K)

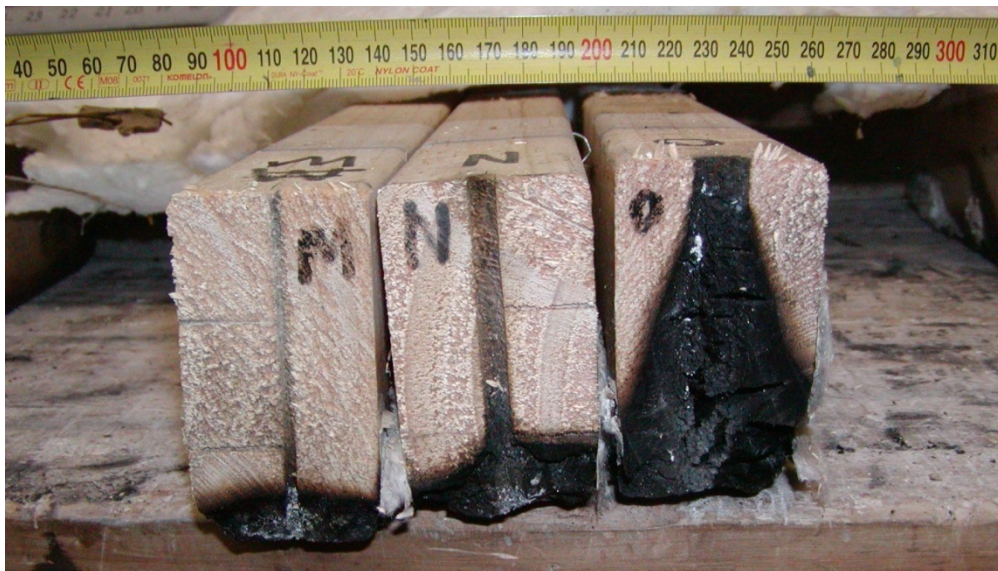
Figure 117: Charring in 3 to 12 mm holes at -2.52 Pa after 120 minutes (left to right M, N and O)

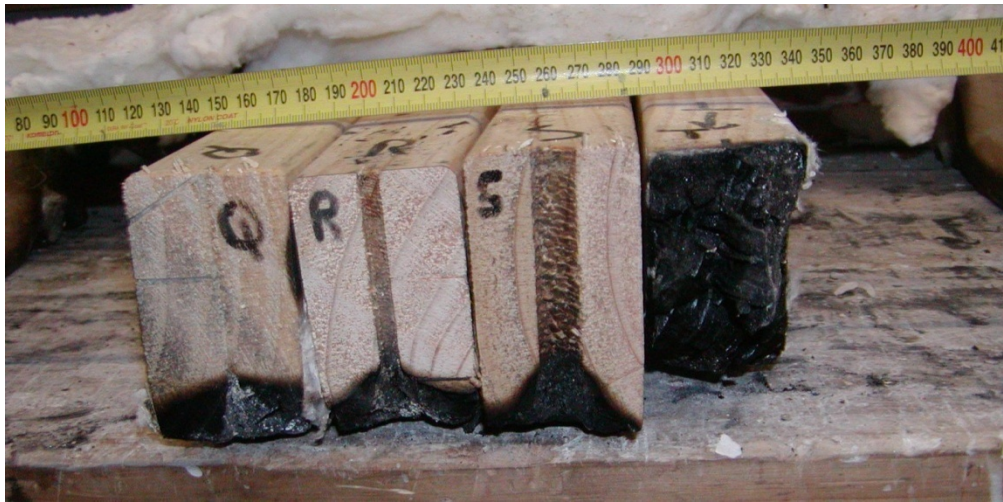
Figure 118: Charring in 3 to 24 mm holes at -7.24 Pa after 120 minutes (left to right Q, R, S and T)

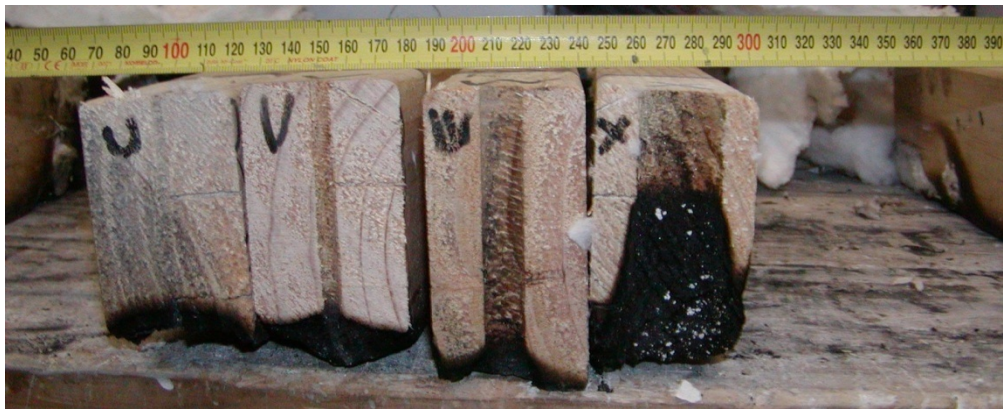
Figure 119: Charring in 3 to 24 mm holes at -11.96 Pa after 120 minutes (left to right U, V, W and X)
