# **STUDY REPORT**

**SR 335 (2015)**

## **New house construction quality survey 2014**

**I.C. Page**

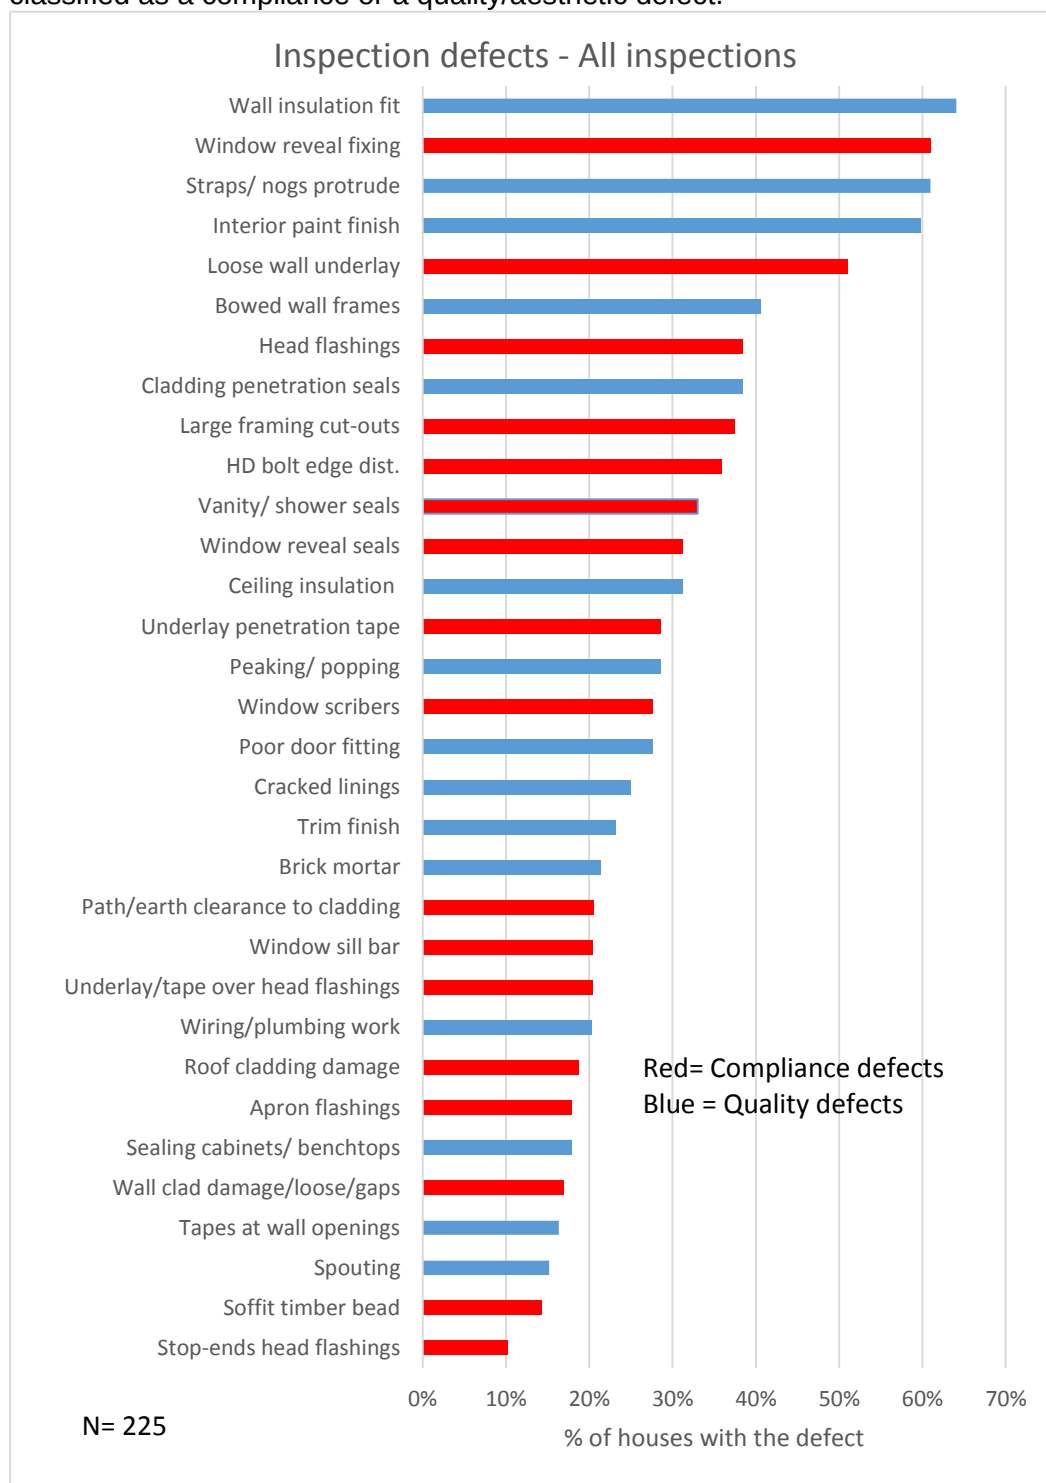
**Figure 1 Defect incidences from all inspections**

The incidence of defects found in the inspections is shown in Figure 1 for all three inspection types. The blue bars are quality type or aesthetic defects and the red bars are building code compliance defects. The percentages are calculated using the number of houses inspected for that particular type of defect. A total of 225 inspections were done (112 final, 49 post-underlay and 64 pre-lining). There is a quite high incidence of defects, between 10% and 65% of all houses.

Some of defects shown in Figure 1 could be classed in either of the two categories, compliance or quality. For example, an insulation fit defect arises when the insulation is cut incorrectly leaving gaps or causing compression at the edges. Almost always it is the latter and this does affect performance. However it was decided to classify this as a quality issue because the insulation is still performing a useful function even when it is not operating optimally.

Loose wall or roof underlay could cause weather-tightness problems. When it is sufficiently loose and extensive then wicking of water can occur between the cladding, flexible underlay and insulation. It was decided to class it as a compliance defect because where it occurred it was generally on more than one place on the envelope.

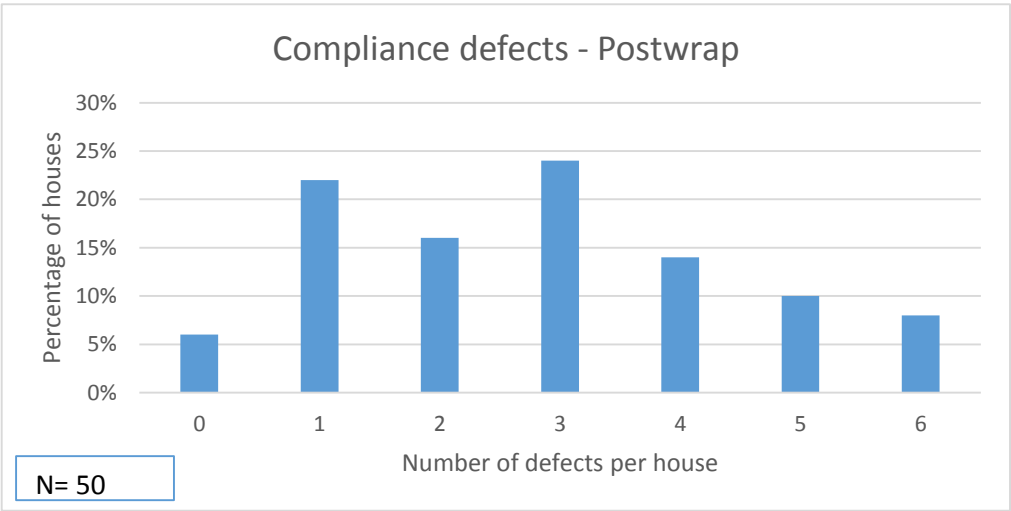
Figure 2 Compliance defects post underlay

To obtain a better feel for serious defects the number of compliance defects per house was analysed as shown in Figure 2 to Figure 4. Many of these defects are completely visible for one inspection only. For example, the assembly for wall flashings and cavity battens are visible only at the post-wrap stage. Insulation and services cabling are visible at the pre-lining stage. The final inspections check the linings, paint finishes and cladding details. Wall and roof flashings are also checked in the finals mainly for their positioning on claddings.

The three stages of inspections indicate a quite high level of compliance problems. There are between 6% and 27% of new houses with no defect, depending on the type of inspection (i.e. post-underlay, pre-lining, and final). We could assume a house with one or two defects is able to survive with minimal damage, though that depends somewhat on the actual defect. There are between 16% and 30% of houses with one to two defects, depending on the type of inspection.

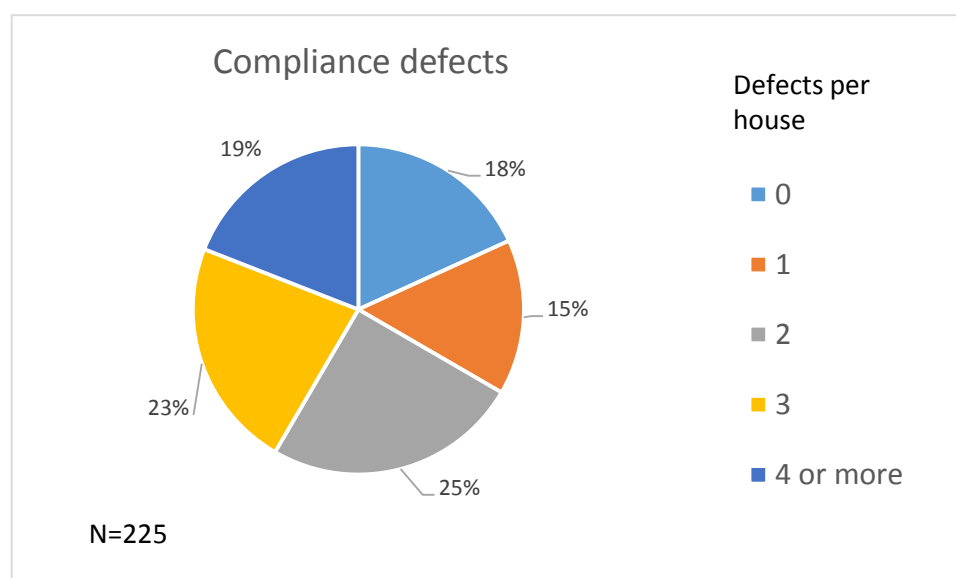
**Figure 5 All inspections compliance defects**

The table shows the average number of compliance defects across all three inspection types is 2.2. It indicates about 18% of new houses have no defects, and about 40% have one or two defects. 23% of houses have three compliance defects, and 19% with four or more defects. Figure 5 has the same information in pie chart form. We somewhat arbitrarily assume four or more defects is indicative of serious compliance issues, and in particular poor workmanship.

As noted above some post-wrap and pre-lining defects recorded by Realsure will likely be remedied. So the 19% share of houses with four or more compliance defects is an upper limit. A more realistic measure is from the finals inspections because earlier defects picked up in the council inspections would have been remedied. The final inspection has a rate of about 15% of houses with four or more compliance defects. We assume, perhaps optimistically, half of these are remedied before occupancy leaving a compliance defect rate of about 8%.

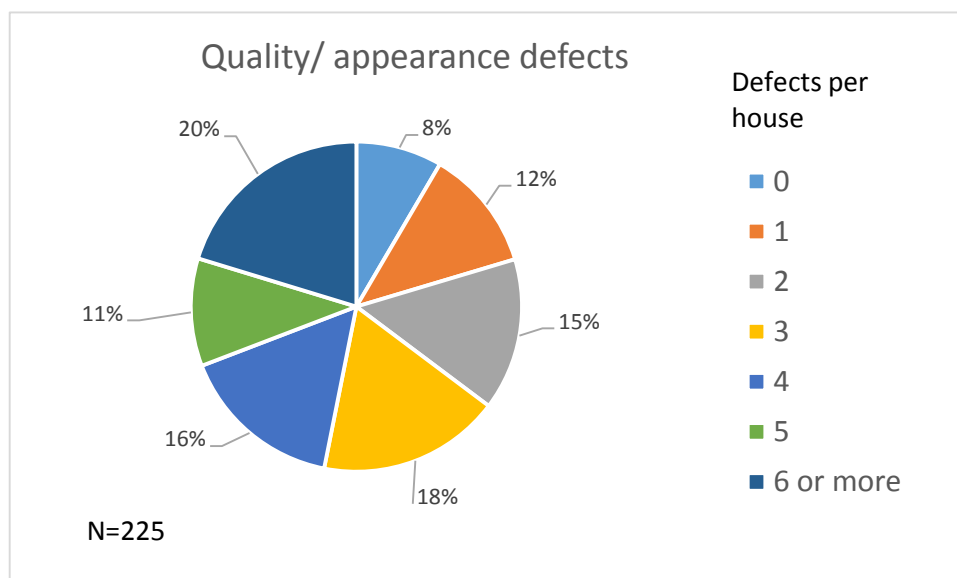
Figure 6 Quality defects at final inspection

These are defined as all defects not classified as compliance defects and are shown in Figure 6. The average number per house is 4.2 and there was only 8% of houses with no quality defects.

Figure 1 shows these quality defects included interior and exterior paint finish, ceiling insulation, popping of fixings in plasterboard, poor trim work, ill-fitting cupboards, and cracked linings. Other inspection types (apart from the final inspection) also indicate wall insulation installation is poor, and some walls are not straight or have protruding straps and nogs which affect the surface finish.

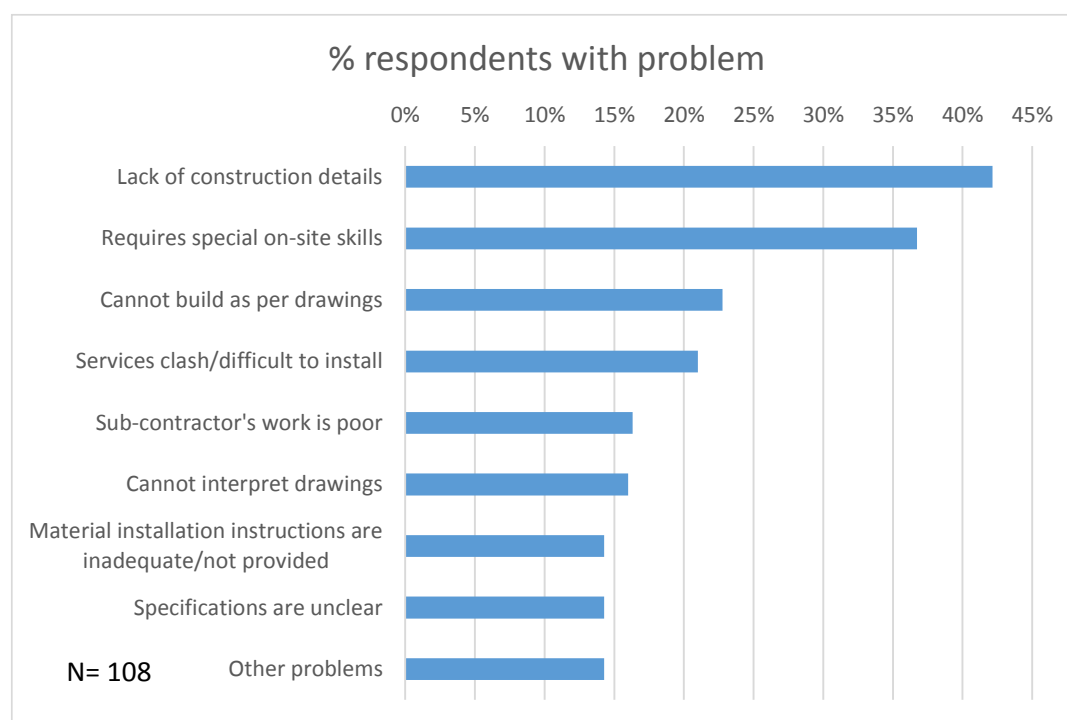
**Figure 7 Types and incidence of problems experienced by builders.**

The top three issues relate to lack of buildable details on the drawings, and lack of appropriate skills. Over 40% of builders have experienced lack of details at least once in the past year. The responses may indicate a lack of knowledge about where to find details, e.g. E2/AS1 and NZS3604 or inability to translate the drawings into what needs to be done on-site. So the top three items in the chart could partly be caused by insufficient skills of the workforce, rather than insufficient detail being provided on the drawings or available from other sources.

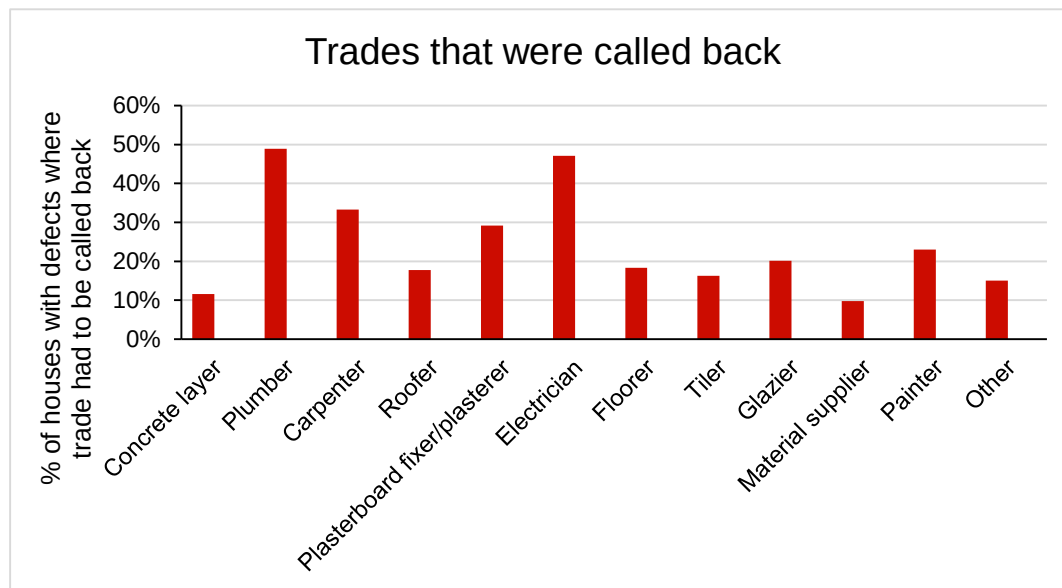
**Figure 8 New home owners survey 2014**

BRANZ has anecdotal reports and has done formal surveys indicating that new homeowners very often need to call back their builders to repair defects. The BRANZ New Home Owners Satisfaction Survey (Curtis 2015) has been recording these defects for a number of years now. The latest finds that 81% of new owners had call-backs. The types of defects were recorded by trade, see Figure 8. The most common trades called-back were plumbers and electricians, followed by carpenters (doors, trim, cabinets, etc.), plasterer (linings) and the painters. These are all related to aesthetics, and fixtures and fittings. Any structural or weather-tight defects would generally be hidden or unknown by the owner. However 18% of the call-backs

Despite the high call-backs new owners were generally happy with the quality of their new home. 88% of respondents reported being at least fairly satisfied with the overall quality (on a scale of 1 to 5, where 4= fairly satisfied) of their home. This was the aspect with the highest level of satisfaction achieved in the latest survey, though this is down from 91% in the 2013 survey.
