BULLETIN

December 2003

NUMBER 444

LESSONS FROM THE 1987 EDGECOMBE EARTHQUAKE

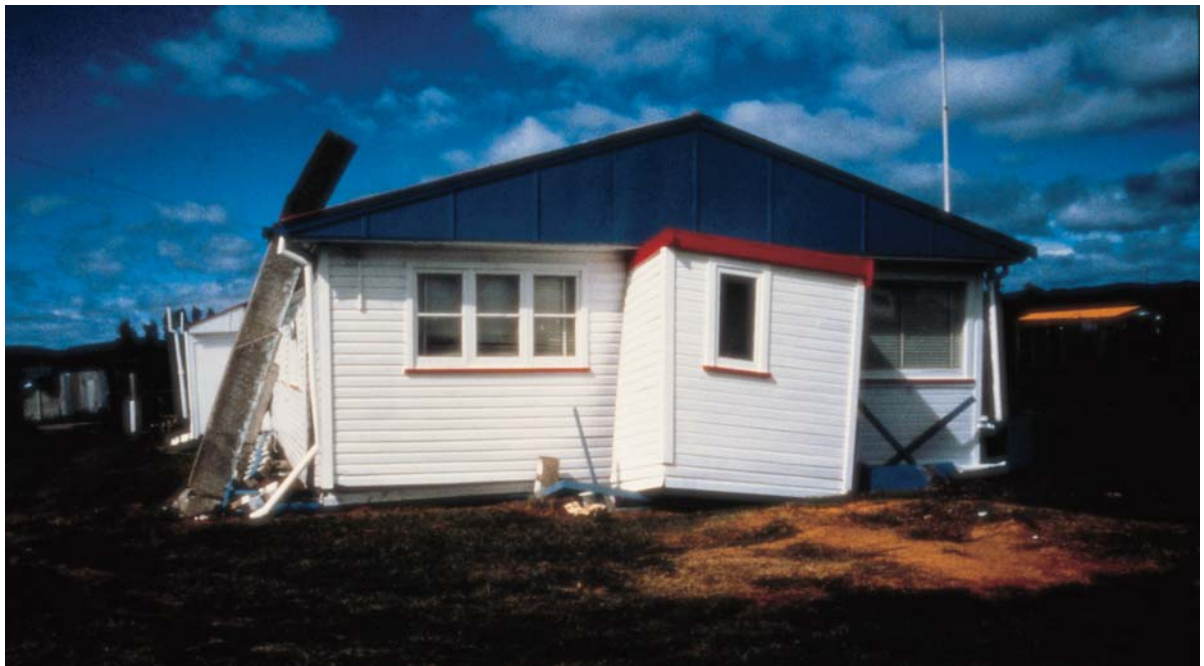
- ❑ Houses on simple piles are vulnerable to foundation failure unless adequate bracing of the sub-floor system is provided.
- ❑ Houses constructed in accordance with the requirements of NZS 3604 and also well-built older houses survived the earthquake without structural damage.
- ❑ Different types of shaking result when separate parts of a building are founded on different types of foundation. Often damage will occur at the junction of the differing parts.
- ❑ Chimneys are particularly vulnerable. It is essential that precast chimney units are properly reinforced, and that the chimney is adequately attached to the structure or is designed to stand independently.
