BULLETIN

ISSUE 546

HOUSE CONDITION SURVEY – EXTERNAL ENVELOPE

April 2012

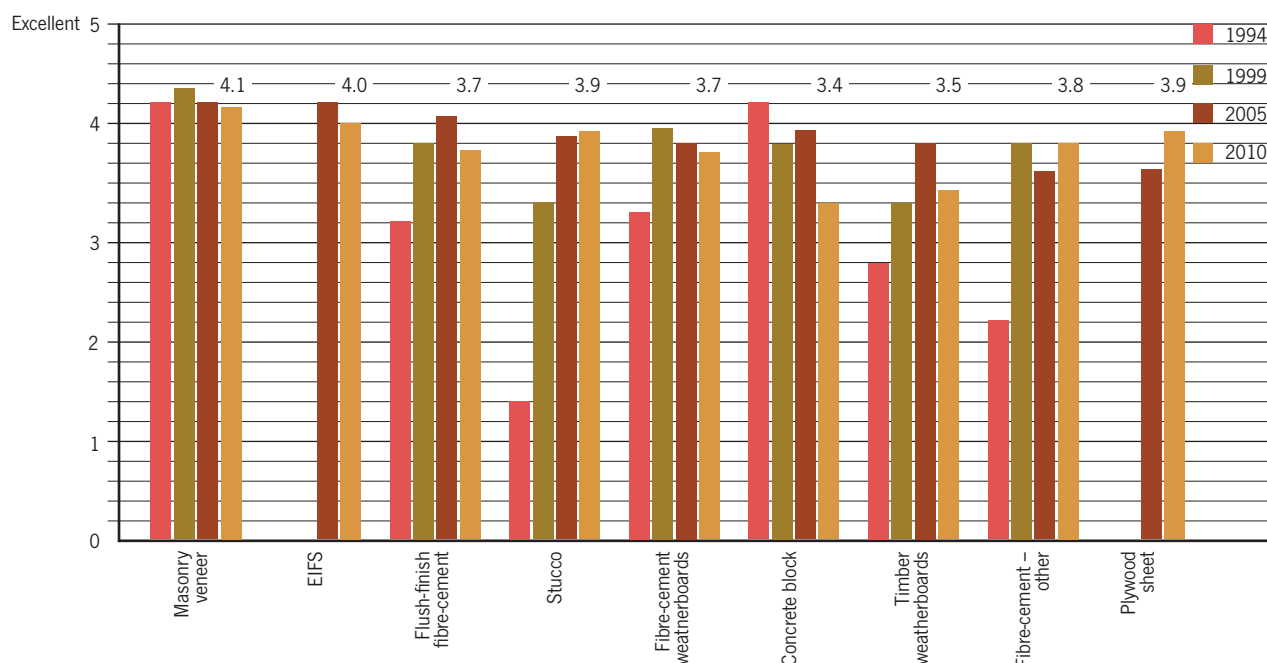
6.3.2 The average ages of houses using the different wall claddings and windows are shown in brackets where the sample size was sufficient, so that average condition ratings can be assessed against the likely age of the materials. Roofs are not considered, as their replacement generally has less to do with their age and more with the conditions they are exposed to.

Figure 3. Condition of external materials – wall claddings.

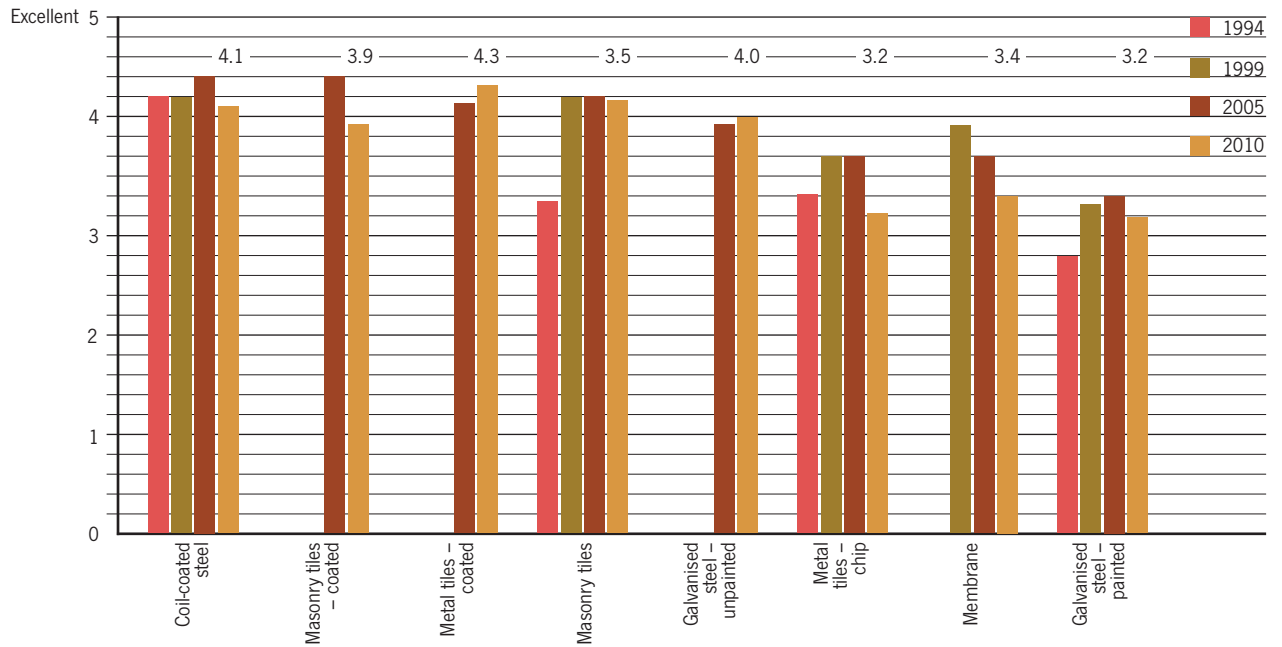
Figure 4. Condition of external materials – roof claddings.

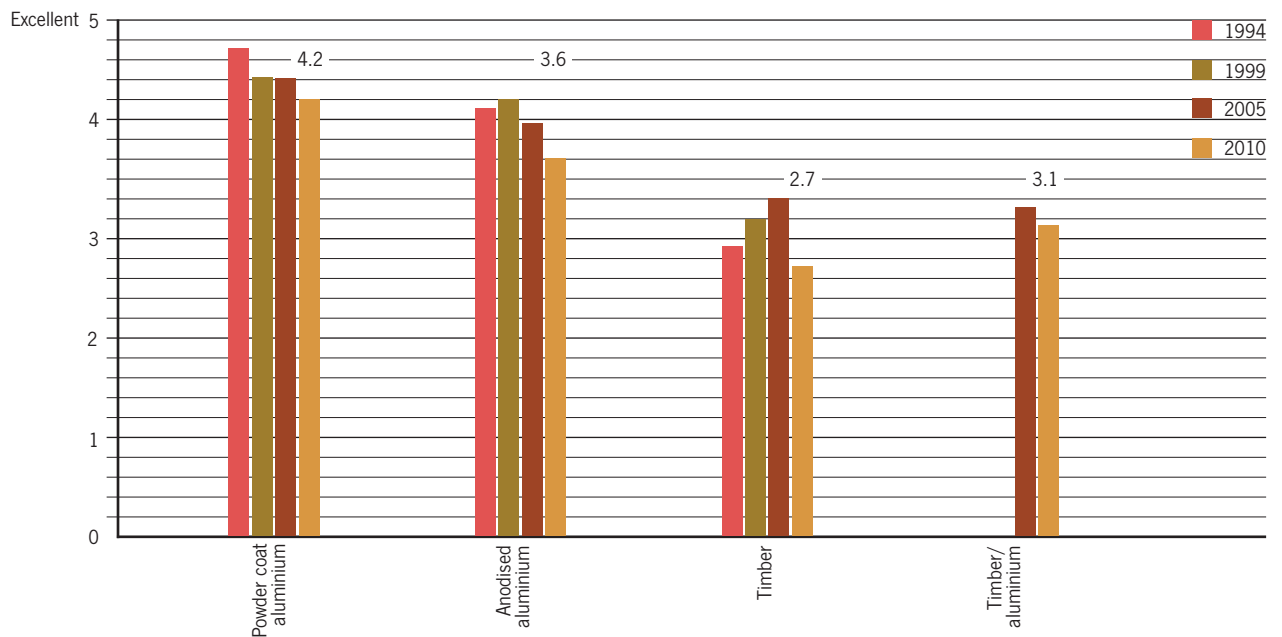
- Paint deterioration (57%)
- Putty cracks (57%)
- Joint cracks (52%)
- Top coat deterioration (45%)
- Dislodged putty (43%).

Figure 5. Condition of external materials – windows.
