BULLETIN ISSUE594

EXCESSIVE MOISTURE IN ENCLOSED SUBFLOOR SPACES

February 2016

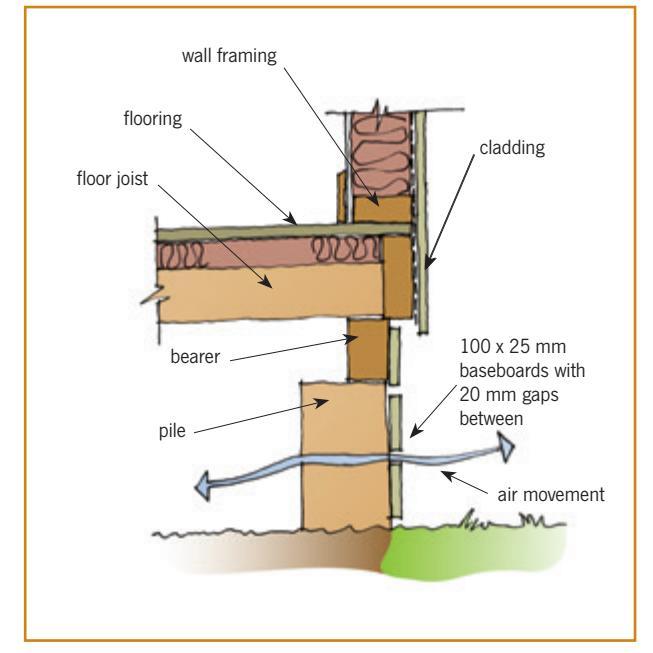
Figure 1. Baseboards with 20 mm gap.

- baseboards with 20 mm wide gaps between them (Figure 1)
- regularly spaced ventilators, starting 750 mm from each corner and no more than 1.8 m apart
- a 50 mm gap between the wall plates and a boundary joist at the ends of cantilevered floor joists and the wall plate and joist where the bearer is cantilevered (Figure 2).

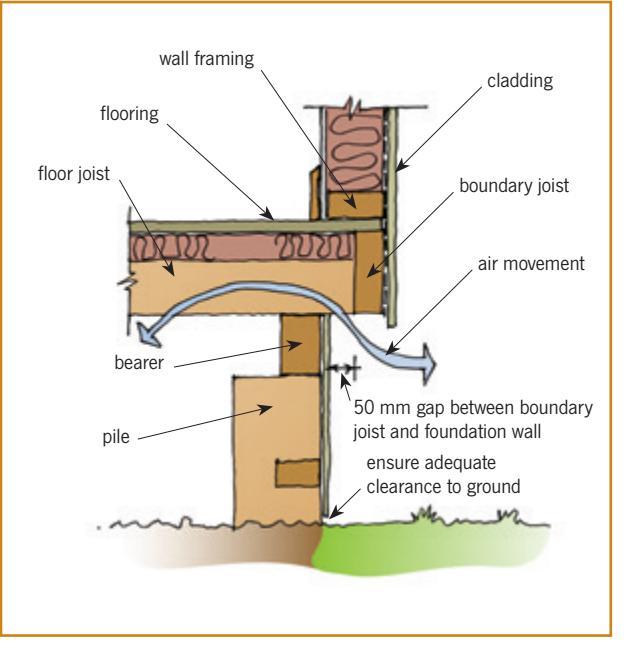
Figure 2. Ventilation with cantilevered joists.

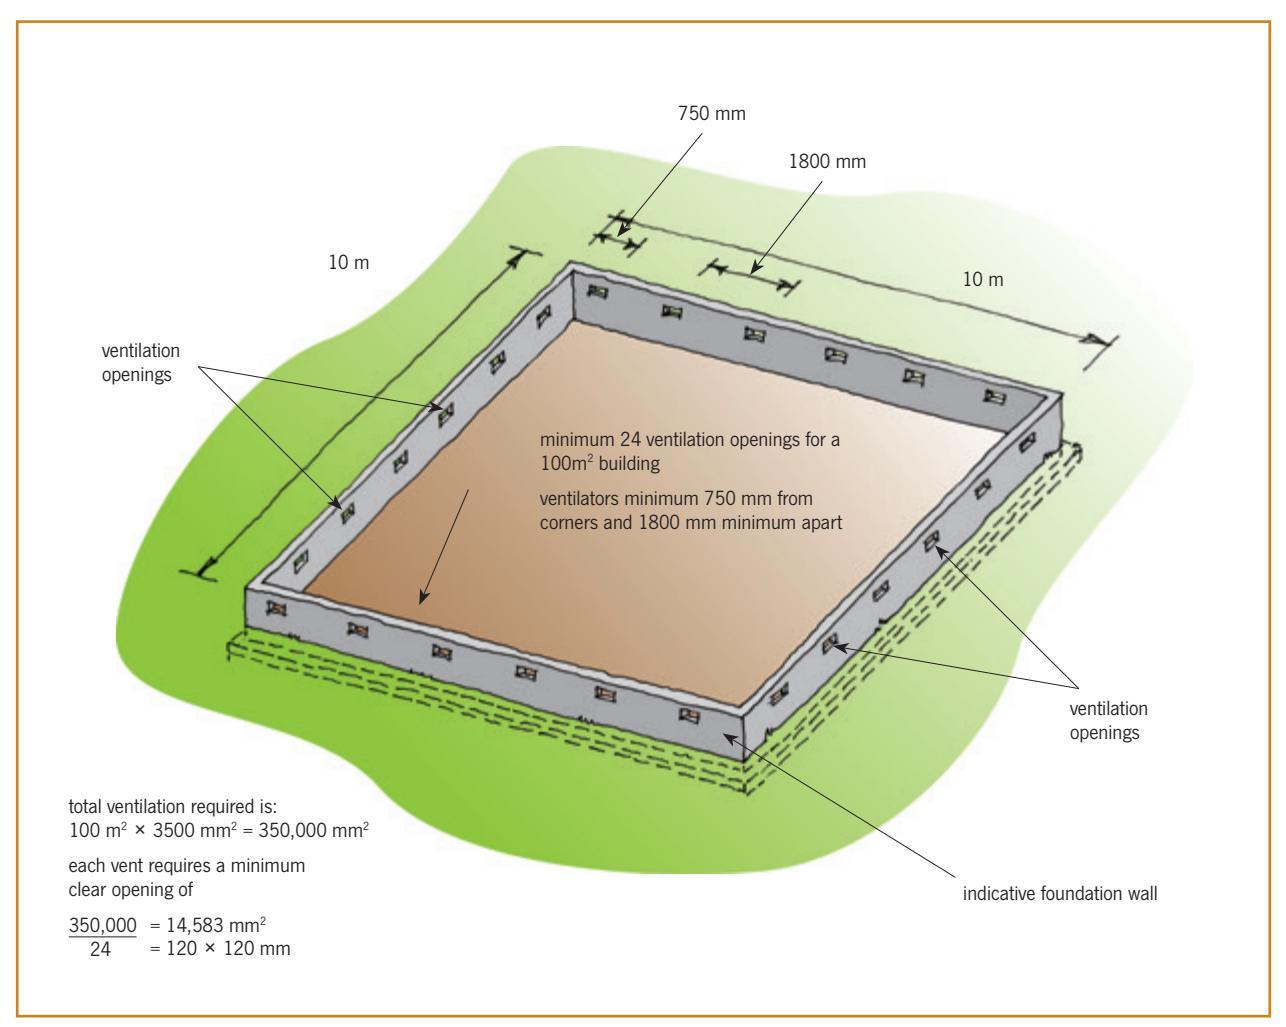
Figure 4. Acceptable ventilation in NZS 3604:2011 Timber-framed buildings.

3.0.2 When calculating the amount of ventilation to be provided, the distribution of vents as well as the total amount of opening must be considered. Even if the minimum total ventilation is achieved, if vent positions exceed the maximum permissible centres, extra vents must be added to meet the minimum requirement for spacing (Figure 4).
