ISSUE 627 **BULLETIN**

## THE IMPACT OF GEOTHERMAL ENVIRONMENTS ON METALS AND WOOD

August 2018

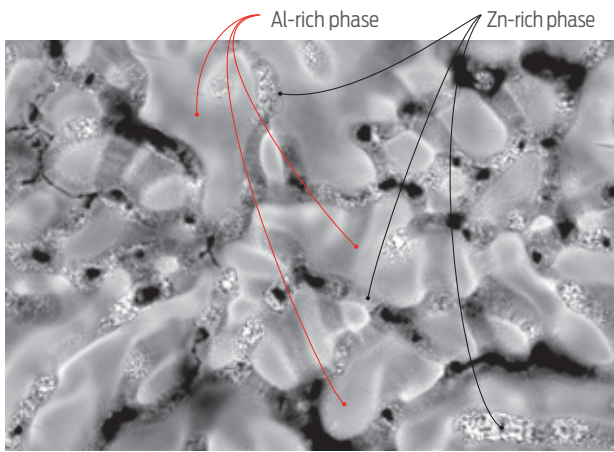
Figure 4. Typical surface structure of Al-Zn alloy coating.

**4.0.3** The microstructure of Al-Zn alloy coating has an aluminium-rich phase and a zinc-rich phase [Figure 4]. The aluminium-rich phase forms into dendrites – tiny metallic crystal structures that look a bit like snowflakes or trees. The zinc-rich phase occupies the regions between the dendrites and is therefore often called the interdendritic phase. The dendrites constitute approximately 80% of the coating volume. An intermetallic layer is normally formed to bond the coating to the steel substrate. Silicon can also be present in the microstructure as needle-like particles in the interdendritic regions.
