# ISSUE674 BULLETIN

# SEISMIC RETROFITTING HOUSES WITH PILED FOUNDATIONS ON SLOPING SITES

August 2022

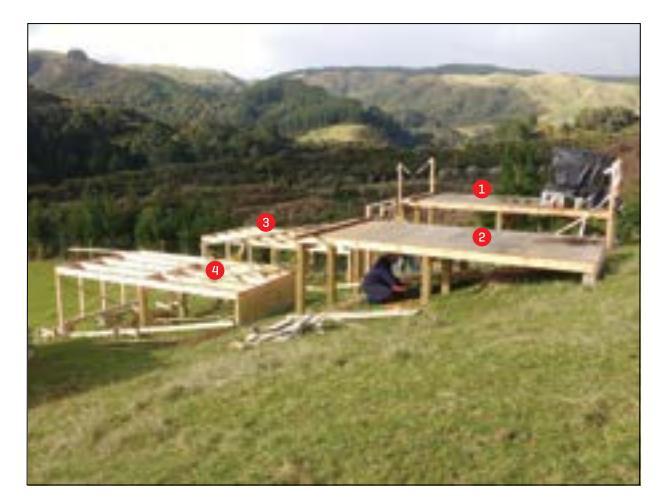
Test foundations being built.

**3.0.2** Four test foundations of approximately 2.4 m across slope by 4.8 m upslope were built (see photograph):
