BRANZ STUDY REPORT

A SURVEY OF MOISTURE DAMAGE IN SOUTHERN NEW ZEALAND BUILDINGS

H.A. Trethowen and
G. Middlemass

BRANZ Study Report SR 7

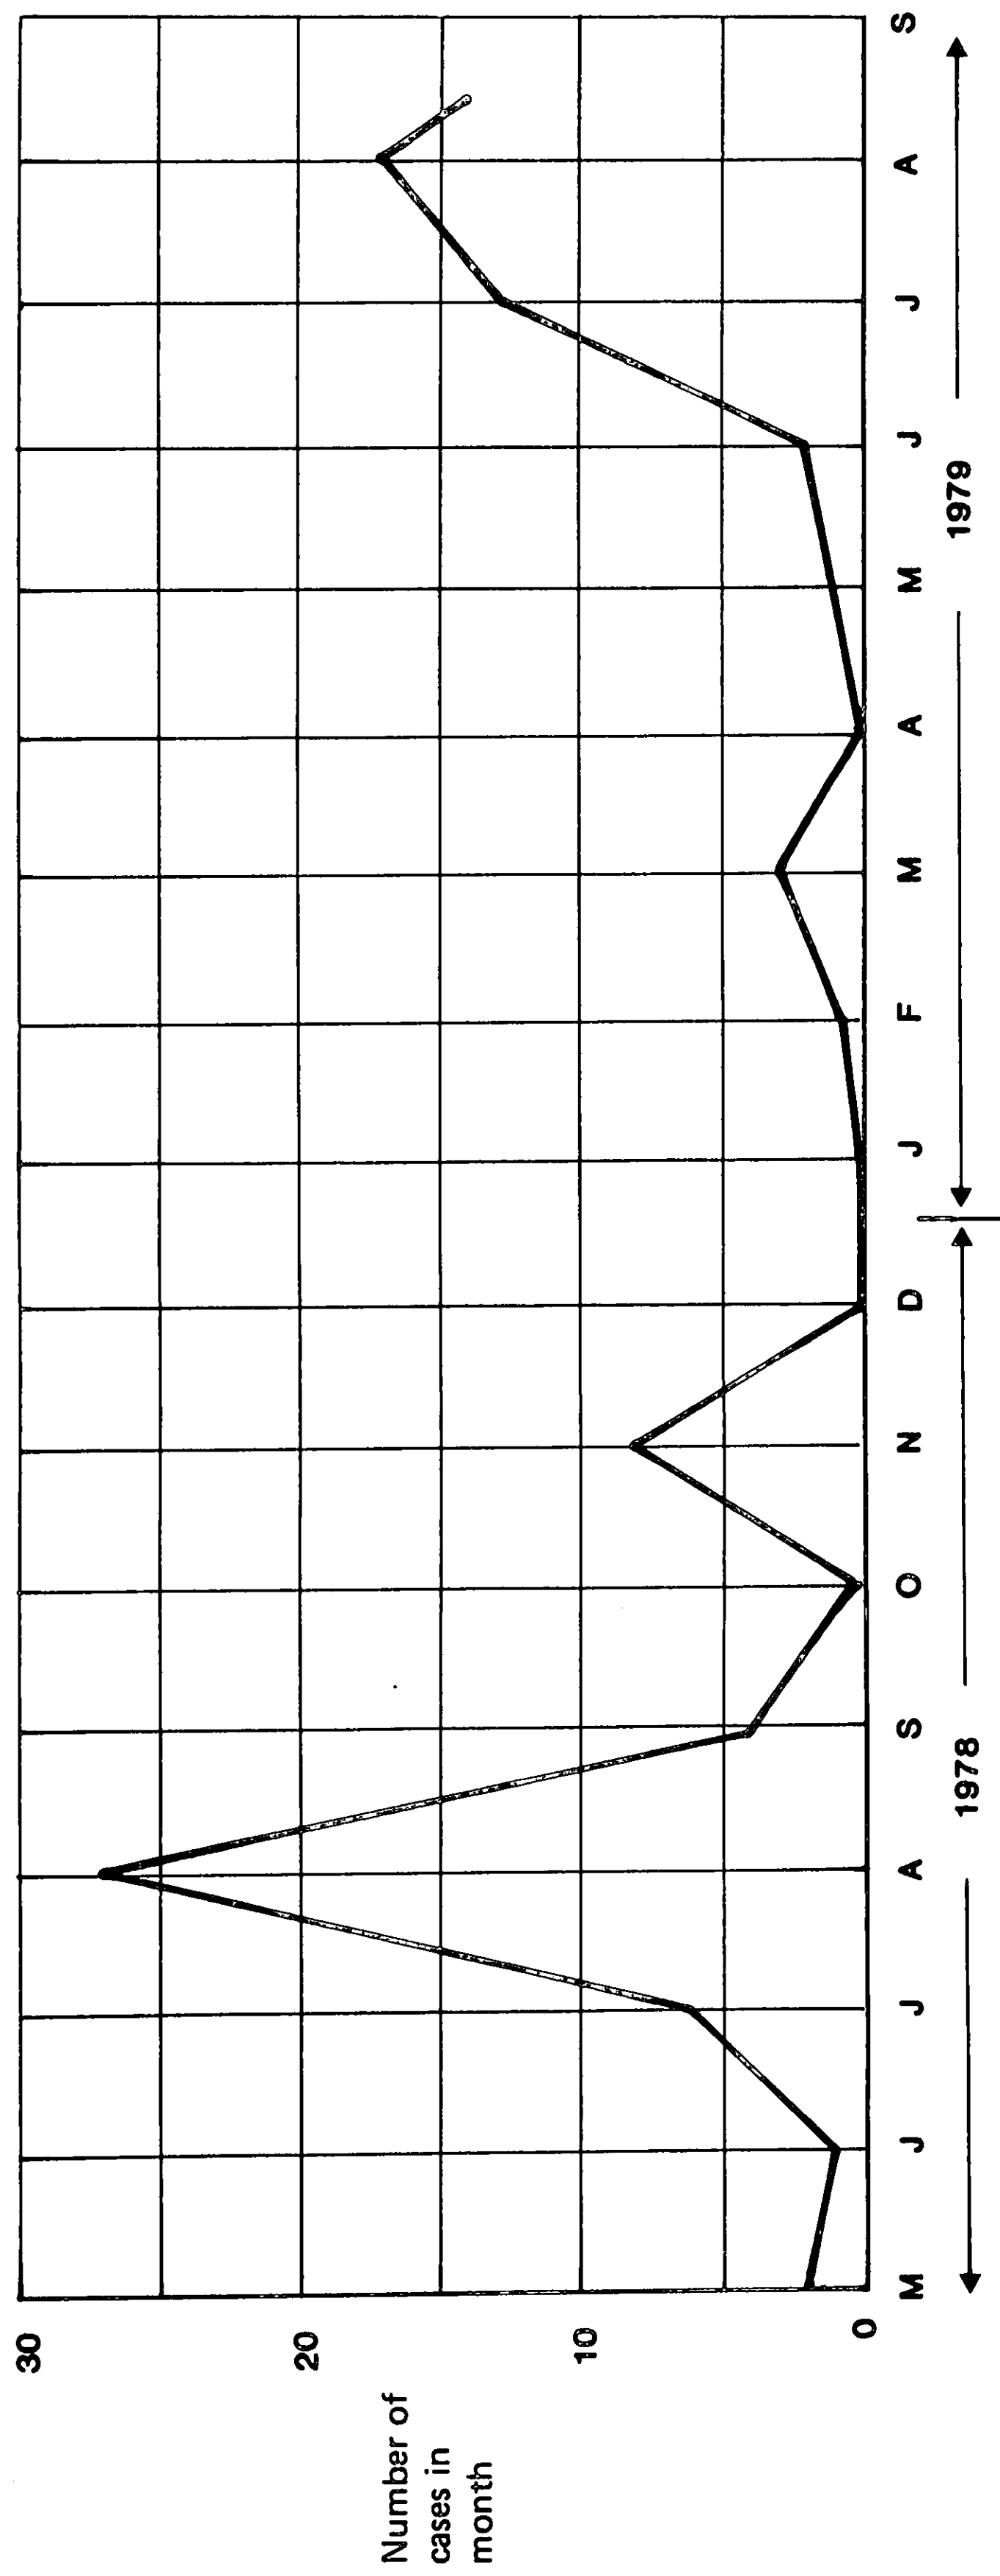
FIGURE 1: ANNUAL DISTRIBUTION OF MOISTURE PROBLEMS REPORTED

The location, date, and brief details of each case are listed in the Appendix. Figure 1, illustrating the number of enquiries received each month, shows as expected that most moisture problems arise in winter, but that a small number continue throughout the year. Figures 2 and 3 illustrate typical cases of moisture damage most commonly encountered by BRANZ up to that time.

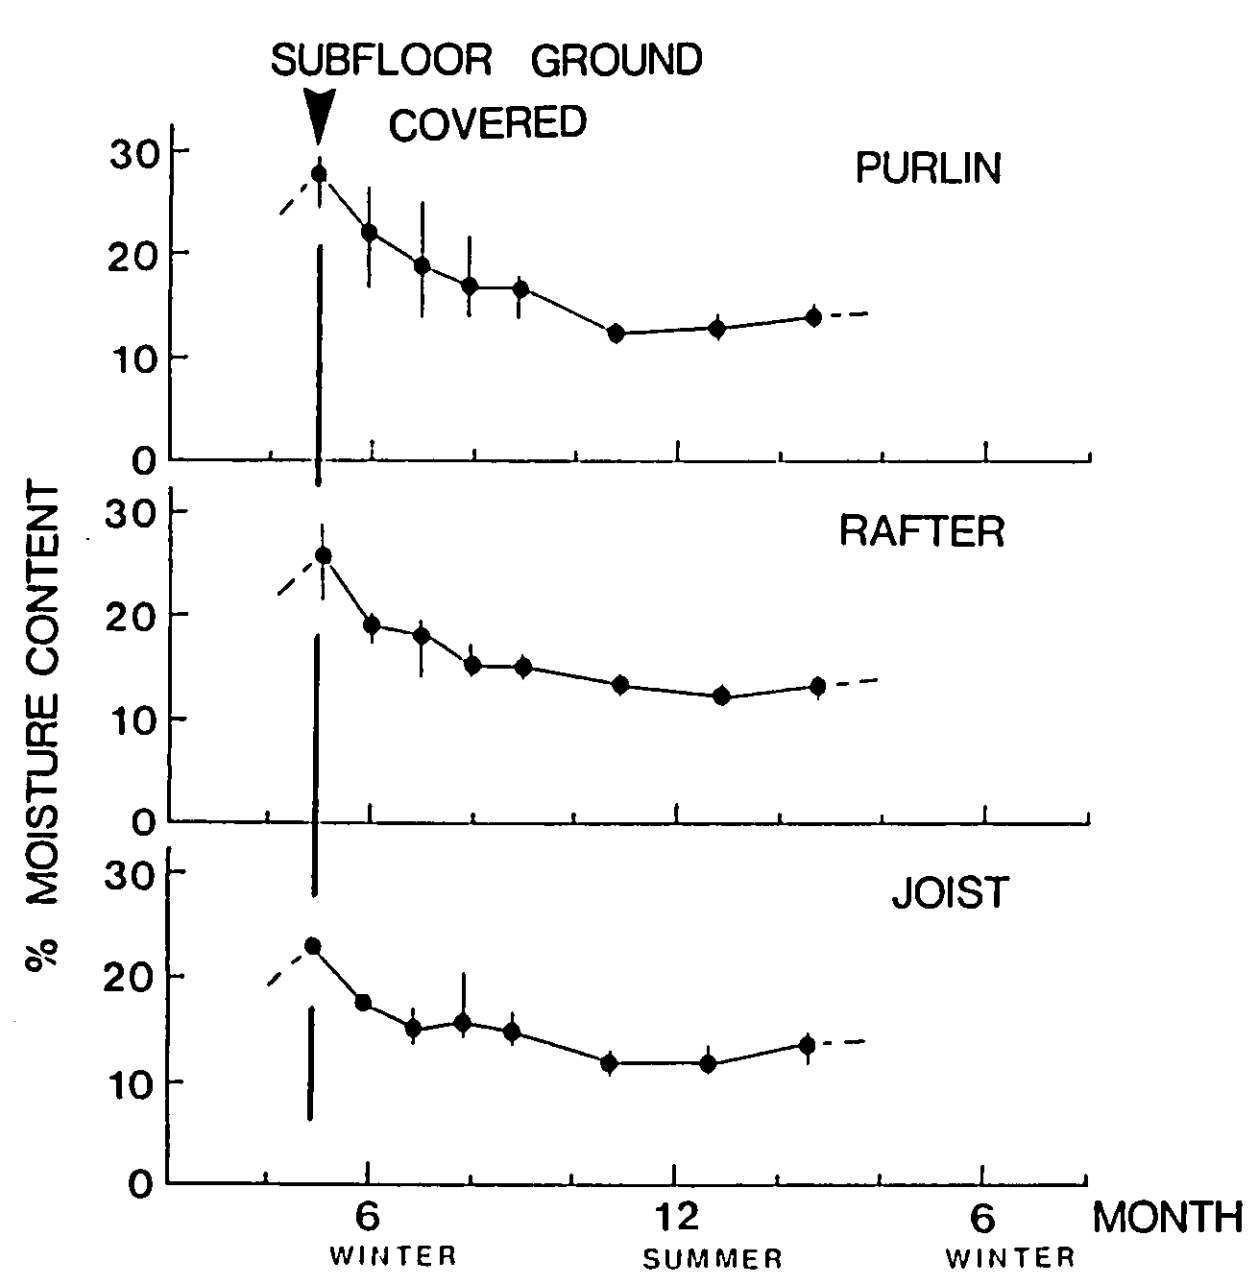
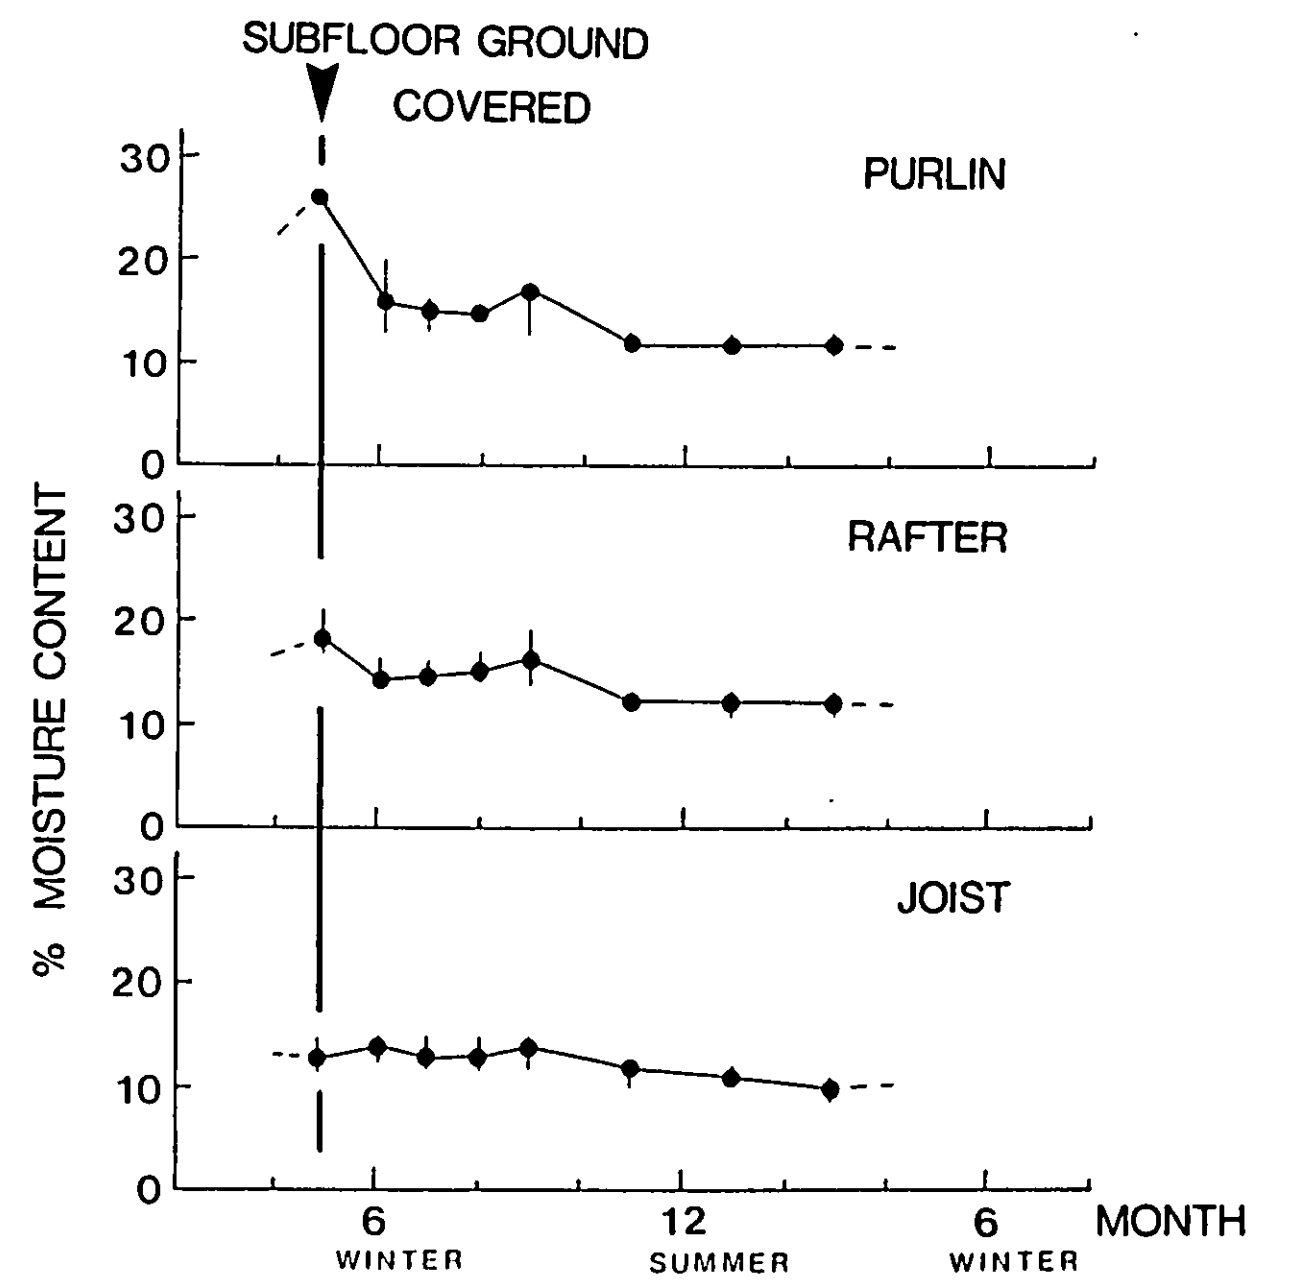
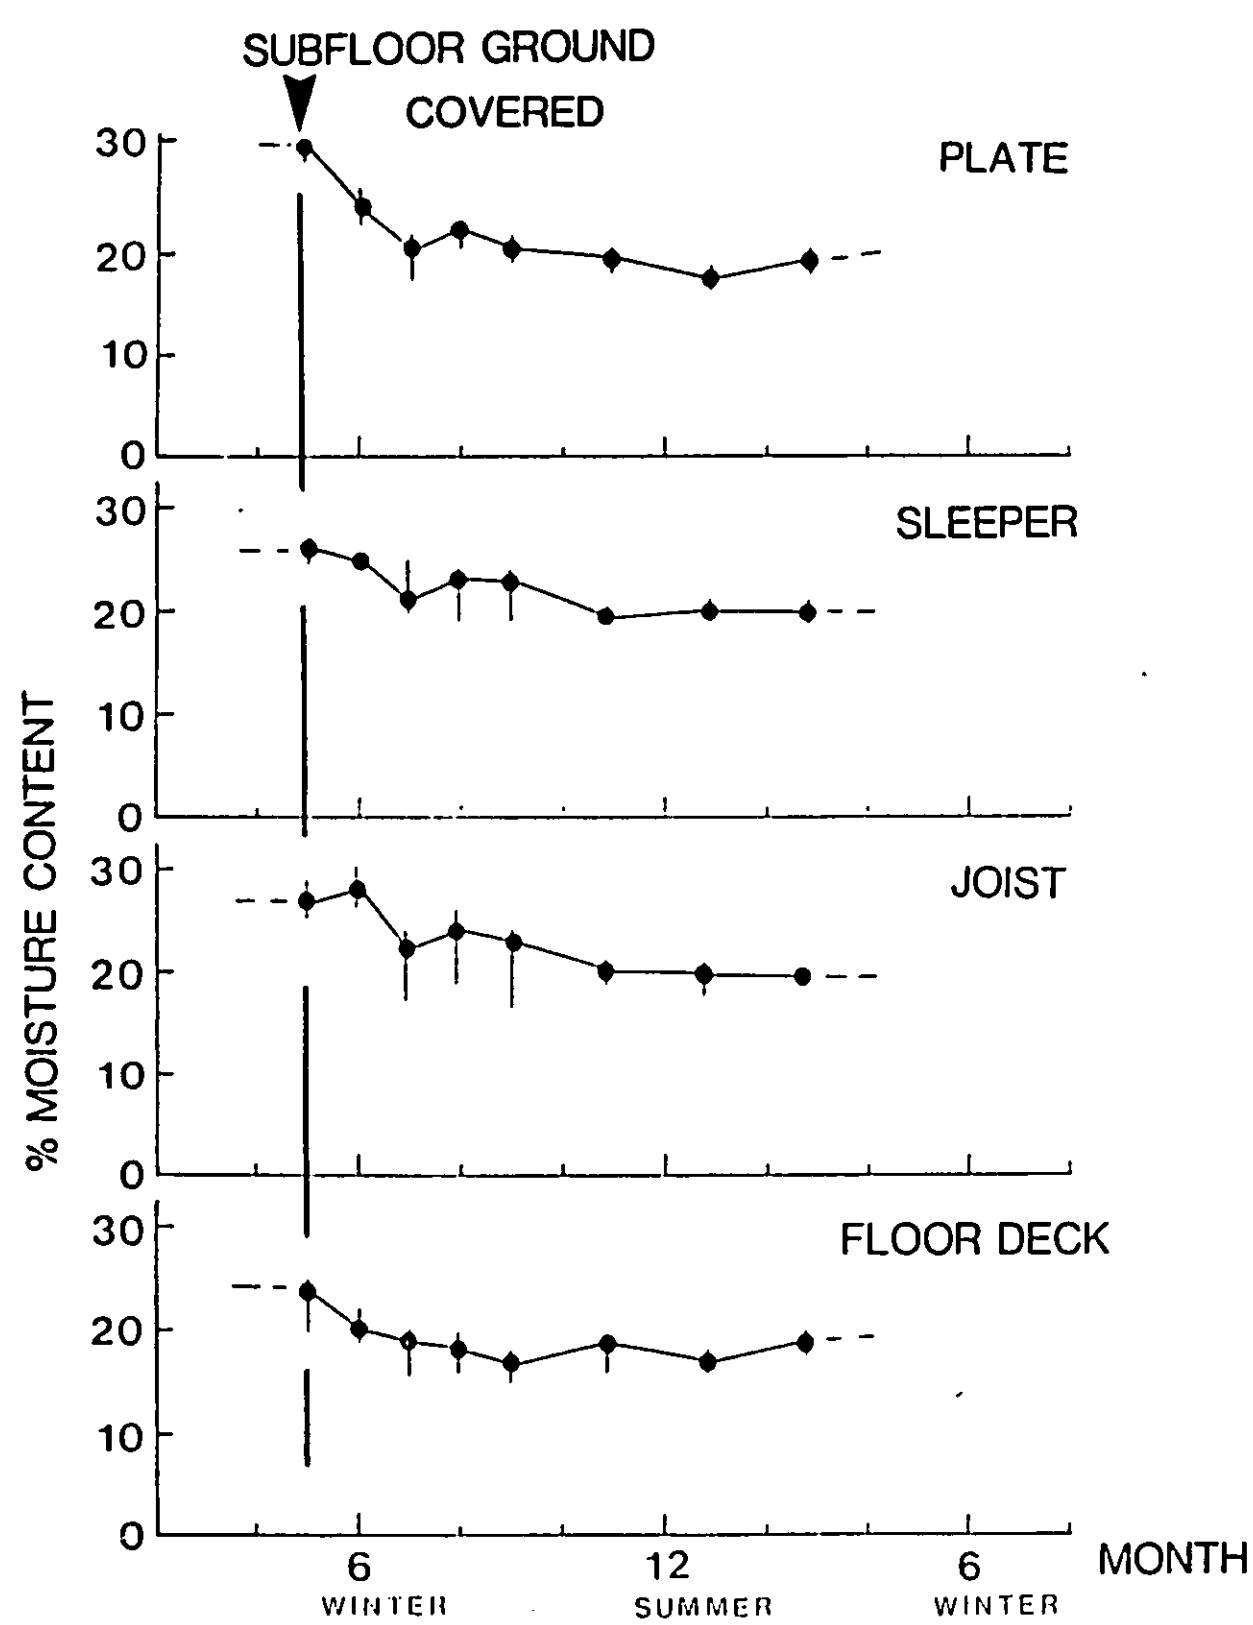
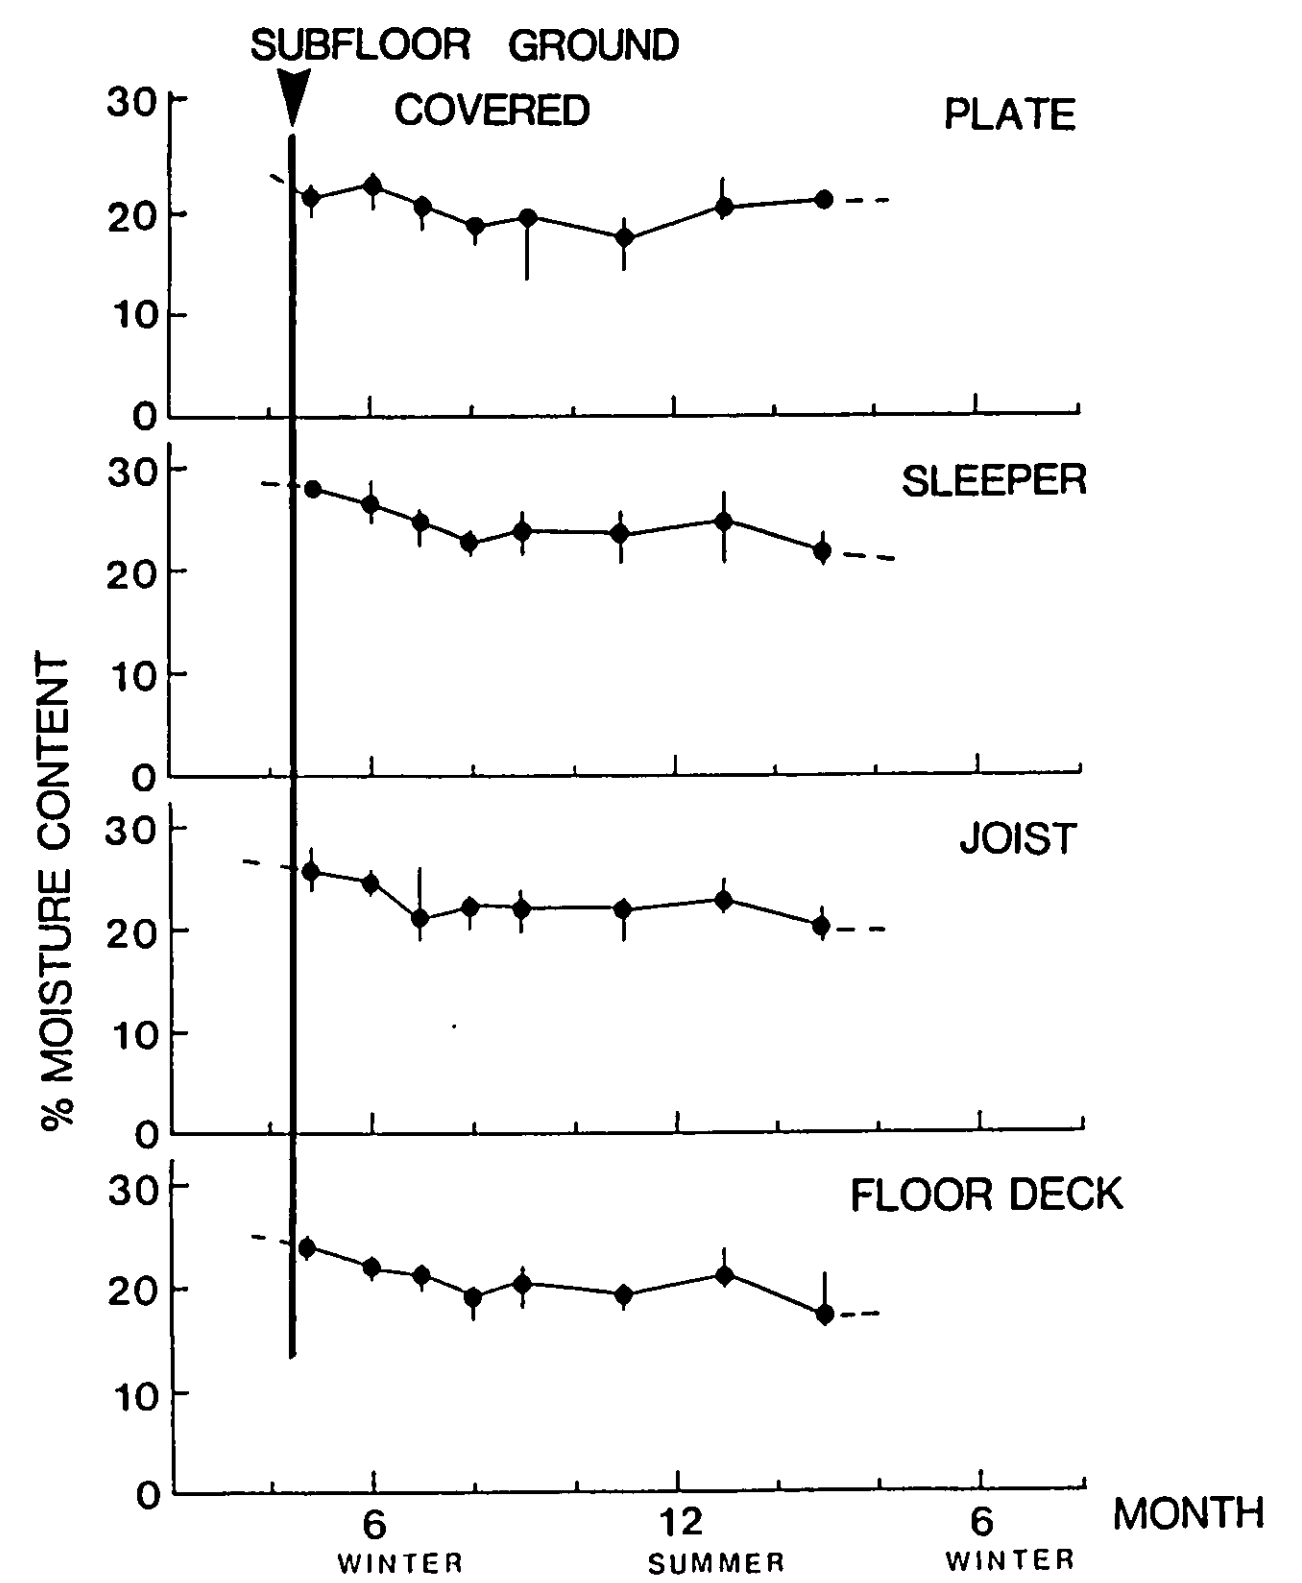
Fig 8 (a) : Individual m.c. observations in 10 houses.

The moisture contents for each of the ten houses, recorded at each inspection are illustrated in Figures 8 and 9.
