# STUDY REPORT

No. 91 (2000)

**NEW ZEALAND HOUSE**

**CONDITION SURVEY**

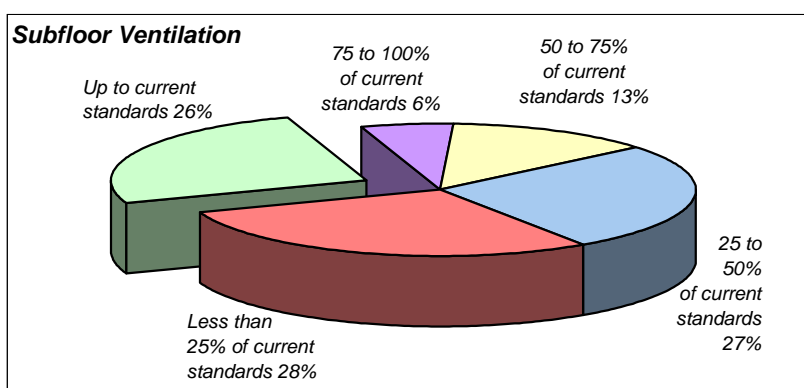
*Figure 30: Subfloor Ventilation*

As shown in *Figure 30*, only a quarter of timber-floor houses were assessed as adequate, while many had only a small fraction of the amount of ventilation currently required in new houses.

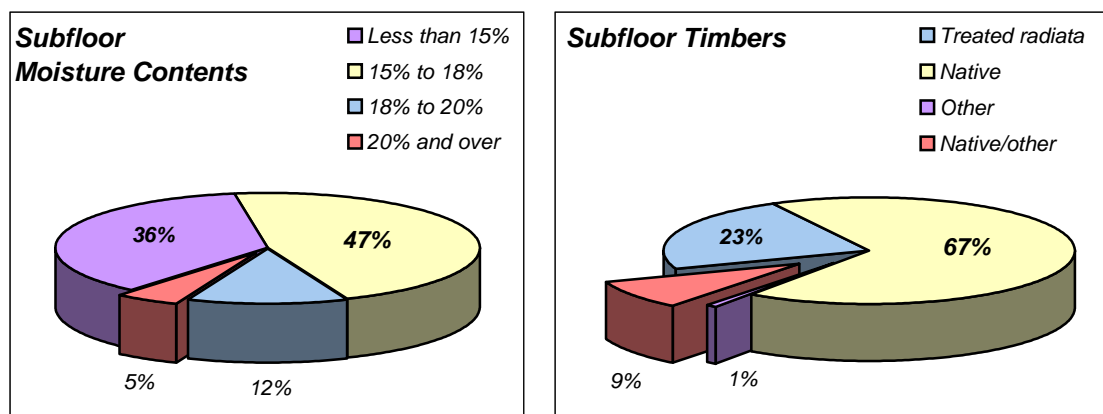
*Figure 31: Subfloor Species & Moisture Contents*

As shown, a large proportion of houses have high moisture contents - with 5% over the threshold where decay is likely to start. The threshold for borer attack has in the past been considered to be around 18%, but timber scientists are now finding that this may (in some cases) be as low as 12%. As only 1% of the sample had moisture levels below 12%, those with levels between 15% and 18% have been isolated in the pie chart in order to present a more detailed picture. The danger of borer infestation is of particular concern because of the high percentage of native timber use. As shown, around three-quarters of houses have subfloor framing of native timbers.

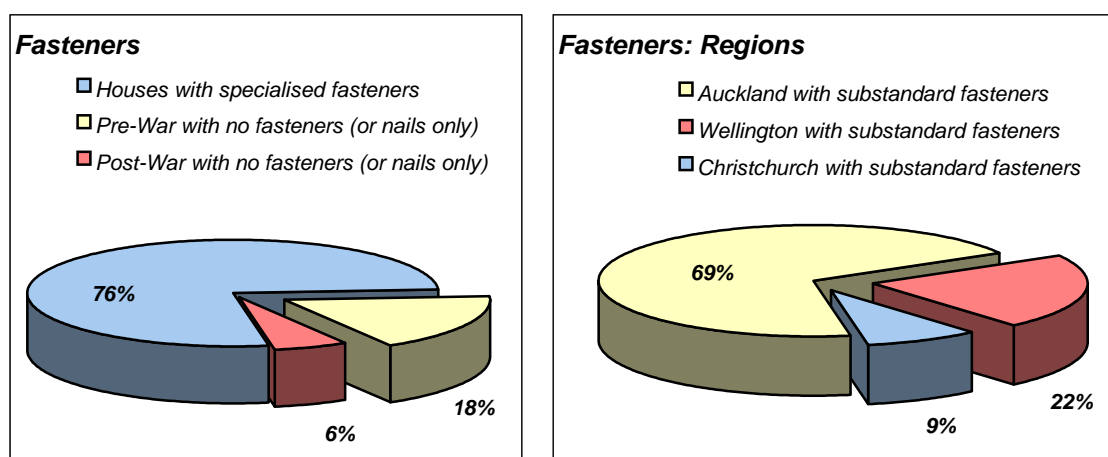
**Figure 32: Fasteners**

As can be seen, almost a quarter had no fasteners; a quarter of which were in **post-war** houses. The regional breakdown shows that the majority (almost 70%) of the houses with substandard fasteners were in Auckland. Because of this unexpected proportion, Auckland houses have been further broken down into age groups, and the result is given in *Figure 33*.

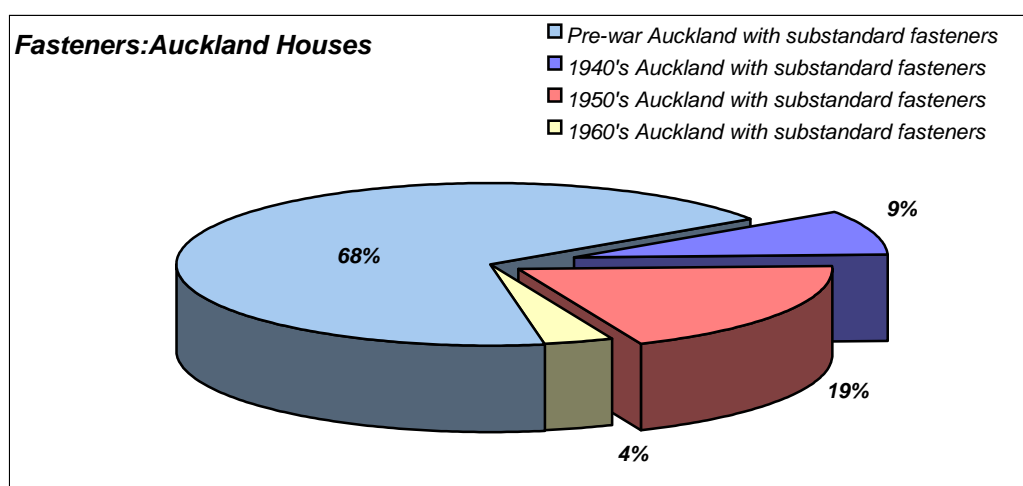
**Figure 33: Auckland Fasteners**

More than 30% of the Auckland houses with substandard fasteners were built since the Second World War. Almost 20% were built in the 1950's and 4% as late as the 1960's. This would seem unusual, particularly when contrasted to the other two regions, and may warrant further investigation.

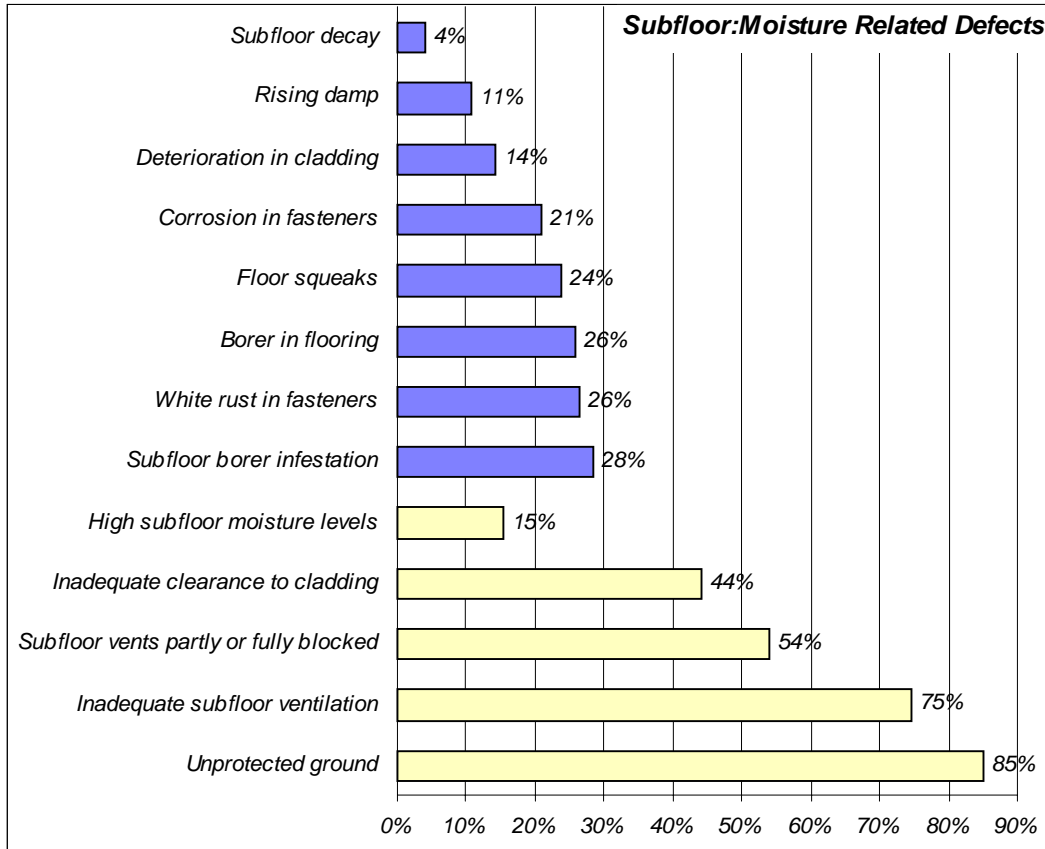
**Figure 34: Moisture Related Problems**

The following charts present the most common defects found in the subfloor area, divided into moisture-related and structural defects. In the chart on moisture, the unshaded areas show the house characteristics or problems, while the shaded areas show what may be associated defects.

As may be seen, the presence of moisture-encouraging conditions such as inadequate subfloor ventilation is much more prevalent than the actual defects usually associated with moisture. The level of such defects is nevertheless important (particularly corrosion and borer), and the defects are of the type that will increase in the future if conditions permit.

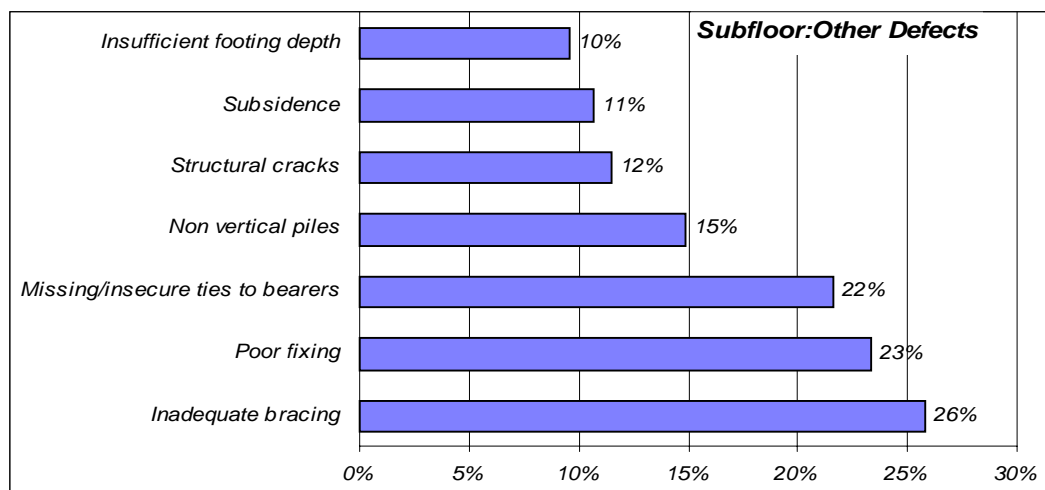
**Figure 35: Other Subfloor Defects**

The most common structural defects found in the survey were associated with fixings (as discussed earlier) and lack of adequate bracing.

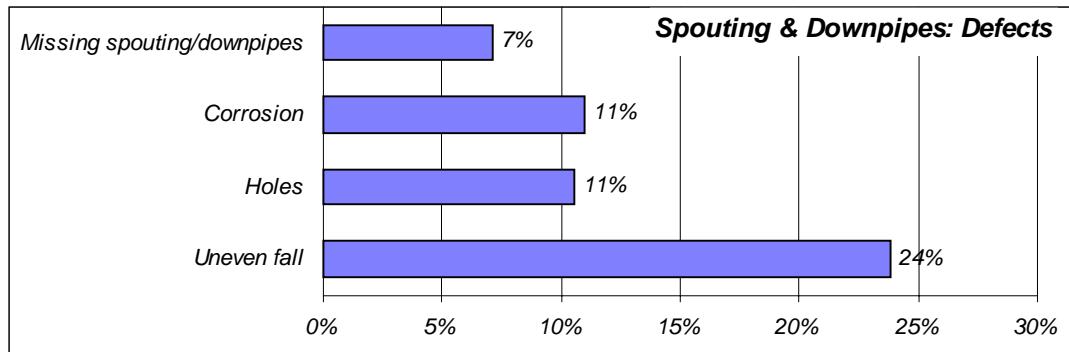
**Figure 36: Defects in Spouting & Downpipes**

The most common defects identified by the inspectors were uneven falls in guttering and those defects associated with galvanised steel guttering i.e. corrosion and holes. The frequency of defects is shown in *Figure 36*.

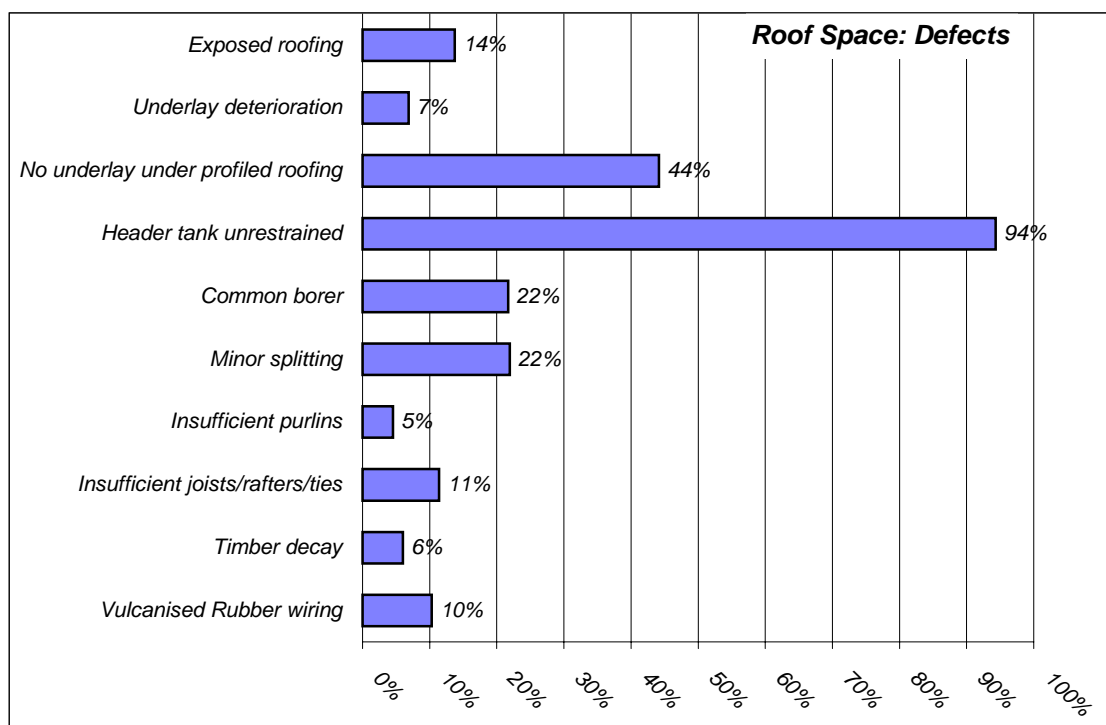
**Figure 37: Roof Space Defects**

The most common defects identified by the inspectors were unrestrained header tanks, lack of roofing underlays, minor splitting, and borer infestation<sup>38</sup>. The frequency of defects is shown in *Figure 37*.

One point worth noting from *Figure 37* is that there are still around 10% of houses using old rubber insulated wiring.

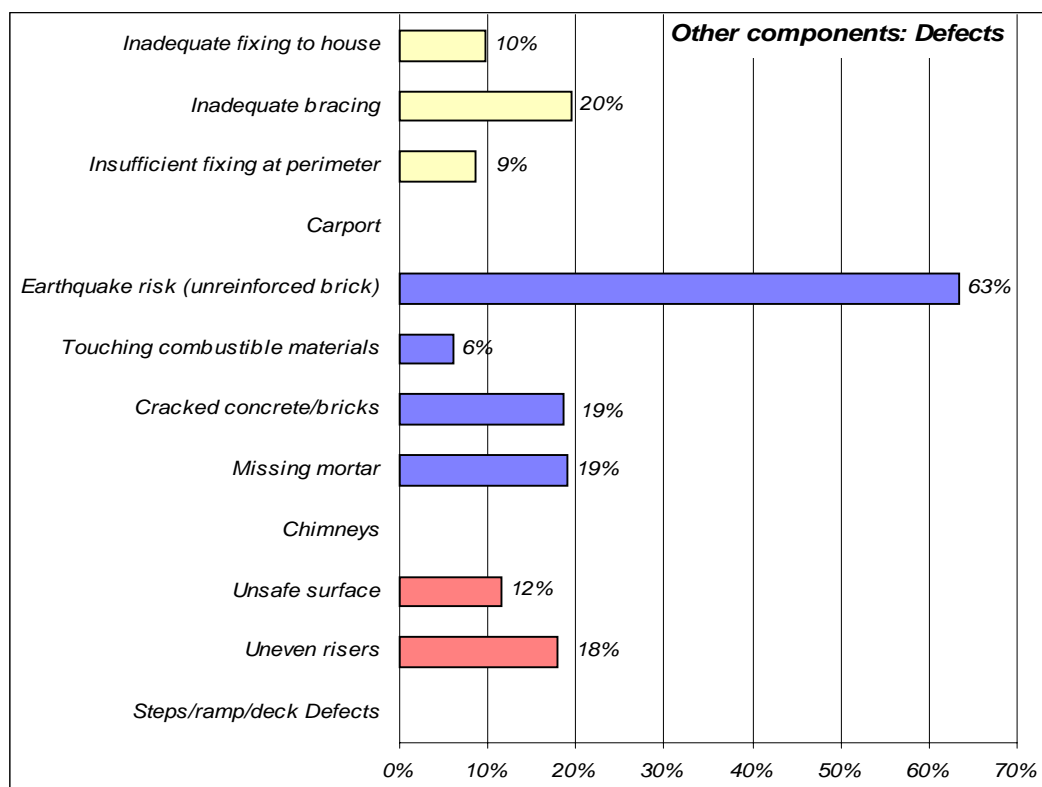
**Figure 38: Defects in Other Components**

As shown later in *Figure 38: Defects in Other Components*, the major defects found in carports were inadequate bracing (in around 20% of those surveyed), and inadequate fixings at perimeters and/or to the house (around 10%).

As shown later in *Figure 38: Defects in Other Components*, the major defects were uneven risers to steps (almost 20% of those inspected), and unsafe surfaces (more than 10%). The latter was usually a result of unevenness or slipperiness.

Figure 38 covers the common defects identified in these other components. The light shaded areas relate to carports, while the darker relates to chimneys.

The main point worth noting is that the highest level of defects in chimneys are generally associated with unreinforced brick chimneys in older houses. While these chimneys were in line with building practices of the time (and are often still in good condition), they do not meet current earthquake standards and are likely to be unsafe in a major earthquake. Many of the oldest also use lime-based mortar that has a tendency to crumble with age. This relates to the high percentage of cases (almost 20%) where chimneys were missing mortar, so creating potential fire hazards. The incidence of cracked concrete or bricks<sup>39</sup> is also high (almost 20%), and this can also be a potential fire hazard.

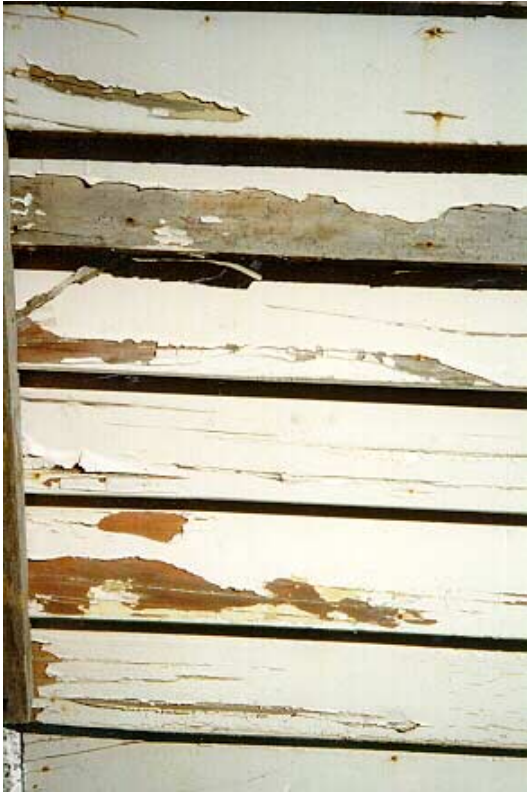
*15 Left: Deterioration of paintwork on 1930's Christchurch house. Cladding has rusting nails, major splitting of boards and severe borer.*

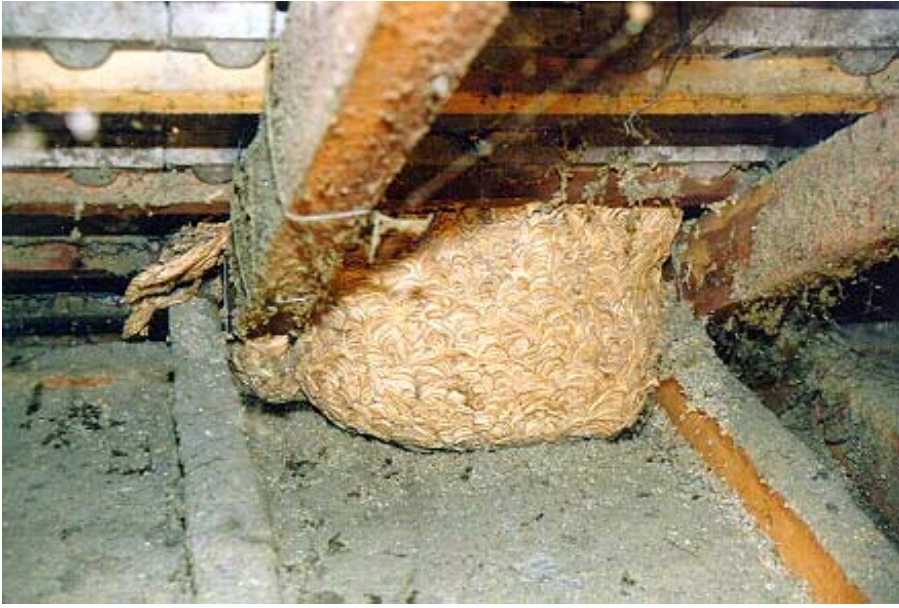
27 Above: *Wasps' nest.*

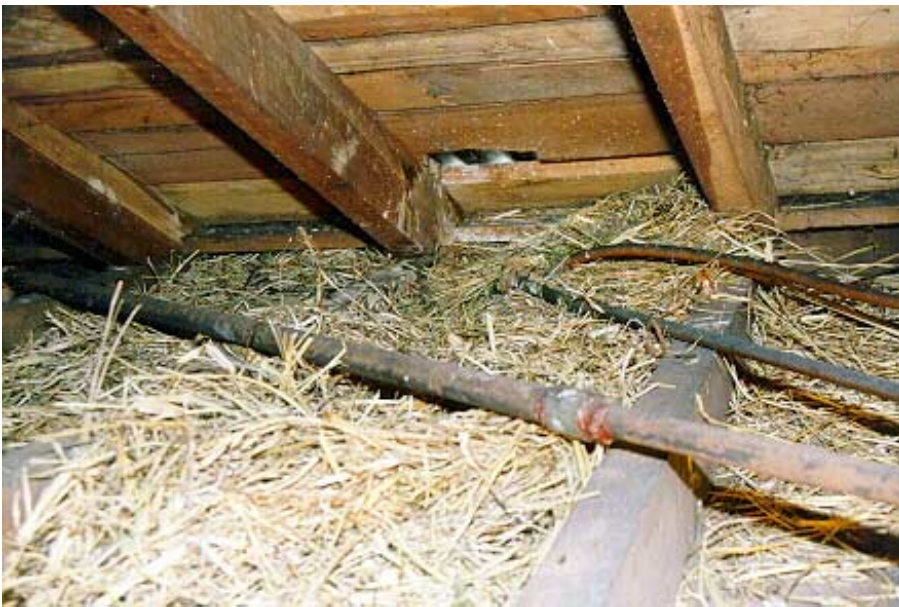
28 Above: *Birds' nests.*

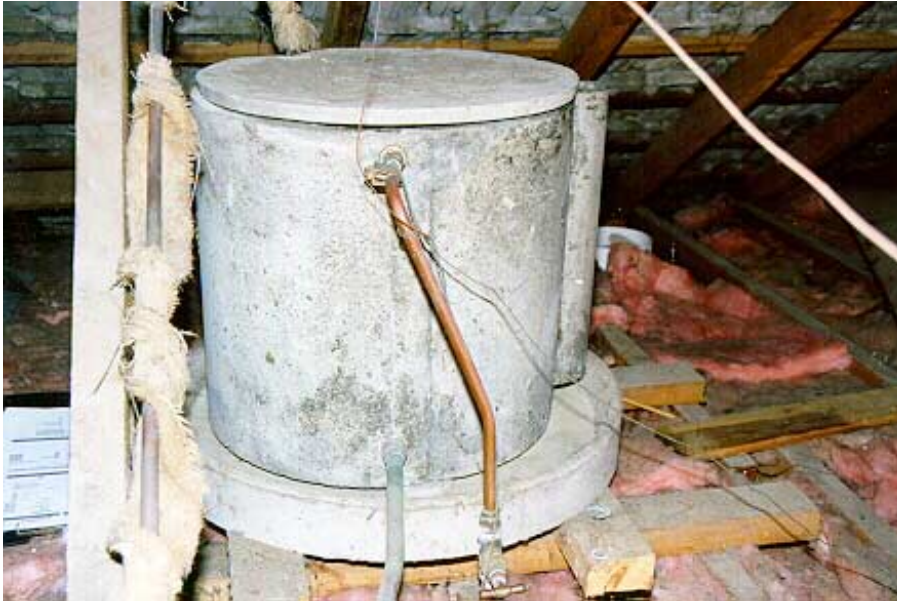
29 Above: Heavy concrete header tank not restrained against earthquake movement (note also the state of the pipe lagging and ceiling insulation).

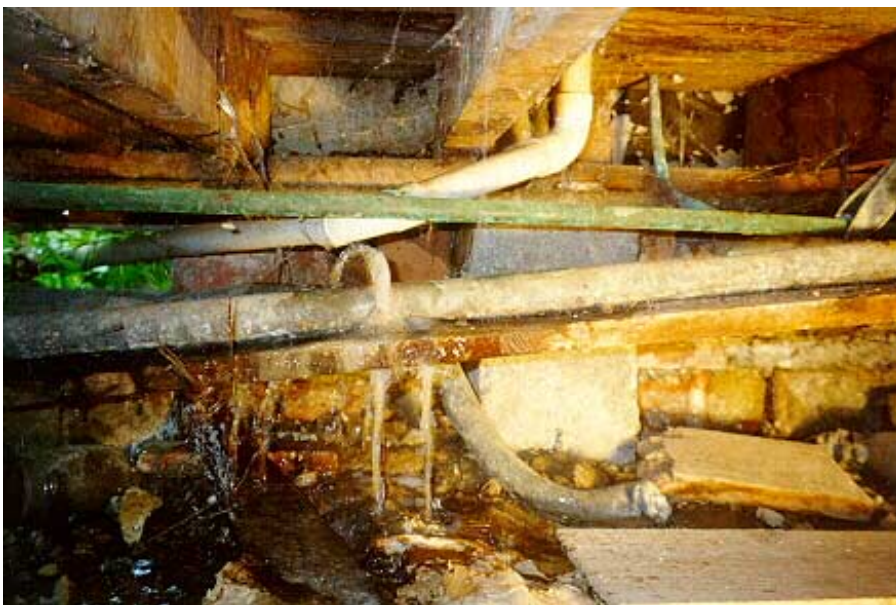
*34 Below: Deterioration in 60 year old lead waste pipes lead to undetected discharge into subfloor space. Unable to detect how long pipe had been leaking, but moisture levels were high and the native timbers were heavily infested with borer.*

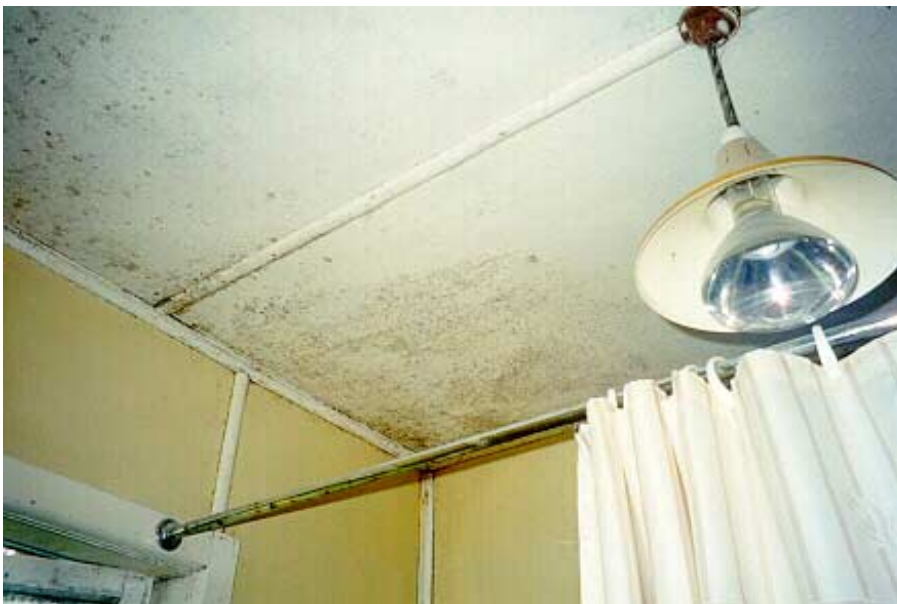
45 Above: Lack of bathroom ventilation causing high levels of mould and mildew on painted hardboard linings.
