# STUDY REPORT

No. 123 (2003)

## Repair and Reinstatement of Earthquake Damaged Houses – Derivation of Repair Techniques – Phase II

G.J. Beattie

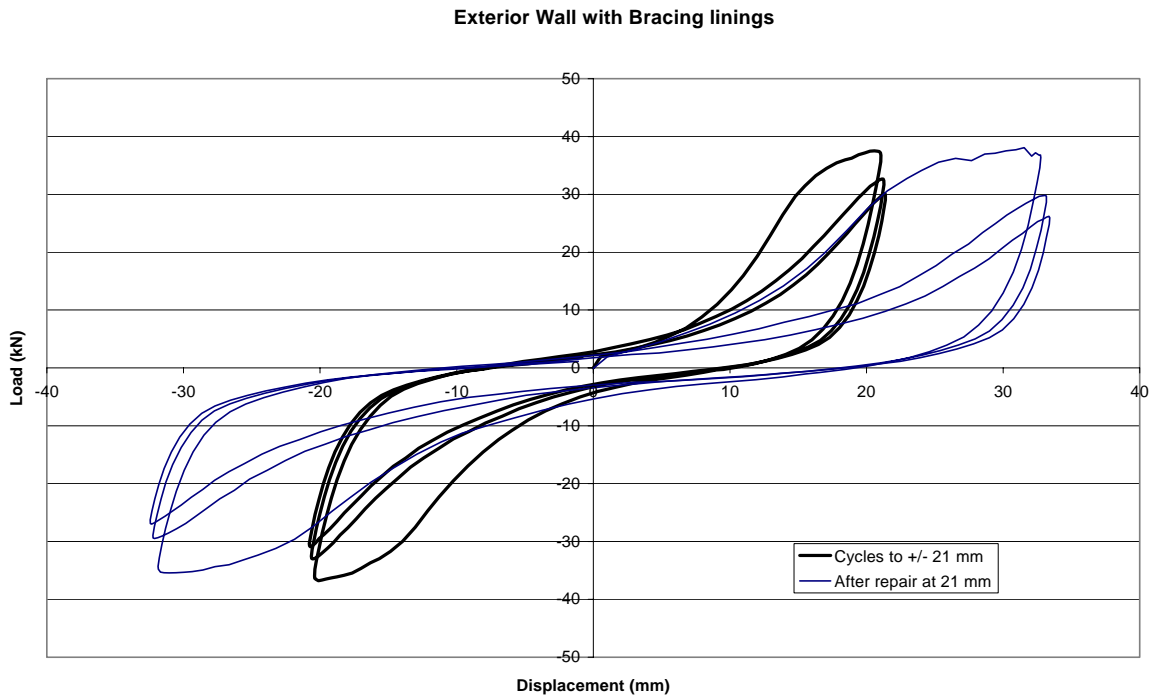
Re-fixing of the sheets beneath the skirtings and the scotias was undertaken and the specimen was cycled to  $\pm 32$  mm. During the first cycle to 32 mm, as the displacement reached 21 mm the resistance climbed to the same level that it was during the third cycle to this displacement before the repair, indicating that the repair had improved the strength (Figure 12). However, the

'pinched' nature of the loops (i.e. large displacements before load increases) meant that the wall was still quite flexible, despite the repair having been undertaken.

**Figure 12: Load – displacement plot before and after repair at 21 mm**

It is therefore recommended that if internal wall linings are showing fresh signs of damage (e.g. new cracks at the junctions with skirting boards and scotias, nail popping and cracking on joints between sheets), the skirting boards and scotias be removed and the sheets be re-fixed at 150 mm centres along both the top and bottom edges.

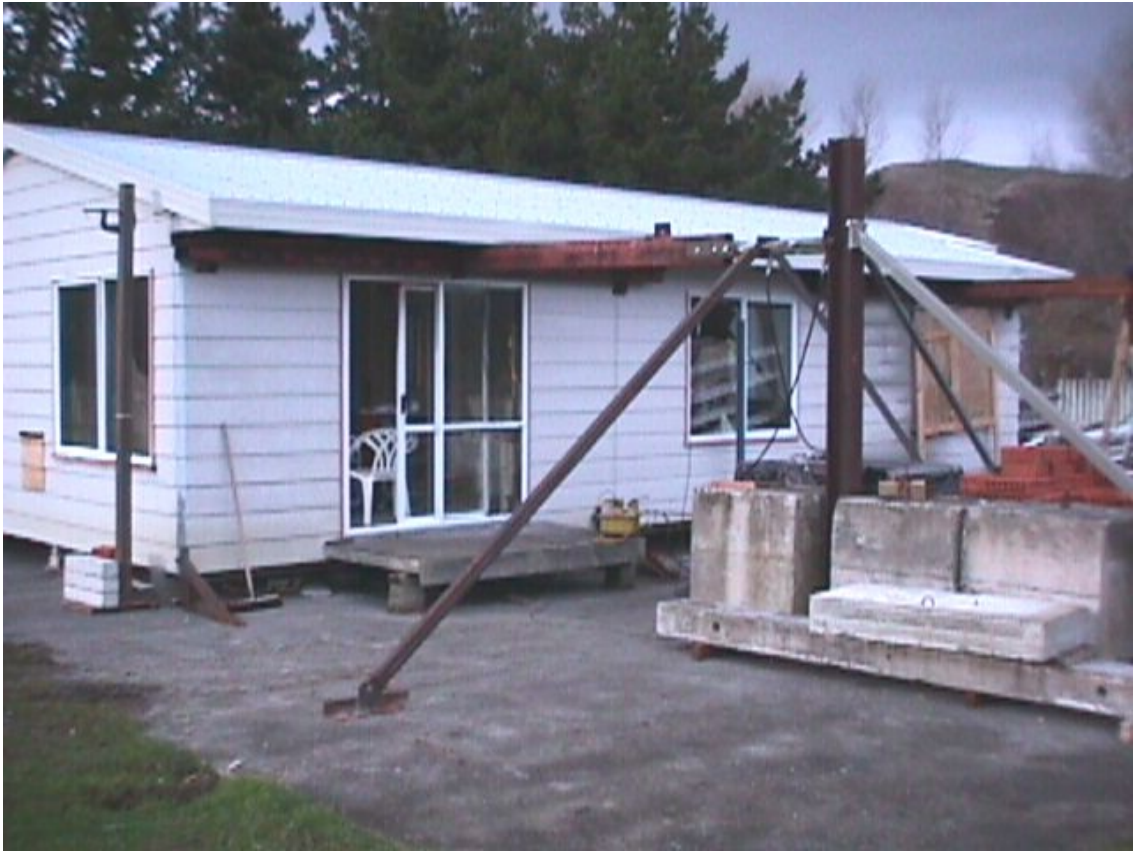
An opportunity arose to attempt to straighten a house at the BRANZ site that had been pushed out-of-plumb in an earlier research project. The structure was a single storey dwelling with a corrugated galvanised steel roof and fibre-cement weatherboards and was supported on a pile foundation (Figure 13).

The house had been displaced in the transverse (short) direction at the eaves level in a previous research investigation and was left with a permanent offset at eaves level. The aim of the testing

**Figure 13: House to be plumbed (aligned vertically)**

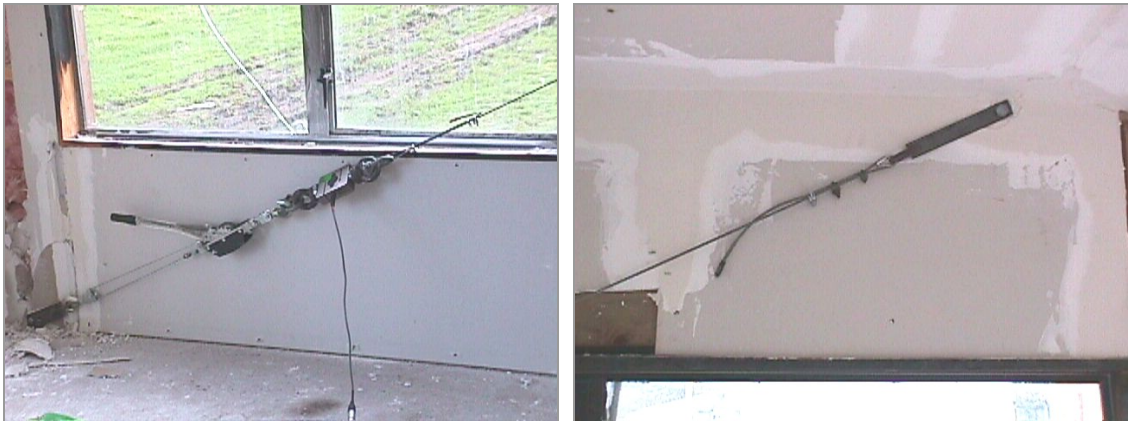
First, an attempt was made to realign Wall 1 using a light wire rope and ratchet winch (commonly available from a builder's merchant) fitted across the long diagonal of the wall while the internal linings were still in place (Figure 15). A light gauge (3 mm thick) steel plate at each end of the rope was attached to the top and bottom plates of the wall with a 12 mm diameter coach screw. The rating of the ratchet winch was 2 tonne, but it was found that no more than a 700 kg force was able to be applied before the winch began to distort within itself.

**Figure 15: Light wire rope tensioning device and remote end connection**

At a load of 700 kg, it was possible to pull Wall 1 towards a vertical orientation (but not all the way), and on release of the load the displacement increased again.

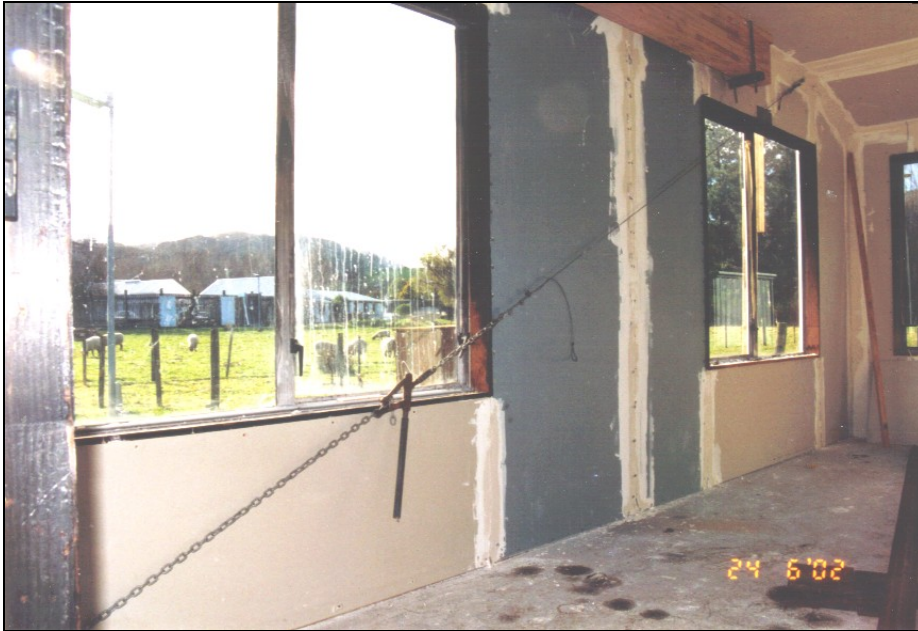
Wall 1 was then loaded on the same diagonal with a wire fence strainer (Figure 16), but the loading mechanism was too coarse and did not allow easy increase of the load. A 700 kg force was again the maximum that could be achieved.

**Figure 16: Wire fence strainer used to try to re-align the wall**

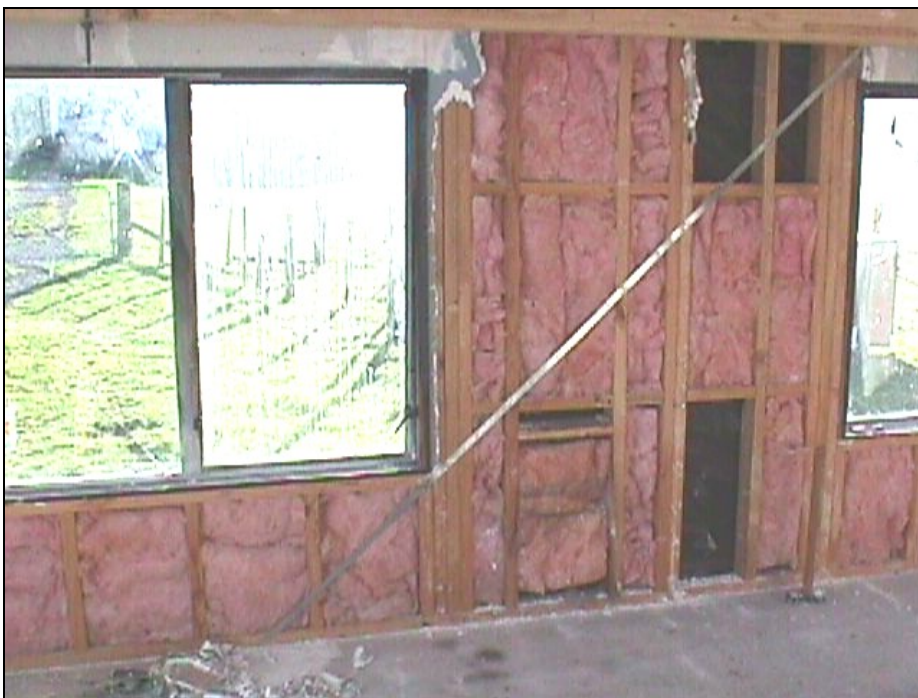
It took a 3 tonne capacity 'cum-along' rigger's hoist loaded to its capacity attached to the exterior of the house in the region of Walls 1 and 2 to pull the walls 11 mm past vertical. Once that stage had been reached, a light gauge steel strap brace was fixed to Wall 1 with 35 x 2.87 mm diameter nails (Figure 17) before the externally applied load was removed. The house relaxed, but remained in a close to vertical orientation. The problem with employing this procedure after an earthquake is that there is not likely to be a suitable reaction point remote from the house, and also significant damage would be caused connecting to the house.

**Figure 17: Light steel strap brace (was fixed to Wall 1 while pulled to a position beyond vertical)**

From the observed response, it would seem that the plasterboard ceiling, and possibly the roofing to a lesser extent, were providing an effective load transfer mechanism between walls. To realign a whole house in a simple manner it will be necessary to load all parallel walls at the same time so that any elastic resistance can be overcome. If this does not work, it may be necessary to remove the wall linings before loading and installing metal strap braces to hold the frame in position to maintain alignment before adding new linings.

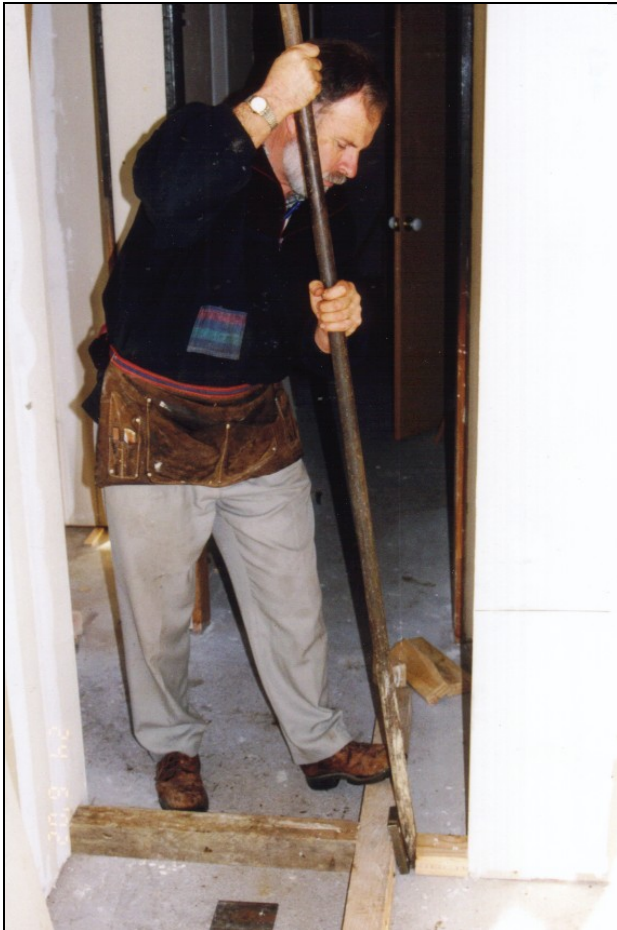
The only requirement for fixing the bottom plates of internal walls of a house that are not bracing walls and are not load bearing walls is two 100 x 4 mm nails at 600 mm centres along the plate. It is likely that such walls will move longitudinally with respect to the flooring during an earthquake because these nail pairs will not be able to resist the earthquake forces. In this house, Wall 2 was one such wall and it translated approximately 20 mm along the floor as a rigid body. To restore this wall to its original position, two methods were attempted. The first of these involved nailing a block to the floor nearby to the end of the wall in question and using a crow bar to lever the bottom plate back into place (Figure 18). This method was only mildly successful. The wall could not be moved far before the block began to prise off the floor.

**Figure 18: Re-aligning Wall 2 with a crow bar**

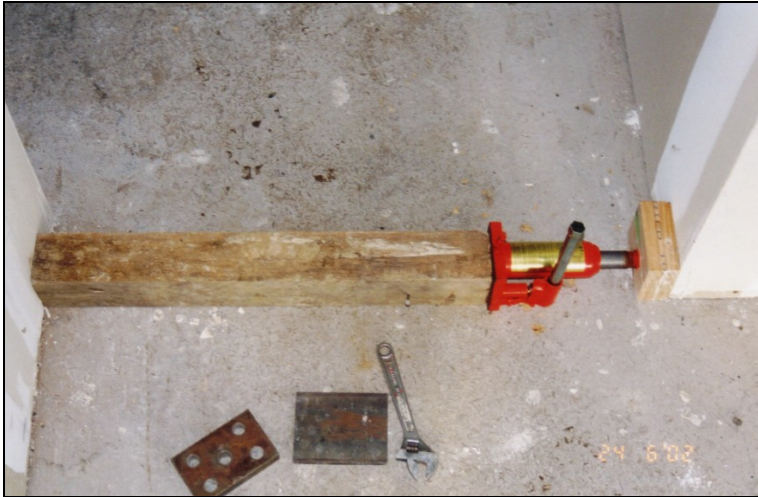
A 2 tonne capacity car bottle jack was introduced to provide the necessary push to return the wall to its original position. The reaction to the jack load was provided once again with the timber block nailed to the floor, but this was also propped against a wall on the opposite side of the hallway and another block was nailed to the floor on the other side of that to provide the necessary reaction strength. As Wall 2 was moved to its original position the bottom plate of the wall (which was a 70 x 45 member) buckled quite significantly out of the wall plane and the bottom plate of the adjacent orthogonal wall also showed signs of misalignment (Figure 20). Further jacking would have been required further along this wall to straighten the plate. Wall 2 would have required temporary lateral guides to prevent out-of-plane buckling during the house realignment process.

**Figure 19: Car bottle jack used to translate the wall**

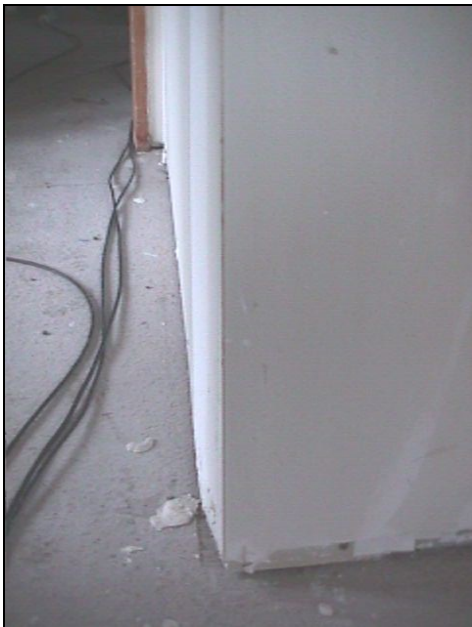
**Figure 20: View showing misalignment of the plate in the orthogonal wall**
