# **STUDY REPORT**

**No. 158 (2006)**

## **Repair and Reinstatement of Earthquake Damaged Houses – Phase III**

**G J Beattie**

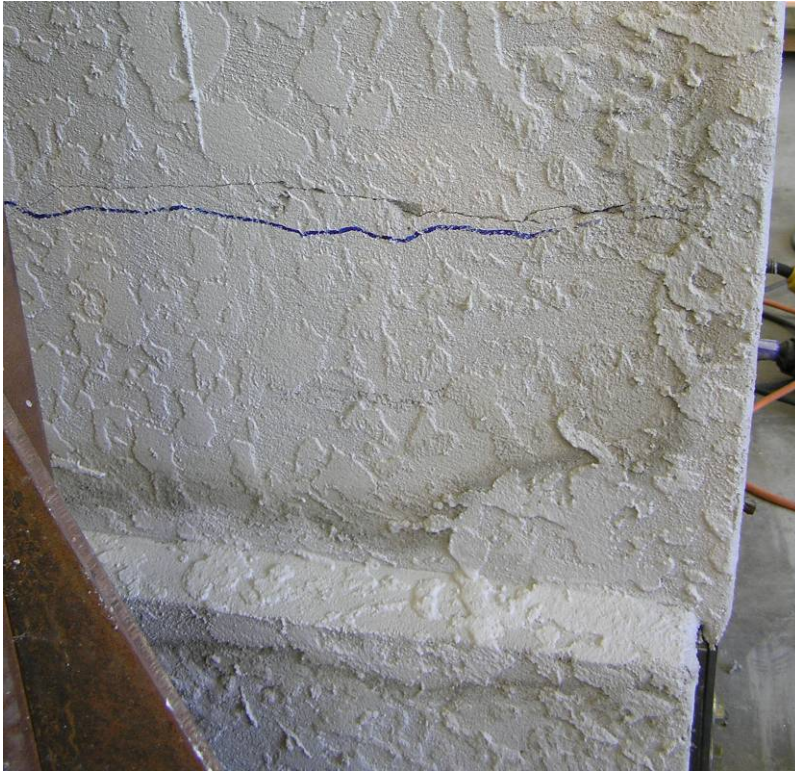
Repairs were undertaken on the stucco joint at the foundation and at the ends and top corners of the wall. At the junction with the foundation, the loose plaster was chipped and raked out (Figure 7) and new plaster was applied (Figure 8). At the corners, new mesh was added where the old mesh had been damaged. No other repairs were undertaken on the finer cracks in the body of the wall. A good match was achieved between the old rough cast pattern and the new pattern (Figure 9). Some staining is visible in Figure 9 at the interface of the old and new plaster, but this would be easily covered by new paint.

**Figure 9: Good match of cured repair plaster with old plaster**

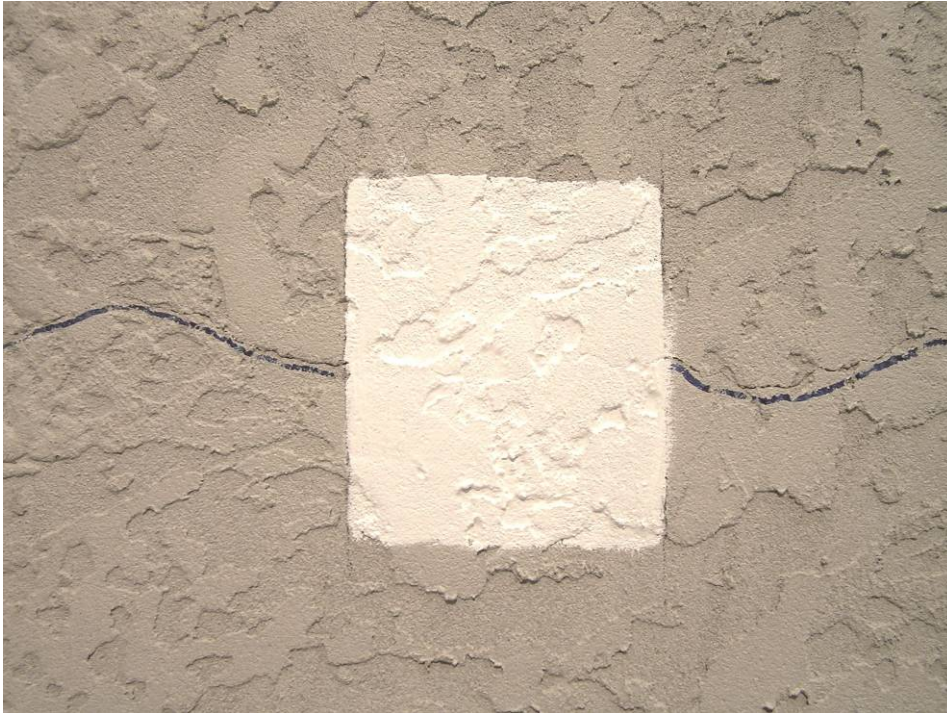
Fine cracks, less than 0.5 mm wide, may be adequately repaired by painting over with a flexible acrylic paint. The sequence of photographs in Figure 14 show an example crack before the application of paint, after the application of an acrylic primer undercoat (white), and after the application of a top coat of acrylic paint (grey).

**Figure 15: Crack after the application of the undercoat**

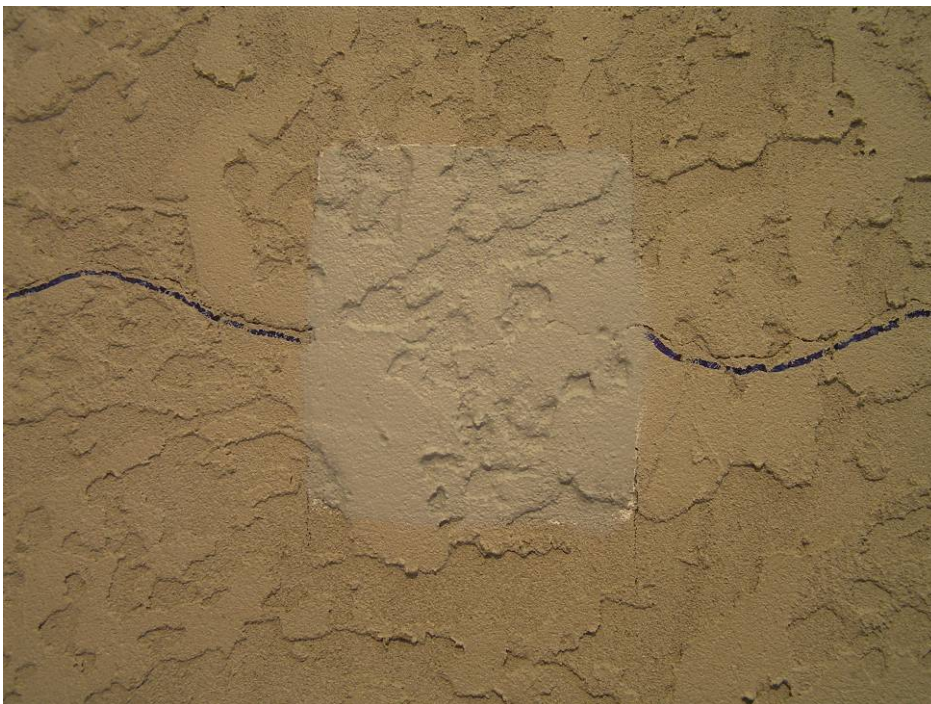
**Figure 16: Crack after application of the top coat**

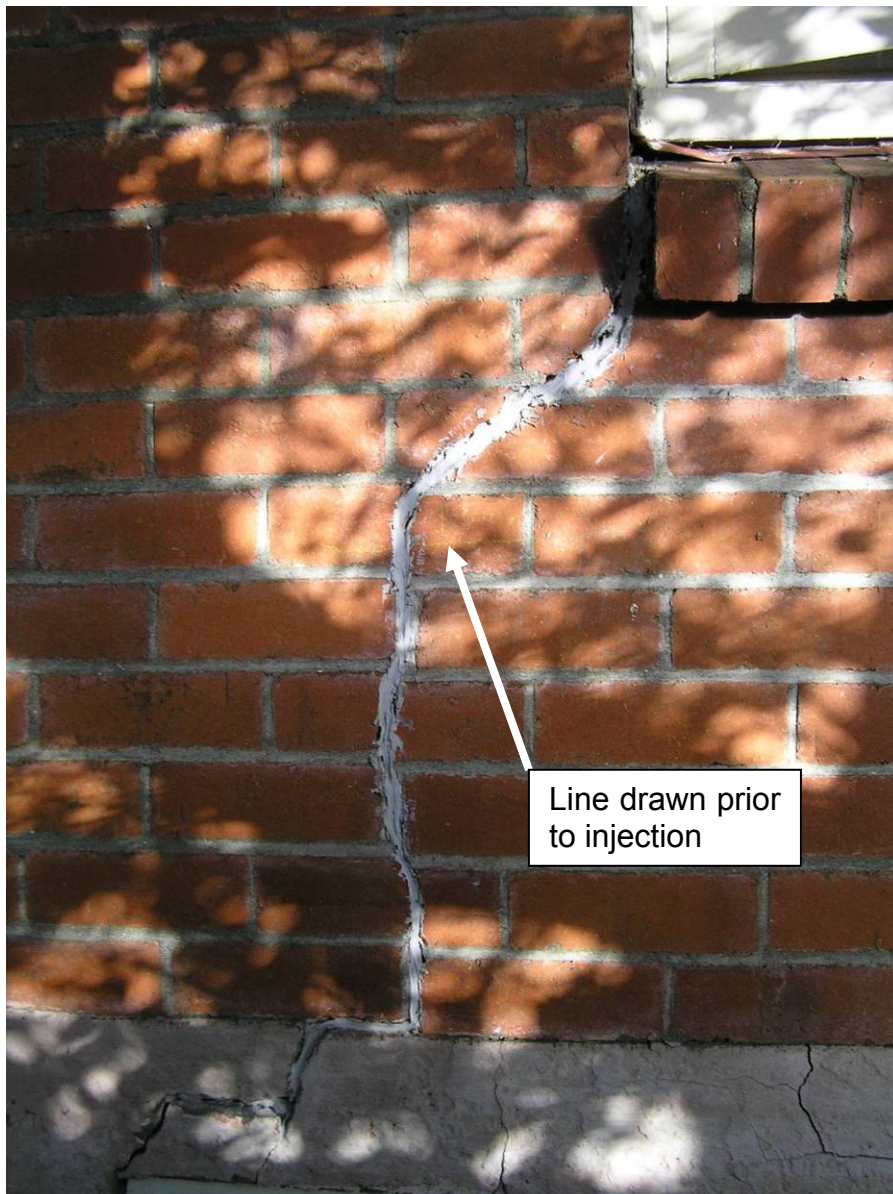
The crack and misalignment were clearly visible at the time of the BRANZ visit. This indicated that the foundation had not been lifted to a level state. This requires some qualification, however. The intersection of an addition to the front of the property, constructed after the corner had settled, would have been damaged had the wall been fully lifted. The owner also advised that more product could have been injected than was, but he had authorised the injection crew to stop because of the extra cost that would be involved. A horizontal line had been drawn across the crack before the injection commenced and the owner advised that there had been a definite difference in level between the two halves when the injection was complete. At the time of the BRANZ visit, the two halves had aligned again (Figure 38), suggesting that possible settlement had occurred since the injection work.

**Figure 38: Line drawn at the time of injection**
