STUDY REPORT

SR0265 (2012)

Effect and Remediation of the Loss of Building Lateral Stiffness Caused by Earthquake Loading

SJ Thurston

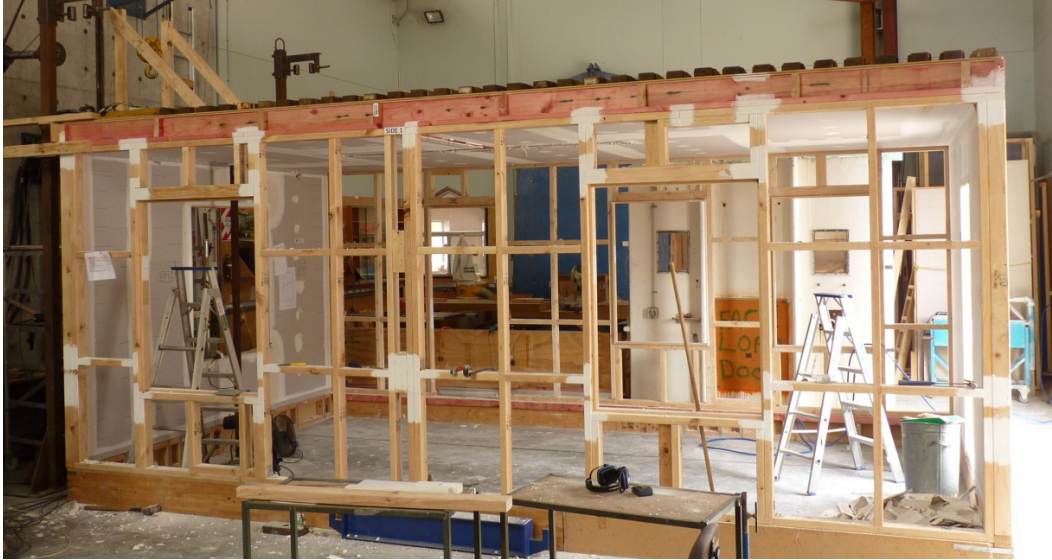
Figure 5 Construction for Phase 6

The internal walls were removed and the plasterboard removed from Side 1 and Side 2 as shown in Figure 5.

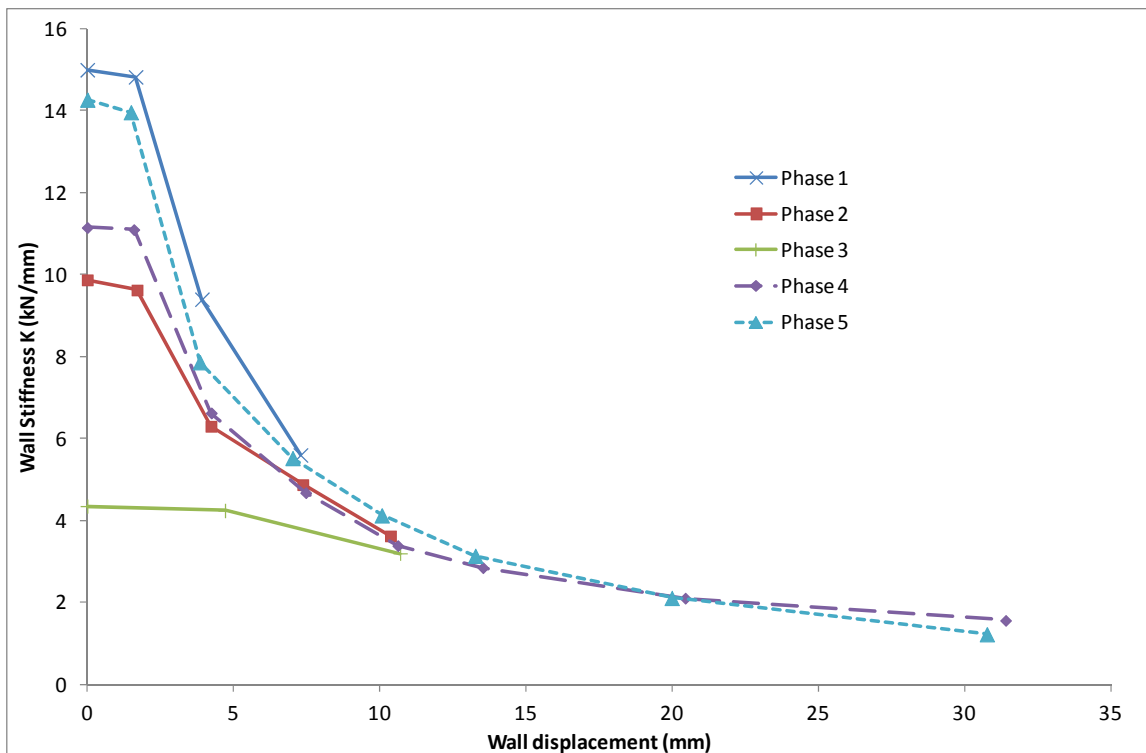
Figure 7 Change in building stiffness with degree of building racking for each test phase

Figure 7 plots the change of building stiffness with building deflection for each Test Phase. Values are also summarised in Table 3. In all cases building stiffness drops rapidly with increased wall deflection. Comments on Figure 7 are:

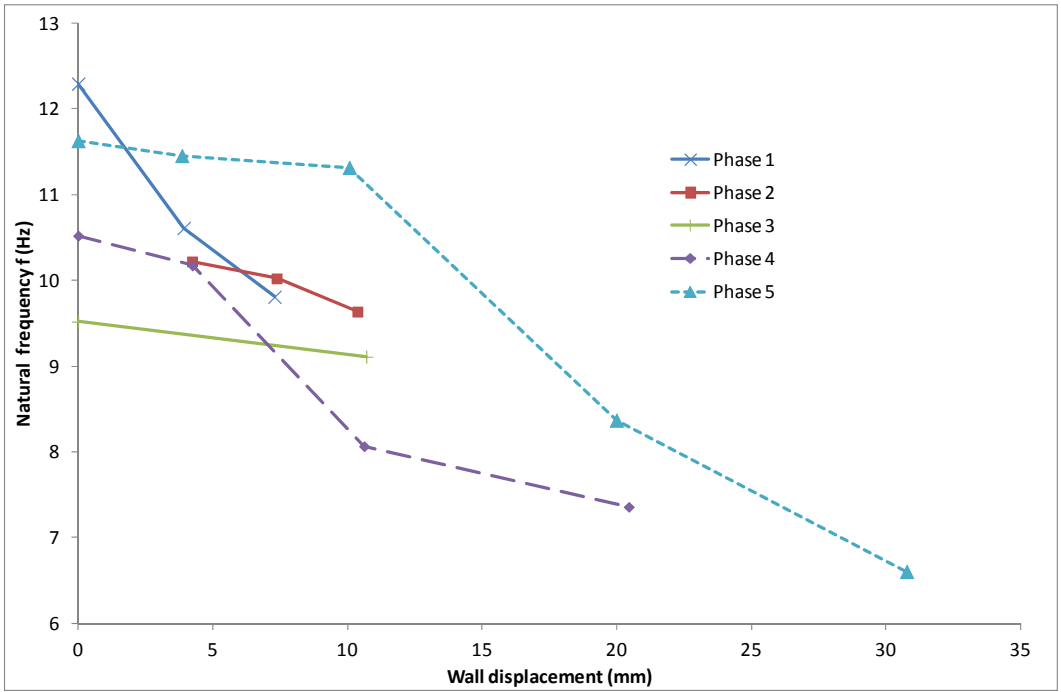
Figure 8 Change in building natural frequency with degree of building racking for each test phase

Figure 8 plots the change of building natural frequency with side wall deflection for each Test Phase. Values are also summarised in Table 3. In all cases the building natural period reduces with increased deflection. Comments are:

- Phase 5 results generally show greater natural frequency values at corresponding deflections than the other test results indicating that the repair strategy was successful.

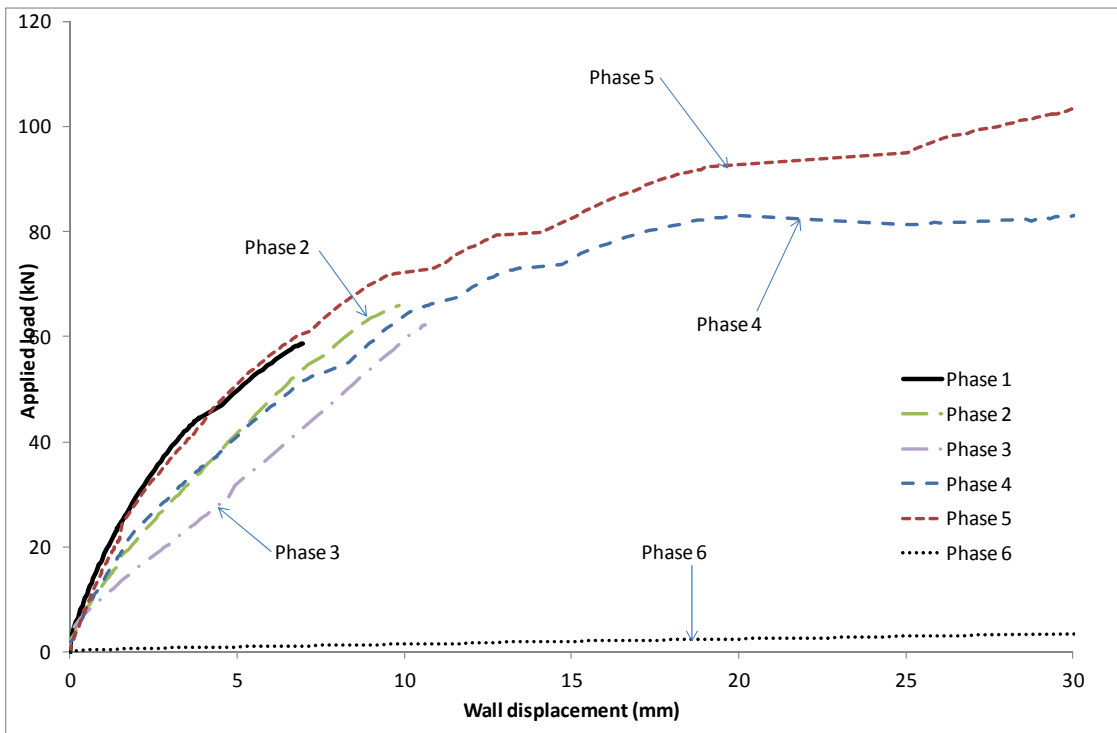
Figure 11 Comparison of backbone curves from each test phase
(Refer to Table 2 for Phase description)

A comparison of the backbone curves for each Test Phase is given in Figure 11. Figure 11 indicates the Phase 5 repair fully reinstated the building load versus deflection behaviour. Phases 2 and 4 show a moderate drop from Phase 1, but the difference is not large.

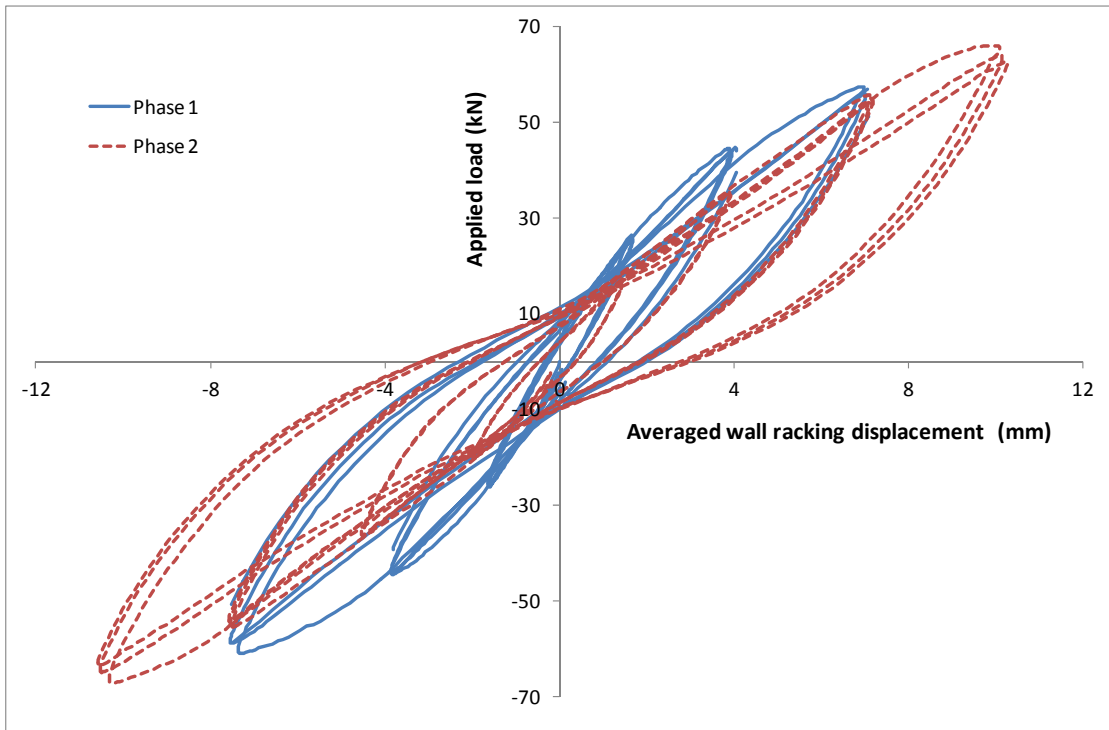
Figure 12 Comparison of hysteresis loops for Phase 1 and Phase 2

Figure 12 compares the hysteresis loops for Phase 1 and 2. These show almost identical loops for displacements up to 7.3 mm. Greater displacements up to 10.4 mm were applied in Phase 2 and the loops for these are consistent with the notion that the cosmetic repair prior to Phase 2 had been effective.

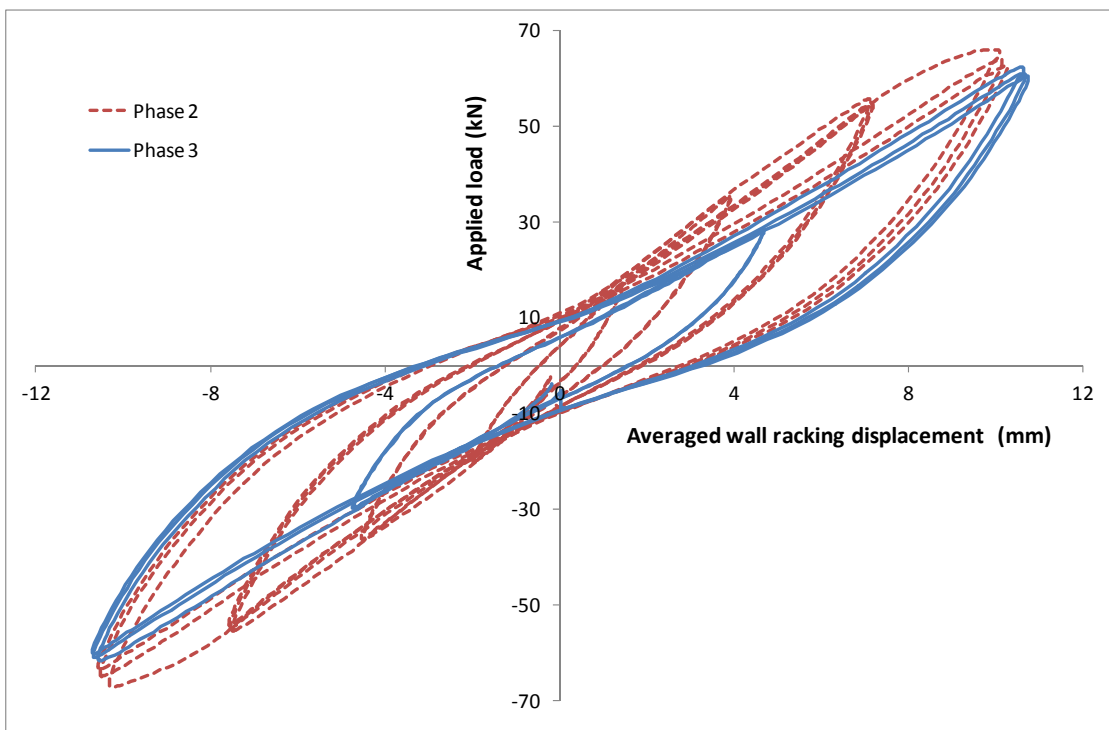
Figure 13 Comparison of hysteresis loops for Phase 2 and Phase 3

Figure 13 compares the hysteresis loops for Phase 2 and 3. The Phase 3 loops at the maximum displacement match what would have been expected if additional cycles had been performed with Phase 2. The results are thus consistent with the notion that the glue fixings had added little to the building stiffness or strength.

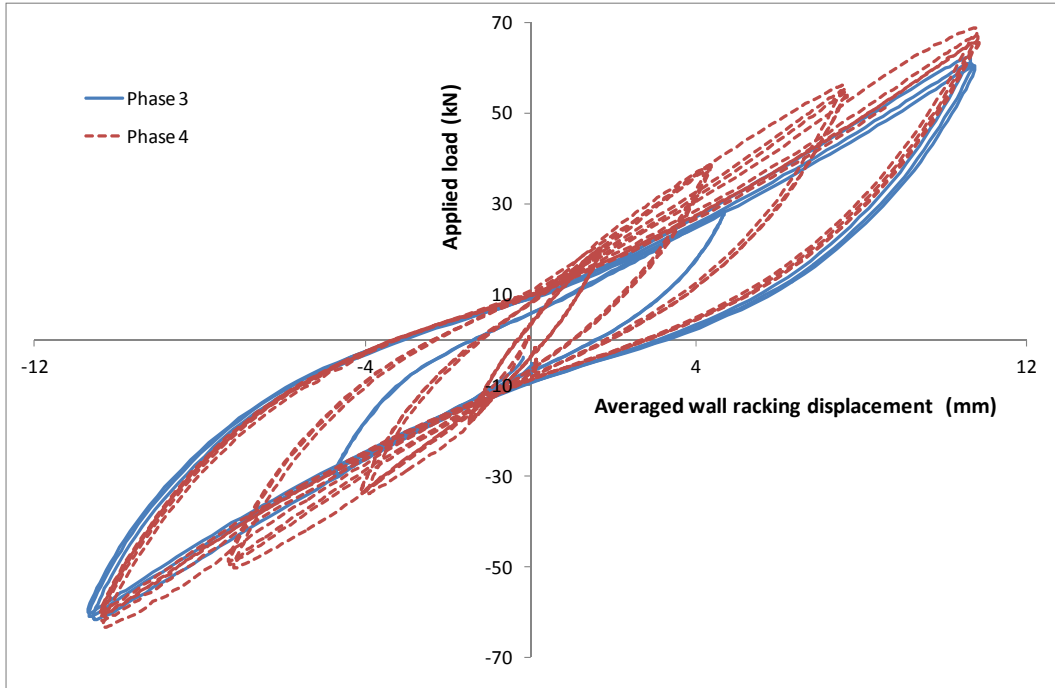
Figure 14 Comparison of hysteresis loops for Phase 3 and Phase 4

Figure 14 compares the hysteresis loops for Phase 3 and 4. These indicate the Phase 4 strengthening had added little to the building strength.

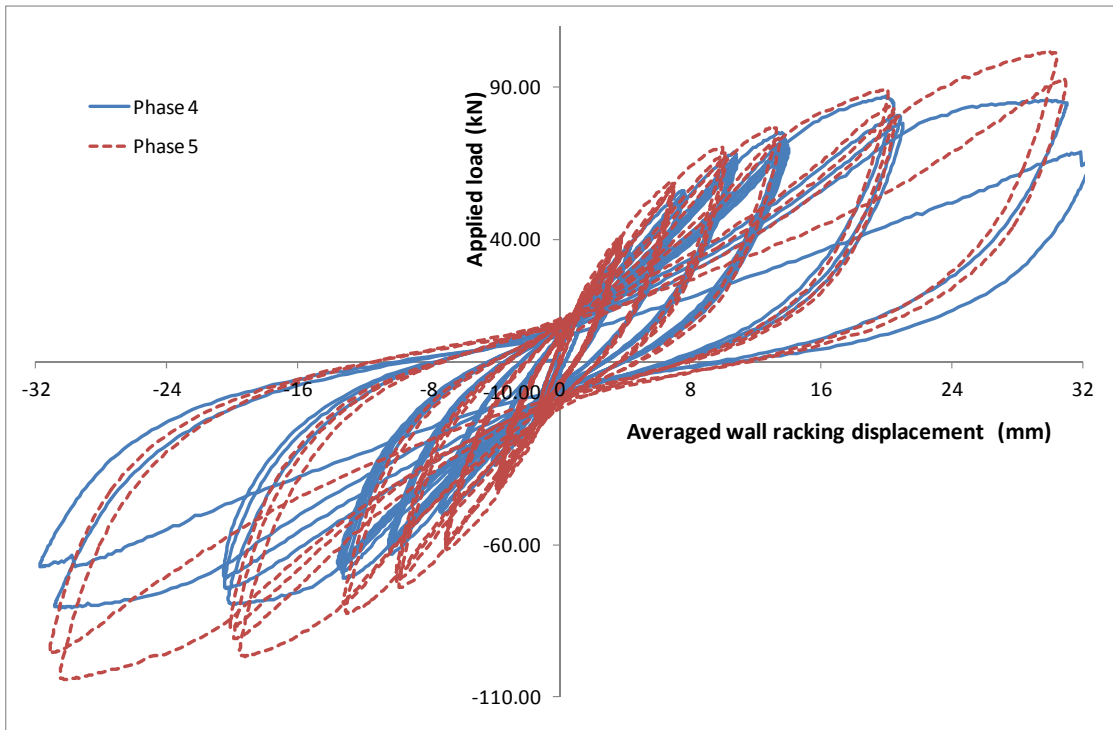
Figure 18 Comparison of hysteresis loops for Phase 4 and Phase 5

Figure 18 compares the hysteresis loops for Phase 4 and 5. The Phase 5 loops show a moderate improvement over Phase 4.
