STUDY REPORT

SR 316 (2014)

New housing condition – A preliminary assessment

I C Page

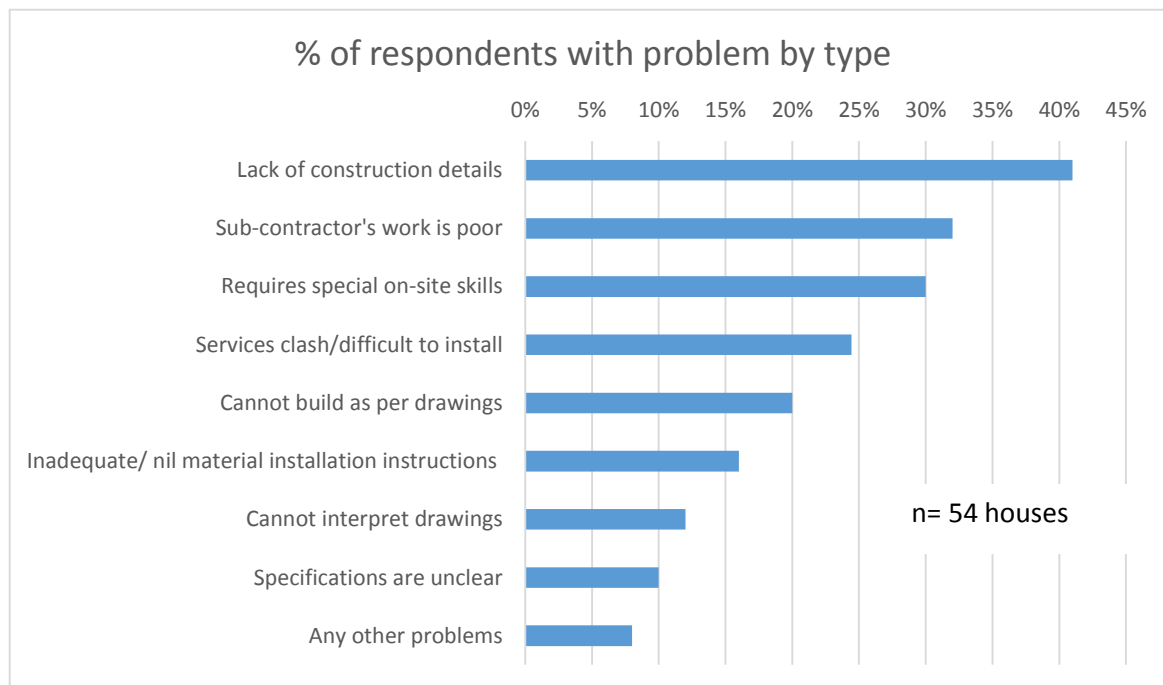
Figure 6 Problems areas by frequency

In addition to on-site inspection a postal survey was sent to builders asking about their problem areas in constructing new houses, see Figure 9 in the appendix. A list of problems was provided and respondents ticked those they have experienced in the last year on their housing projects. See Figure 6 for the results.

Over 40% of respondents had issues with lack of construction details. The results by component are in Figure 7 and indicate the difficult or problem areas are roof and wall flashings (i.e. window and door openings), with over 55% of respondents having issues.

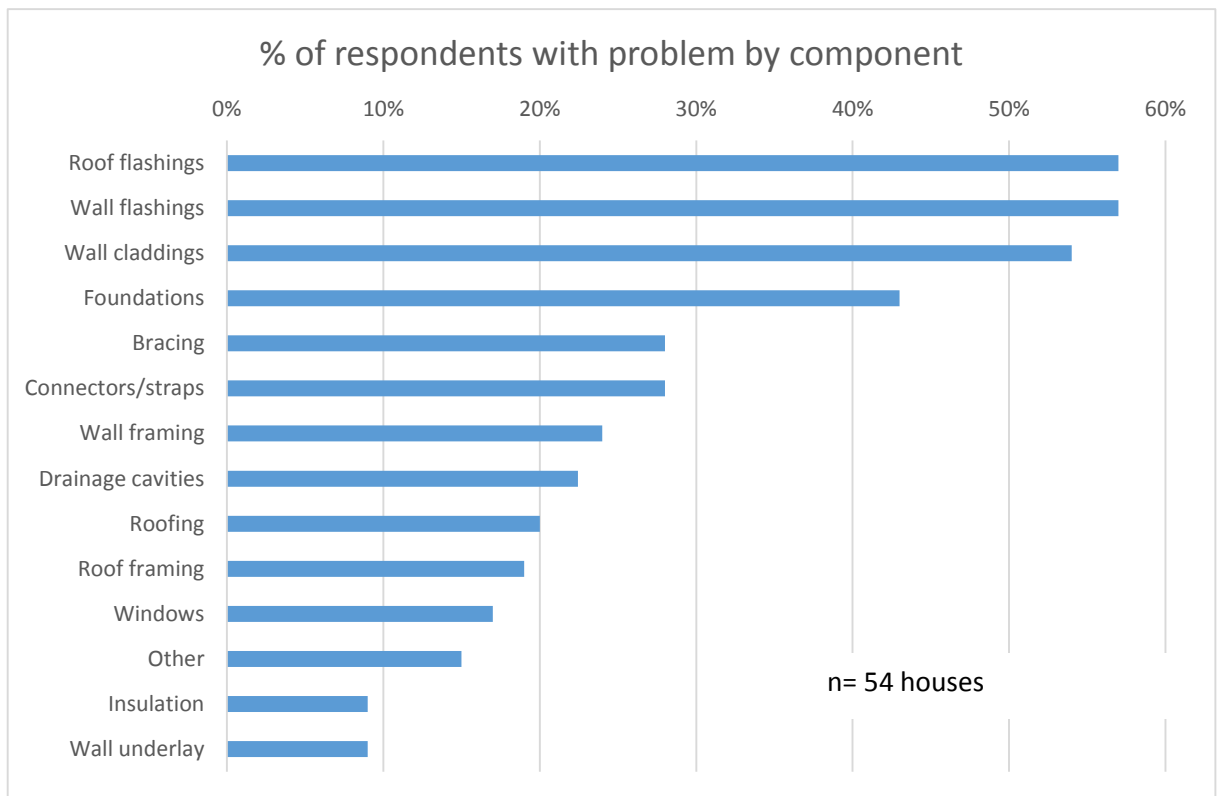
Figure 7 Problem areas by component

The most mentioned problem areas, flashings and wall claddings, are similar in ranking to those from the house inspections. The postal survey asked for builder's experience over a year and it shows that over 50% of builders had problems with these components over that time.
