STUDY REPORT

No. 142 (2005)

NEW ZEALAND 2005 HOUSE CONDITION SURVEY

Susan J. Clark, Mark Jones
&
Ian C. Page

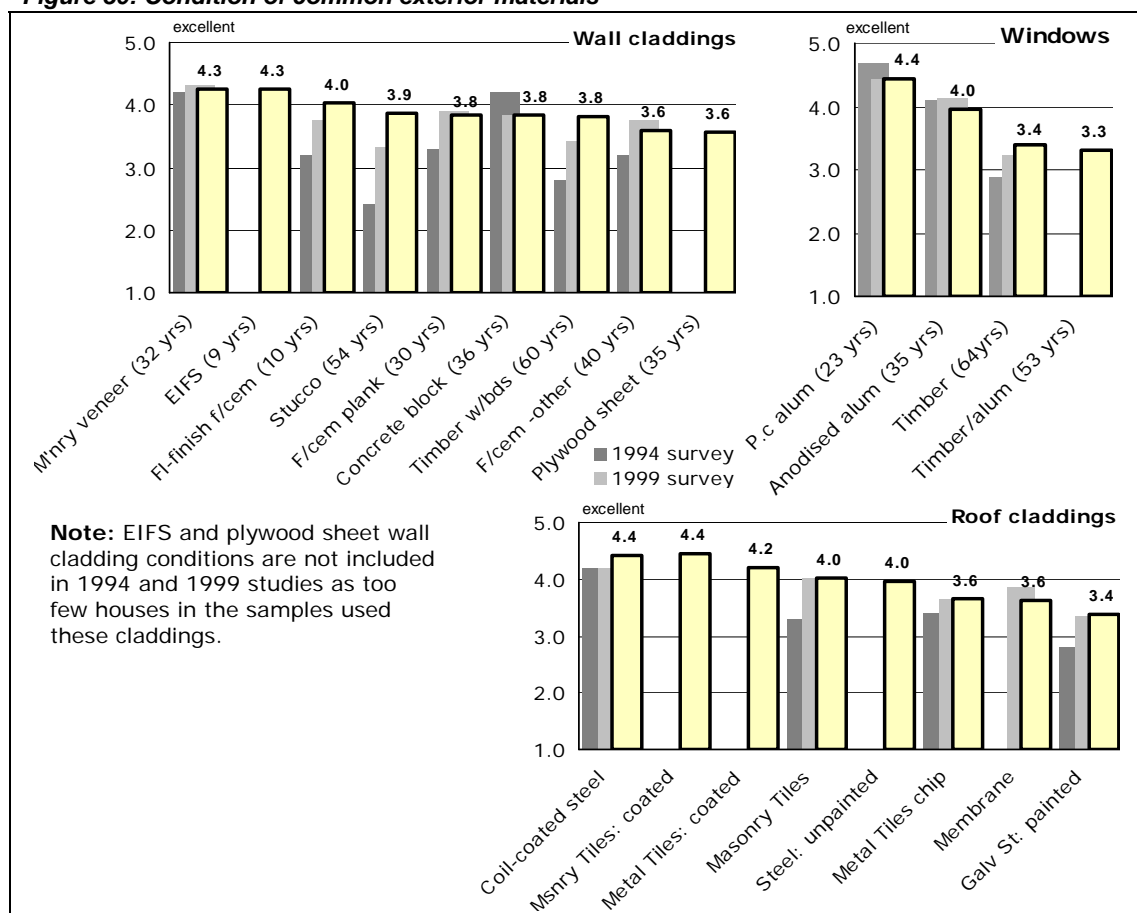
Figure 30: Condition of common exterior materials

The average condition of all of the more common materials identified by the inspectors has been calculated, and this is shown in Figure 30 together with the equivalent figures for the 1999 and 1994 surveys. Full tables, including condition ratings for regions, are provided in Appendix 16.1.1.

For most materials, the average condition was similar, to or better than, that shown in the past surveys. Timber weatherboards and stucco had improved. However, stucco was used in only 5% of houses (of varying ages) in the 2005 survey so caution should be used when assessing results.

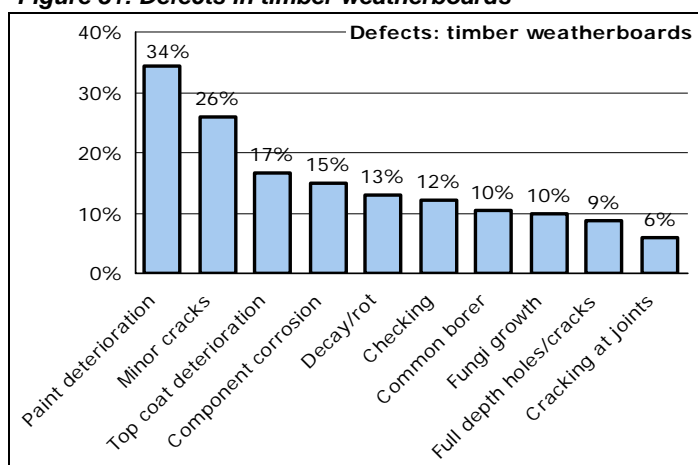
Figure 31: Defects in timber weatherboards

Timber weatherboards were used in more than 60% of houses, and had the oldest average age of 60 years with one of the lower average condition ratings at 3.8. Figure 31 shows the most common defects found in timber weatherboards, and Figure 32 shows the frequency that these defects occur, indicating the level of severity.

As expected, the most common defect, with the most frequency, is paint deterioration. Minor cracks are also common. Corrosion of metal fixings and other components is common, particularly in coastal areas. Decay and

rot, while reasonably common, was usually of low frequency – as was borer.

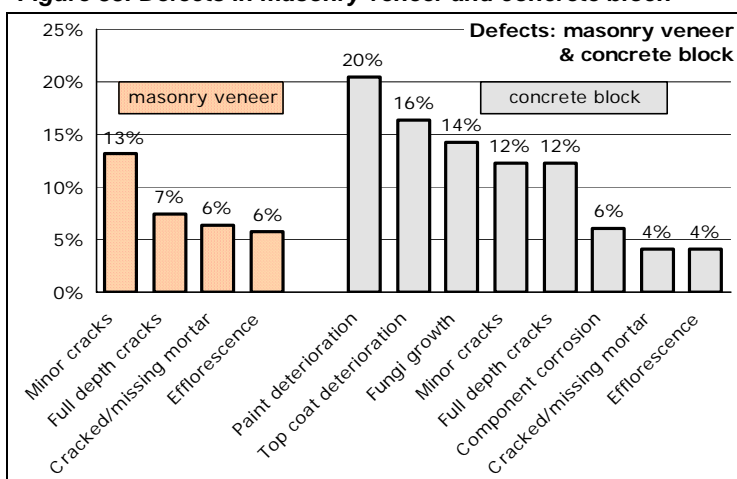
Figure 33: Defects in masonry veneer and concrete block

The most common defects for both of these materials are shown in Figure 33. This shows the percentages of masonry walls that exhibited the defects noted.

The main defects in masonry veneer are related to mortar problems, while those in concrete block tend to be cosmetic defects such as paint or topcoat deterioration and fungi growth.

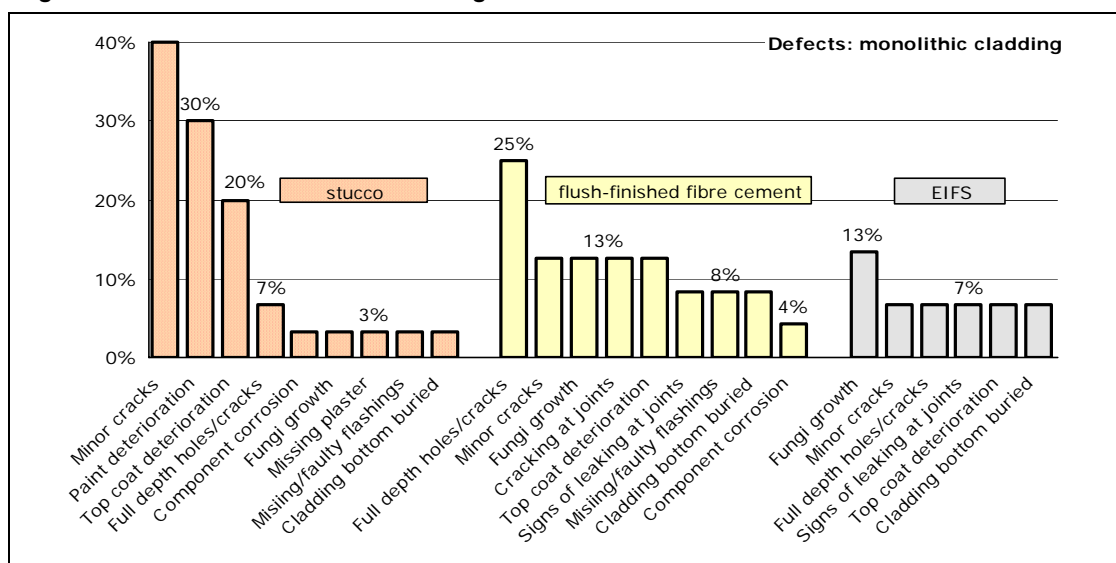
Figure 34: Defects in monolithic claddings

Monolithic wall claddings comprise stucco, flush-finished fibre-cement sheet and EIFS, and defects found in these claddings are shown in Figure 34.

The apparent condition of EIFS and flush-finished fibre-cement sheet was high, reflecting an average age of 10 years or less. Stucco was used mainly on old houses in the survey, reflected in the average age of 54 years. However, the condition still appeared to be high, at an average of 3.9.

It should also be noted that the condition of monolithic cladding may be difficult to assess, as the surface appearance can conceal underlying faults that are not readily apparent without in-depth investigation. Condition ratings should therefore be treated with some caution.

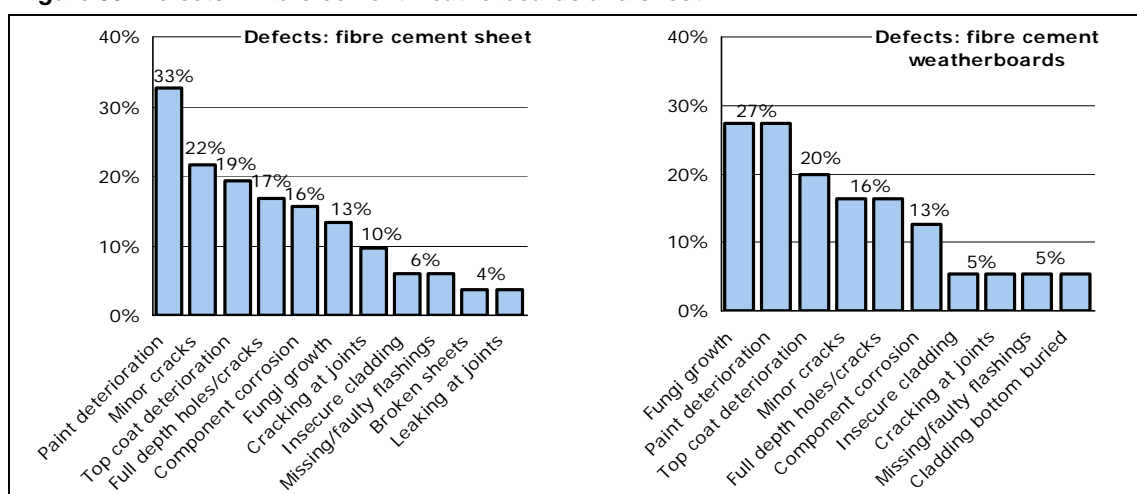
Figure 35: Defects in fibre-cement weatherboards and sheet

Fibre cement weatherboards (with an average age of 30 years) and other older-style fibre-cement sheet claddings (with an average age of 40 years) were common on surveyed houses, together comprising a total of 25% of wall claddings. The defects in other fibre-cement claddings are shown in Figure 35.

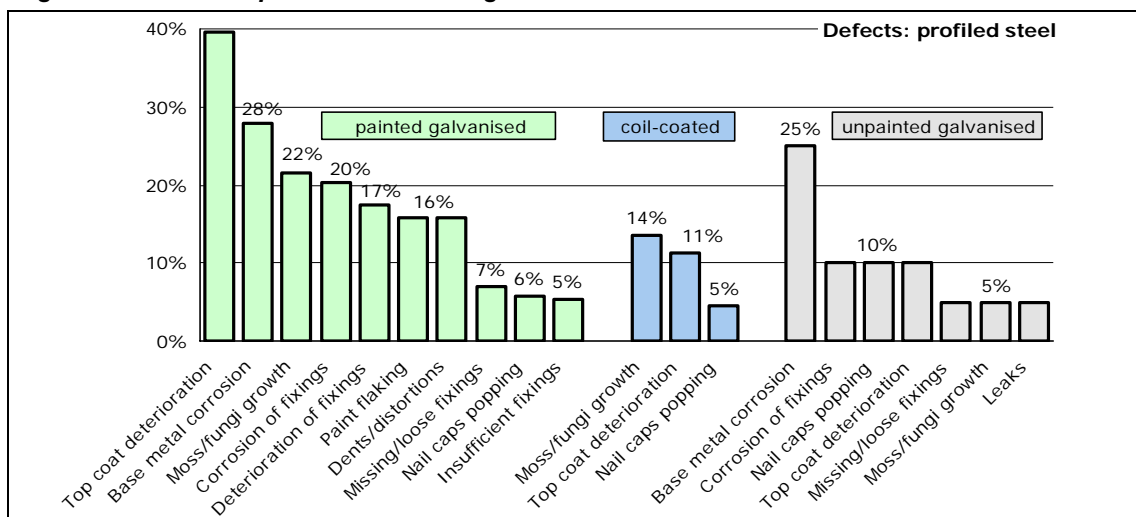
Figure 36: Defects in profiled steel roofing

As shown in Figure 29, this is the most common roof cladding – used on more than half of sample houses. The most frequently observed defects are shown in Figure 36.

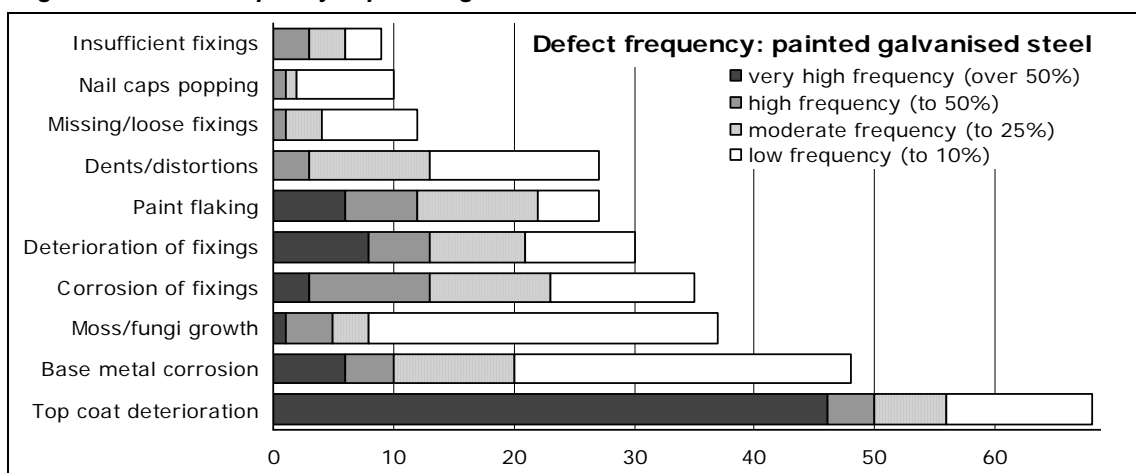
Figure 37: Defect frequency in painted galvanised steel

Although its use is decreasing, painted galvanised steel roofing was still the most common roofing (at more than 30%) used on sample houses². The average age of houses using this roofing is more than 70 years. The oldest houses will not have original roofs, and even replacement roofs are likely to be aging by now. 1950s and 1960s houses may still have original roofs, and these can be expected to be in poor condition by now. This is reflected in the types of defects shown in Figure 36, such as corrosion and fixing deterioration. The frequency of defects in painted steel is shown in Figure 37.

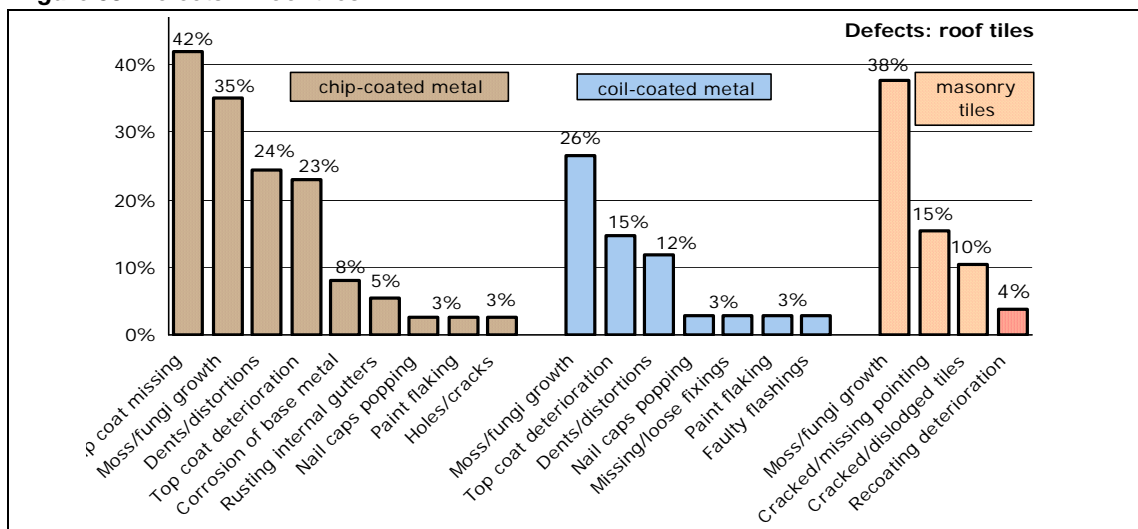
Figure 38: Defects in roof tiles

As shown, the most common defects in chip-coated metal tiles are the erosion of the chip coating, moss and fungi growth and dents in the tiles. The latter three defects are also found in coil-coated metal tiles.

For masonry tiles, the only non-cosmetic defects are cracked or missing pointing and cracked or dislodged tiles. Recoating of older masonry tiles is increasing (at almost 10%), but the practice is still too recent to show much in the way of deterioration.

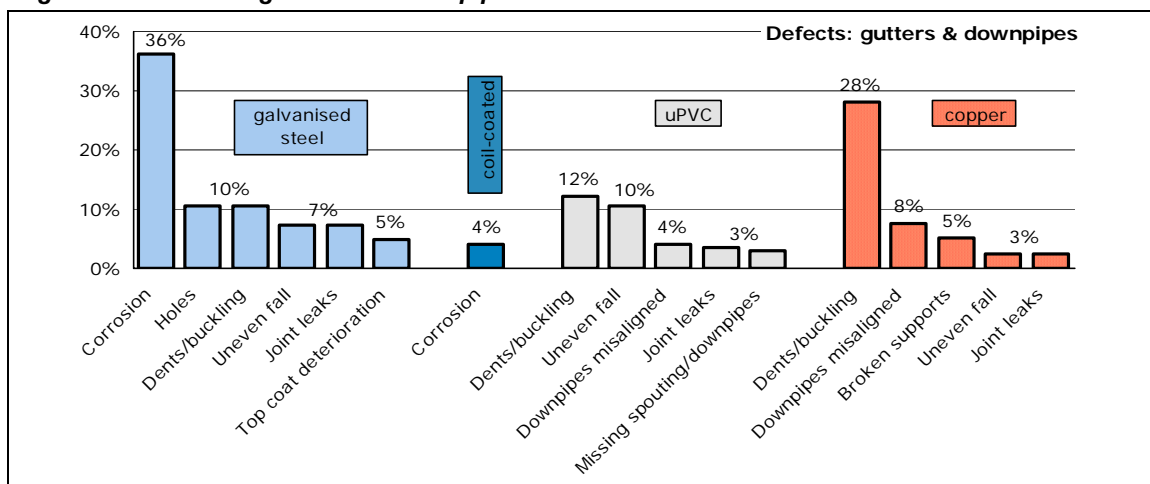
Figure 39: Defects in gutters and downpipes

As shown, corrosion is the main defect for galvanised steel gutters, while dents are the major problem with copper gutters. Other defects are similar for each type of spouting.

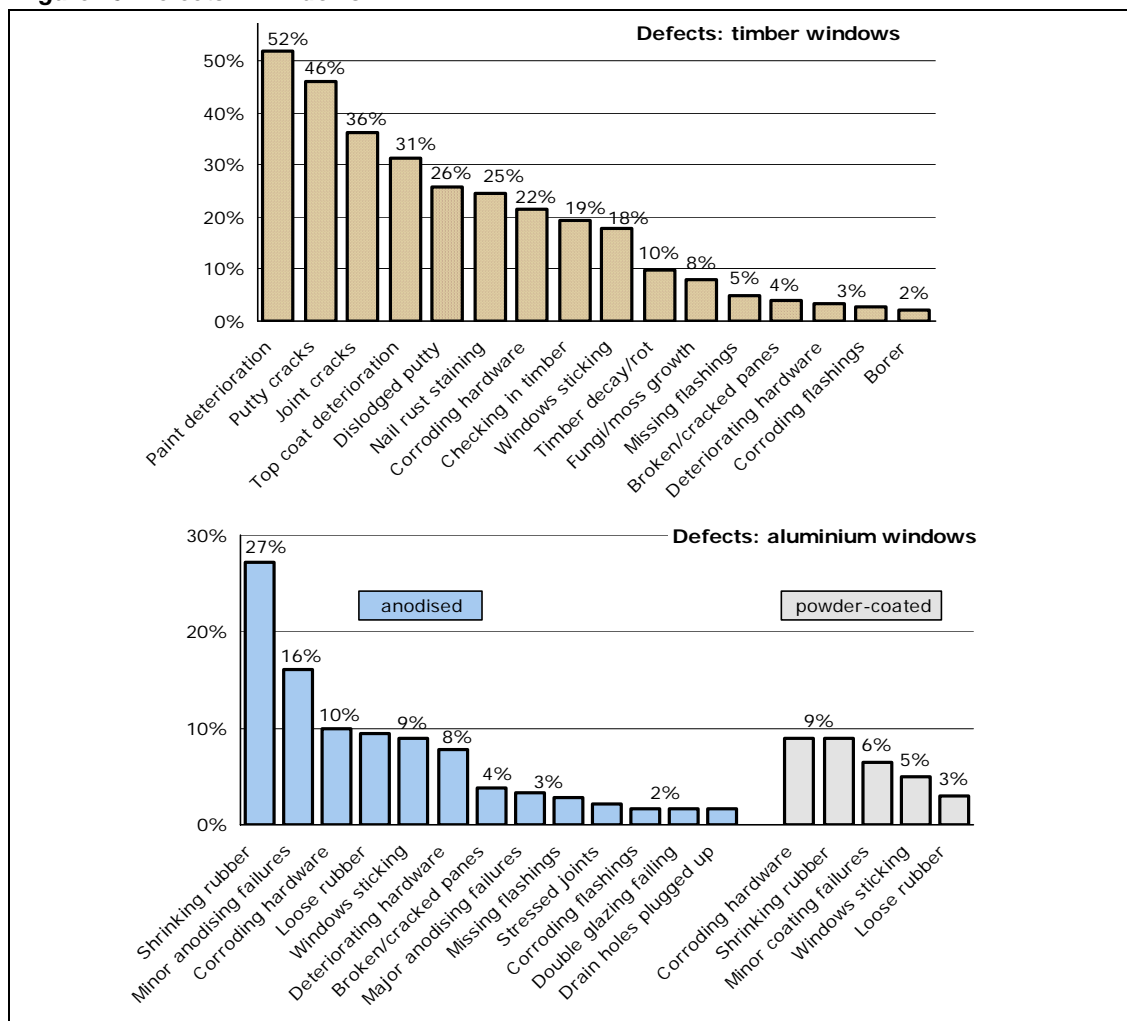
Figure 40: Defects in windows

As expected, the most common defects in timber windows were related to regular painting tasks or to the results of the lack of regular repainting. There were 10% or less of the more significant defects such as borer, decay and missing flashings.

For aluminium windows, the main defects were shrinking and loose rubber glazing seals, minor anodising failures, corroding hardware and windows sticking.

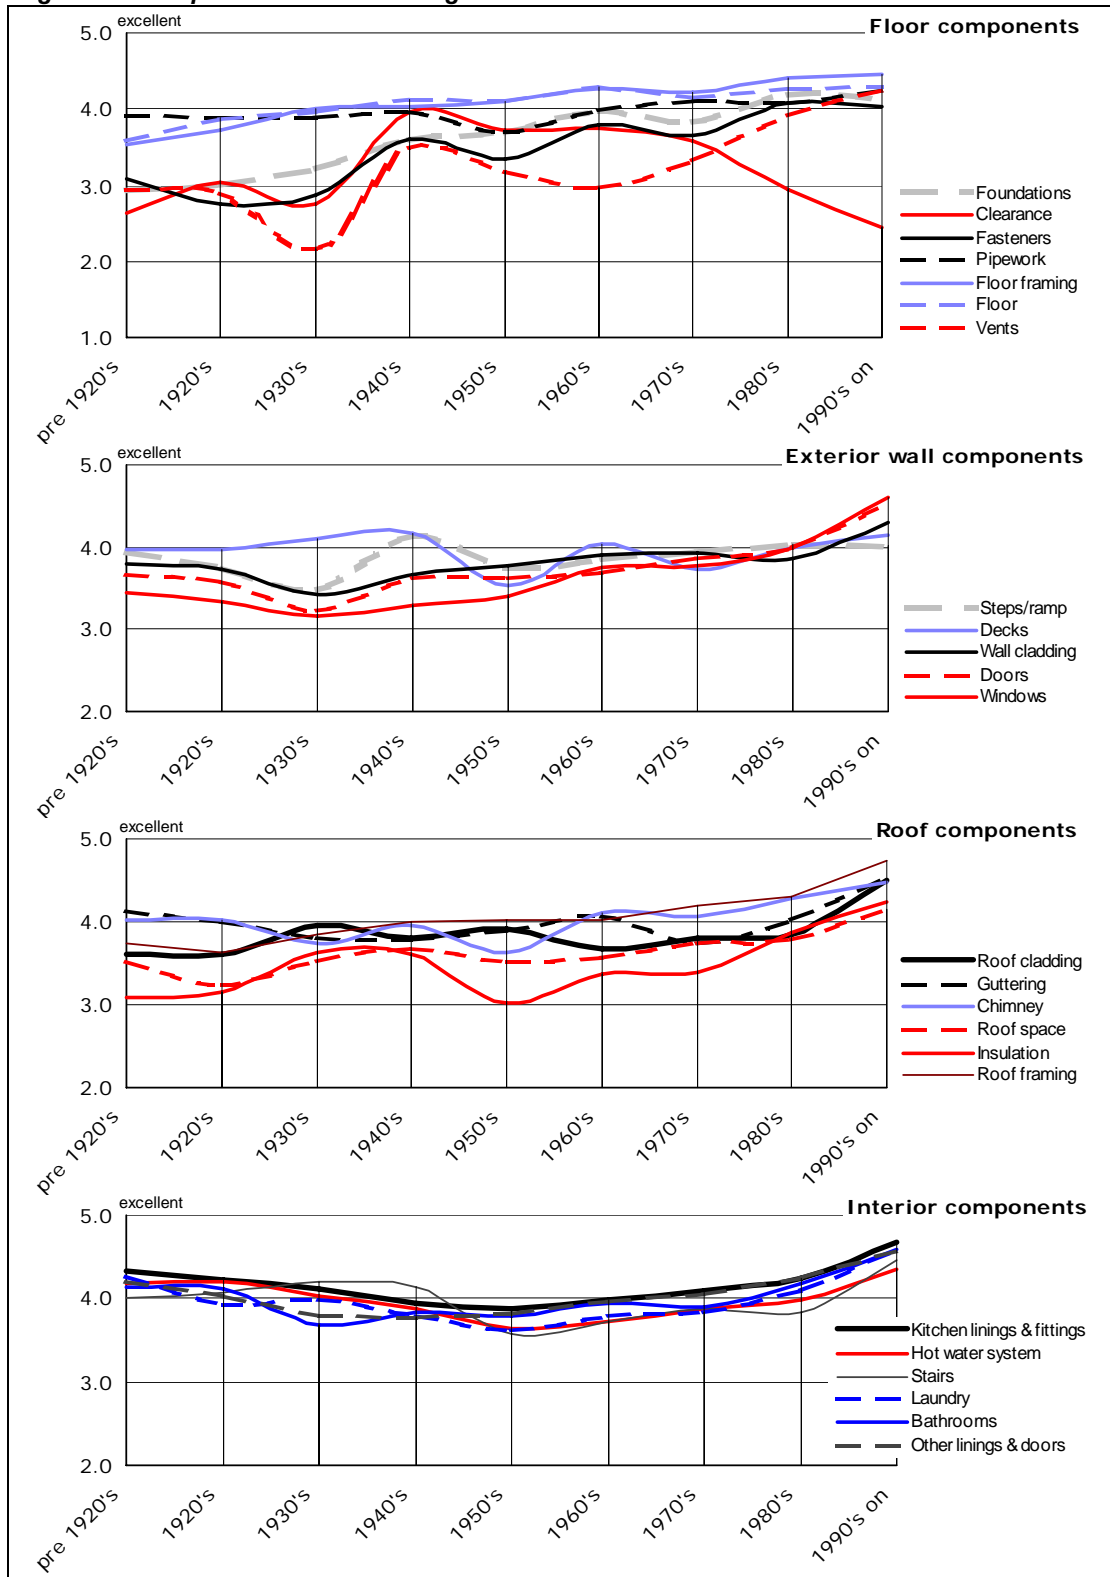
Figure 41: Component condition for age

The collection of components making up this element is the most variable of the groups - with cladding clearance, sub-floor vents and fasteners having varying ratings over age groups, while other components showing gradual deterioration with increasing age.

Ground clearance (the height of the cladding above the adjacent ground or paving level) is rated by comparison to current building standards, and can be related to sub-floor ventilation problems. In common with past surveys, ground clearance and sub-floor ventilation are particular problem areas as shown in Figure 17 and Figure 19. Defects in these components often relate more to design inadequacy than to physical condition, and shortcomings are not necessarily associated with older houses. In fact, pre-1930s houses commonly used spaced baseboards at sub-floor levels, which provided more than sufficient ventilation. From the 1930s onwards, solid perimeter foundation walls became more common and vents were limited to “holes” in these – often too small and too few in number. The Floor components graph in Figure 41 shows that this inadequacy has remained right up until the 1970s cohort. In addition to the inadequacy of constructed vents, owners themselves have often contributed to the problem by blocking vents.

Ground clearance continues to show concerning trends, with the average rating decreasing markedly in younger houses (1980s onwards). This is very similar to the results found in 1994 and 1999, and is likely to relate to changes in the way that New Zealanders use their houses, and the increasing attention given to linking the inside and outside of the house, with changes in levels minimised at the expense of good building practice. In particular, the increasing use of concrete slabs in more recent houses has allowed interior floor levels to carry through to outside areas, sometimes with insufficient means of providing adequate separation of cladding materials from adjacent ground levels. The 2005 survey shows that the newest houses have the lowest cladding clearance rating of all age groups.

If the deck and steps components are excluded, the components making up this element are reasonably consistent with the overall average pattern shown in Figure 21. The 1999 survey showed component conditions stabilising for the oldest houses, but this survey shows the wall components deteriorating with age until the 1930s, and then improving for the oldest houses.

The condition of components making up the roof element is also reasonably consistent with the overall average pattern shown in Figure 21. In common with the 1999 survey, the ratings of ceiling insulation reflect upgrading activity in older houses, and it is interesting to note that the 1950s cohort has the lowest average insulation rating. The numbers of 1930s and 1940s houses in the sample are small, so high insulation rating should not be taken as indicative of these age groups as a whole (refer Section 9.4.2).

Interior components are also consistent with each other and with the overall average pattern. These components deteriorate with age until around the 1950s cohort, after which there is an improvement over most components for older houses. The condition of all linings is similar, and well above *moderate*, from the oldest houses right up until the most recent ages - those of the 1990s and newer.

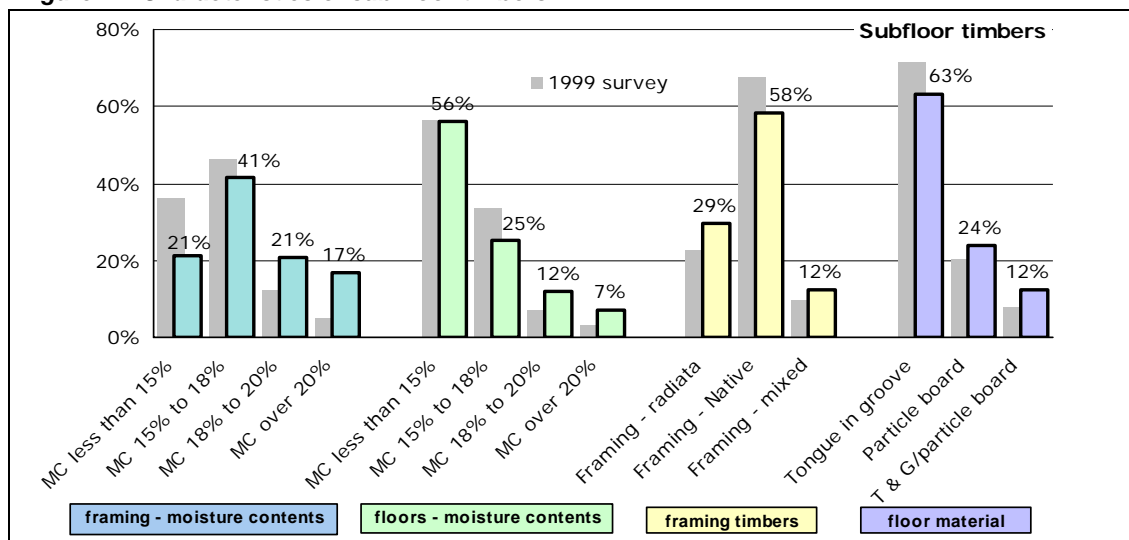
Figure 42: Characteristics of sub-floor timbers

As shown, characteristics are similar to those found in the 1999 survey. However, there is a higher proportion of framing and flooring over 18% despite better sub-floor ventilation as shown in Figure 17 and Figure 19 – so other factors may be influencing this. Materials have changed in line with the increasing proportion of newer houses included in the 2005 survey – with a decrease in the proportion of native sub-floor timbers and tongue-in-groove flooring, and an associated increase in radiata pine sub-floor framing and particleboard flooring.

As discussed earlier, sub-floor dampness was identified as a particular problem area, and Figure 42 included the ranges of moisture contents recorded in sub-floor timbers, showing:

- **Sub-floor framing:** 38% with moisture contents at 18% or more and 17% at more than 20%
- **Floors:** 19% with moisture contents recorded at 18% or more and 7% at more than 20%

Sub-floor framing with moisture contents of 20% is over the threshold recommended to avoid problems such as corroding fasteners, mould growth or, in extreme cases, decay of some framing timbers. The threshold for borer attack has in the past been considered to be around 18%, but timber scientists are now finding that the level may be lower – of concern as almost 60% of houses have native sub-floor timbers.

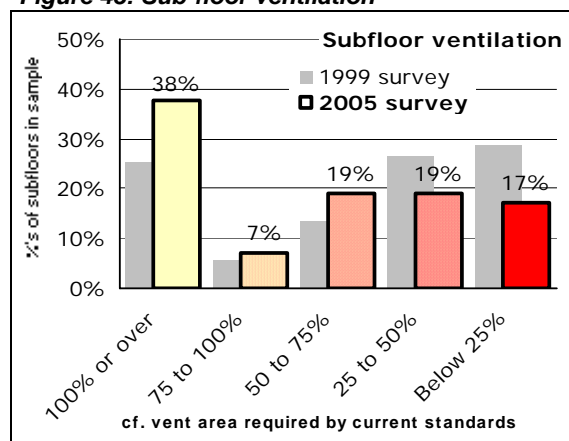
Figure 43: Sub-floor ventilation

Sub-floor ventilation was also identified as a particular problem in past surveys and Figure 43 shows the 2005 results in comparison with those for the 1999 survey.

As shown in Figure 43, the 2005 survey shows an improvement over the 1999 results, with almost 40% having adequate ventilation in contrast to around 25% in 1999. However, this still leaves the majority substandard.

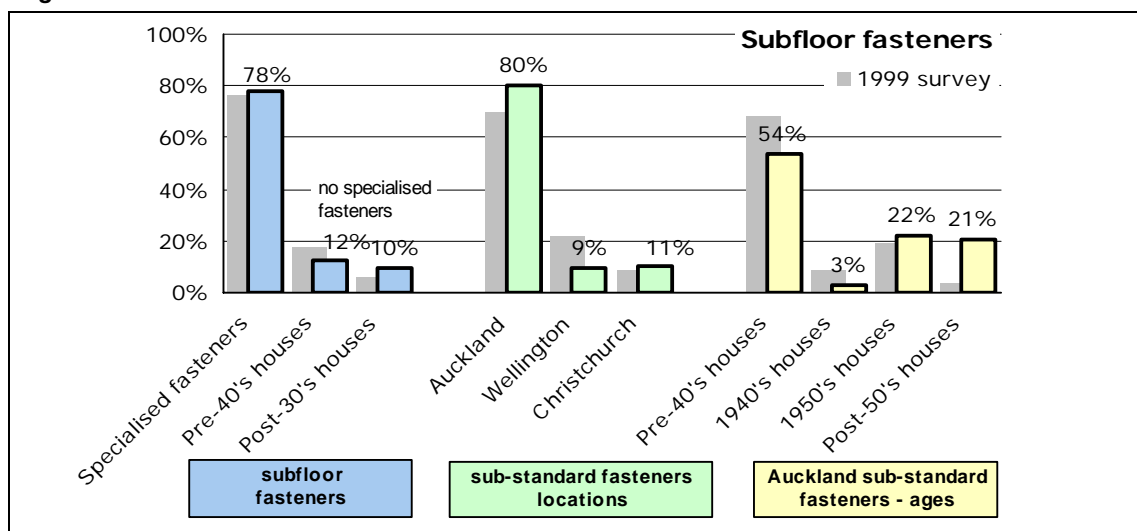
Figure 44: Sub-floor fasteners

Another common problem identified in the 1999 survey related to the lack of appropriate sub-floor fasteners, with many houses having no specialised fasteners between concrete piles and framing timbers. These included more recent post-1940s houses, as well as older houses, and was particularly apparent in houses in the Auckland region. Figure 44 gives the same analysis, comparing 2005 results with those from the 1999 study.

As shown, results in 2005 are similar to those in 1999, with the following features noted:

- More than 20% of houses have no specialised fasteners
- Of these, almost half are in 1940s and newer houses
- 80% of the houses without specialised fasteners are in the Auckland region
- Of this Auckland subset, more than 20% are in 1950s houses and more than 20% are in newer houses built since the 1950s.

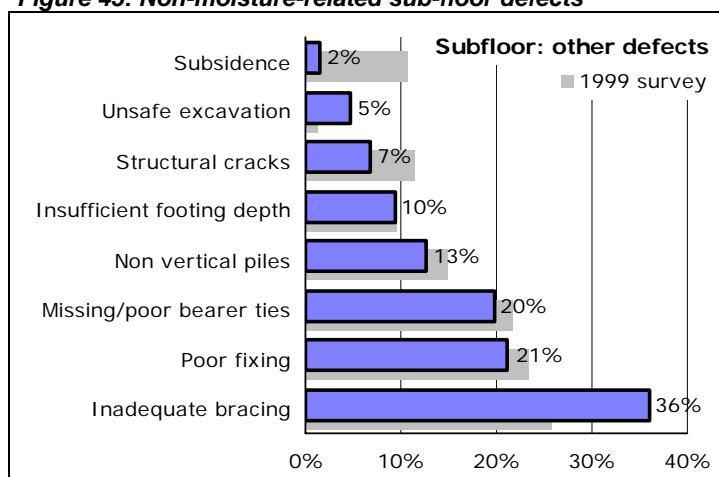
Figure 45: Non-moisture-related sub-floor defects

Figure 45 gives defects, (unrelated to moisture) found in sub-floor areas, and compares these to 1999 defects.

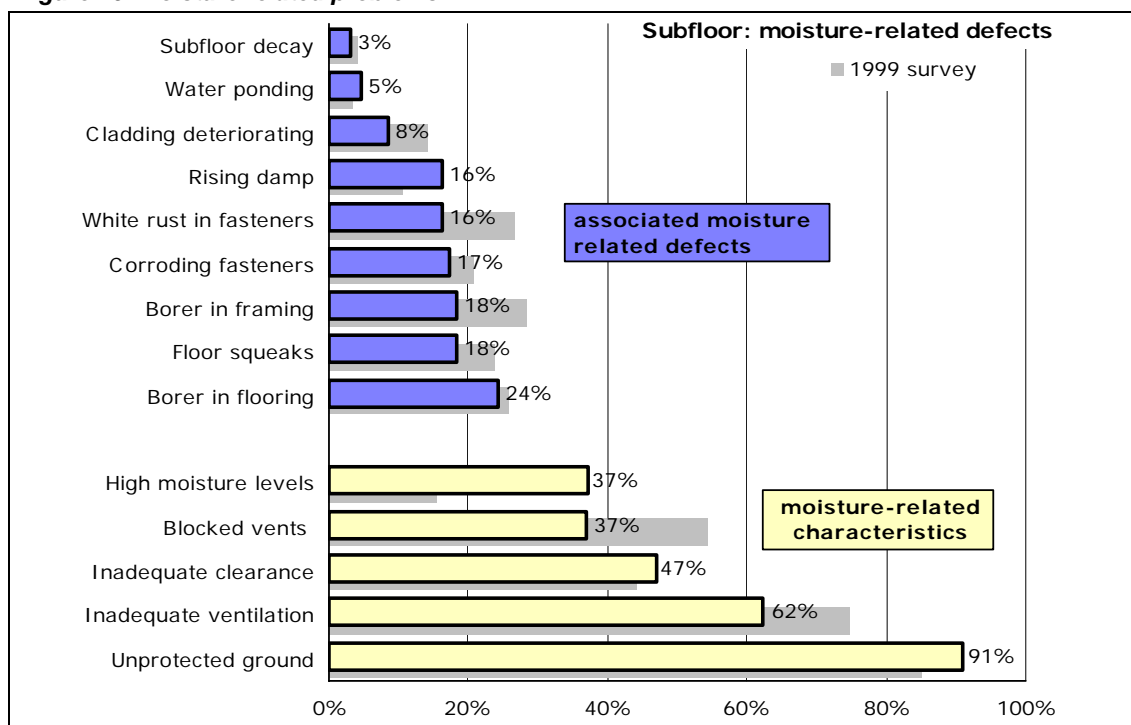
Figure 46: Moisture related problems

Figure 46 gives moisture-related characteristics, along with associated moisture-related defects. The percentages shown reflect the portion of accessible sub-floors that exhibit the particular defect.

As shown, results are generally similar to those found in 1999. As in the 1999 study, the proportion of houses with inadequate sub-floor ventilation is considerably higher than the proportions of moisture-associated defects. No direct correlation was able to be established between inadequate ventilation and high moisture levels in sub-floor timbers. However, moisture-related defects are likely to increase over time, if sub-floor ventilation remains inadequate and moisture levels remain high.

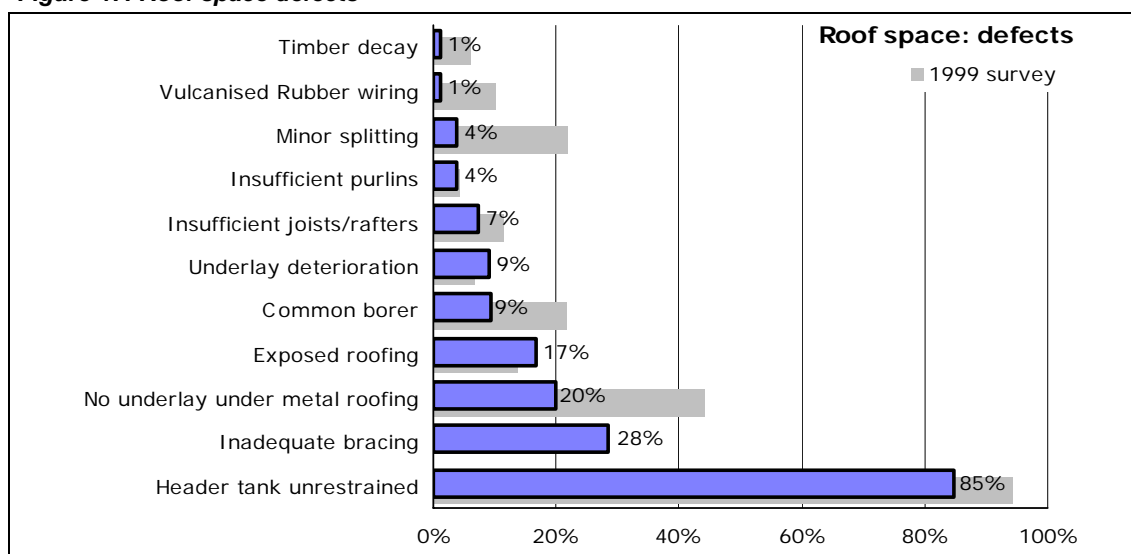
Figure 47: Roof space defects

The most common defects identified by the inspectors were similar to those identified in the 1999 survey, such as unrestrained header-tanks (however less than 20% of accessible roof spaces contained operating header-tanks), lack of bracing, missing or deteriorating roof underlays and borer infestation (it should be noted that no problems of high moisture contents in roof space timbers were noted from the readings taken). Defects found in the roof space during inspections are shown in Figure 47.

Figure 47 shows that the proportion of houses with old rubber insulated wiring has decreased from 10% in 1999 to only 1% in 2005 (part of which is attributable to the change in age distribution within the sample).

The number of water systems with header-tanks is decreasing as aging cylinders are replaced with valve-vented or high pressure cylinders. Less than 20% of the sample houses now have header-tanks, which is discussed further in Section 10.1. For the remaining operable header-tanks, 85% do not have adequate restraints against earthquake movement.

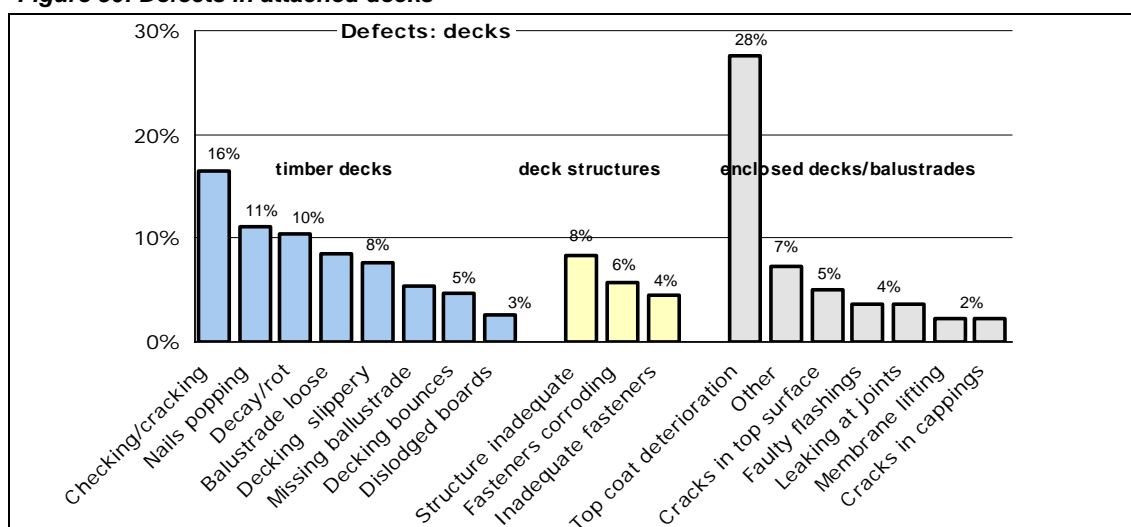
Figure 50: Defects in attached decks

Defects found in decks are shown in Figure 50, and are separated into the structure and deck types.

As shown, the most common defects in timber spaced decks are checking or cracking, nail popping, decay, loose balustrades and slippery surfaces. In enclosed decks, the most common defect is the deterioration of the topcoat (mostly associated with older painted concrete decks and largely cosmetic). 8% of deck structures are not up to current standards and 10% have corroding or inadequate fasteners.

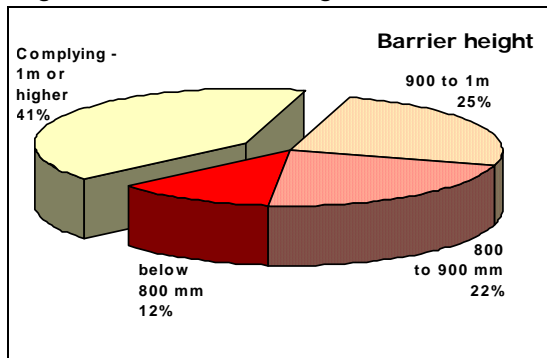
Figure 51: Deck barrier heights

Balustrades were assessed for various characteristics in order to establish compliance with Clause F4[7] of the Building Code.

It was found that 78% of barriers were non-compliant due to missing barriers, barriers that were too low or barriers with openings that were too large. This included many barriers with horizontal rails and decks more than 1000 mm high with no barrier.

As shown in Figure 51, almost 60% of barriers are less than 1000 mm high, and around one third are less than 900 mm high.

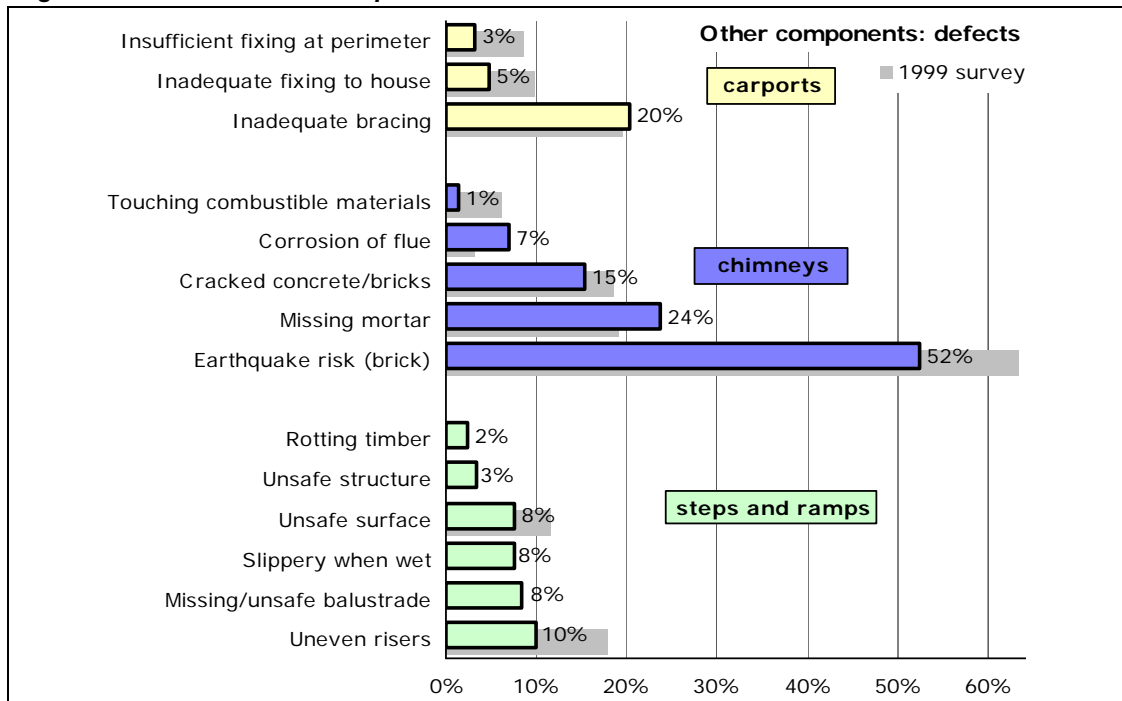
Figure 52: Defects in other components

Figure 52 covers the common defects identified in carports, chimneys and steps or ramps.

As shown, defects are generally similar to those found in 1999. The main defect in carports remains the lack of adequate bracing. In common with the 1999 survey, the most frequent defect in chimneys is generally associated with unreinforced brick chimneys in older houses. The decrease since the 1999 survey reflects the increase in the number of newer houses in the sample, together with the removal of chimneys in a number of the older houses – rather than an improvement in chimney condition.

These chimneys were in line with building practices of the time (and are often still in good condition), they do not meet current earthquake standards and are likely to be unsafe in a major earthquake. Many of the oldest also use lime-based mortar that has a tendency to crumble with age, reflected by the high percentage of cases (24%) where chimneys were missing mortar, so creating potential fire hazards. The incidence of cracked concrete or bricks in newer chimneys, with cement-based mortars, is also high (at 15%), providing a potential fire hazard if full-depth cracks are within the house envelope.

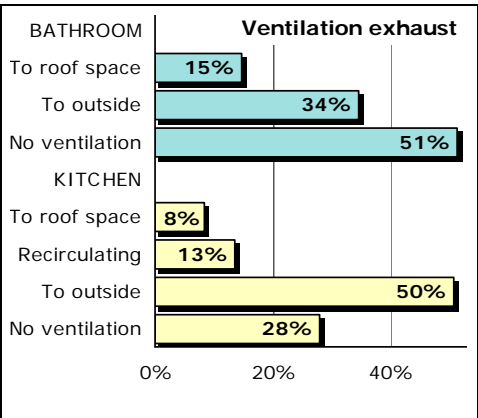
Figure 53: Kitchen and bathroom venting

Figure 53 shows that most bathrooms have inadequate ventilation – with only one third venting to the outside, and 15% venting into the roof space.

Half the kitchens vent cooking fumes to outside, but 20% either exhaust into the roof space, or simply recirculate the air, suggesting that more emphasis may be placed on extracting odours, rather than on extracting moisture.

These defects in ventilation are concerning, as kitchens and bathrooms produce considerable water vapour that, if not adequately vented, can cause subsequent damage to materials and finishes.

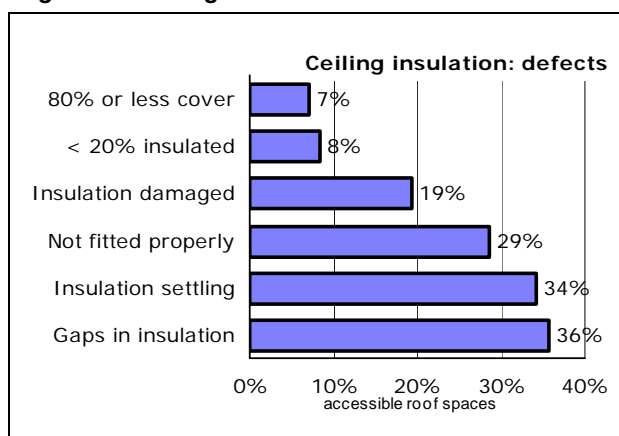
Figure 66: Ceiling insulation defects

Figure 66 shows the incidence of defects in ceiling insulation in accessible roof spaces. As shown, major defects are settling, gaps, lack of proper installation and damage (e.g. removal of batts by tradespeople without replacement).

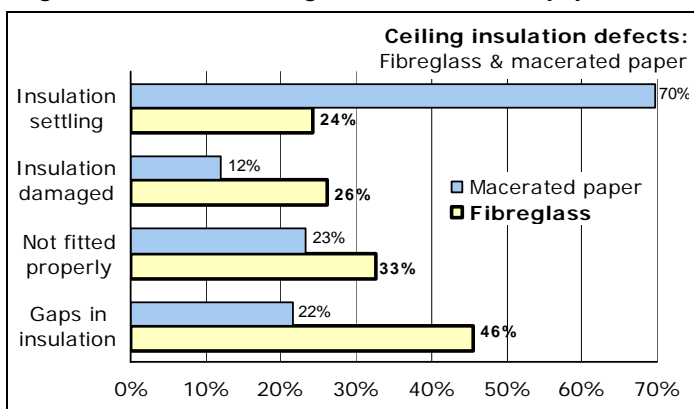
Figure 67: Defects – fibreglass and macerated paper

The main points to note in Figure 67 is the degree of settling noted for macerated paper ceiling insulation in contrast to that for fibreglass.

It is also interesting to note 46% of fibreglass insulation had gaps – either from not being fitted properly or from damage after installation.

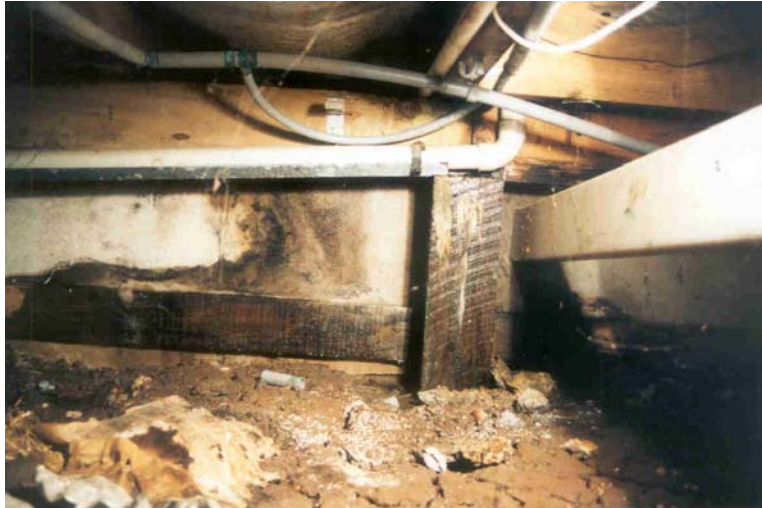
Photo 1: interior leaks

- 1980s Wellington house
- Treated timber piles
- Dampness and localised timber decay resulting from a leaking wastepipe
- Sub-floor ventilation generally adequate

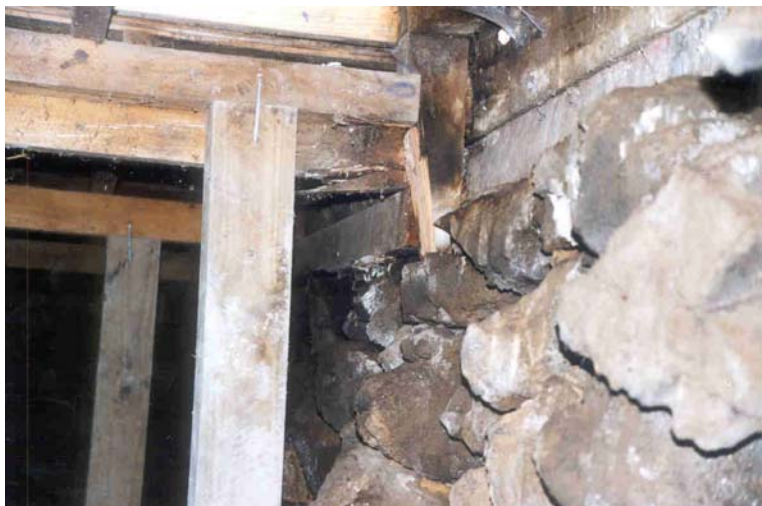
Photo 3: exterior moisture

- 1920s Auckland house
- Re-piled with treated timber piles
- Sub-floor framing mixture of radiata pine and rimu
- Unsafe excavation, decay and borer in bottom plates of exterior wall framing
- Bottom of weatherboard cladding buried
- No sub-floor ventilation provided.

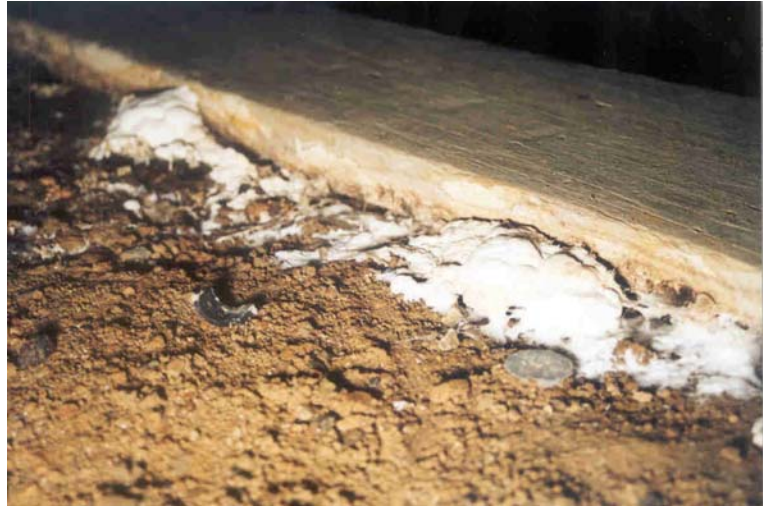
Photo 7: soil fungi

- 1980s Wellington house
- Concrete perimeter wall and piles, pine framing
- Debris stored in sub-floor
- Corroding fasteners and some timber decay
- Water staining on particle board flooring
- Fungi growth under leaking wastepipe
- No cladding clearance
- Sub-floor ventilation 34% of required level

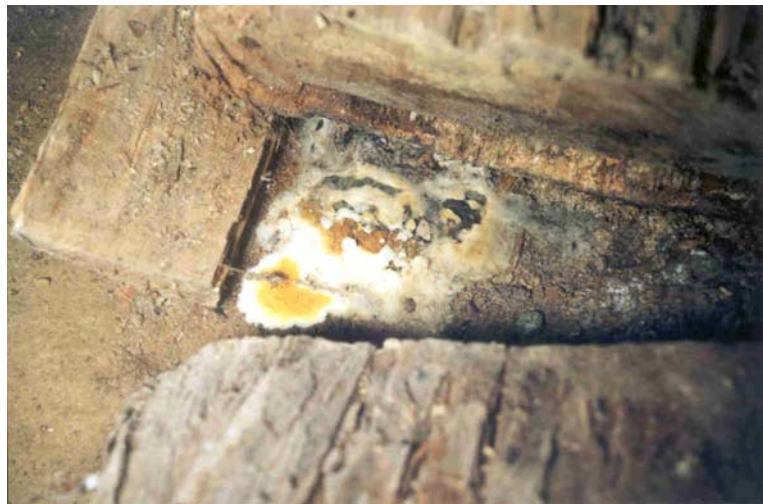
Photo 8: soil fungi

- 1960s Wellington house
- Concrete perimeter wall and piles, rimu and pine framing, rimu flooring
- Debris stored in sub-floor
- Fungi growth under leaking wastepipe
- Leaking wastepipe
- Corroding fasteners
- No sign of timber decay
- No cladding clearance
- Sub-floor ventilation 60% of required level

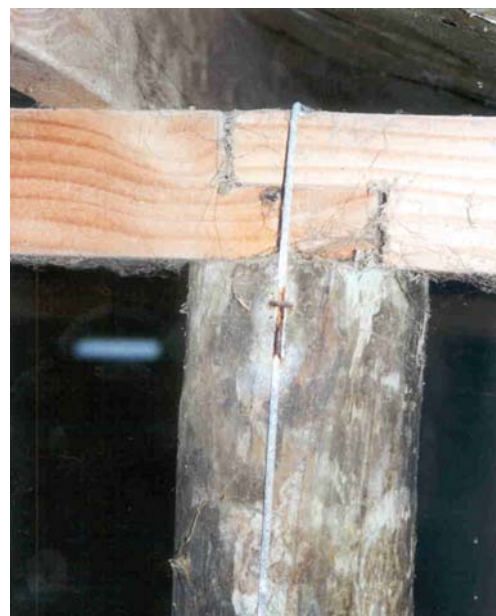
Photo 9: wire and staples

- 1980s Auckland house
- Treated timber piles, radiata pine framing and particle board flooring
- Joist moisture levels at upper level of normal range
- Inspected in late summer, so corrosion may indicate damp conditions during other seasons
- No sign of timber decay
- Adequate sub-floor ventilation provided

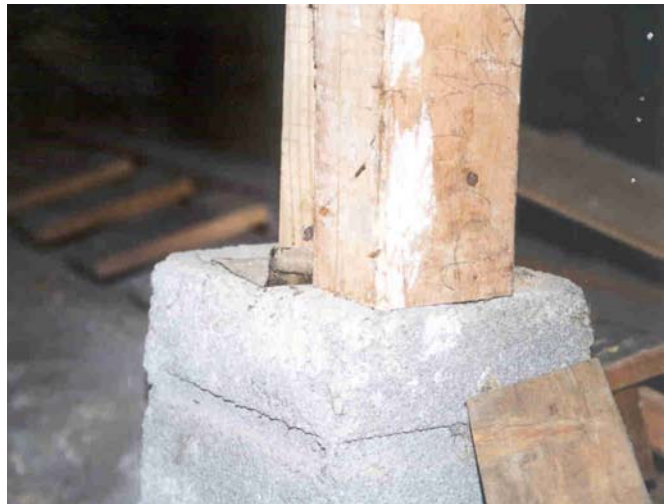
Photo 10: inadequate fixing

- Large 1970s Auckland house
- Large house with concrete block perimeter wall and piles, radiata pine framing, particle board flooring
- No specialised fasteners – nails only
- No DPC under jack studs
- No sub-floor ventilation provided

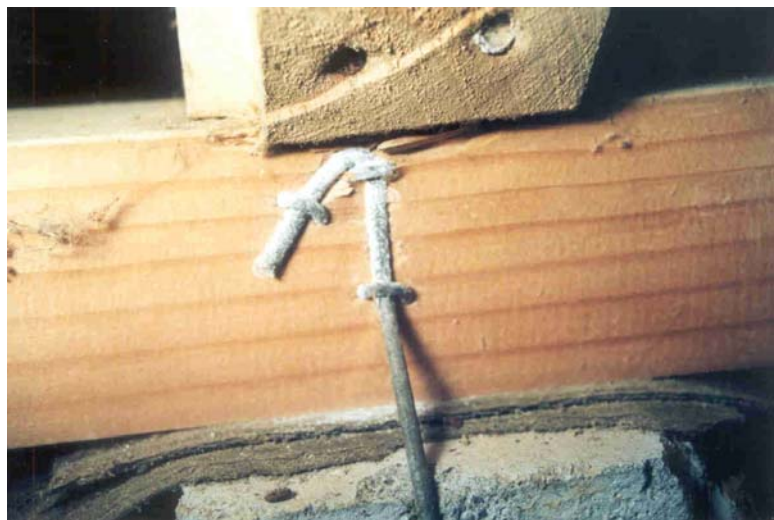
Photo 11: white rust

- 1960s Wellington house
- Concrete perimeter wall and piles, rimu and pine framing, rimu flooring
- Firewood stored
- Fungi growth
- Leaking wastepipe
- Corroding fasteners
- No sign of timber decay
- No cladding clearance
- Sub-floor ventilation 60% of required level

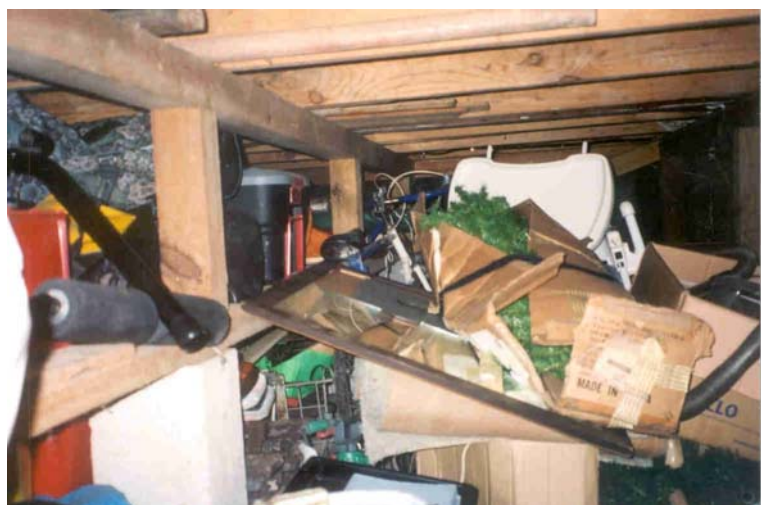
Photo 12: storage in sub-floor

- 1980s Auckland house
- Concrete piles, radiata pine framing and particle board flooring
- Sub-floor space filled with stored items
- Storage typical of many houses in survey
- No sign of present moisture problems
- Sub-floor ventilation 66% of required level

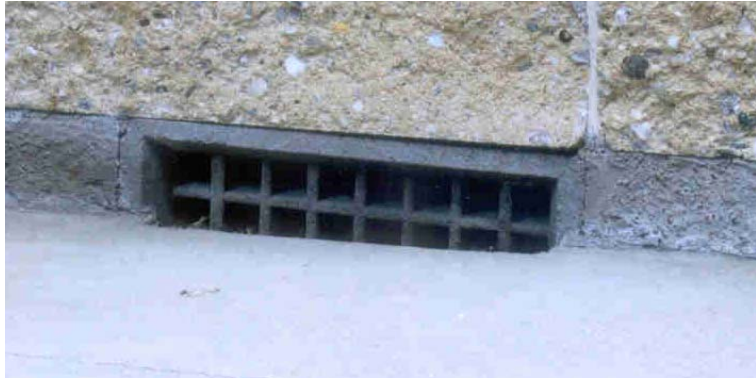
Photo 23: blocked vents

- 1960s Christchurch house on flat site with minimal clearance under bearers
- Concrete perimeter wall and piles
- Garden soil blocking vents
- Sub-floor ventilation 70% of required level

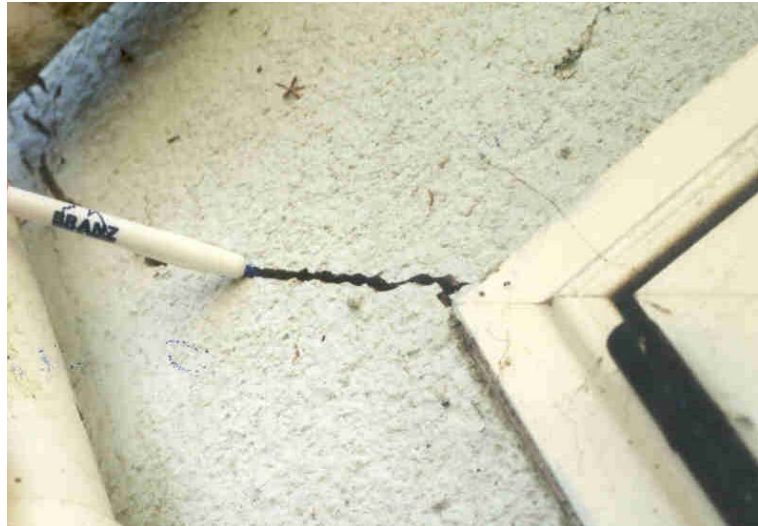
Photo 30: old stucco

- 1920s Wellington house close to coast
- Cladding stucco on wire mesh
- Full depth cracks in plaster
- Maintenance neglected over long period of time (note roof condition)
