STUDY REPORT

No. 142 (2005)

NEW ZEALAND 2005 HOUSE CONDITION SURVEY

Susan J. Clark, Mark Jones
&
Ian C. Page

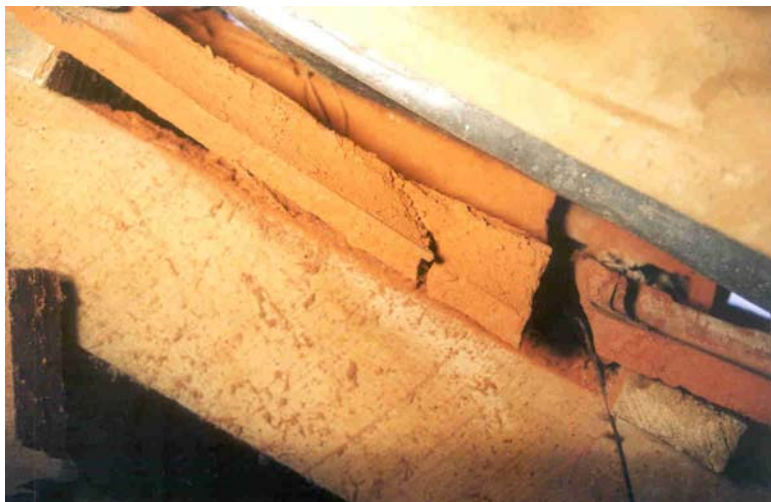
Photo 53: corroding gutters

- 1920s Wellington house close to coast
- Wall cladding stucco on wire mesh
- Roof corrugation iron – no repainting for many years
- Very old galvanised steel gutters rusted out in many areas and leaking badly
- Maintenance neglected over long period of time.

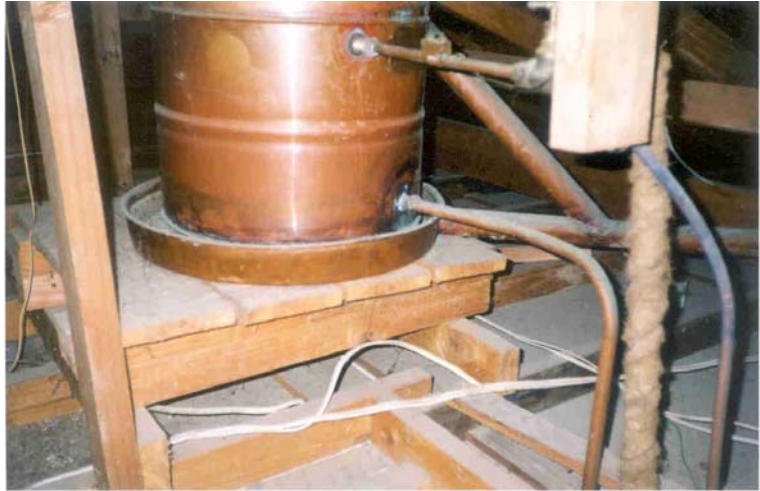
Photo 60: unrestrained header-tank

- 1920s Wellington house
- Header-tank generally in good condition, but not restrained against earthquake movement
- Note lack of pipe lagging
- Note also the lack of any ceiling insulation

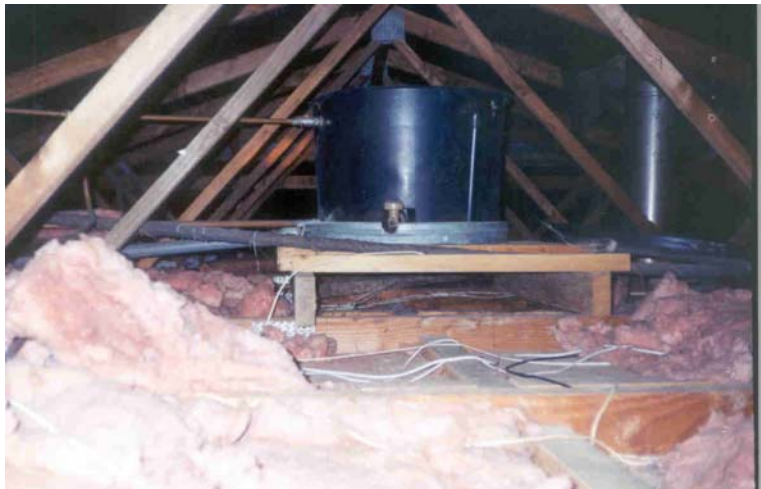
Photo 63: insulation damage

- 1960s Auckland house
- Fibreglass batts damaged and not put back after installation of fan in ceiling space

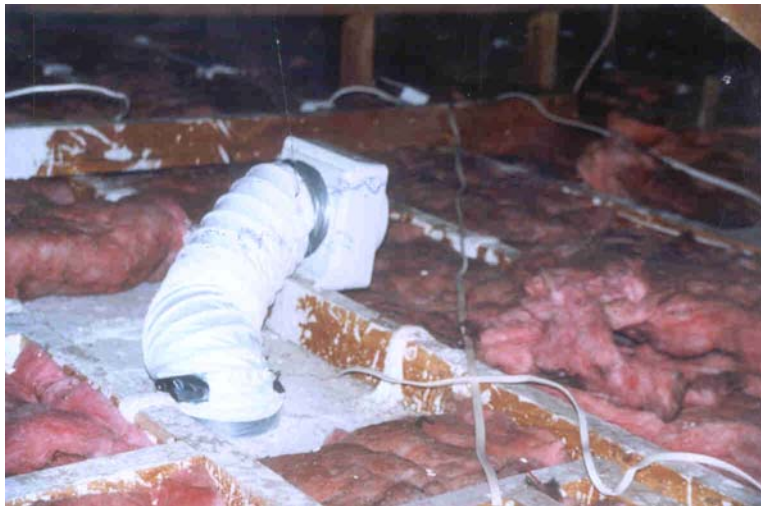
Photo 64: insulation damage

- 1940s Auckland house
- Fibreglass batts damaged and not put back after installation of fan in ceiling space

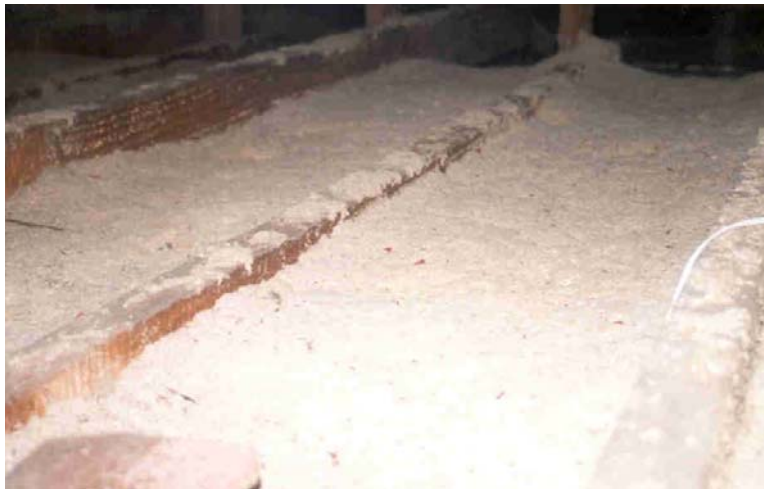
Photo 66: insulation settling

- 1990s Auckland house
- Loose fill macerated paper insulation settling over time
- Thickness uneven with most areas only about 50 mm thick
- Also poor installed with gaps in insulation cover

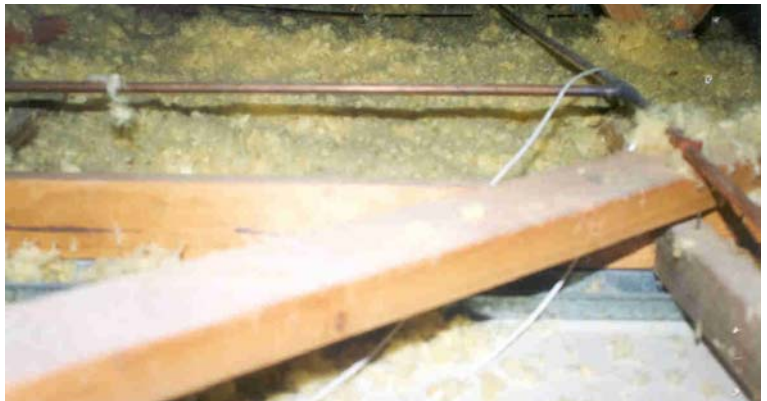
Photo 67: blown fibreglass

- 1990s Auckland house
- Loose fill fibreglass insulation settling over time
- Poorly installed with gaps and uneven thickness
- Insulation also damaged when later work done in roof space

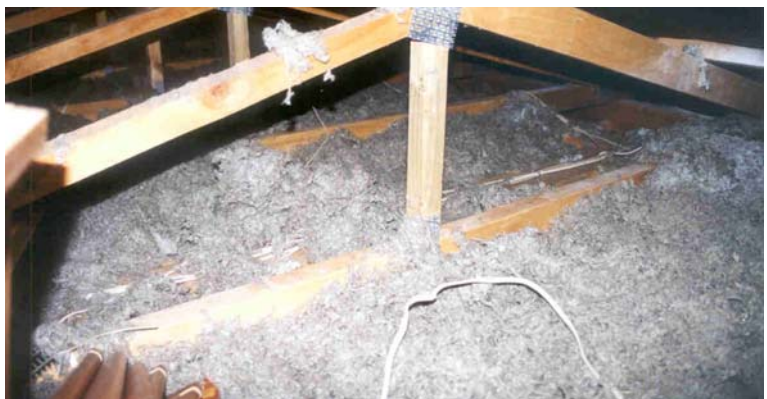
Photo 68: blown rockwool

- 1990s Auckland house
- Loose fill wool insulation
- Insulation poorly installed with gaps, settling and later damage

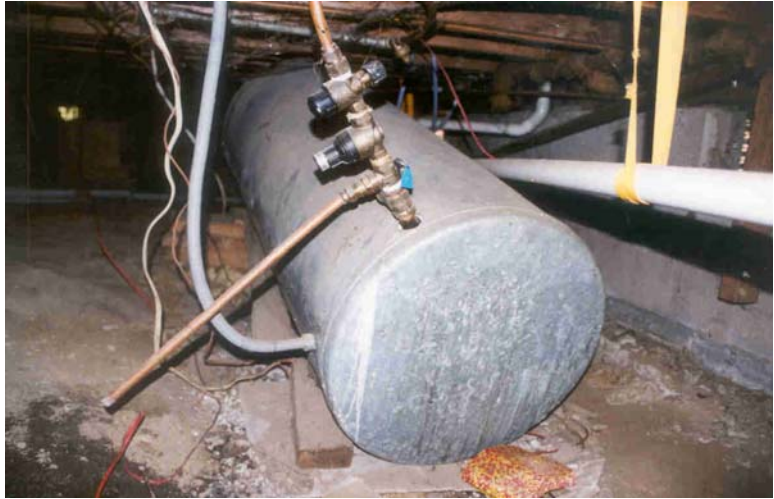
Photo 69: sub-floor HWC

- 1950s Auckland house
- 1982 HWC installed in sub-floor space
- Cylinder corroding
- Thermostat difficult to access
- No pipe insulation

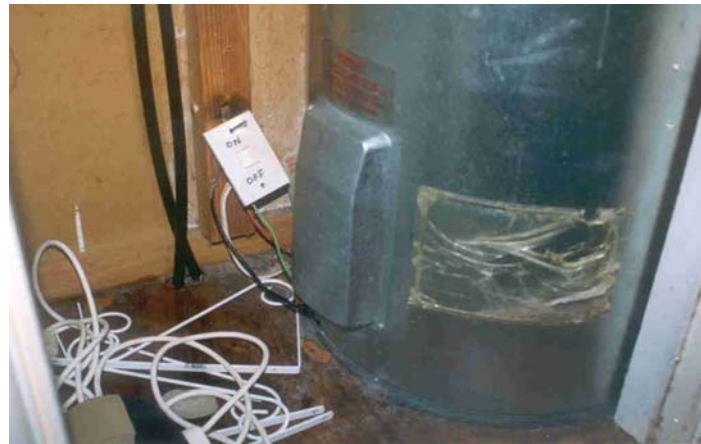
Photo 70: wiring to HWC

- 1950s Auckland house
- Original HWC – about 50 years old
- Dangerous wiring to switch
- Deteriorating pipe lagging

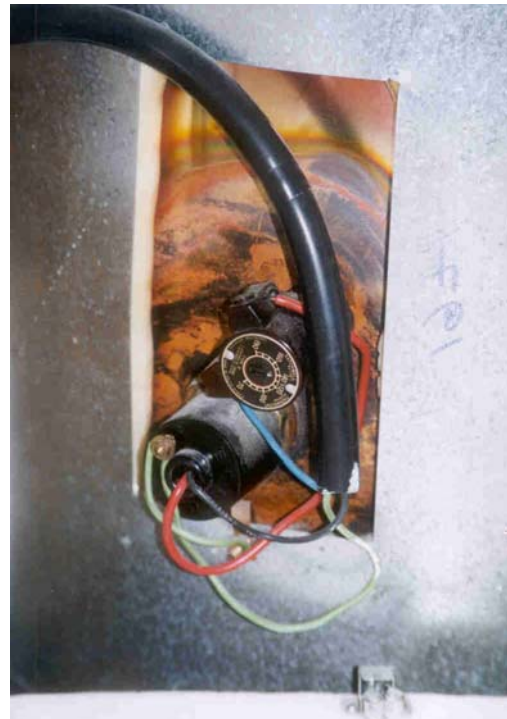
Photo 71: wiring to HWC

- 1940s Auckland house
- 10 year old HWC
- No cover to thermostat
- Wiring exposed

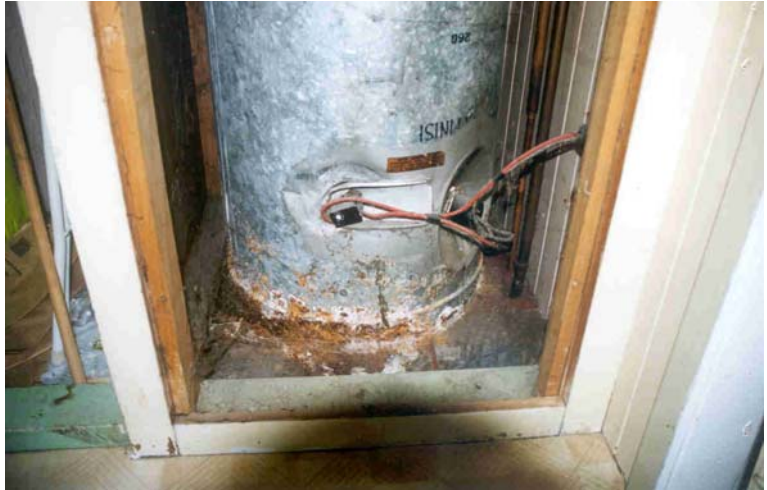
Photo 72: corroding HWC

- 1940s Auckland house
- Original cylinder – almost 60 years old
- Cylinder corroding badly at base, and leaking
- Thermostat unreliable – hot water delivered 15°C above setting
- Thermostat difficult to access
- No pipe insulation

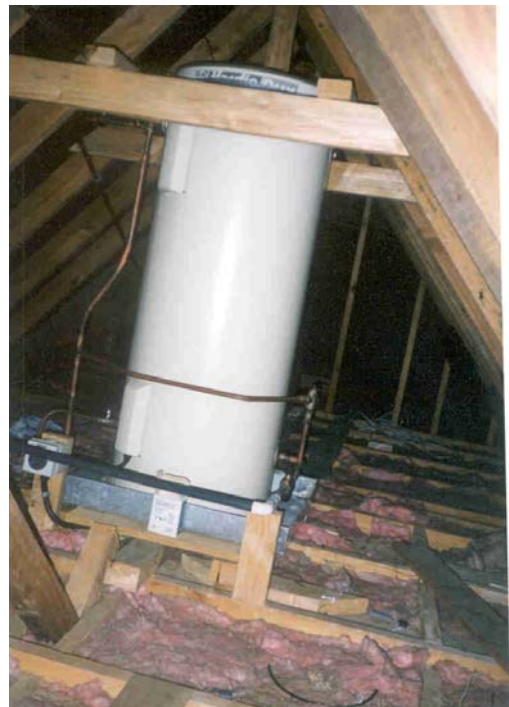
Photo 73: roof space HWC

- 1970s Auckland house
- 1999 second HWC installed in ceiling space above bathroom
- No earthquake restraint
- No pipe insulation

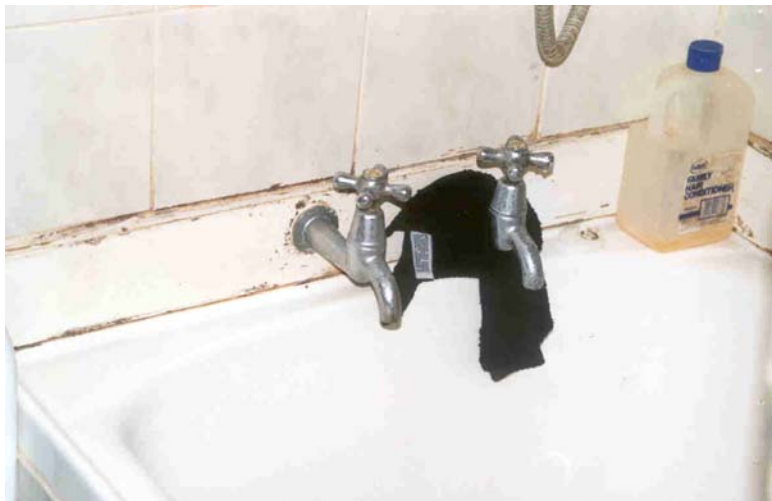
Photo 74: bathroom mildew

- 1900s Auckland house
- Bathroom renovated in 1950s and refurbished in last 5 years
- Typical condition of timber plate around bath – mildew and paint deterioration
- No mechanical ventilation or heating in bathroom

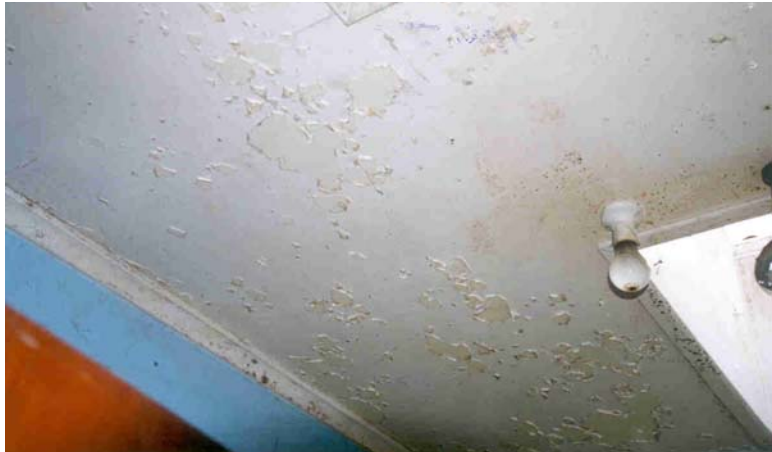
Photo 75: bathroom mildew

- 1950s Auckland house
- Extensive mould on ceiling
- Moisture damage to paintwork
- No mechanical ventilation or heating in bathroom
- Shower over bath – flow rate too low at 3 litres/min

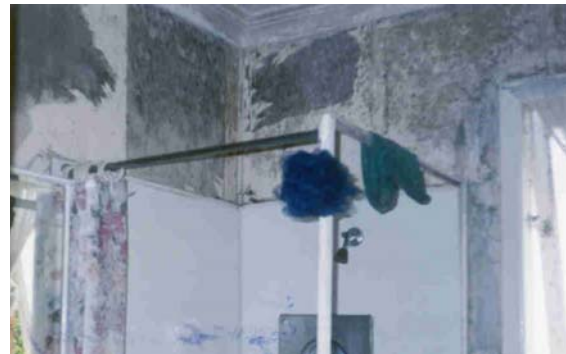
Photo 76: bathroom mildew

- 1950s Auckland house
- Extensive black mould throughout house
- Moisture damage
- No mechanical ventilation or heating in bathroom
- No insulation in walls or ceilings

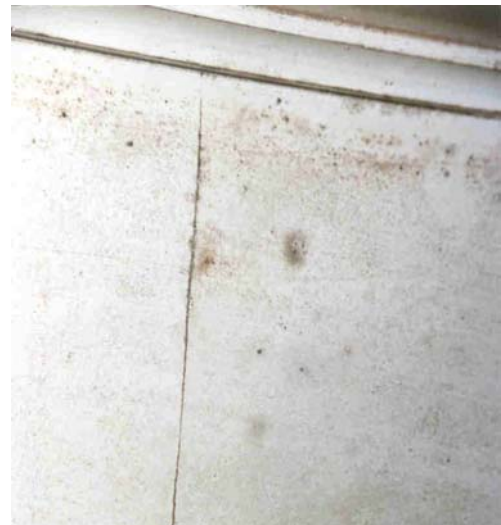
Photo 77: bathroom mildew

- 1960s Auckland house
- Extensive mould on ceiling
- Moisture damage to linings
- No mechanical ventilation or heating in bathroom
- No wall insulation
- Ceiling insulation macerated paper – only 50 mm thick

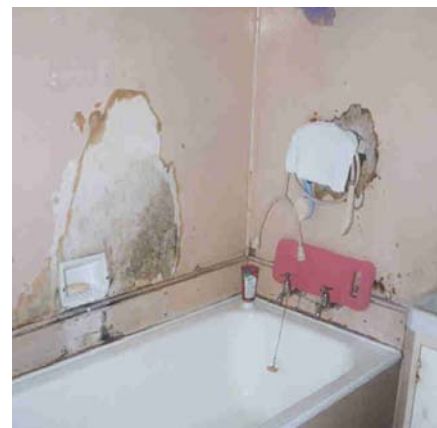
Photo 78: water damage

- 1950s Auckland house
- Refer above comments
- Moisture damage to linings – wallpaper peeling
- Inadequate finishes around bath
- No mechanical ventilation or heating in bathroom

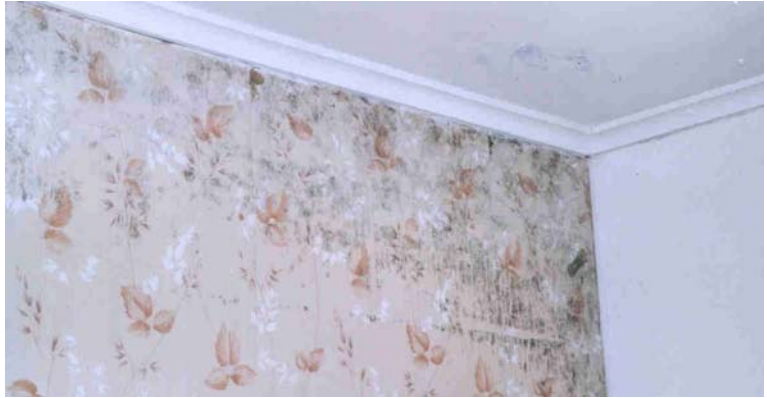
Photo 79: bedroom mildew

- 1970s Auckland house
- Mildew to bedroom wall
- No wall insulation
- No access to ceiling space to check insulation

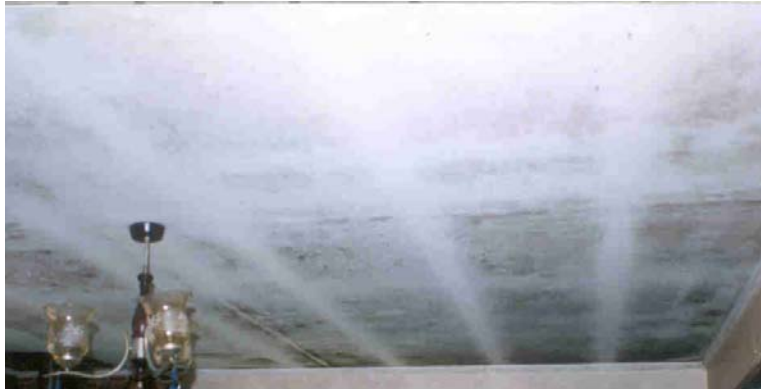
Photo 80: ceiling mildew

- 1970s Auckland house
- Extensive black mildew to living room ceiling
- No ceiling or wall insulation
- Limited heating – 1 small portable electric radiator and an enclosed woodburner

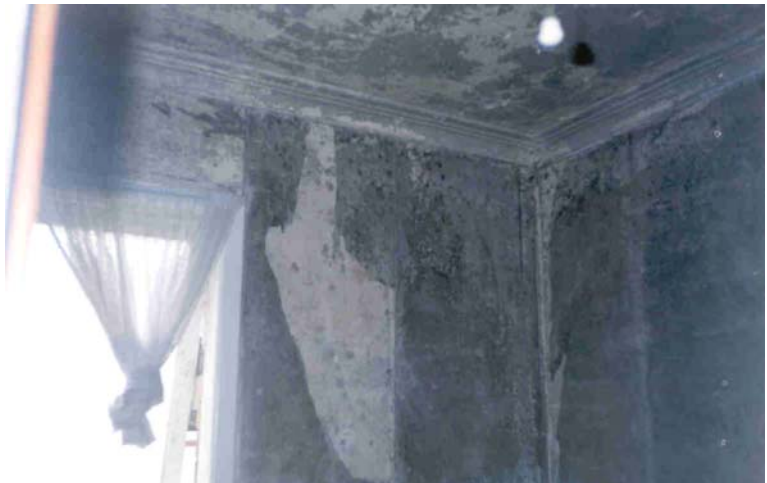
Photo 81: bedroom mildew

- 1950s Auckland house
- Photo of bedroom
- Extensive black mould throughout house
- Moisture damage to linings and finishes
- Only heating - enclosed woodburner
- No insulation in walls or ceilings

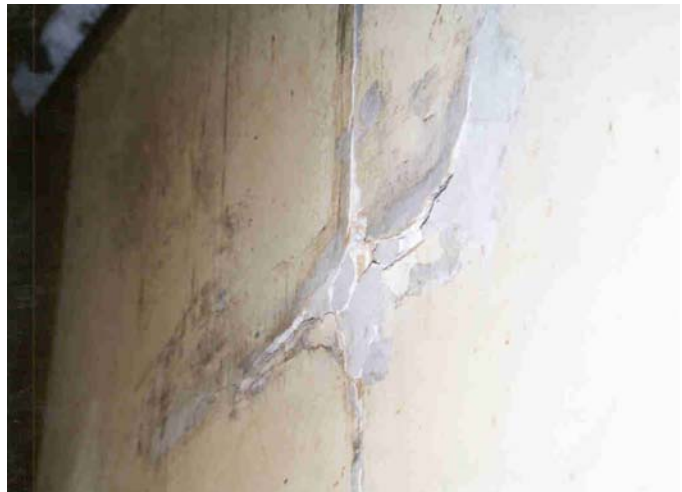
Photo 82: wall finishes

- 1950s Auckland house
- Photo of bedroom
- Extensive mould in bedrooms, some in living areas
- Finishes poor – holes, cracks, poor repairs, water stains, borer
- Heating – open fire and LPG heater
- No insulation in walls or ceilings
