SR 240 (2011)

Preliminary BRANZ 2010 House Condition Survey Report – Second Edition

BRANZ Study Report SR 240

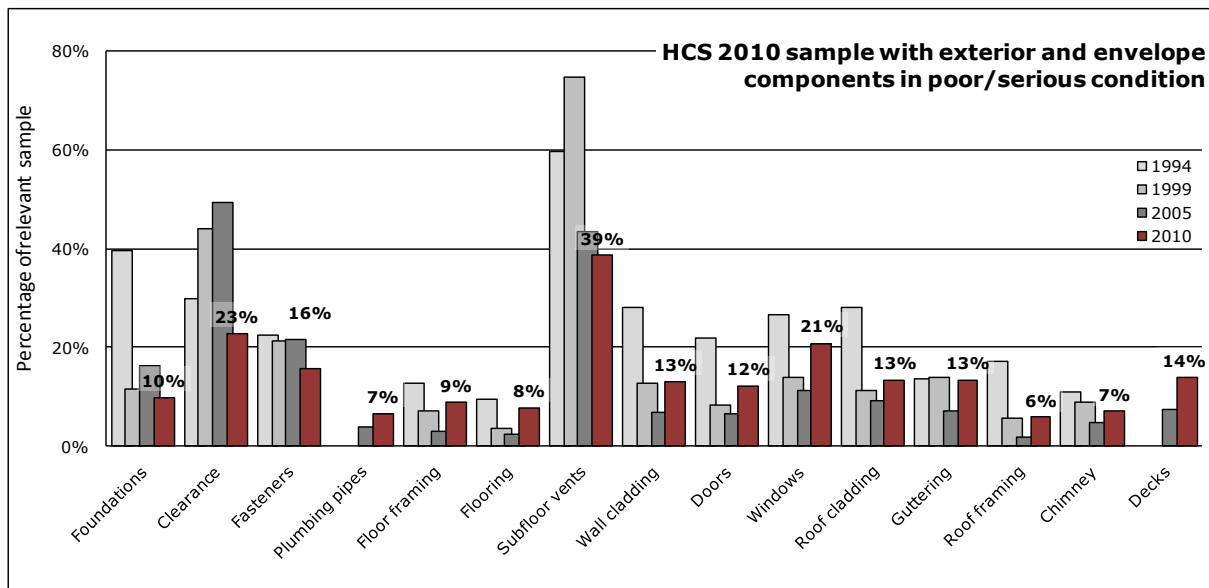
Figure 5: Envelope component condition ratings

Figure 5 shows similar areas with higher percentages of certain components in poor/serious condition. There was an overall reduction in the percentages of poor/serious condition components in most cases but there are some areas where the poor/serious condition category rose including the percentage of decks from around 7% in 2005 to 14% in 2010. Other changes observed between the surveys include:

- The percentage of houses with suspended timber floors with subfloor vents in poor/serious condition has fallen in both surveys since 1999.
- Roof and wall claddings in poor to serious condition increased after consecutive decreases in each of the previous surveys.
- Subfloor plumbing pipes were incorporated into the 2005 survey and carried through to 2010. An increase in the number in the poor/serious condition was observed, although it still represents a small proportion of the sample at 7%.

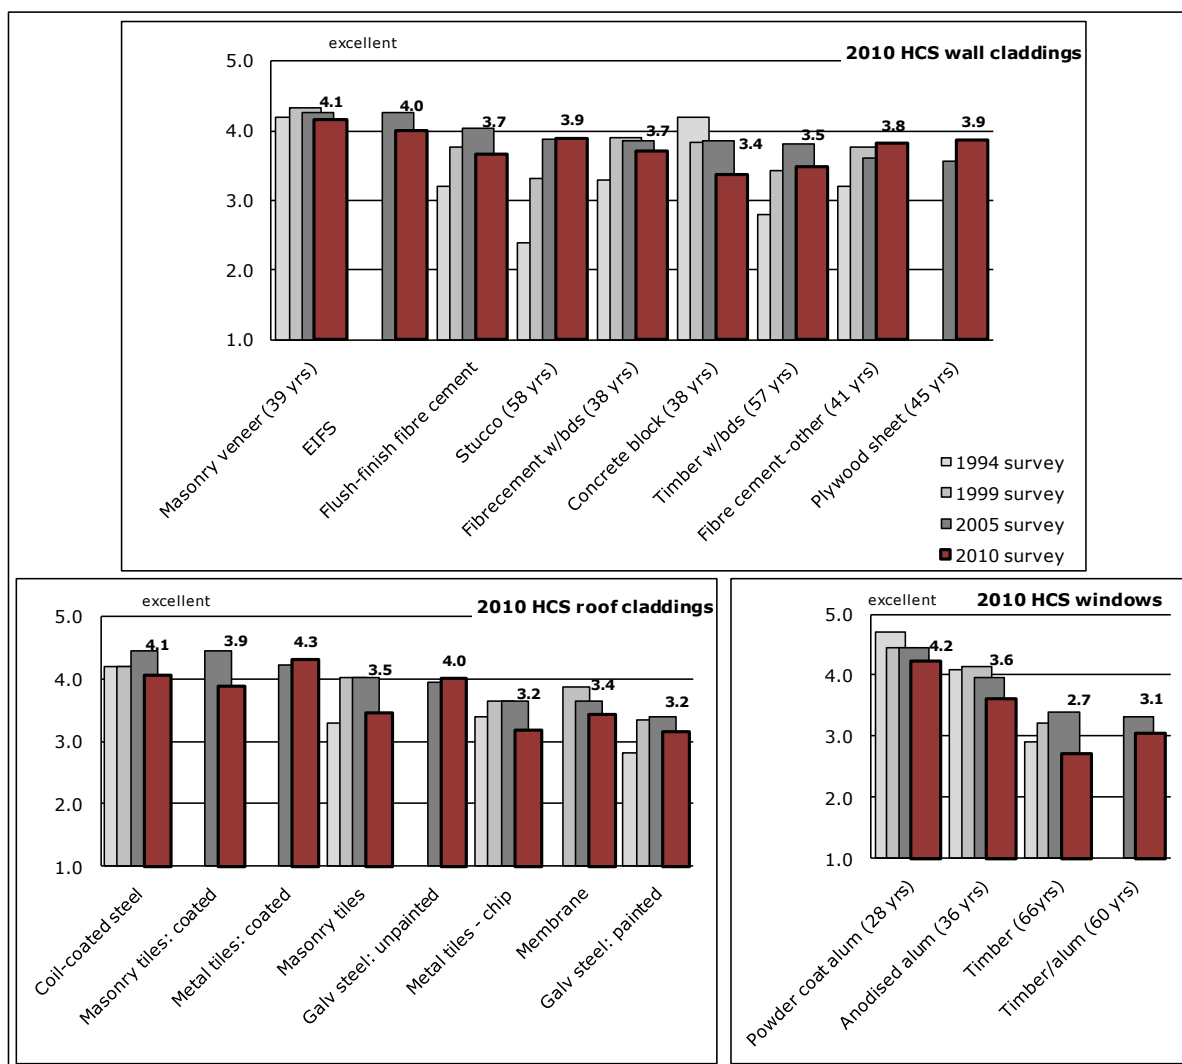
Figure 9: Condition of external materials

The average condition of all of the more common materials identified by the inspectors has been calculated, and this is shown in Figure 9 together with the equivalent figures for the 2005, 1999 and 1994 surveys.

The average ages of houses using the different types of wall cladding and windows are shown in brackets where the sample of houses with the material was sufficient, so that average condition ratings can be assessed against the likely age of the materials. Roofs are not considered, as their replacement generally has less to do with the age of the house and more with the conditions they are exposed to.

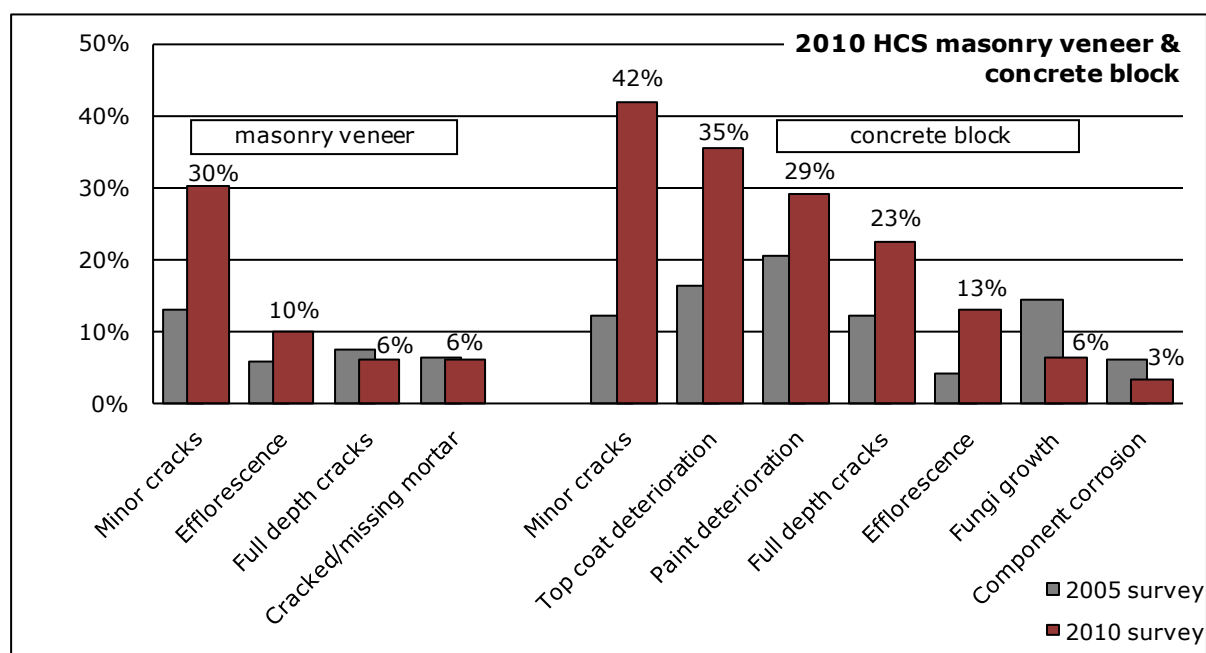
Figure 12: Defects in masonry veneer and concrete block

Around one-third of the houses had at least some masonry veneer cladding, and around 6% had concrete block wall(s). The most common defects for masonry veneer and concrete block are displayed in Figure 12.

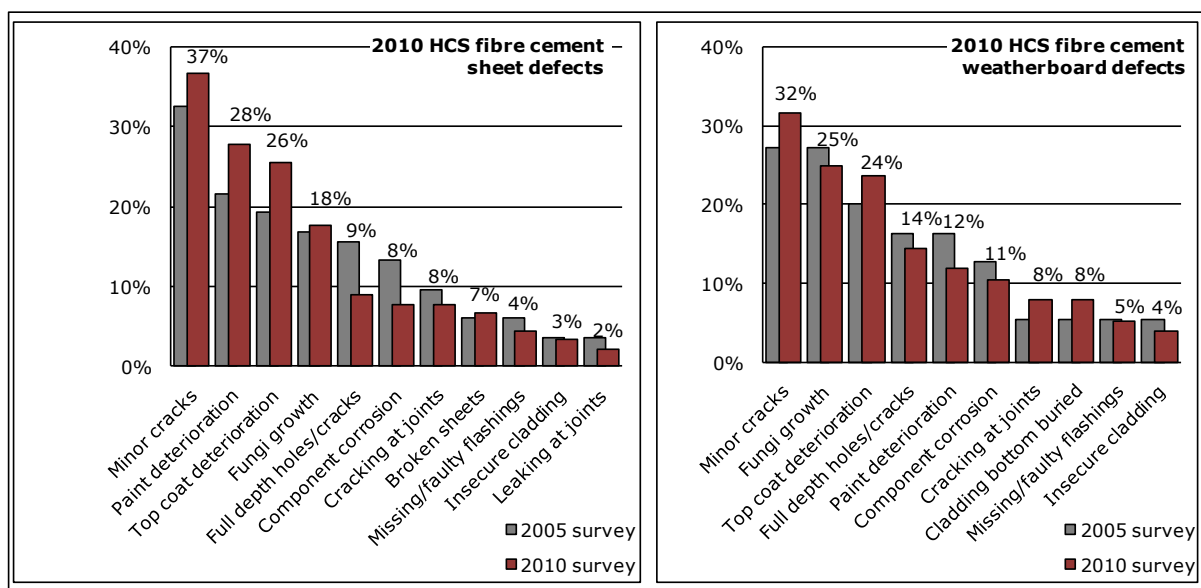
Figure 14: Fibre-cement wall cladding defects – sheet and weatherboard

The most common defect in both fibre-cement sheets and weatherboards was paint deterioration. Interestingly, more fibre-cement weatherboards had fungi growth compared to

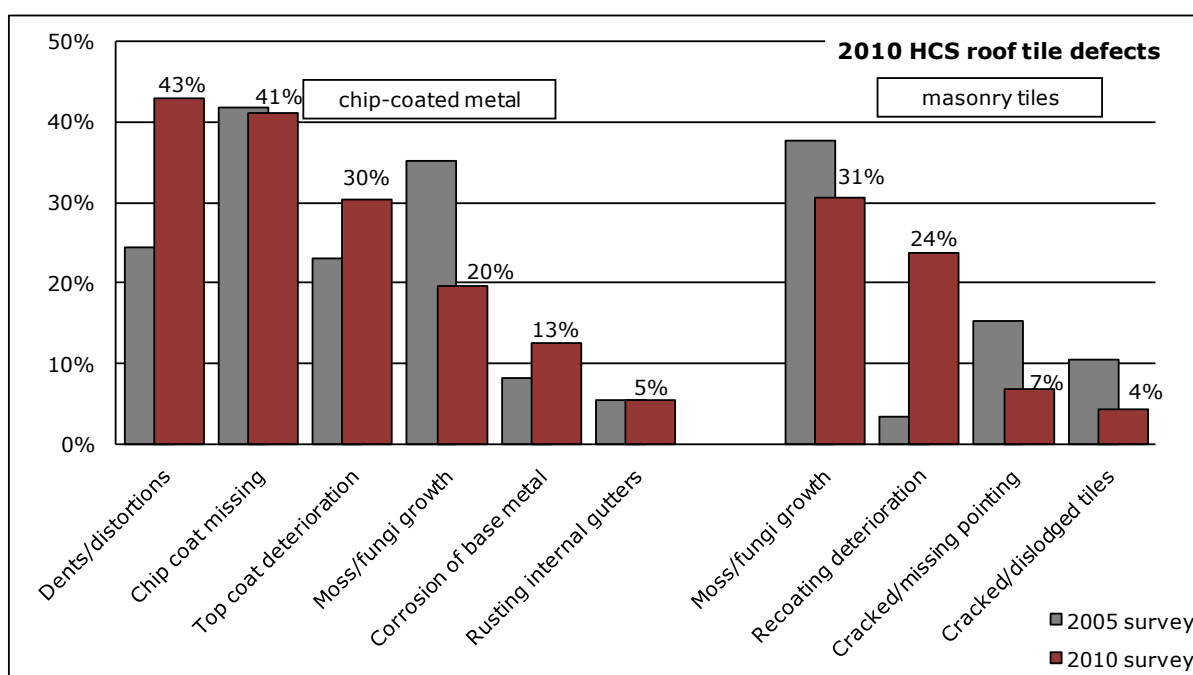
Figure 17: Defects in roof tiles

As shown, the most common defects in chip-coated metal tiles are the erosion of the chip coating, dents and top-coat deterioration. The percentage of chip-coated metal roofs with dents has increased to 43%, which may be related to thinner gauges of steel used on newer tiles, or perhaps increased foot traffic due to maintenance, including moss and fungi removal, or recoating. The reduction in the percentage of chip-coated metal tiles roofs affected by moss and/or fungi suggests this is a strong possibility.

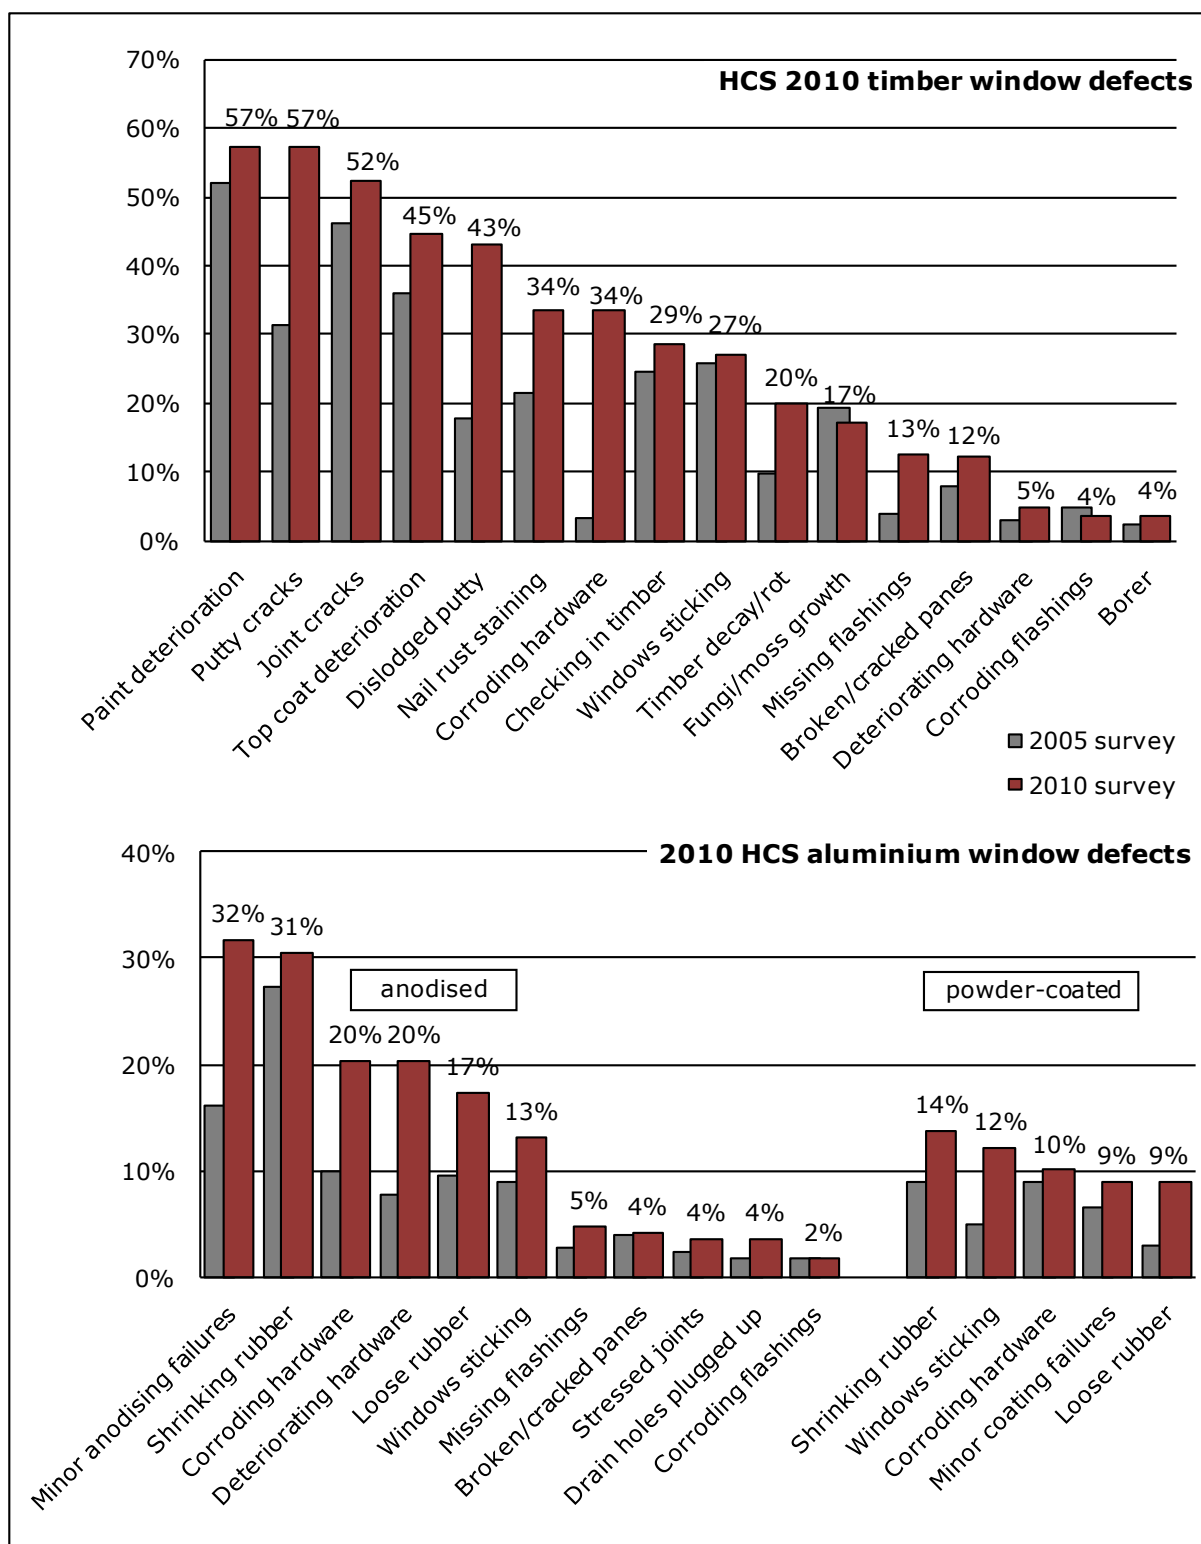
Figure 20: Defects in windows

Figure 20 shows the most common defect for timber windows was the deterioration of paintwork related to the lack of regular/well-executed paint jobs. There was less than 10% of the sample with windows affected by borer, or corroding or missing flashings.

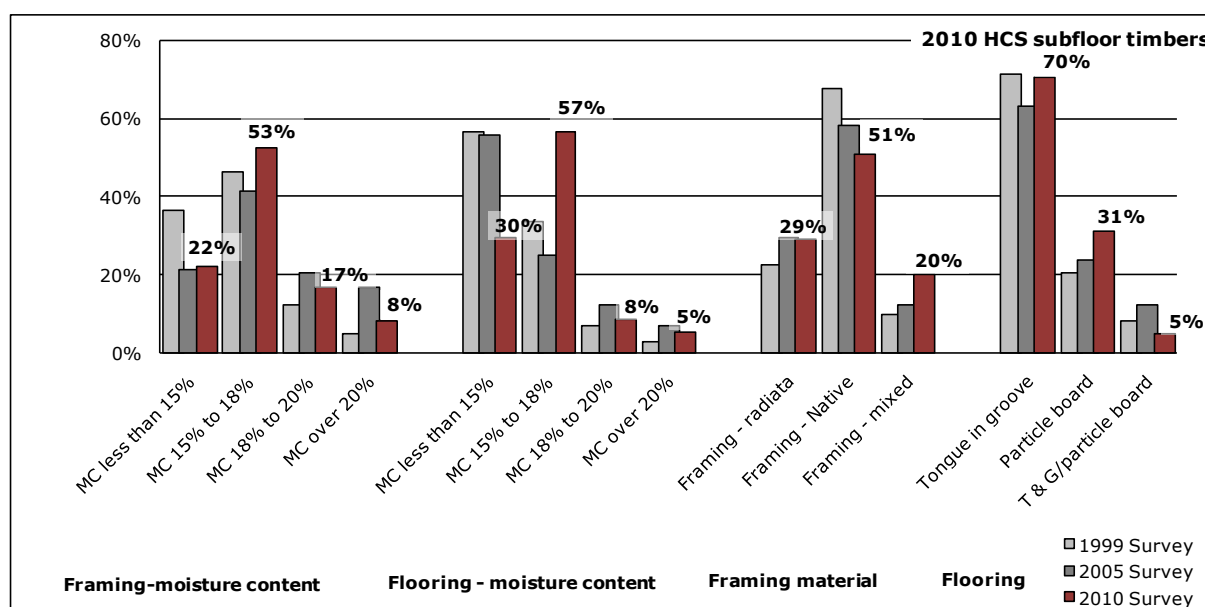
Figure 21: Characteristics of subfloor timbers

As shown, characteristics are similar to those found in the 1999 and 2005 surveys. There is a lower proportion of framing and flooring with moisture content over 18% than observed in 2005, although it is still slightly higher than what was found in 1999. The amount of timber flooring is less than in previous surveys, in part due to the shift in the sample including a higher proportion of concrete slab floors. There was a large increase in the amount of radiata timber, a more modern framing material, and a decrease in native timber framing. This is likely to be due to the increased number of houses in the sample built with modern building materials, and modern alterations to older homes.

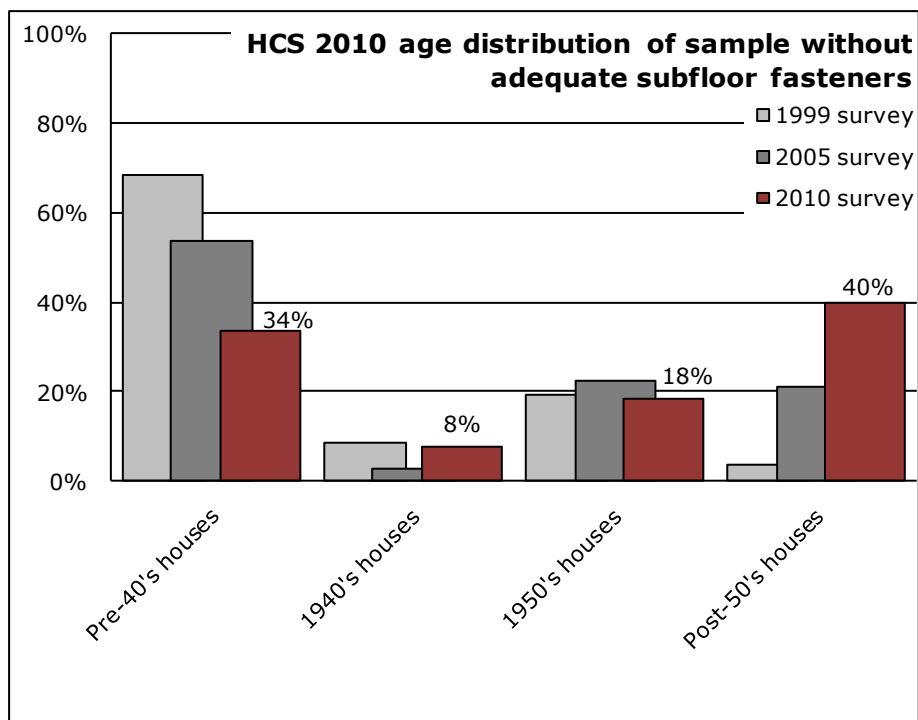
Figure 23: Age distribution of sample without adequate subfloor fasteners

Since the 1999 survey, the percentage of houses without specialised fasteners has fallen from nearly 70% being built pre-1940 to 34%. This could be the result of retrofitting of these subfloor areas, or conversely a larger number of modern homes being built without adequate subfloor fasteners.

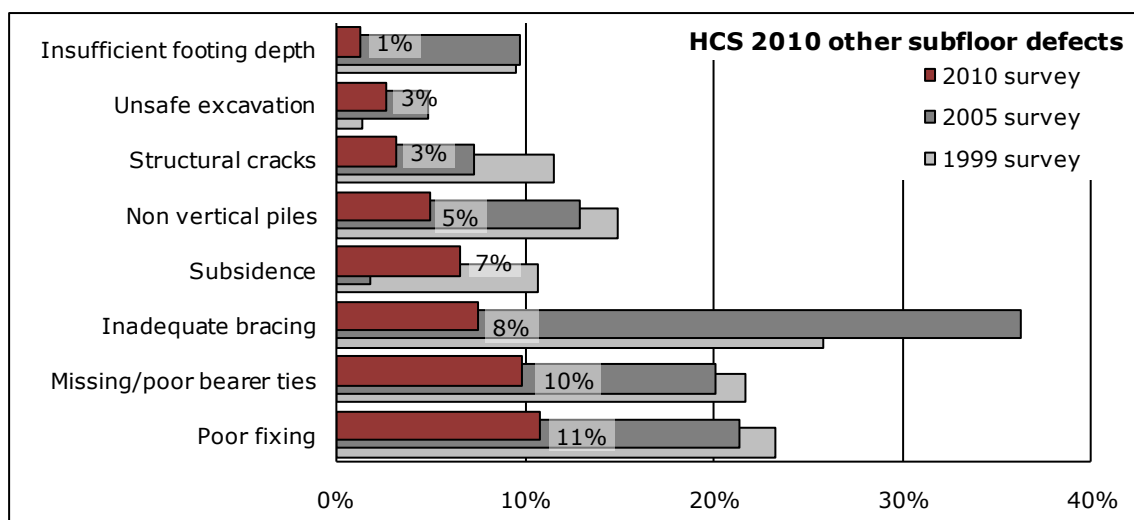
Figure 24: Other subfloor defects

Figure 24 gives non-moisture related defects found in subfloor areas, and compares these to both 2005 and 1999 survey defect findings. The percentages shown reflect the portion of accessible subfloors that exhibit the particular defect, which means that any particular subfloor may have more than one defect.

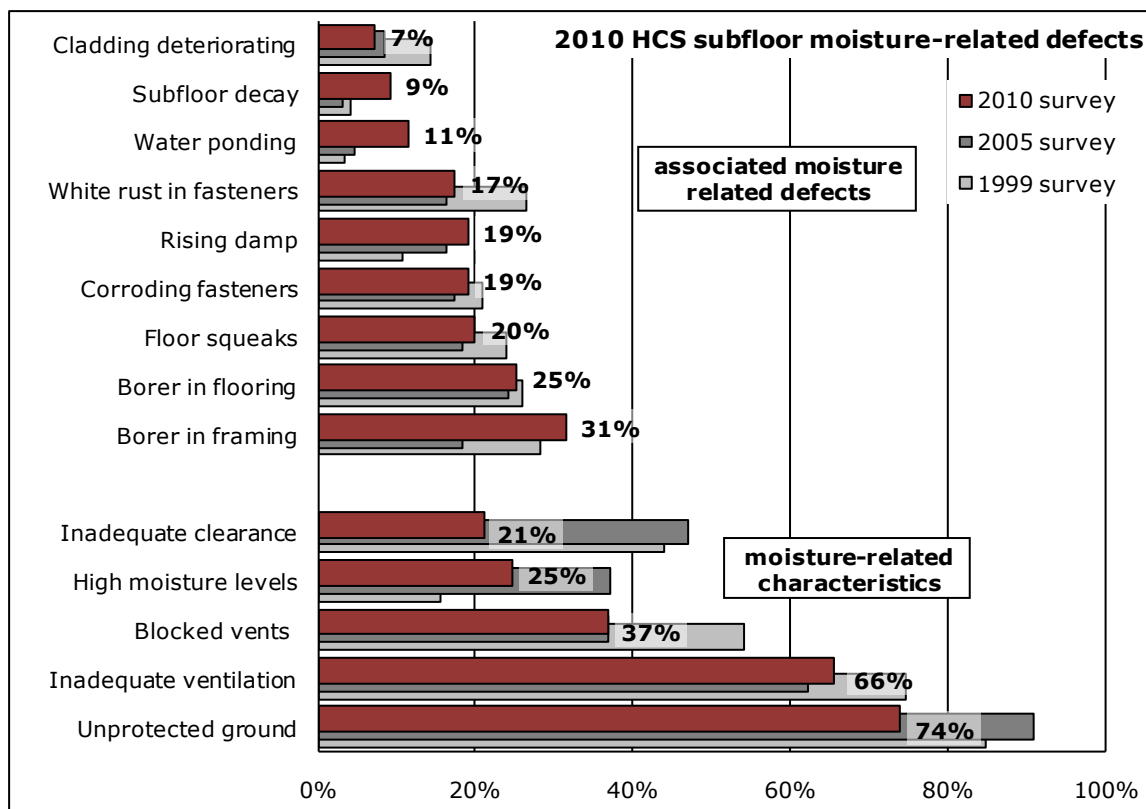
Figure 26: Moisture-related defects in subfloors

The results from 2010 are broadly similar to those of 2005 and 1999. Moisture-related characteristics are higher than the proportion of moisture-related defects, illustrating that there is not a direct correlation. However, there is an influence with increased likelihood of the defects occurring over time if the situation is not remedied.

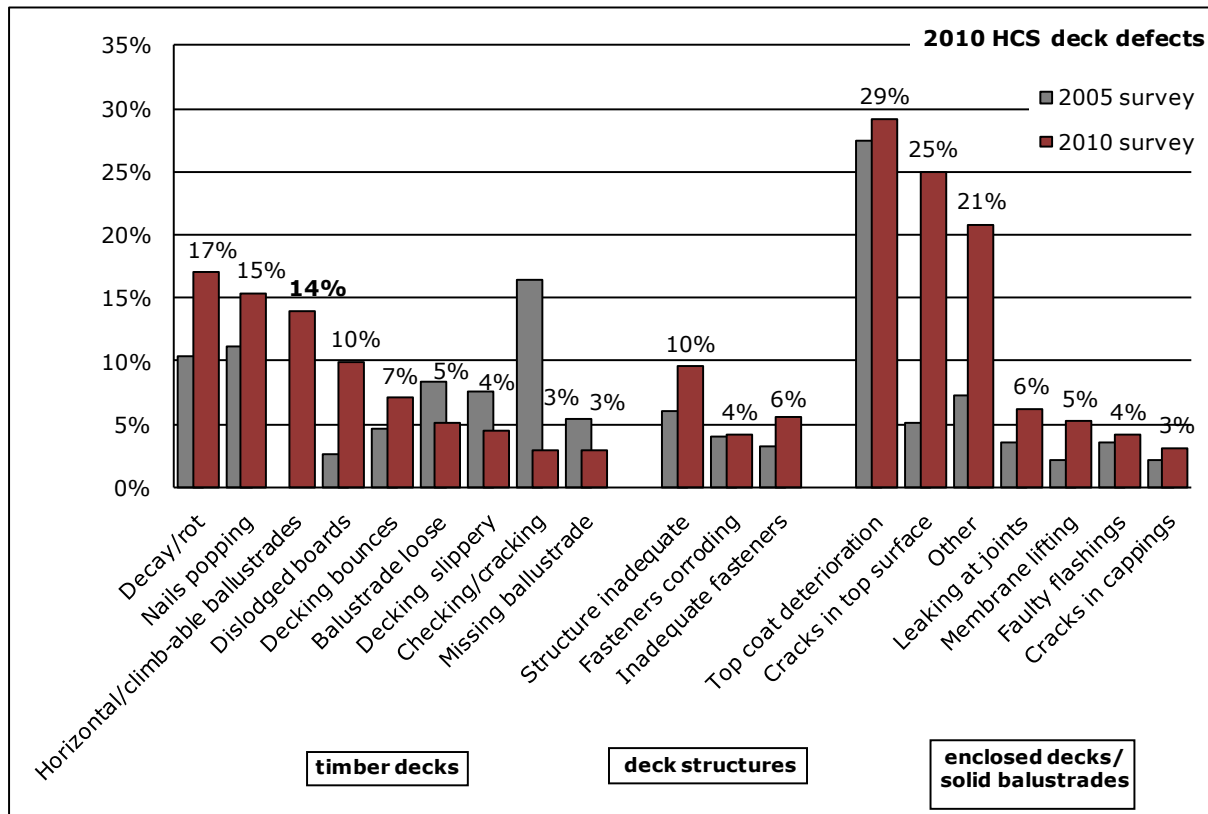
Figure 29: Defects in attached decks

The most common defects in timber spaced decks were decay, nails popping and dislodged boards. For enclosed decks, the most common defect affecting 29% of this type of deck was deterioration of the top-coat. This is mostly cosmetic, unless the paint is a moisture barrier. Ten percent of the deck structures were inadequate by today's standards, and 6% had inadequate fasteners.

14% of timber decks were non-compliant due to having either horizontal balustrades or rails which could be climbed (the data label highlighted in bold). The next section (6.4.3) looks at the compliance of the decks in the sample to current standards.

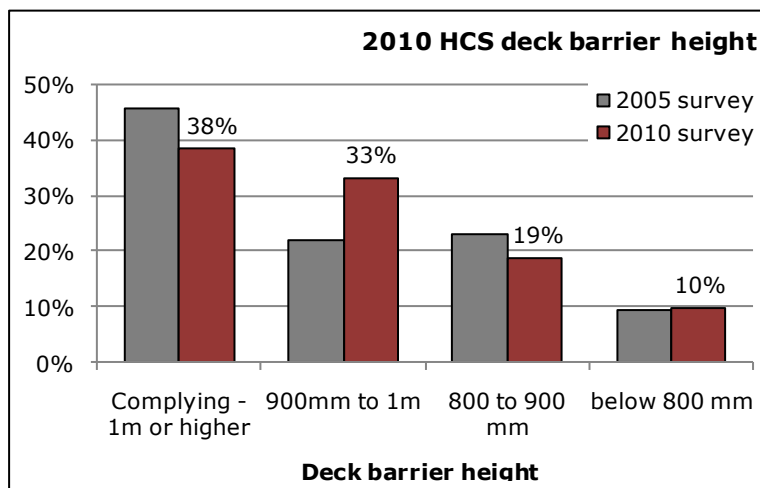
Figure 30: Deck barrier heights – 2010 and 2005

Deck barriers or balustrades were assessed for compliance with Clause F4 of the New Zealand Building Code (Building Code) (BIA 1992), and the results can be seen in Figure 30. The percentage of complying balustrades has fallen from 46% in 2005 to 38% in 2010, at least in part due to the larger number of post-1992 houses in the sample. The other 62% of barriers were non-compliant by modern standards due to either missing balustrades (either removed or never attached to decks above 1000 mm high), balustrades that were too low, openings that were too wide, or balustrades that could be climbed by small children (i.e. horizontal rails).
