CORROSION OF METAL FASTENERS EMBEDDED IN TIMBER

J.R. Duncan

Reprinted from *PROCEEDINGS OF THE AUSTRALIAN CORROSION ASSOCIATION ANNUAL CONFERENCE 26*, Adelaide 17-21 November 1986.

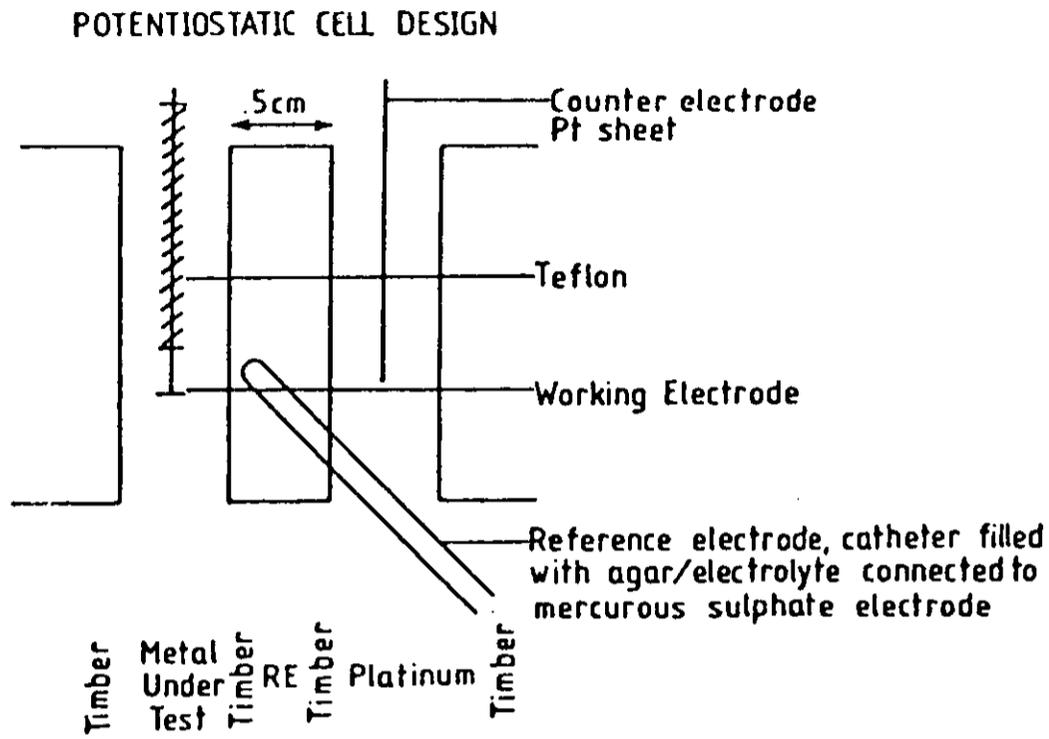
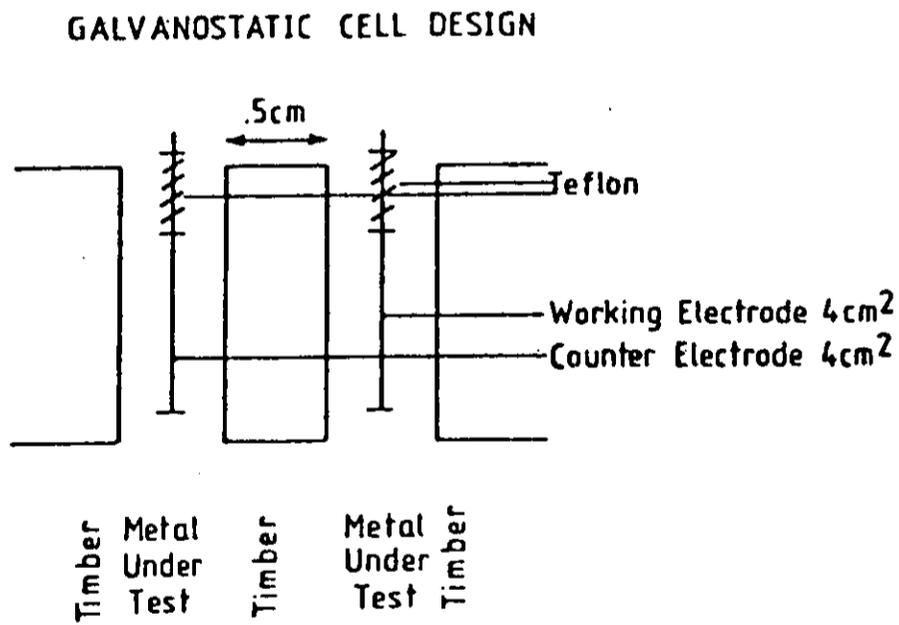
Figure 1 : Cell designs used in study of, metal electrochemistry using a treated timber electrolyte. (from contract report submitted by Smedley).

Cells were constructed using a working electrode plate of zinc or iron clamped tightly between sawn-open halves of blocks of *Pinus radiata* (Figure 1). This cell assembly was equilibrated at different relative humidities to give timber moisture contents of approximately 13-14%, 22%, 26% and 28%, and some cells were also saturated with water. *Pinus radiata* blocks which were untreated or treated to C7 or C2 Specification (20) were used.

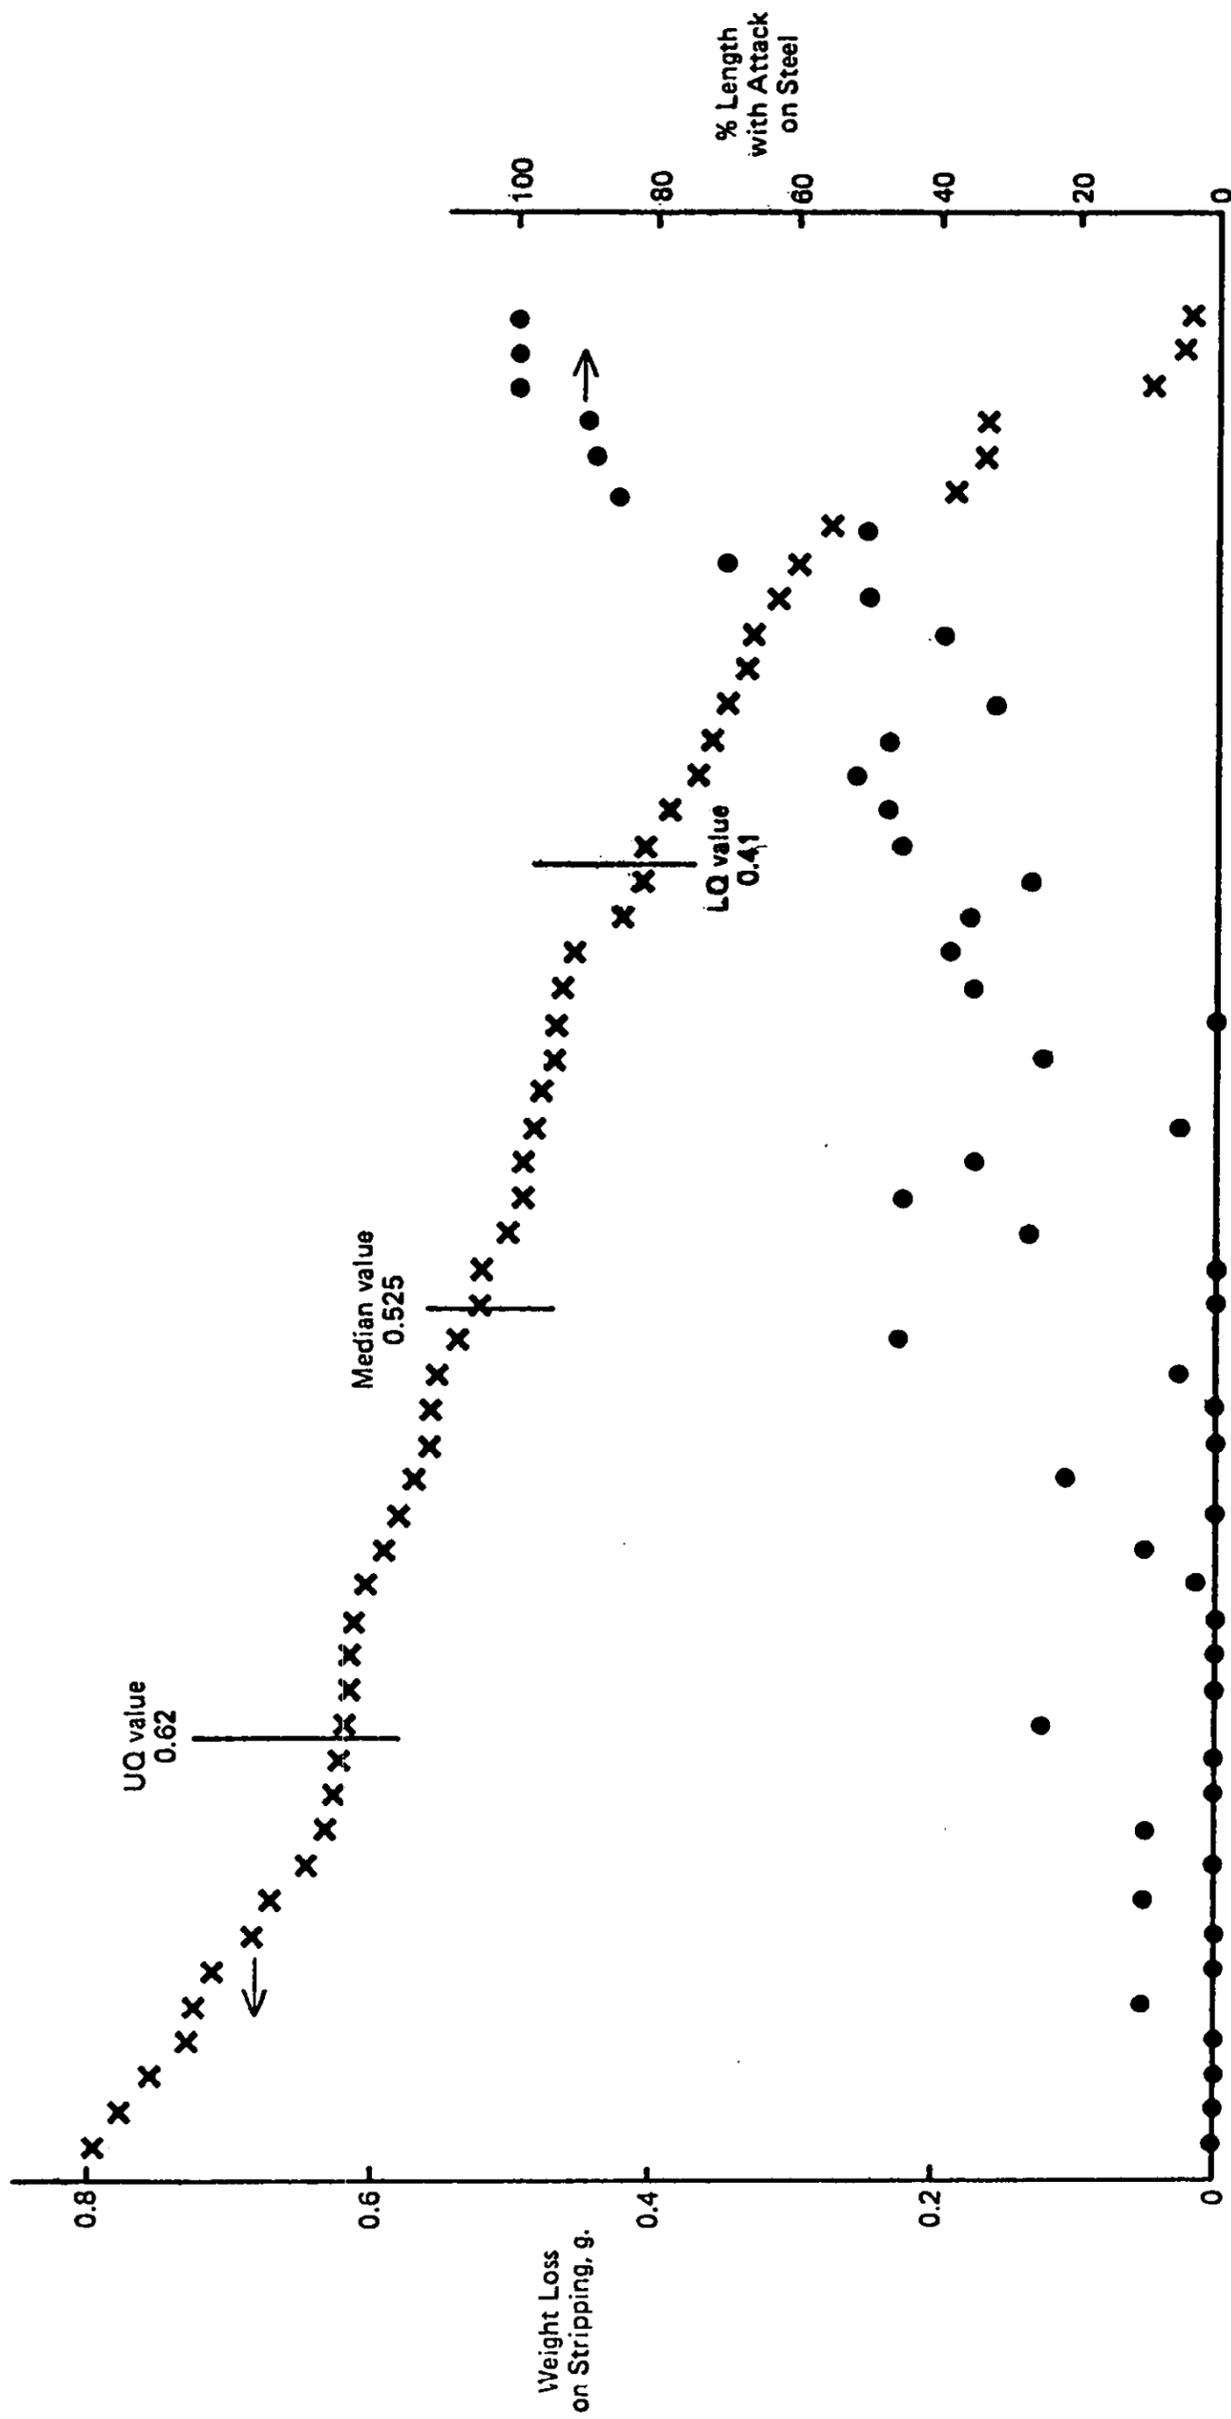
Figure 2 : Residual zinc weights and assessment of attack on steel for hot dipped galvanised steel nails taken from CCA-treated timber fence after eight years.

The second case is that of treated timber which is to be fastened and will remain wet for long periods in service. If copper is present in the preservative, the environment can be very corrosive for aluminium or hot-dipped galvanising. A study of 53 hot-dipped galvanised nails from an 8-year old timber fence at BRANZ Judgeford research station showed that over 60% of the nails had lost so much zinc that the steel was beginning to corrode. The residual zinc weights on the nails are shown in Figure 2. Zinc electroplated mild steel bolts which had held gate hardware were also studied. These bolts had lost virtually all their zinc and the result was severe corrosion of the underlying steel. Copper is a satisfactory fastening material in this application, though surface staining around the heads of exposed fasteners can cause some aesthetic problems. The most favoured material for nails or staples in this application is austenitic stainless steel.
