ISSUE 642 **BULLETIN**

## CHANGES IN THE CONDITION OF NEW ZEALAND HOUSES OVER 25 YEARS

December 2019

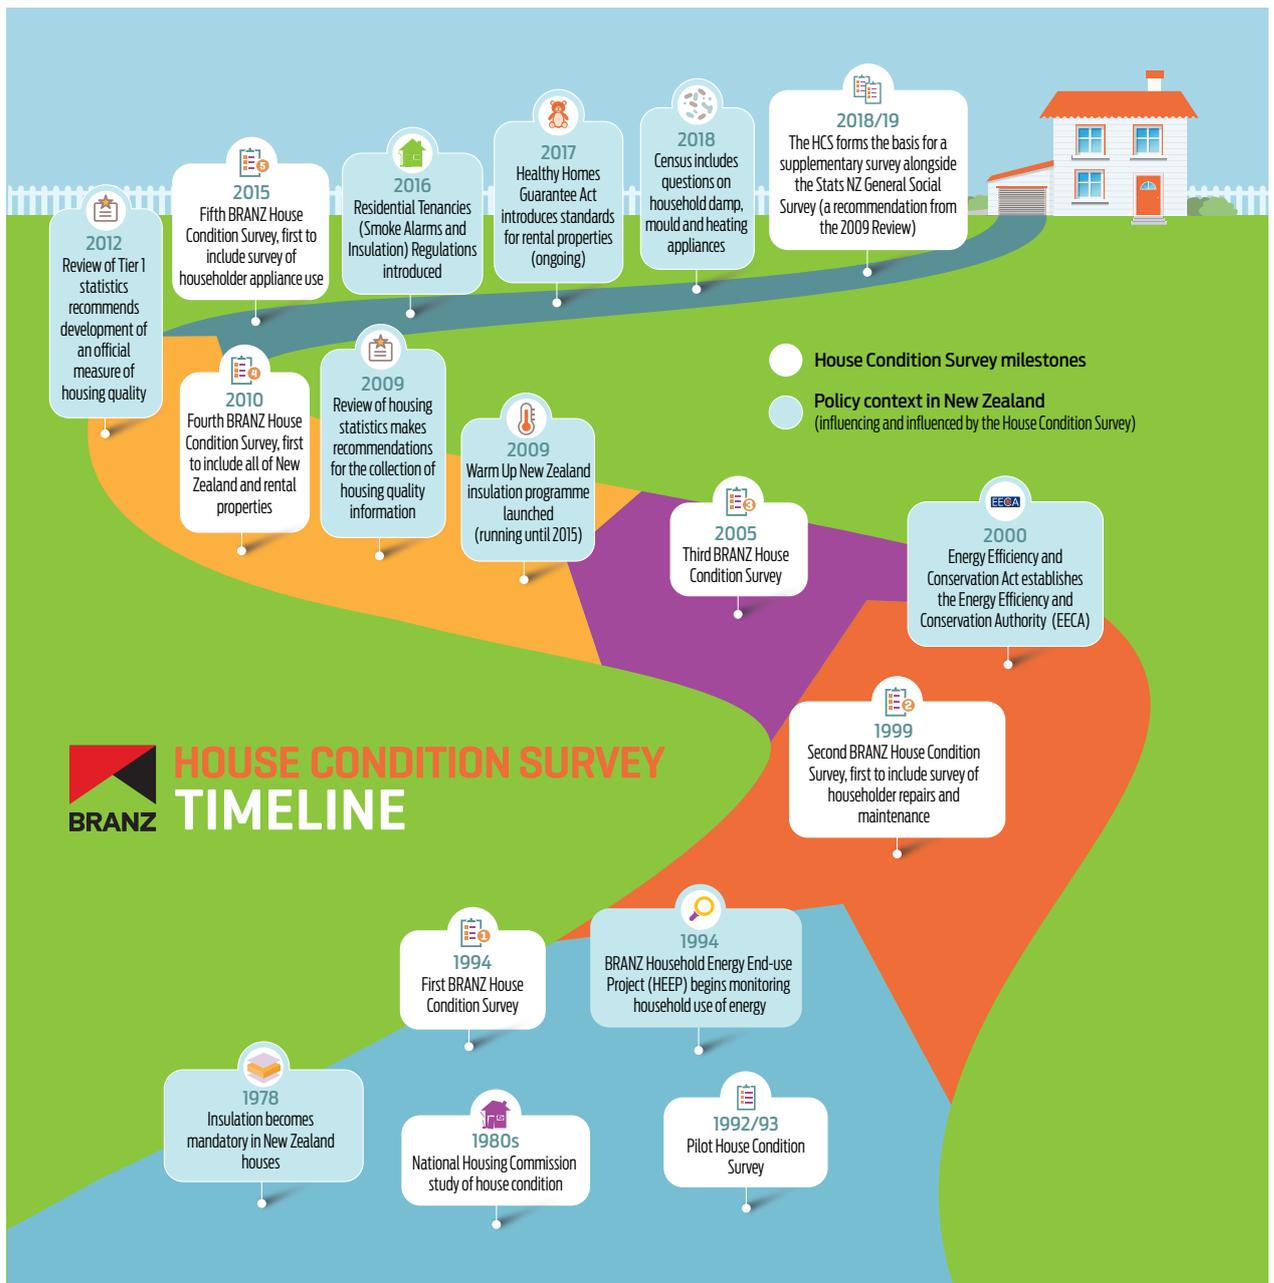
Figure 1. The House Condition Survey timeline.

**2.0.1** The survey has evolved over the years in both content and coverage to meet changing data needs (Figure 1).

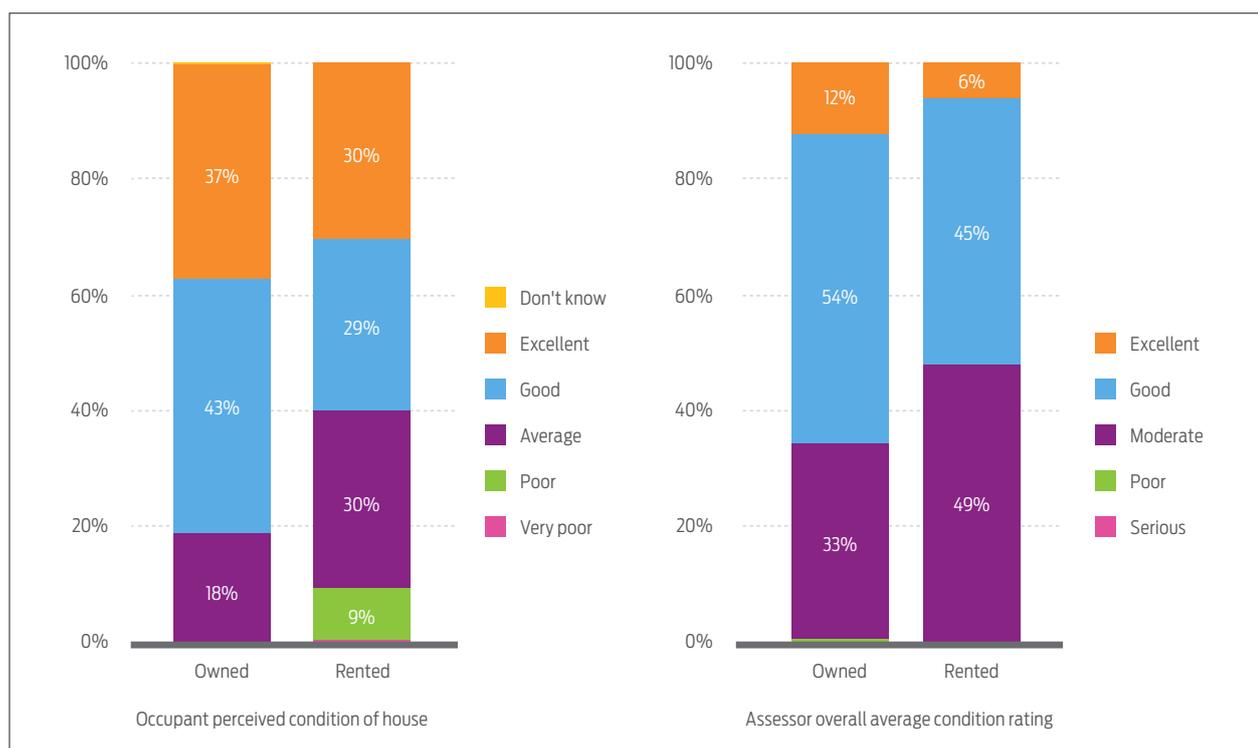
Figure 2. Occupant and assessor ratings of overall house condition.

**3.0.6** The more recent surveys have asked the house owners/occupants to assess the condition of the houses they live in. Each time this question has been asked, for both the rental and owner-occupied properties, the owners/occupants perceive their home to be in significantly better condition than the BRANZ assessor ratings [Figure 2].

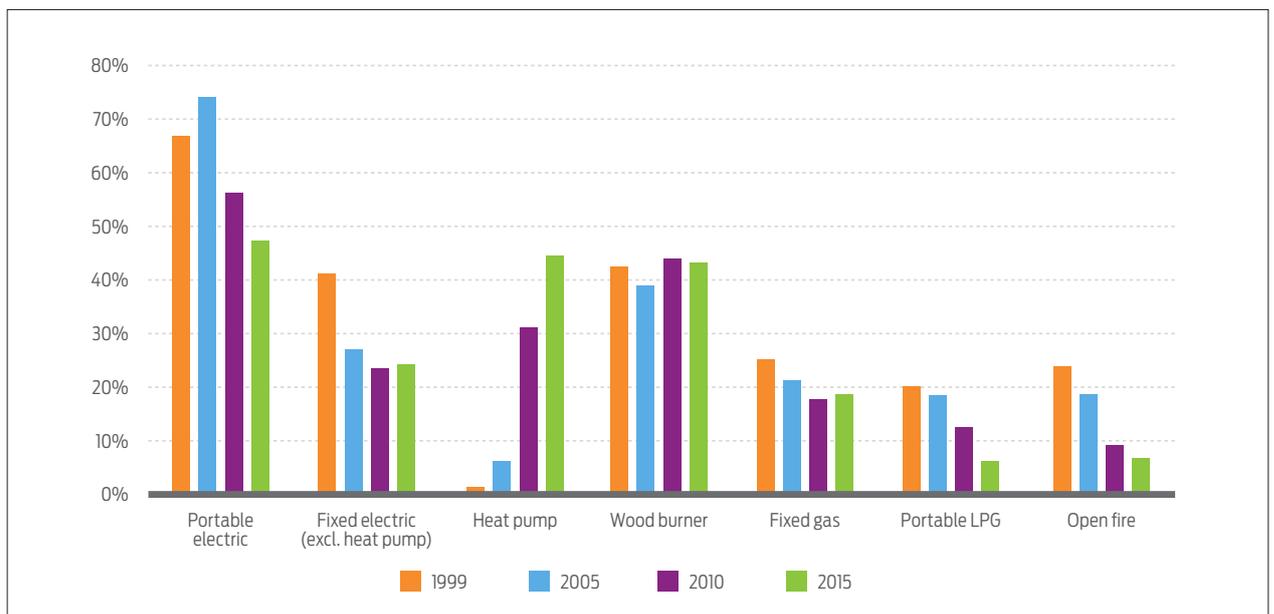
Figure 3. Types of heater in owner-occupied houses, 1999-2015.

**5.1.1** Looking at space heating, the number of wood burners was relatively unchanged over 15 years, being found in around 43% of houses [Figure 3]. Beyond that, there were significant changes:

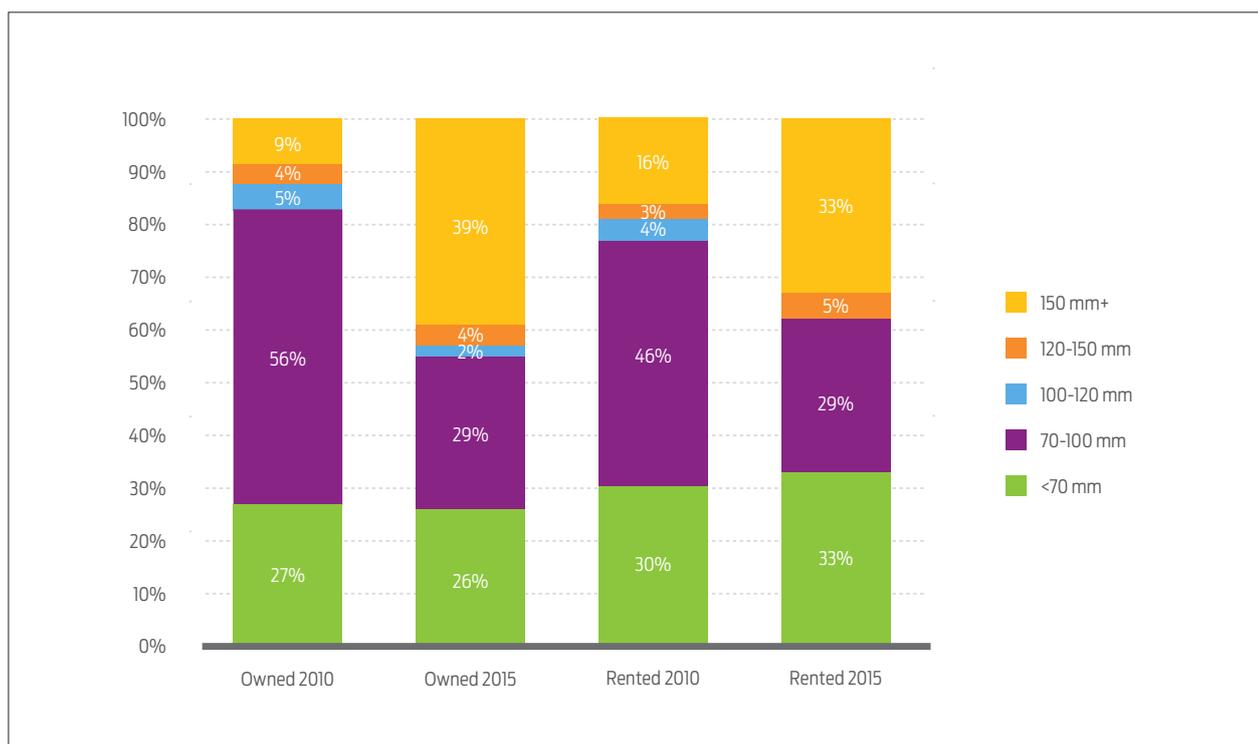
Figure 4. Depth of ceiling insulation [owned and rented houses, 2010 and 2015] where there was at least 80% coverage of the roof space.

**5.4.2** A particularly large increase in insulation was recorded between 2010 and 2015 [Figure 4]. Part of the explanation for this may be the government-funded Warm Up New Zealand programme. This scheme, which ran from 2009 to 2016, provided \$465 million to install insulation in almost 300,000 homes of lower-income households.

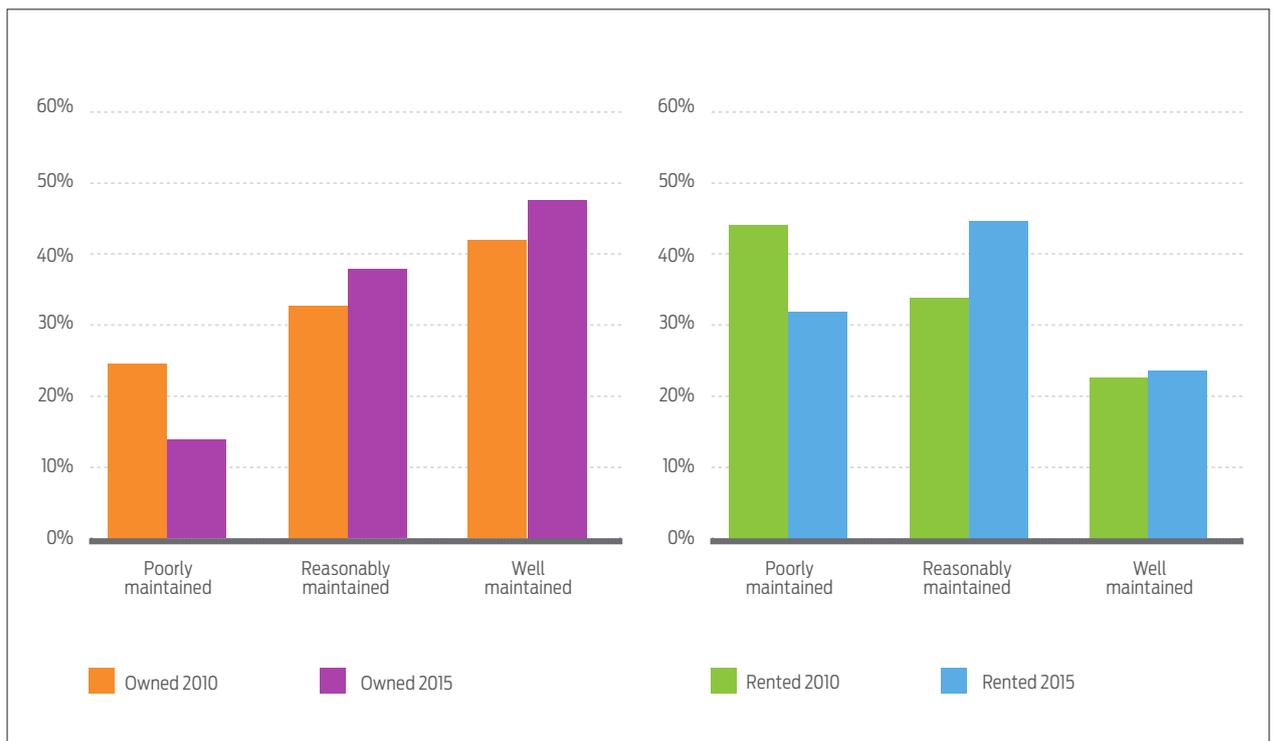
Figure 5. Changes in overall assessed level of maintenance between 2010 and 2015.

**7.0.3** Looking at the 2010 and 2015 data, there are indications that house maintenance may be improving, with a clear drop in the number of both owner-occupied houses and rentals assessed as poorly maintained (Figure 5).
