STUDY REPORT

SR 316 (2014)

New housing condition – A preliminary assessment

I C Page

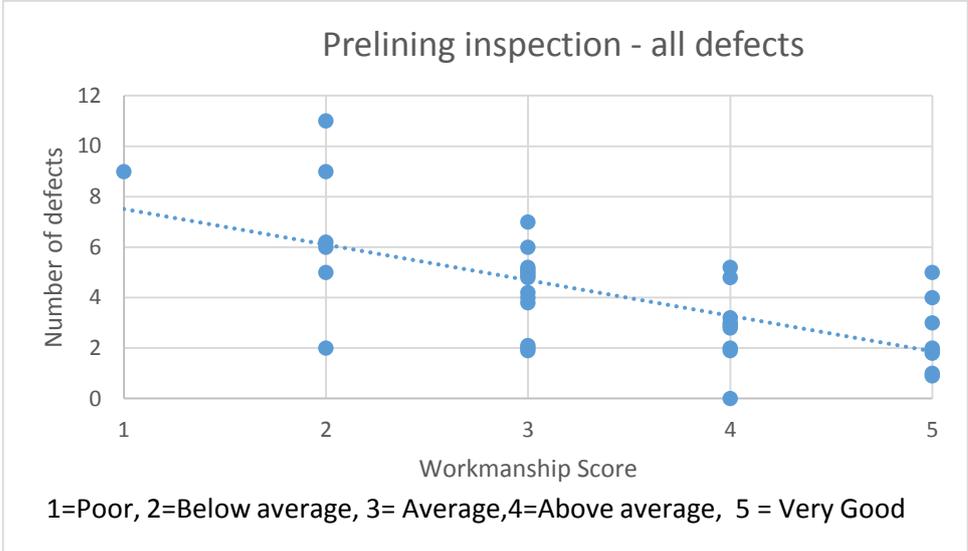
An overall assessment of workmanship was made on a five point scale ranging from very good to poor. Figure 1 shows a scatter chart of results for the 36 houses in the sample. The vertical axis is a count of the number of defects in a house, including code compliance defects and amenity or quality type defects. Generally houses with more defects were rated lower in overall workmanship, as is to be expected. The most common defects were incorrectly fixed window joinery, poorly fitting insulation, and straps and nogs sitting proud of the framing.

Figure 1 Pre-lining inspection defects v workmanship score

The inspectors were asked to give an overall rating for workmanship on a 1 to 5 scale with 1= poor, 2= below average, 3= average, 4= above average and 5= good. Figure 1 and Figure 2 show the number of defects against their workmanship score. The trend is downward from left to right, as expected but even with a good workmanship score there are still a significant number of defects in some houses. This suggests there may need to be refinement in scoring overall workmanship. Further investigations are needed in how the inspectors assess the workmanship score.

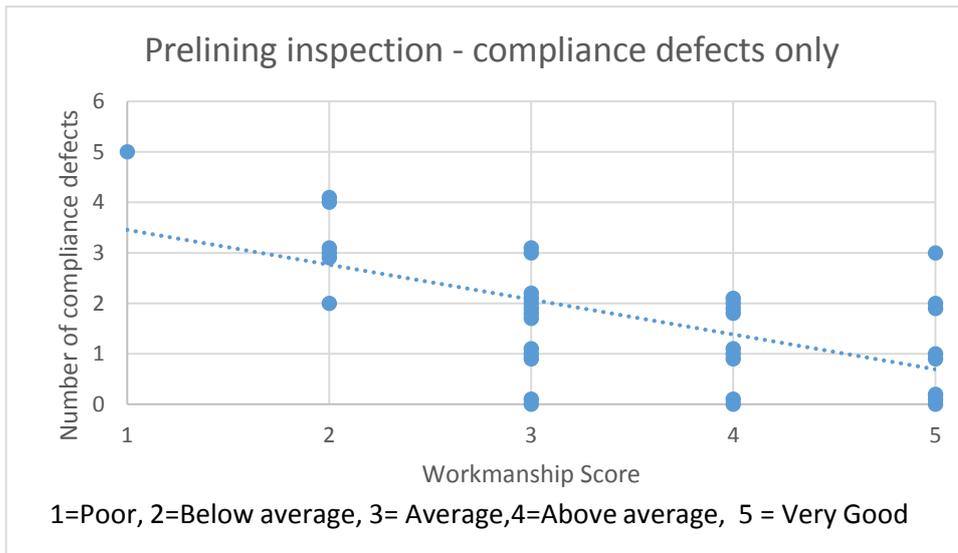
Figure 2 shows the same data but for code compliance defects only. These defects relate to the frame and connectors and the defects counted were inadequate window fixing and air seals, large cut-outs in frames, inadequate holding down bolts, and penetrations not sealed to the wrap correctly. Other defects including misaligned studs and nogs, compressed/missing insulation, and particleboard flooring in wet areas were counted as “quality” type defects and not included in the compliance defects. The reason was the work has been done, but not to a completely satisfactory standard, affecting the performance or finish so it is counted as a quality defect rather than affecting code compliance.

Figure 2 Pre-lining inspection defects – compliance defects only

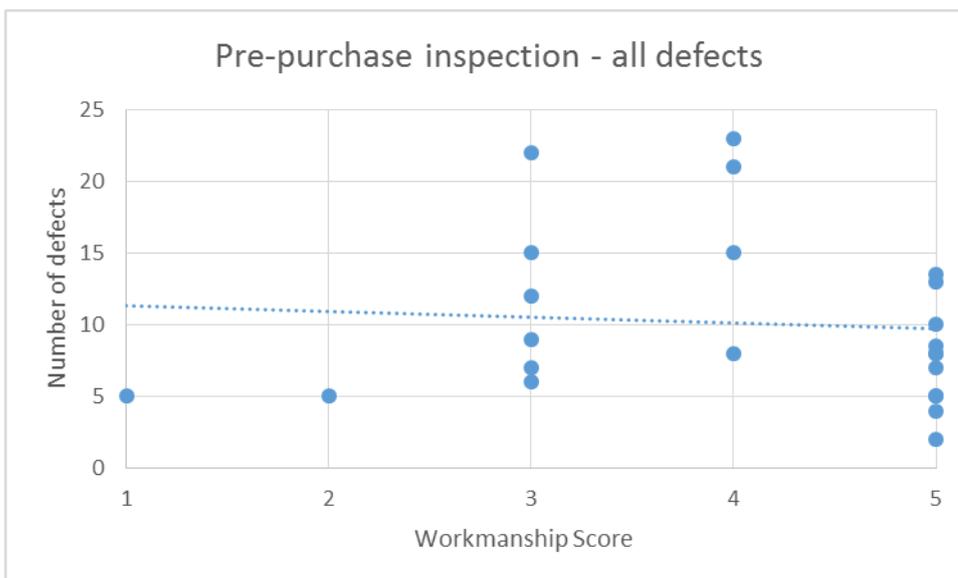
Figure 3 shows a scatter chart of results for the houses inspected. The vertical axis is a count of the number of defects in a house, including code compliance defects and amenity or quality type defects. Generally houses with more defects were rated lower in overall workmanship although the link was not as strong as for the pre-lining inspections.

Figure 3 Pre-purchase inspection defects v workmanship score

The **pre-purchase inspection** results are shown in Figure 3, Figure 4, and Figure 5.

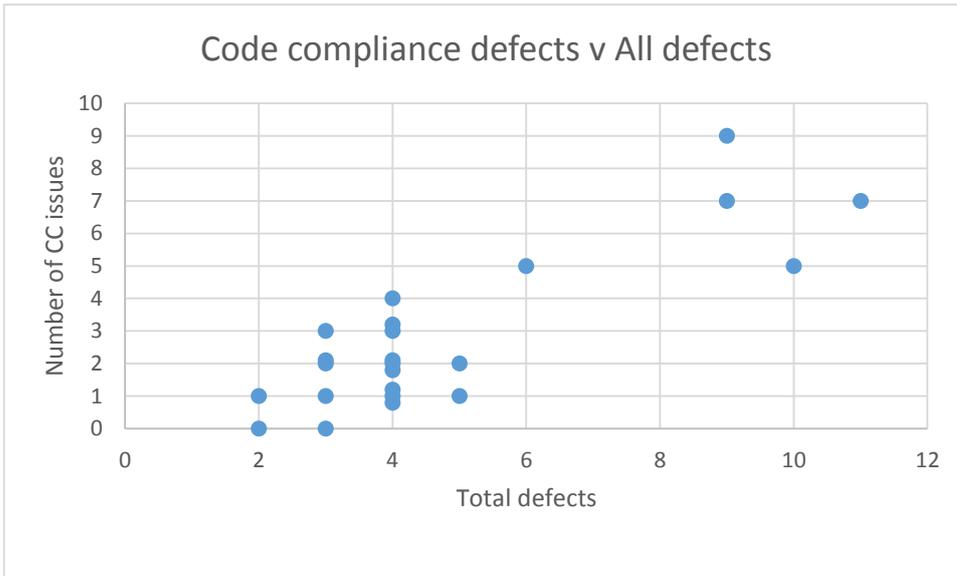
Figure 4 shows a scatter chart of code compliance defects on the vertical axis, against total defects on the horizontal axis. The two are strongly related, but houses with smaller numbers of compliance defects also tend to have smaller numbers of *additional* quality defects. For instance, houses with three total defects in total averaged 1.5 compliance defects and 1.5 quality defects. Houses with four total defects averaged around 2.1 compliance defects and 1.9 quality defects.

Figure 4 Pre-purchase inspection defects – Compliance v all defects

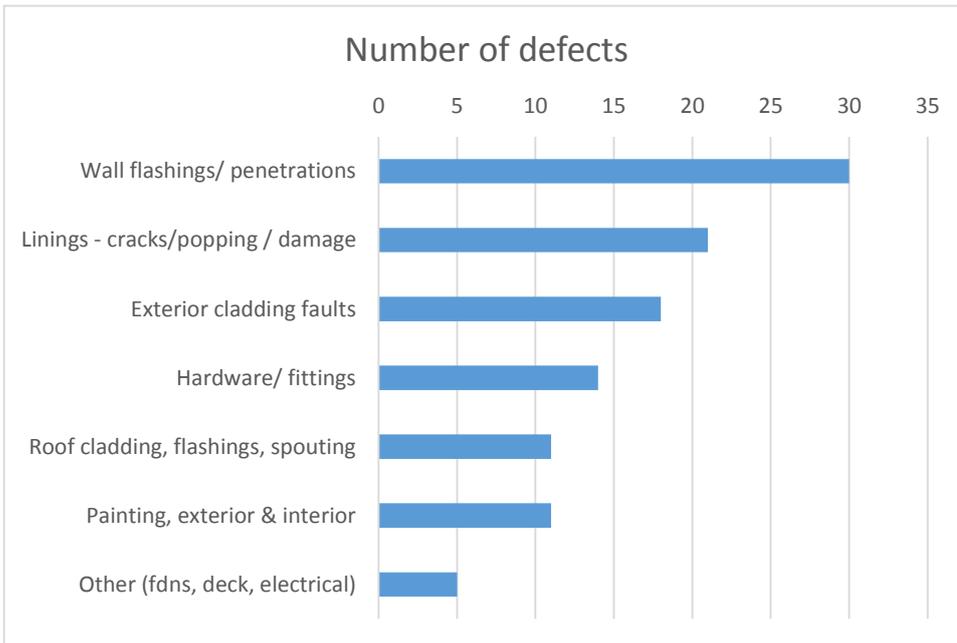
Figure 5 shows the mix of main compliance and quality defects. The most common are wall flashings and penetration defects, cracked linings, and wall cladding defects (cracks/damage, loose bricks/ mortar, inadequate ground clearance to cladding). The defects counted as code compliance issues are wall flashings/ penetrations, exterior cladding cracks and loose bricks, and damaged roof cladding and flashing defects. The other defects in Figure 5 are considered to be quality type defects.

Figure 5 Pre-purchase inspection defects – Types of defects by number

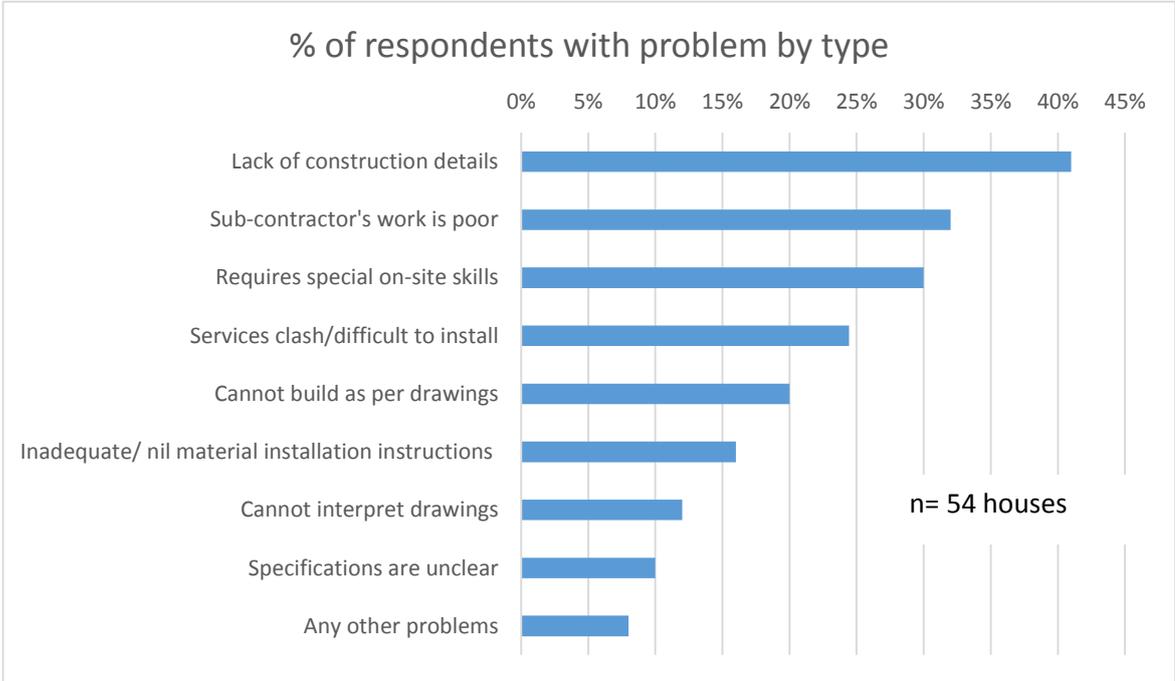
In addition to on-site inspection a postal survey was sent to builders asking about their problem areas in constructing new houses, see Figure 9 in the appendix. A list of problems was provided and respondents ticked those they have experienced in the last year on their housing projects. See Figure 6 for the results.

Figure 6 Problems areas by frequency

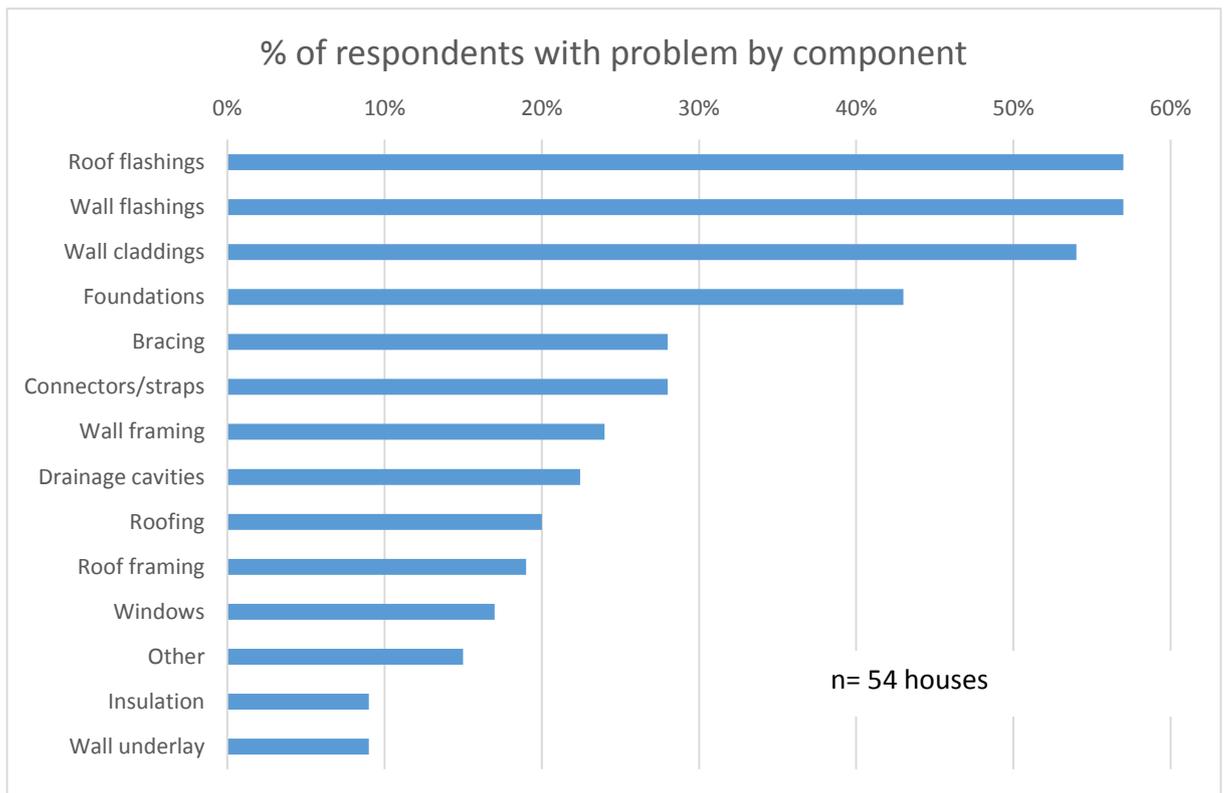
Over 40% of respondents had issues with lack of construction details. The results by component are in Figure 7 and indicate the difficult or problem areas are roof and wall flashings (i.e. window and door openings), with over 55% of respondents having issues.

Figure 7 Problem areas by component

The most mentioned problem areas, flashings and wall claddings, are similar in ranking to those from the house inspections. The postal survey asked for builder's experience over a year and it shows that over 50% of builders had problems with these components over that time.
