The Racking Behaviour of Curtain Wall Glazing During Simulated Earthquake

Andrew B. King and Stuart J. Thurston

From: Proceedings of the Tenth World Congress on Earthquake
Engineering, Vol. 6, pp. 3317-3321, 1992

Building Research Association of New Zealand (BRANZ), New Zealand

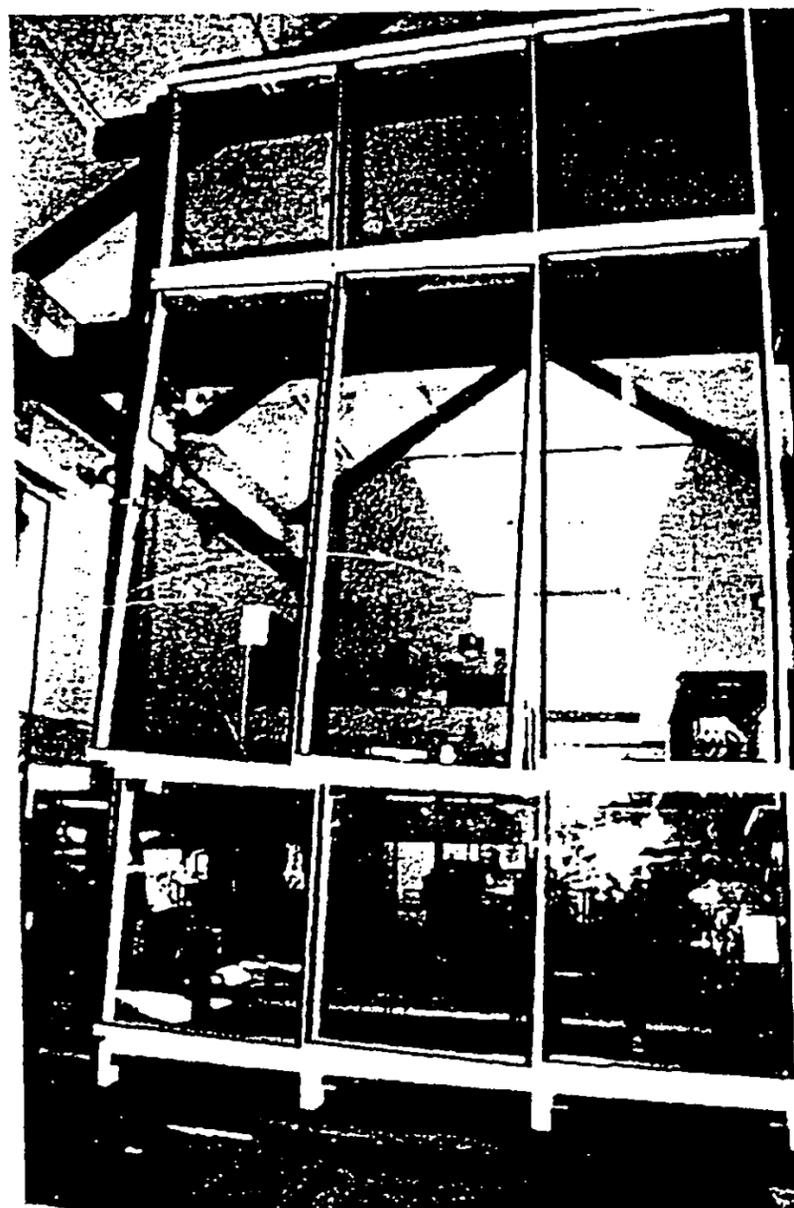
Figure 6: Four sided unitised panels.

The four-sided silicone panels were subjected to displacements in excess 80 mm (0.03H) without "failure". The shear distortion was accommodated by a combination of slip between the units, and relaxation of the support brackets. At high drift levels, the complete panels were observed to rotate (being eccentrically supported) at which stage the panels disengaged from each other (Figure 6). One of the glass panes developed a diagonal crack (within the upper half of the panel) as a result of out-of-plane distortion which occurred following this disengagement. The glass remained attached to the frame through the silicone and therefore did not fulfil the "failure" criteria.
