The Fire Performance of Protected Nail-on Gusset Connections for Loaded Glulam Members

K.Y.S. Lim and A.B. King

Reprinted from *Proceedings of the Second
Pacific Timber Engineering Conference,
University of Auckland,*
28 - 31 August 1989

Structural Engineering Section
Building Research Association of New Zealand

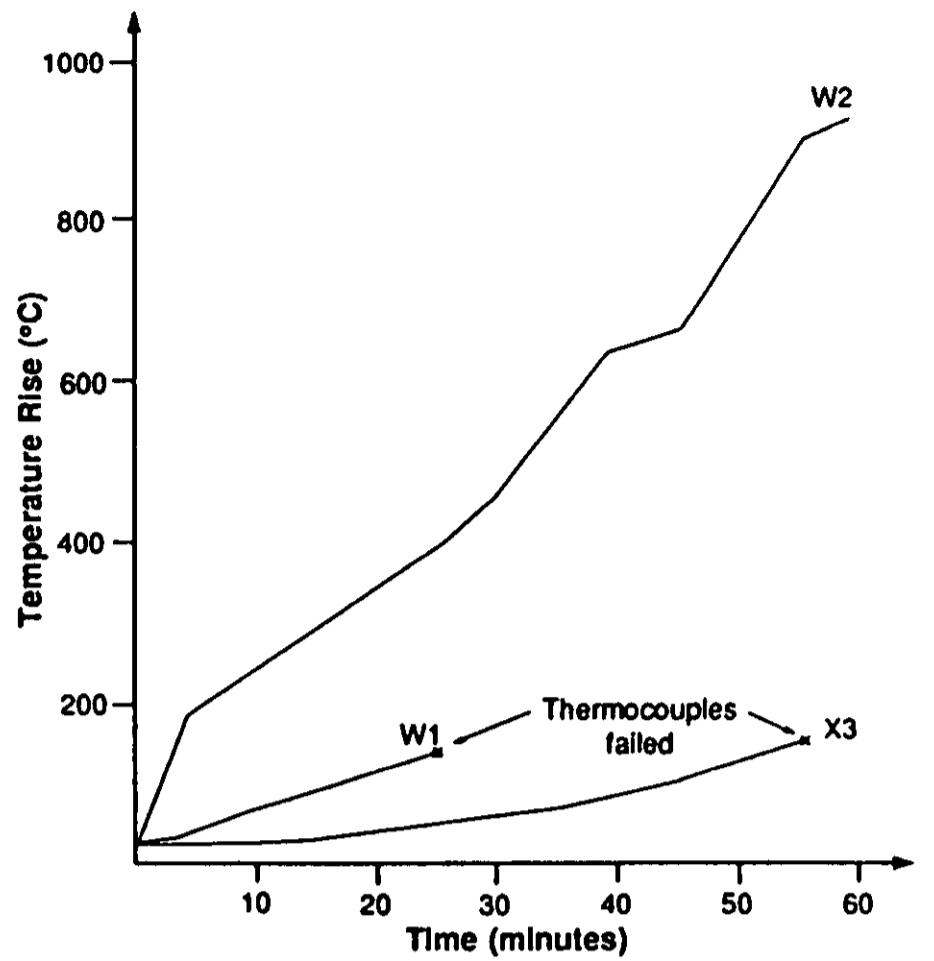
Figure 4a: Temperature on beam surface beneath gussets - Test 2

Though the failure of beam W2 was remote from the joint after 53 minutes, the condition of the joint observed following the completion of the test (60 minutes) was such that its ability to carry the load up to one hour is considered doubtful. As shown in Figure 4a, the glulam beneath the gussets commenced charring after 15 minutes of the test (assuming an 'onset of char' temperature of 300 degrees C). Furthermore, at the time of failure, the deflection

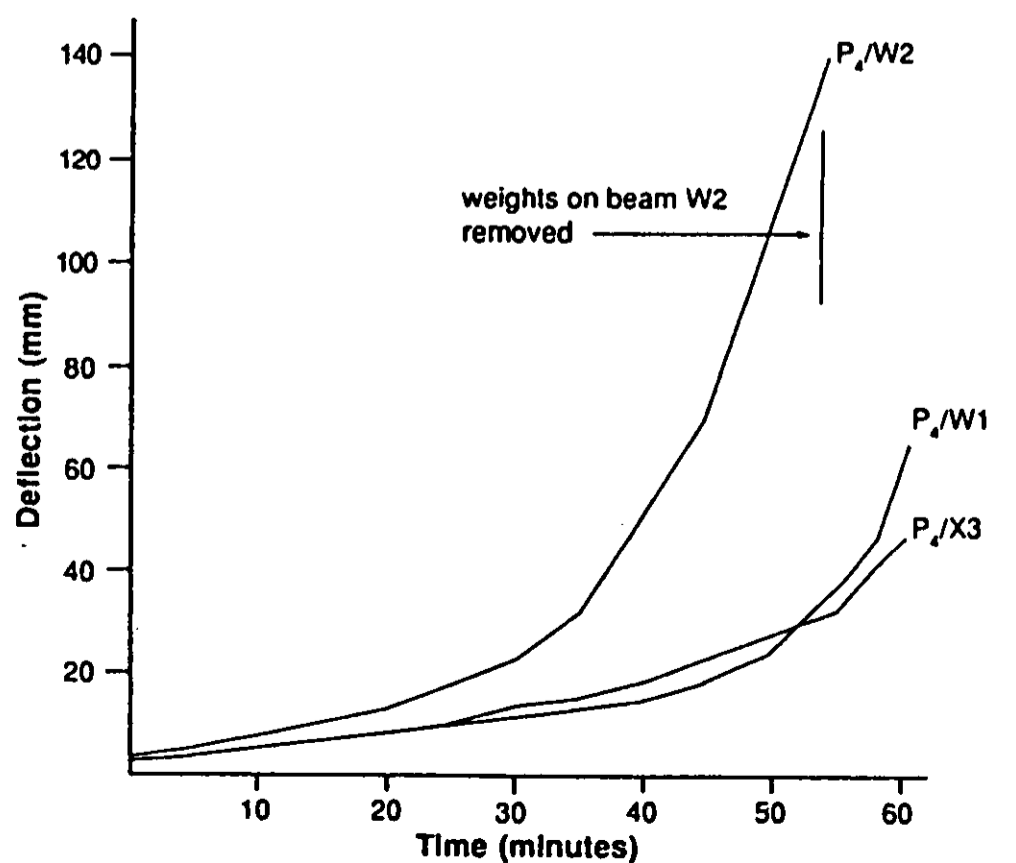
Figure 5a: Midspan deflections - Test 2.

Both beams exhibited similar deformation characteristics up to about 57 minutes as shown in Figure 5a. At one hour, the vertical joint displacement of X3 was 47 mm compared to 64 mm for W1. The plot of joint rotations against time (Figure 5b) indicated that, up to one hour, the joint with the steel gussets had smaller rotations and was therefore slightly more rigid.
