Positional material deterioration over the building envelope of a coastal building

BRANZ is researching how the corrosion of construction materials is affected by building micro-environments and where on a building the material is installed. This Research Now reports on a building very close to the marine influences of Auckland Harbour. Research Now: Positional corrosion #1 and #2 reported on research carried out on a test building on the BRANZ campus at Judgeford, near Porirua, while Research Now: Positional corrosion #4 covers a building in Rotorua's geothermal environment.

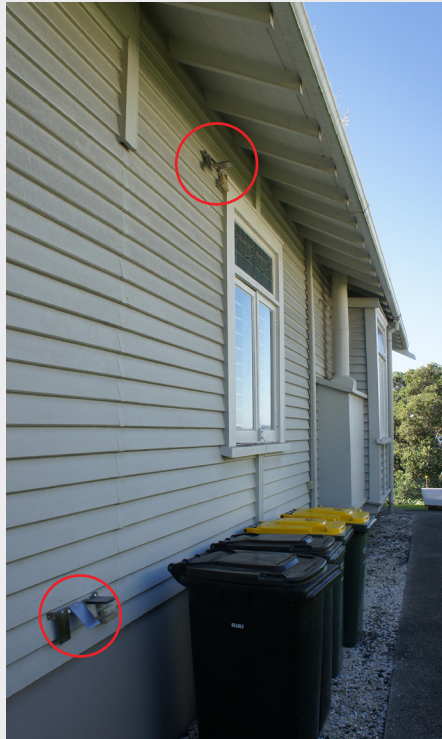
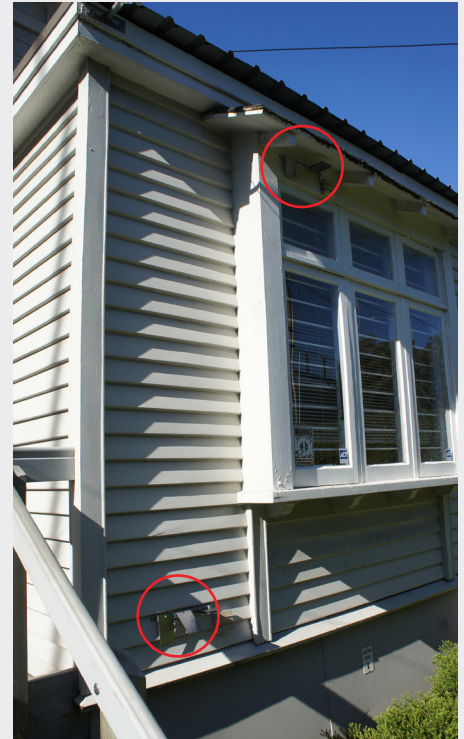
Figure 1. Monitoring positions on the test building.

Monitoring was carried out at two positions on each wall (Figure 1):

- A low position fully exposed to the weather approximately 0.23 m from the bottom of the wall cladding on the north, south, east and west walls.
- A sheltered position under the eave of the north and south walls approximately 0.42 m from the top of the wall.
- A sheltered position under the window awning on the east and west walls.
