Study Report

SR436 [2020]

Linings-on retrofit insulation in weatherboard walls: Ensuring effective water management

BRANZ Study Report SR436

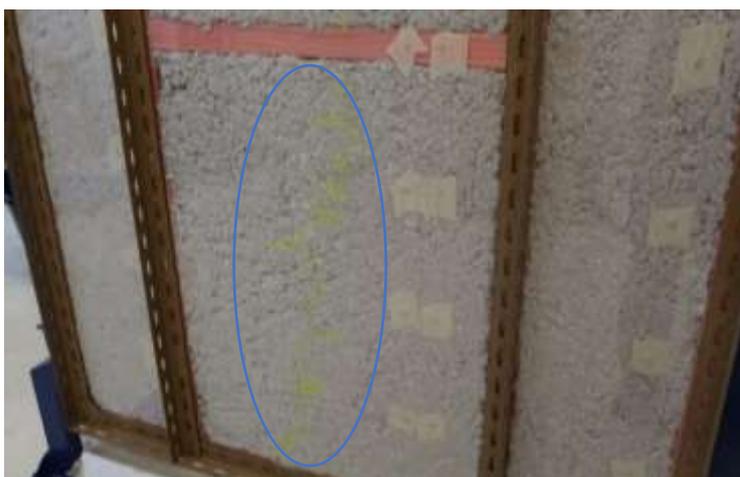
Figure 5. Example of water transfer to inside of loose-fill insulation. Water contains fluorescent yellow dye.

For the purposes of this report, a leak where the water begins at the outer face of the insulation is called a face leak. A leak that starts at a point between the two vertical faces of the insulation is called a body leak. It seems unlikely either bulk insulation or loose-fill insulation will cope with a body leak. A body leak could occur from a defect such as a leaking window flashing or a cladding fixing that has missed the framing that it was meant to be attached to. In practice, body leaks would be expected to be identified by the cavity inspection prior to installing insulation.
